**BUILD AND OPERATE A CLATHRATE  
DESALINATION PILOT PLANT**

**FINAL TECHNICAL REPORT**

**Water Treatment Technology Program Report No. 31**

**May 1998**

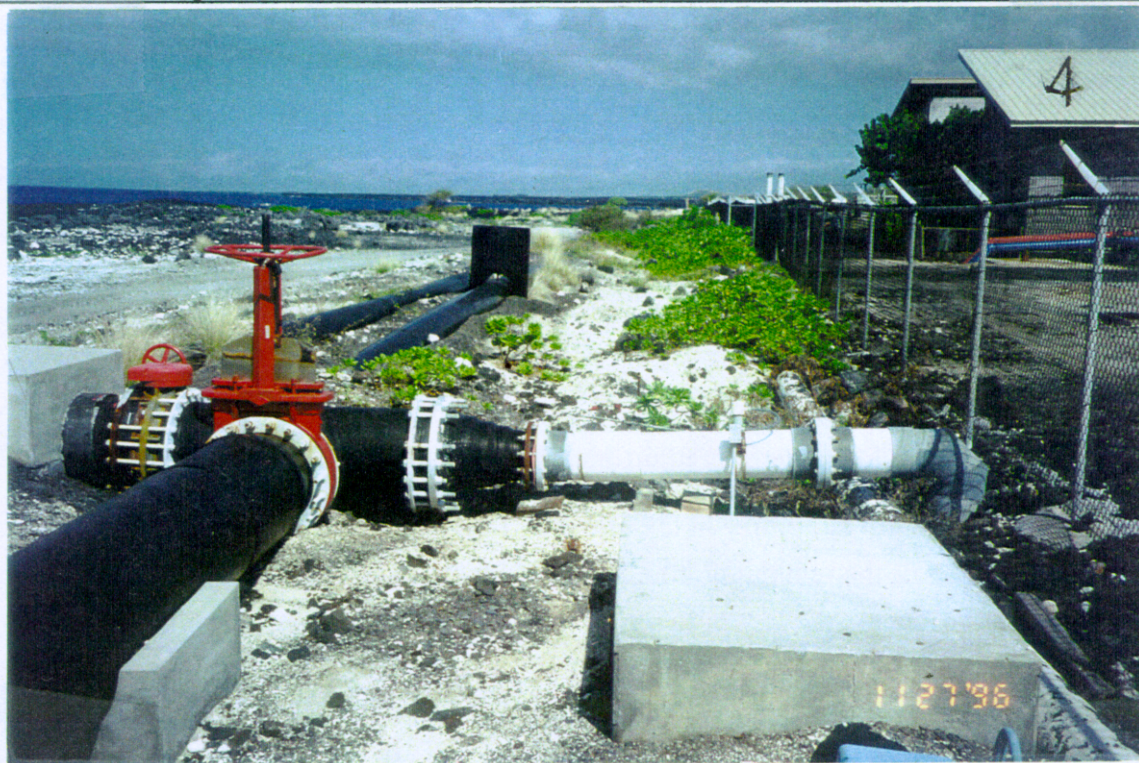
Figure 4-3: View of Crystallizer Laydown Area and Pedestal

useful area. The presence of this pipe created a difficulty in using this area for the **crystallizers** in that the area North of the existing NELH horizontal pipe was not level, and required substantial fill just to establish a uniform slope. The NELH pipe could not be removed so the alternatives were: 1) to bridge the pipe and fill on the South side; 2) to provide enough fill to cover the pipe, and build full-length crystallizers; or, 3) to fill to within a meter (3 feet) of the pipe and reduce the length of the crystallizers. Sufficient fill to level the site was prohibitively expensive so a decision was made to provide a uniform slope for the crystallizers and to limit their length to avoid having to go over the NELH pipe.

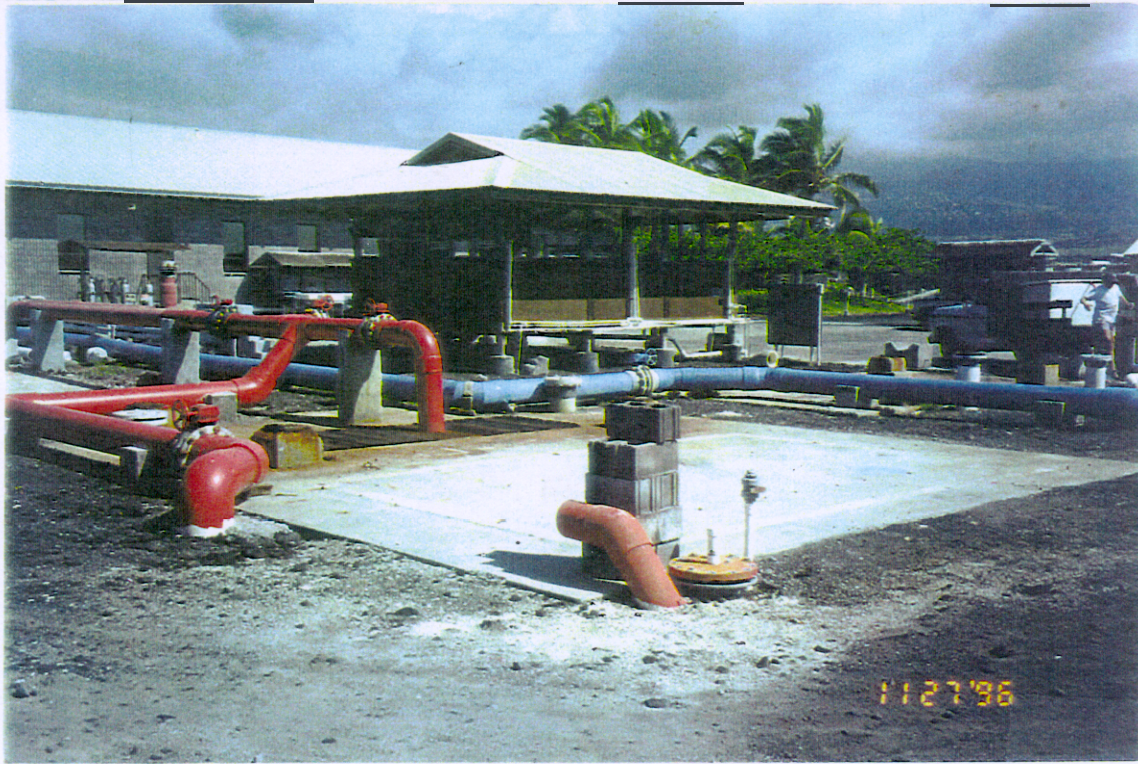
**Figure 4-4: Concrete Pad used for Balance of Plant Equipment**

A view **from** inside the gate given in Figure 4-4 shows the existing concrete pad area that was eventually used for the balance of plant equipment. Most of the pumps and tanks were installed on an existing concrete pad. A small office was moved adjacent to the concrete pad to serve as the project office. The project **office** building was placed at the East side of the concrete pad over the existing cold water piping (large blue pipe) shown in Figure 4-4. Another photograph (Figure 4-5), taken from inside the gate after the office building was in place, shows the proximity to the Keahole Point lighthouse.

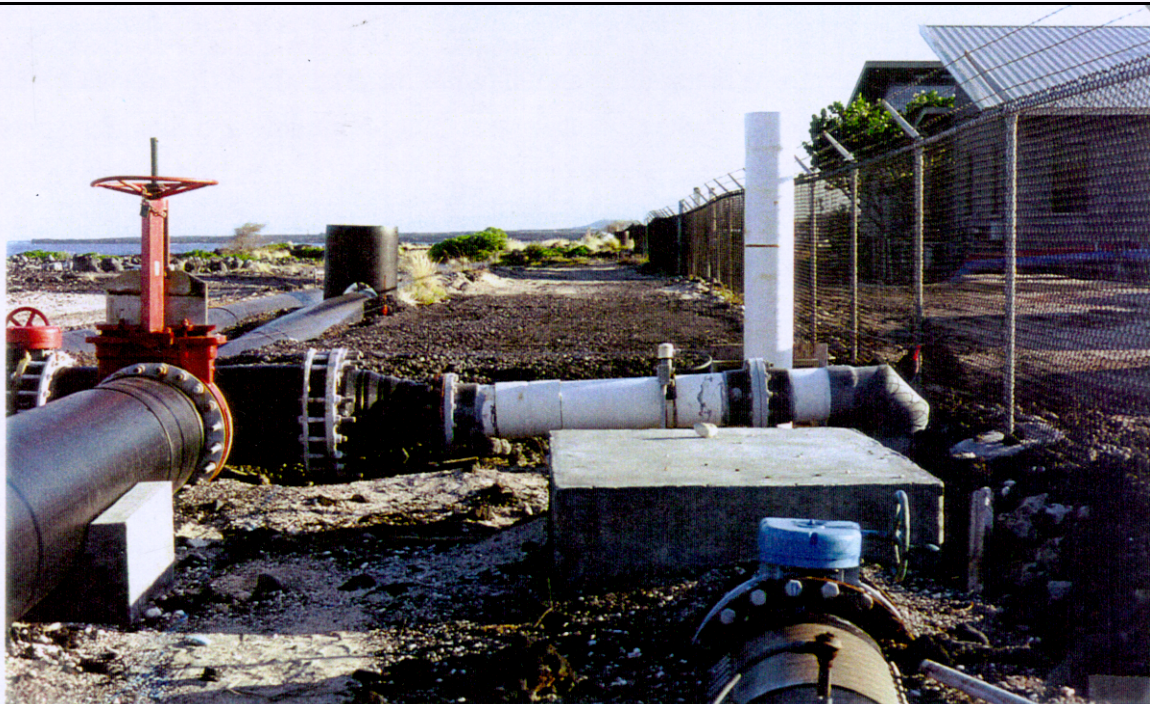
**Figure 5-1: Crvstallizer Graded Bed**

After the crystallizer bed had been filled and graded the shell pipe was brought from the NELH storage area, trimmed in appropriate length segments and welded to the length needed.

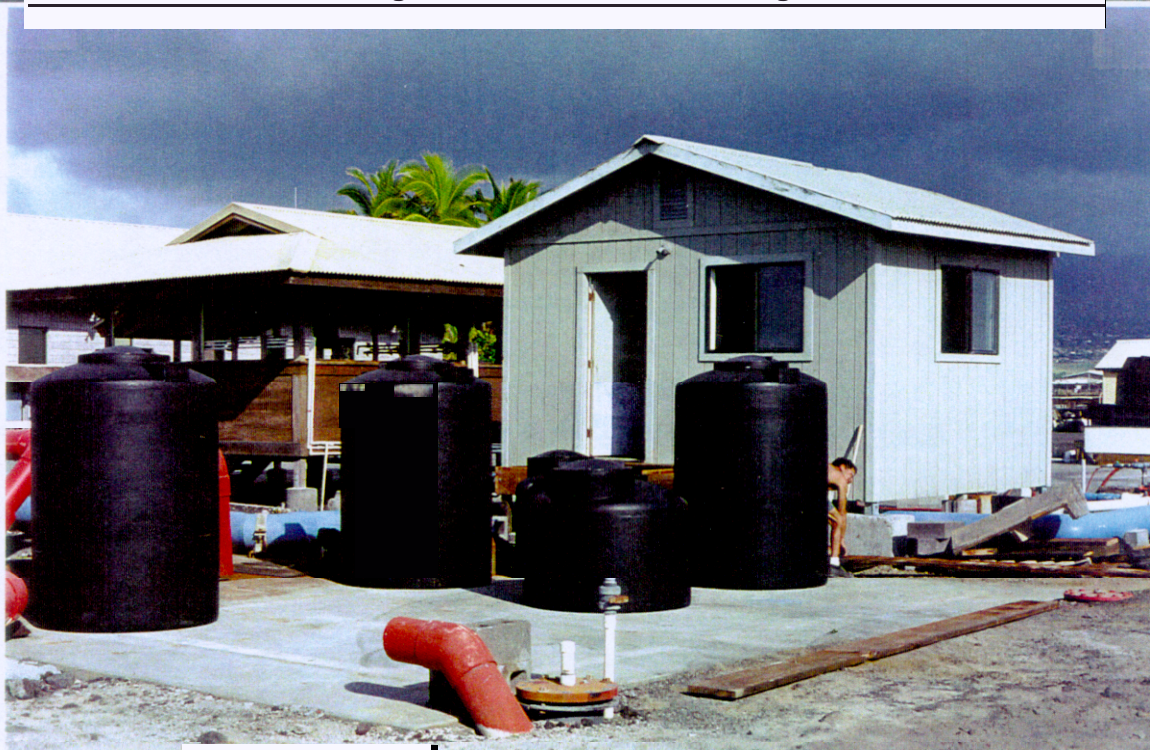
**Figure 5-2: Site Office Building**

A small **frame** building was moved adjacent to the East side of the concrete pad, as shown by the photograph in Figure 5-2. This building served as the site project office, and also housed the plant control system and data acquisition system. The photograph was taken after delivery and temporary staging of the **HDPE** tanks on the concrete pad.

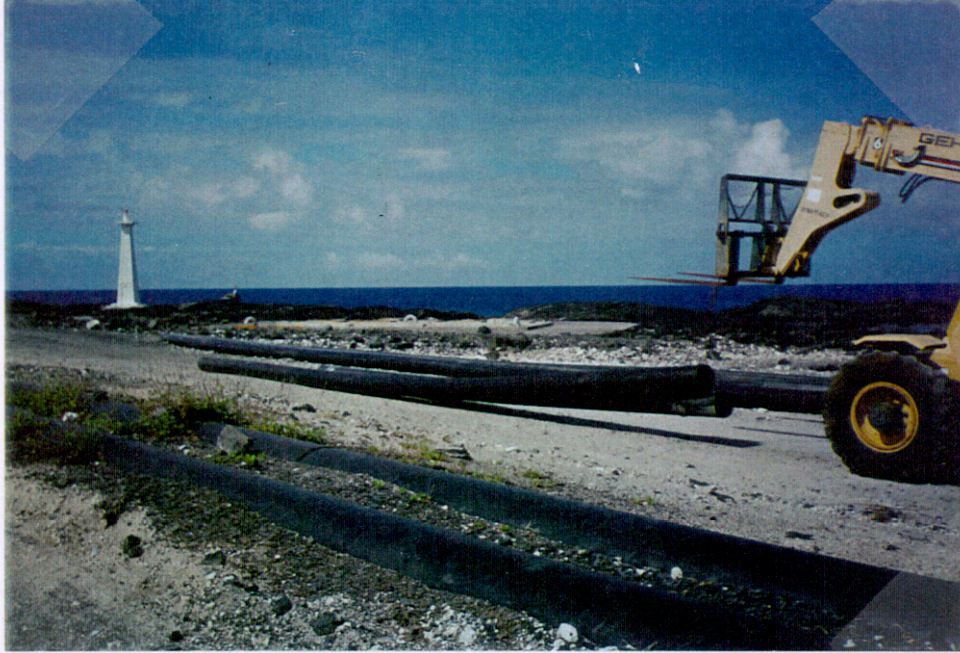
Figures 5-3: Crystallizer Shell Pipe Delivery

The 30 cm (12-inch) HDPE pipe segments for the CHX shells were towed to a road adjacent to the crystallizer bed, as shown in Figure 5-3, with a four-wheel drive forklift. The segments were cut, trimmed, and fusion welded as shown in Figure 5-4 to produce five approximately 220 foot long shells; four for the crystallizers and one to be used as the ice melter.

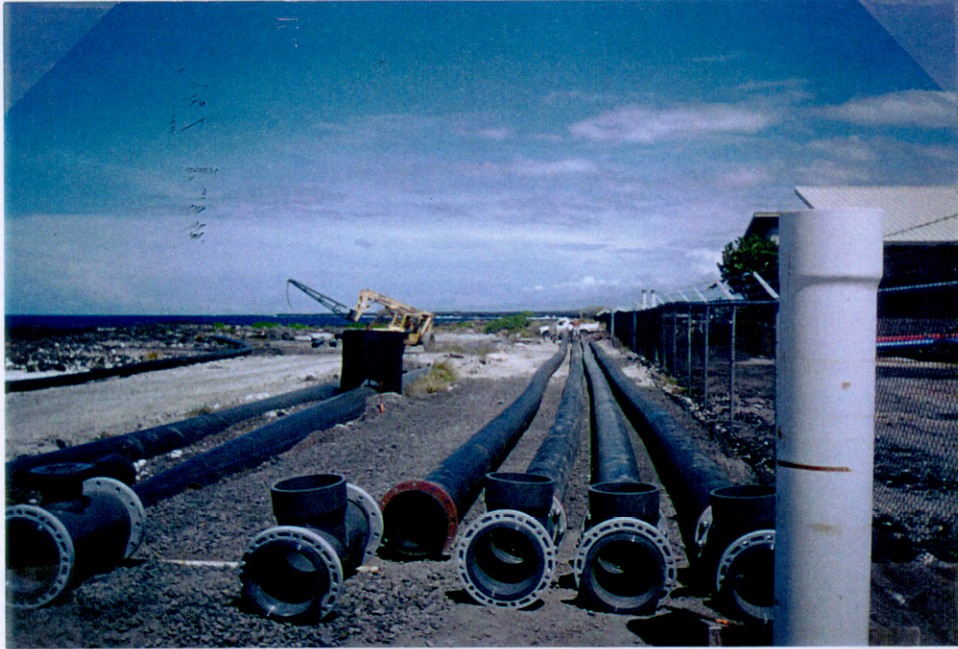
**Figure 5-5: Crystallizer Shell Pipe Emplacement**

The shells were then lifted over the NELH pipe and placed on the graded crystallizer bed between the pipe and the fence as shown in the photograph in Figure 5-5. Van Stone style end flanges were then fusion welded at each end of the crystallizer and ice melter shells.

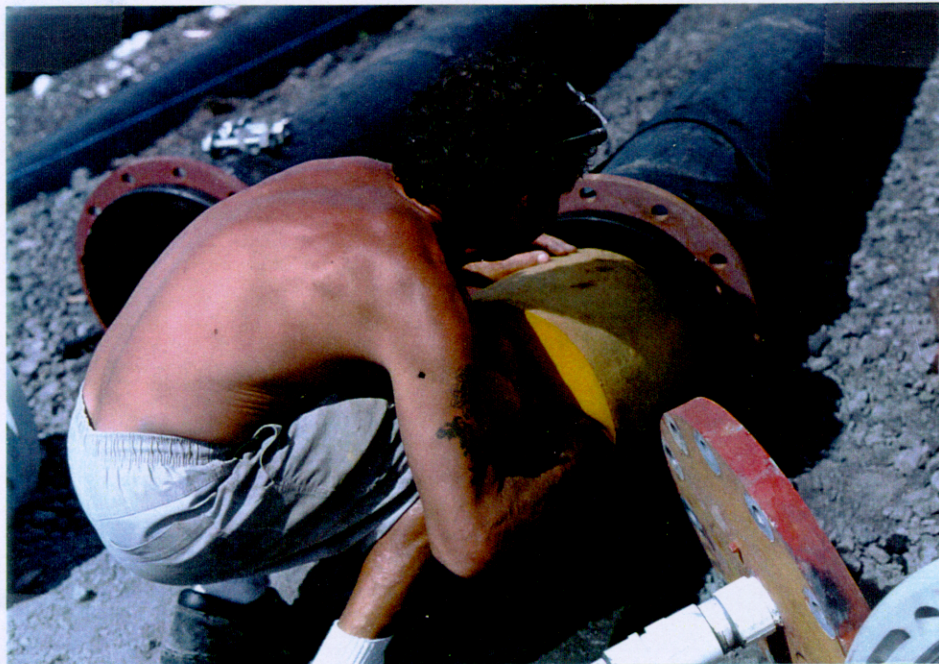
**Figure 5-7: Installation of Crystallizer Heat Exchanger Tubing**

The tees were inverted and the stems of the tees were connected in a short vertical loop formed with **45-degree** ells. At the near end CHX-2 and CHX-3 were connected as shown in the Figure 5-7 photograph. This photograph also shows the connection to the **NELH** deep seawater cooling supply, the pipe extending horizontally to the inlet of the CHX-1 tee. The line **from** CHX-4 to the drain is also shown (Figure 5-7) at the right but is somewhat obscured in this view. At the far end **CHX-1** and CHX-2 were connected with a similar vertical loop, as were CHX-3 and CHX-4. These connections are depicted in Figure 5-8.

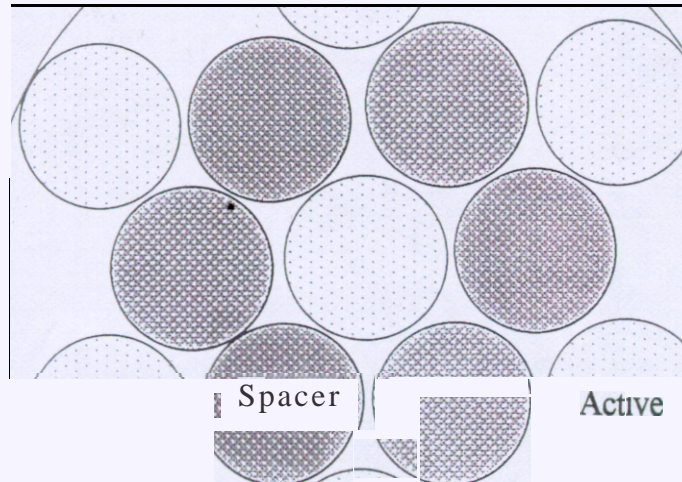
**Figure 5-8: Tube Bundle Pattern**

Tube sheet end boxes were mounted to the flanged ends of each crystallizer. These end boxes each consisted of a tube sheet for connection of the cooling tubes to a common manifold at each end, the inlet and outlet manifolds, and appropriate end covers. At the North end of the **crystallizers** the end box simply turned the product side flow to return to the South end. At the South end the product flow inlets and outlets were connected to place the crystallizer heat exchangers (**CHX**) in series. The crystallizer end components were manufactured by Special Plastic Systems, Inc., a company that produces machined plastic parts for the **film** and semiconductor processing industries.

The **HDPE** tubing inside the heat exchangers was extruded as a special order to provide a thinner wall than standard 2.5 centimeter (1 -inch) tubing. In this instance, a manufacturer in Hawaii produced 9150 meters (30,000 feet) of tubing with a 1 millimeter (**0.040-inch**) wall thickness. This provided somewhat better heat transfer than would be obtained with the standard 1.5 millimeter (**0.060-inch**) wall thickness. The tubing was connected to PVC hose barbs that had been screwed into the tube sheets. The tubing was clamped on the hose barb with a standard stainless steel worm gear-type clamp.

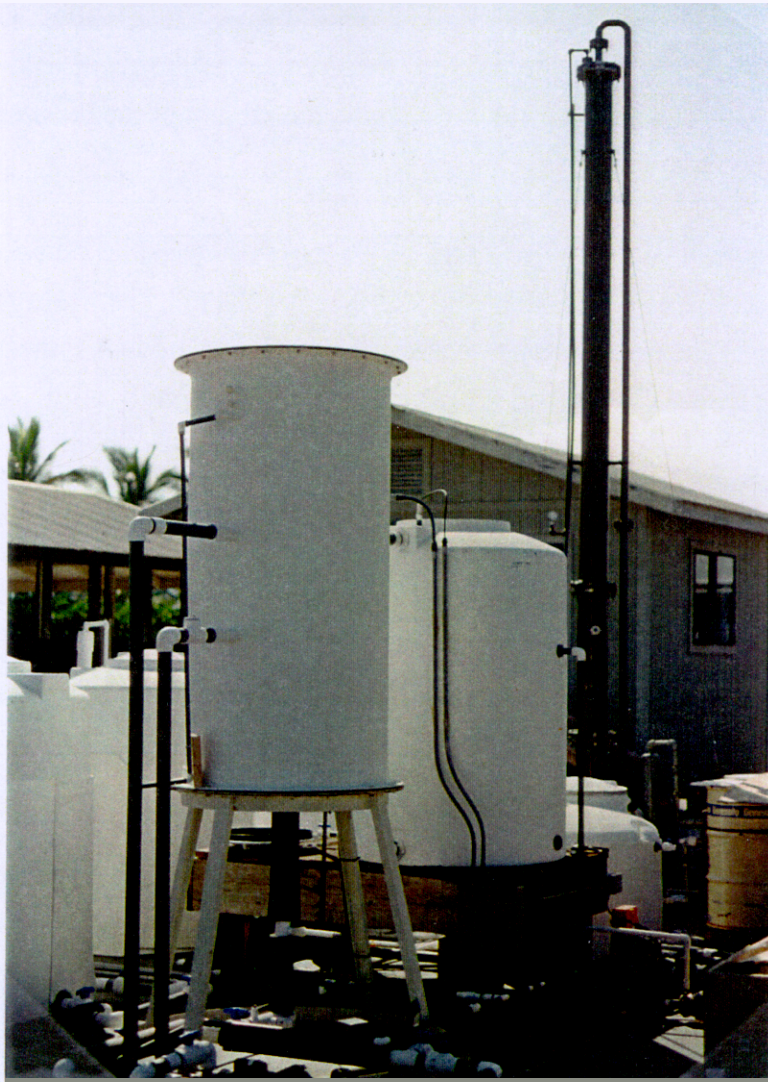
**Figure 5-9: Wash Column, Product Water Tank and Vacuum Tower**

A supplier of HDPE water storage tanks was located in Honolulu with Makai Ocean Engineering's assistance. Five low pressure HDPE tanks were supplied by Rainwater, Inc. : three 1900 liter (500-gallon) capacity and two 950 liter (**250-gallon**) capacity tanks. **One** of the 1900 liter (**500-gallon**) tanks was placed on a platform constructed on-site and the remainder **of the** tanks were set on the concrete slab. The tanks were molded of HDPE with carbon black filler to provide for ultraviolet radiation absorption to prevent deterioration in the intense sunlight at the NELH location. The tanks were painted white with an exterior latex paint to reduce the solar heat load on the system

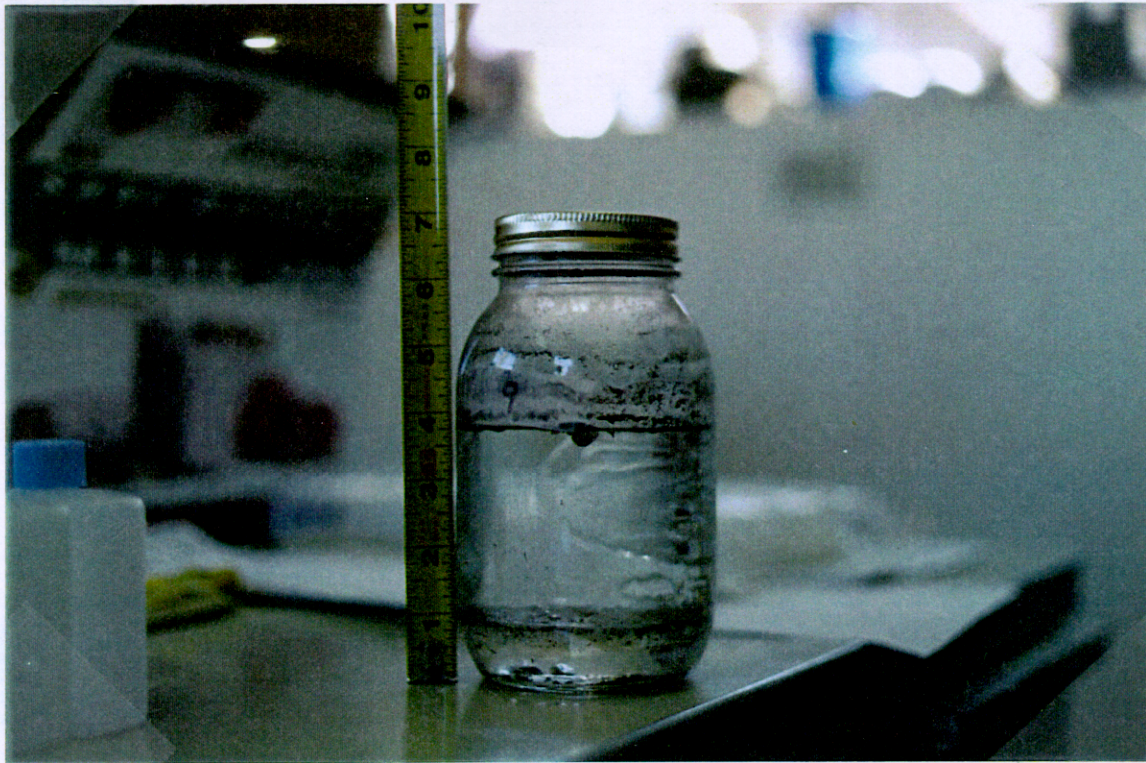
**Figure 6-1: Initial Sample of Product Water and R141b**

amount of **R141b** is an indicator that the washing process was not effective. The water floating on the **R141b** (see Figure 6-1) was drawn off and **analyzed** for **salinity**. The result was a **substantial** reduction in the salt content, from 34,000 ppm to about 4,000 ppm, but a higher level than expected in the product water.

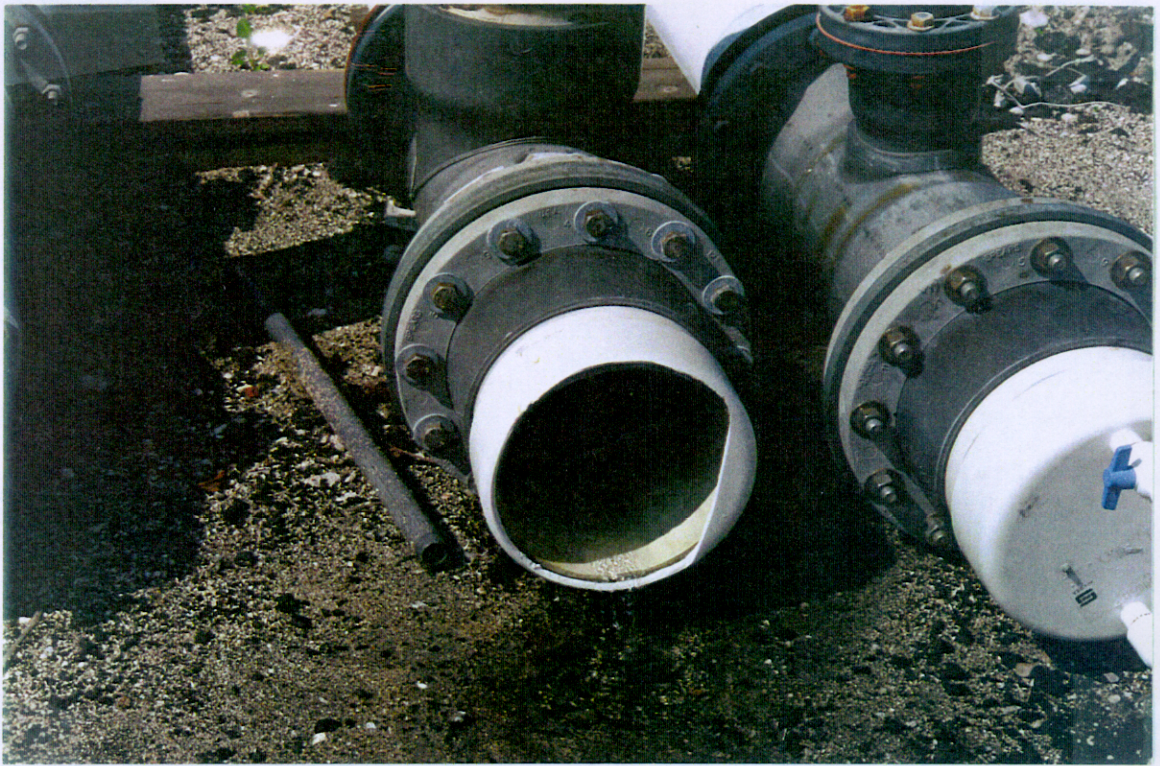
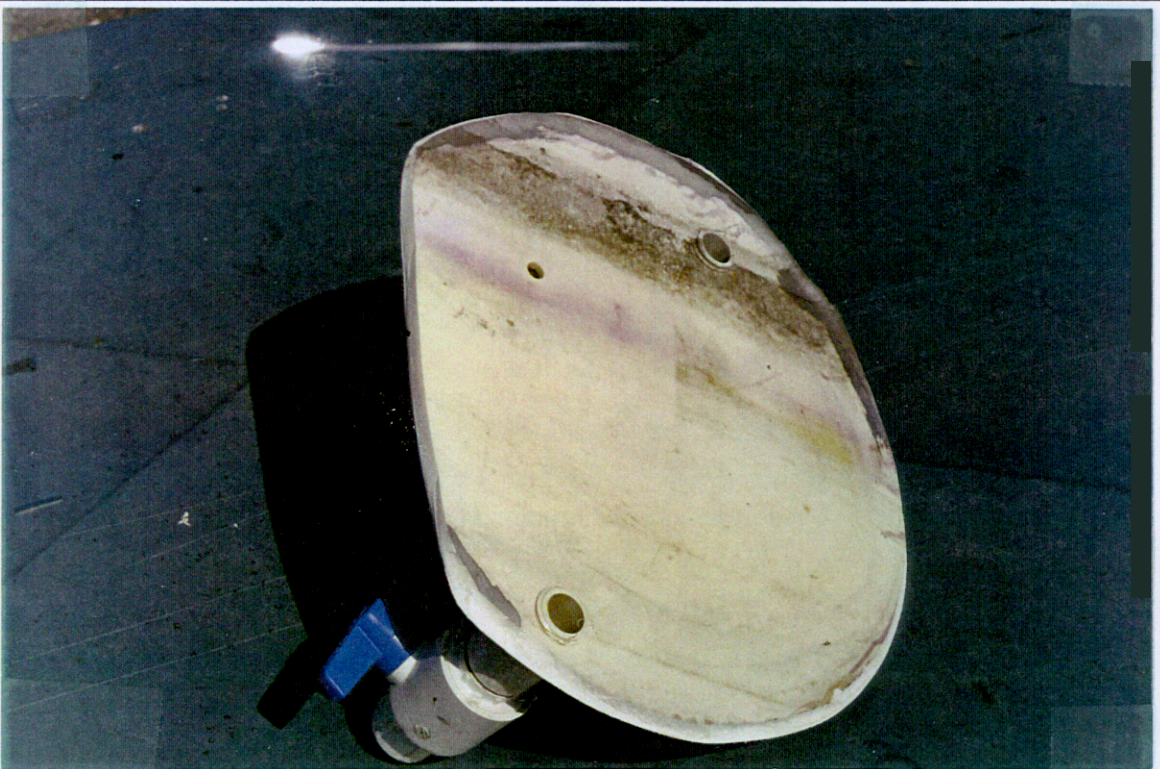
**Figure 6-4: Crystallizer End Cap Rupture**

In this instance, the overflow was detected in time to make adjustments so that clathrate crystals production could continue while an attempt was made to flush the seawater **from** the product water storage tank. During the cleanup, a catastrophic failure of the CHX-1 return end cap occurred, requiring shutdown of the system. The end cap failure, shown in Figures 6-4 and 6-5, resulted in the loss of much of the inventory of the recirculating clathrate crystals and R14 1 b/seawater mixture.

Piping system failures occurred in several locations that also led to cessation of operations. A defective **crystallizer** end cap **failed** catastrophically and was repaired temporarily with **fiberglass reinforced** plastic (**FRP**) in order to resume operations as quickly as possible. The repaired end cap failed after a short period and had to be replaced.

The end cap was repaired as quickly as possible with fiberglass reinforced plastic (**FRP**) resin, and an attempt to continue operation was made. During the repair and curing of the FRP, circulation through the balance of the plant piping and storage tanks was not possible.

A decision was made to attempt a second temporary repair in order to avoid having to shut down the plant. However, during the attempt to make the temporary repair, the end cap completely fractured, rendering the plant inoperable. The product side flow was shut off to avoid losing any additional **R141b**, and to permit installing a replacement end cap. The original end cap was replaced with a Schedule 80 end cap but in the interim, with no product side flow, the balance of plant warmed up enough to prevent immediately resuming operation.

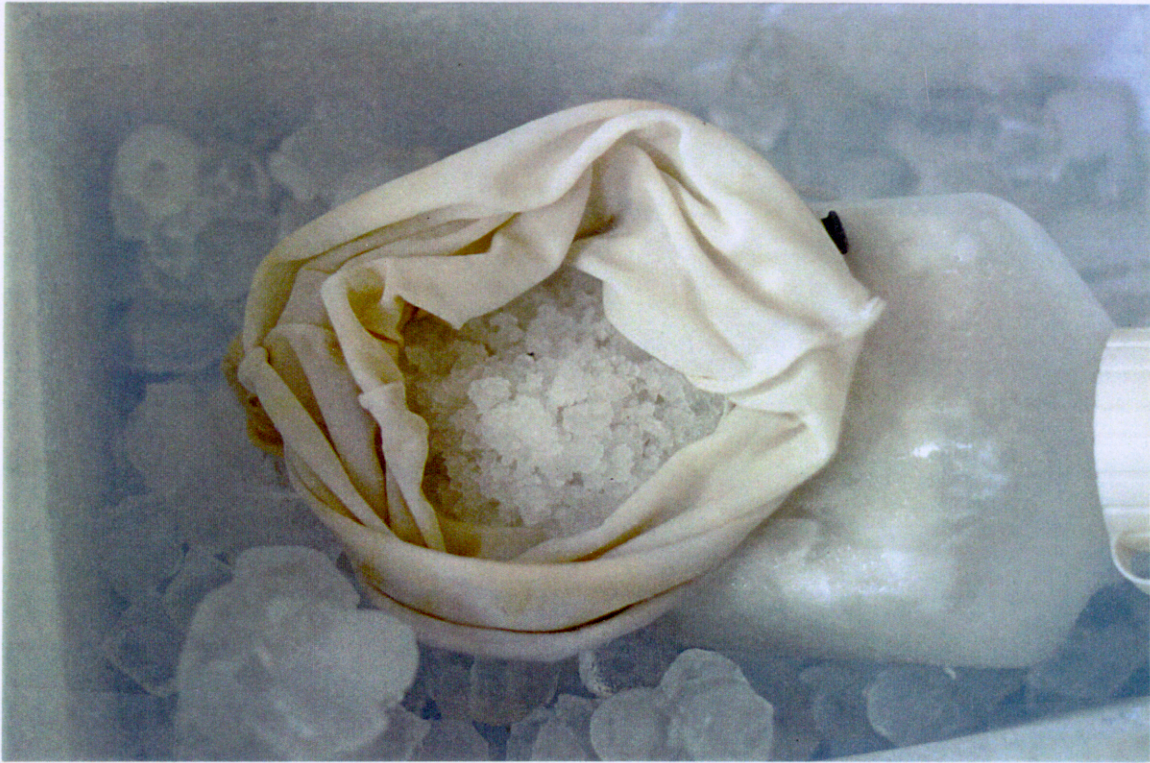
Figure 6-6: Clathrate Ice Sample

Shortly after the end cap failure, samples of clathrate crystals were taken **from** each of the crystallizer drains, and from the wash column drain with a mesh bag. Part of the clathrate sample is shown in the photograph given as Figure 6-6. This sample was still in the collection bag when the photograph was taken. A total of about four liters of crystals were obtained and stored in polyethylene containers. More crystals were in the system but no attempt was made to gather a larger sample. The containers holding the crystals were initially placed on ice in picnic coolers, and then in the freezer compartment of a refrigerator.

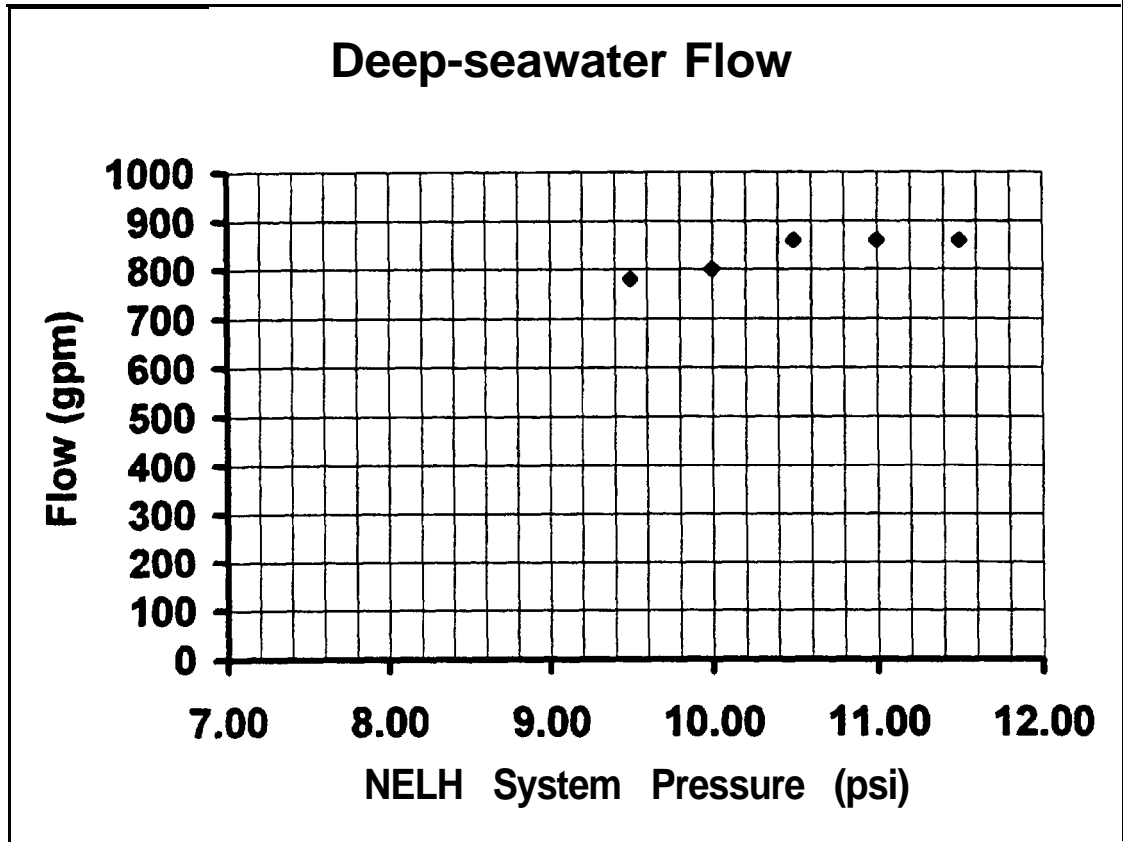
Figure 6-7: Crystallizer Flow/NELH System Pressure Data

The pressure at the outlet is **somewhat** less than atmospheric after the air is evacuated, about -23.4 **kPa** (-3.4 psig) at 3 100 liters (800 gallons) per minute. If the NELH system pressure were increased to 82.7 **kPa** (12 psig), the outlet pressure might increase to -17.2 **kPa** (-2.5 psig). If so, the pressure drop would be about 100 **kPa** (14.5 psi) and the expected **flowrate** would be about 3,640 liters (940 gallons) per minute. The apparent **flowrate** limiting of Figure 6-7 seems to be an **artifact** of measurement error: pressure, flow, or a combination of errors. It appears that the **crystallizer** pressure drop limits the flow with the available NELH

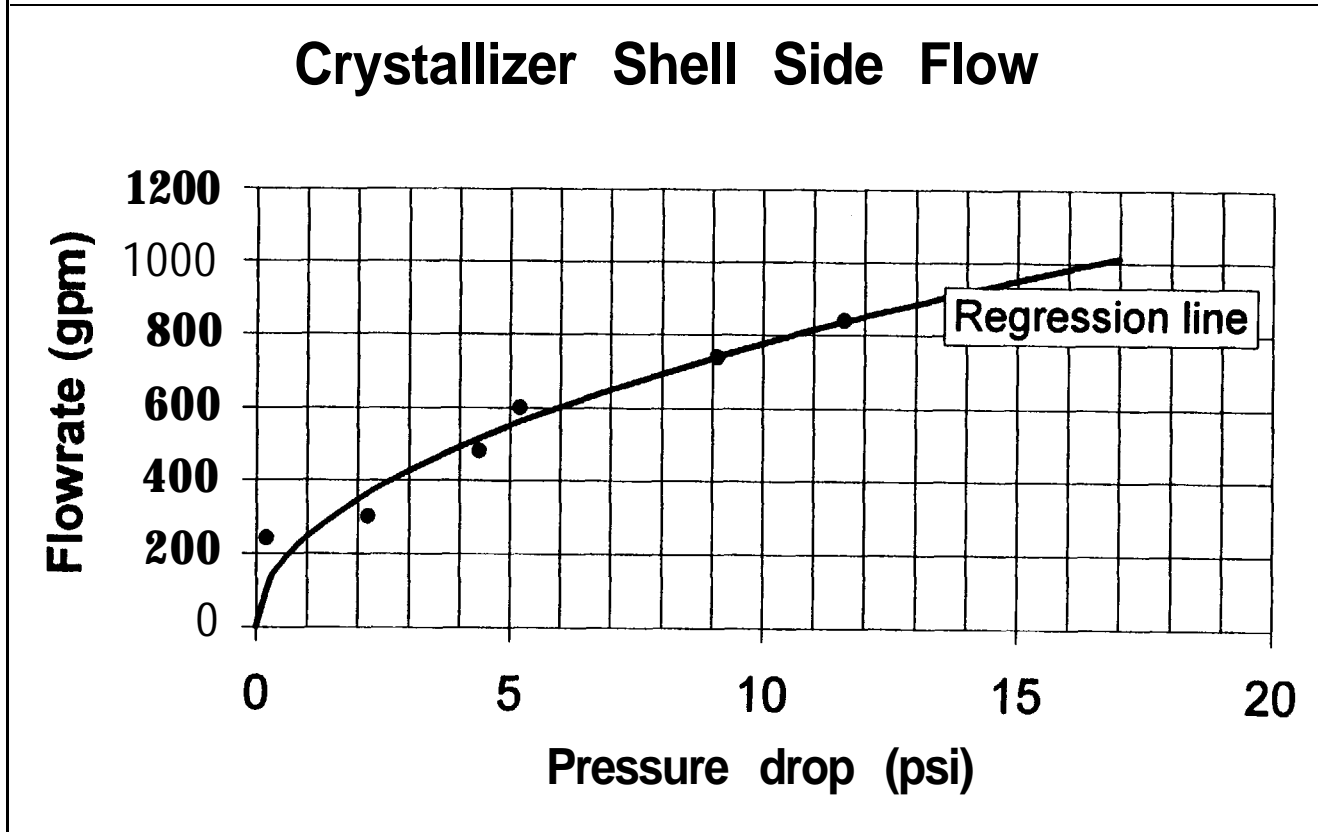
Figure 6-8: Crystallizer Shell Flow and Pressure Drop

pressures to about 3,640 liters (940 gallons) per minute. A potential solution for this is to place a pair of the crystallizers in parallel, with each taking 1940 liters (500 gallons) per minute. This would increase the flow as needed and allow the use of the same **NELH** supply and drain lines.
