**EVALUATION OF REVERSE OSMOSIS SCALING
PREVENTION DEVICES AT HIGH RECOVERY**

**Advanced Water Treatment Program
Report No. 91**

March 2003

**U.S. DEPARTMENT OF THE INTERIOR
Bureau of Reclamation**

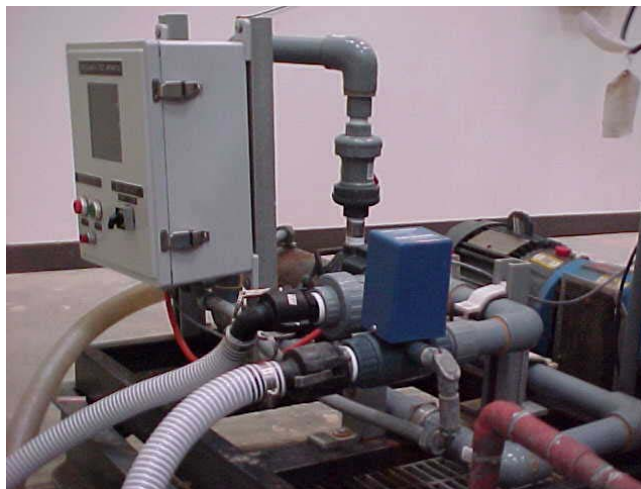
Photo 2.—Circulation Skid for Magnetic Device.

A circulation skid for the MD was fabricated by BRSC during the second quarter of fiscal year 2000. The skid consisted of a pump, automatic valve, and rotameter with the MD on the discharge of the pump. The skid was fabricated to ensure the minimum velocity of 7 feet per second through the MD was achieved, as recommended by the manufacturer. The manufacturer advised that a flow rate of 19 gallons per minute (gpm) through the MD would achieve the minimum velocity required [9]. The circulation skid is shown in photo 2, and the MD is shown in photo 3.

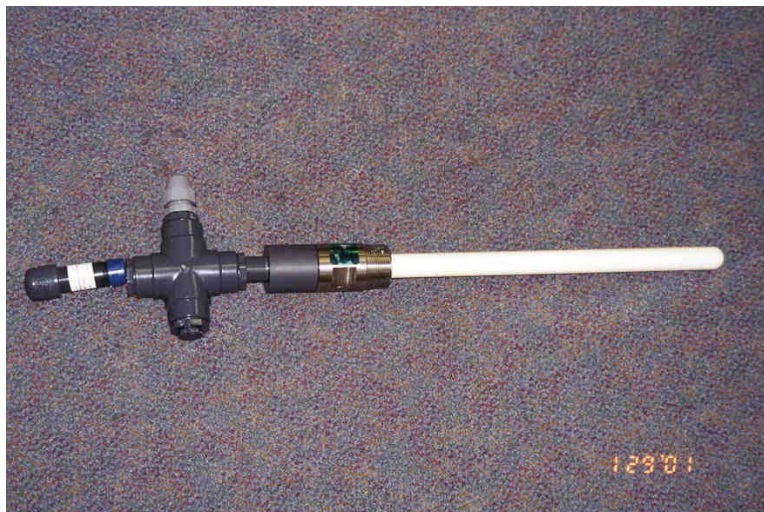
Photo 4.—High Voltage Capacitance Device.

The HVC tested at the WQIC was the Zeta Rod™ ZR18S and is shown in photo 4. The HVC functions by inducing an alteration of the natural surface charge density of dielectric colloidal particles irrespective of the particle composition. The installation of the HVC forms a cylindrical capacitor, much like those pictured in physics texts. Electrochemical dispersion of colloidal organic and inorganic particles, as well as microorganisms, has been practiced for many years to treat the water in small commercial and industrial water systems [10]. The HVC has also been shown effective as a means of preventing biofilm formation on RO membranes [11].

The conducting surfaces are the metallic lining of the HVC and the metal of the pipes or vessels. The ceramic dielectric of the HVC establishes a static electric field within the piping system or the vessel. A direct current power supply charges the capacitor system. The field strength across the water is a function of charge voltage, system dimensions, and the dielectric constant of the water [10].

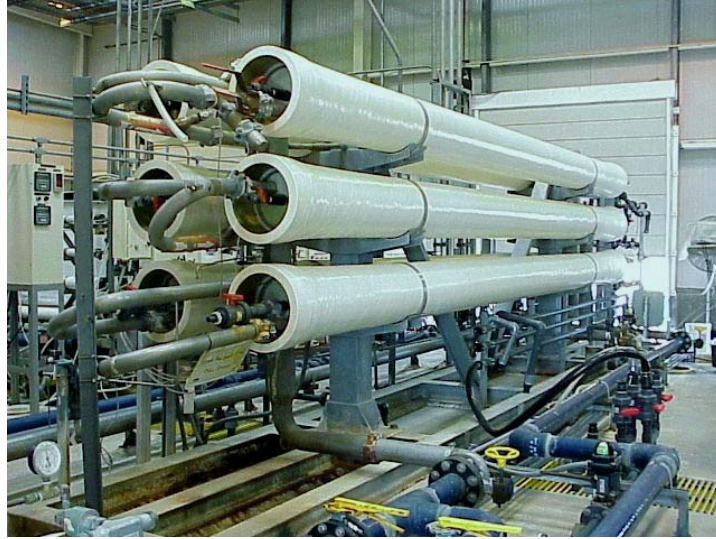
Photo 5.—Fluid Systems Reverse Osmosis Unit.

Pilot System 1 (PS 1) is a 600-gpm pilot plant, located within the YDP, and is installed as a 1/100th model of the YDP with similar types of equipment and process flows. The PS 1 pretreatment equipment includes a grit basin, intake pumping, solid contact reactor, dual media gravity filters, and clearwell. PS 1 models the YDP for optimization studies, performance verification, personnel training, developmental testing of new systems, and serves as the potable water source for the YAO. This equipment is similar in type and design that was furnished for the YDP so that the results of tests can be readily scaled up and applied to the operation of the YDP. Solids and sludge handling for PS 1 are processed in the equipment furnished for the YDP [7]. The RO desalting equipment was supplied by Hydranautics (HWS) and Fluid Systems (FS) in a 2:1 array as in the YDP. The concentrate from PS 1 FS RO was the feed source for all HR, MD, and HVC tests conducted at the WQIC. The PS 1 FS RO unit is shown in photo 5.

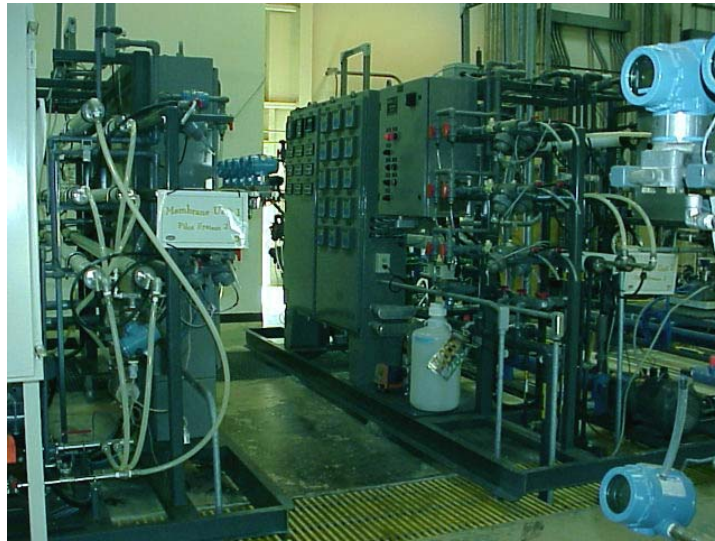
Photo 6.—Membrane Unit.

The MU high pressure feed pumps utilize variable speed drives to enable operation over a wide flow range of 3 to 12 gpm and a wide pressure range of 60 to 500 pounds per square inch. Automatic control valves are incorporated to ensure precise process control. A typical MU is shown in photo 6.

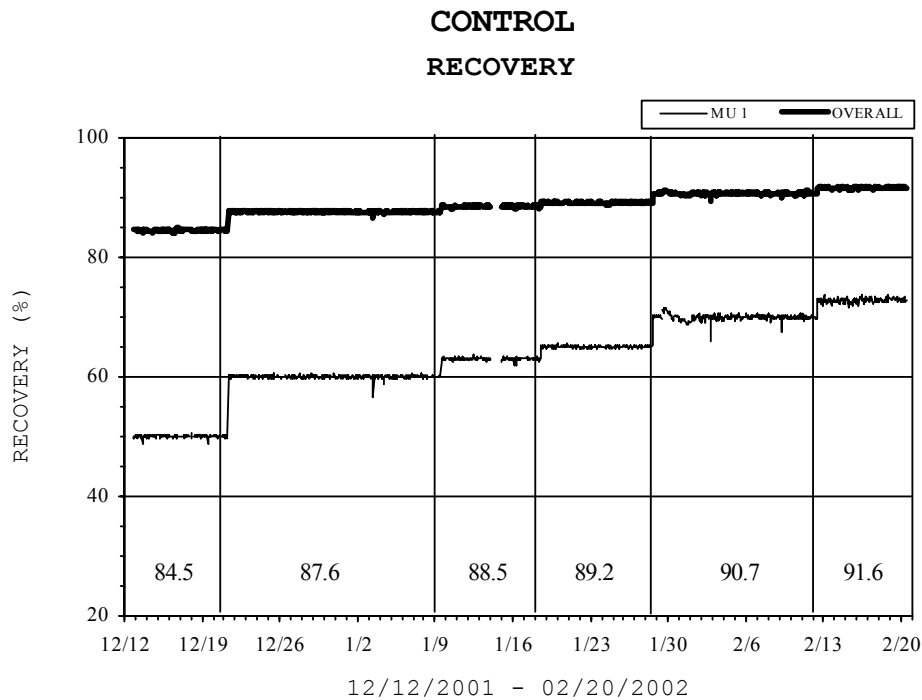
Figure 7.—Recovery – Control.

The overall and MU 1 recoveries, for the control, are shown in figure 7. During this period, PS 1 FS RO recovery averaged 69.1 percent. MU 1 was initially operated to achieve an overall recovery that was below where calcium sulfate scaling occurred without SHMP or antiscalant addition. This ensured MU 1 was operating properly before reaching the point where scaling occurred during the HR testing. MU 1 recovery was gradually increased until scaling was observed. The WTC for E7 dramatically declined when the overall recovery was approximately 90.7 percent. The rate of decline was approximately 5.7 percent per day. The actual decline in WTC for E7 began approximately 6 days after the overall recovery was increased to approximately 90.7 percent.

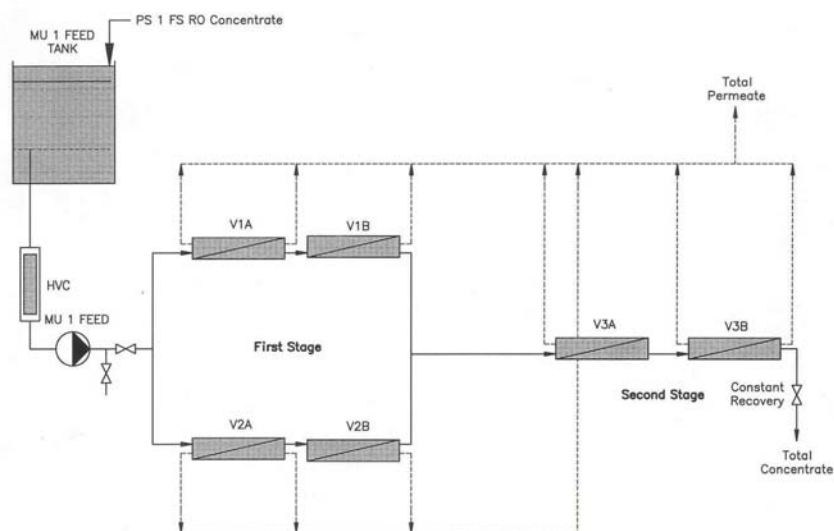
Figure 9.—Flow Schematic - HVC Installed on MU 1 Feed.

The HVC was installed on the suction line to MU 1 high-pressure feed pump. Four new Desal CD 2540T1078 cellulose acetate elements were loaded in the tail-end of MU 1 vessel 3, and testing commenced on April 3, 2002. The feed source for MU 1 was PS 1 FS RO concentrate. A flow schematic for this test configuration is shown in figure 9.

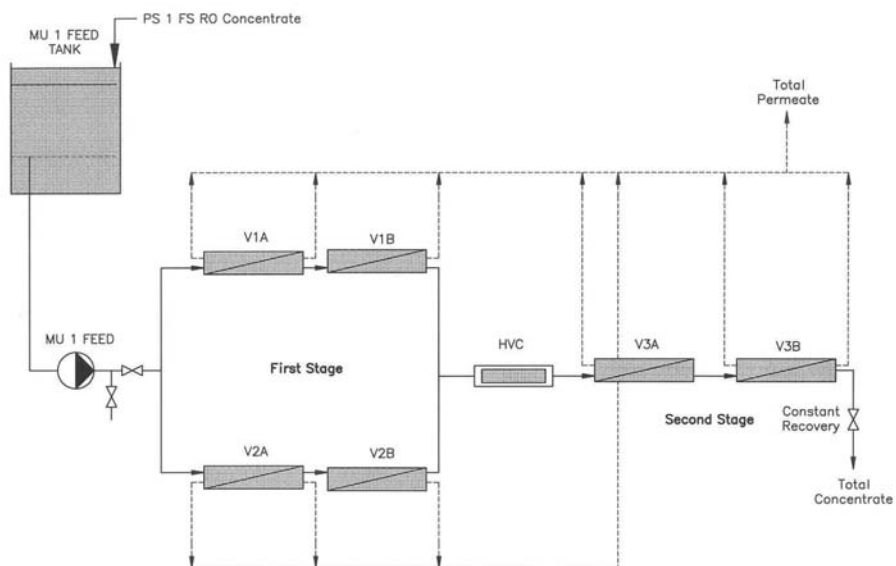
Figure 12.—Flow Schematic - HVC Installed on MU 1 Interstage.

The stainless steel 3-inch housing chamber and HVC were installed on MU 1 interstage. Four new Desal CD 2540T1078 cellulose acetate elements were loaded in the tail-end of MU 1 vessel 3, and testing commenced on May 8, 2002. The feed source for MU 1 was PS 1 FS RO concentrate. A flow schematic for this test configuration is shown in figure 12.
