Preliminary Report for Airborne Data Collected
In Support of US EPA Region VII
Barton Solvents
Valley Center, Kansas

Background

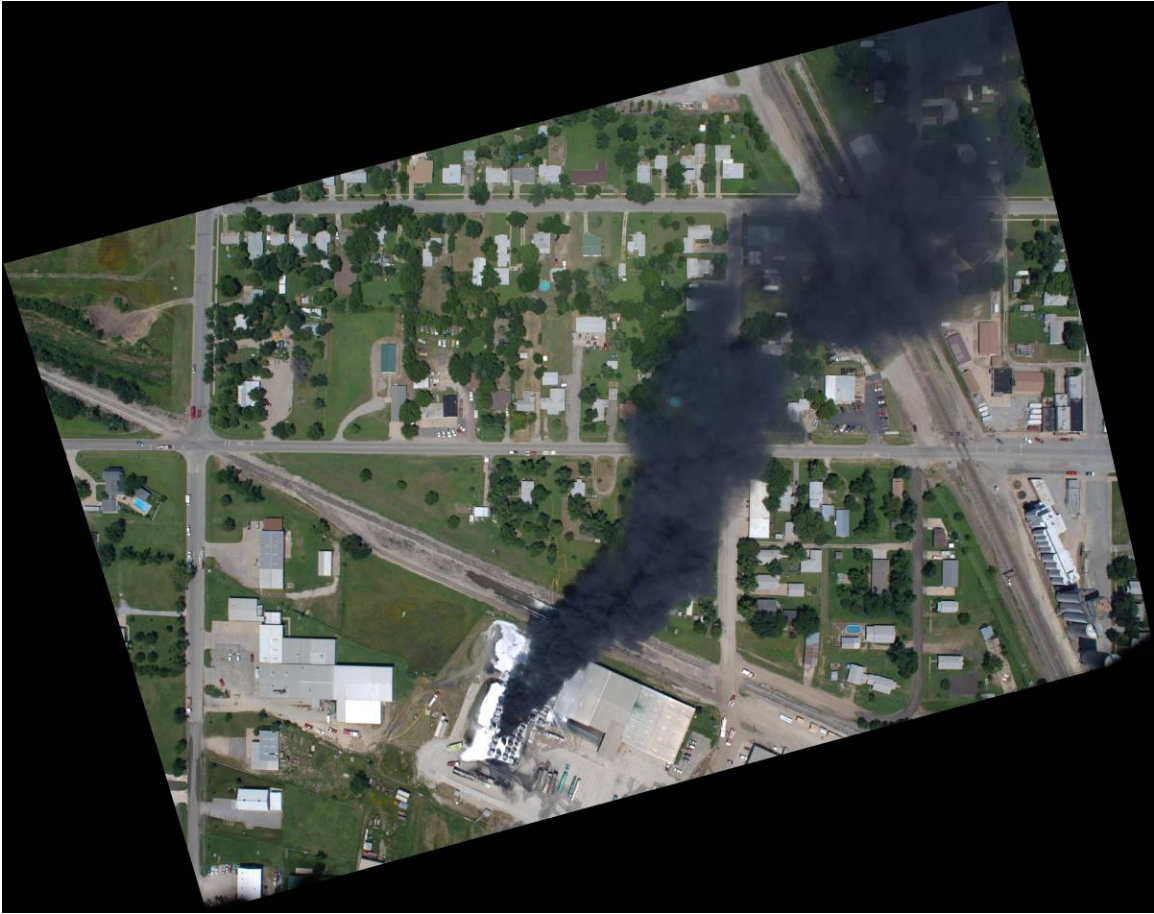
Figure 3. Aerial Image, Barton Solvents, Valley Center, Kansas

At 1630 GMT (1130) the aircraft was airborne from Midway Region Airport (KJWY) Waxahachie, Texas and reported a flight time of approximately 2 hours 11 minutes. At 1820 GMT (1320 Local) the aircraft called in and reported that they were beginning the descent to collect data and approximately 5 minutes from the target. The crew reported that smoke was rising at a 45 degree angle toward the northeast. The plume was reported to level out at about 6000 feet (AGL). An aerial image of the scene is given in Figure 3.

Due to the vertical nature of the plume and the low ceiling, the ASPECT crew was forced to collect some data passes at an oblique angle to keep from flying through the plume. A georectified version of the image is given in Figure 4. The shape of the image is due to attitude of the aircraft while the image was collected.

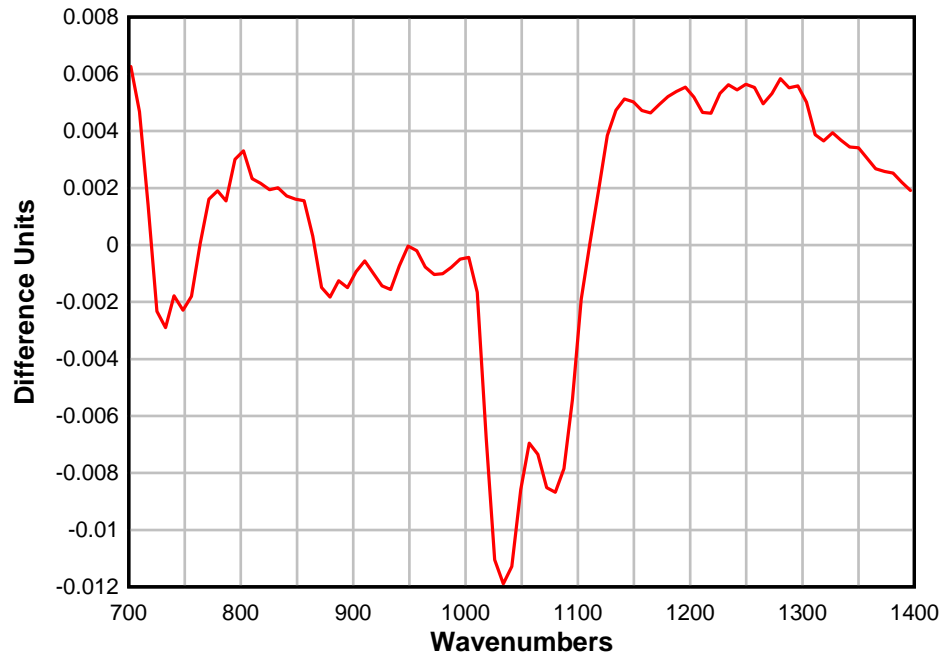
Figure 7. Ozone Spectra, Barton Solvents, Valley Center, Kansas

Analysis of the data tended to show weak detections of ozone and glycol in most of the data passes (with exception of Run 4). A representative spectra for ozone is given in Figure 7. The source of the ozone may be from the fire or may be a result of the high atmospheric temperature and strong solar radiation for this day. Figure 8 shows a representative spectra for glycol. The exact glycol is difficult to determine due to the weak nature of the spectra.

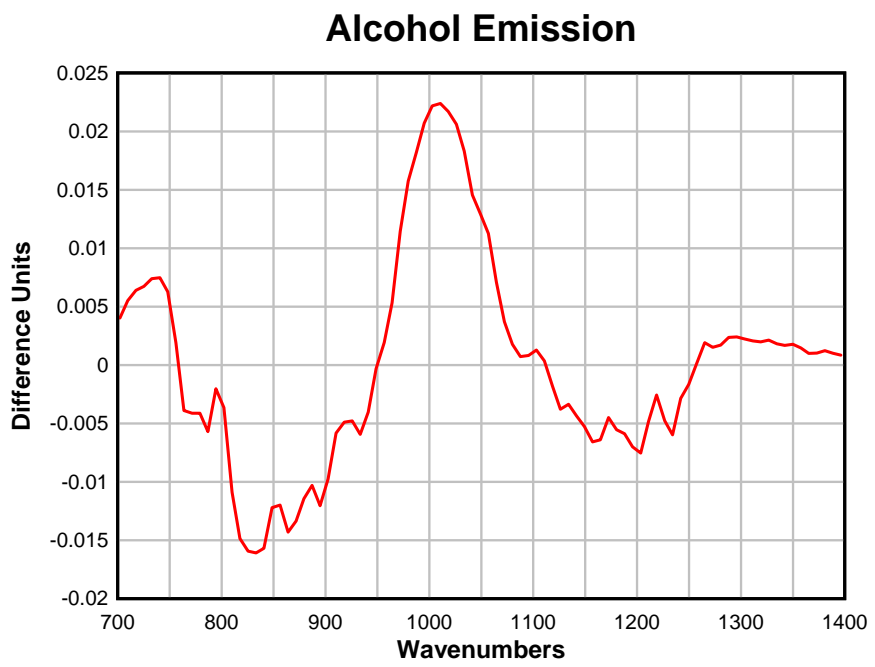
Figure 9. Benzyl Alcohol, Barton Solvents, Valley Center, Kansas

Figure 9 shows a representative spectra for a complex alcohol that is most likely benzyl alcohol due to the strong absorption feature located near 1025 wavenumber. A concentration estimate of 5 ppm was developed based on the absorbance and the plume thickness.

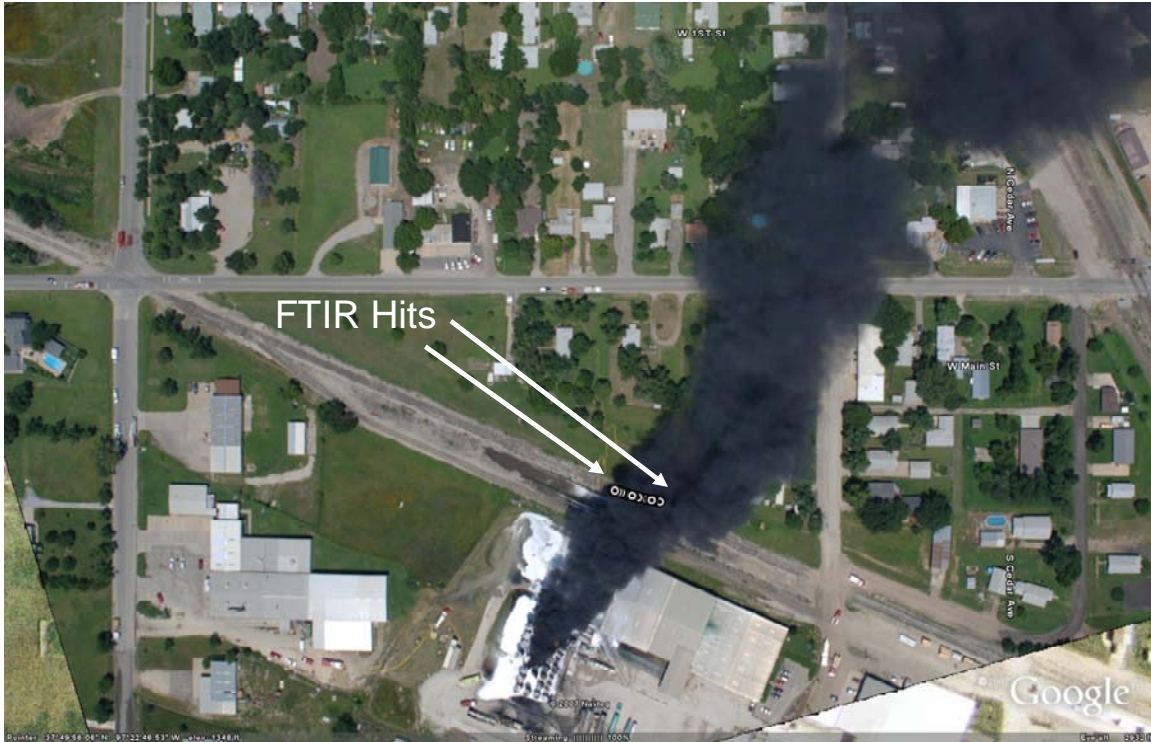
Figure 11. Pattern Recognition Alarm Locations

Figure 11 shows a result of mapping the alcohol alarm hits on top of an aerial image. Agreement between the hits and the aerial image is excellent.
