December 18, 2000  
HETA 2001-0026

On October 13, 2000, the National Institute for Occupational Safety and Health (NIOSH) received a request from the Cabinet for Health Services in the Commonwealth of Kentucky to evaluate carbon monoxide (CO) concentrations associated with the operation of houseboats on Lake Cumberland. On October 23 - 25, 2000, NIOSH investigators conducted a site visit at Lake Cumberland to investigate CO concentrations on houseboats located at the State dock, Jamestown dock, and Alligator II dock. This letter describes our evaluation methods, findings, and conclusions.

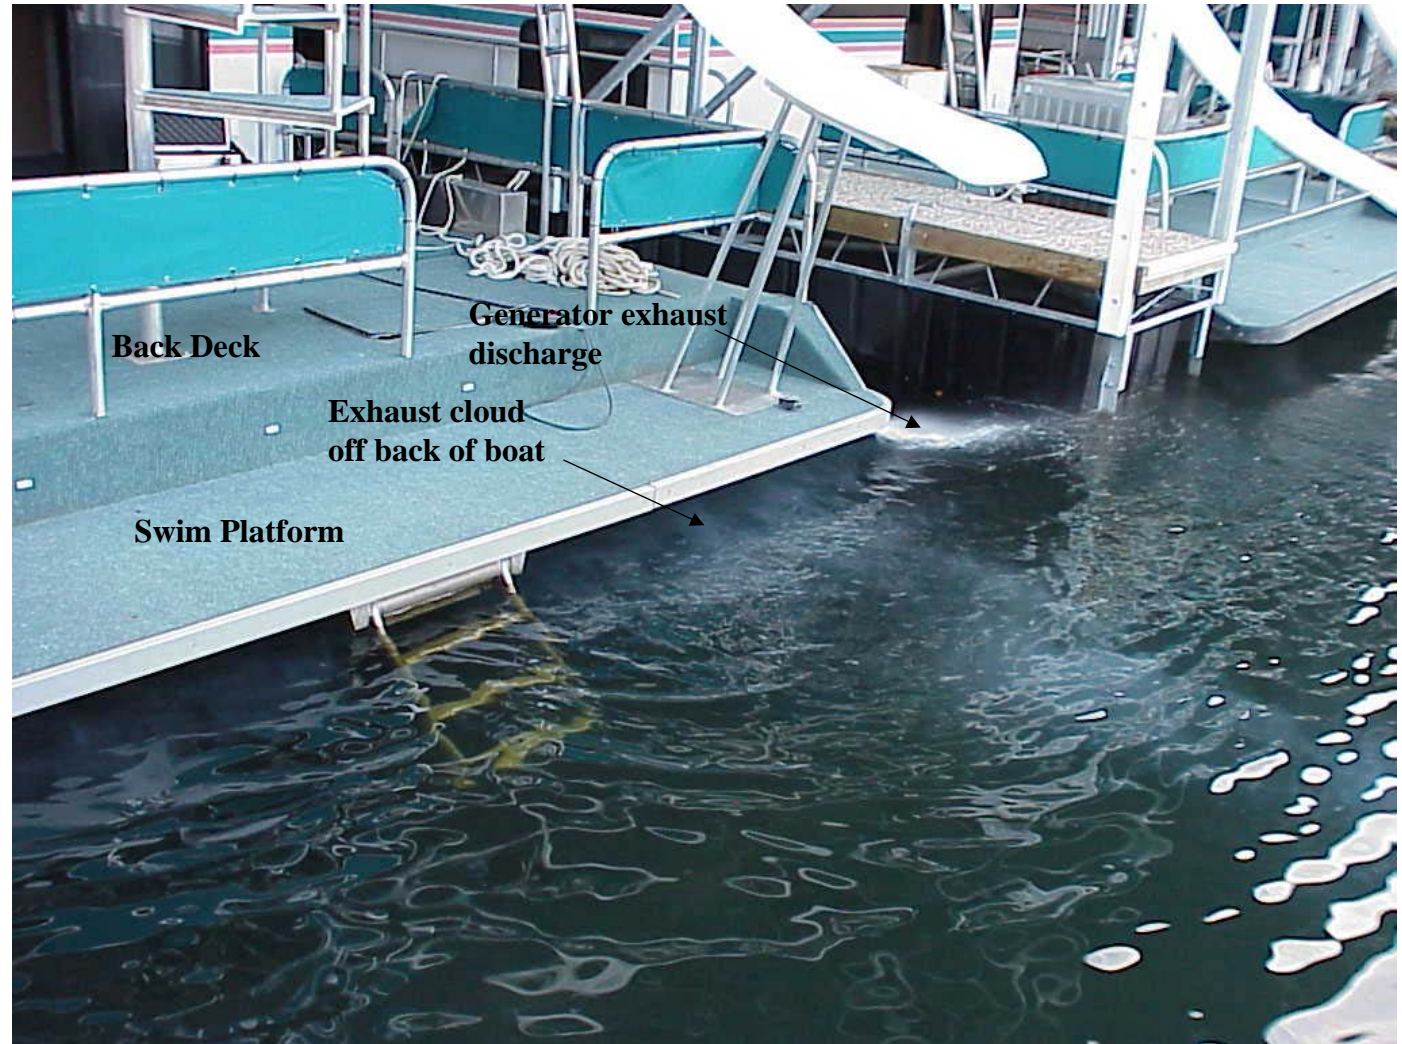
**Figure 2.** Back View of Navigator boat and generator exhaust discharge.

Figure 2 shows a portion of the back deck of the Navigator houseboat, and also illustrates the generator exhaust discharging out the back corner of the swim platform. An evacuated glass container measurement in this area indicated a CO concentration of 13 ppm. A similar measurement collected in an exhaust cloud off the back of the swim platform, at the water when both the generator and motors were in operation, indicated a CO concentration of 27 ppm. A third evacuated container sample collected on the swim platform with only the generator in operation did not detect CO.

\* CO monitors on the right and left sides of the swim platform were placed in exhaust cloud (see Figure 2) off the back of the swim platform resulting in the reported CO peak concentrations.

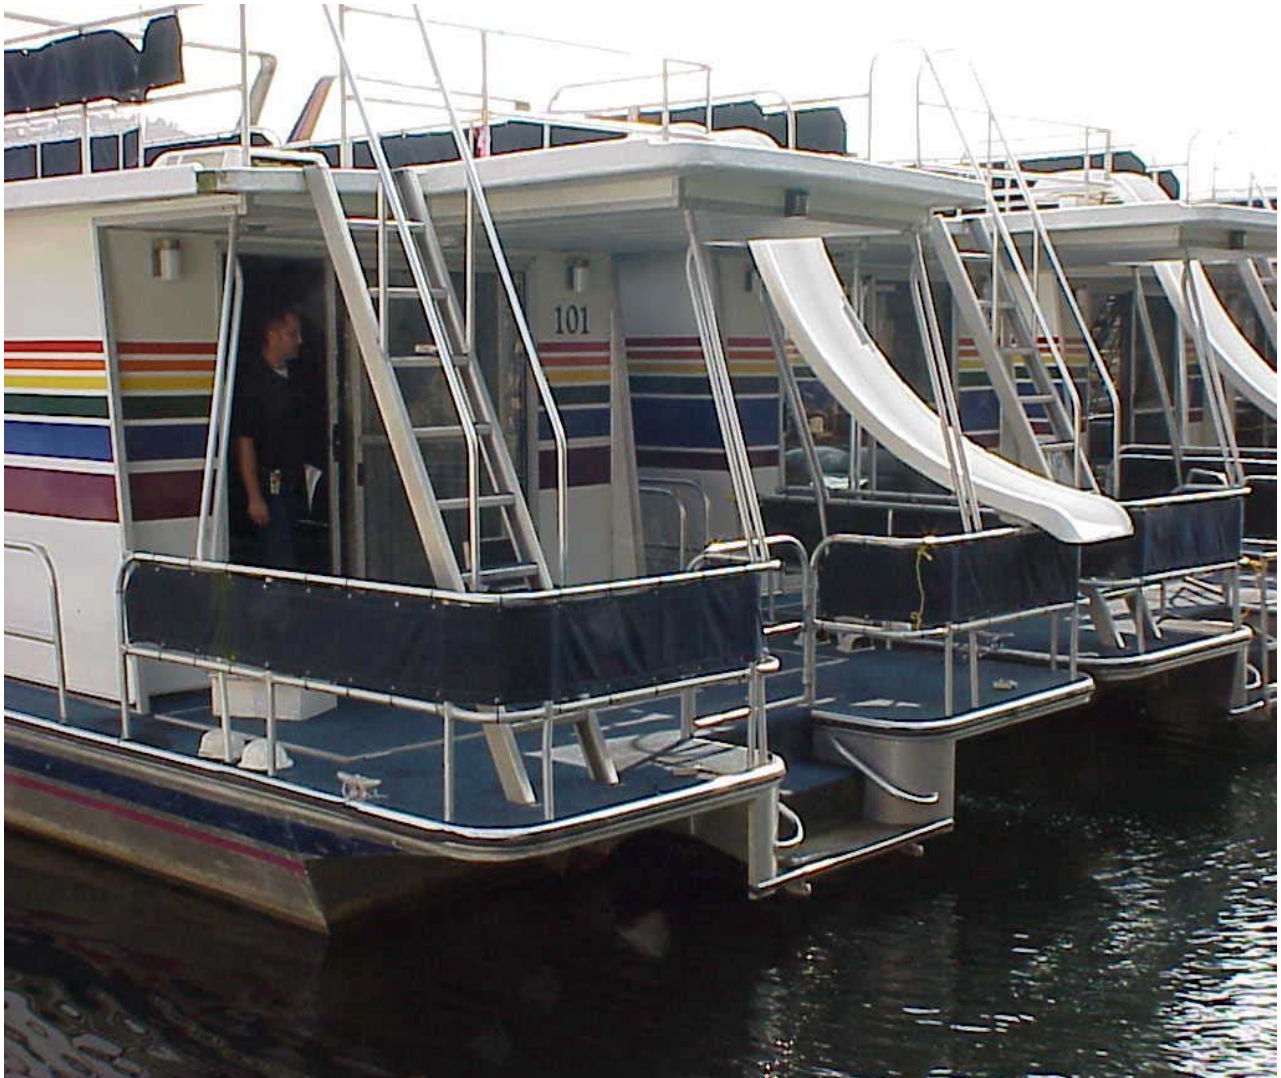
**Figure 6.** Back deck of Jamestown Deluxe Houseboat

The Jamestown Deluxe houseboat did not have a swim platform that extended down to the water level like other boats evaluated (see Figure 6). The generator and motor exhaust discharged out the back of the boat into the area under the back deck. Evacuated glass container samples and detector tube samples were collected approximately 12 inches above the water level off the back deck when the generator was in operation. CO samples were also collected near the bottom of the stairs that lead down to the water off the back deck (see Figure 6) where individuals could conceivably swim around, and enter and exit the water.

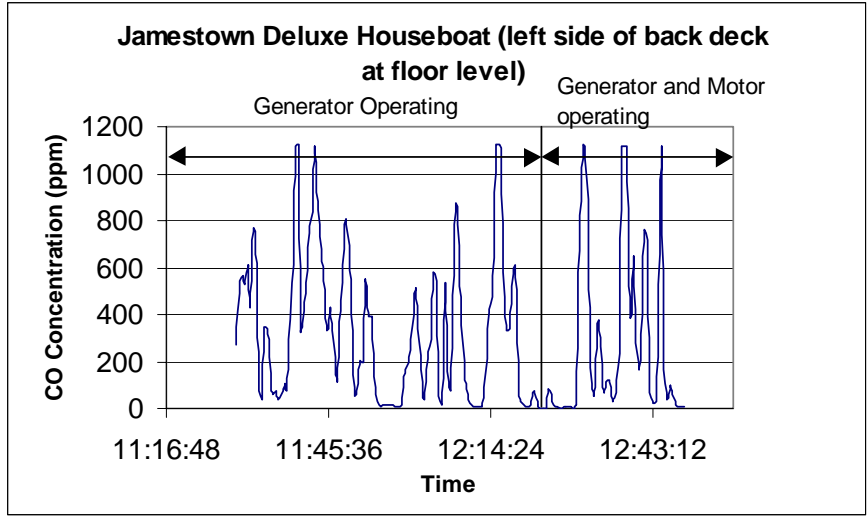
Figure 7. Graphical display of CO concentration data collected on the left side of back deck.

\* See Figure 7 and 8 for graphical displays of the data collected at floor level on the back deck.

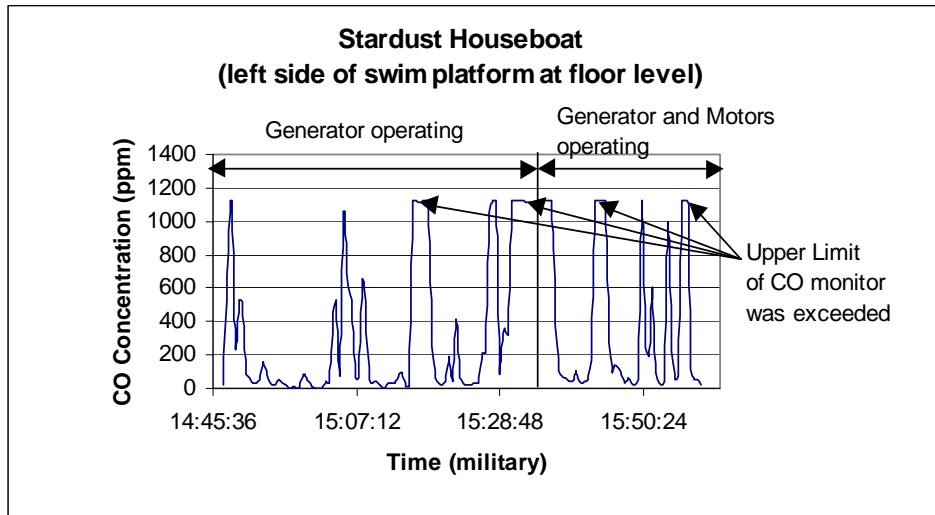
Figure 10. CO monitor results on the left side of swim platform (Stardust Houseboat 1998 model).

\* See Figure 10 and 11 for graphical displays of the data collected on the swim platform. The upper limit of the CO monitors were exceeded at times and the graphs depict flat lines at the top of these peaks.

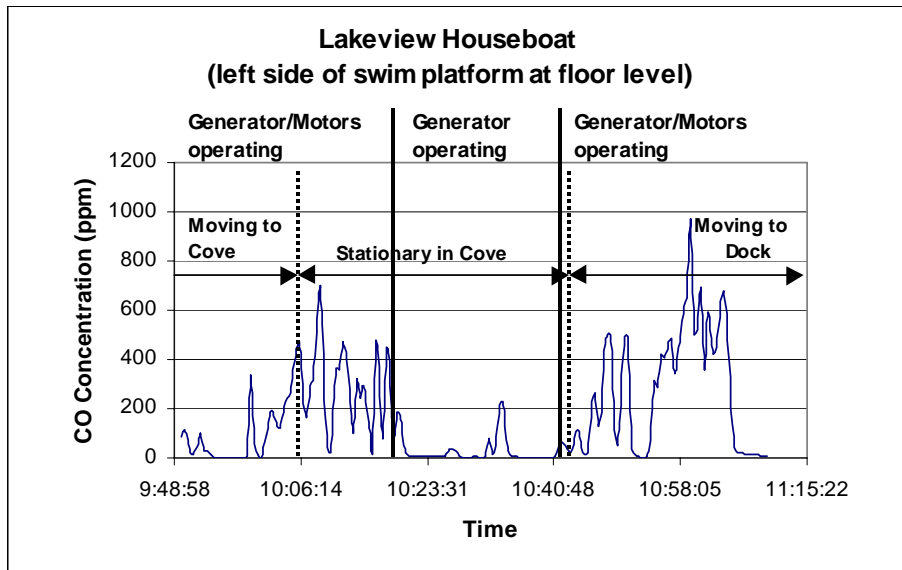
Figure 12. CO monitor results on the left side of swim platform (Lakeview Houseboat).
