# Characterization of Microturbine Materials

Mechanical Property Characterization of EBCs

M. K. Ferber and H. T. Lin  
*Structural Ceramics Group*  
*Oak Ridge National Laboratory*

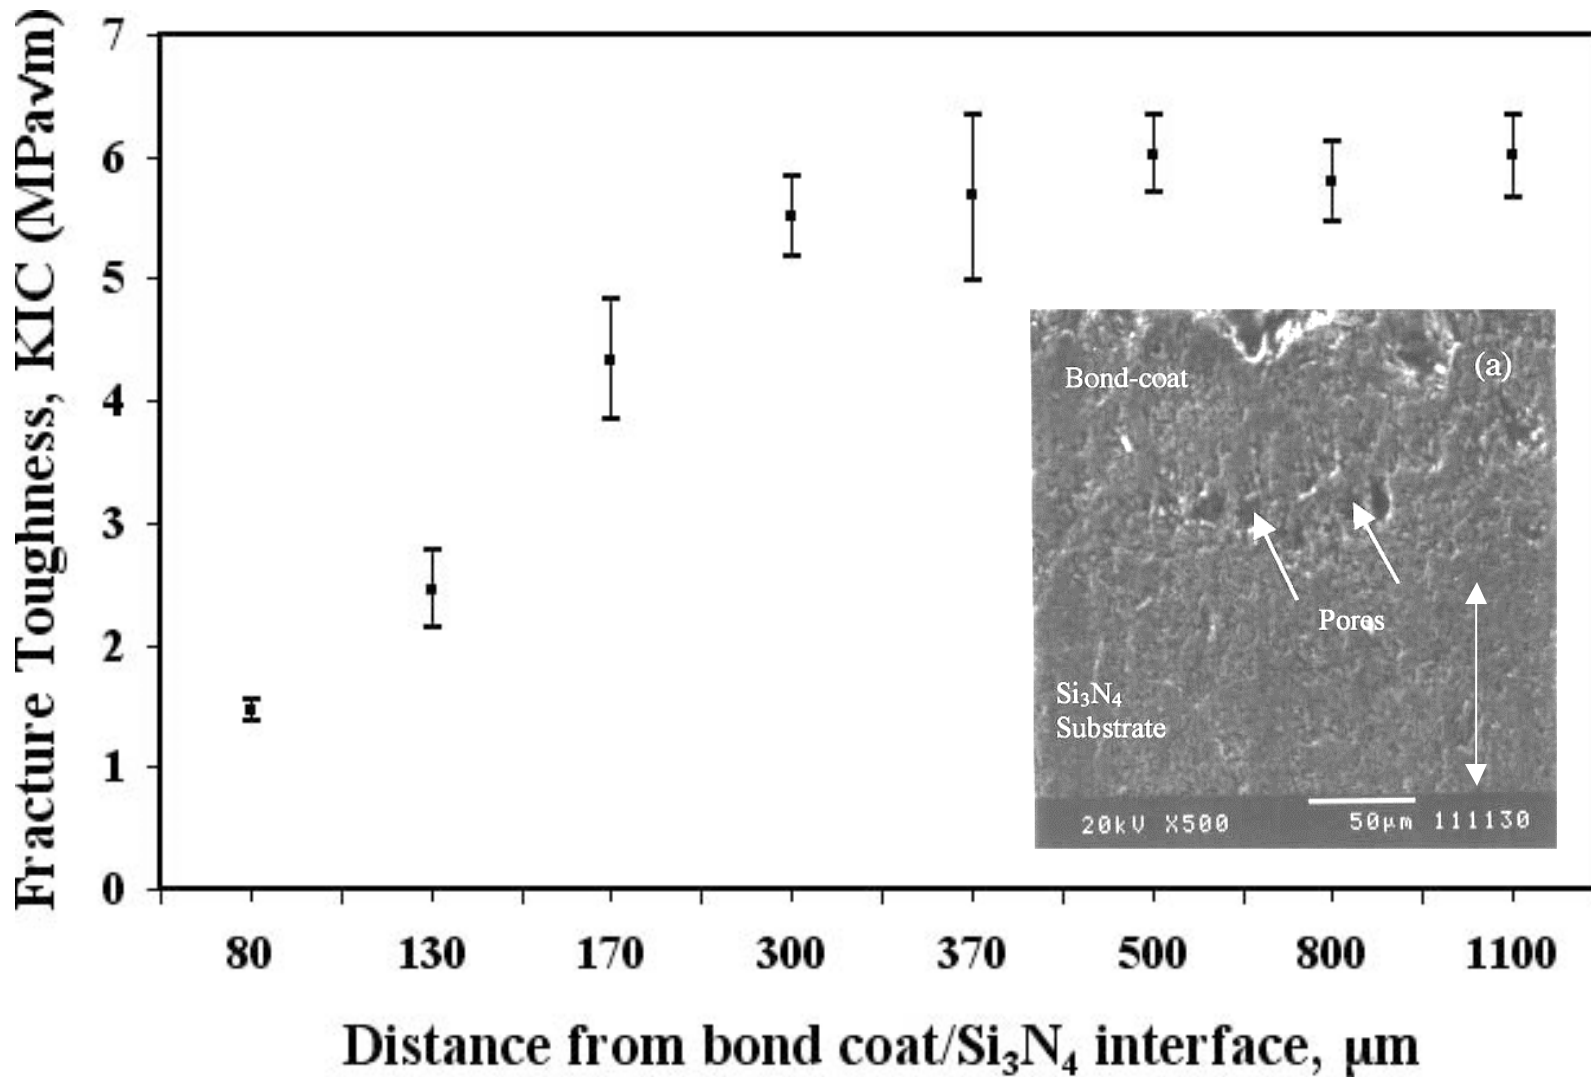
# Micro-Mechanical Characterization Has Been Used to Evaluate Effect of EBC on Fracture Toughness

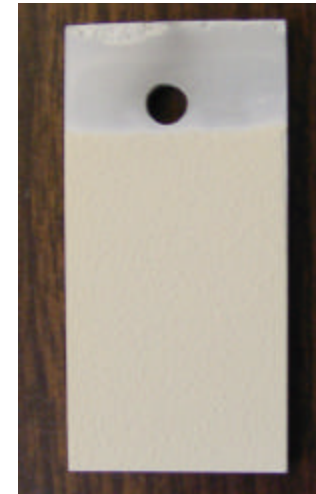
Keiser Rig Coupon

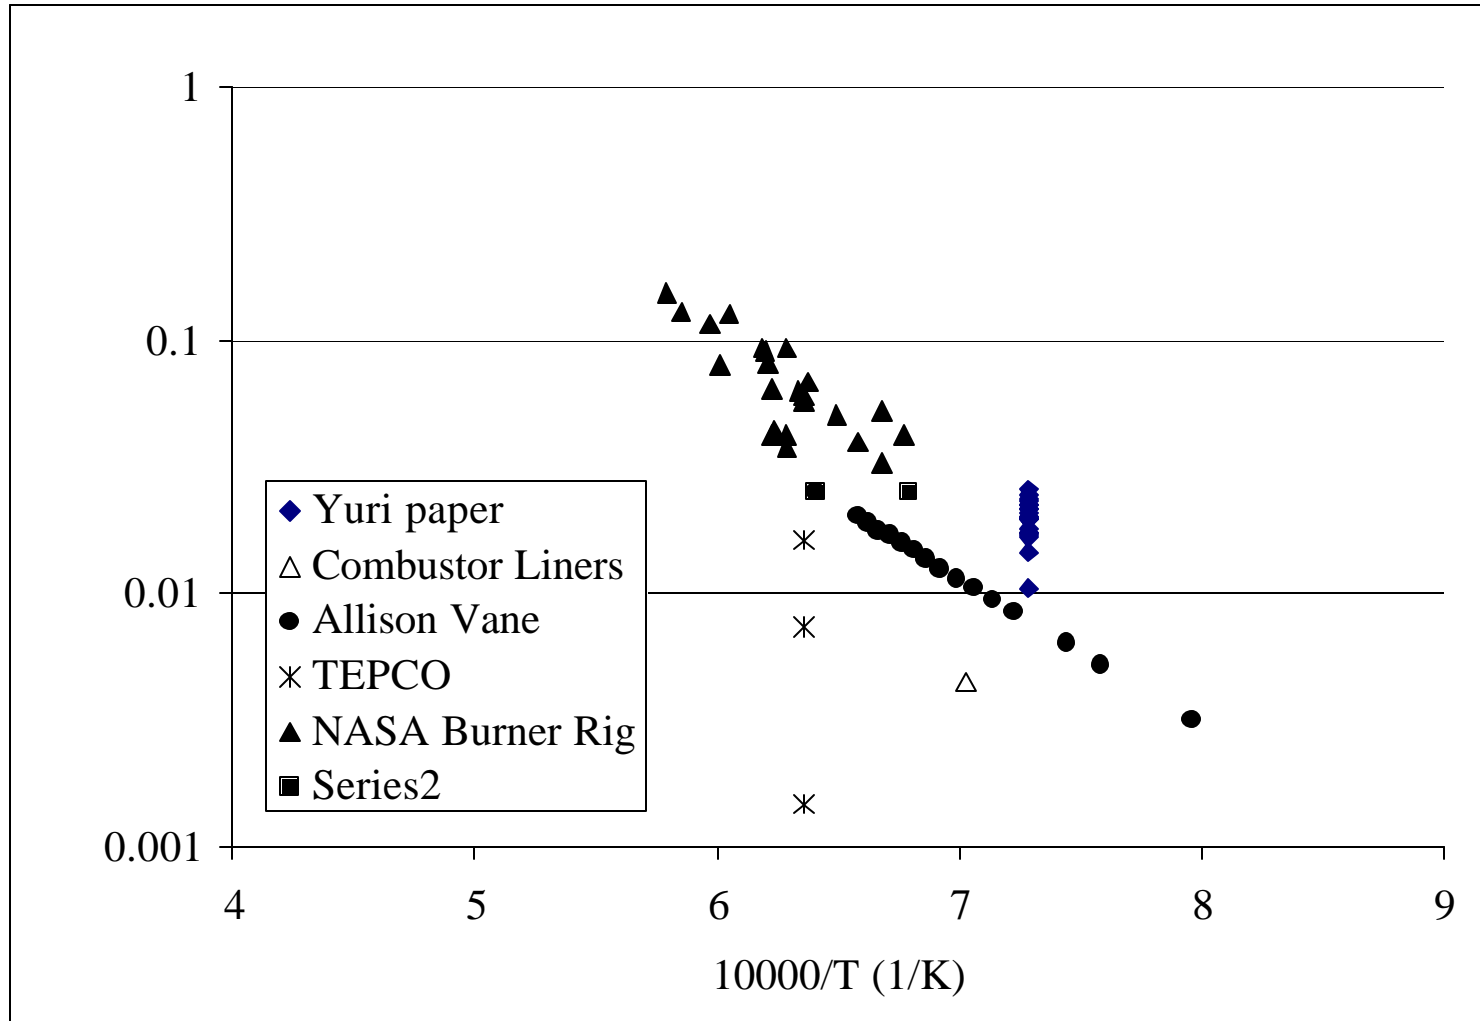
# Recession Results are In Agreement with Data Obtained in Other Programs

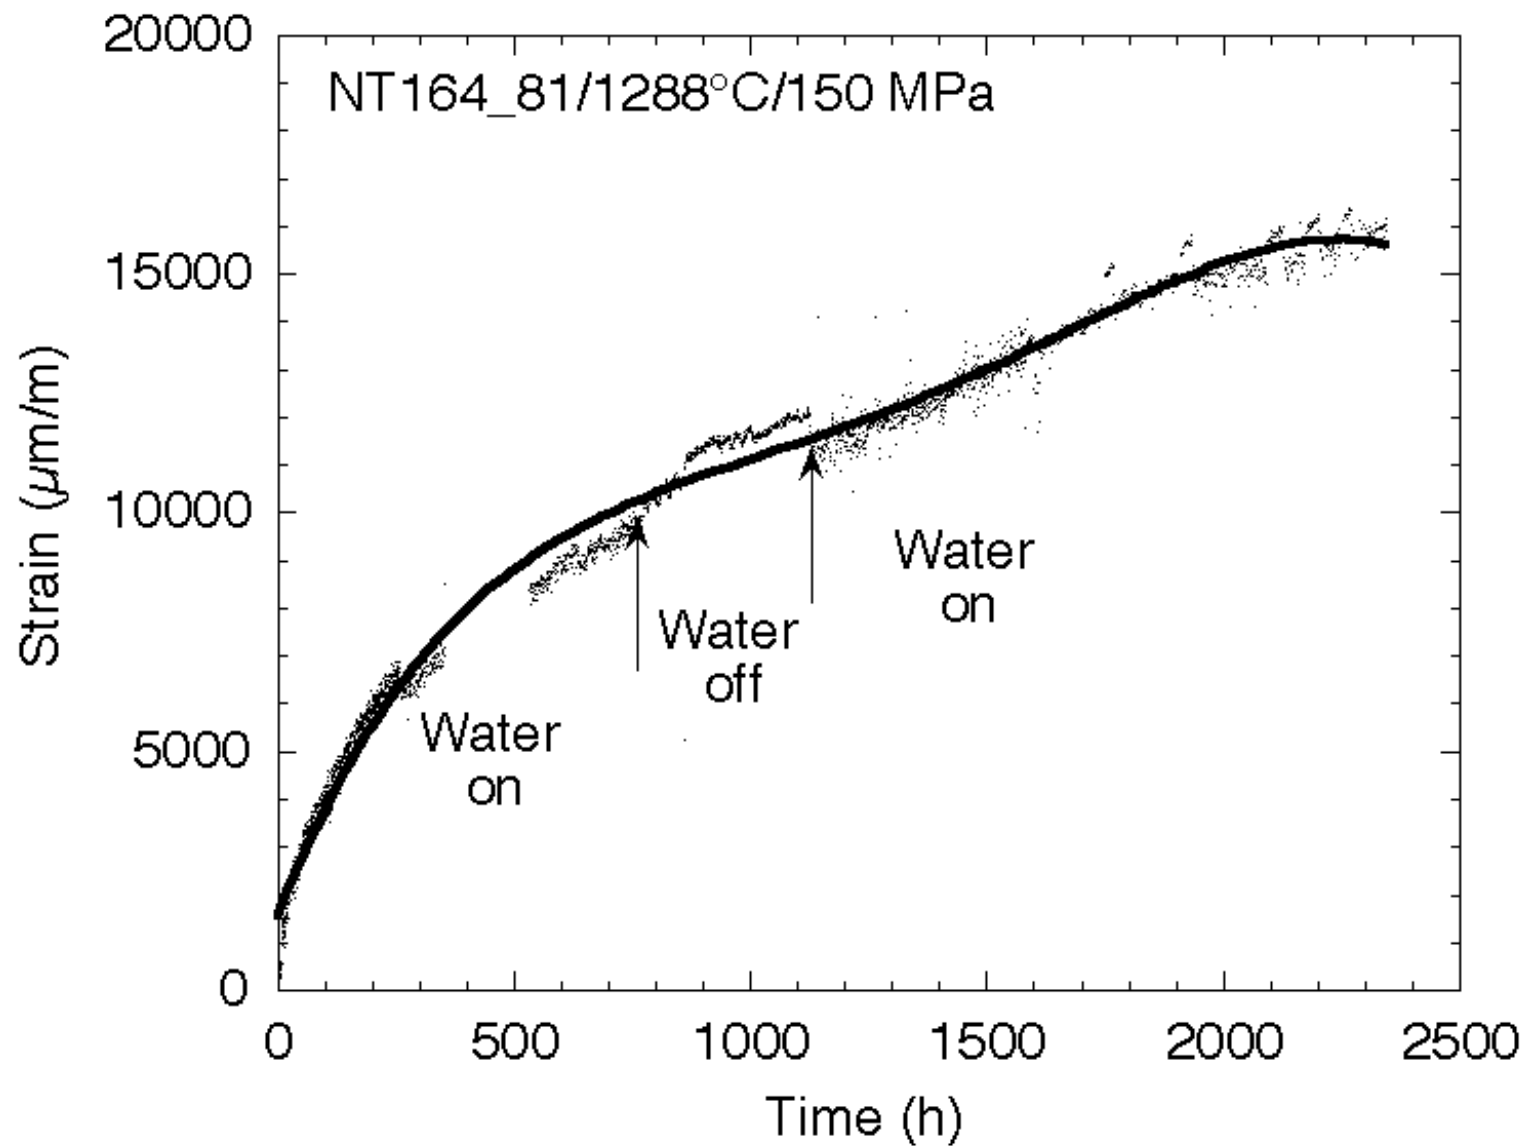
# The Affect of Water Vapor on Creep of NT164 Appears to Be Negligible
