# UTRC Environmental Barrier Coating Development and Demonstration

**Ellen Sun, Harry Eaton, John Holowczak and Gary Linsey**

**United Technologies Research Center  
East Hartford, Connecticut**

Presented at DOE EBC Workshop in Nashville on November 6, 2002

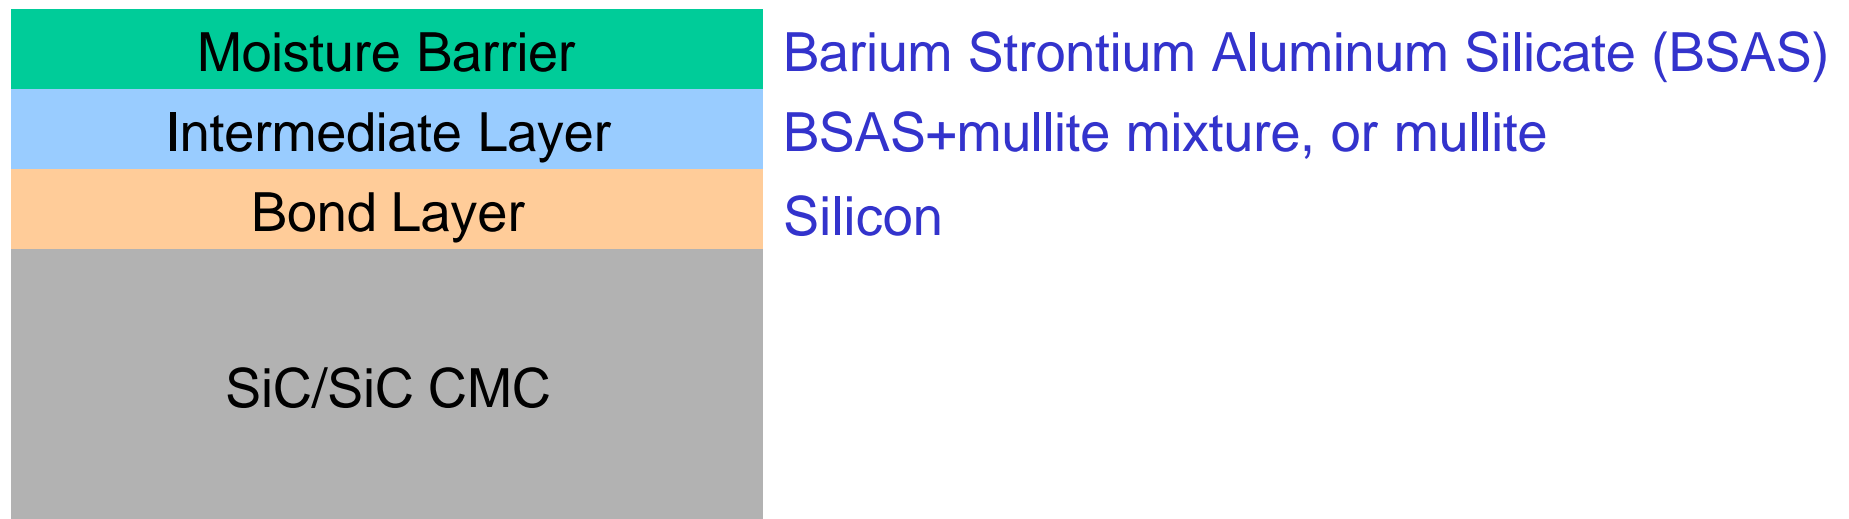
- EBC development was initiated under NASA HSCT EPM program, to prevent recession of SiC/SiC CMC in gas turbine combustion environment due to accelerated oxidation and subsequent volatilization of silica
- Three-layer EBC systems were developed

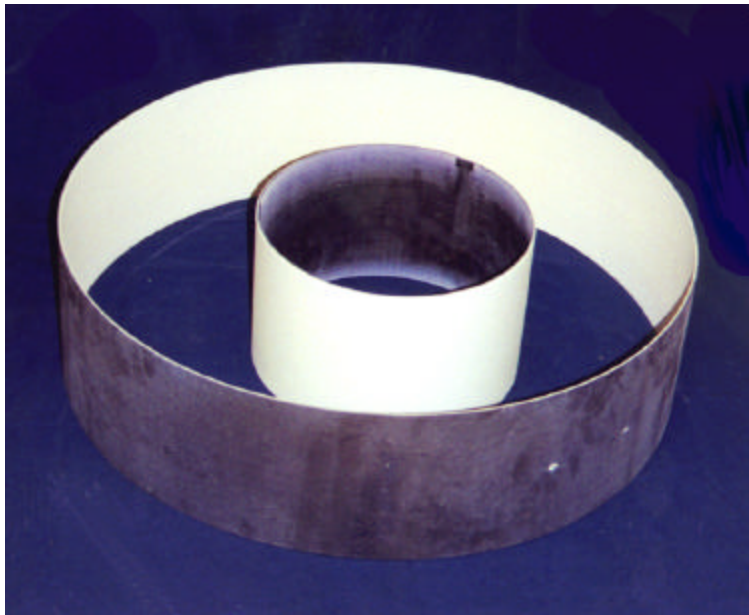
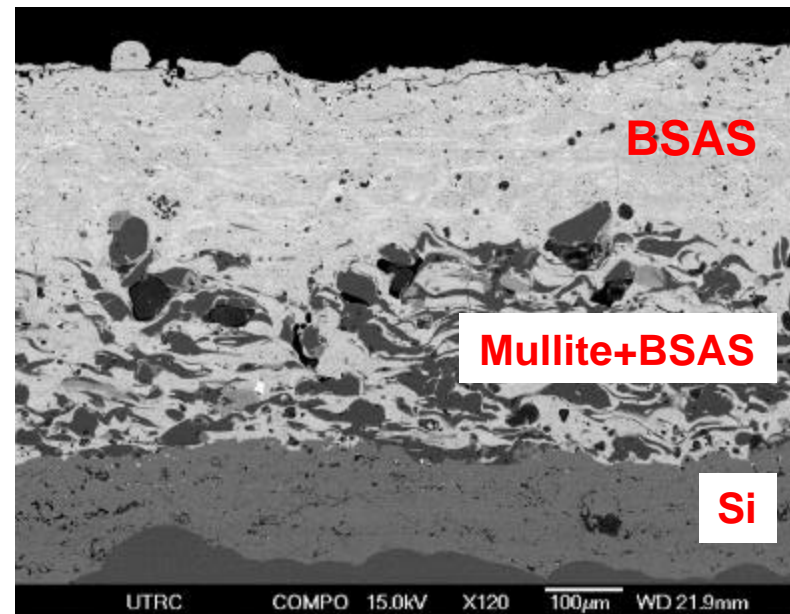
- EBC scaled-up and improved under DOE/Solar Turbines CSGT program
- Earlier work encountered difficulty in producing dense and crack free layers. Cracks affect EBC protectiveness.
- The current “standard”  $EBC_{SiC}$  is a three layer system with a Si layer, a BSAS-mullite intermediate layer, and a BSAS top layer.

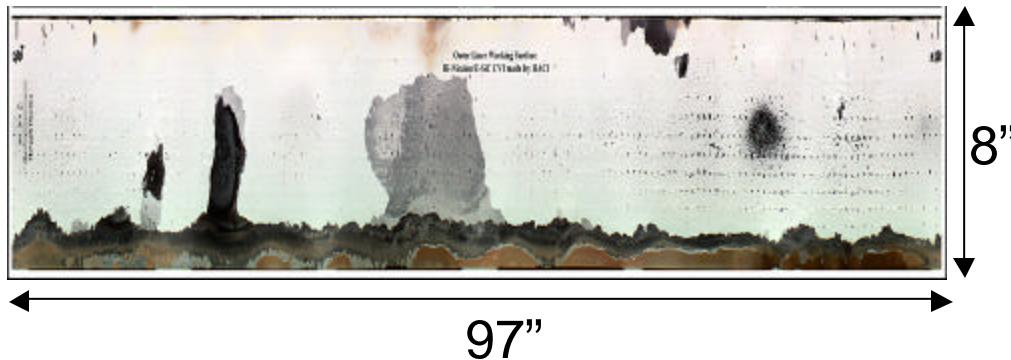
*EBC on a combustor outer liner after  
~13,937 hour operation at Bakersfield.*

>40,000 hours field tests in Solar Turbines, Inc. Centaur 50S engine

Bakersfield, CA: 13,937 hours, test terminated

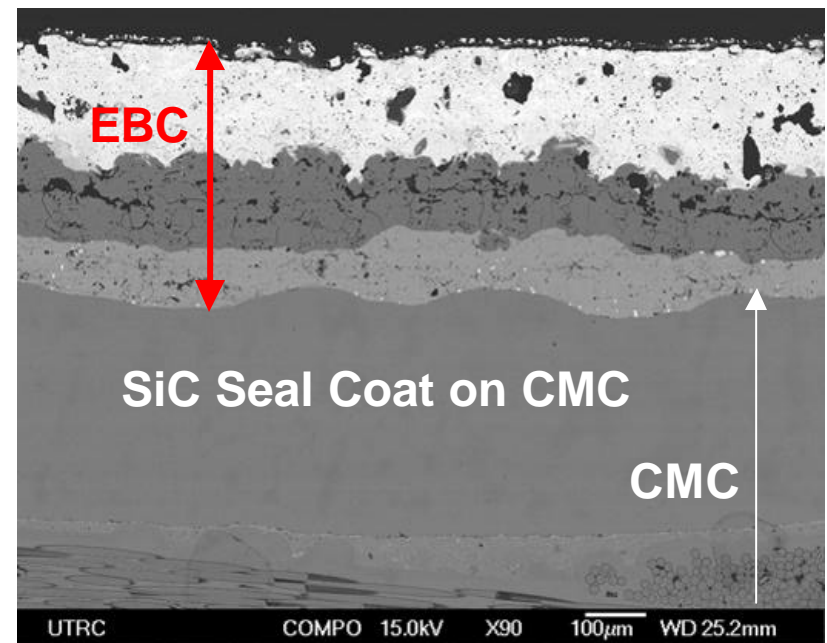
*CMC well protected in areas where  
EBC remained intact*

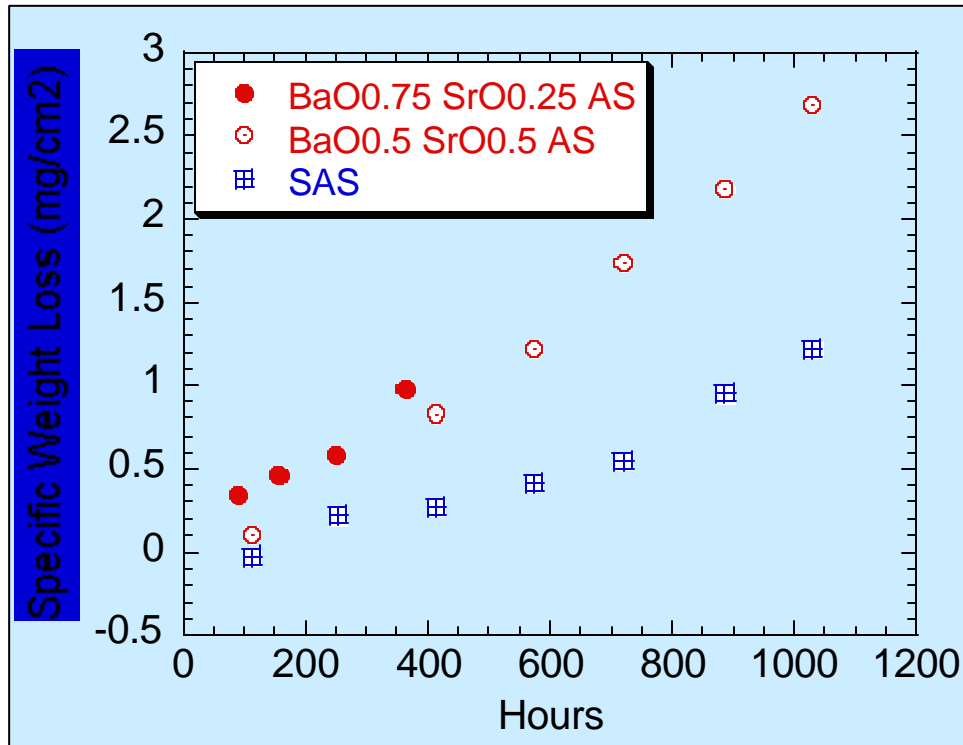
- SAS exhibits better steam stability compared to BSAS
- SAS-based EBC has been applied to Solar CMC liners

\*Hot-pressed sample at 2732°F (1500°C) in 90% Steam

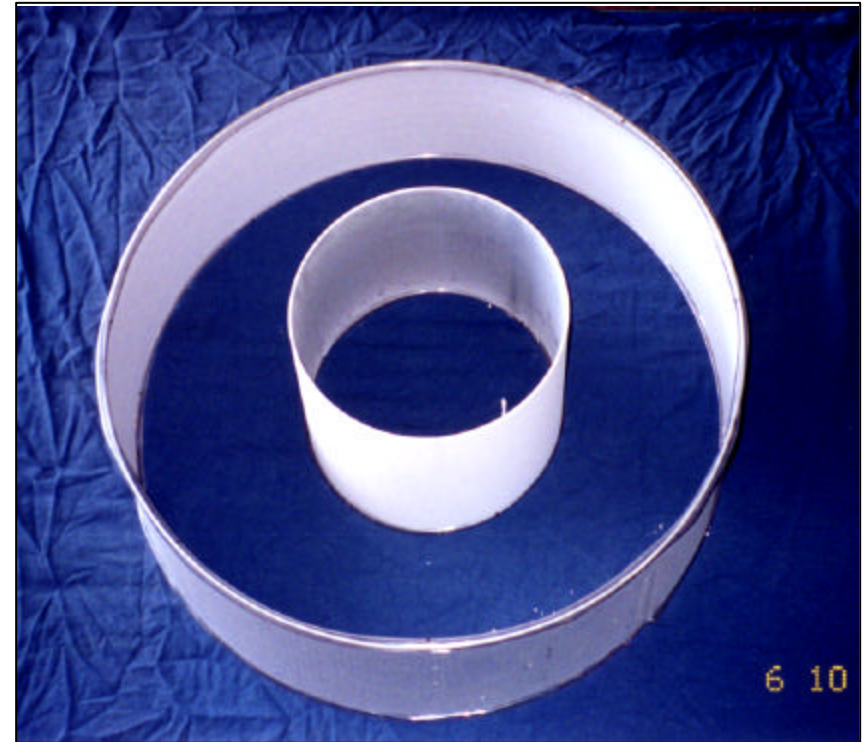
SAS EBC applied to Solar Centaur 50S combustor liners for Malden Mill II test

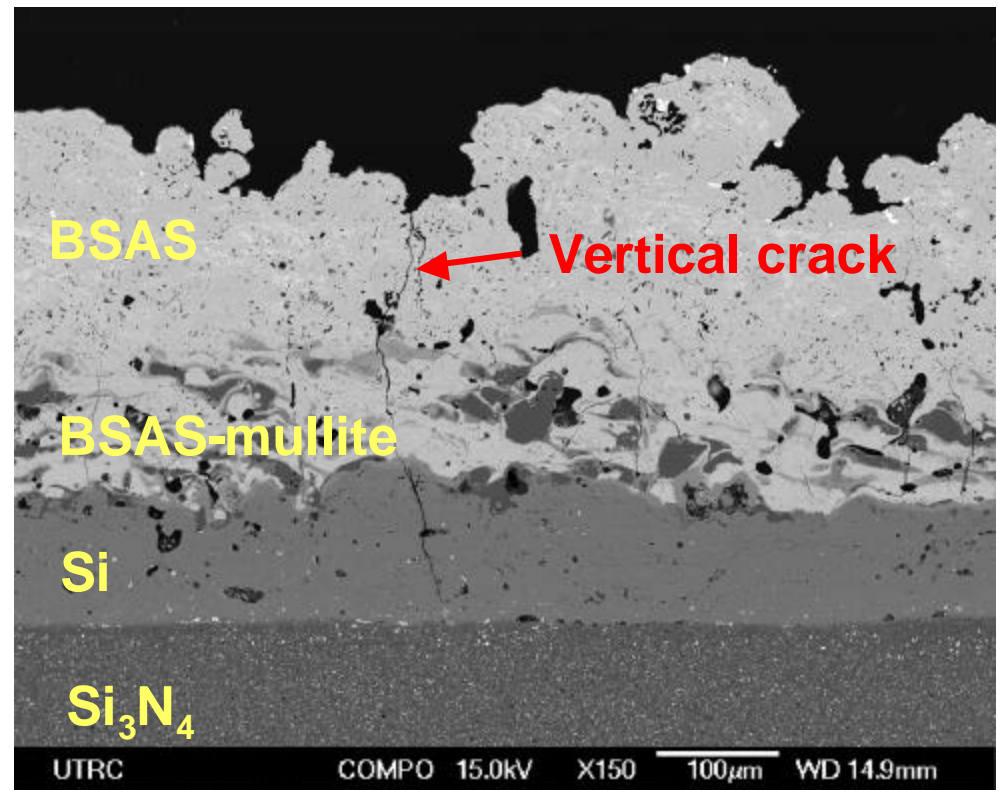
- $EBC_{SiC}$  (RT-1200°C: ~5.0 ppm/°C)
- $Si_3N_4$  (RT-1200°C: 3.0-3.2 ppm/C)
- Vertical through thickness cracks observed in as-processed coating

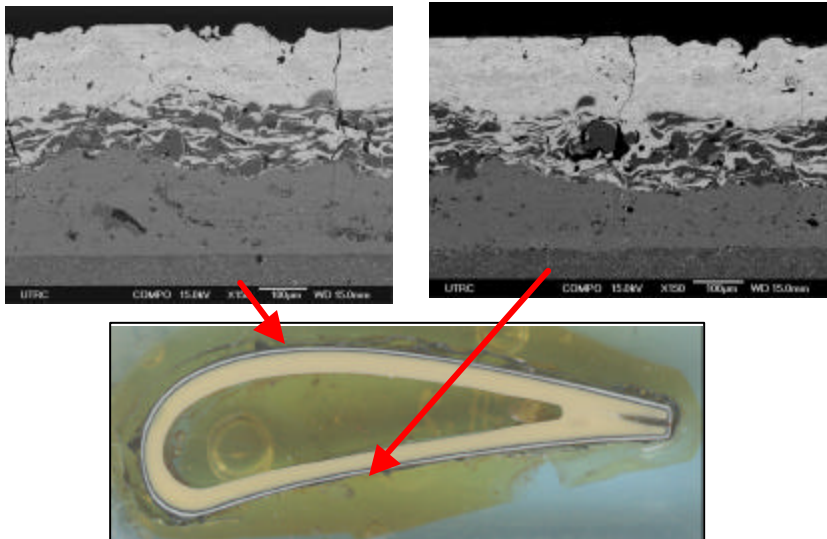
### Uniform coating thickness around airfoil

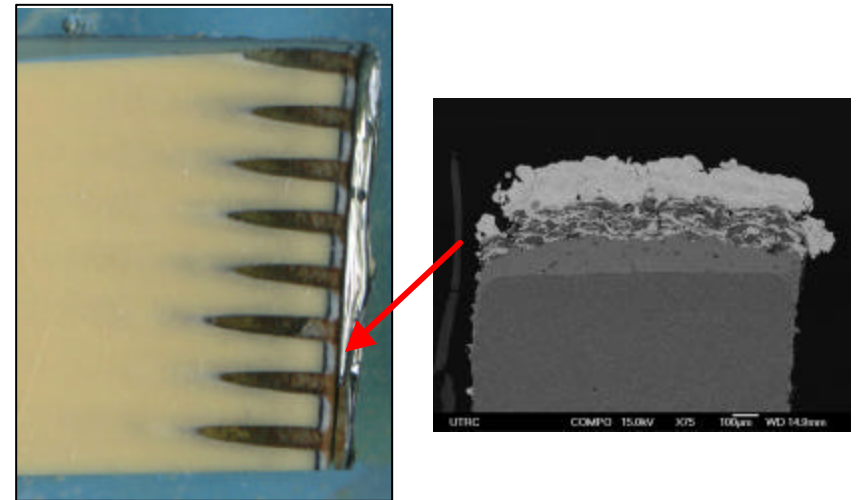
### EBC for cooling hole demonstrated

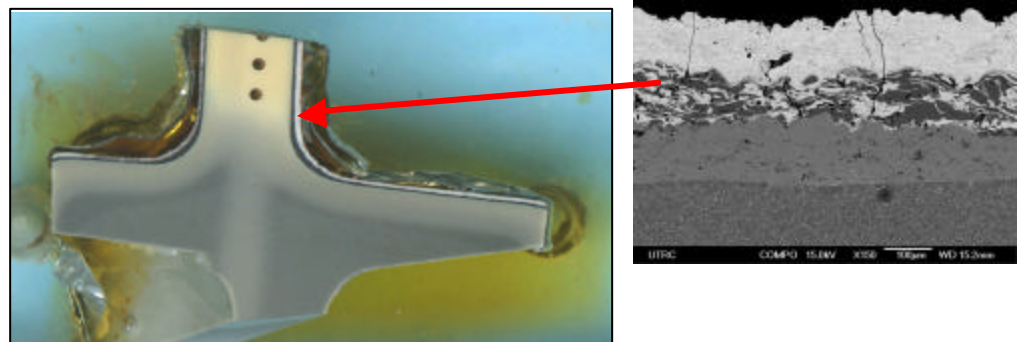
### Airfoil-to-platform transition capability demonstrated

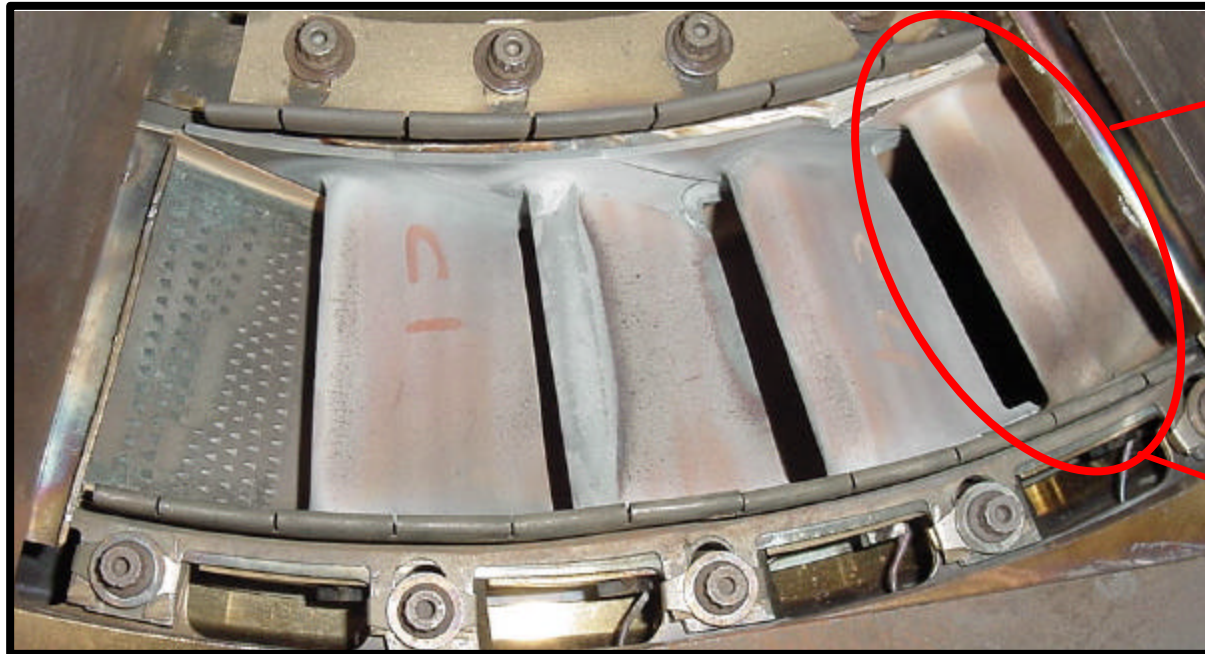
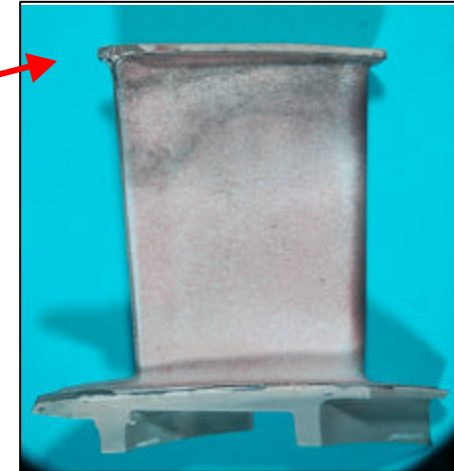
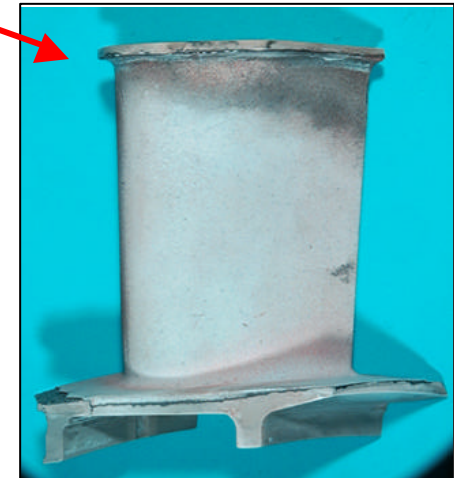
*EBC<sub>SiC</sub> Applied to Cooled FT8 Si<sub>3</sub>N<sub>4</sub> Vane and Survived Two Trip Shutdowns*

Pressure Side

Suction Side

- SN282 vane uncoated
- AS800 vane coated with EBC<sub>SiC</sub>
- 30 hours at 70% power (1230°C at coated vane), 2 trip shutdowns from ~60% power, 1 hour at 80% power (1260°C at coated vane)

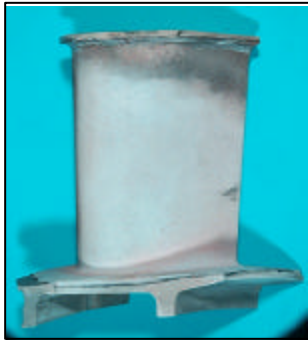
No reaction/oxidation observed in the substrate of **coated** vane

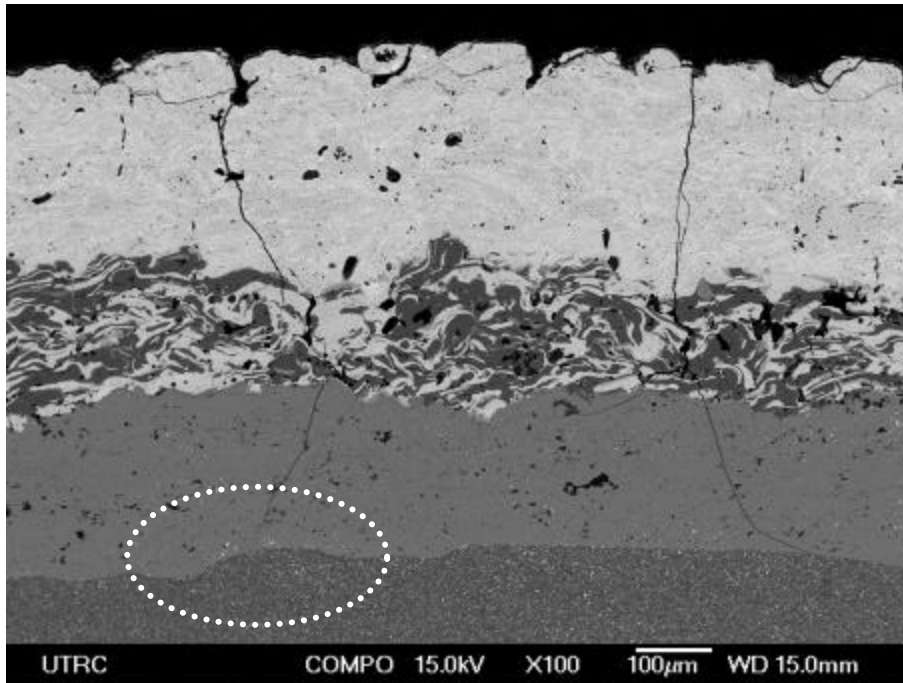
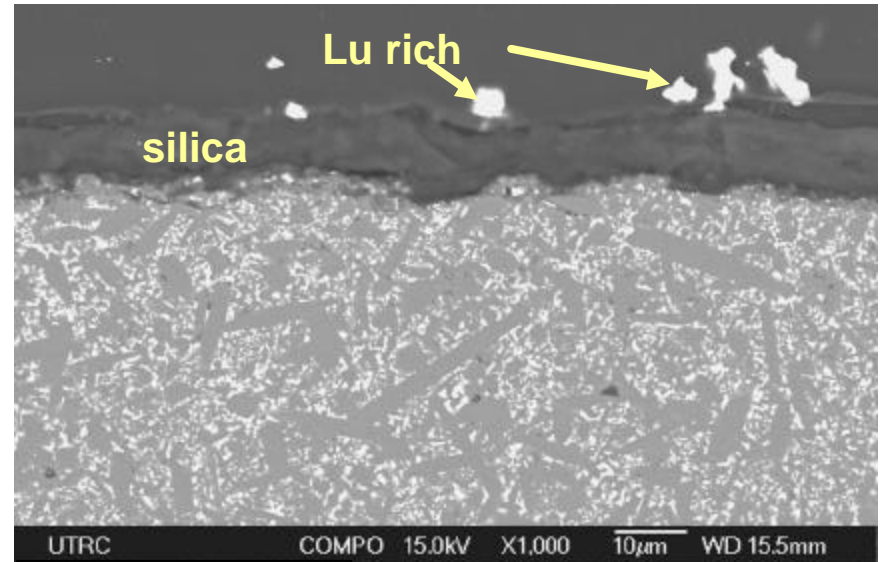
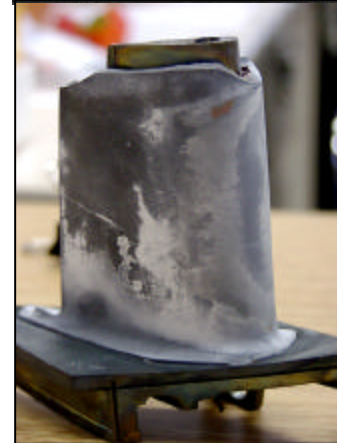
oxidation occurred with silica formation and RE-silicate white powder on the surface of **uncoated** vane

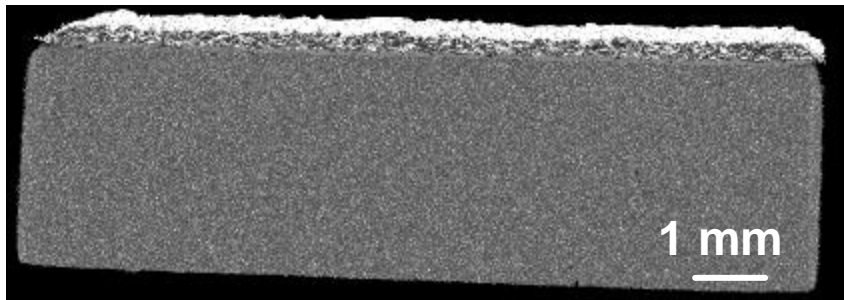
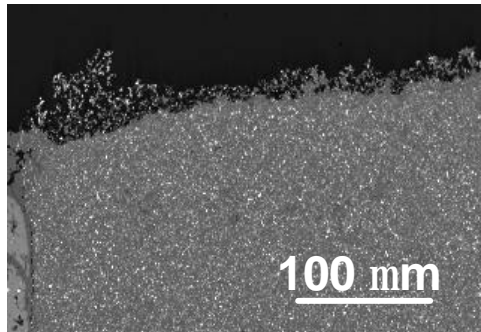
Uncoated surface after 1500-hr  
steam exposure at 1200°C

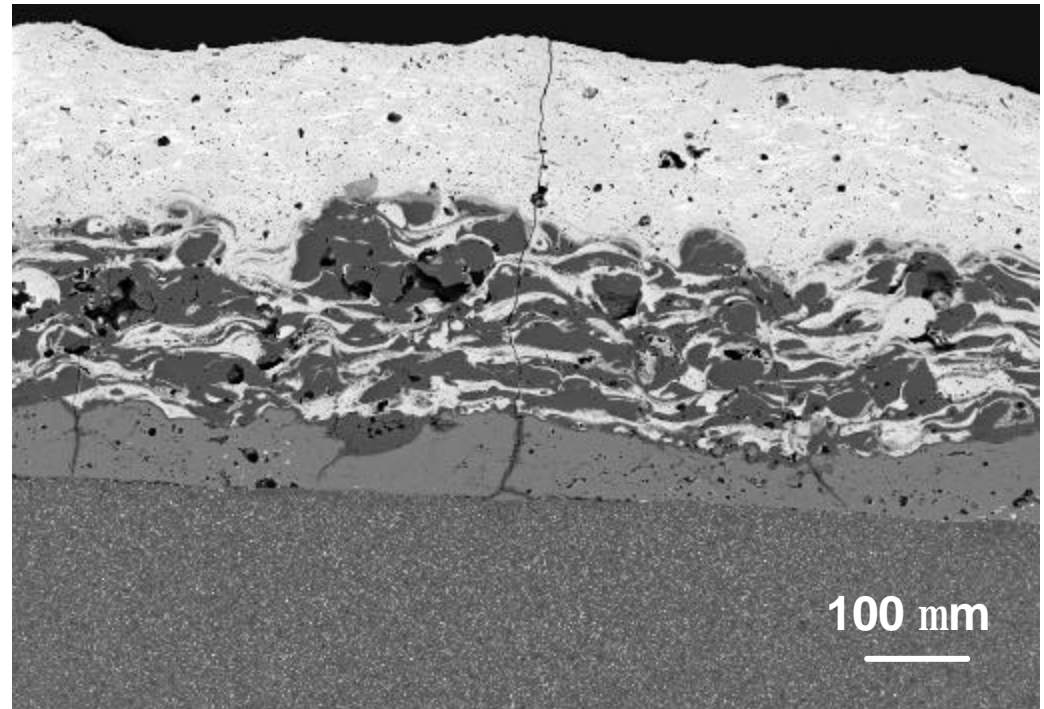
- No oxidation observed in the AS800 substrate underneath after 2000-hr steam exposure at 1200°C
- Coating remained intact except through thickness cracks due to CTE mismatch

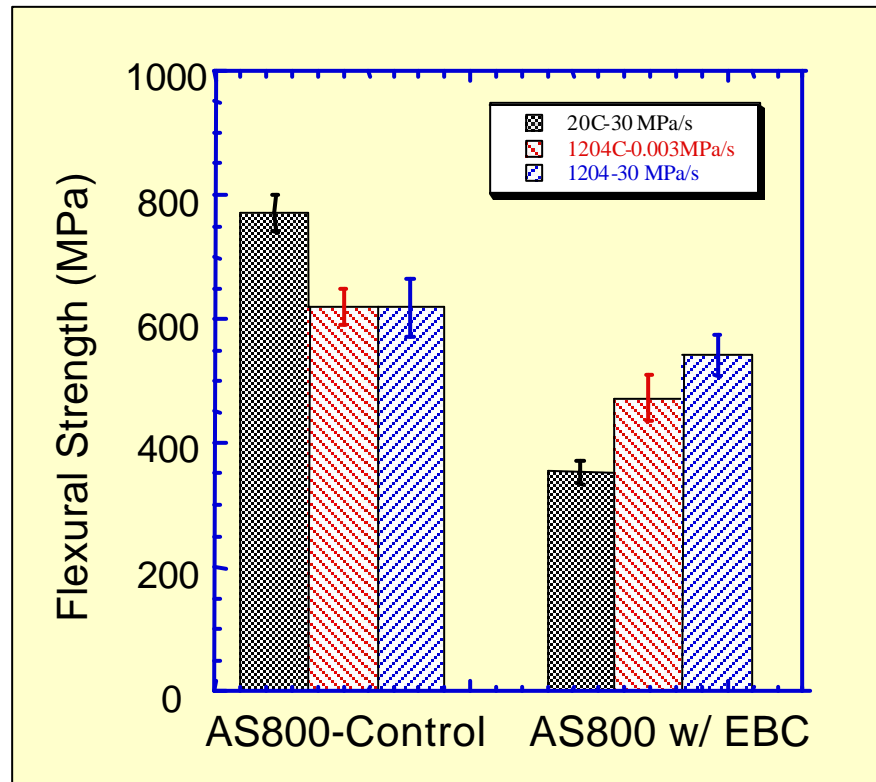
$EBC_{SiC}$  Significantly Reduces Room Temperature Strength of  $Si_3N_4$

- RT strength knockdown first discovered in Solar SN282 nozzle, later confirmed in AS800 and SN88
- <15% knockdown at high temperature

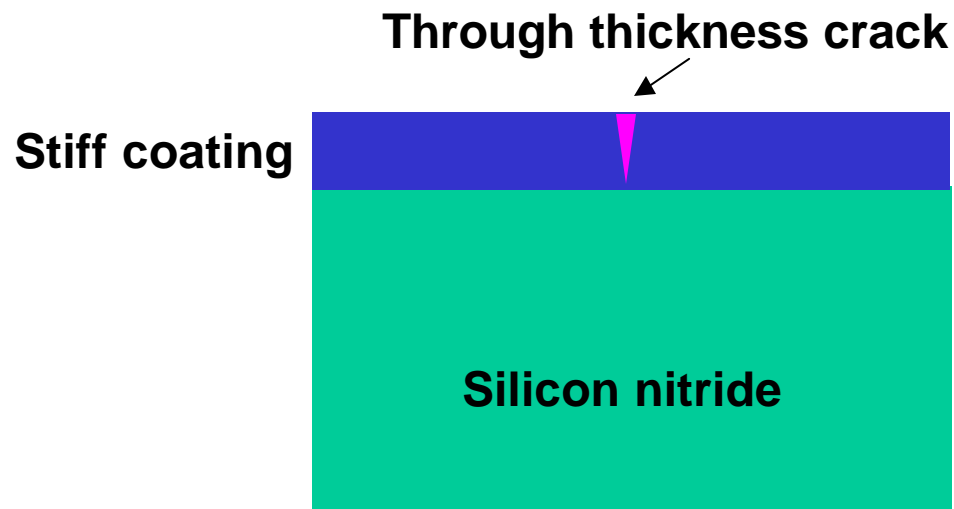
- No effect of surface preparation
- No evidence of chemical interaction between coating and substrate causing strength debit.
- Thermal expansion mismatch between coating and substrate induces cracks in the coating. The cracks in the coating act as strength controlling flaws and reduce substrate strength.

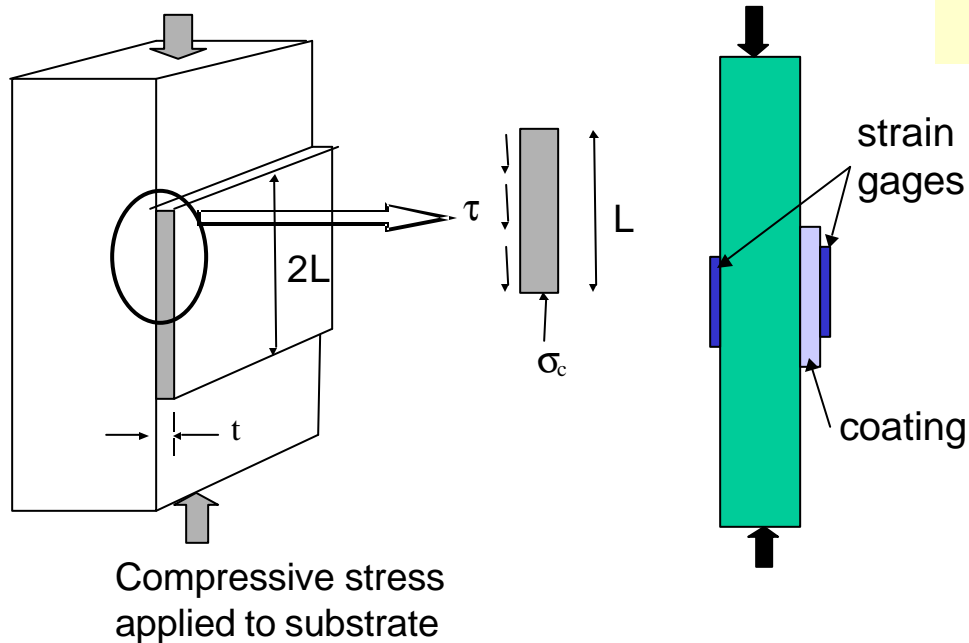
## Compression Test

- Coating is delaminated in shear
- Shear adhesive strength is determined by measuring substrate and coating strain

$$t_{av} = t e_s E_c / L$$
