Signs/Markings

One Airport's Experiences

Salt Lake City
International Airport

FAA Northwest Mountain Region Airports Conference

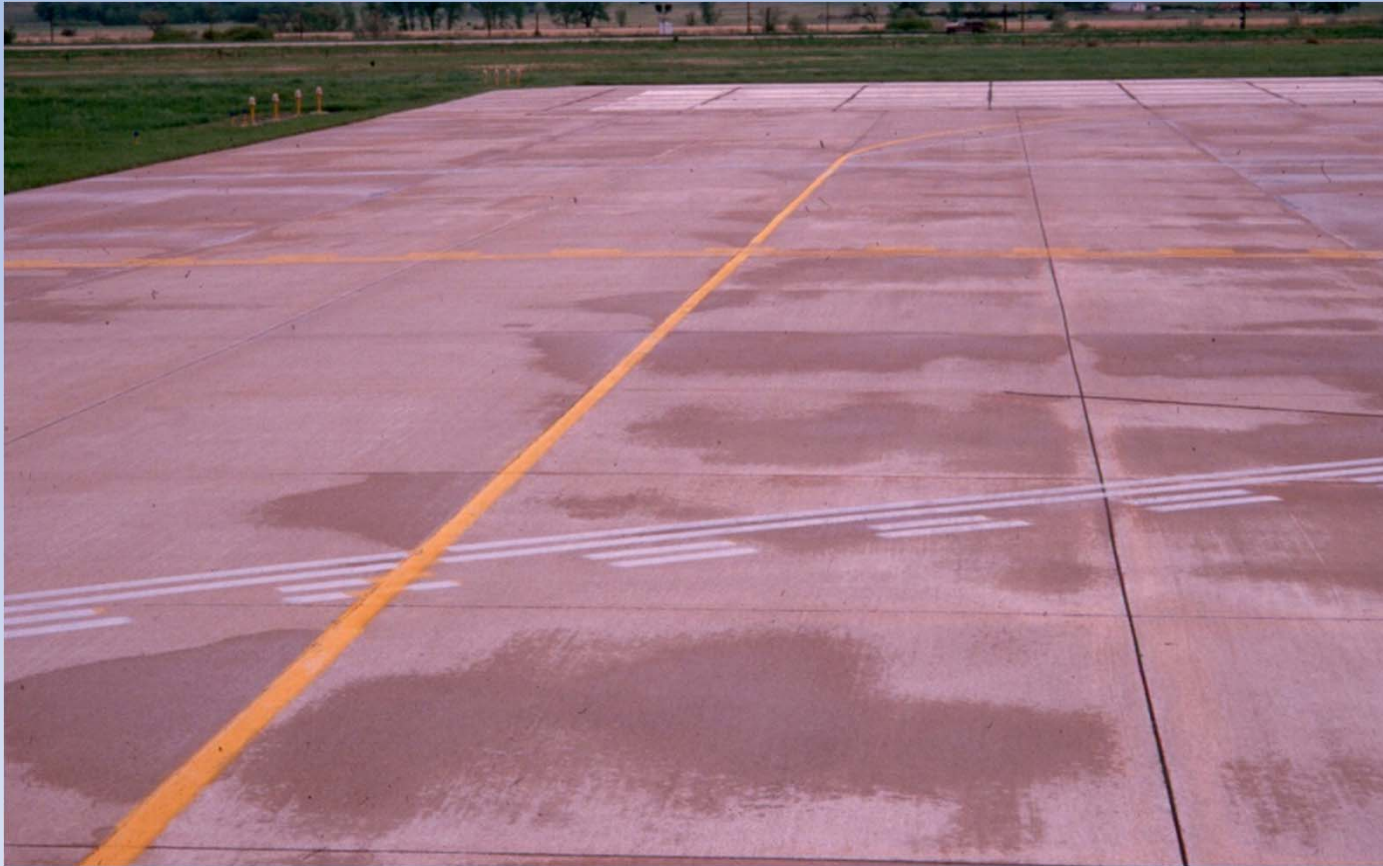
Airport relocated the runway holding position marking. The old marking was painted over with grey paint which most closely matches the color of concrete.

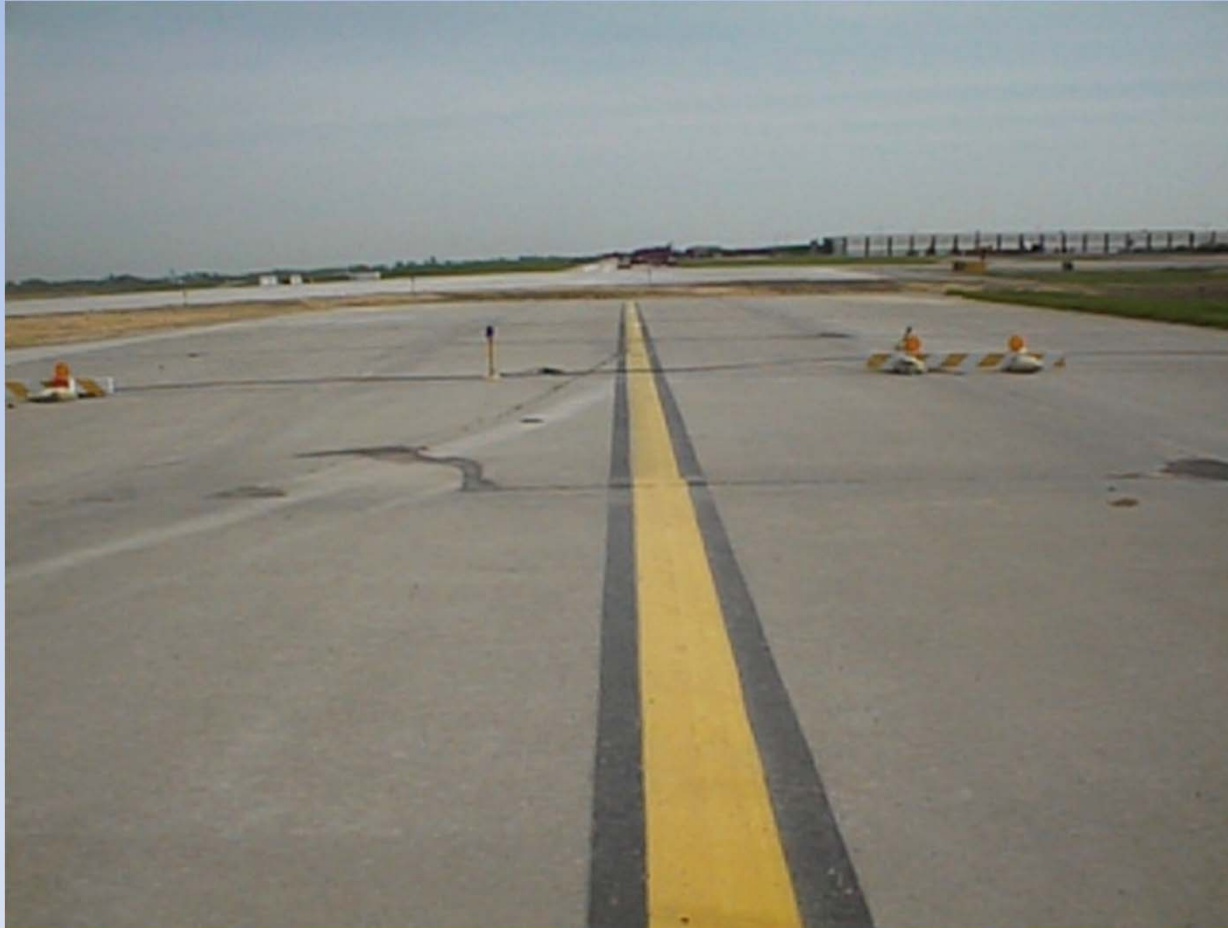
Taxiway centerline leading into a dead end construction zone.

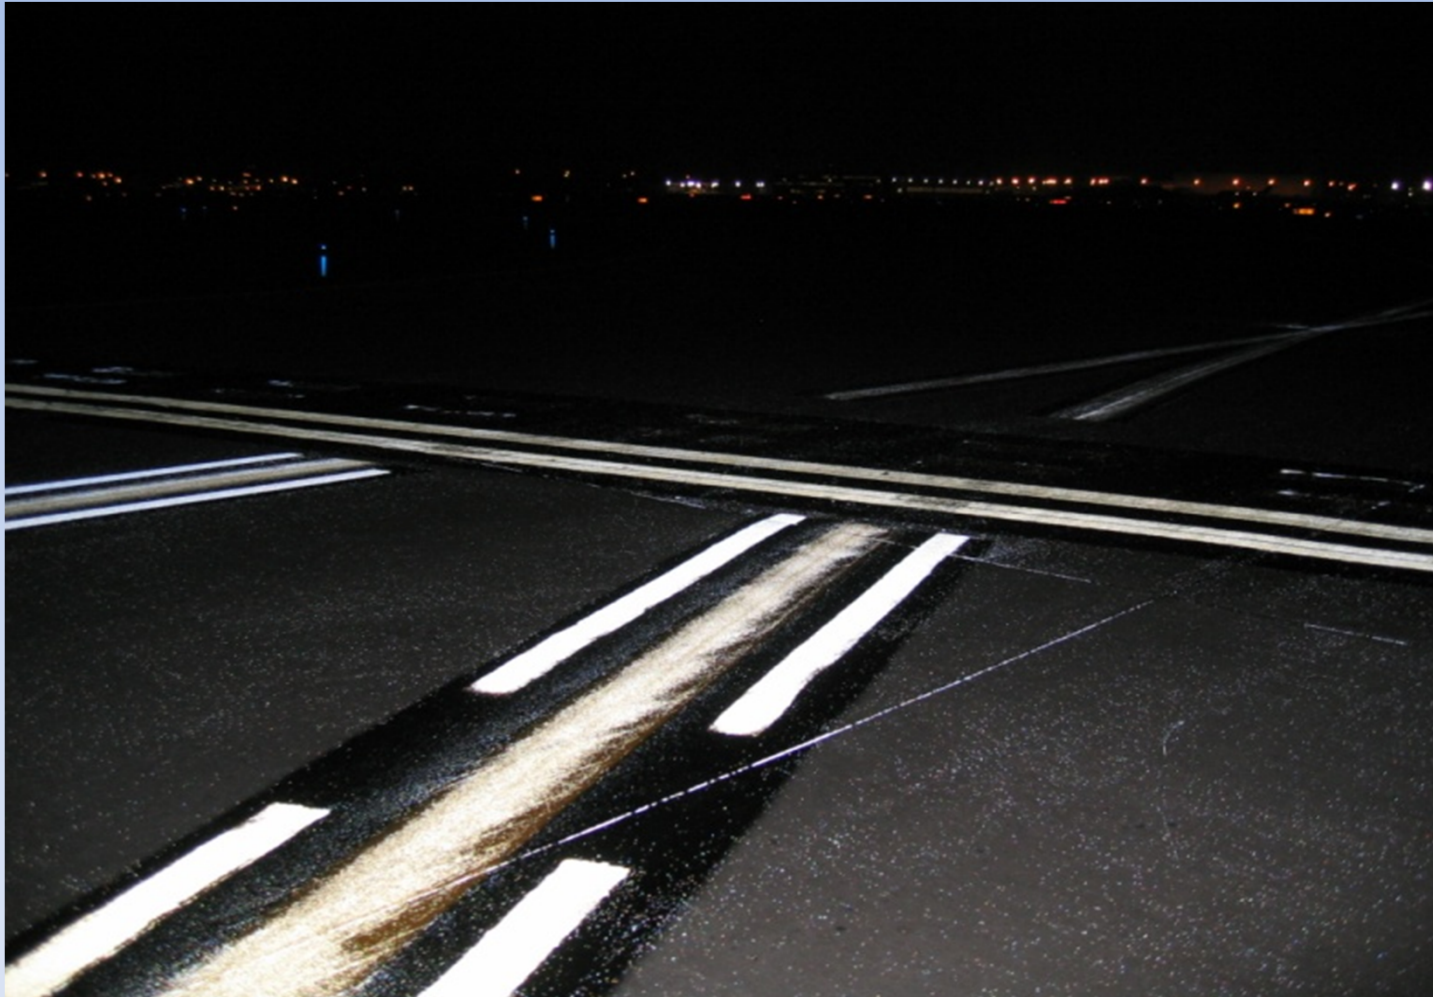
Holding position marking at night gives the appearance of a taxiway edge line due to lack of reflectivity.

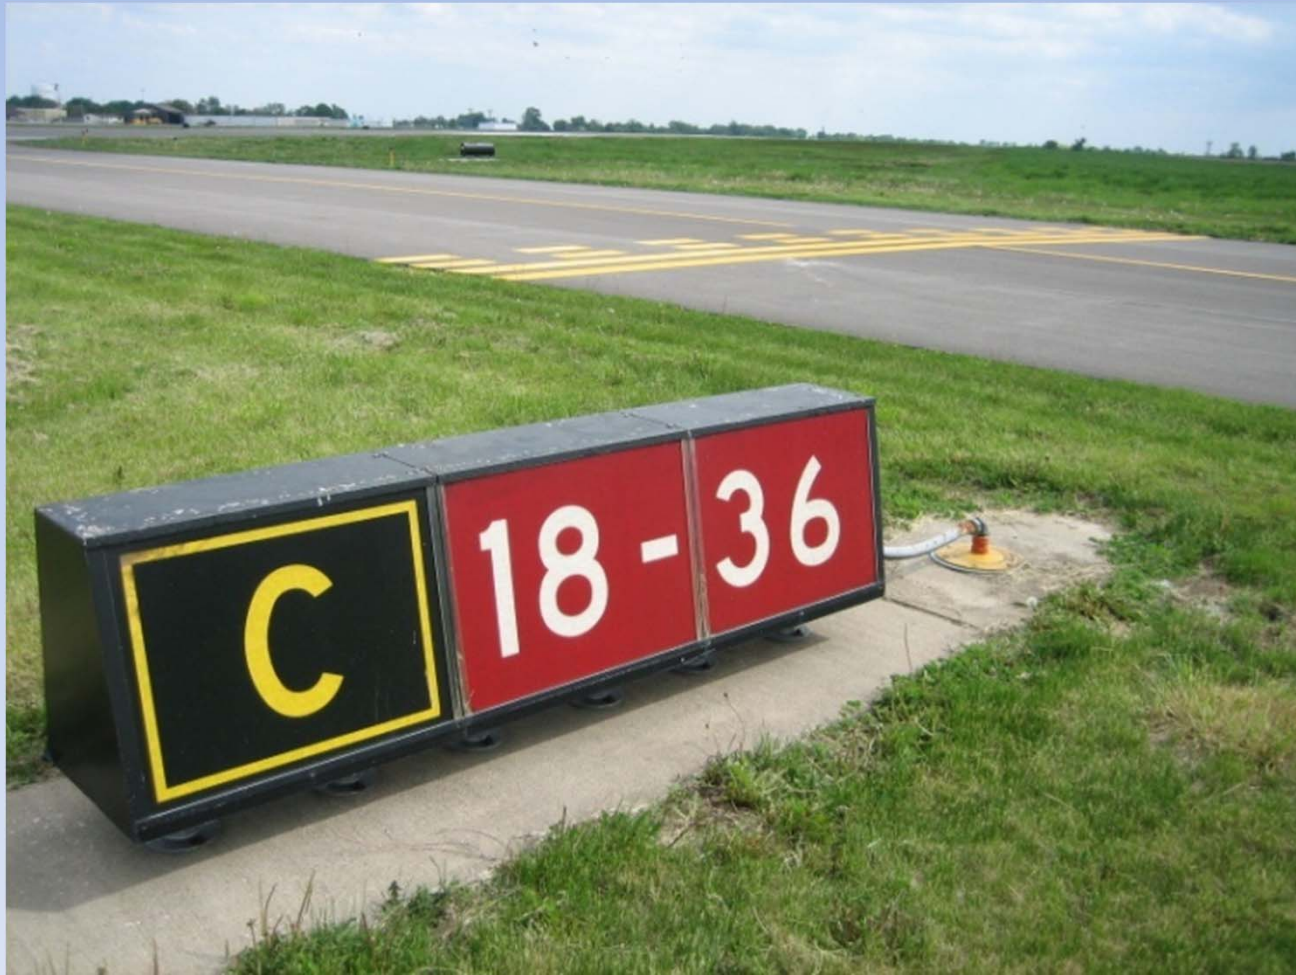
Holding position marking installed 250' from centerline. The marking should be painted at the location of the sign.

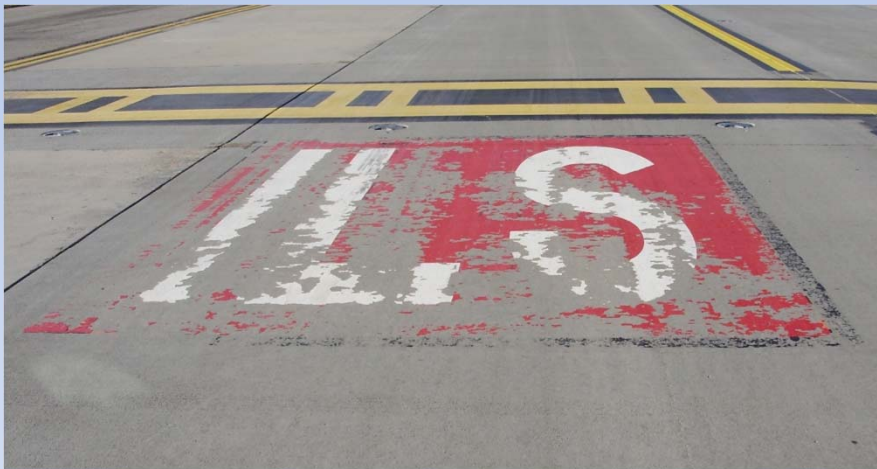
- Temperature
 - Markings below painted November 13, 2010 at around 1830 local – High 43°F and Low 34°F

Behind schedule due to construction in area.

- Never paint when ground temperatures are below 55°
 - If painting must be done, inspect the markings often and expect to re-paint the markings as needed
- Inspect markings closely after snow operations
 - Expect reflectivity to diminish from winter operations
 - Refresh and replenish all markings every year

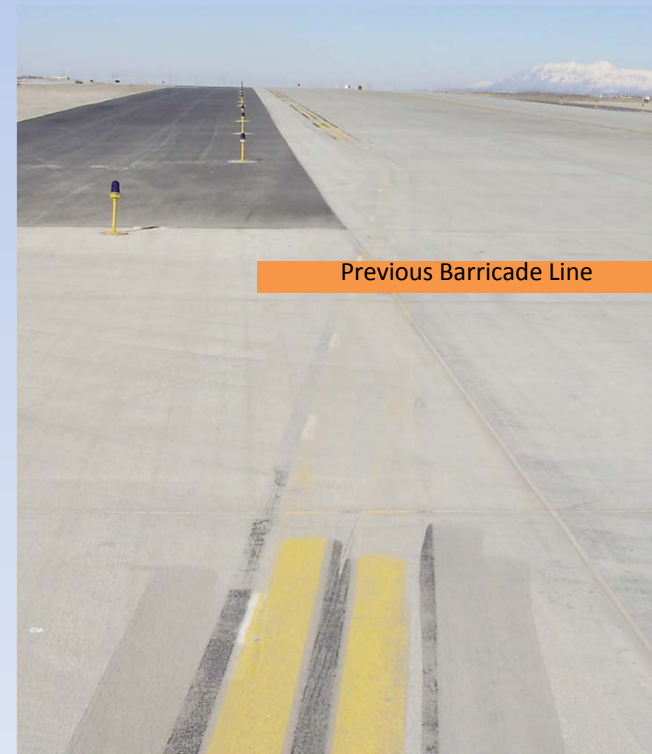
100' of edge marking painted after barricades pulled on new taxiway. Visible markings painted two weeks prior.

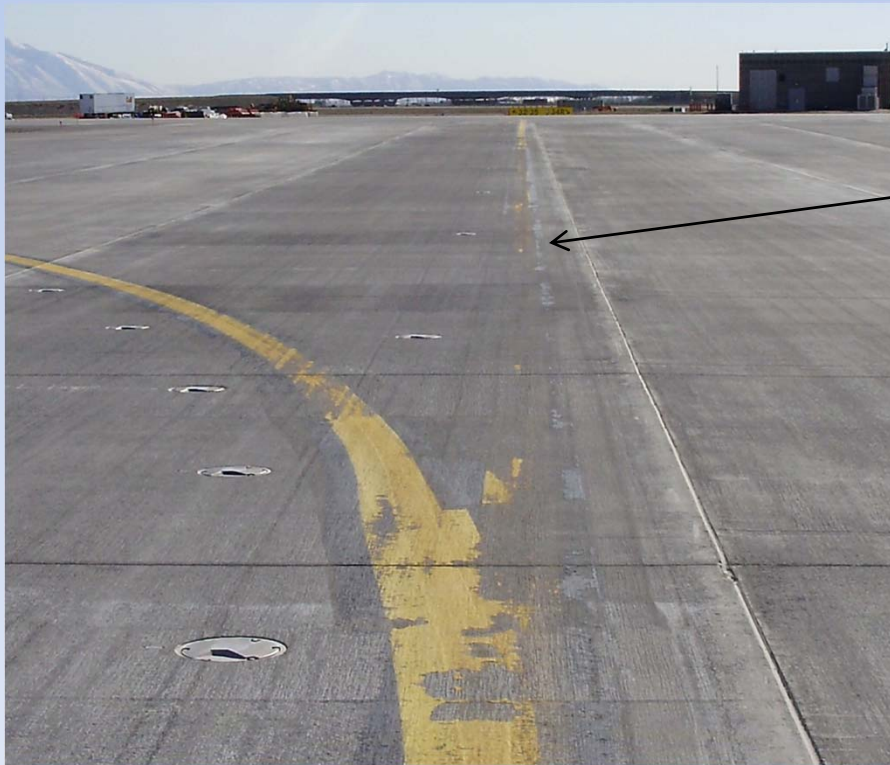
- Temperature
 - Marking again painted in early November on newly completed taxiway

*Missing Taxiway
Centerline*

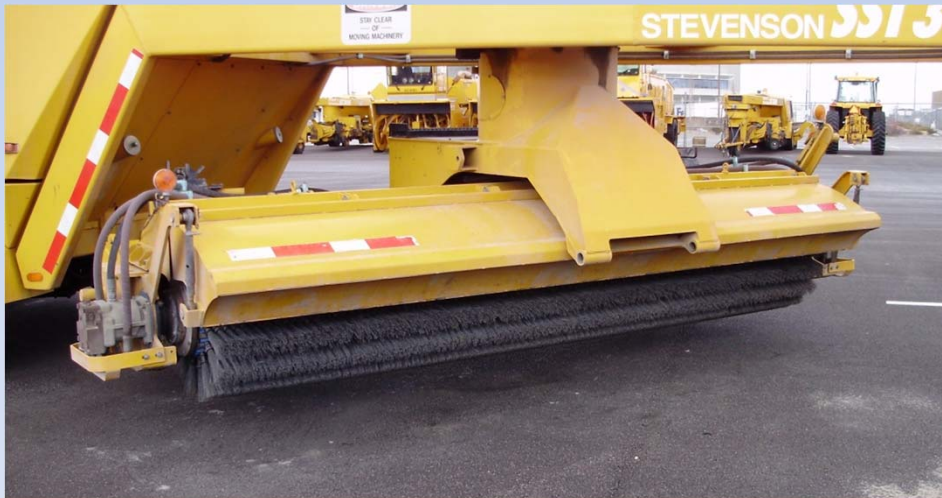
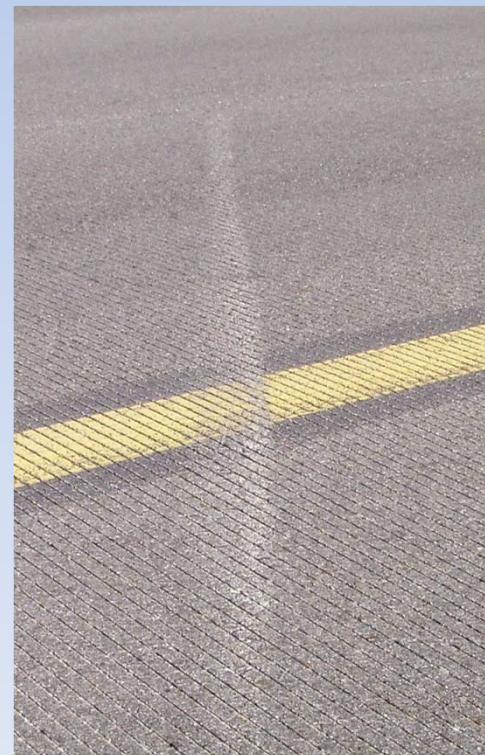
- Snow Removal Brooms and Plows
 - Some paint markings worn from snow removal equipment

Broom mark on the taxiway across the centerline.

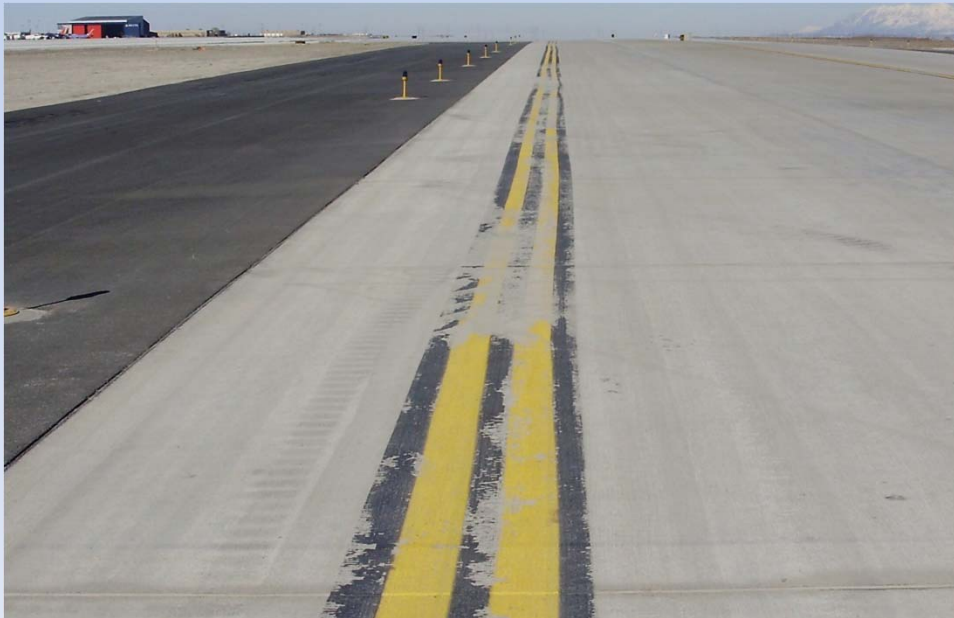
Area was not properly cleaned after construction and paint did not completely adhere.

- Ensure Contractors meet standards and expectations of FAR 139
 - Train and provide contractors with the applicable AC's
 - Require contractors to rectify sub-standard work
- Write contracts for “in-house” painting on airfield construction projects

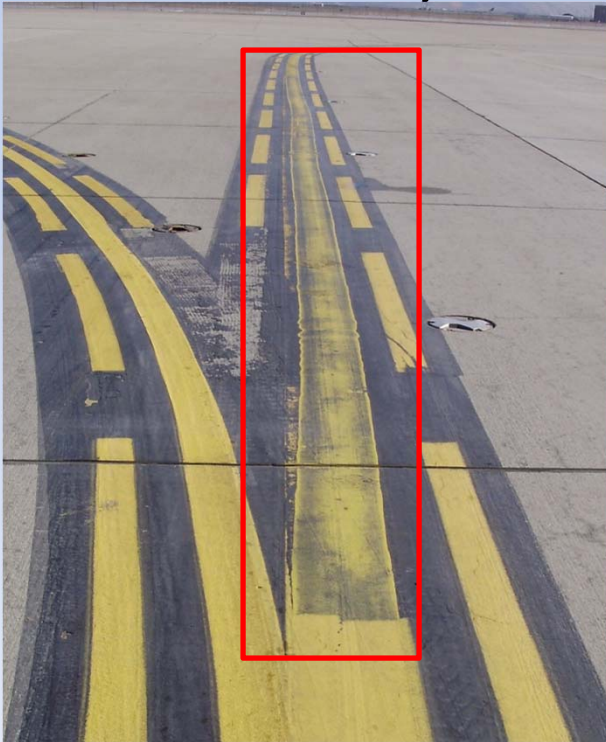
Area highlighted shows contractor applied paint after a construction project where paint application rate was lower and glass beads were not applied.

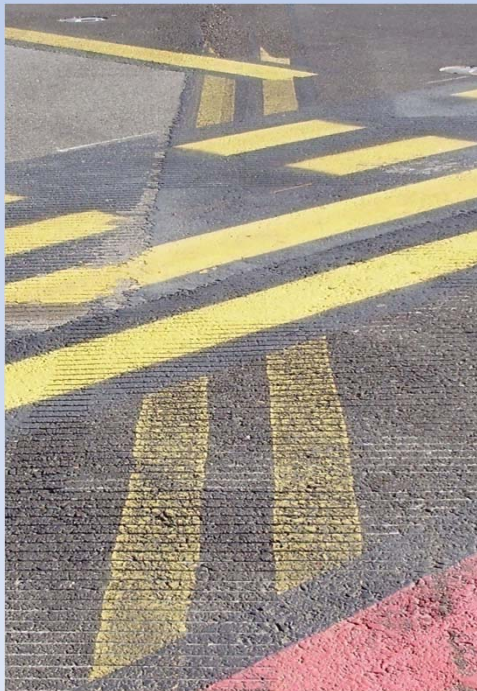
Contractor did not sand blast these two small sections of taxiway edge markings but instead blacked them out. Now they are showing through.

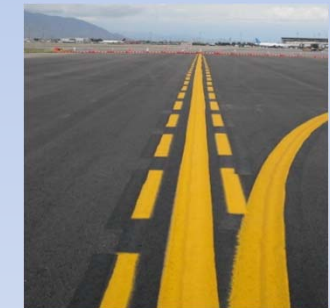
Contractor misread construction plans and painted enhanced centerline too long on newly overlaid taxiway. Paint markings had to be sand blasted.

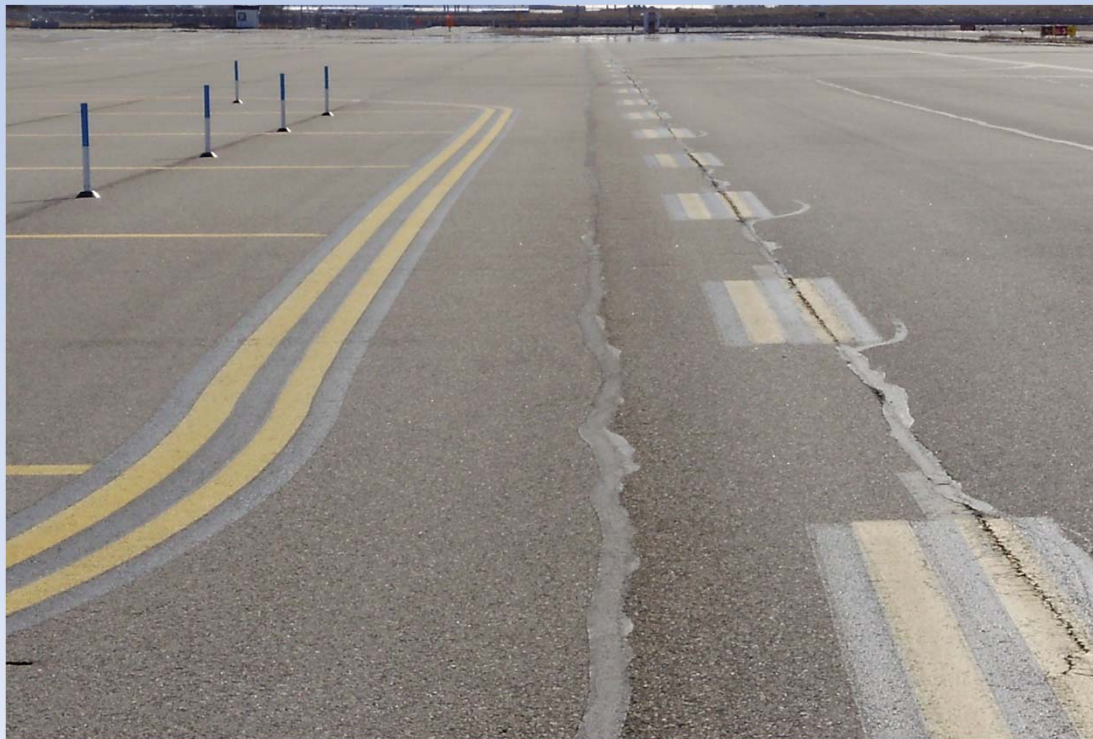
Two markings that conflict with each other.

- Put emphasis on marking specific training
- Develop paint marking “experts” out of maintenance and operations personnel

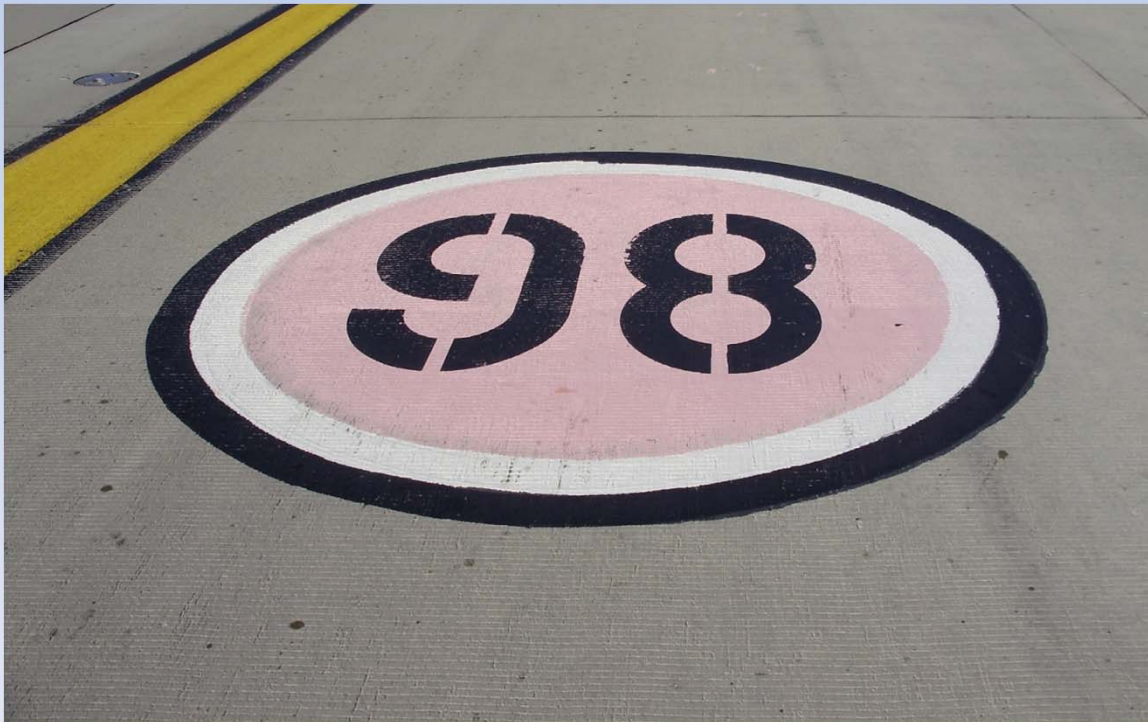
Stencil marks should not be present in paint markings.

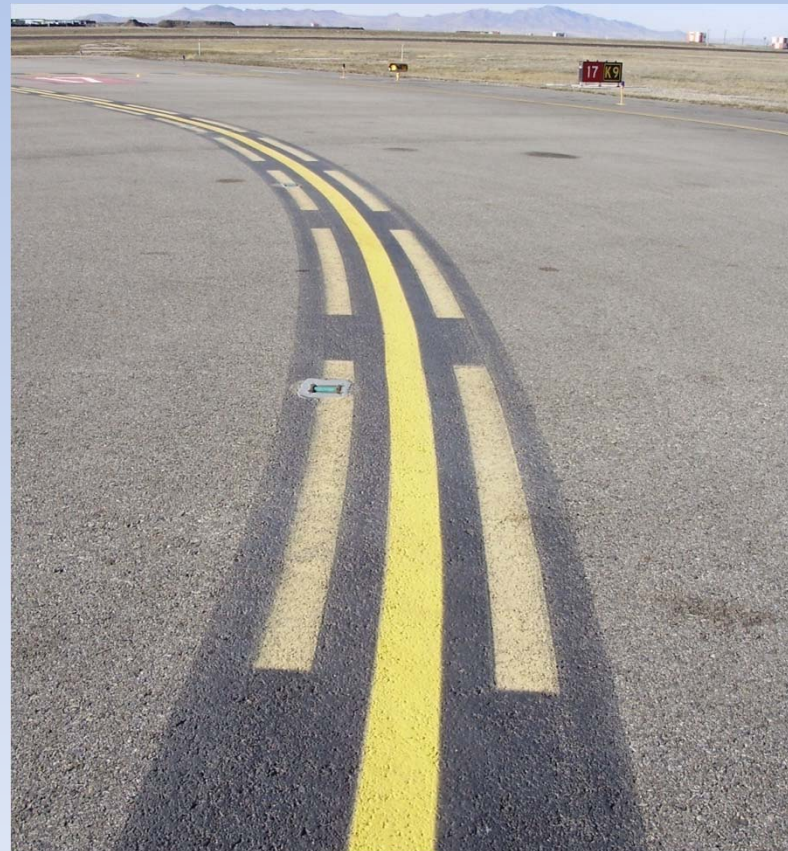
Centerline and enhancements are different shades of yellow. Enhancements painted in the previous year.

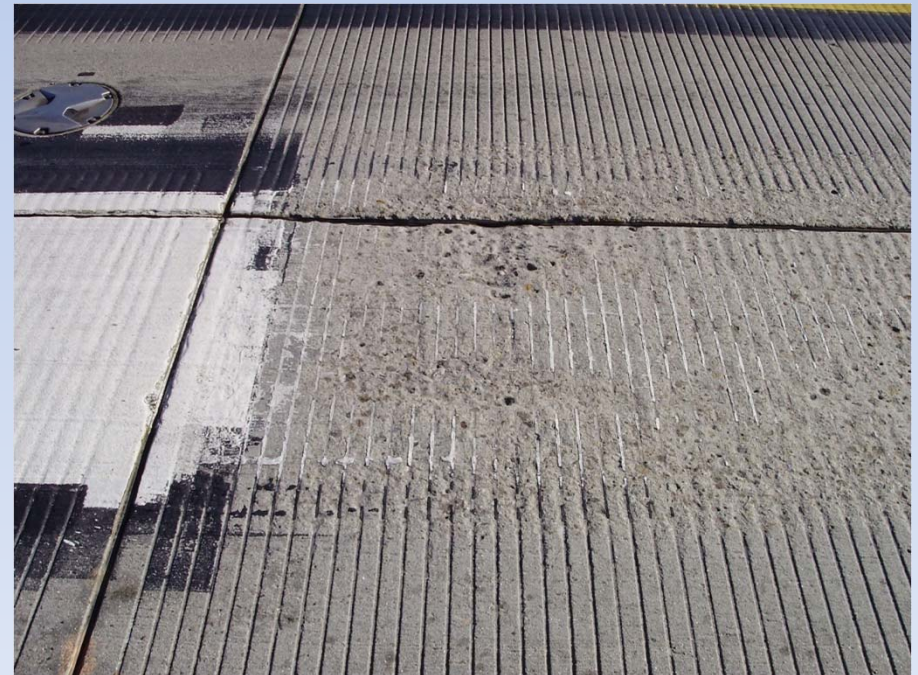
Visible pavement scars caused by grinding of paint markings.

- Employ better techniques that are less scarring to the pavement
 - High pressure water blasting or sand blasting
- Monitor tenant operations to ensure spills are cleaned
- Inspect non-movement areas for paint discrepancies
- Establish a schedule for runway rubber removal

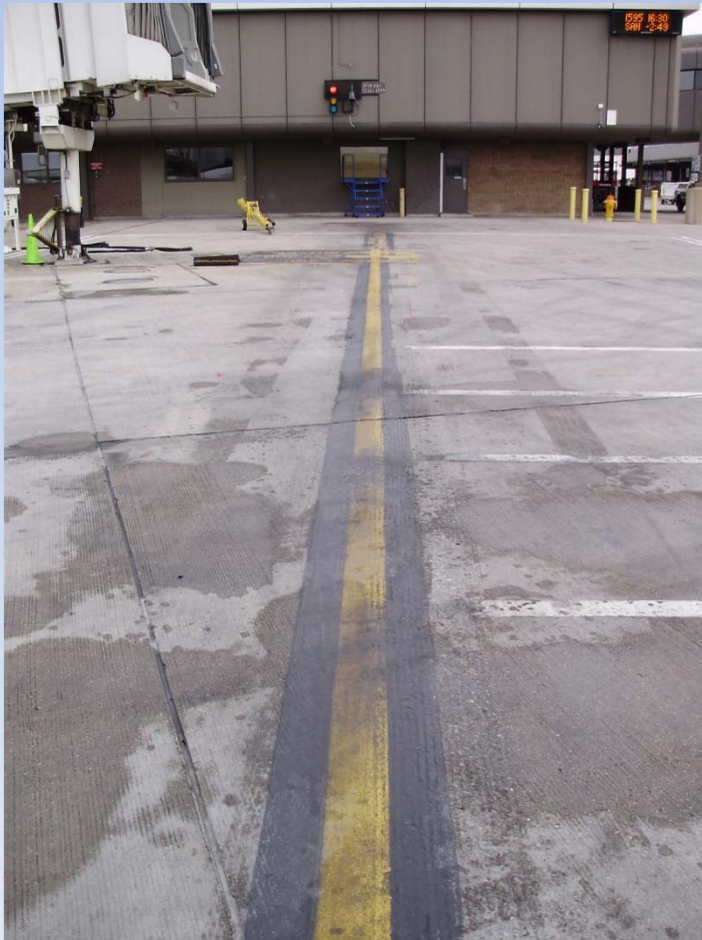
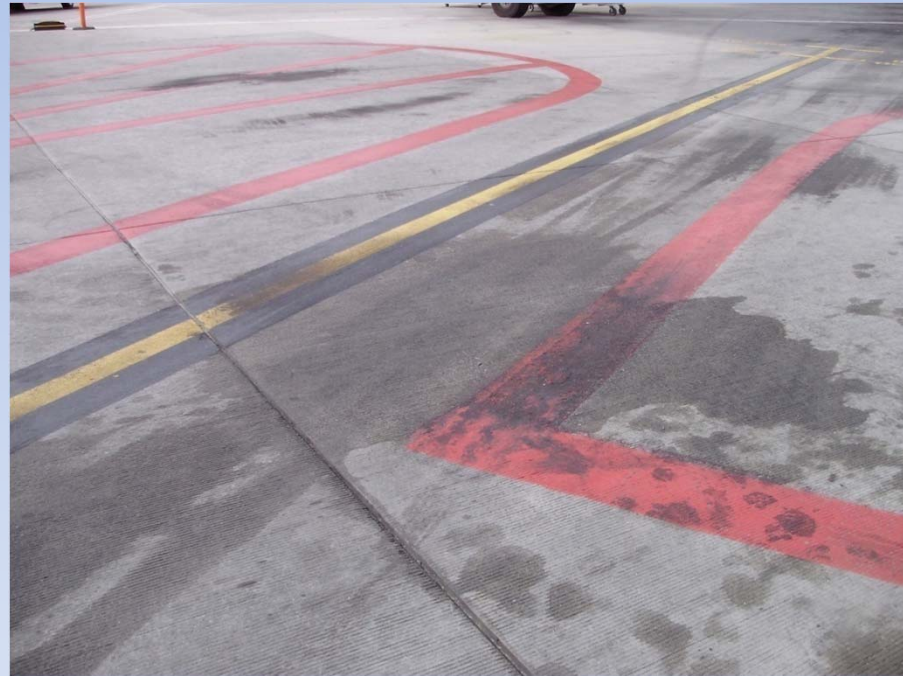
Oil, fuel, and other products cause fading to paint markings over time.

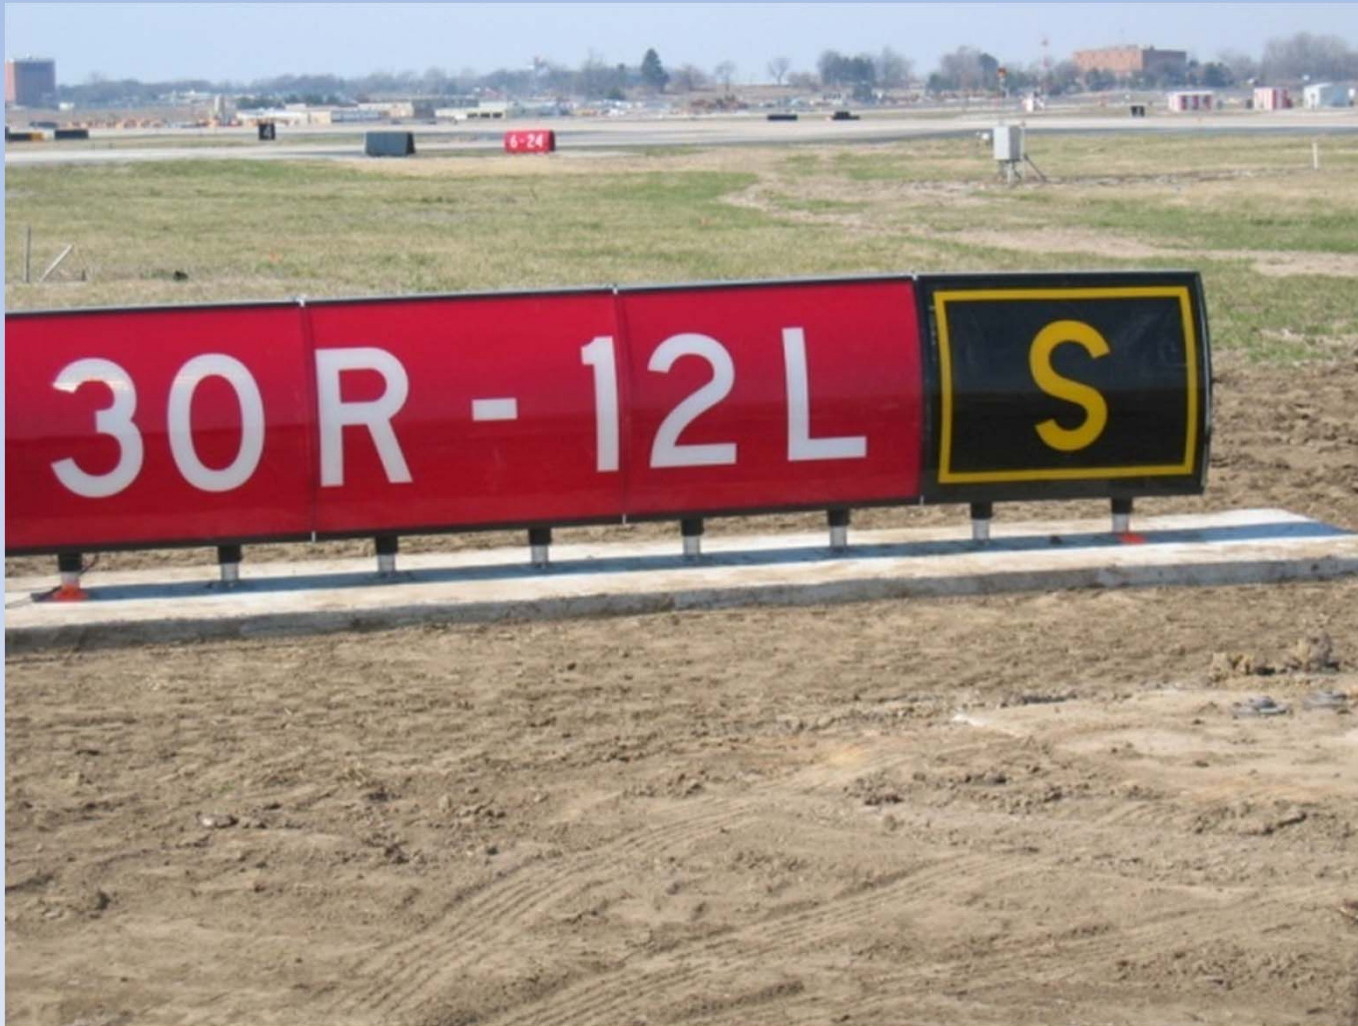
Easy fix, just need to turn the location sign panel over.

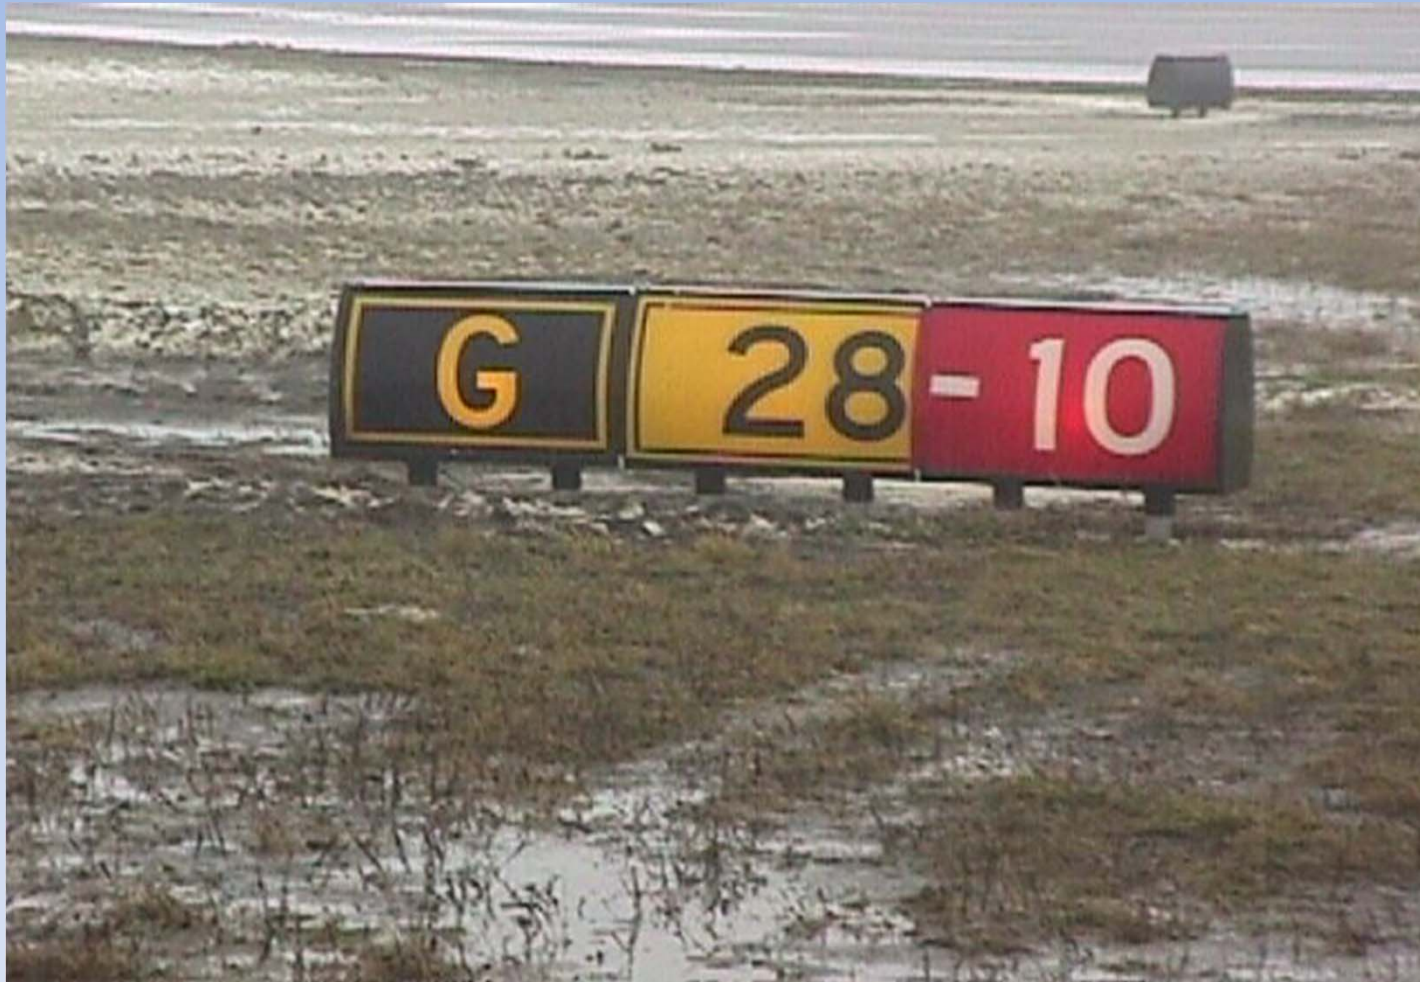
Airport maintenance personnel replaced a broken sign panel with a non-standard panel from an old destination sign. A new panel had not been ordered.

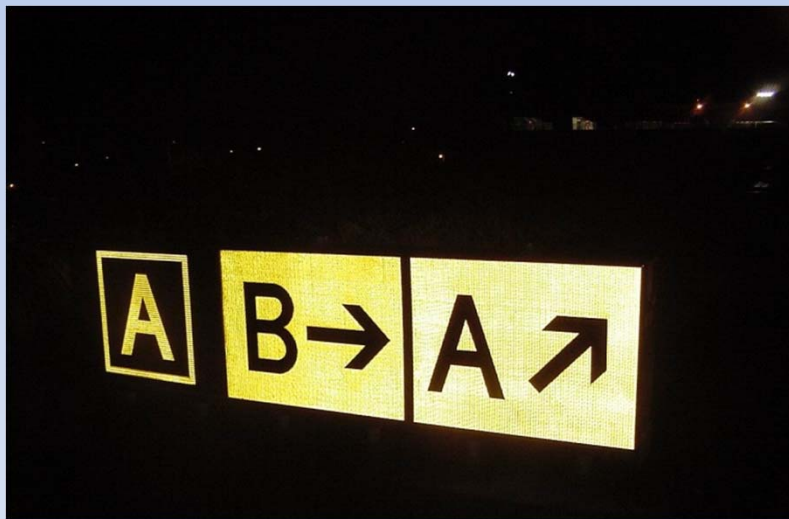
Direction signs and their respective arrows are to be arranged left to right in a clockwise manner.

The A and B direction signs should be switched.

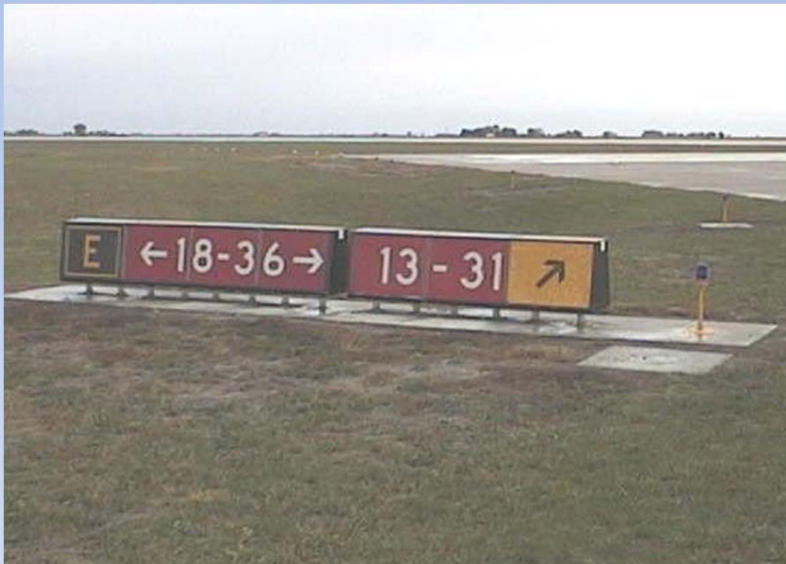
Direction sign arrow on a holding position sign

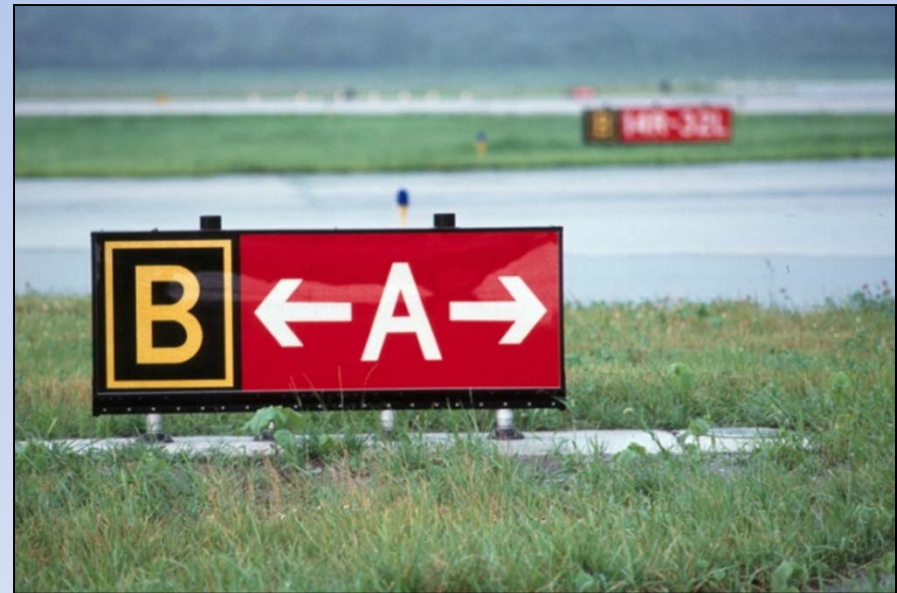
Taxiway direction sign?

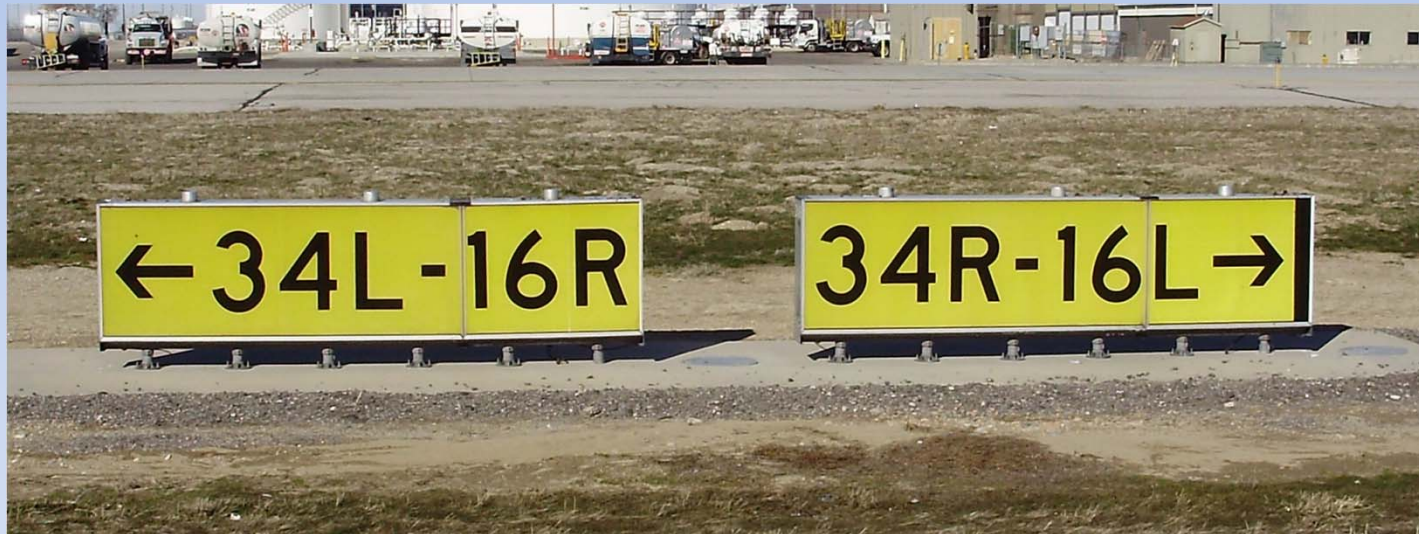
AC 150/5340-18 states "A dash is used only with mandatory instruction signs" and "a dot...is used on signs where one arrow is common to two destinations". This sign should have a dot instead of a dash.

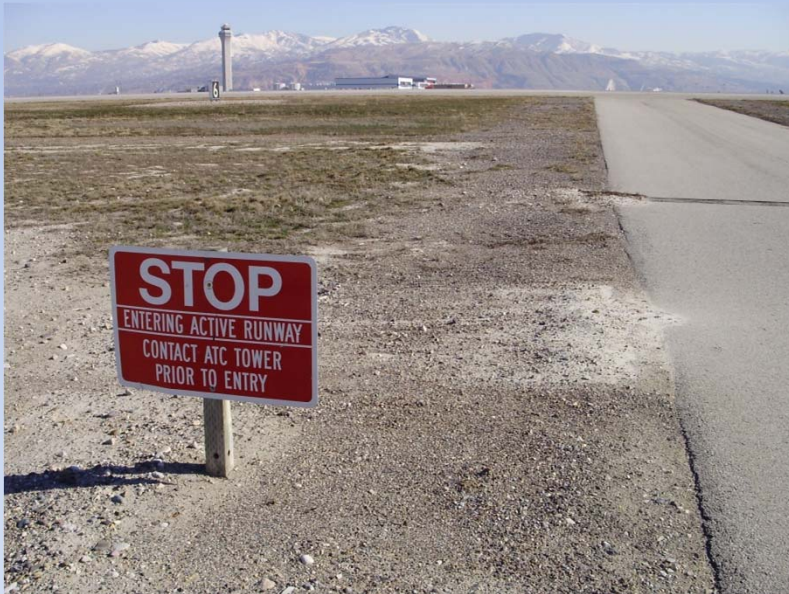
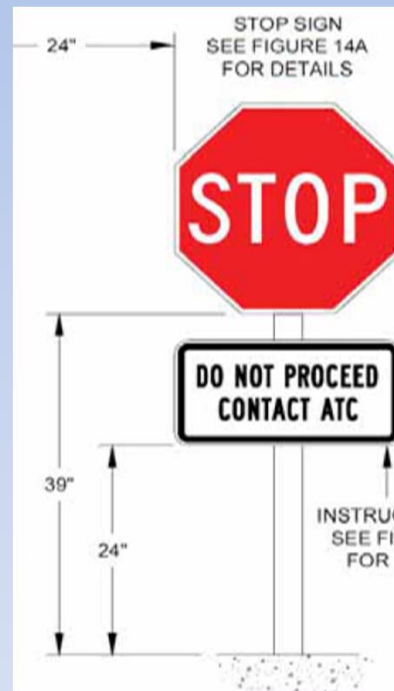
The 2010 revision of the AC states "For an airport with more than one runway, where vehicle service roads enter or intersect a runway a standard retroreflective runway hold position sign should be installed..."

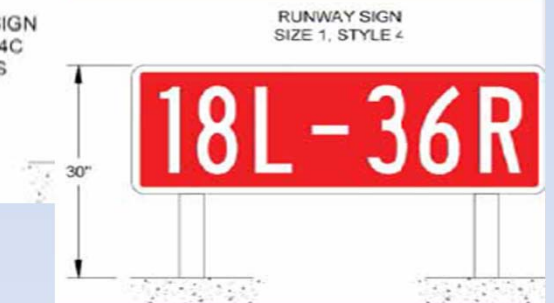
AC 150/5340-18 states "Install standard highway stop signs on vehicle roadways at the intersection of each roadway with a runway or taxiway".

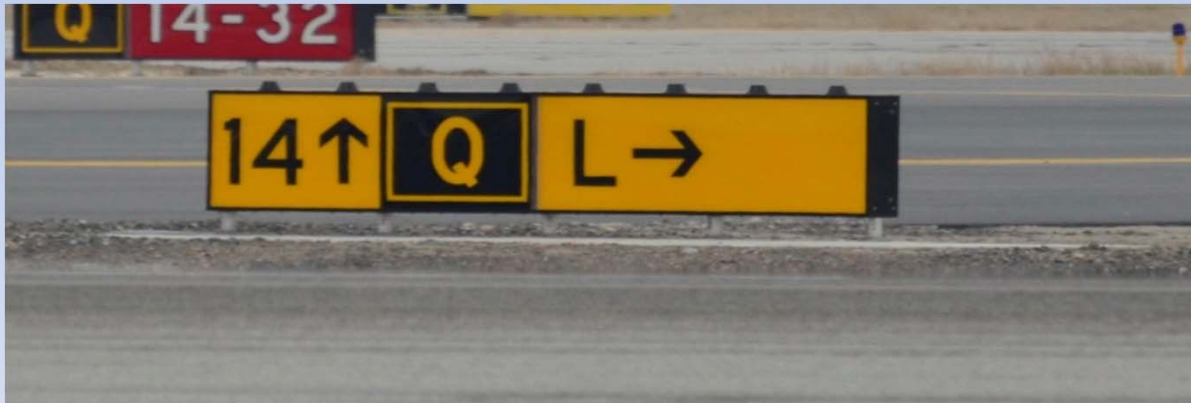
Construction plans for this sign show a black panel being placed on the right half of the sign. Sign was manufactured and installed with large yellow background extending far beyond the legend. Also, destination signs are “not normally collocated with other signs”. Previous versions of the AC restricted destination signs being collocated with other signs.

- Send proposed modified or new construction sign plan to the FAA for review before installation or construction
 - Prevents expensive alterations of signs after installation
- Ensure installed signs meet the sign plan as written

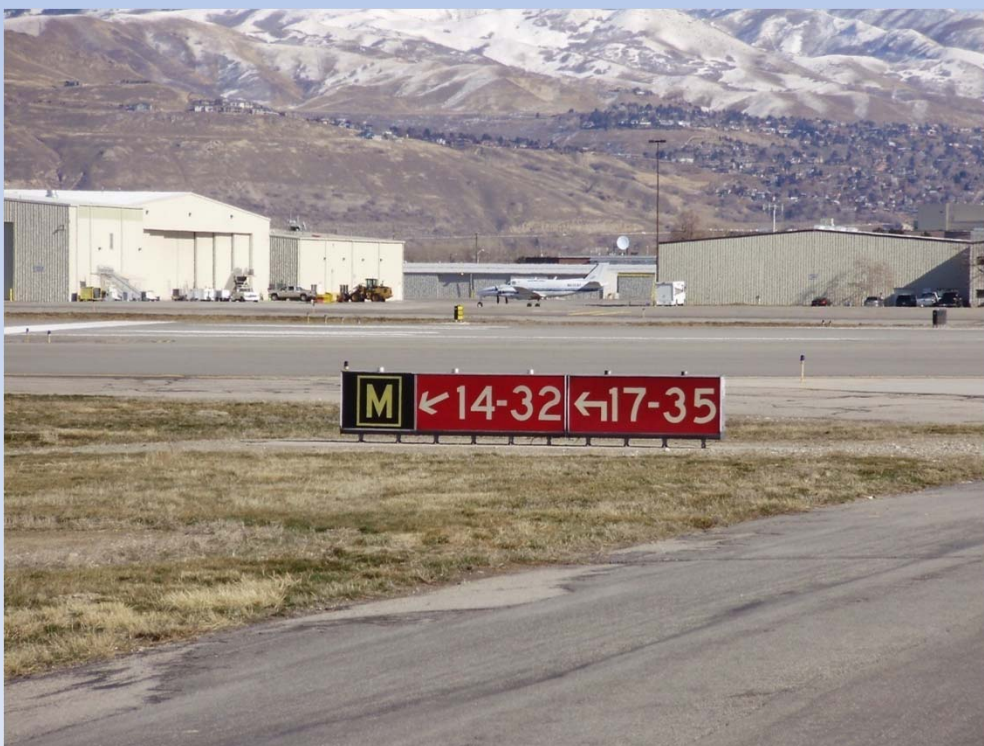
Unconventional arrow on mandatory sign for runway 17/35, with intent to prevent pilots from mistakenly lining up on runway 32 for a runway 35 departure.

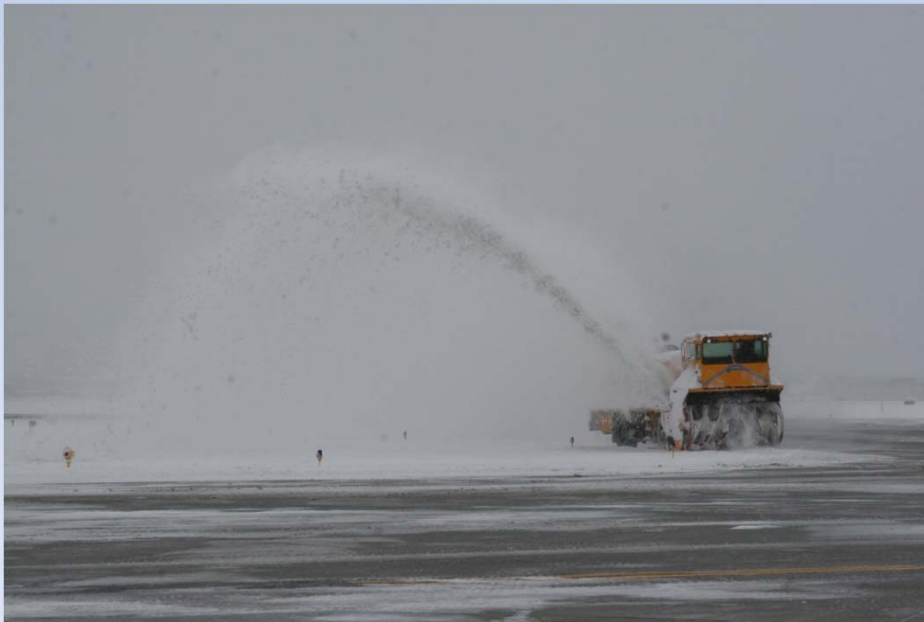
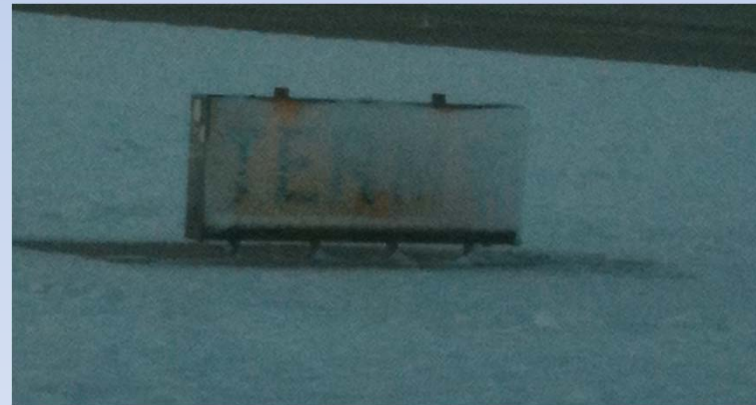
- Snow
 - Equipment on occasion damages sign faces
 - Snow obscures signs

- Inspect all signs after winter events
- Record sign damage with weather data to determine trends
 - Don't rule out equipment operation training
- Continually clean signs during winter events
 - Use a squeegee to prevent sign face damage and never use ice scrappers
