# Tech Notes

## TEMPORARY PROTECTION

### VILLARD HOUSES

### Temporary Protection of Historic Stairways during Rehabilitation Work

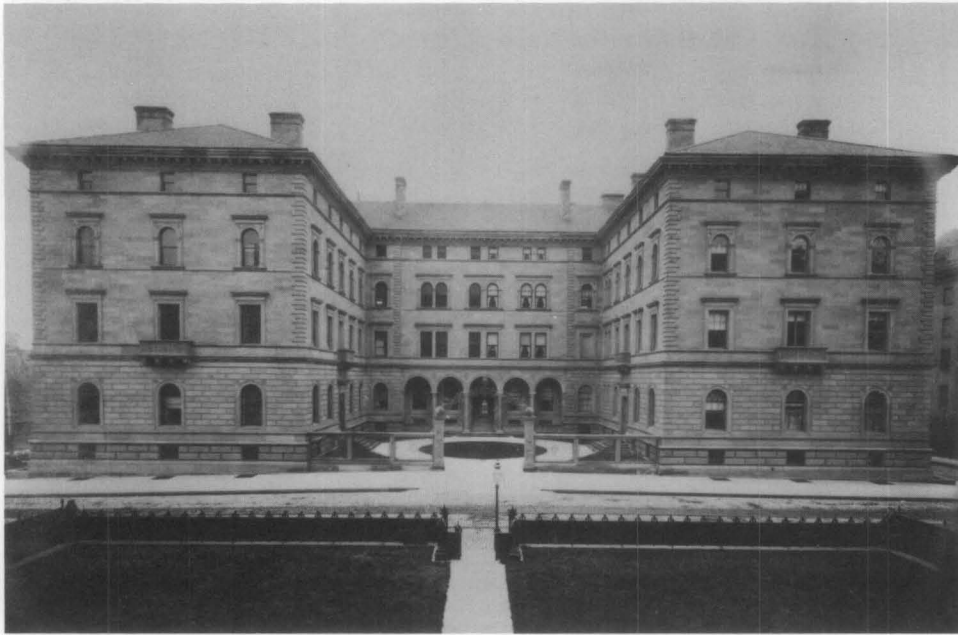
**Figure 1.** The Villard Houses include stairways ranging from very elegant (seen here) to quite simple. All could have been damaged if not protected during the extensive rehabilitation work. Photo: Steven Zane, HABS Collection.

The original residences known as the Villard Houses were designed by the firm of McKim, Mead and White and constructed in the 1880s in the style of a Neo-Italian Renaissance palazzo. The interiors of the buildings contain a remarkably high quality of design and workmanship with extensive use of decorative paintings, mosaics, paneling and marble. The elegant interior staircases which contribute to the richness of the interior spaces were constructed in a variety of designs and materials (*see figure 1*).

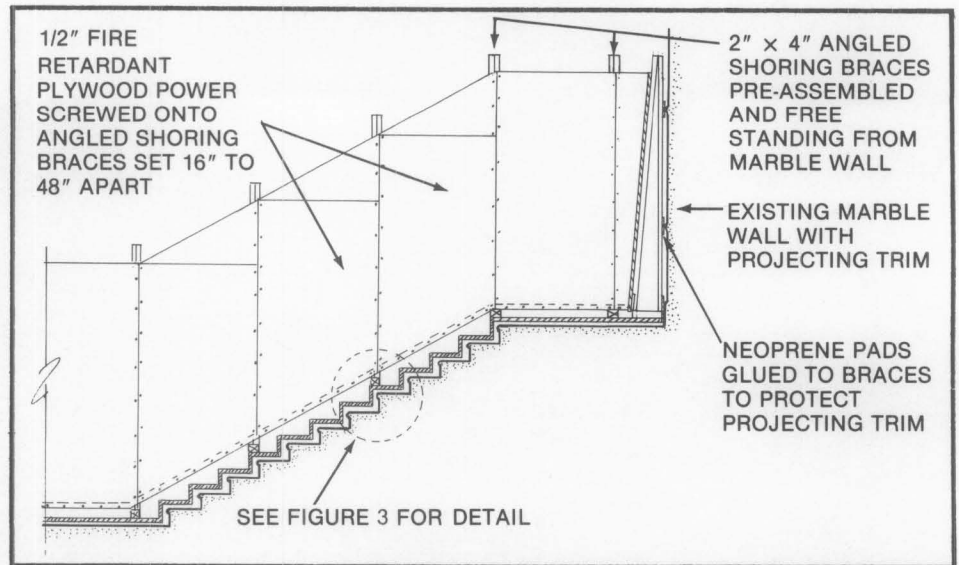
**Figure 2.** A system for protecting the decorative staircases was drawn and specified by the project architect. Drawing: Christina Henry.

The basic system consisted of using plywood and padding to cover the walls, steps and balustrade without using any anchoring devices that would damage historic material (see figure 2). Screws were used rather than nails in fastening the wooden temporary pieces together to lessen the chances of accidental damage to historic fabric and to facilitate disassembly.

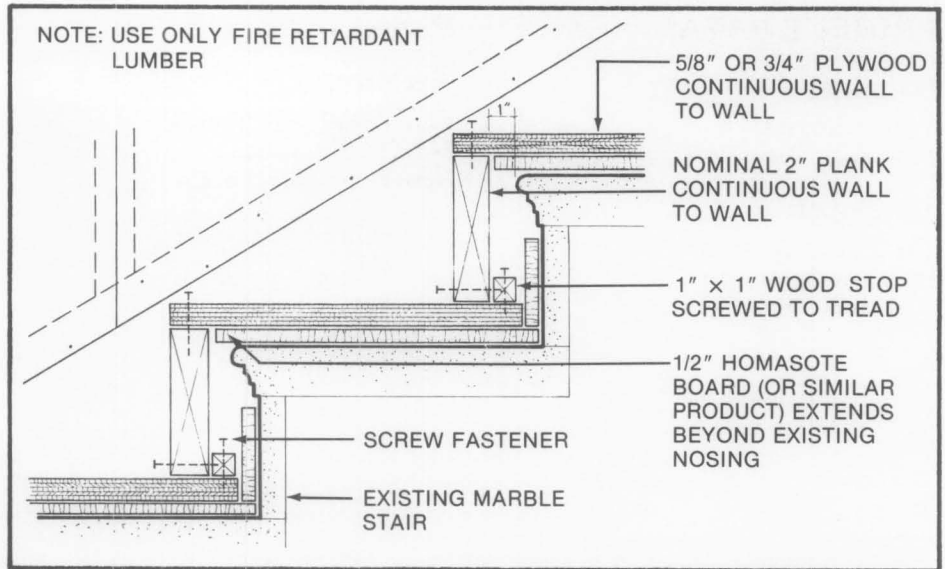
Figure 4. This cross-section of one of the staircases shows that the entire historic balustrade was temporarily encased in wood during the renovation work. Drawing: Christina Henry.

Once the temporary wood floors were installed, the balustrades were encased in plywood (see figure 4). For the sections running on top of the handrail, 5/8" or 3/4" plywood was used, cut wider than the handrail to permit attachment of 2 by 4 blocking on the underside for securing the 1/2" plywood side walls away from the balustrade (see figure 5). For padding, neoprene was glued to the face of the blocking closest to the edge of the handrail as a cushion in case the covering was jarred. The handrail was cushioned further by soft fiberboard glued to the underside of the plywood top. After the top section was assembled, the side plywood walls were cut and attached; the side walls were additionally blocked out wherever the newel posts protruded beyond the balustrade (figure 6). The entire assemblage was secured tightly with judicious use of braces and blocking or where necessary was screwed to the temporary wood floor.

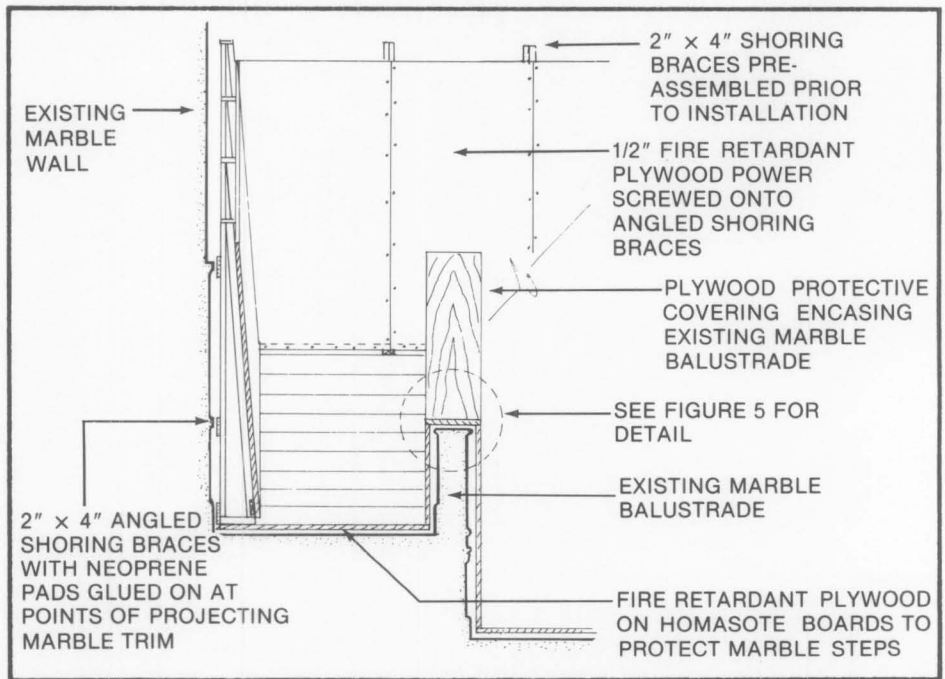
Figure 5. As with the step detailing, the temporary protection over the balustrade and hand railing used plywood padding, blocking, and screw fasteners to minimize possible damage. Drawing: Christina Henry.

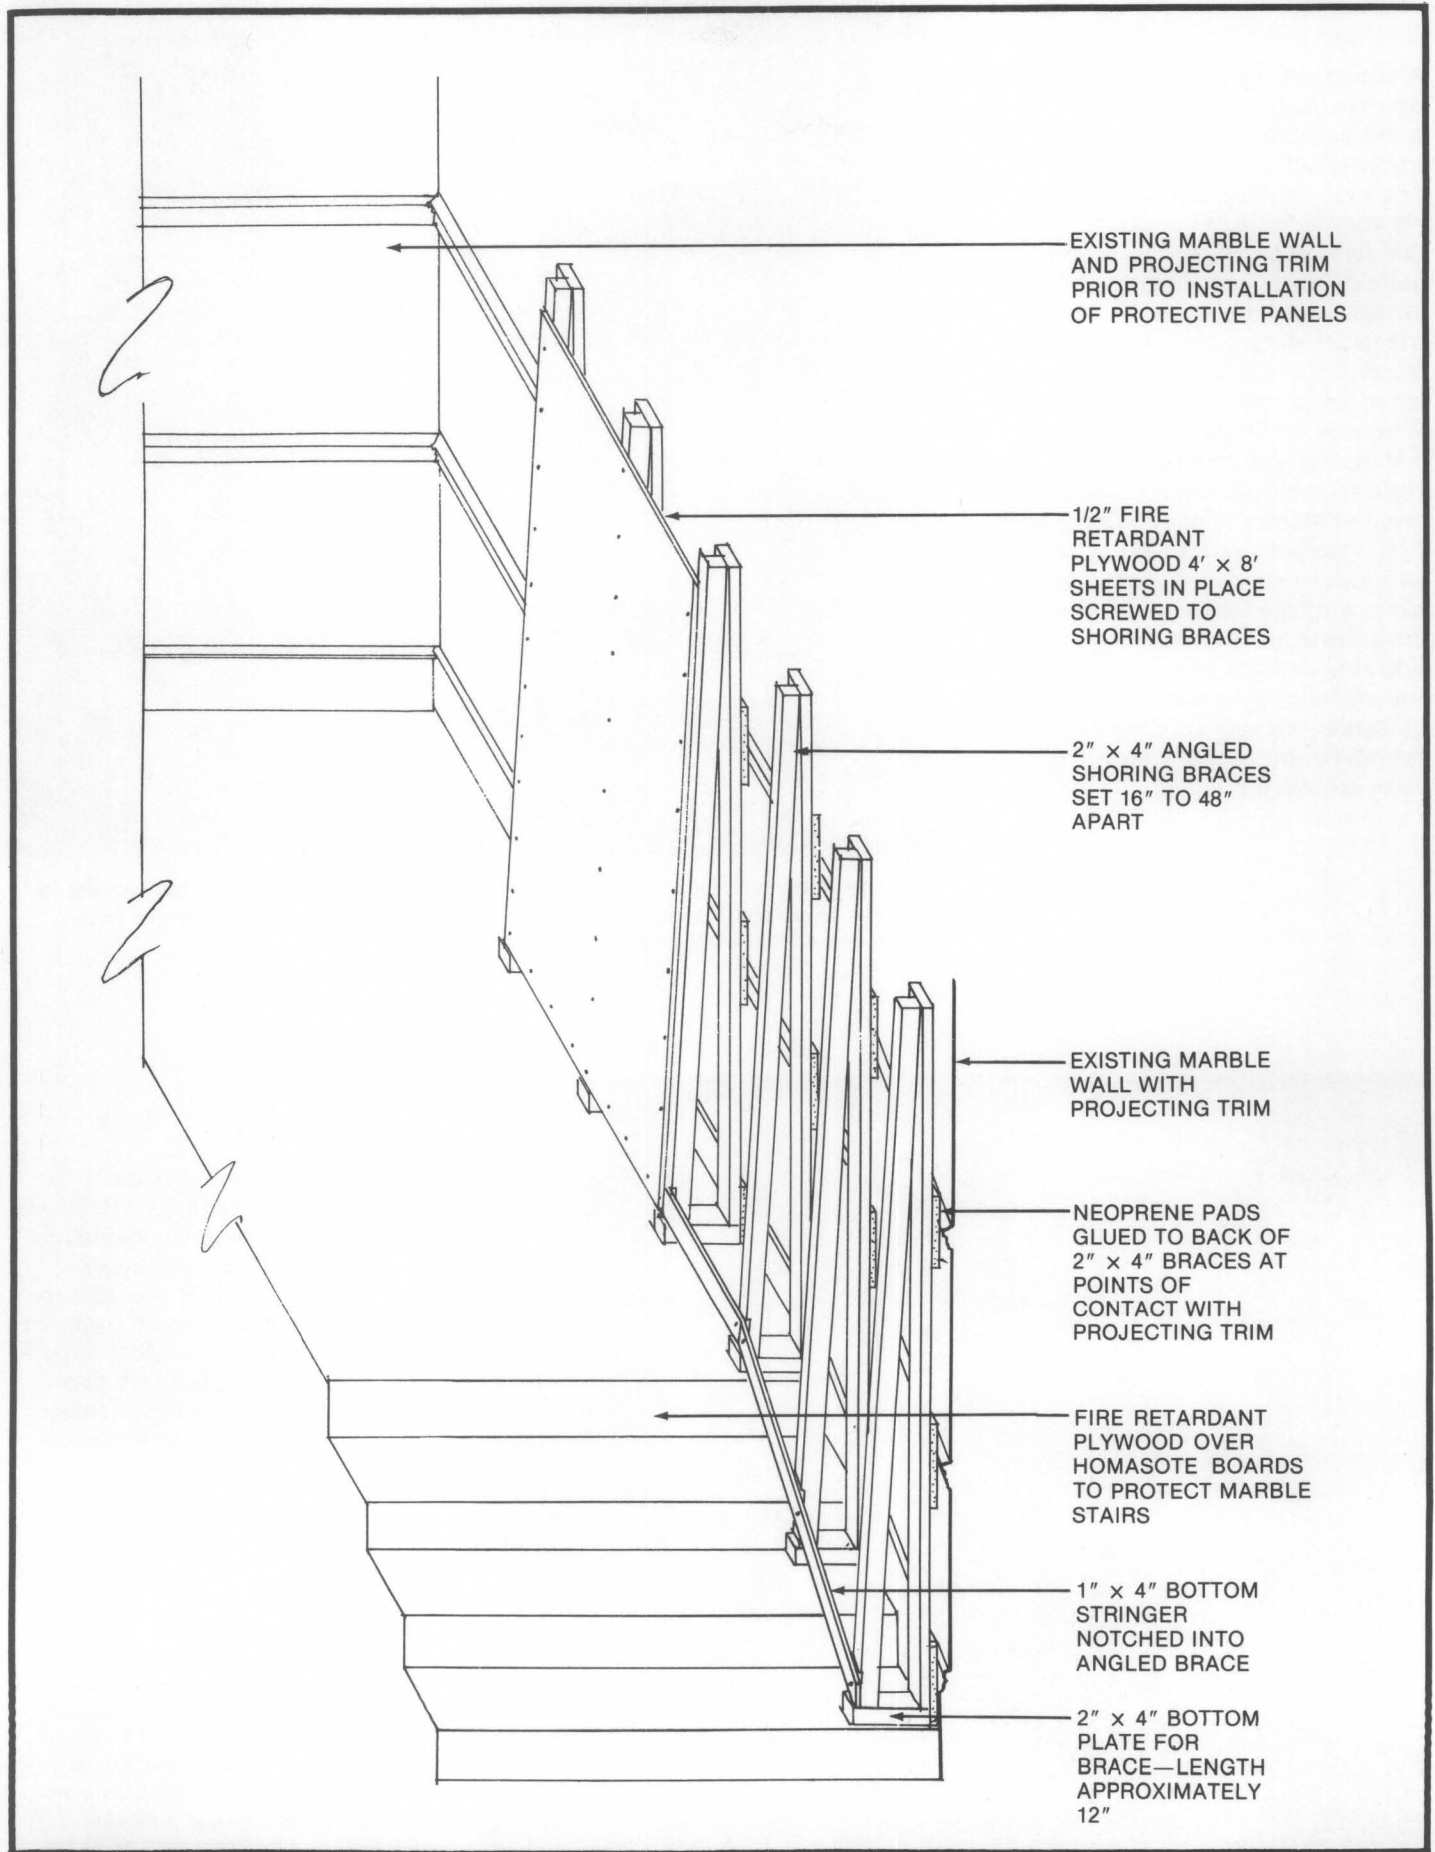
Figure 7. The temporary wall covering going up the stairs consisted of plywood mounted on a wooden frame. Neoprene padding was used where the frame abutted the historic walls. The method shown here requires no fasteners to be used, avoiding possible damage to the decorative walls. Drawing: Sharon Park, A.I.A.

A temporary eight foot high wall was constructed to protect the historic wood paneling, marble and decorative trim typically found along the stairs. The wall covering consisted of plywood attached to a wood frame that had been designed so as to require no anchor attachments to the historic walls (*see figure 7*). The triangular shaped sections of the frame which supported the plywood rested on the plywood floor covering. Wherever the frame abutted historic material, a thin neoprene pad was glued to the wood beforehand to avoid scratching. For greater rigidity, 2 by 4 sleepers were added in various locations to connect the triangular sections of the frame. In cases where the historic handrail protruded considerably and was not temporarily removed during construction, the triangular sections were not pre-assembled, but rather constructed in place around the railing.

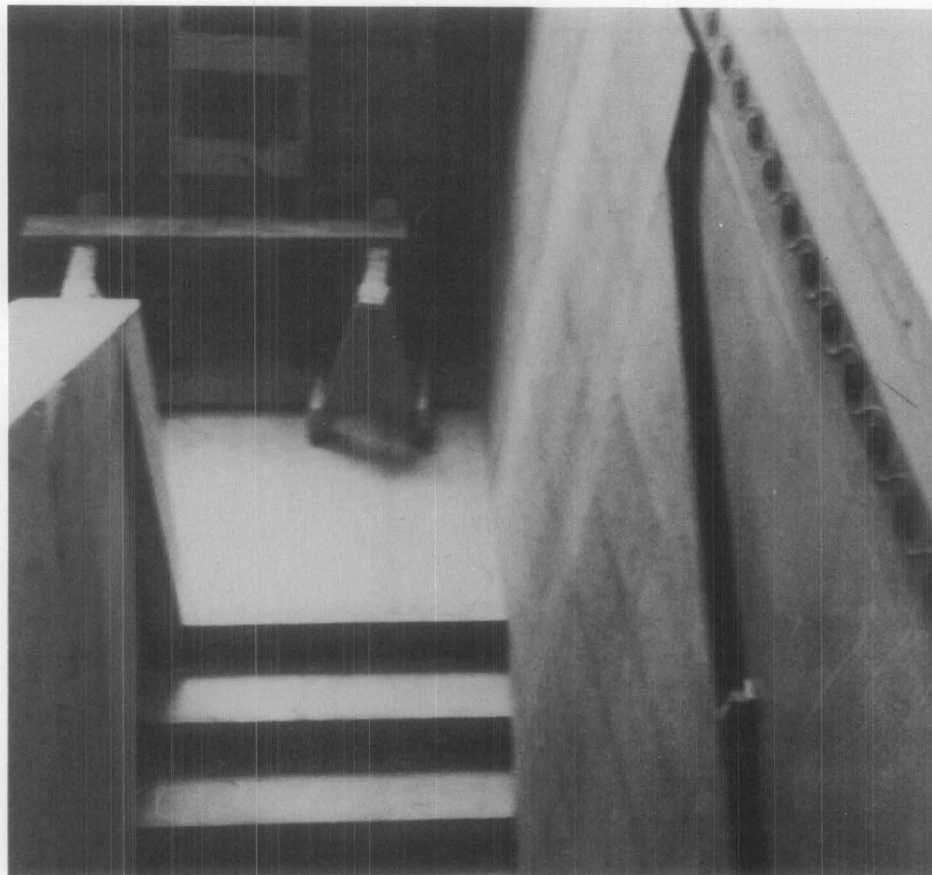
Figure 6. The balustrade on the left side of the photograph has been entirely encased in plywood to protect it from damage. Note that the kick-out at the end is due to the protrusion of the newel post. Photo: Charles Fisher.

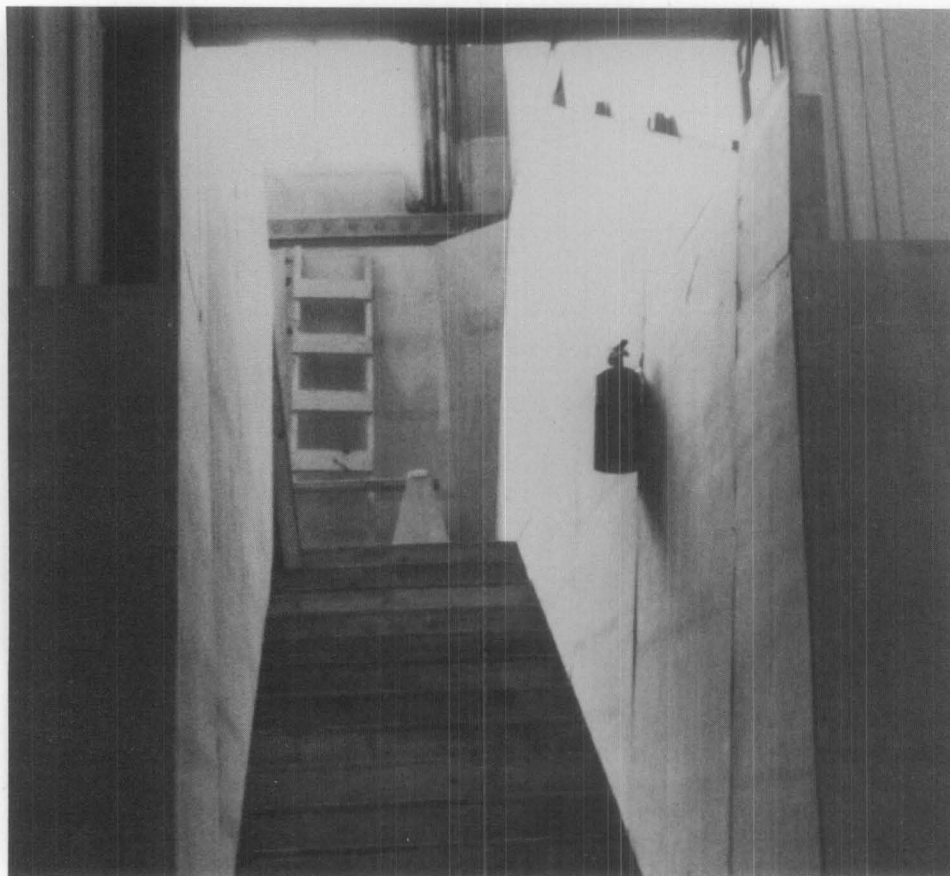
Figure 8. The entire historic staircase has been protected against possible damage during the renovation work. The balustrade on the left has been encased in plywood; the floors have been covered; and a temporary plywood wall constructed, shown on the right and at the landing. Note that the plywood wraps around the wall at the entranceway. Photo: Charles Fisher.

The cost of this work was quite modest and the protective system was sufficiently flexible to be adapted to staircases of different dimensions, designs and material. It was easy to construct and required only common fasteners and materials. Most importantly, this system effectively protected the staircases against damage during the renovation work (*see figure 8*).
