Post-Fire Treatment Effectiveness for Hillslope Stabilization

Peter R. Robichaud, Louise E. Ashmun, and Bruce D. Sims

A SUMMARY OF
KNOWLEDGE FROM THE

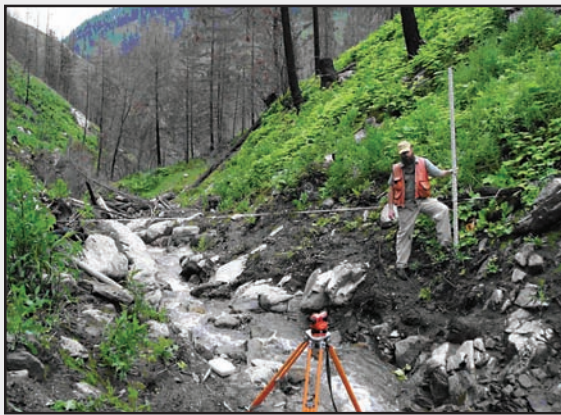
SB1-figure 1. Cross-section measurements were used to model the storm flow and estimate the parameters of the post-fire debris flow in this channel.

A year after the 2005 Blackerby Fire in north-central Idaho, a rain event (1.5 inch [38 mm] of rain in 54 min) triggered a large hydrological response on a steep area burned at high severity. The runoff concentrated in the upper and mid reaches of the channels in predictably high volumes, and sediment and debris (rock and some woody materials) were quickly entrained in the flow. As the debris torrent entered the lower reaches, nearly all of the larger material (debris) was deposited, and the high density (sediment-laden) flood flow continued down the channel. The addition of sediment and debris to the concentrated runoff flow increased the flow volume multi-fold. Using measured channel cross sections of the debris torrent and using models to predict the runoff/flow volume, the proportion of water to sediment and debris was estimated (SB1-fig. 1).

Upslope from the culvert locations, cross-sectional areas were almost five times greater for the debris torrent (60.2 ft² [5.60 m²]) when compared to the predicted water flow cross-sections (12.4 ft² [1.15 m²]); volume estimates for the debris torrent (620 ft³ s⁻¹ [18 m³ s⁻¹]) were nearly an order of magnitude greater than the flow volume estimated for water alone (SB1-fig. 2). Protection of values-at-risk such as culverts, bridges, and stream-adjacent infrastructure is dependent on an adequate treatment response, and in turn, treatment decisions are dependent on accurate predictions of potential post-fire response.

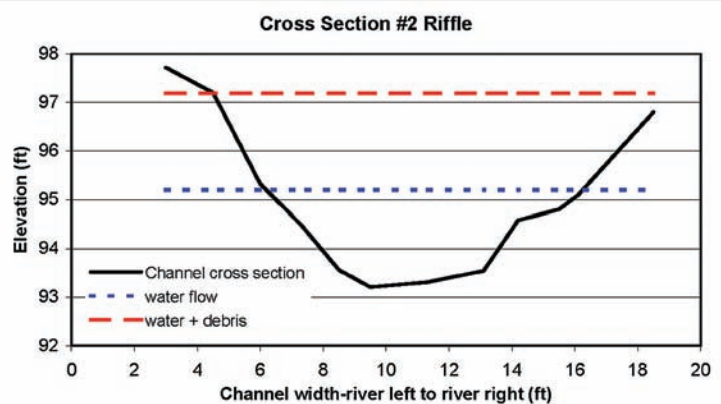
SB1-figure 2. Channel cross-section diagram showing the base channel structure, estimated cross-sectional area of water flow in the channel (based on hydrological modeling), and measured cross-sectional area of the debris torrent (water flow plus debris).

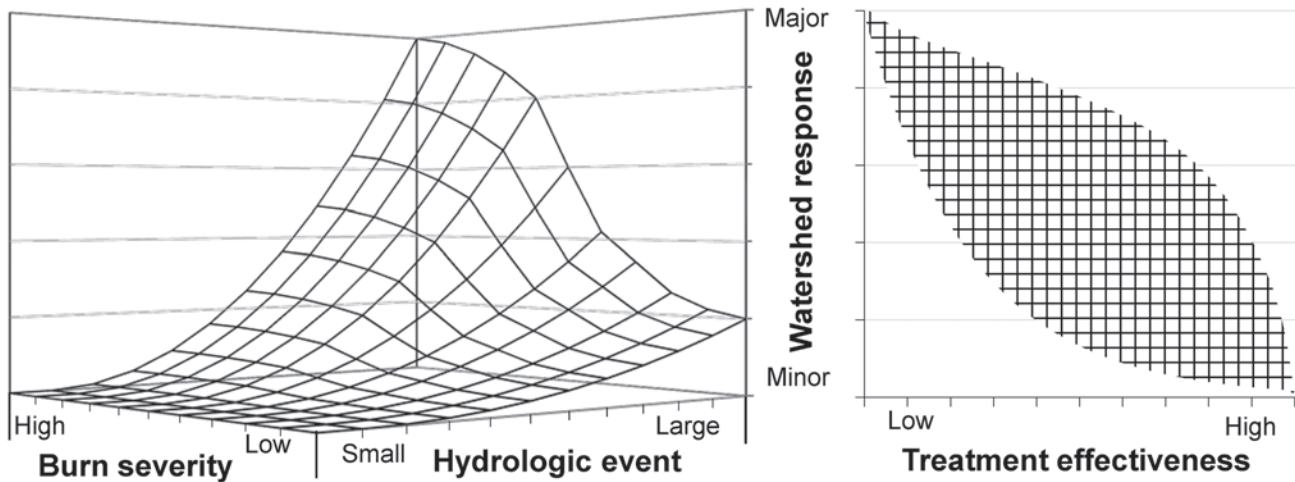
Figure 2. The three-dimensional chart on the left is a conceptual diagram (after Neary and others 2005b) that illustrates the relationships between burn severity (low to high), hydrological event (small to large), and watershed response (minor to major). The chart on the right uses the same vertical axis (watershed response) and adds a fourth dimension—treatment effectiveness (low to high)—that is represented by a cross-hatched area. Treatment effectiveness varies by treatment type but generally decreases as watershed response increases.

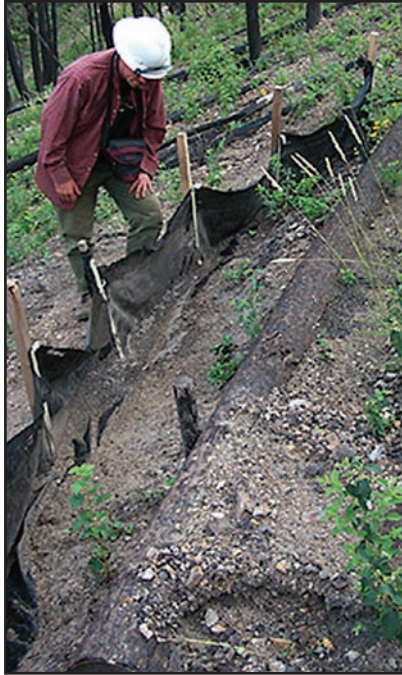
Figure 6. Hillslope plot that incorporates a swale with a double silt fence at the base for sediment collection on the 2000 Bobcat Fire in Colorado.

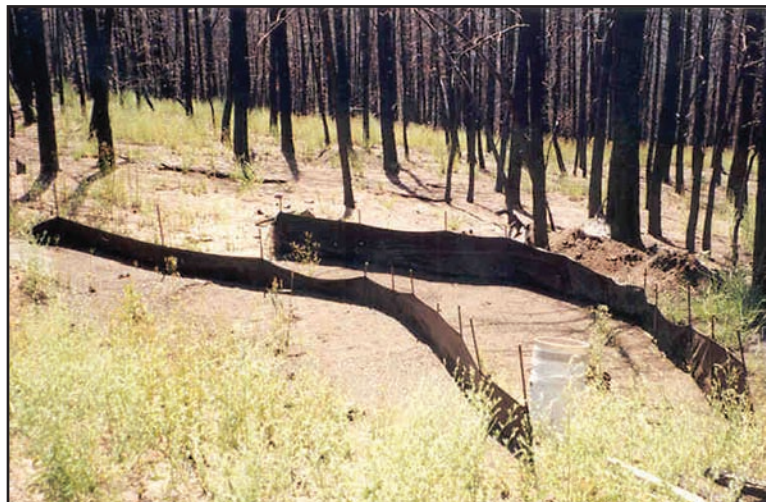
Figure 7. Cleaned-out sediment basin at the outlet of a catchment study site on the 2002 Hayman Fire in Colorado.

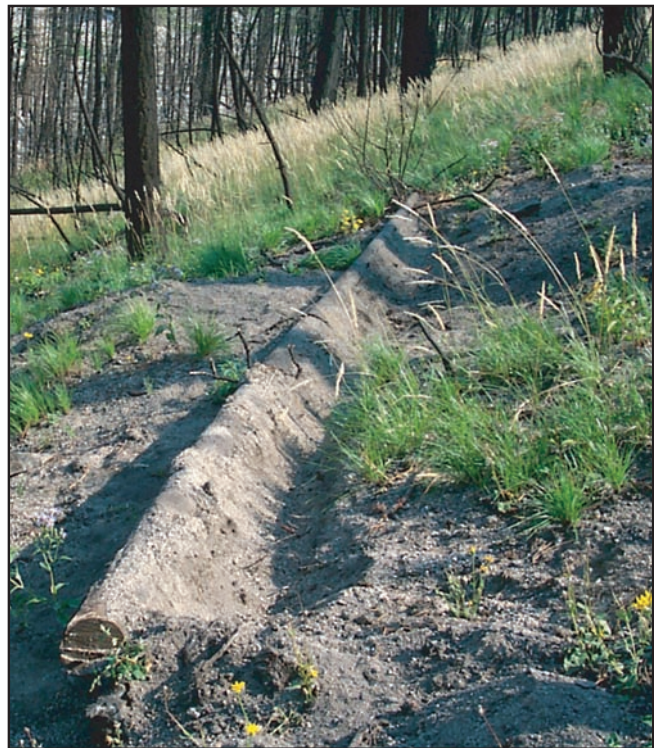
Figure 8. A contour-felled log erosion barrier with soil end berms to increase sediment storage capacity.

These structures are designed to slow runoff, cause localized ponding, and store eroded sediment. When the erosion barriers function as designed, they can decrease the erosive energy of runoff, increase infiltration, and reduce downstream sedimentation (Robichaud 2005). Common post-wildfire hillslope erosion barriers include contour-felled logs (LEBs) (fig. 8), straw wattles (10 inches [0.25 m] diameter, 13 to 20 ft [4 to 6 m] long nylon mesh tubes filled with straw) (fig. 9), contour trenches (hand or machine dug trenches), and straw bales (blocks of straw bound with twine) (fig. 10). To eliminate long uninterrupted flow paths, erosion barriers are generally installed in staggered tiers with the center of each erosion barrier directly downslope from the gap between the two erosion barriers above it.

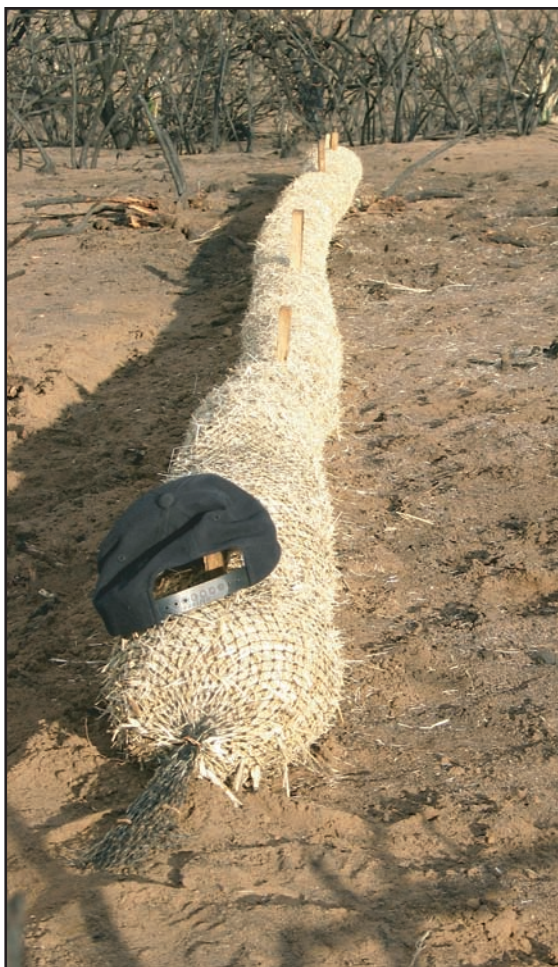
Figure 9. A recently installed straw wattle erosion barrier.

Straw wattles have been used as a reasonable alternative to LEBs in burned areas where logs were scarce or poorly shaped (for example, in the chaparral areas of southern California, as seen in fig. 9). Straw wattles are permeable barriers that detain surface runoff long enough to reduce flow velocity and provide for some sediment storage. Like LEBs, straw wattles can be laid out in staggered tiers on a hillslope (fig. 11) but are flexible and conform to the soil surface so that gaps rarely occur. The disadvantages of straw wattles include the expense of manufacturing and shipping, and the potential for the straw fill to be a source of non-native seed and an attractive food source for animals.

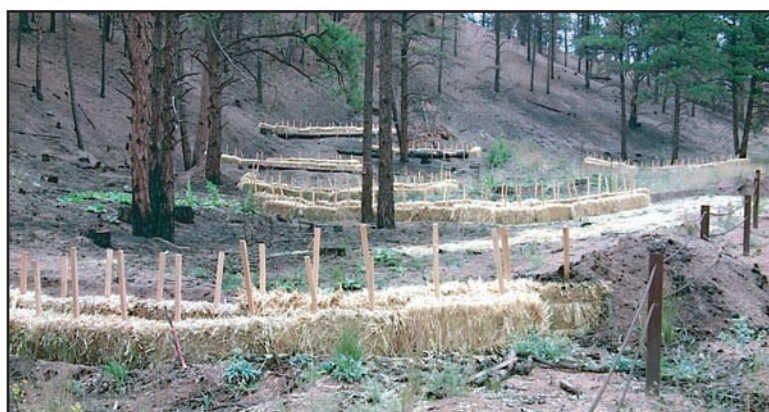
Figure 10. A set of straw bale erosion barriers installed in a burned swale on the 2002 Hayman Fire in Colorado.

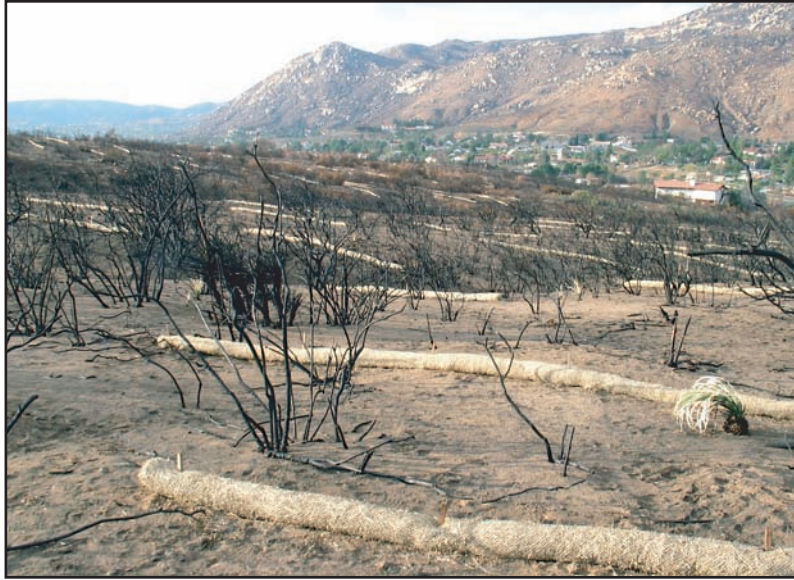
Figure 11. Straw wattles installed in a staggered layout on a burned hillslope.

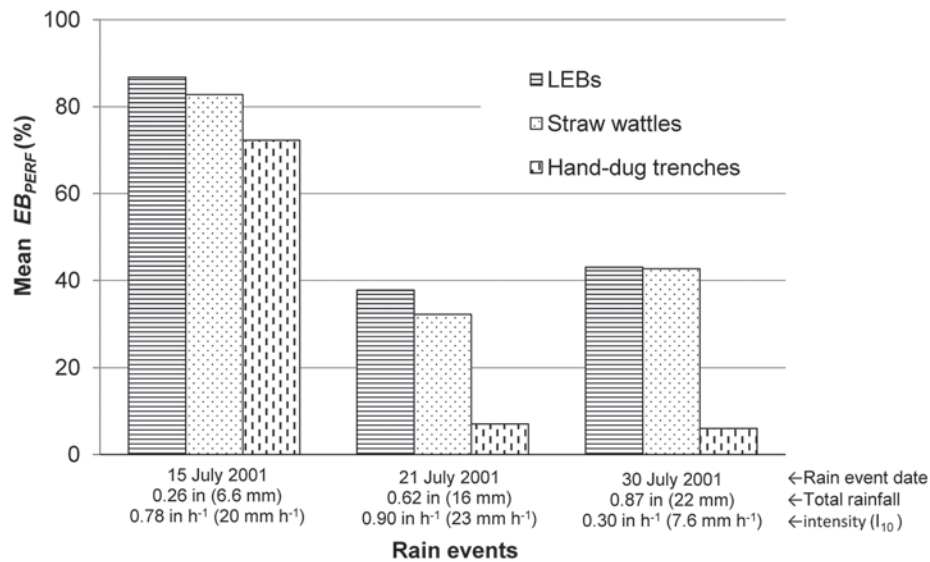
Figure 12. Mean erosion barrier performance (EB_{PERF} [%]) for three successive natural rainfall events in post-fire year one as measured on hillslope study plots established on the 2000 Valley Complex Fires in western Montana. The date, total rainfall amount, and maximum 10-min rainfall intensity are listed for each event (Robichaud and others 2008a).

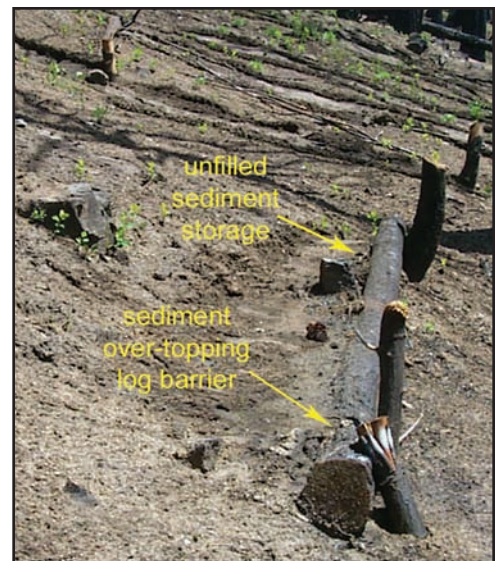
Figure 14. A partially filled LEB with unused sediment storage capacity indicated.

Another erosion barrier performance measurement compares the actual volume of sediment stored behind an erosion barrier to the total sediment storage capacity of that erosion barrier (fig. 13). The sediment-trapping ability of any erosion barrier installation is dependent on the site characteristics (for example, slope and soil type), the individual erosion barrier features (such as diameter, length, accuracy of contour placement, and seal between the barrier and the ground), and the density and pattern of erosion barriers over the landscape. When LEB installations have been examined to determine how much sediment-holding capacity is used, the mean sediment storage performance of the barriers is around 60 to 70 percent (Robichaud and others 2008a, b). Robichaud and others (2008a) qualitatively evaluated erosion barrier performance over three natural rain events. In 13 of 29 observations, runoff and sediment flowed over the top of the barrier, yet only 3 of the 13 barriers were filled to capacity and 5 barriers were at or below 50 percent full. Overland flow patterns and LEB shapes often result in uneven filling of the sediment storage area above the LEB that leaves a portion of sediment storage capacity unused (fig. 14).

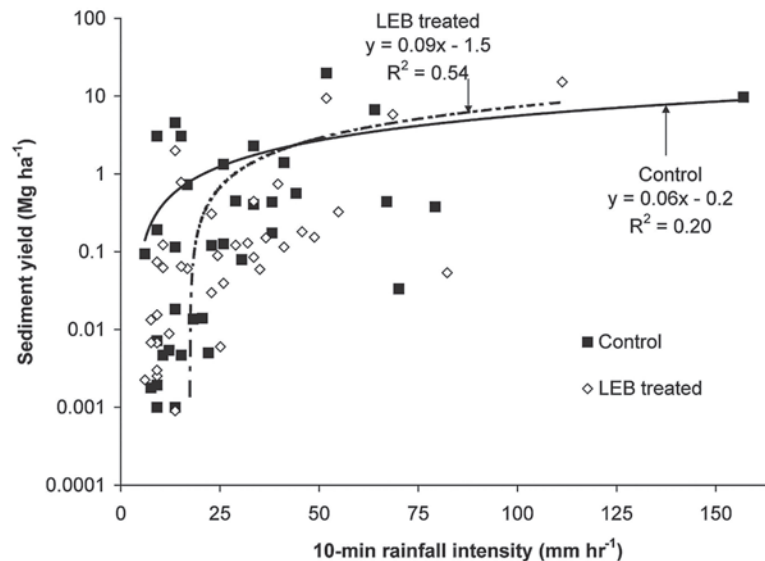
Figure 15. Rainfall intensity versus sediment yield (logarithm scale) from a paired watershed study that involved six sites and data from up to six post-fire years in the western United States (Robichaud and others 2008b).

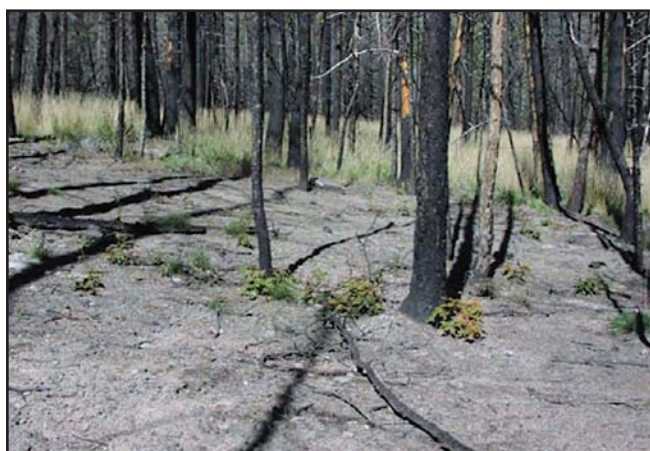
Figure 16. Following the 2000 Cerro Grande Fire near Los Alamos, New Mexico, areas were treated with aerial seeding and mulching. After three growing seasons, the ground cover in the mulched and seeded area (background) is much greater than in the seeded only area (foreground).

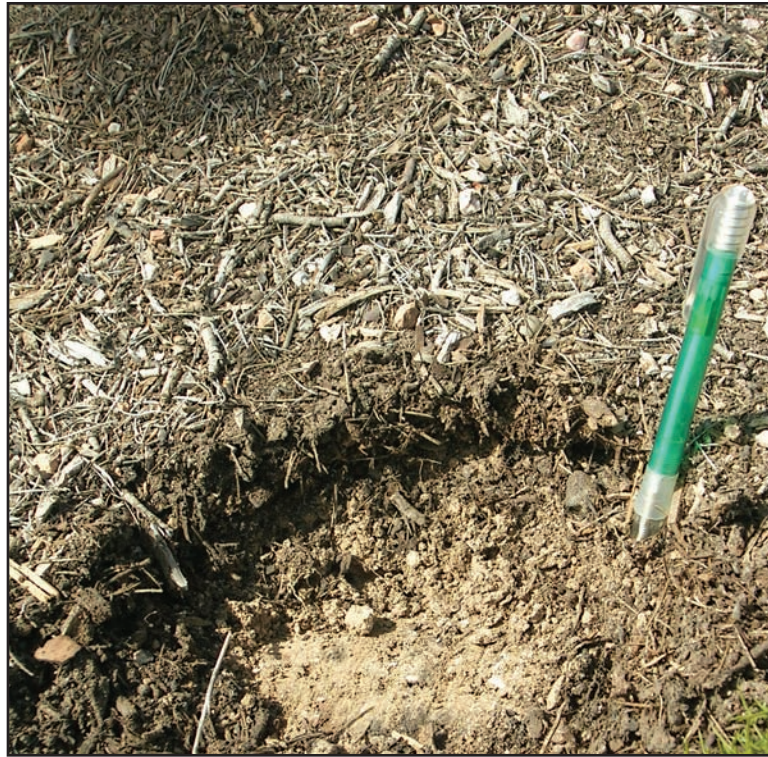
Figure 17. Woody mulch made from forest debris. Photo by S. Bautista.

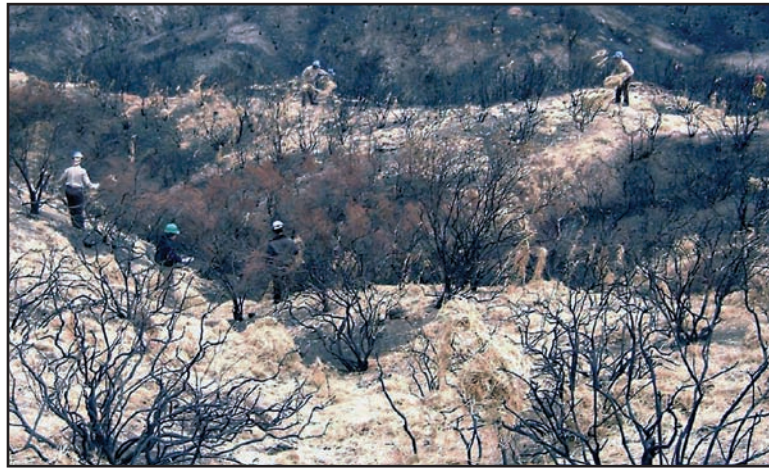
Figure 18. Hand application of post-fire straw mulch treatment (photo from Napper 2006: 28)

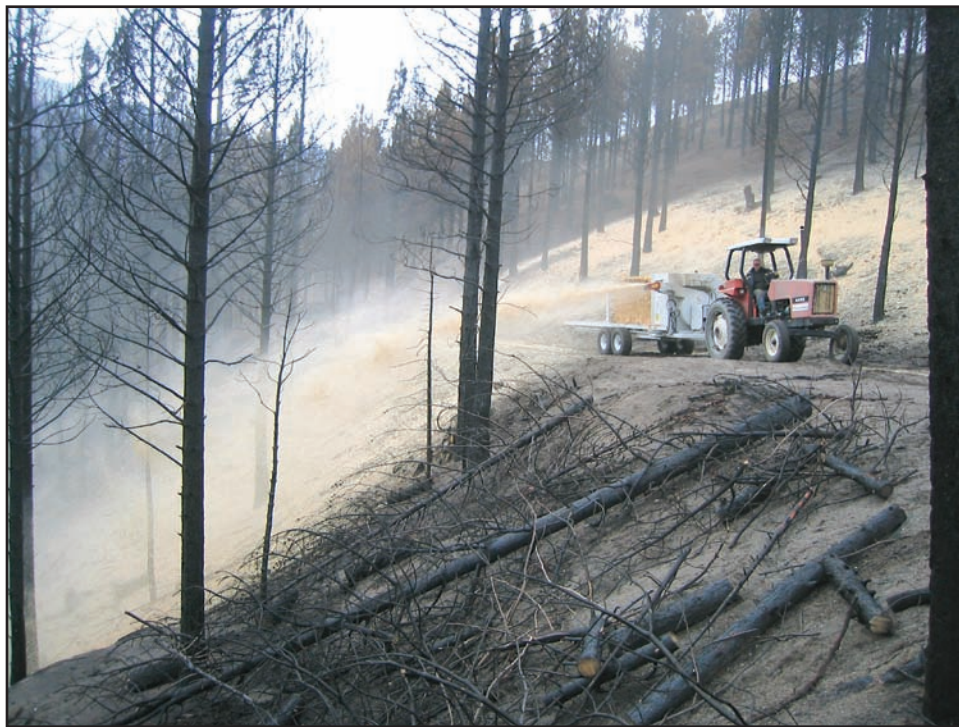
Figure 19. Post-fire straw mulch treatment being applied downslope from a road using a trailer-mounted blower pulled by a tractor on the 2007 Cascade Complex Fires in Idaho.

Ground Cover Amounts and Application Techniques—Straw mulch can be applied by hand, with blowers, or from aircraft. Ground application is preferred for relatively small areas where 100 percent of the ground can be covered by a thin, even mulch layer. However, hand application requires large crews to get the mulch cover in place in a timely manner (fig. 18). Trailer- or truck-mounted blowers, although faster than hand distribution, are limited to areas above and below roads or other drivable areas such as fire lines (fig. 19). Helicopters were first used to apply

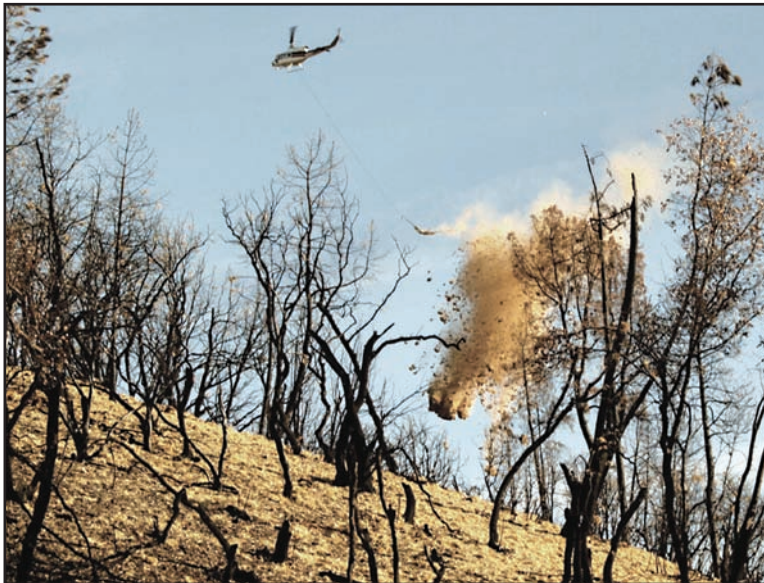
Figure 20. Aerial application of post-fire straw mulch treatment using a cargo net suspended below a helicopter; the cargo net is released over the target area (photo from Napper 2006: 25).

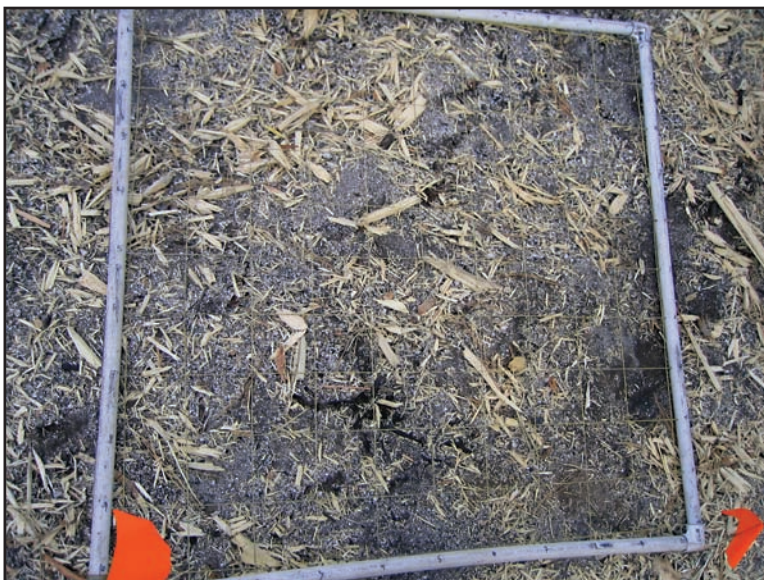
Figure 21. Wood shred coverage after aerial application on an experimental watershed site established on an area burned at high severity on the 2007 Cascade Complex Fires in Idaho. The PVC pipe frame (39 inches [1 m] on a side) is strung with twine to form 100 intersection points and is used to sample ground cover.

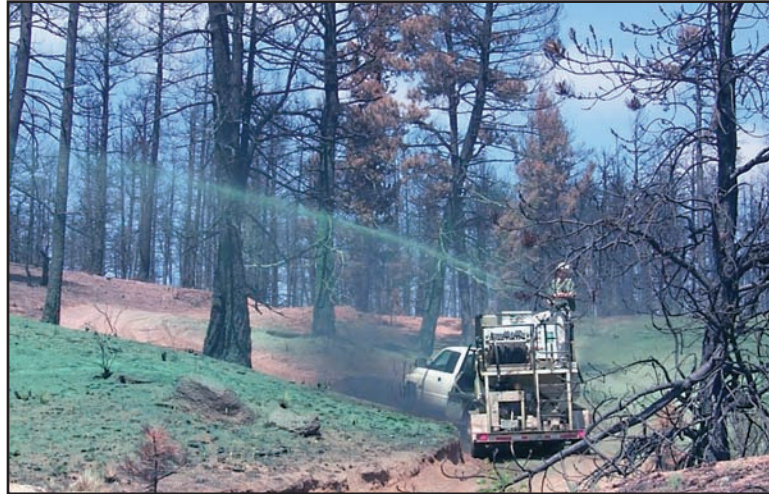
Figure 22. Trailer-mounted sprayer used to apply hydromulch from the road as a post-fire hillslope treatment on the 2002 Hayman Fire in Colorado.

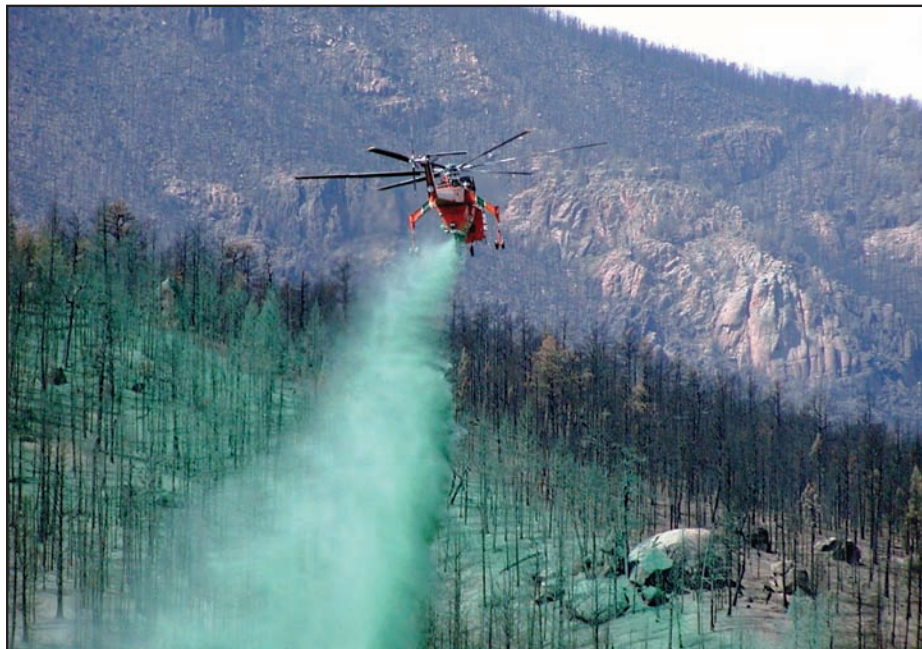
Figure 23. Large-capacity helicopters fitted with slurry tanks are used to apply hydromulch as a post-fire hillslope treatment on the 2002 Hayman Fire in Colorado.

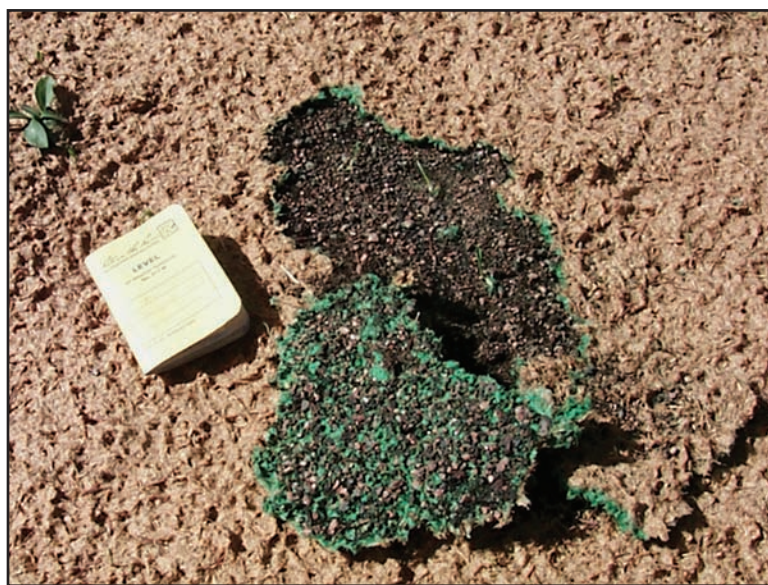
Figure 24. A small piece of the aerielly-applied hydromulch mat (exposed surface is brown) has been lifted off the burned soil (black) and flipped over to expose the underside of the mat (black and green). The pocket-sized field notebook is included for scale.

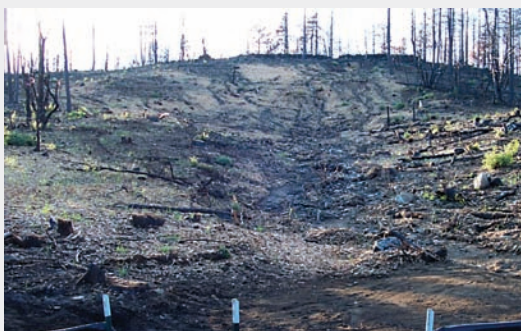
SB3-fig. 1. Wood chips used for post-fire hillslope treatment. Note that wood chips that were entrained in the overland flow are piled at the outlet of the swale.

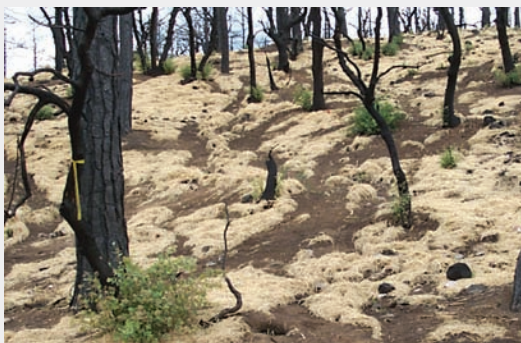
SB3-fig. 2. Rice straw applied as post-fire hillslope treatment.

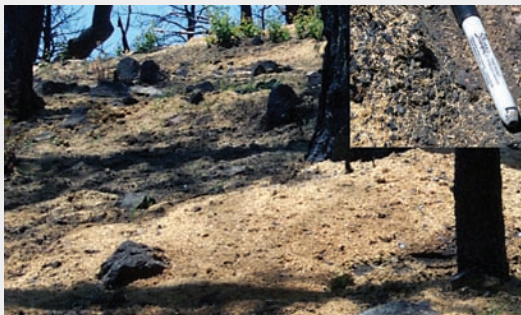
SB3-fig. 3. Pellets of pulverized rice straw and granular PAM were applied dry and compressed and are shown here after a rain expanded the pellets. The insert in the upper right corner shows the small rice straw fibers more closely (felt tip pen inserted for scale).

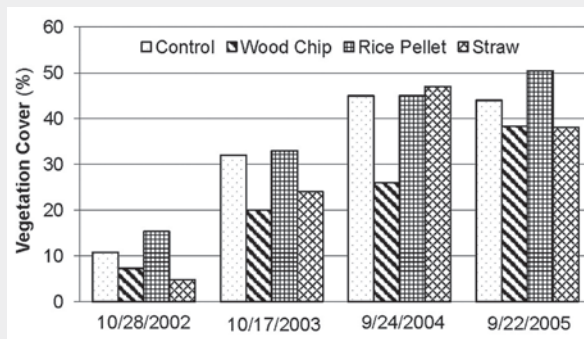
SB3-fig. 4. The mean percent cover that is live vegetation is shown by treatment and by post-fire year.

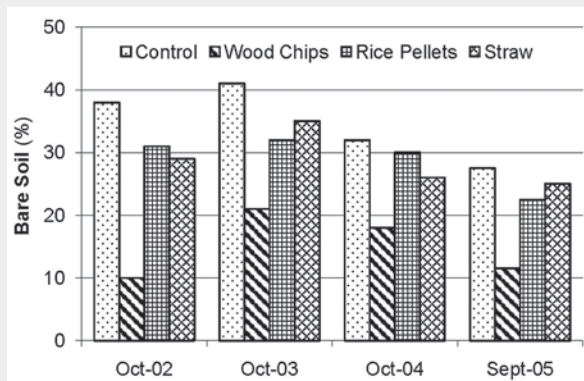
SB3-fig. 5. The mean percent bare soil is shown by treatment and by post-fire year.

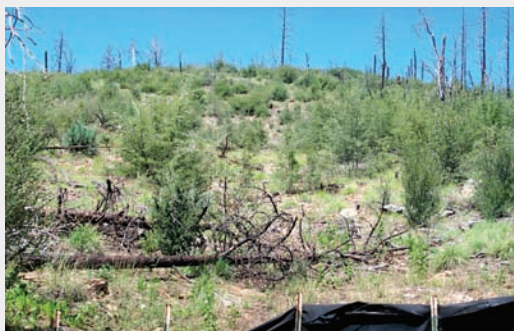
SB3-fig. 6. The same swale (treated with wood chips) shown in SB3-fig. 1 is pictured here in 2007—post-fire year five.

By 2007, five years after the fire, no difference in vegetation recovery was observed among treatments (SB3-fig. 6) (Beyers, personal communication).

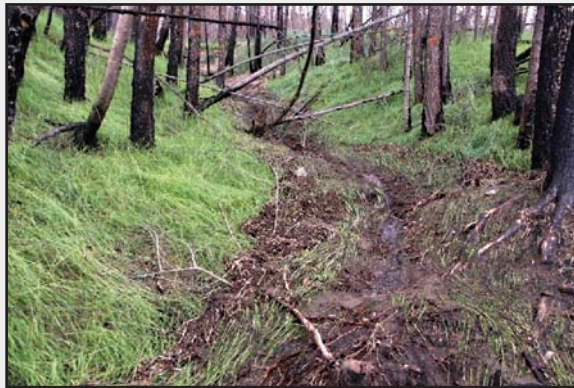
SB4-fig. 1. Photo taken after the 4 July 2004 storm showing overland flow in a swale near the top of the ridge above Myrtle Creek.

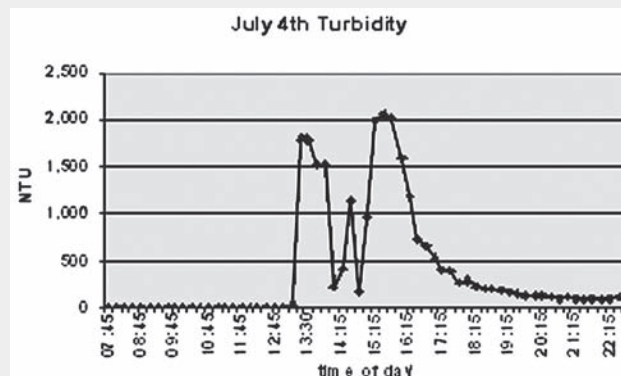
SB4-fig. 2. Graph of the hourly turbidity monitoring measurements for Myrtle Creek, Bonners Ferry primary municipal water source, on 4 July 2004, 10 months after the Myrtle Creek Fire. The graph shows a pulse of sediment that passed through the system due to storm runoff. (Water Quality monitoring data from the City of Bonners Ferry Water and Sewer Department.)

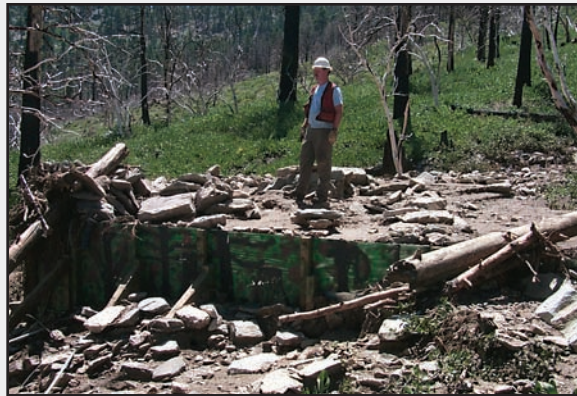
SB5-fig. 1. In post-fire year four, a paired watershed study site on the 2002 Cannon Fire in California had a rainfall event with maximum 10-min intensity (I_{10}) of 6.22 inch h^{-1} (158 mm h^{-1}). The sediment basin filled and then over-topped, depositing large rocks and tree debris both inside and outside the sheet metal wall that forms the sediment basin. The sediment yield from the contour-felled log treated catchment was estimated at over 3.9 ton ac^{-1} (8.7 Mg ha^{-1}) (see table AB-9 in Appendix B).
