**Final REPORT**  
For  
**2008-2009 Long-Term Characterization Test  
Of the Sutron Fischer Porter Rebuild**

**Version 4  
October 2009**

**Prepared for  
National Weather Service W/OPS22**

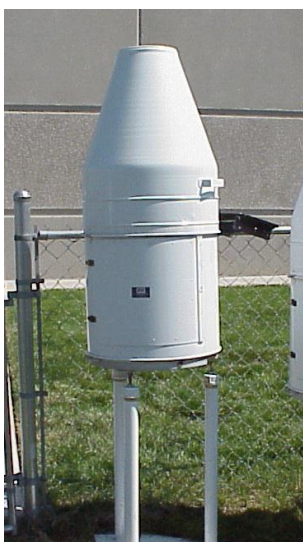
The original Fischer and Porter gauge (Figure 1) is a weighing gauge that records the weight of accumulated precipitation by punching a paper tape. A dial readout that displays the current amount of precipitation in the reservoir is also provided. Precipitation is collected and stored in a collection bucket. A spring balance-weighing device mechanically positions a coded disk and a dial. At a predetermined interval of 15 minutes, the code position of the disk is punched on paper tape, thereby recording the amount of accumulated precipitation to the nearest tenth of an inch. The measuring range is 0 – 19.5 inches water equivalent.<sup>1</sup>

**Figure 1:** Fischer and Porter Gauge

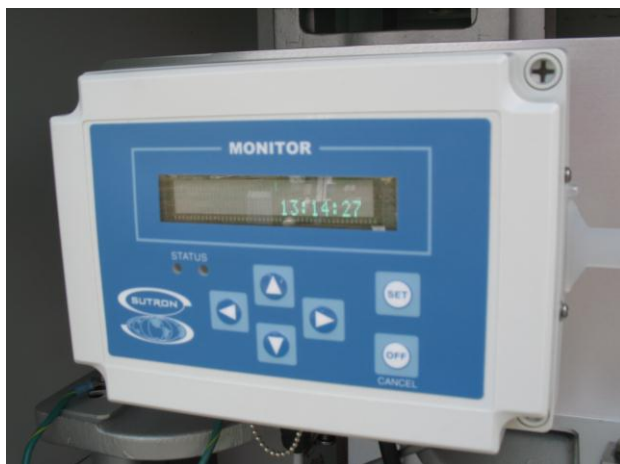
All of the rebuild kits were designed to replace the function of the paper tape recording mechanism. In fact, the entire paper tape mechanism was removed from the gauge to make room for the new equipment. Each Sutron FPR kit was required to have the following main elements: a load cell to measure the weight inside the gauge's reservoir, a data logger computer to record and store the information, a memory card interface unit, a data display unit, a power supply unit, a battery unit, and a solar power panel. All of these devices (with the exception of the solar panel) were designed to fit inside the shell of a standard Fischer and Porter gauge. In the case of the Sutron kits, the data logger, data display, and SDI-12 memory card interface were all combined into a single unit, called the Monitor. The data logger is capable of holding 300,000 readings, and is also capable of connecting to an optional temperature sensor. Sutron gauges were installed in the new testbed at Sterling on October 16, 2008.

**Figure 3:** Sutron FPR Upgrade Kit

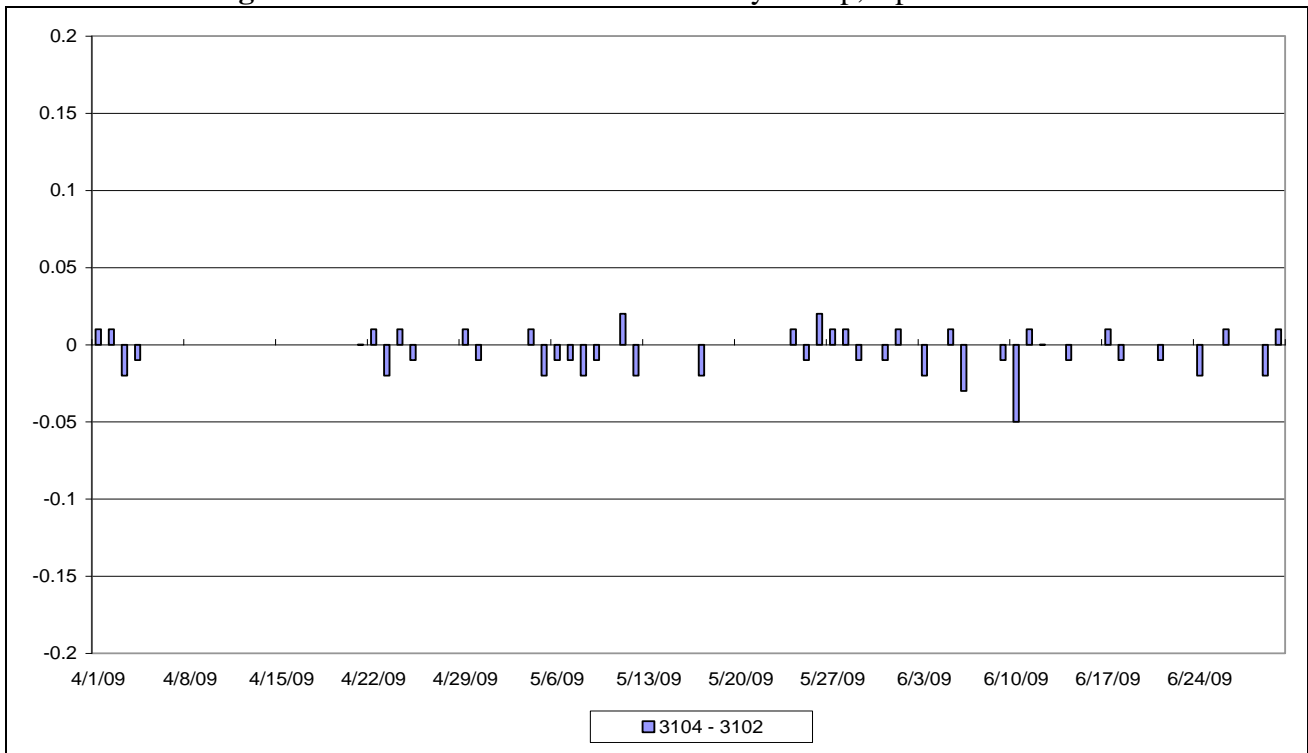
**Figure 6:** Difference between Sutron Daily Precip, April – June 2009

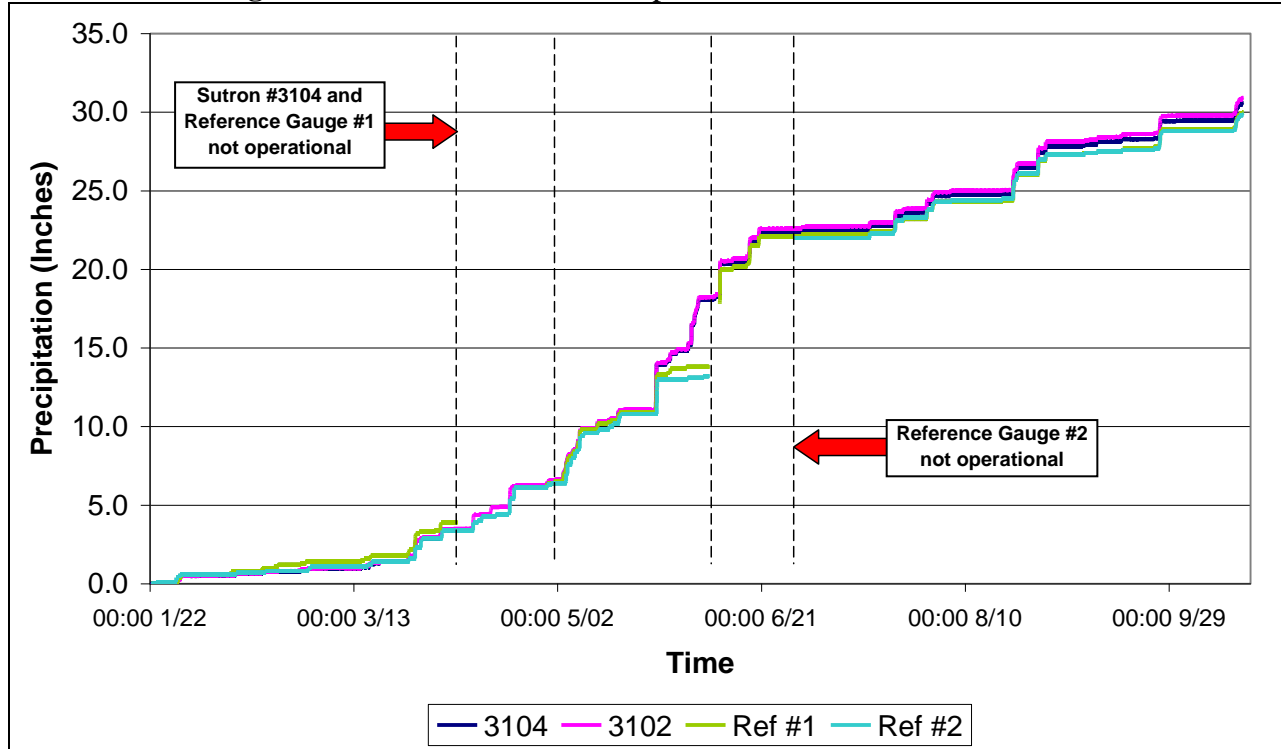
The Sutron FPR kits performed outside the specification when compared to the reference sensors, as both FPR kits reported more precipitation than each reference sensor (Figures 8 and 9). However, the comparison between the FPR kits and the reference gauges remained within the specification during the majority of testing.

**Figure 8: Sutron Functional Comparison, 1/22/2008 – 10/16/2009**

Both FPR kits showed similar precipitation trends when compared to the reference sensors. The results from the Sutron FPR kits showed a positive functional comparison, by outperforming both reference gauges (Table 2). When 24-hour precipitation accumulations of the FPR and reference gauges are compared, results showed that the FPR kits caught more on a daily basis as well (see Appendix B, Figures B-19 through B-22). Overall, the Sutron FPR kits exceed the performance of the reference gauges.

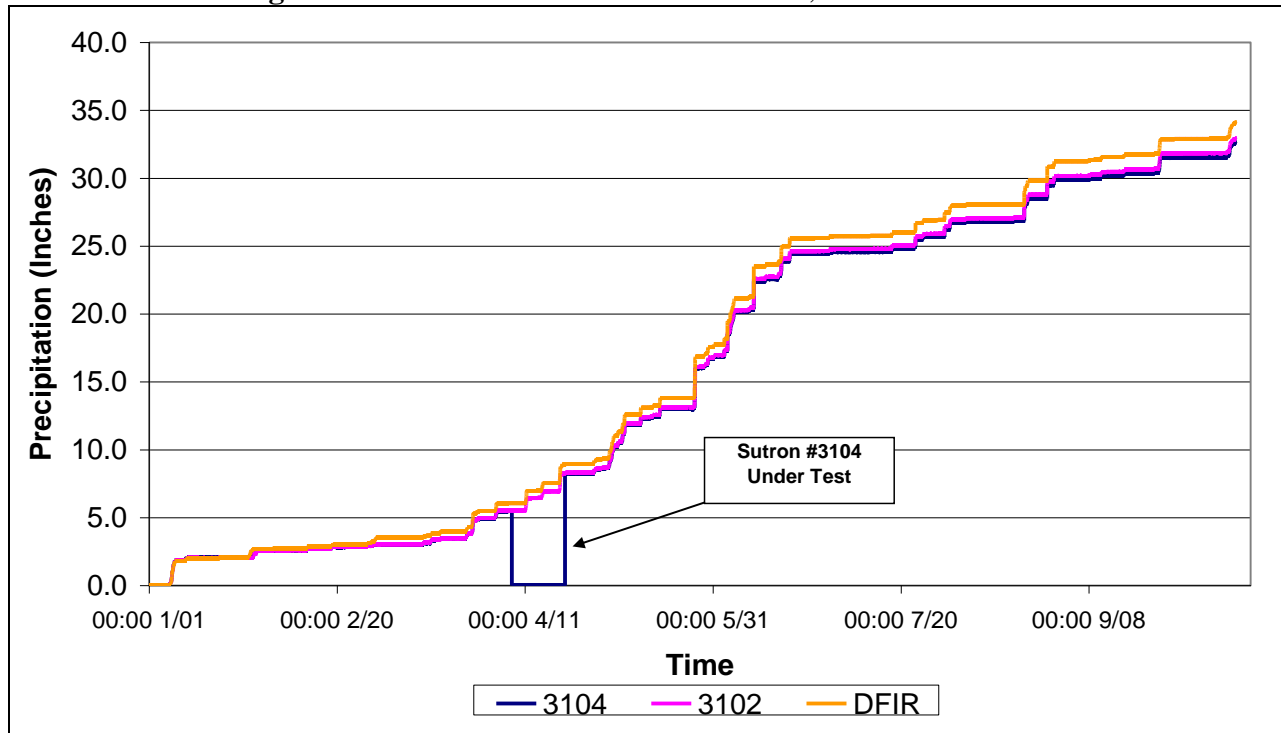
The AWPAG inside the DFIR was also used to compare precipitation amounts with the Sutron FPR kits. The Sutron gauges showed similar trends to the AWPAG in regards to timing of precipitation (Figure 9). Without any wind shields surrounding the Sutron gauges, total precipitation catches were lower than those reported by the AWPAG in the DFIR. This was expected, as the DFIR was specifically designed to reduce the negative impact of the wind on precipitation catch efficiency, thus enabling the AWPAG gauge inside the DFIR to catch more precipitation.

**Figure 9:** Sutron Normalized Data w/ DFIR; 1/1/09 – 10/16/09

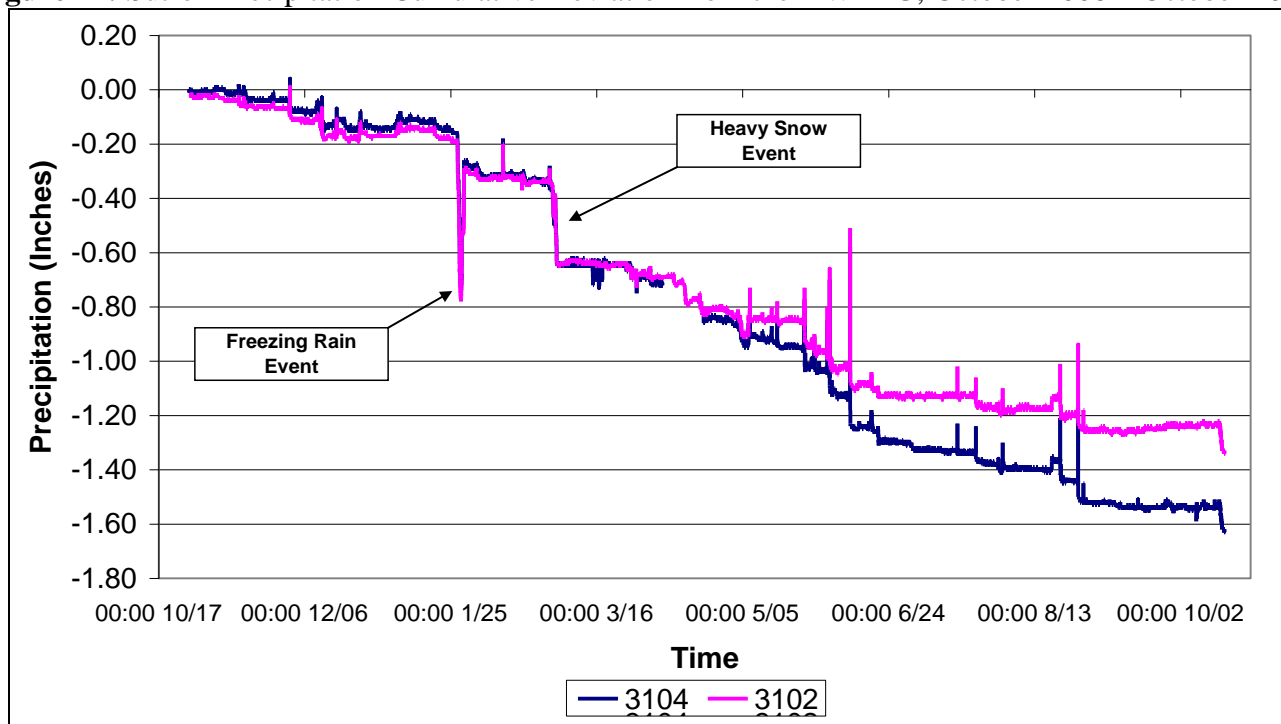
The largest disparities between the FPR gauges and the AWPAG in the DFIR occurred during heavy and frozen precipitation events. Not only does the AWPAG record precipitation more quickly than the FPR gauges, but the AWPAG inside the DFIR has much higher catch efficiency during wind-blown snow events. The AWPAG is also equipped with an orifice heater and is able to melt any precipitation that freezes onto its orifice. Precipitation froze to the orifice of the FPR gauges during the freezing rain event of January 28, 2009 and did not fall into the collection buckets until temperatures rose above freezing the next day (Figure 11).

**Figure 11:** Sutron Precipitation Cumulative Deviation from the AWPAG, October 2008 – October 2009

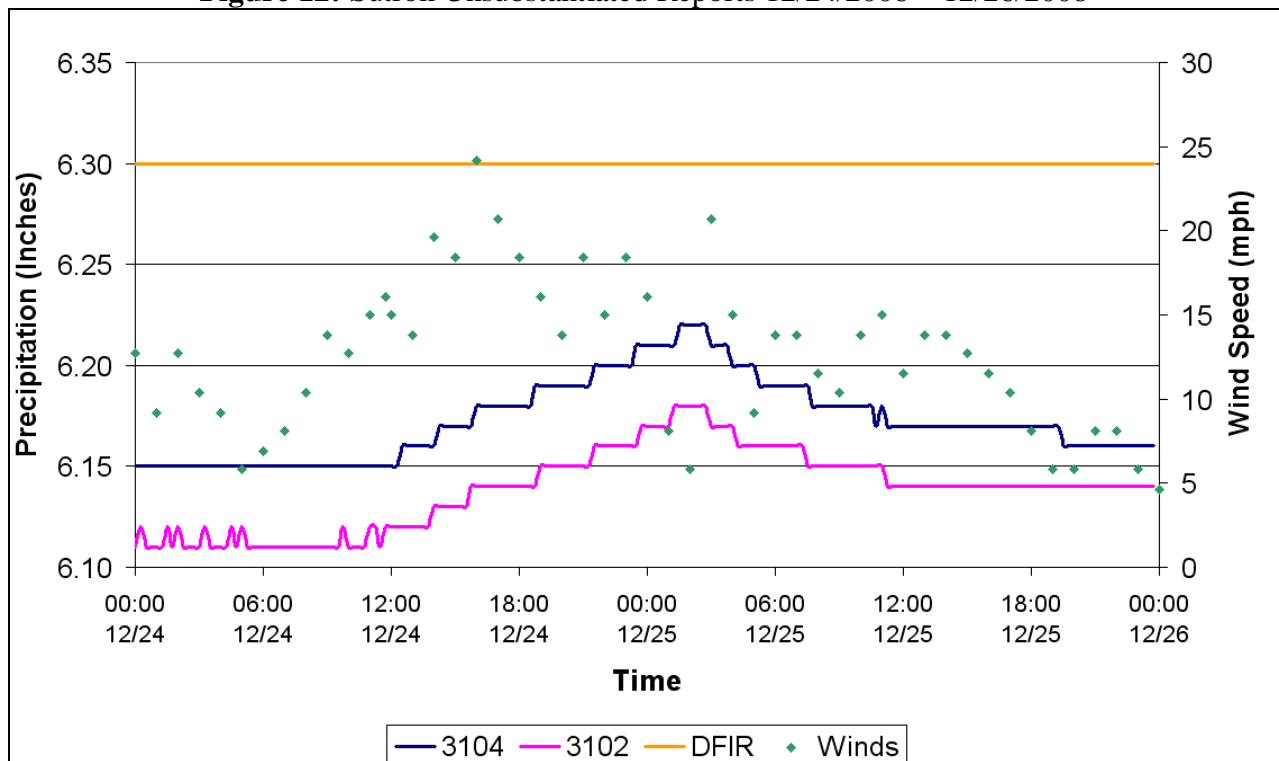
A twenty-four hour period of unsubstantiated reports was identified on December 24-25, 2008. During this time, there were no reports of precipitation from the AWPAG in the DFIR, yet both Sutron FPR kits reported precipitation accumulation (Figure 12). The weather observations were also checked, and showed no precipitation in the area during the time of the unsubstantiated reports. Both Sutron kits in the field began showing precipitation accumulating around 12:30PM on the 24<sup>th</sup>; these amounts slowly continued to rise until about 1:30AM on the 25<sup>th</sup>. At this time precipitation values began to decrease, and by 11:15AM on the 25<sup>th</sup>, both kits returned to values similar to where they initially stood, twenty four hours prior. The number of unsubstantiated reports is small compared to the total number of 15-minute periods collected throughout the characterization test (Table 6).

**Figure 12:** Sutron Unsubstantiated Reports 12/24/2008 – 12/26/2008

It is suspected that these unsubstantiated reports may have been caused by “wind pumping”. This phenomena is created when high winds blow across the orifice of a precipitation gauge and creates a pressure differential inside the precipitation bucket, and thus an up and down force on the load cell of the FPR kit. Winds during the time of unsubstantiated reporting were reported at 8 to 24 mph, with gusts up

to 36 mph. Despite these false accumulations reported by both Sutron kits, neither unit deviated from the AWPAG in the DFIR above 0.1 inches, thus remaining compliant with the specification.

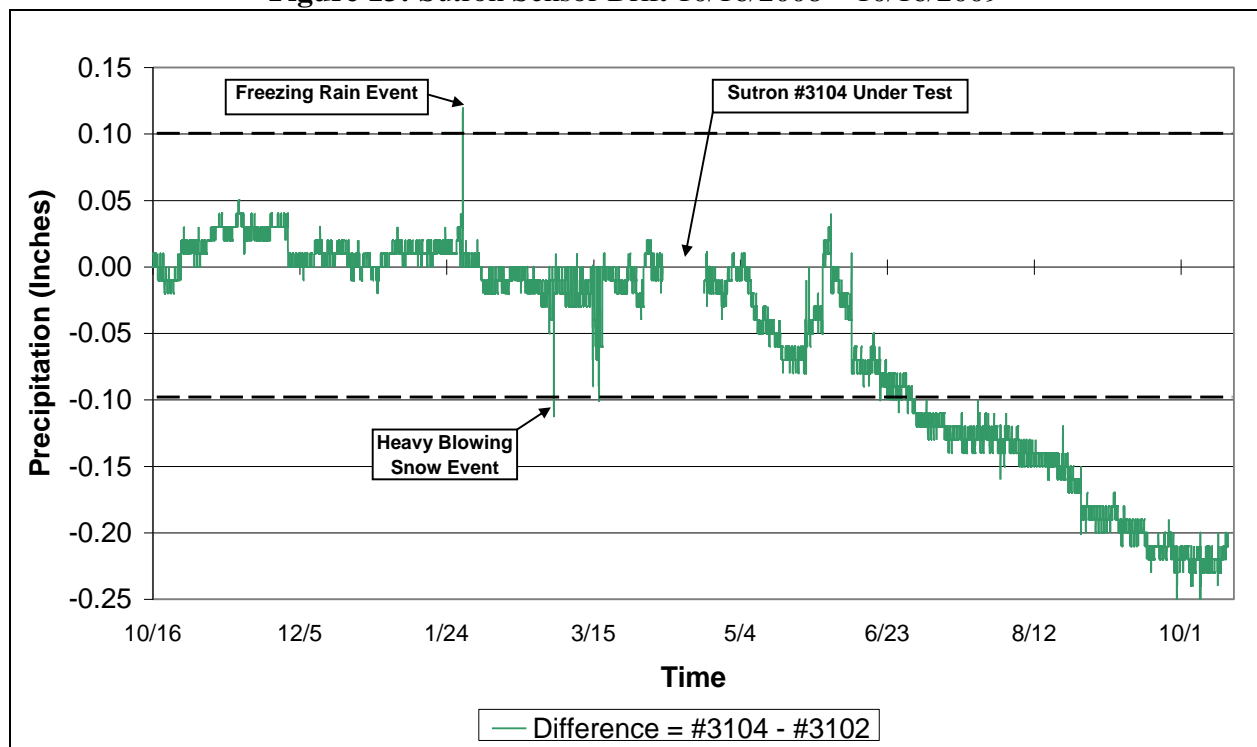
Over the course of one year, the Sutron units showed a slight drift in total precipitation catch. At the beginning of testing the units were normalized; at the end of the year, the gauges reported a difference in precipitation of 0.27 inches (Figure 13). This amount is outside of the specification, and should be noted when considering the long term performance of the FPR kits. However, it should also be noted that the daily and monthly accumulation totals remained within the specification throughout the long term characterization test. Overall, the deviation between the gauges averaged 0.00074 inches of drift per day. The Sutron FPR kits installed in the field met the specifications throughout 69.82% of the test

**Figure 13: Sutron Sensor Drift 10/16/2008 – 10/16/2009**

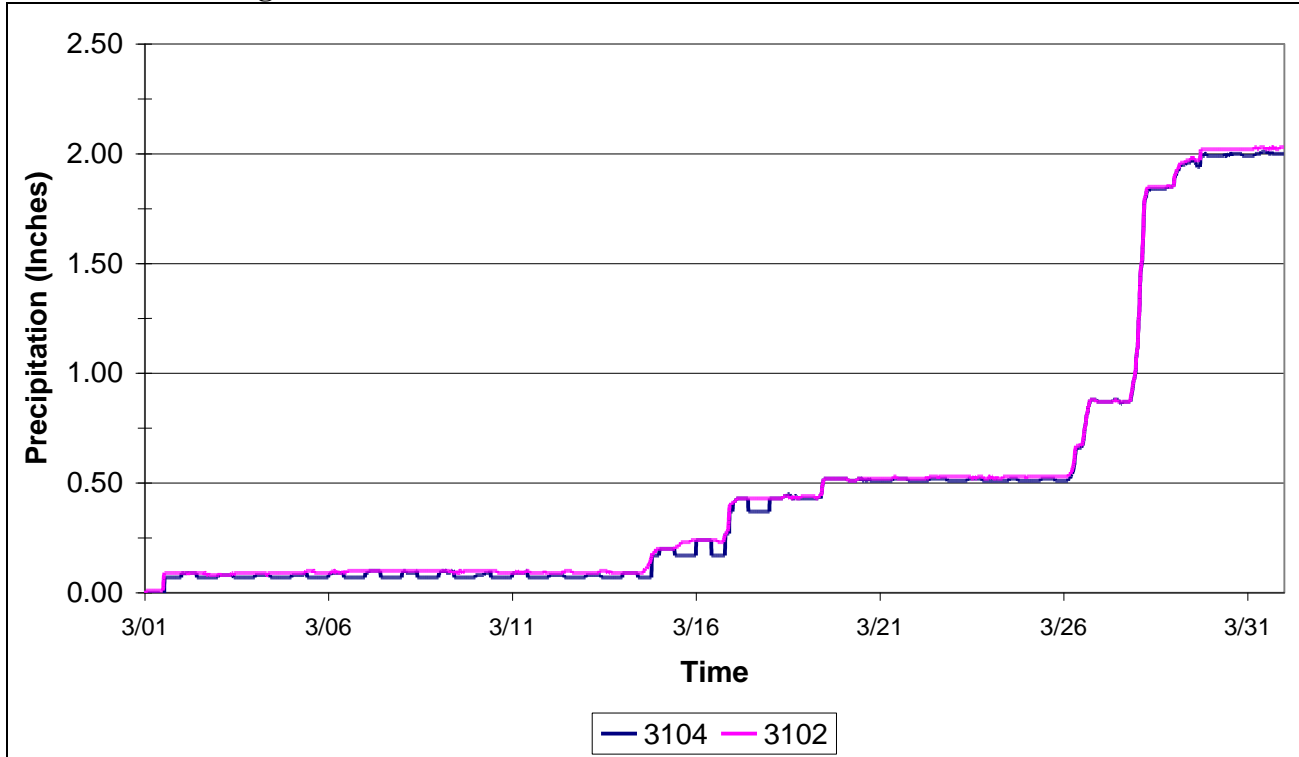
Despite the variation, both of the gauges performed within the specification during this period. Testing from March of 2009 (Figure 15) confirmed that a diurnal variation cycle continued to occur.

**Figure 15:** Sutron Normalized Data Results 3/1/2009 – 3/31/2009

The Sutron gauges experienced consistent differences throughout March, but performed within the specification throughout most of the month. See Section 6.3.2 for further details on time periods that were out of the specification.

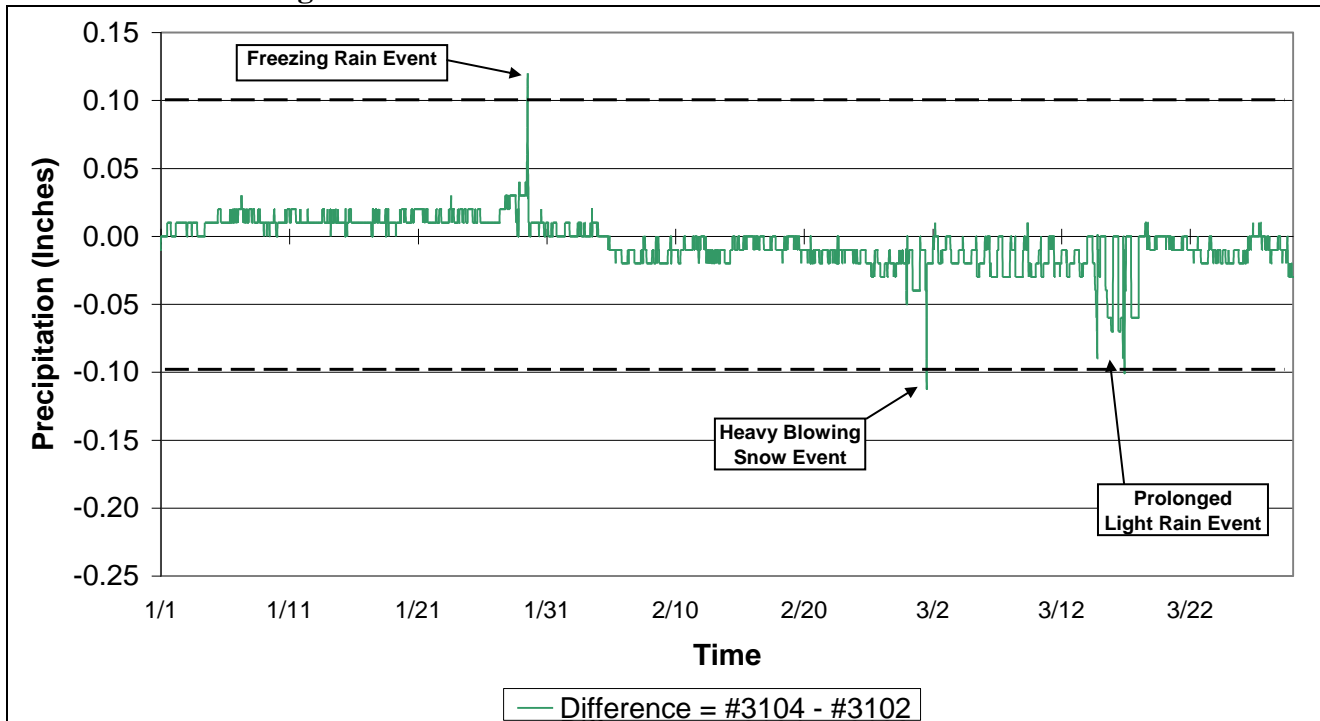
During the first 6 months of testing, there were two occasions in which the Sutron gauges deviated by more than 0.1 inches from each other (Figure 18).

Figure 18: Sutron Functional Precision 1/1/2009 – 3/31/2009

During this time, Sutron #3104 showed a maximum difference of +0.12 inches from Sutron #3102. Additionally, Sutron gauge #3104 experienced even higher deviations as the testing period progressed, while #3102 appeared to operate normally. The overall discrepancy remained within the specification over the majority of the outdoor tests, until July 1, 2009. At this time, the gauges ventured outside of the specification, and remained that way until the end of the test.

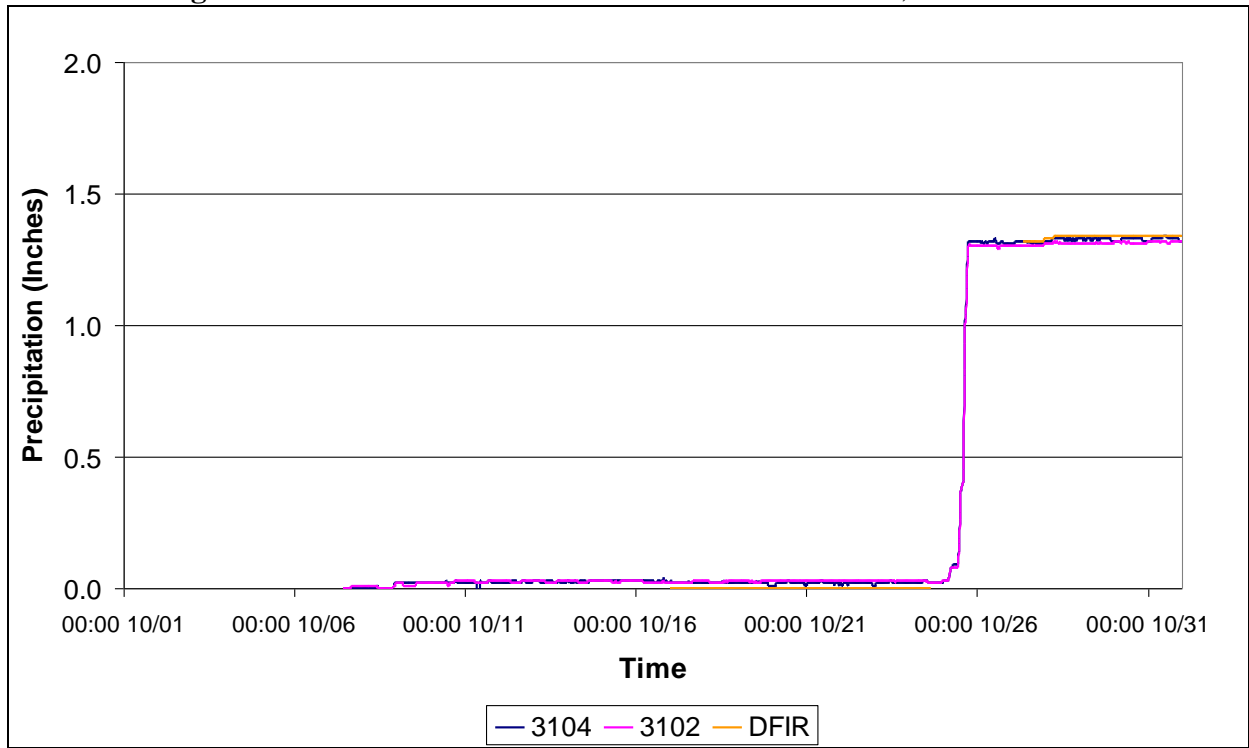
**Figure B-1: Sutron & AWPAG Normalized Data Results, October 2008**

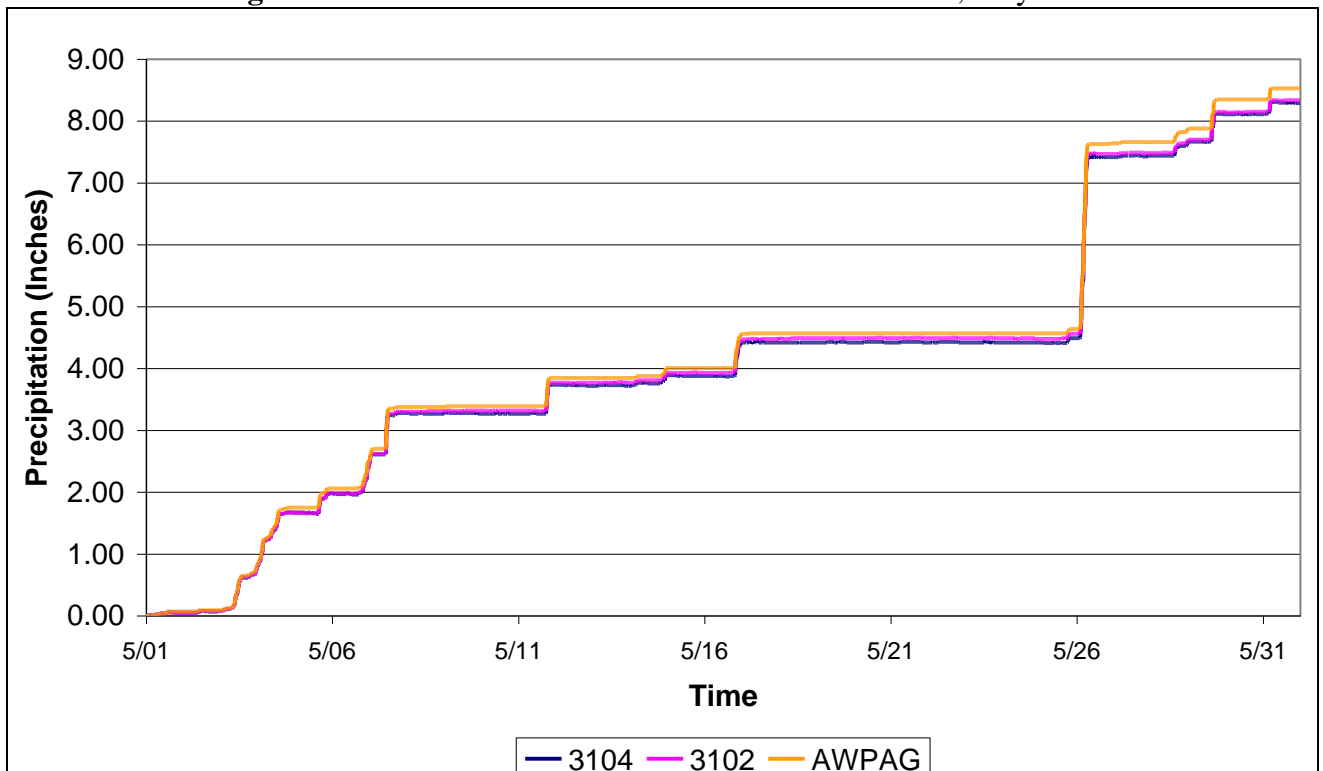
**Figure B-8: Sutron & AWPAG Normalized Data Results, May 2009**

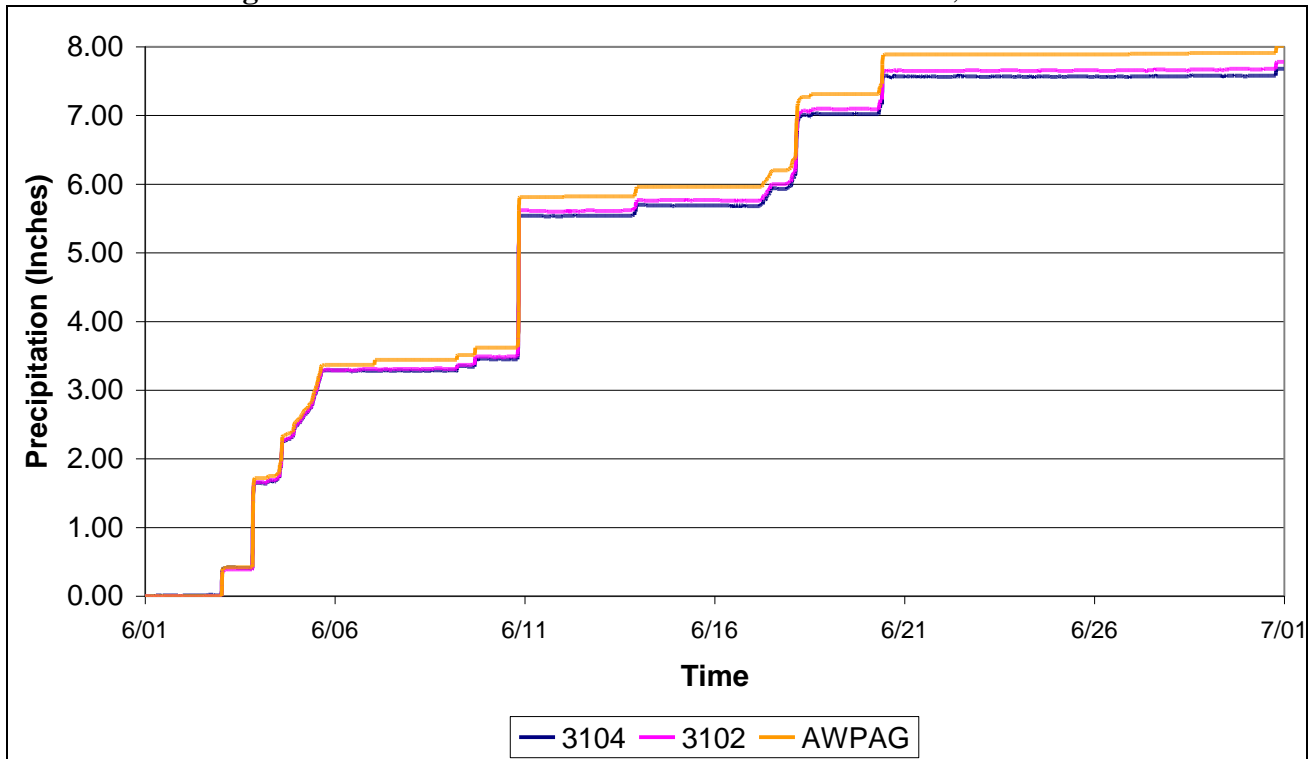
**Figure B-9:** Sutron & AWPAG Normalized Data Results, June 2009

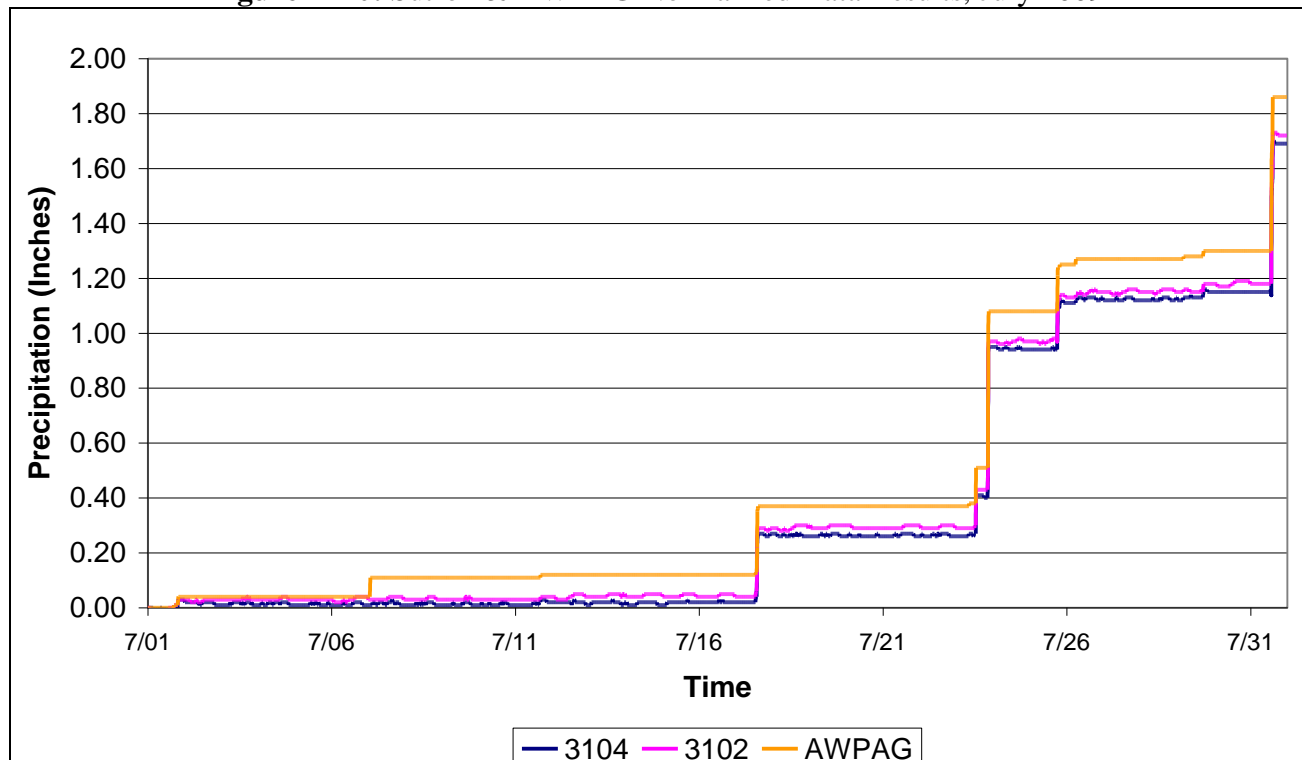
**Figure B-10:** Sutron & AWPAG Normalized Data Results, July 2009

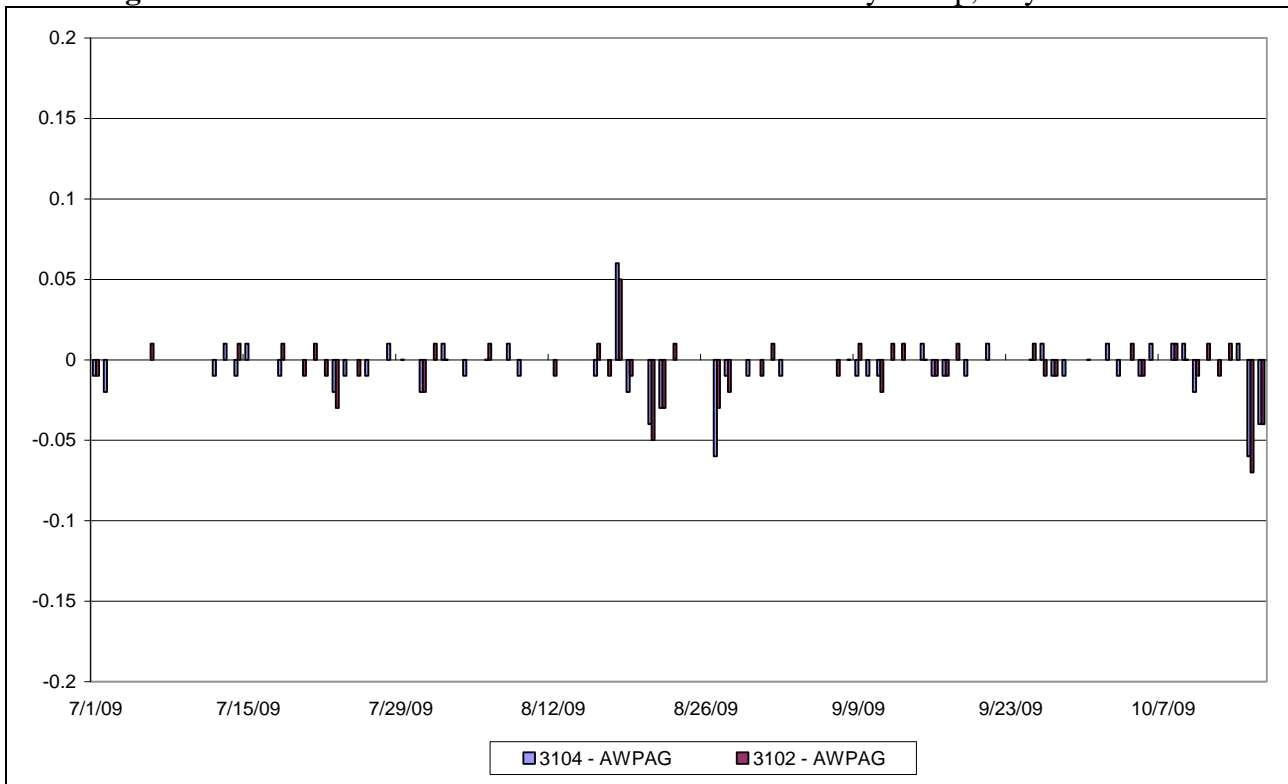
**Figure B-26:** Difference between Sutron and AWPAG Daily Precip, July – Oct. 2009
