Achieving Very High Efficiency and Net Zero Energy in an Existing Home in a Hot-Humid Climate: Long-Term Utility and Preliminary Monitoring Data

D. Parker and J. Sherwin
BA-PIRC

February 2012

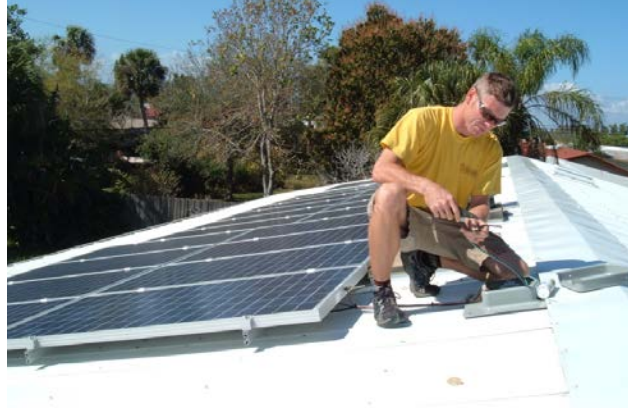
Figure ES-1. 4.9-kW rooftop PV system is connected in February 2009. The white metal roof was part of house improvements in the 1998 remodel.

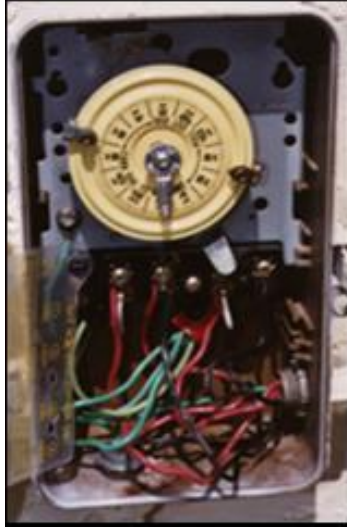
Figure 4. Pool pump timer. Immediately after taking over the house, this was set from 8 h/day to only 3–4 h/day, saving an estimated 2000 kWh annually.

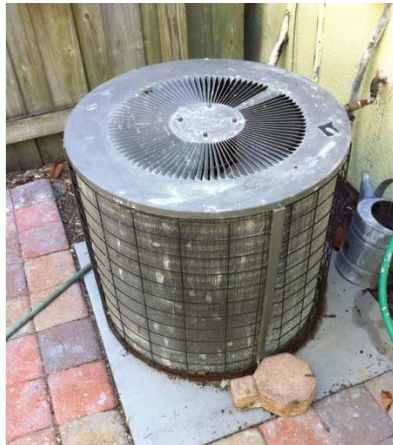
Figure 5. Outdoor unit for SEER 10, 2-ton A/C installed in 1995 and still in use

In June 1995, a new SEER 10, two-ton air conditioner was installed (Figure 5). Air handler and outdoor unit power were approximately 2,800 W at 92°F and constant run. For two years prior, the household had used a WH fan for summer cooling and suffered through the cooling season in a failed effort to see if comfort could be achieved without A/C. An AFUE 78% natural gas furnace was installed in January 1993.

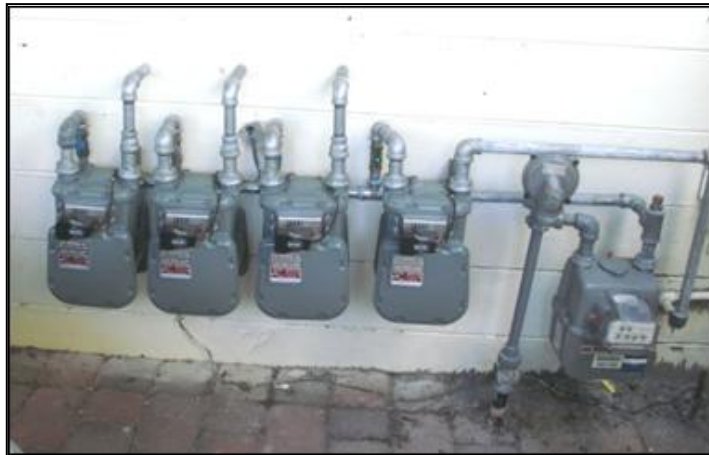
Figure 6. Multiple pulse initiation gas meters to measure gas end use

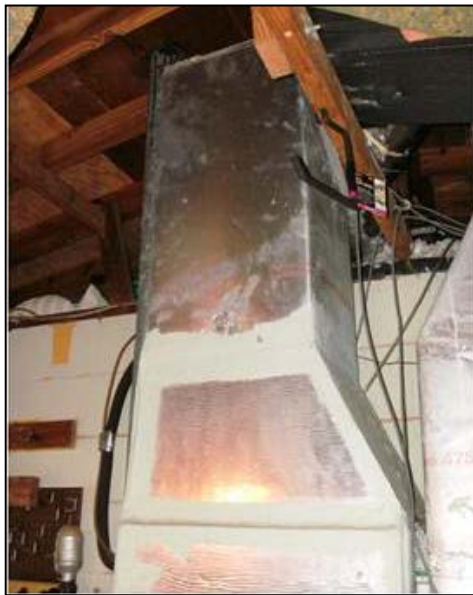
Figure 7. A/C evaporator and plenum showing segments sealed with mastic

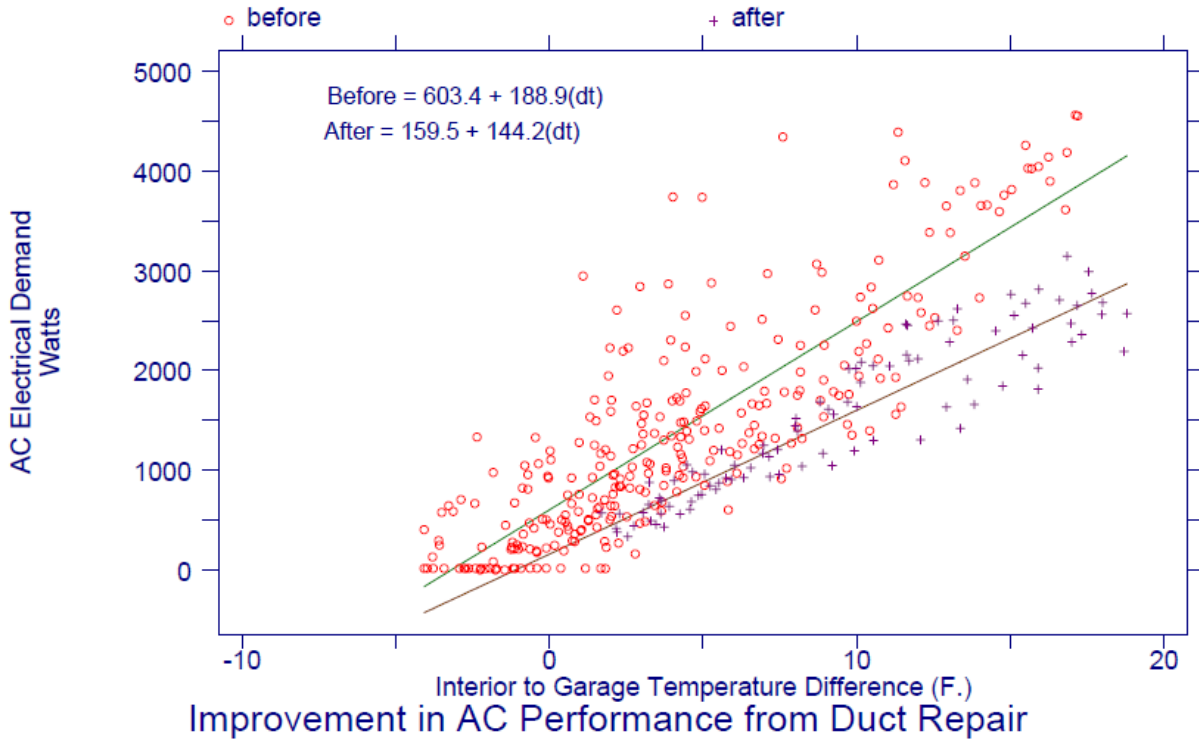
Figure 8. Hourly A/C demand before and after duct leakage repair, plotted against interior to garage temperature difference in 1992

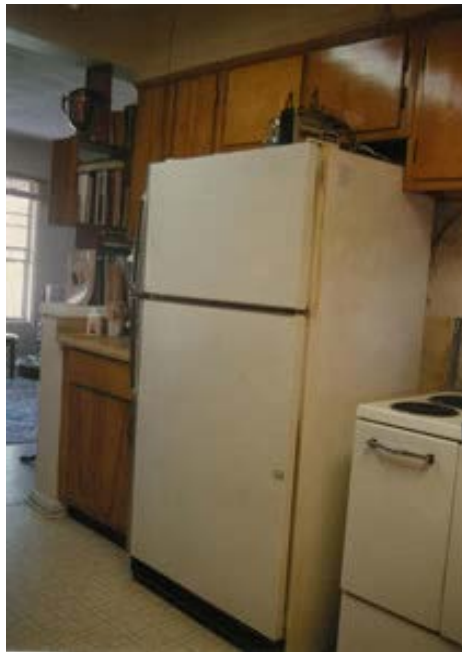
Figure 9. Original kitchen refrigerator in 1990

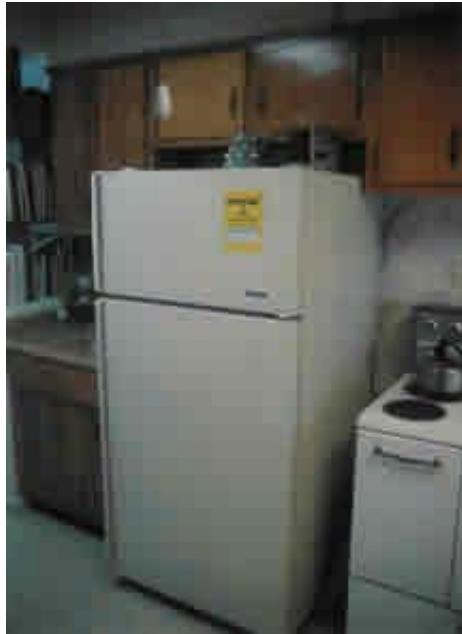
Figure 10. Replacement refrigerator in August 1991

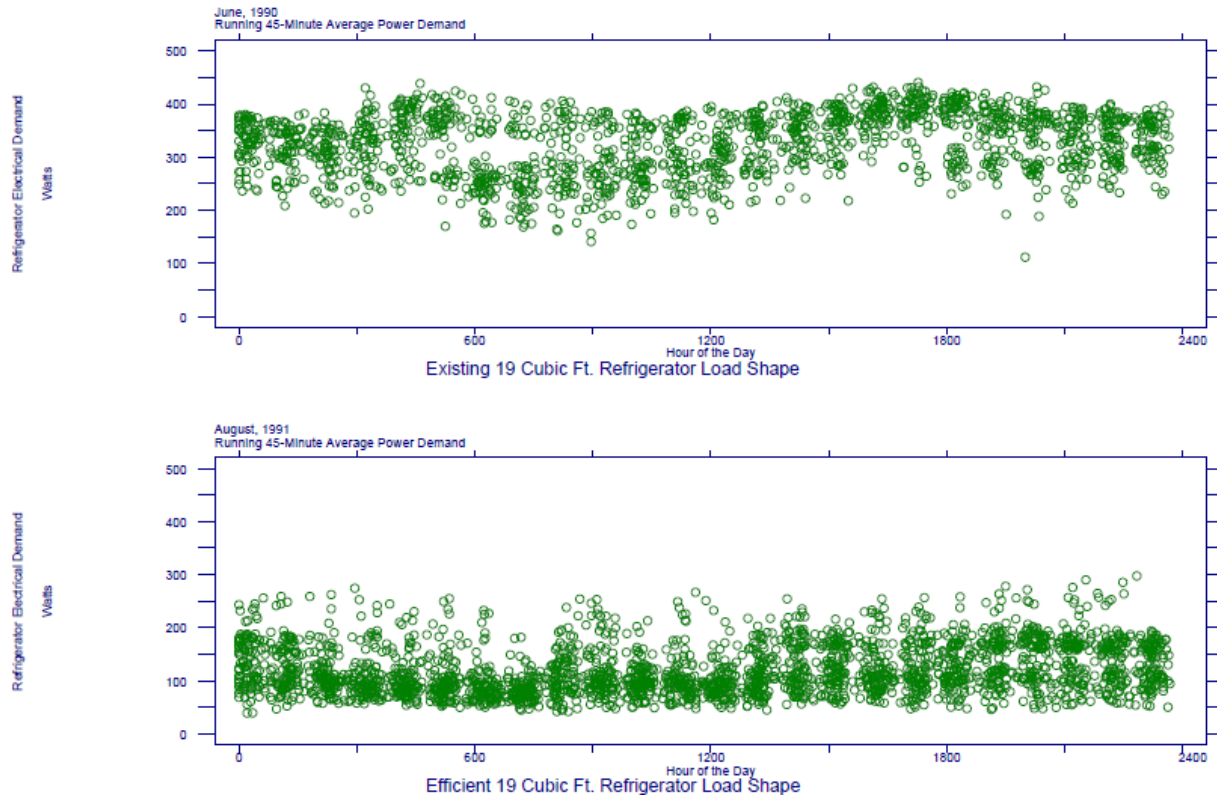
Figure 11. Month of June 1990, showing the measured 15 minute W of the original refrigerator. The lower plot month of August 1991 shows the power of the replacement more efficient refrigerator.

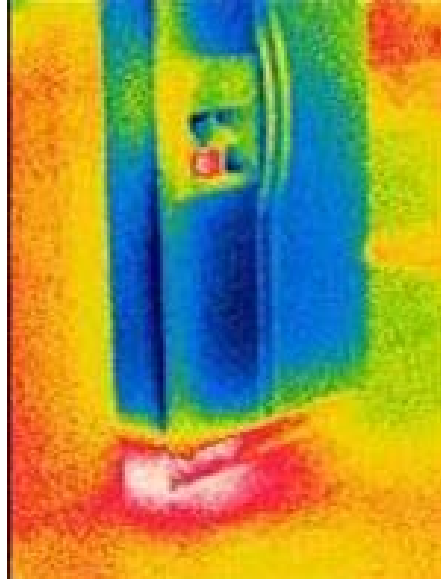
Figure 12. Infrared image of 25-ft³ refrigerator showing heat rejection at the base of the unit, but also warm temperatures near through the wall ice and water access. The unit was using 4.4 kWh/day prior to replacement in January 2011.

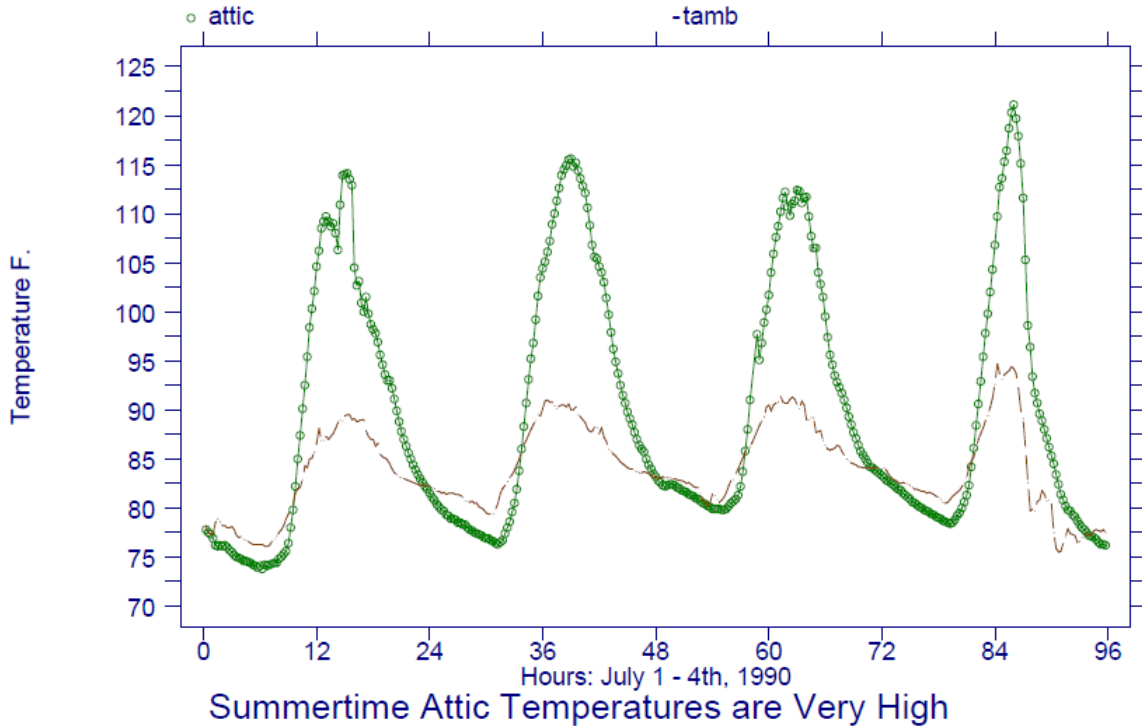
Figure 20. Attic against ambient air temperature over a four-day period in the summer 1990

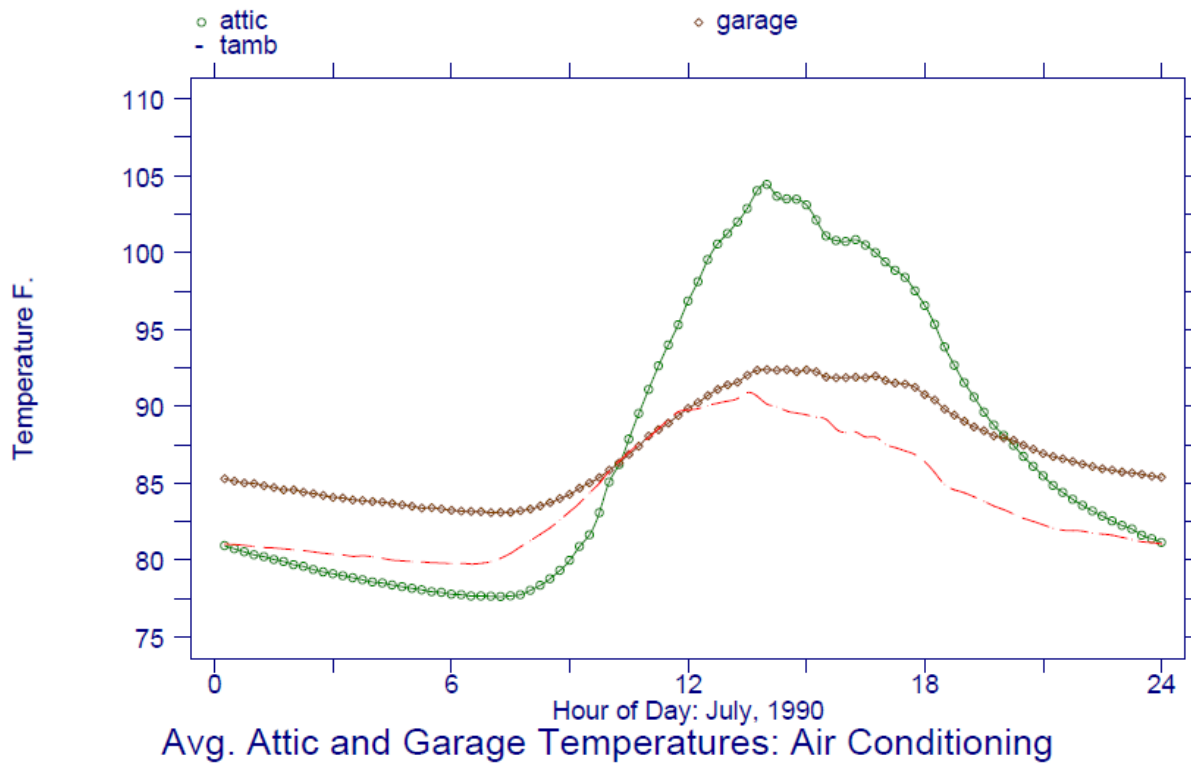
Figure 21. Average garage, ambient, and attic air temperatures when air conditioning over the month of July 1990

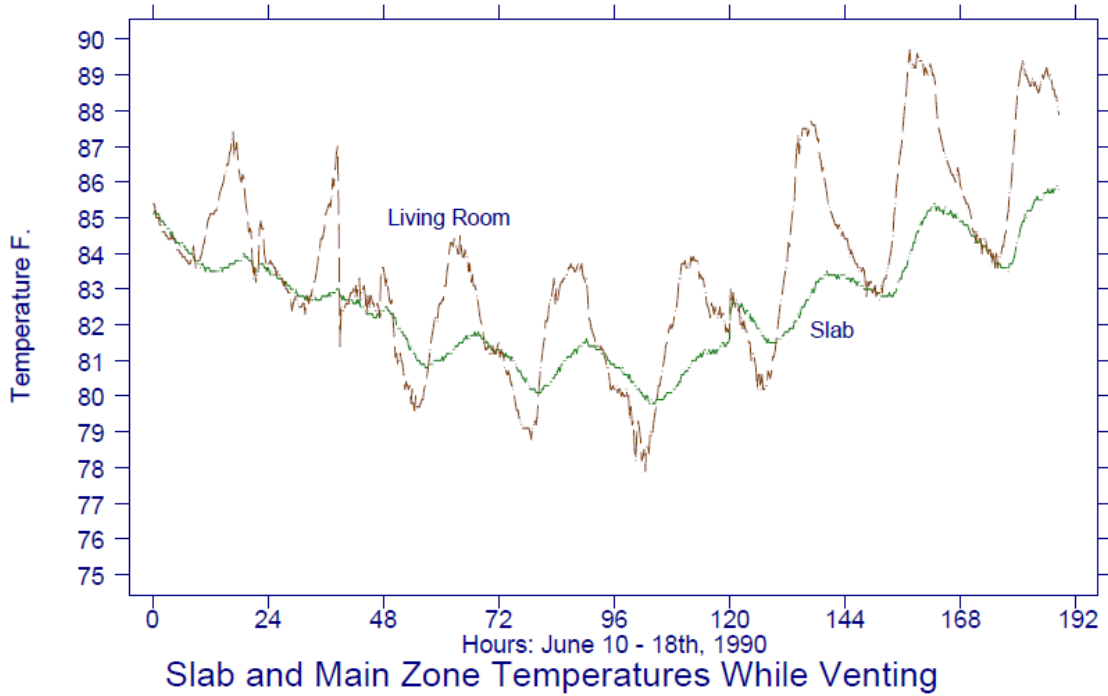
Figure 25. Interior floor slab and main zone temperatures during an uncomfortable period when natural ventilation was used: June 1990

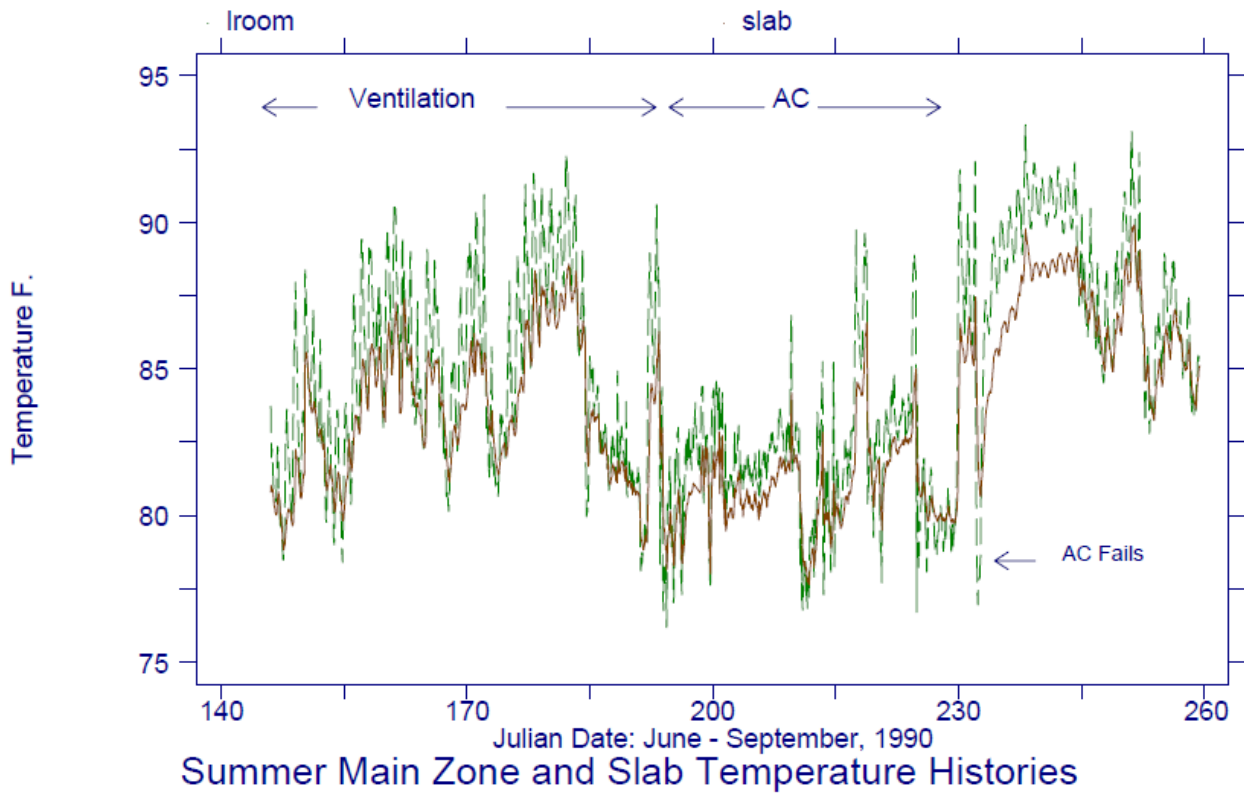
Figure 26. Summer living room and slab temperatures during periods of natural ventilation and A/C

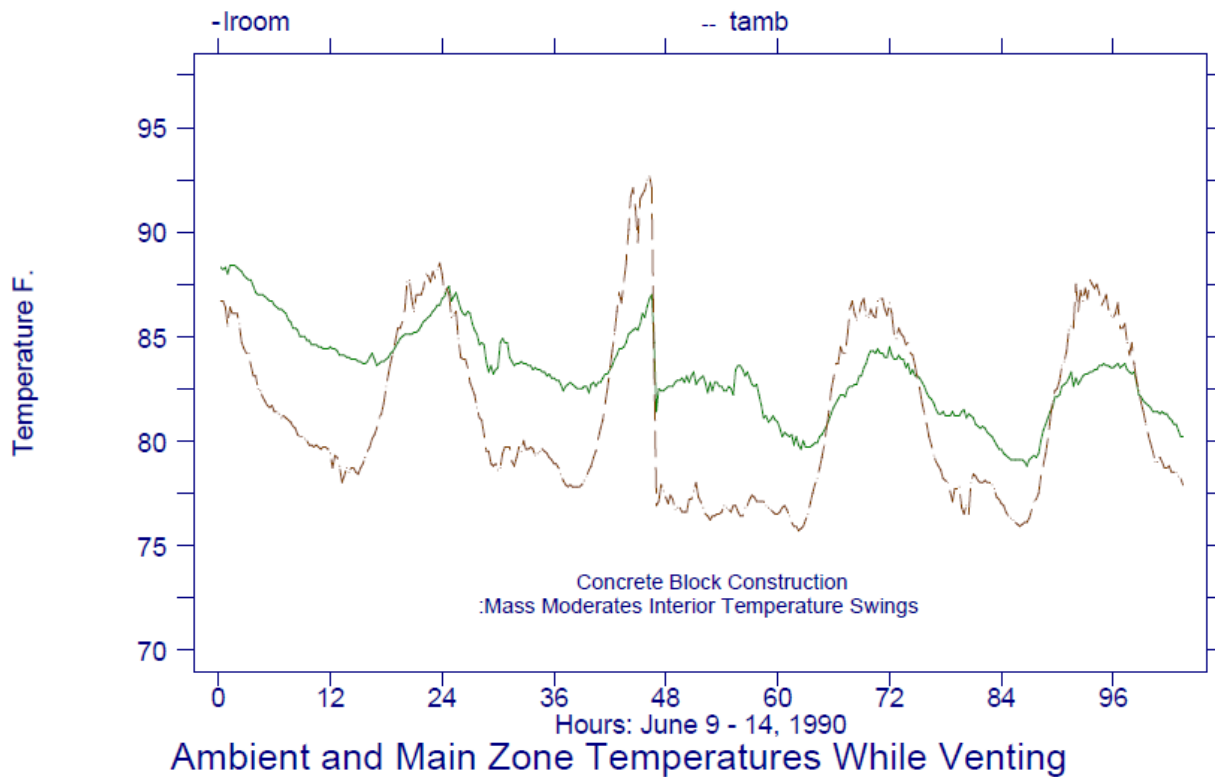
Figure 30. Ambient (red) and living room (green) zone temperatures over a four-day period during attempted natural ventilation in June 1990

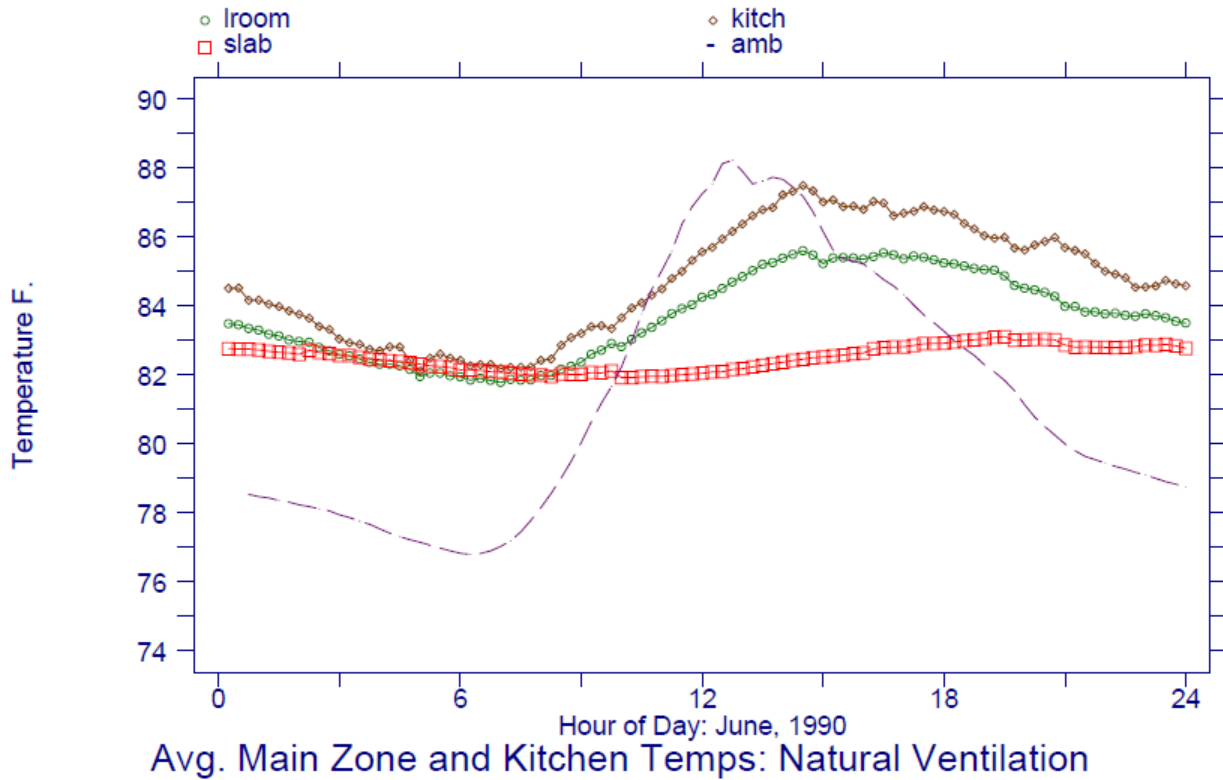
Figure 31. Average zone temperatures and ambient air temperature during natural ventilation in summer 1990

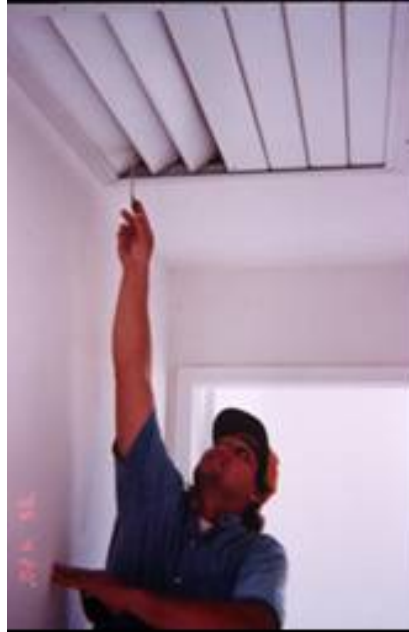
Figure 33. First WH fan installed showing operable louvers that open during operation

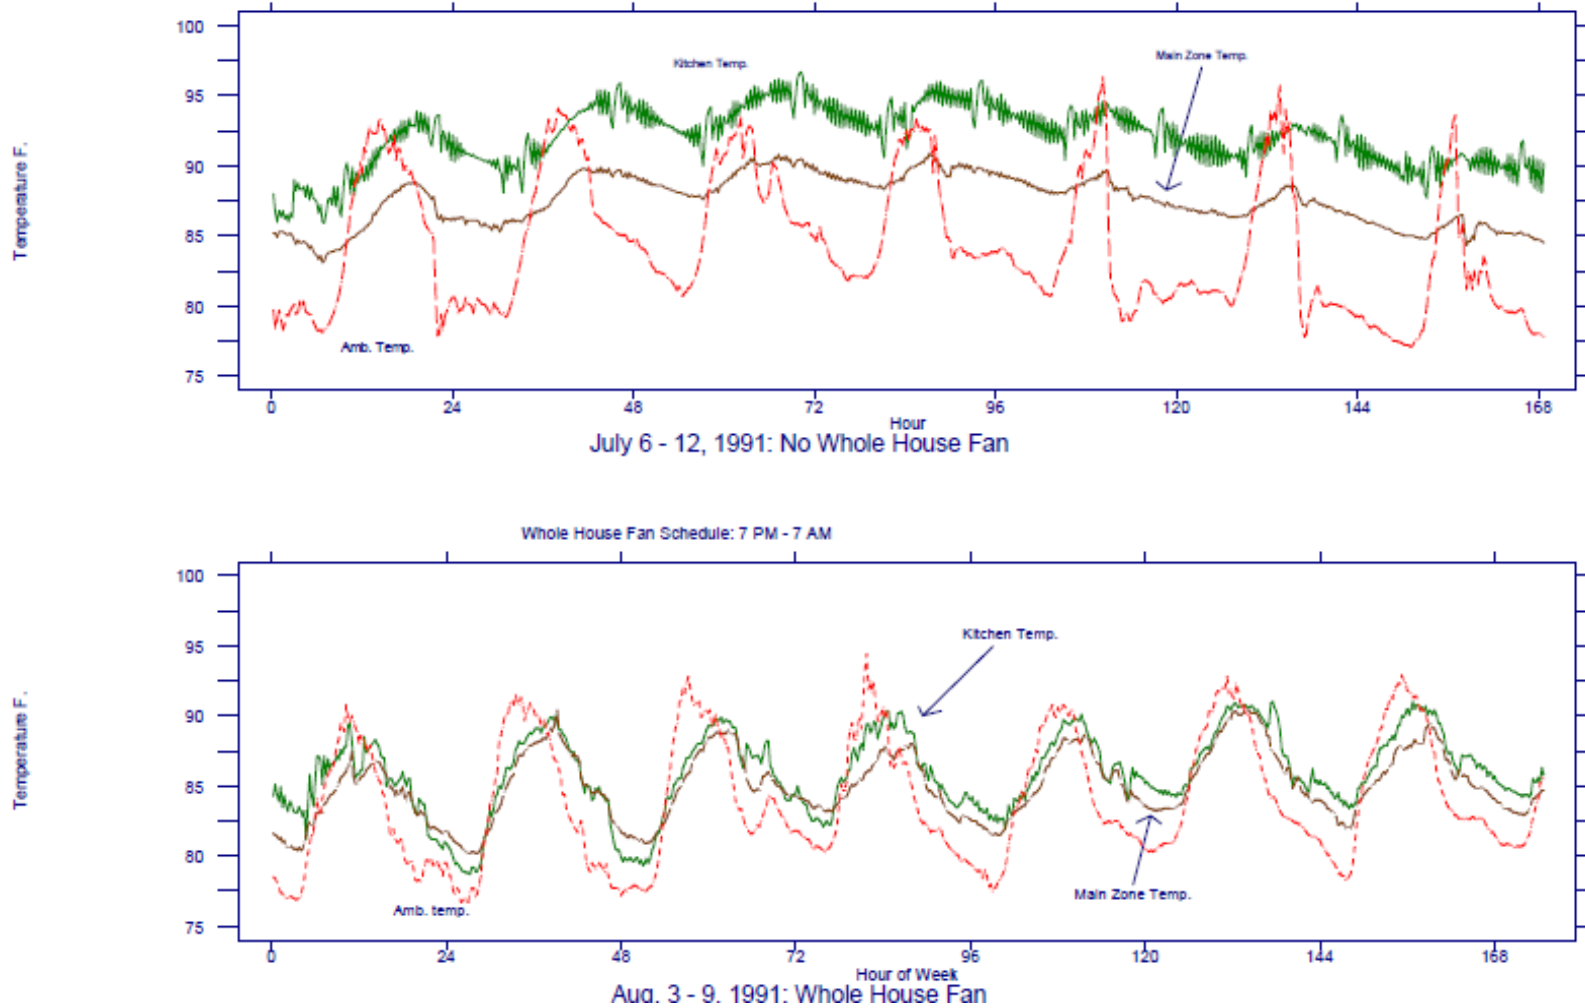
Figure 34. Two plots showing six-day periods in summer 1991 before and after a WH fan was installed to augment natural ventilation

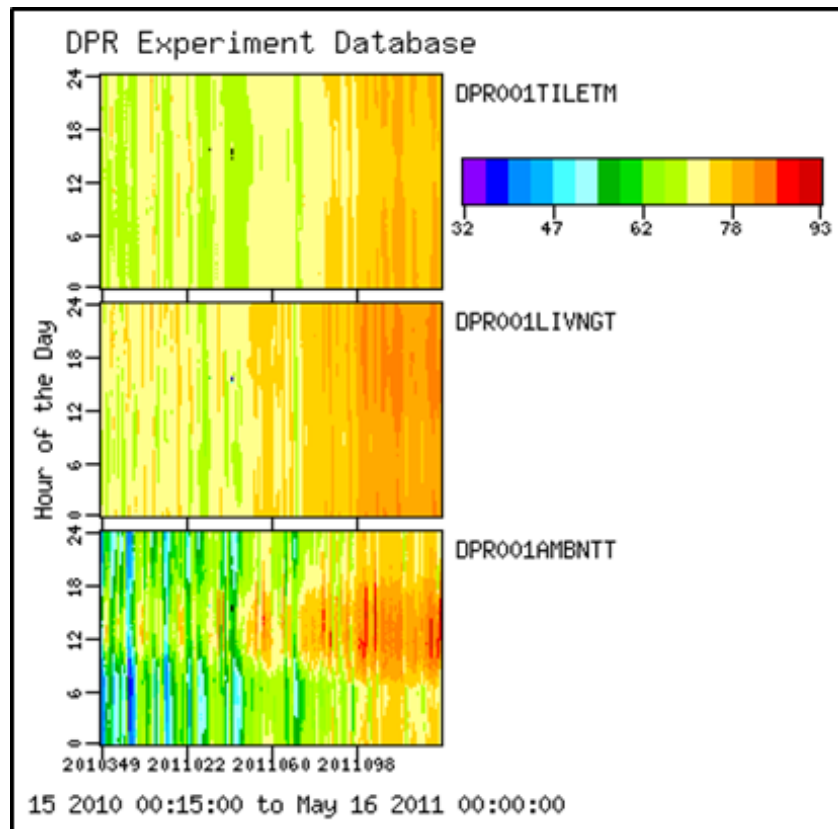
Figure 35. Image plot of tile surface temperature (top), house indoor temperature (middle) and outdoor ambient temperature (bottom) from December to May 2011. Color is proportional to temperature and X-axis is the Julian date. Note that the tile temperatures are slowly warming, with the house indoor temperatures generally warmer than the outdoor temperatures, particularly at night from internal heat gains.

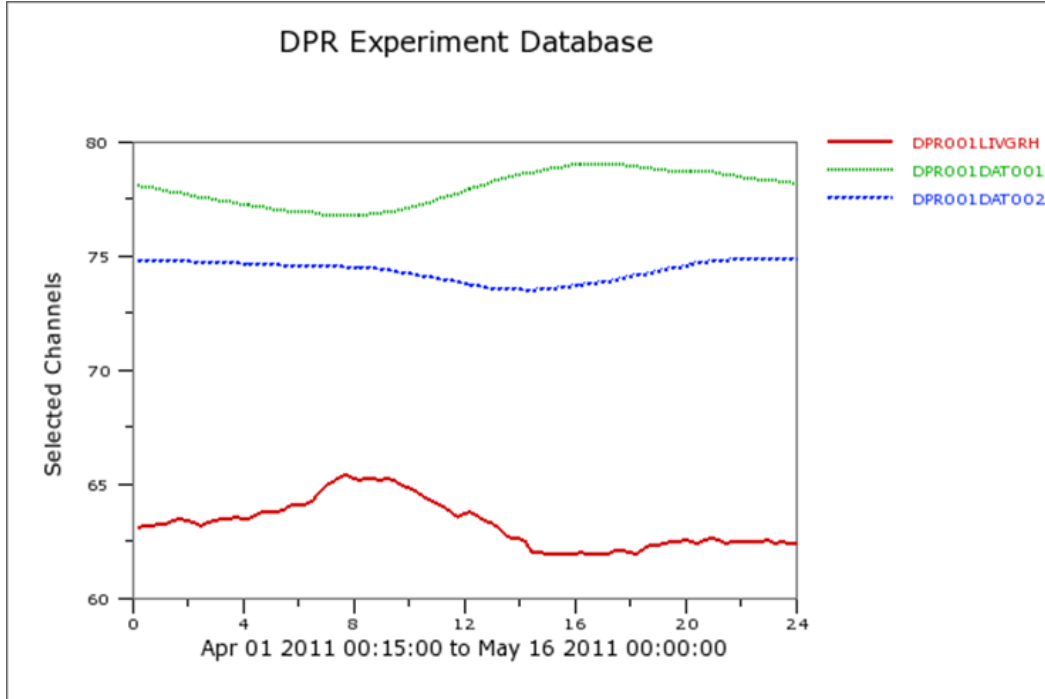
Figure 37. Average living room temperature (green), average tile surface temperature (blue), and living room relative humidity (red) during the time when the WH fan was used for cooling in spring 2011.

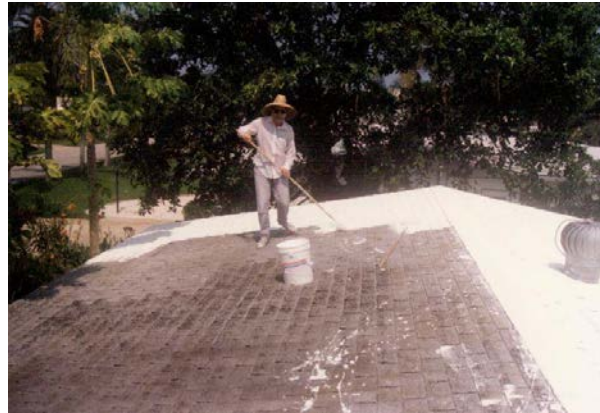
Figure 40. A highly reflective elastomeric coating was applied over shingles in an experiment in July 1992 (a practice that is no longer recommended because of moisture-related problems)

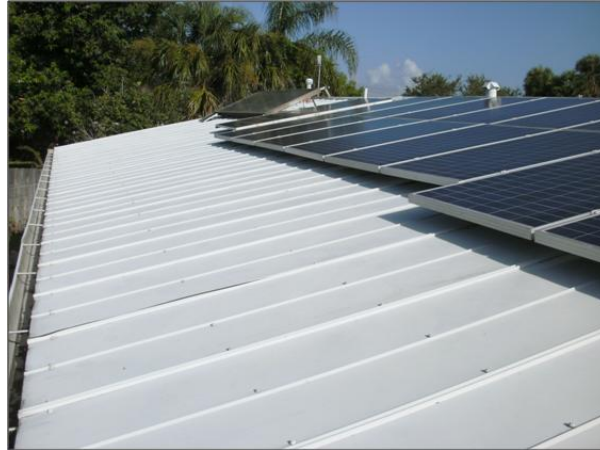
Figure 42. White metal roof after 12 years of weathering on the south exposure. The 5-vee metal panels have maintained their reflectance. PV modules are seen in the image with the solar water heater at the far end.

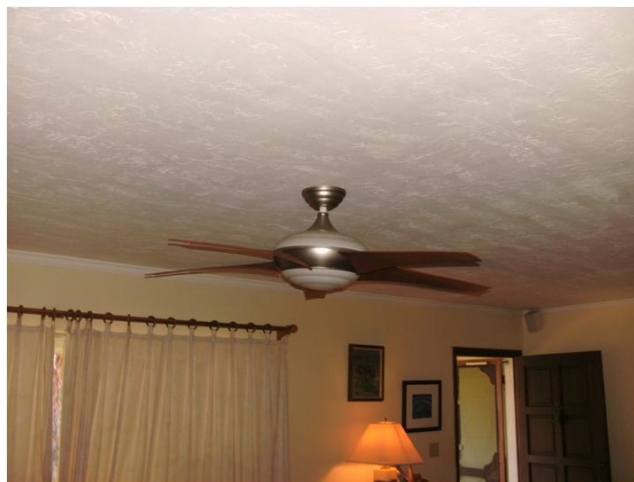
Figure 43. During the home remodel in 1998, high-efficiency ceiling fans were installed throughout the house to help shorten the A/C season (number of weeks A/C was necessary for comfort).

Within the home the second phase of improvements continued in order to decrease energy use. Improvements have spanned a 22-year period that has included two additions to the family, adding 660 ft² to the home, and a host of other changes (Figure 43), both helpful and unhelpful, to reducing energy consumption.

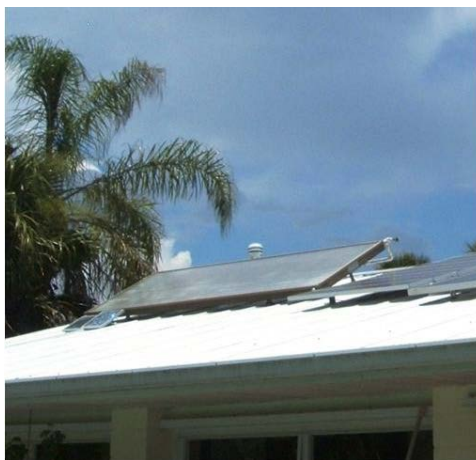
Figure 47. 4 ft × 8 ft solar collector. System is PV pumped by two 5-W PV modules mounted in parallel.

Within a month of having a natural gas water heater installed, we had a solar water heating system mounted on the roof as the primary water heating system. This consisted of a used AET 4 ft × 8-ft collector, pumped by two 5-W PV modules mounted in parallel and a small El-Sid DC pump (Figure 47). Storage consisted of an 80-gal tank that was plumbed such that it convectively circulated to the elevated auxiliary 40-gal natural gas tank whenever the 40-gal storage exceeded the temperature of the water in the natural gas tank (FSEC, 2006). This effectively provided 80 gal of storage for the solar water heating system. The system provided about 50% of annual water heating required, although this was reduced by the inefficient auxiliary tank.

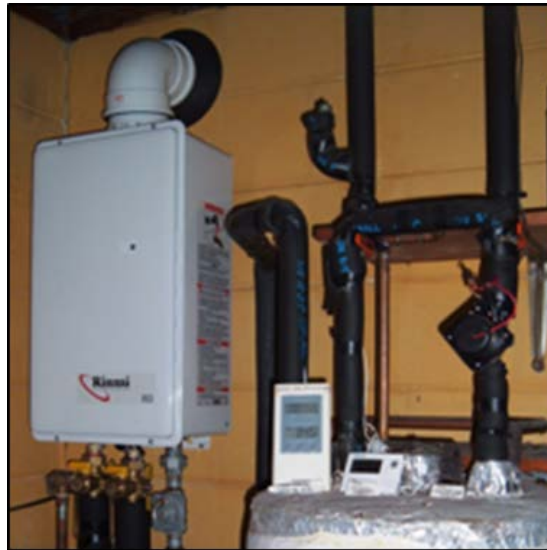
Figure 48. Tankless water heater elevated above 80-gal storage tank (lower right)

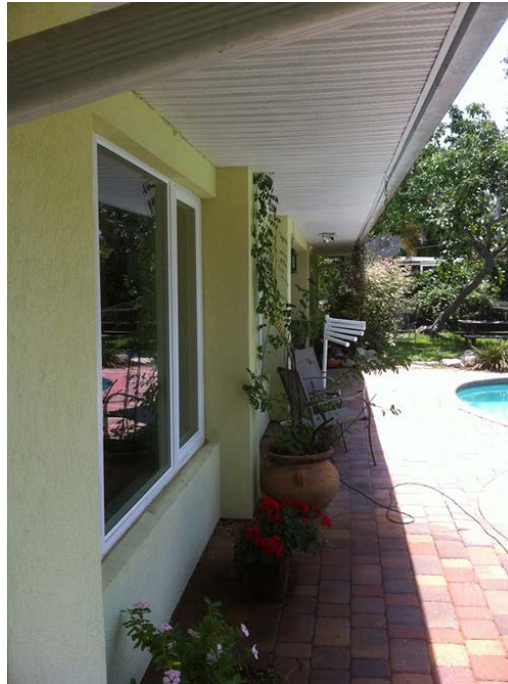
Figure 54. Three-foot overhang on the south face of the home and resulting shading pattern shown at noon on June 10, 2011. Note that the windows, walls, and foundation are fully shaded.

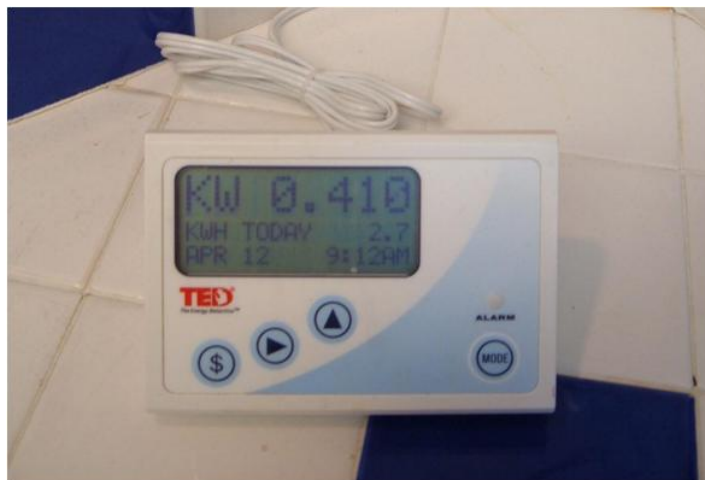
Figure 57. The Energy Detective real-time energy feedback device

In mid-2005, we installed a real-time electricity use feedback (The Energy Detective) device (Figure 57). This allowed us to monitor real-time household power and to track how well we were doing relative to power consumption.

In April 2006, we used the feedback device with a protocol to locate approximately 90 W of phantom loads that were being wasted. This included power use in the entertainment center, the home office, rechargeable tools in the garage, an unused transformer, and a potter's wheel inadvertently left on. The protocol allows isolation of household loads through a two-person audit procedure with circuit breakers and plugs used to isolate all house-specific electricity end uses (Parker, Hoak, Meier, & Brown, 2006). The monthly electricity consumption (see in Figure 79) shows a measurable saving from this intervention at about the same time that the ENERGY STAR clothes washer was installed. The relatively low level of reduction seen on the installation of the device compared with actions shown at April 2006 suggests that feedback will be most productive when linked to actions to reduce energy, such as replacement of aging appliances, identified though using the devices as a diagnostic tool.

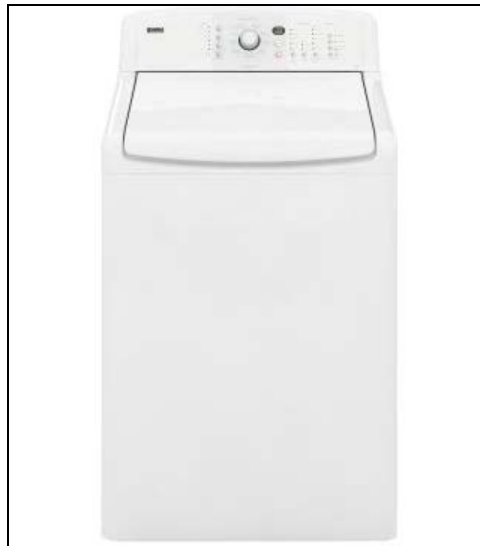
Figure 58. Kenmore 2706 ENERGY STAR washer

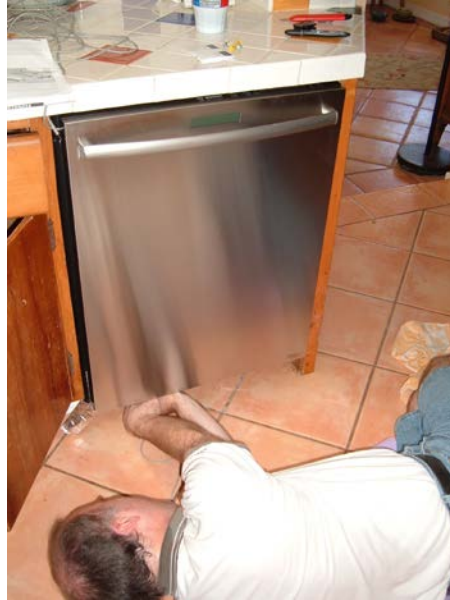
Figure 61. Installation of new ENERGY STAR dishwasher

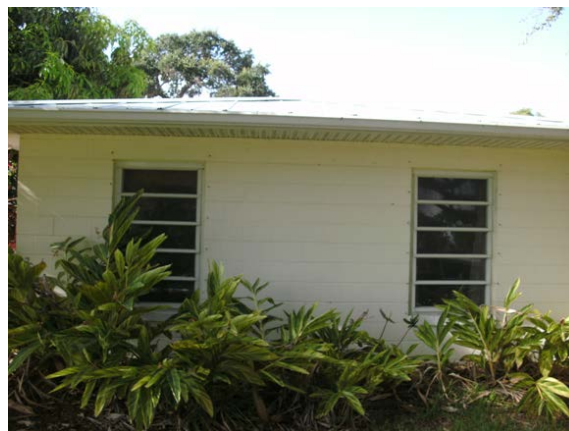
Figure 62. Poorly fitting single-glazed awning windows with aluminum frames before retrofit

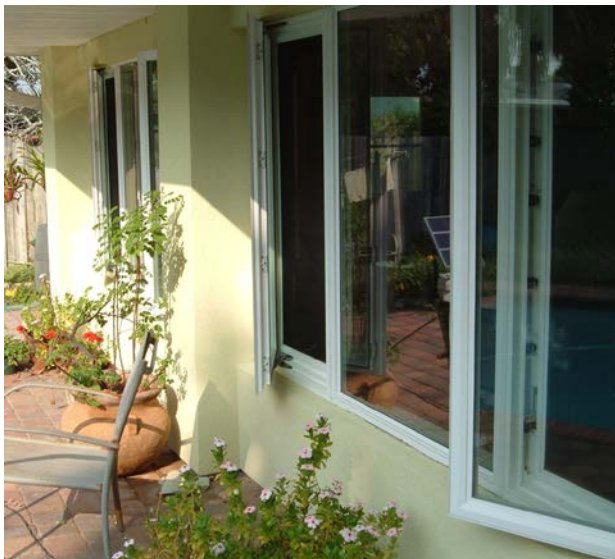
Figure 63. New high-efficiency solar control low-e windows on the south side of the home installed in August 2010. These casements open fully for ventilation.

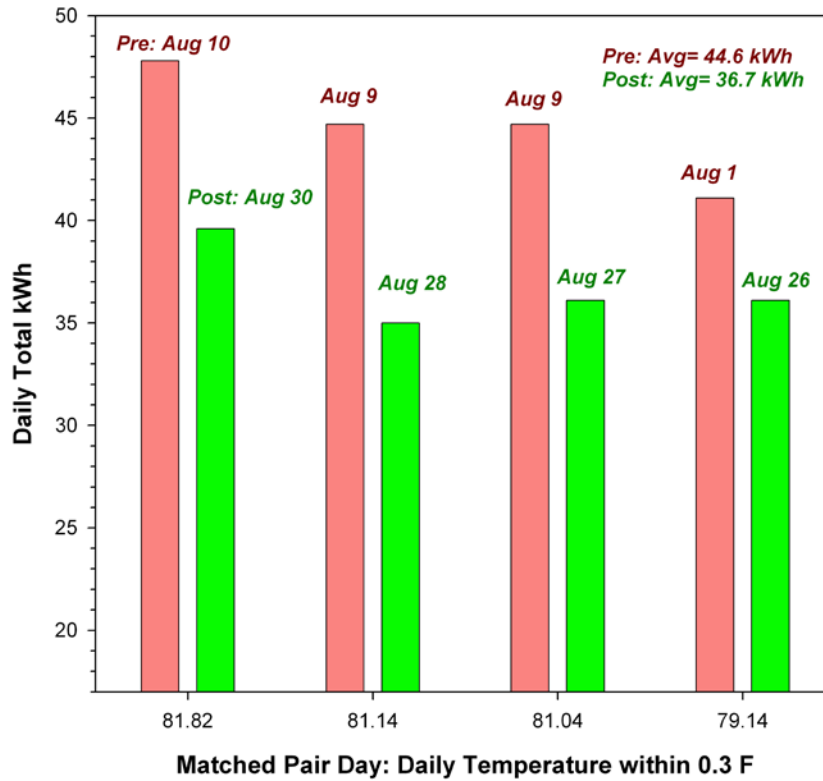
Figure 64. Measured household total electric power before and after retrofit to energy-efficient windows. Thermostat was set to a constant level; non-A/C loads averaged about 16 kWh/day. Savings appear to be approximately 8 kWh/day.

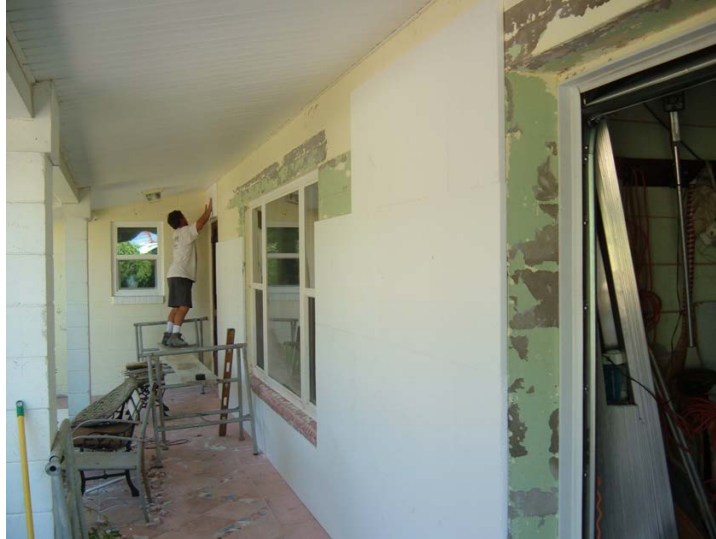
Figure 65. Exterior EIFS wall insulation retrofit in progress. Insulation consists of 1 in. of expanded polystyrene on the exterior covered by fiberglass mesh and vinyl texture stucco.

The concrete block walls were insulated to R-5 on the exterior with an EIFS system in September–October 2010. Figure 65 shows the wall insulation retrofit in progress. The final system consisted of a vinyl stucco coat over fiberglass mesh and the 1 in. of expanded polystyrene. The final coating R-value is likely around R-5.5 Btu/ft²-h-°F.

The total cost of the improvement was \$11,300 to cover a gross wall area of approximately 1,830 ft². The net area less doors and windows was 1,398 ft², so the net cost was approximately \$8/ft².

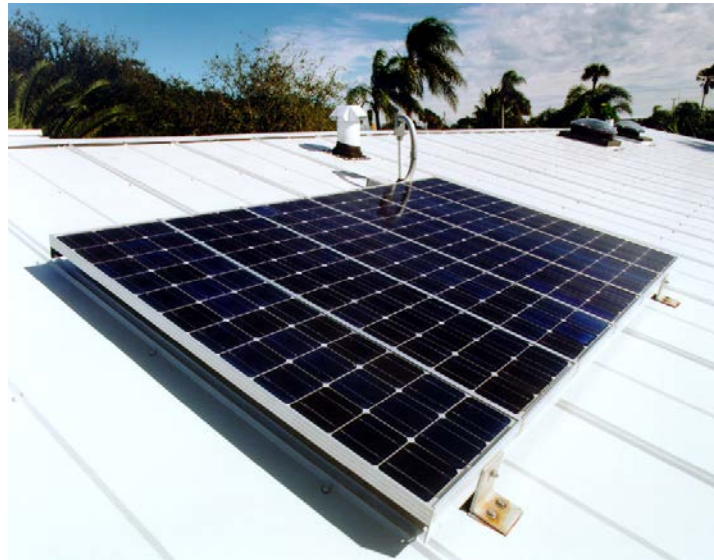
Figure 66. 450 W of solar modules powers pool pump directly. Solatube on white metal roof can be seen in the background. Array shown before installation of larger 4.9-kW PV system.

In an effort to totally eliminate this electricity end use, it was substituted with a PV-powered $\frac{1}{2}$ hp DC pool pump (ETA Engineering 90 Volt DC pump). The pump runs as long as the sun is up each day from a dedicated 450 W of PV (six 75-W modules), shown in Figure 66. The system works very well compared to the $\frac{3}{4}$ hp A/C pump that was removed. It fully operates the automated pool cleaning system (Figure 67). The addition of the system produced a noticeable drop in total household electric power, as seen in monthly electricity consumption in Figure 79 (Section 16).

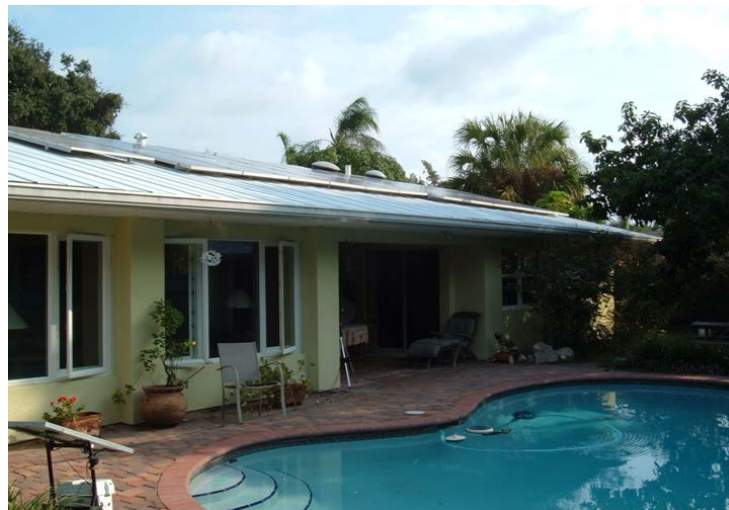
Figure 67. PV-powered pool pump in operation with the automatic pool cleaner operating during daytime. This retrofit saved at least 2000 kWh/year.

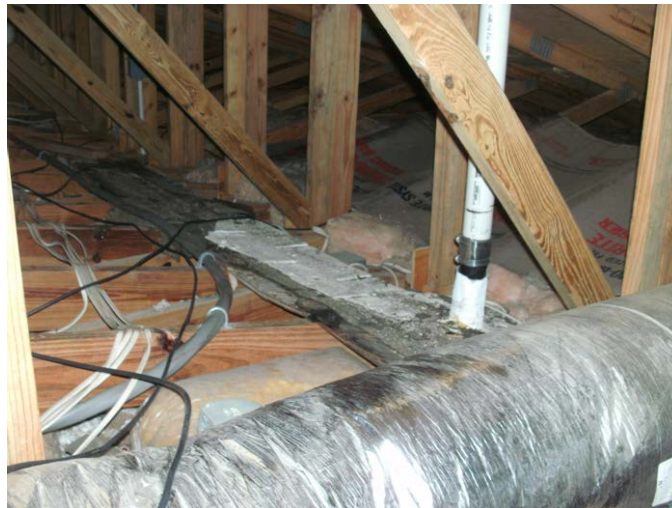
Figure 68. Attic ducts, while sealed, are only insulated to R-6 and a major source of heating system heat loss in winter and cooling season heat gain in summer. Using the mini-split allows the duct system to be largely abandoned in place without these losses for space conditioning.

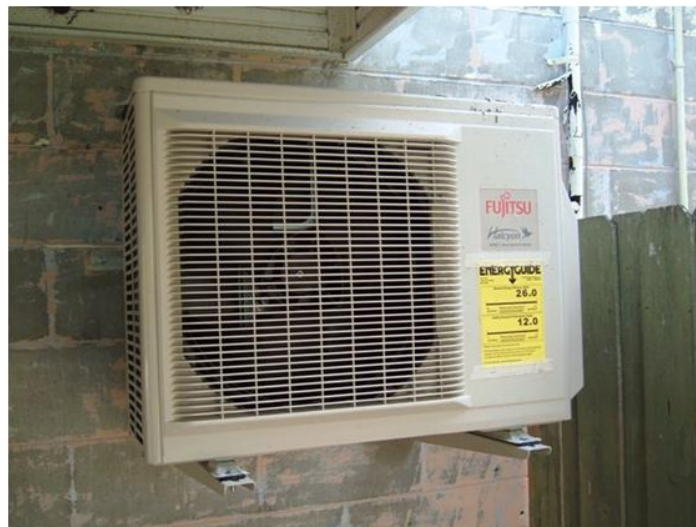
Figure 69. Outdoor unit of Fujitsu 9RLS mini-split heat pump as it appeared during the installation of the wall insulation retrofit. The outdoor unit is located outside the west garage.

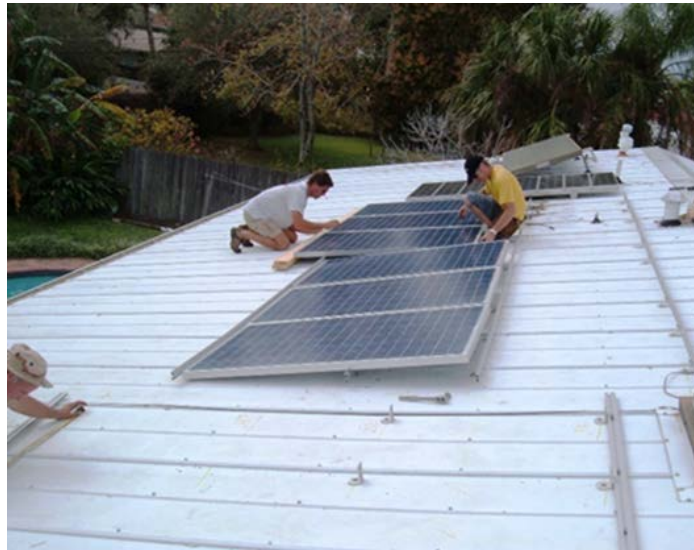
Figure 73. Installation of 4.1-kW PV system in February 2009

The attempt to reach a zero energy existing home required renewable energy generation. As one of the most expensive elements in the overall project, it was carefully planned. After evaluating multiple bids, at the end of January 2009, we installed a 4.1-kW PV system, although the net metering did not go in until the following month. Figure 73 shows the south face of the house during the retrofit with its PV system in January 2009. The original system consisted of 20 south-facing Evergreen ESA 205 modules grid connected to an SMA-5000 inverter located on the east side of the house (Figure 74). In October 2009, we added another 820 W (4 modules) to expand the capacity to 4.92 kW (Figure 75). Average power production since the system was finalized has averaged about 20.3 kWh/day. Figure 76 shows a calendar plot of power produced by the PV system in April 2011.

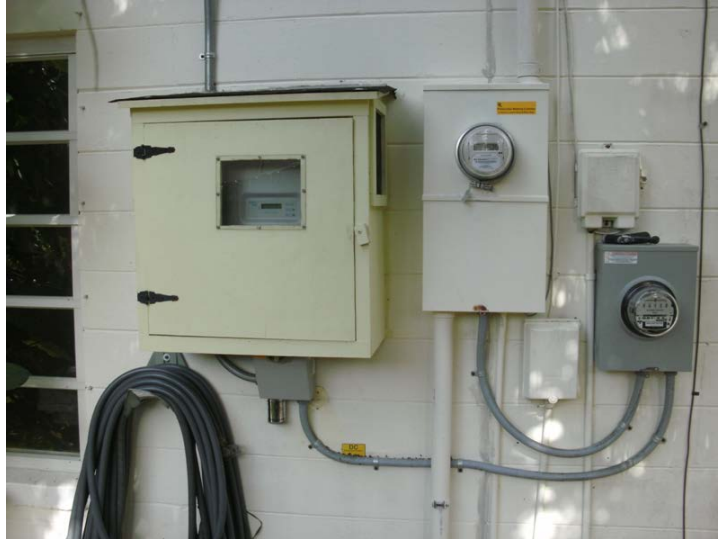
Figure 74. SMA 5000-W inverter is located on the east side of the home with the utility bidirectional meter. A ventilated enclosure was built to protect the inverter from sun and rain.

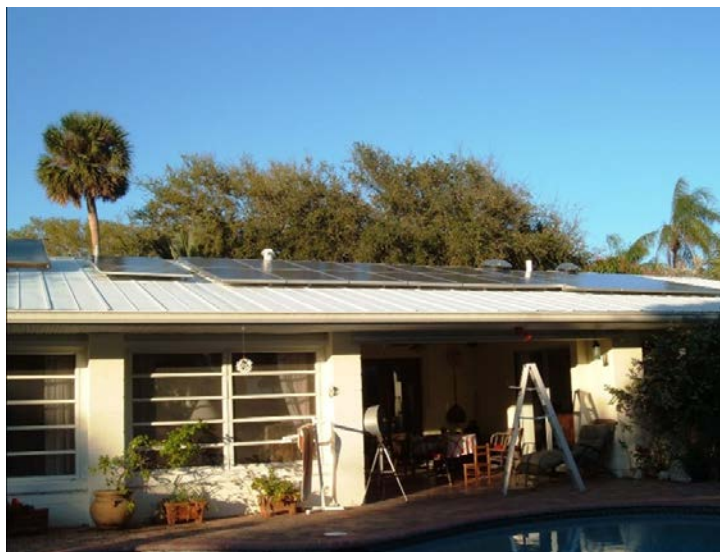
Figure 75. South roof of the home showing 4.92-kW PV system, 450-W PV pumping array, and solar water heating system (far left).
