Achieving Very High Efficiency and Net Zero Energy in an Existing Home in a Hot-Humid Climate: Long-Term Utility and Preliminary Monitoring Data

D. Parker and J. Sherwin
BA-PIRC

February 2012

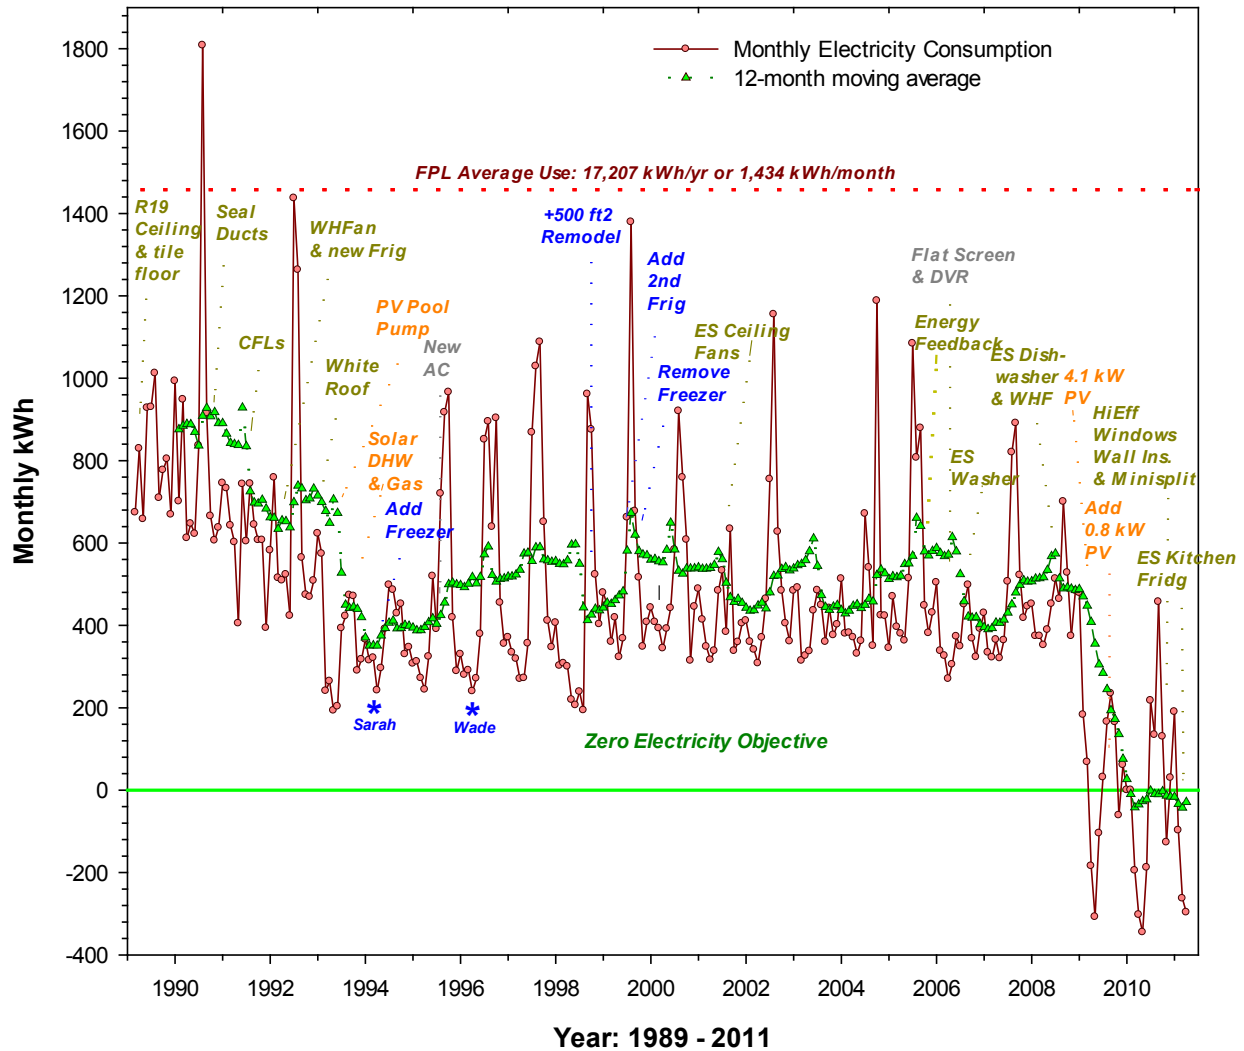
Figure 79. Changes to electricity consumption over the 22-year occupancy of the home
