Inventory and Prioritization of Impaired Sites in the Yellow River Watershed in Alabama and Florida

Final Report

Steven J. Herrington, Ph.D.
The Nature Conservancy: Florida Chapter
November 2011

DoD Legacy Program project number: 09-432

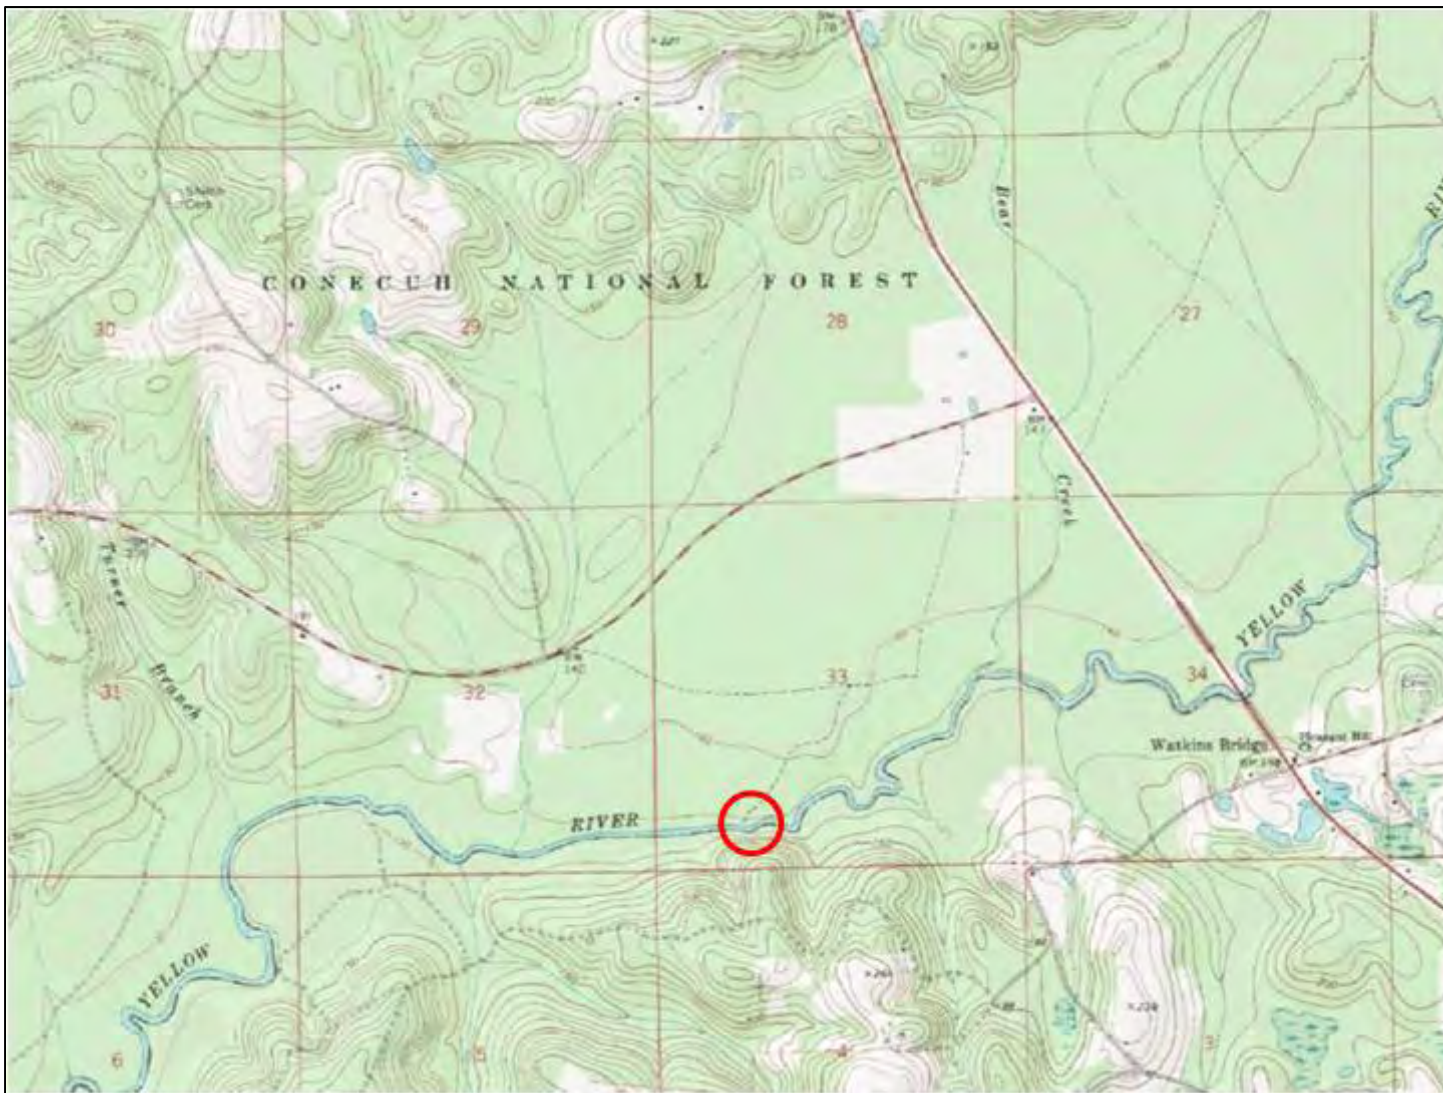
Figure 20. Dripping Rock (site co-0610-001; circled in red), Covington Co., AL. Photo courtesy Topozone.com

Based on the results of Phase I, we identified site number co-0610-001 in the Conecuh National Forest Focal Area as the location for site restoration (Appendix D). This location, known locally as “Dripping Rock”, is located on the western bank of the Yellow River approximately two miles downriver of Alabama State Highway 55, in Covington County, AL (Figs. 20 and 21). This location received a severity score of 4.25, resulting in a “Moderate” impairment ranking.

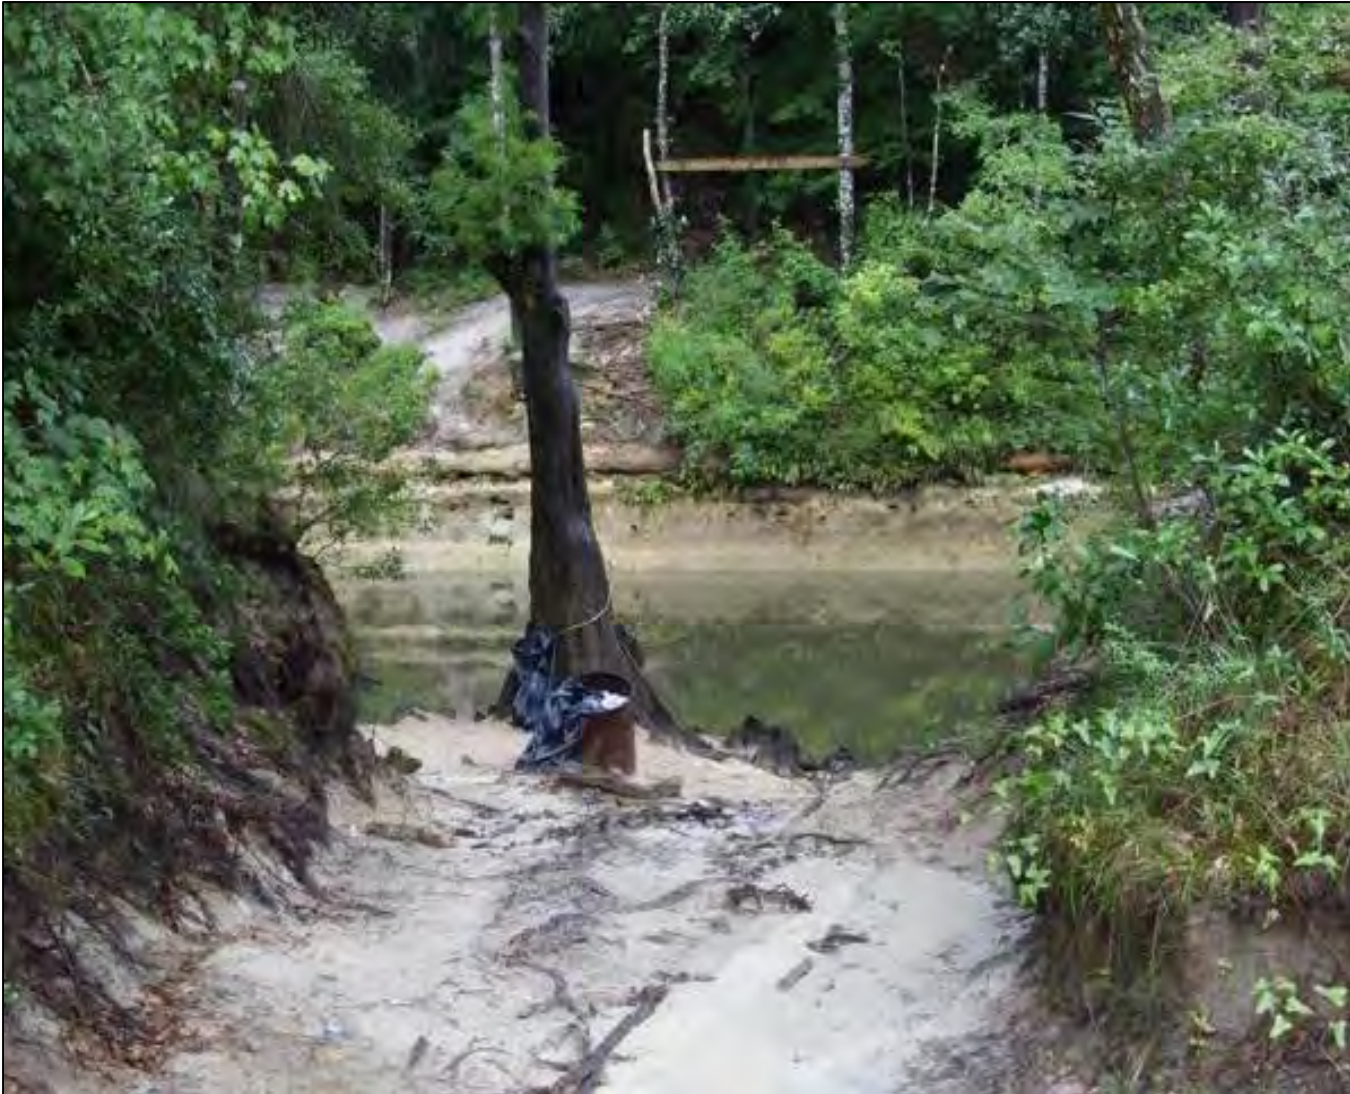
Figure 22. Denuded and breached riverbank at Dripping Rock. Photo credit: The Nature Conservancy.

We restored the riverbank as well as the unpaved road leading to the riverbank at Dripping Rock from July 5 – 10, 2011. Although the site is accessible to the public from the Yellow River, we worked with several private landowners to access and stabilize the unpaved road which traversed their properties and was the source of sediment pollution at the site. We used standard unpaved road and river corridor restoration techniques according to restoration designs drafted by the U.S. Fish and Wildlife Service, Panama City Field Office (Appendix O). River corridor was restored by grading, stabilizing & revegetating the breached bank to floodplain level, rather than rebuilding & reconnecting to the adjacent natural levee, in order to help reduce sheer stress from natural rises in river levels thereby reducing chance of failure (Fig. 28). The unpaved road was stabilized by grading, filling, and seeding (Fig. 29). Specifically, we (1) stabilized the length of the impacted streambank and floodplain using natural fiber erosion control cloth; (2) provided native shrub and tree material planting along the stream corridor for future stabilization and habitat recovery; (3) seeded all exposed areas of the road and riverbank with annual and perennial plants; and (4) installed heavy duty gate at road entrance to minimize continued human-induced degradation of the Dripping Rock area (Fig. 30). Materials and supplies for completing the restoration included erosion control fabric for short-term sediment/bank stabilization; stakes for setting the erosion control fabric; trees, shrubs, herbaceous plants, and temporary seed for revegetation and long-term sediment/bank stabilization, and fill dirt for assuring necessary grade; and substrate for long-term revegetation and site stabilization. Figures 31 –36 show pre- and post-restoration photo comparisons at Dripping Rock. See Appendix O for further restoration design and implementation details.

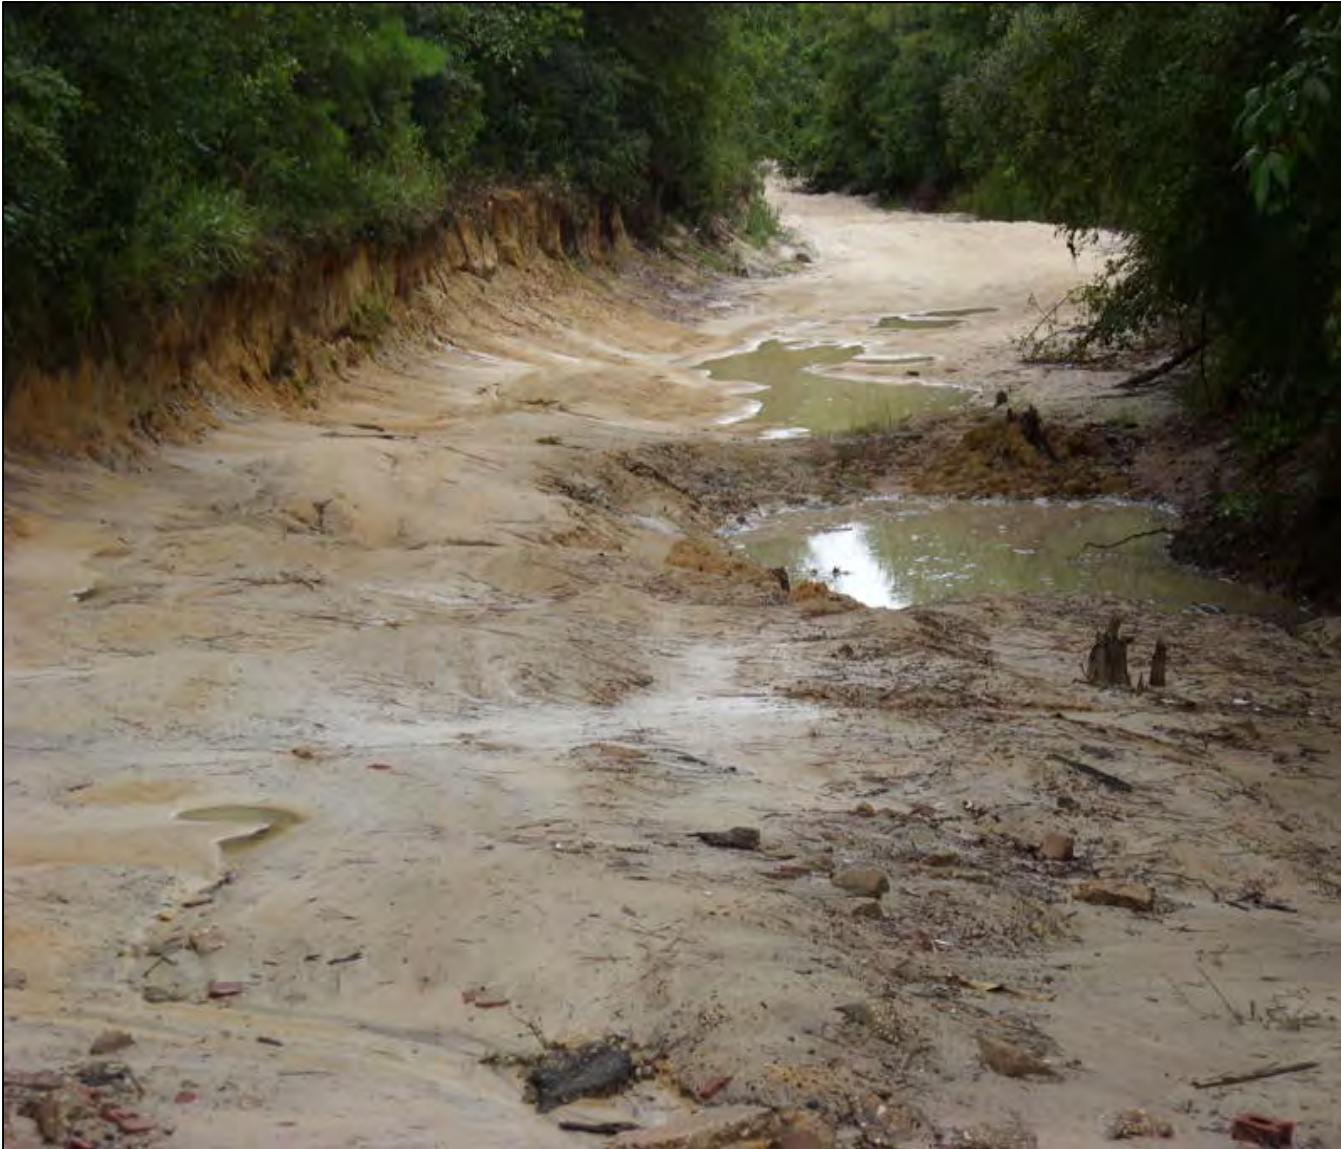
Figure 23. Unpaved road leading to the Dripping Rock site. Photo credit: The Nature Conservancy.

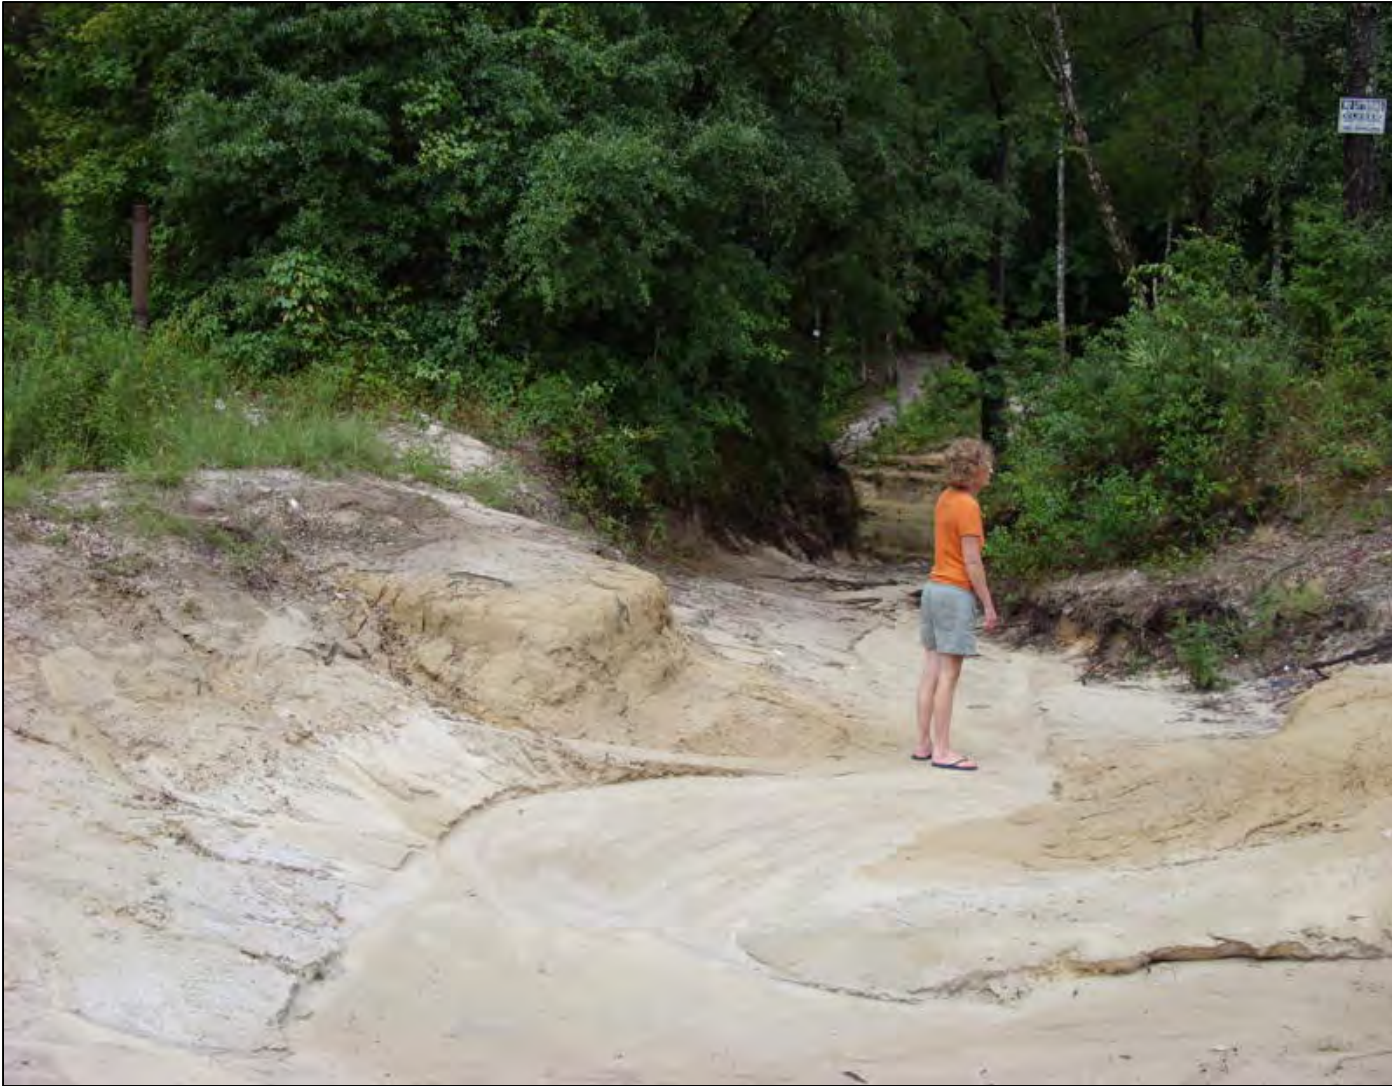
Figure 24. Unpaved road terminating at the denuded and breached riverbank at Dripping Rock. Photo credit: Eilene Beard.

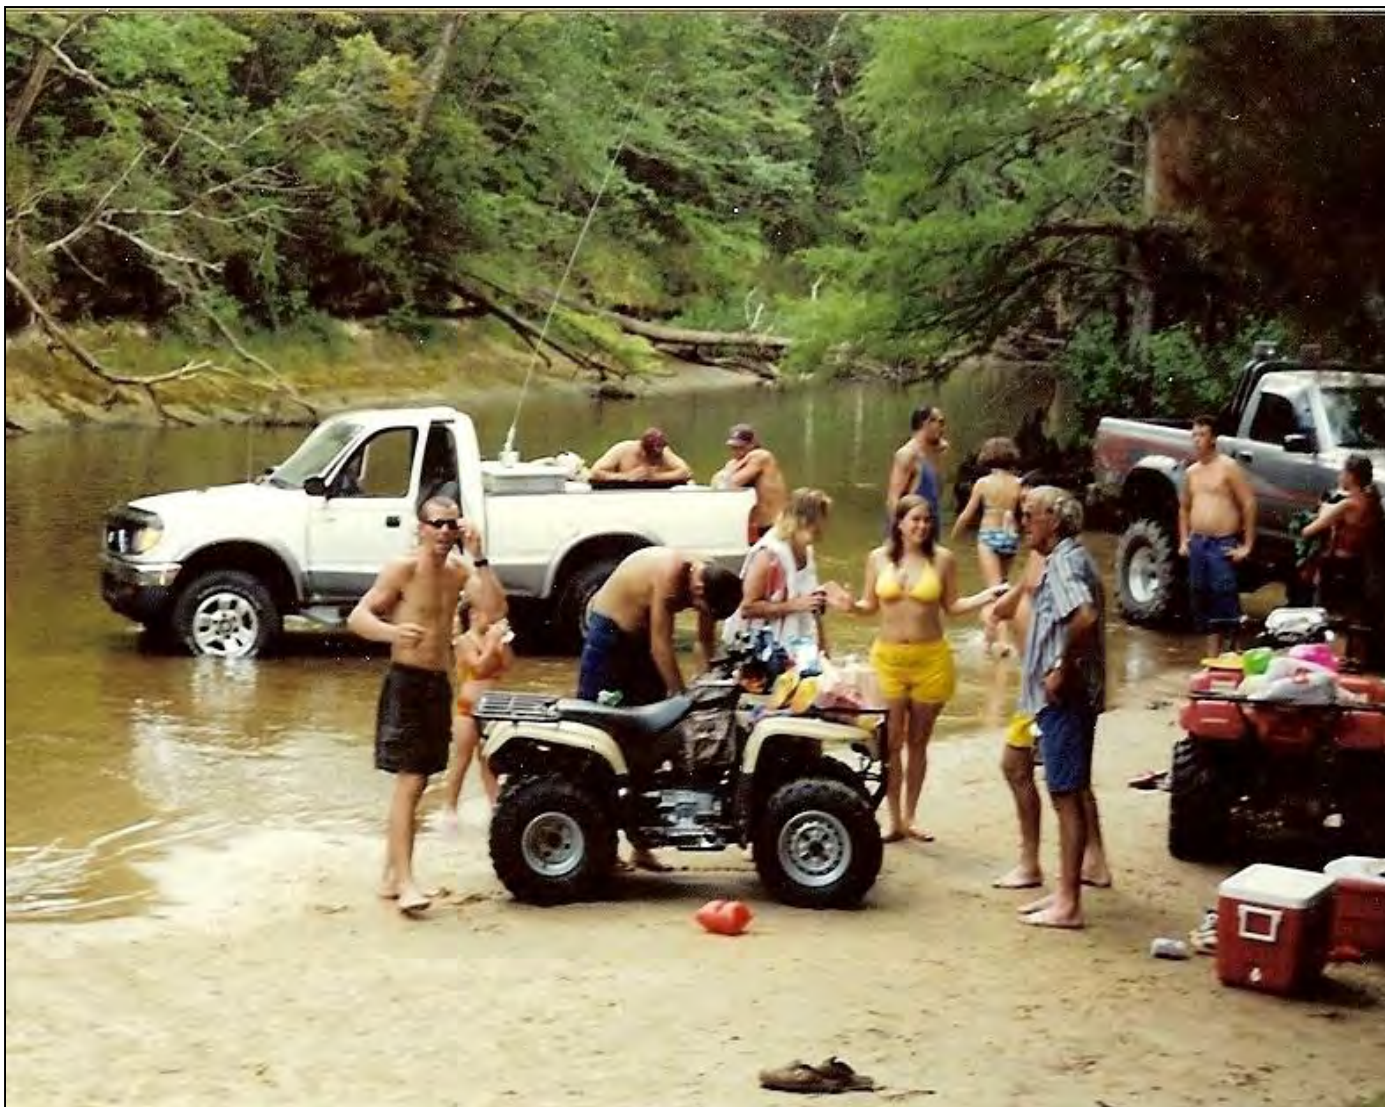
Figure 25. Degradation from public trespassing at the Dripping Rock site. Photo courtesy of U.S. Fish and Wildlife Service.

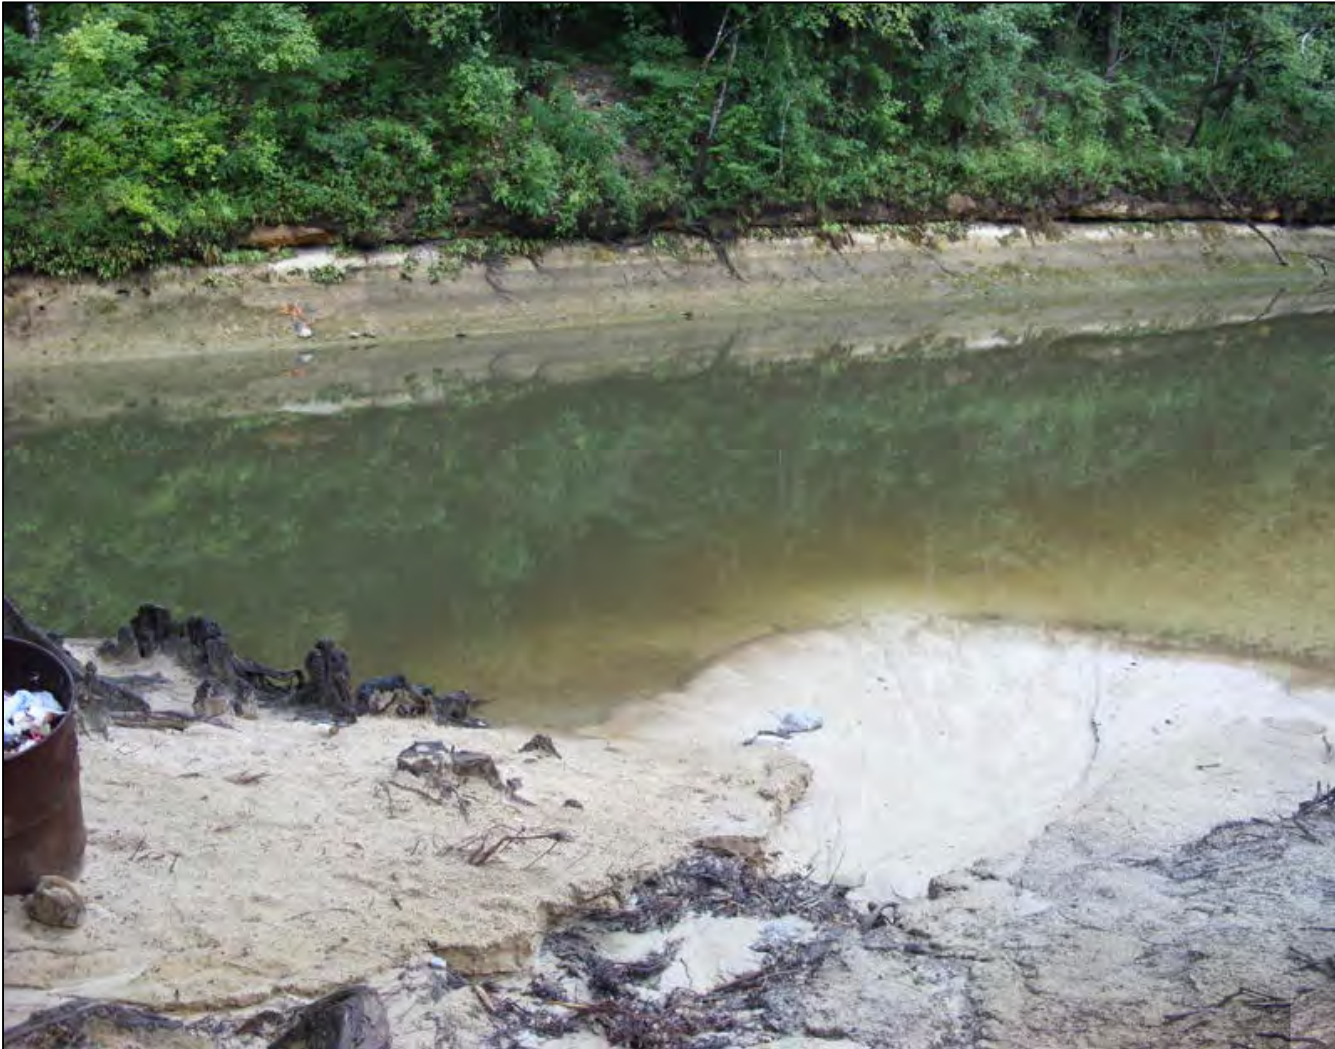
directly enter the river (Chris Metcalf, U.S. Fish and Wildlife Service, pers. comm.) (Fig. 26). Sedimentation originating from the unpaved road and denuded riverbank is considered a “High ranking Sources of Stress” to softwater streams, categorized under the heading “roads” in the CWCS (FWC 2005). The State of Florida has previously identified this location as impacting Florida resources and recommended restoration at this site (FDEP 2002).

Dripping Rock is directly adjacent to one of five potential Gulf sturgeon spawning sites and is the only site from which sturgeon eggs have been documented in the Yellow River (USFWS 2001). Excessive sedimentation is believed to smother and degrade the natural limestone hard-bottom substrate – a rare feature in the basin – needed by Gulf sturgeon and likely other species for spawning in the Yellow River (Fig. 27). The U.S. Fish and Wildlife Service also identified the Southern sandshell (*Hamiota australis*) – one of the five mussels which are currently candidates for protection under the Endangered Species Act – at the site in 2011 (Sandy Pursifull, U.S. Fish and Wildlife Service, pers. comm.). The State of Florida has previously identified this location as impacting Florida resources and recommend restoration at this site (FDEP 2002). In addition, the State of Florida has identified this drainage in both Alabama and Florida as an important conservation unit for Gulf sturgeon and recommend habitat restoration for long-term recovery and conservation of its stocks (Wakeford 2001). The cost of restoring this site was estimated as relatively low in comparison to similar river restoration actions (Appendix O). In total, we selected the Dripping Rock site for restoration given the combination of factors above, particularly the potential to optimize benefit to multiple, sensitive species within a rare but ecologically important geologic area of the river which was being directly degraded by a large amount of excess sedimentation.

Figure 26. Breached riverbank showing sediment pollution from the unpaved road directly entering the Yellow River. Photo credit: The Nature Conservancy.

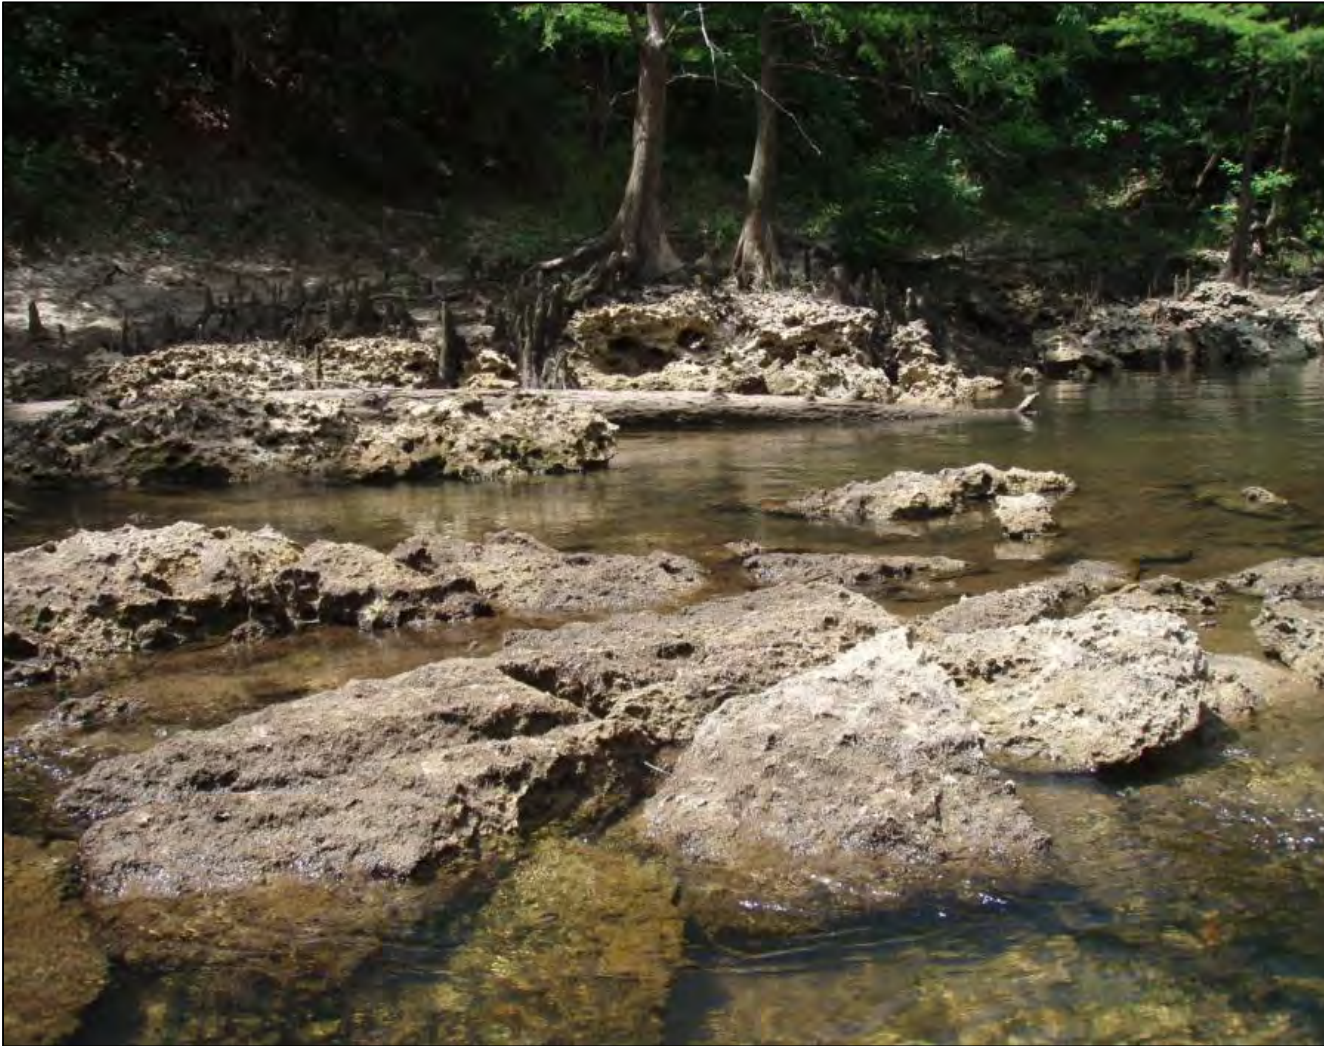
Figure 27. Limestone substrate (shown here exposed due to low river stage) used for spawning by Gulf sturgeon, approximately 0.25 mi. downstream of Dripping Rock. Photo credit: U.S. Fish and Wildlife Service.

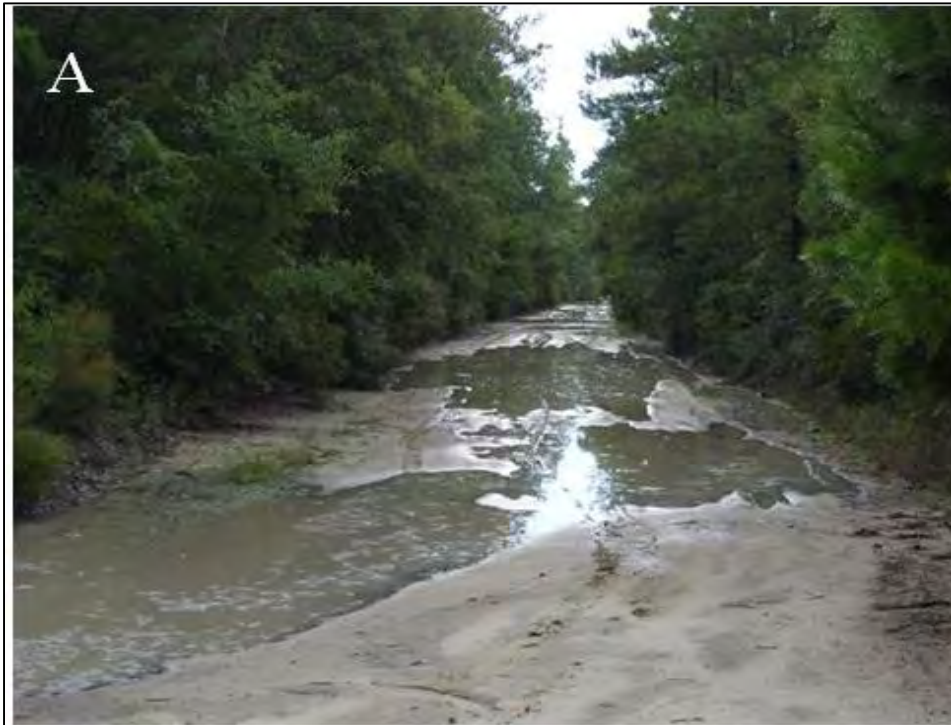
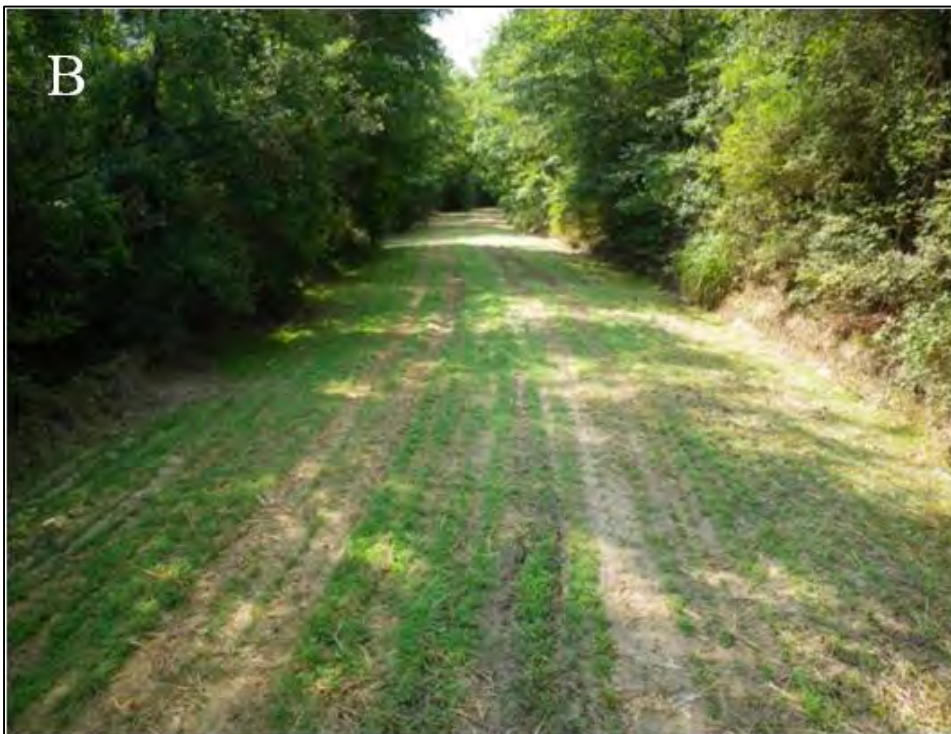
Figure 31. Comparison of unpaved road condition before (A) and after (B) restoration at Dripping Rock. Photo credit: The Nature Conservancy.

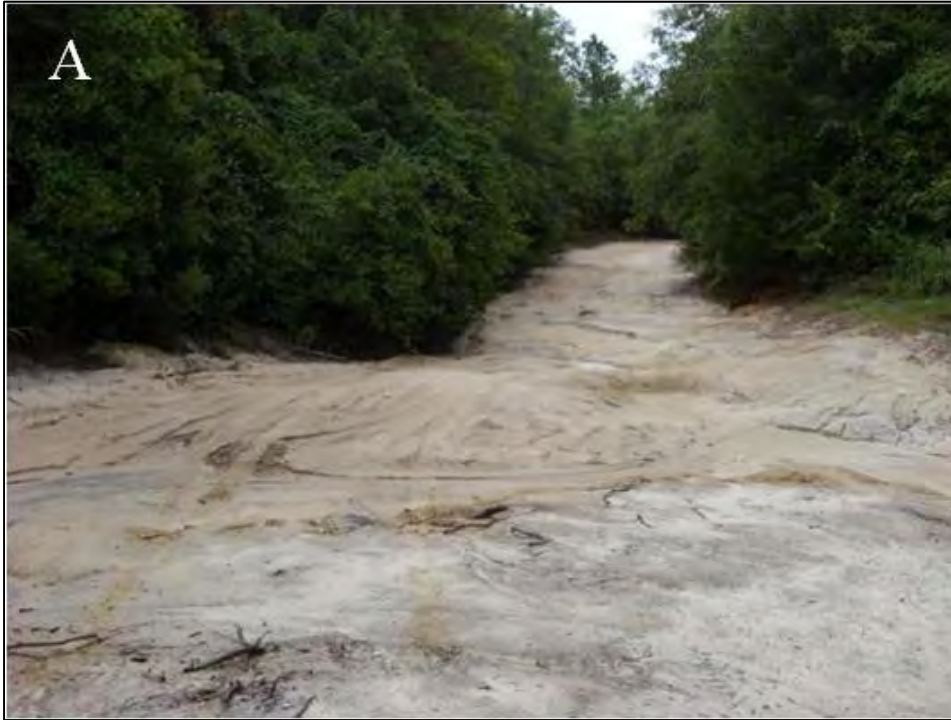
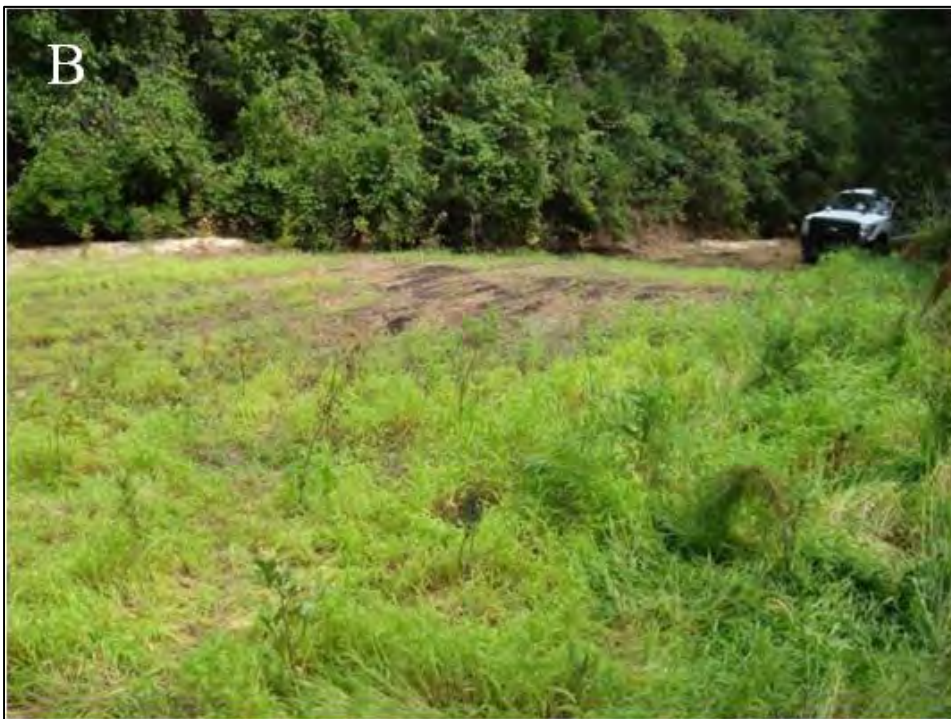
Figure 32. Comparison of condition of the unpaved road terminus at the breached riverbank, facing north towards the road, before (A) and after (B) restoration at Dripping Rock. Photo credit: The Nature Conservancy.

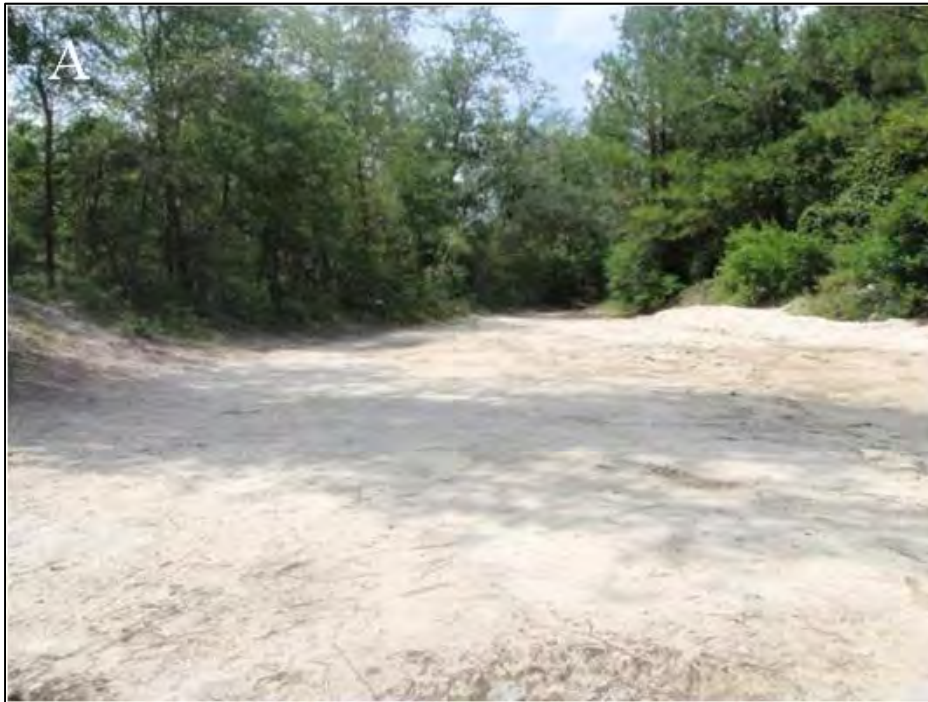
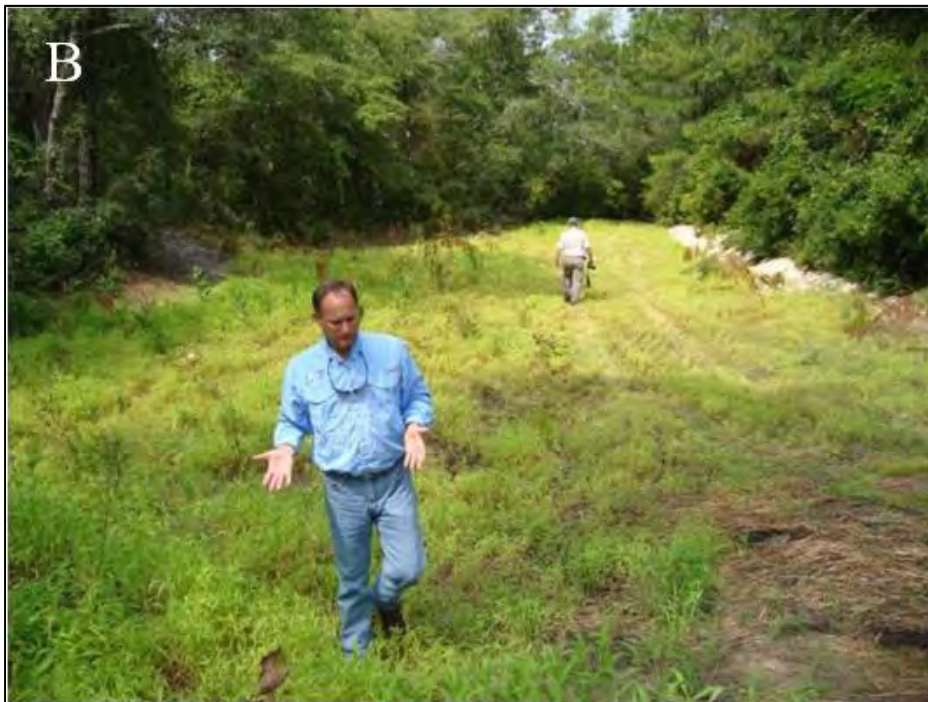
Figure 33. Comparison of condition of the unpaved road terminus at the breached riverbank, facing west along the riverbank, before (A) and after (B) restoration at Dripping Rock. Photo credit: The Nature Conservancy.

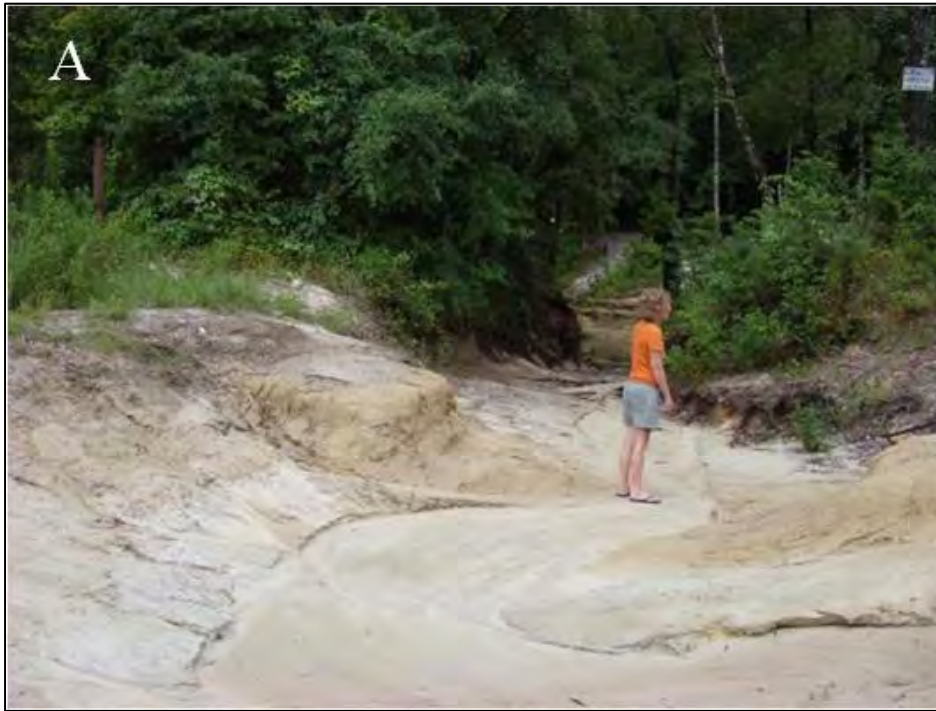
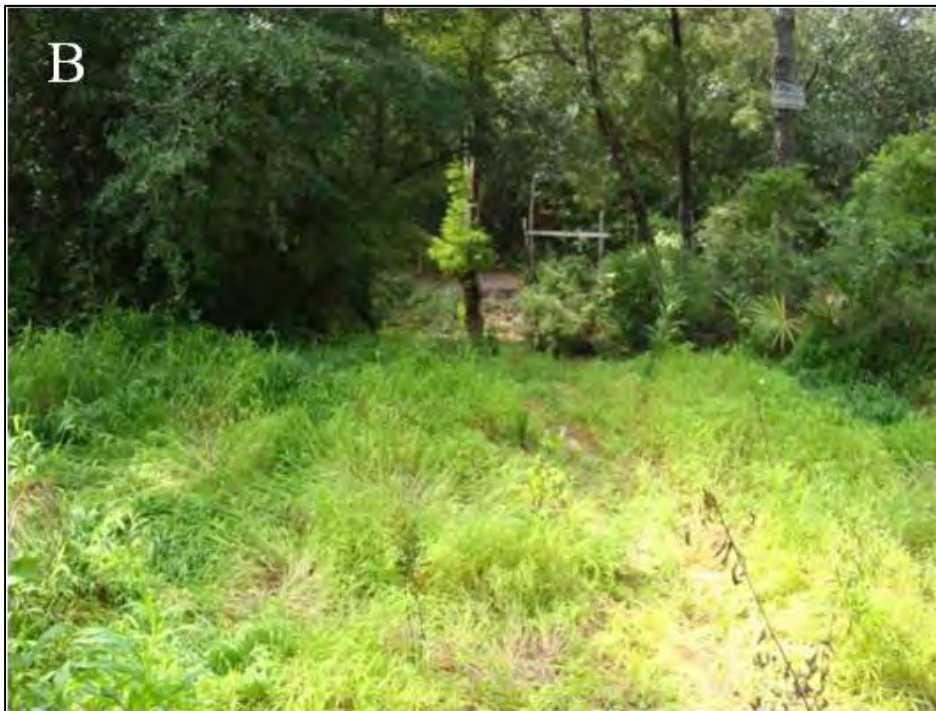
Figure 34. Comparison of condition of the unpaved road terminus at the breached riverbank, facing south towards the Yellow River, before (A) and after (B) restoration at Dripping Rock. Photo credit: Eilene Beard (A) and The Nature Conservancy (B).

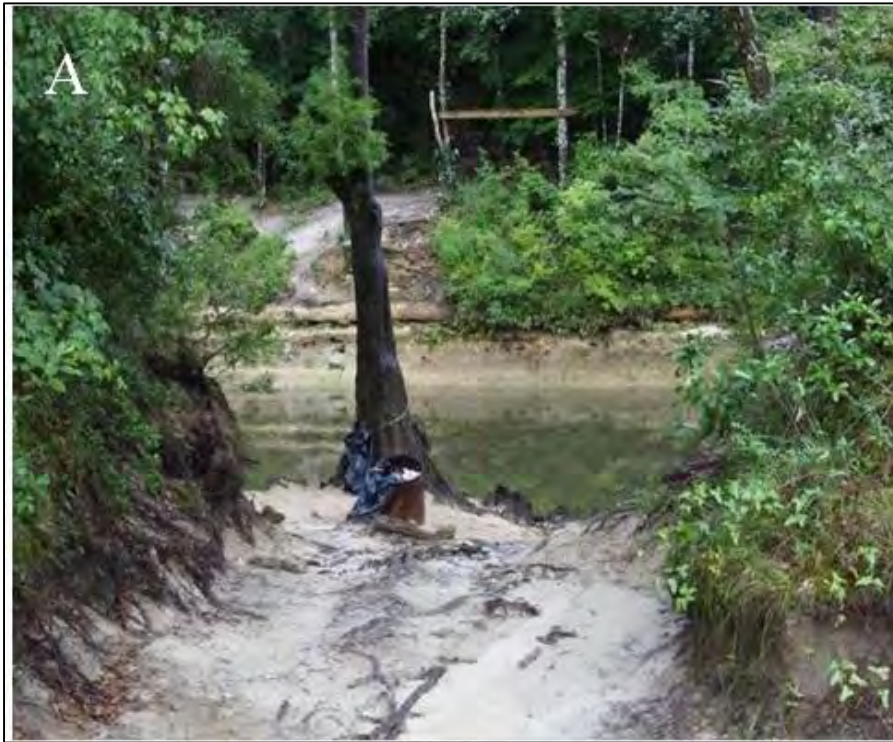
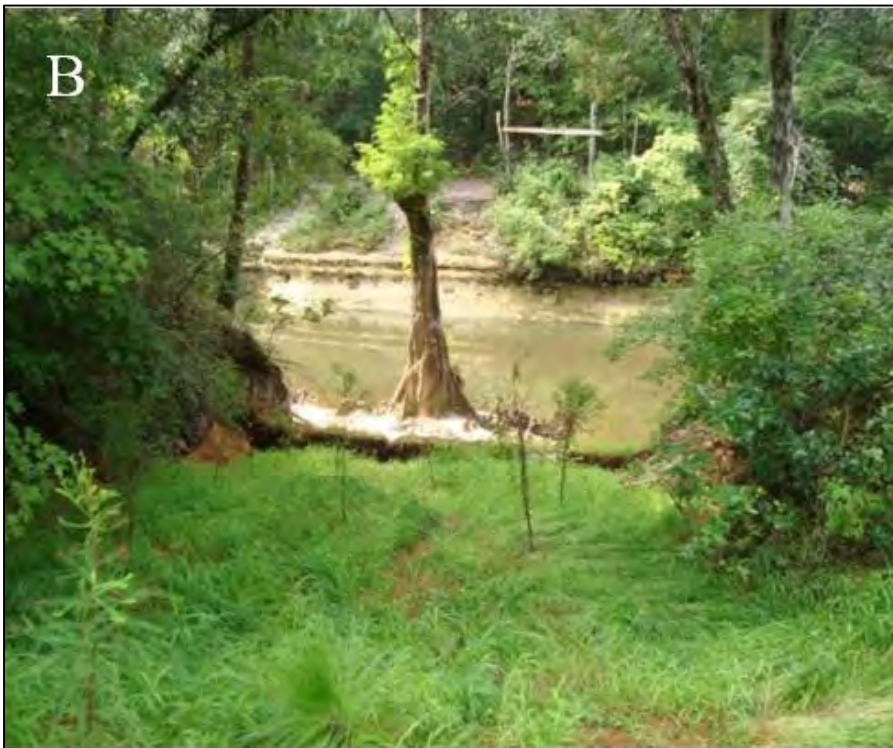
Figure 35. Comparison of condition of the breached riverbank before (A) and after (B) restoration at Dripping Rock. Photo credit: The Nature Conservancy.

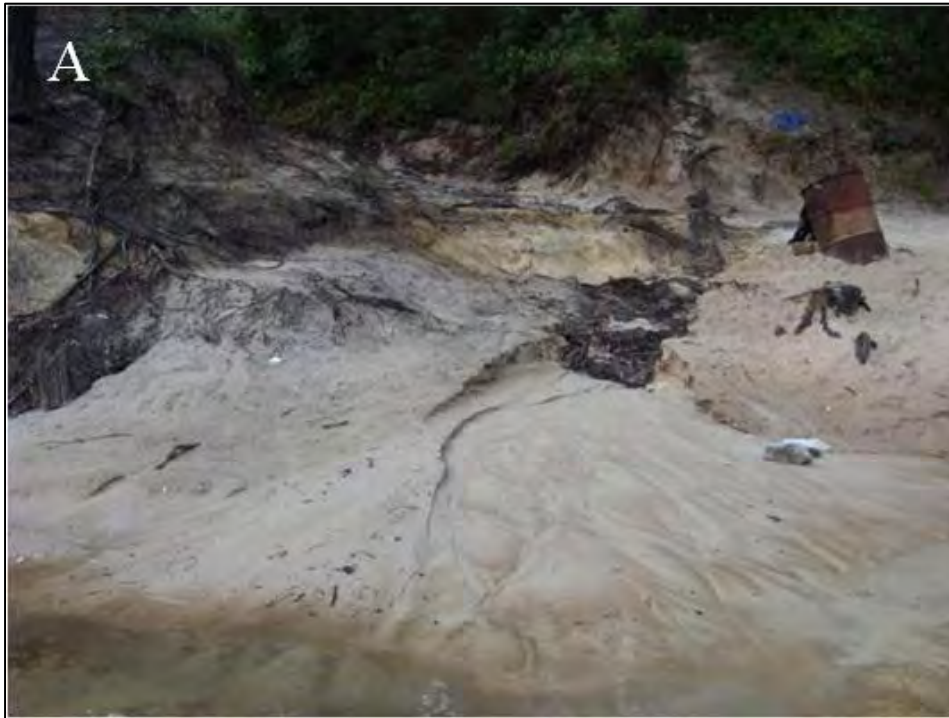
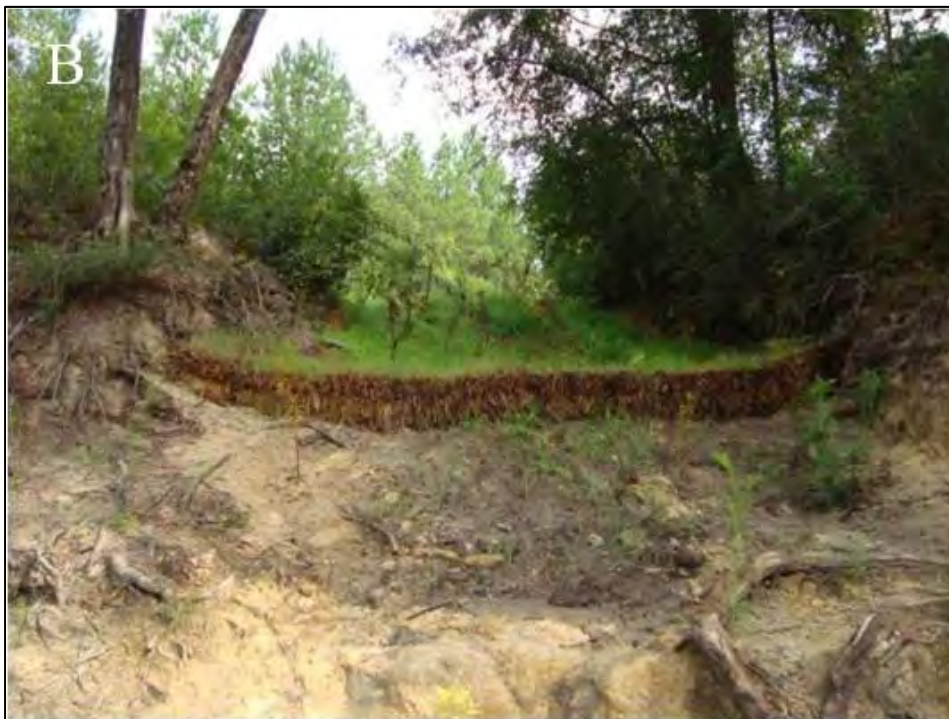
Figure 36. Comparison of condition of the breached riverbank, looking up-slope from the Yellow River, before (A) and after (B) restoration at Dripping Rock. Phot credit: The Nature Conservancy.
