River Corridor Closure Project

Recovery Act Weekly Report

For the week ending February 4, 2011

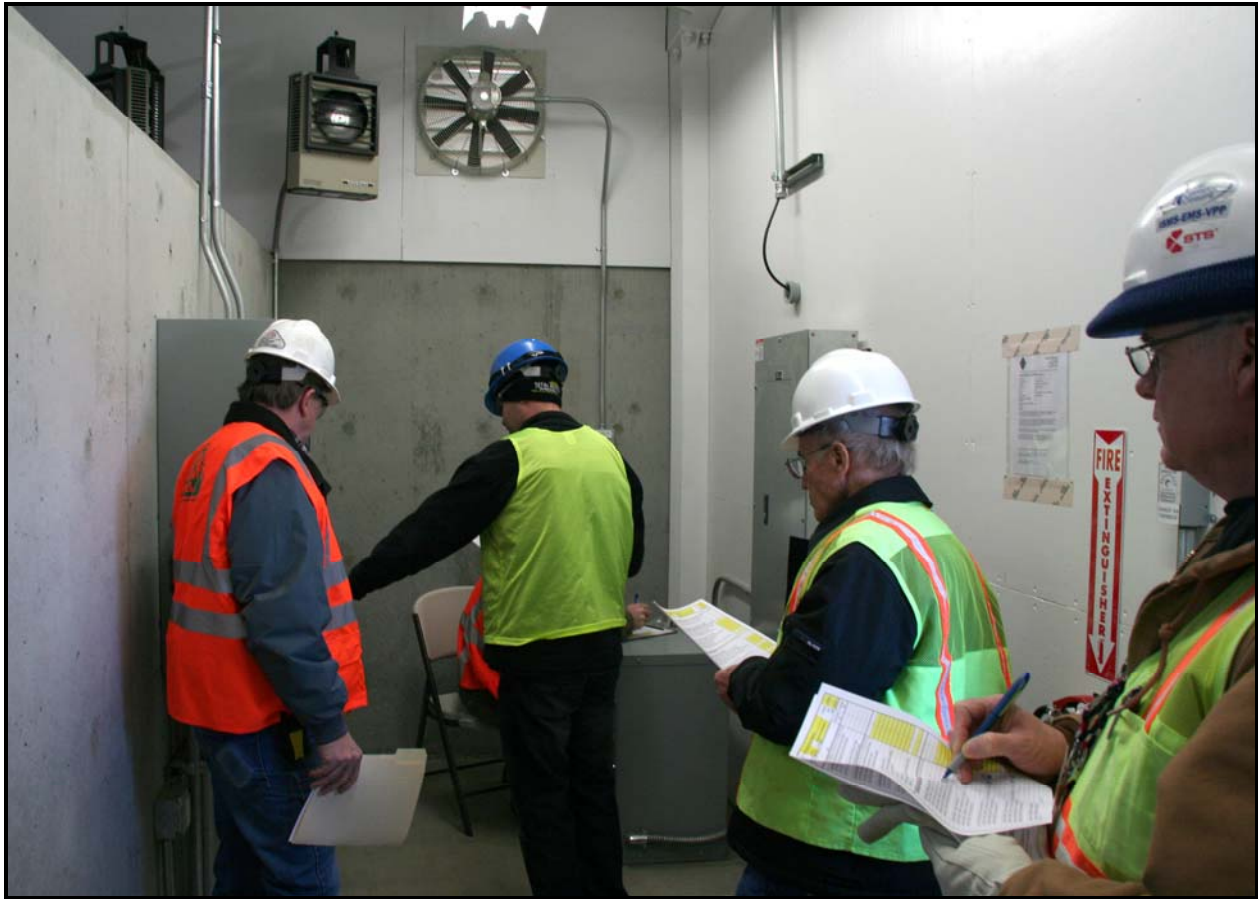
Washington Closure Hanford subcontractor TradeWind Services test the trench pump control panel in crest pad building 10 during final acceptance testing of Leachate Storage Tank No. 4. The testing was conducted with the U.S. Department of Energy and the U.S. Environmental Protection Agency. (Photo 1)

WCH subcontractor TradeWind Services conducted final acceptance testing for super cell 10 with DOE Richland Operations Office and EPA. Super cell 10 is scheduled to begin accepting waste in March. TradeWind also began final acceptance testing for Leachate Storage Tank (LST) No. 3. The majority of testing was completed, but the project team encountered a minor valve problem. Parts are on order, and testing will be completed by mid-February.

Last month, TradeWind conducted final acceptance testing for LST No. 4. The project team is scheduled to begin assembling the dome cover for LST No. 4 next week and will place the dome cover over the tank later this month. Assembly of the dome cover for LST 3 will then begin.

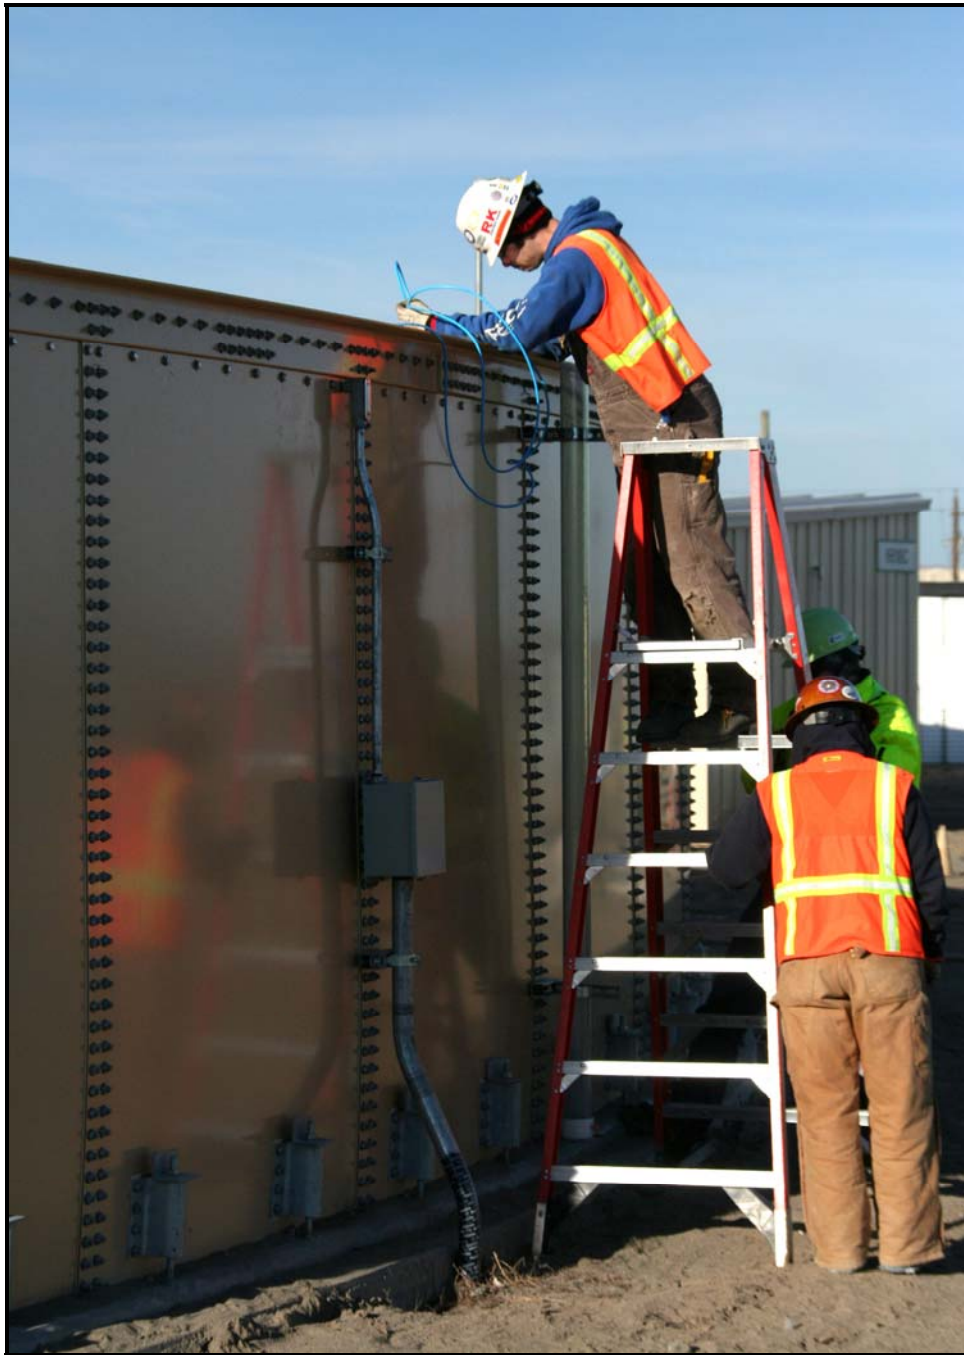
TradeWind lowers a transducer to test alarms at 3.6 feet and 7 feet in Leachate Storage Tank No. 4. If the 7-foot alarm sounds, all the pumps on the site shut off. (Photo 2)

Removal of one of the two original leachate storage tanks was completed in September. The second will be removed when the replacement tanks are in service. Each of the original tanks measured 80 feet in diameter and had a capacity of 275,000 gallons. Each replacement tank is 8 feet tall and 100 feet in diameter with a 425,000-gallon capacity. The dome covers are 12 feet tall.

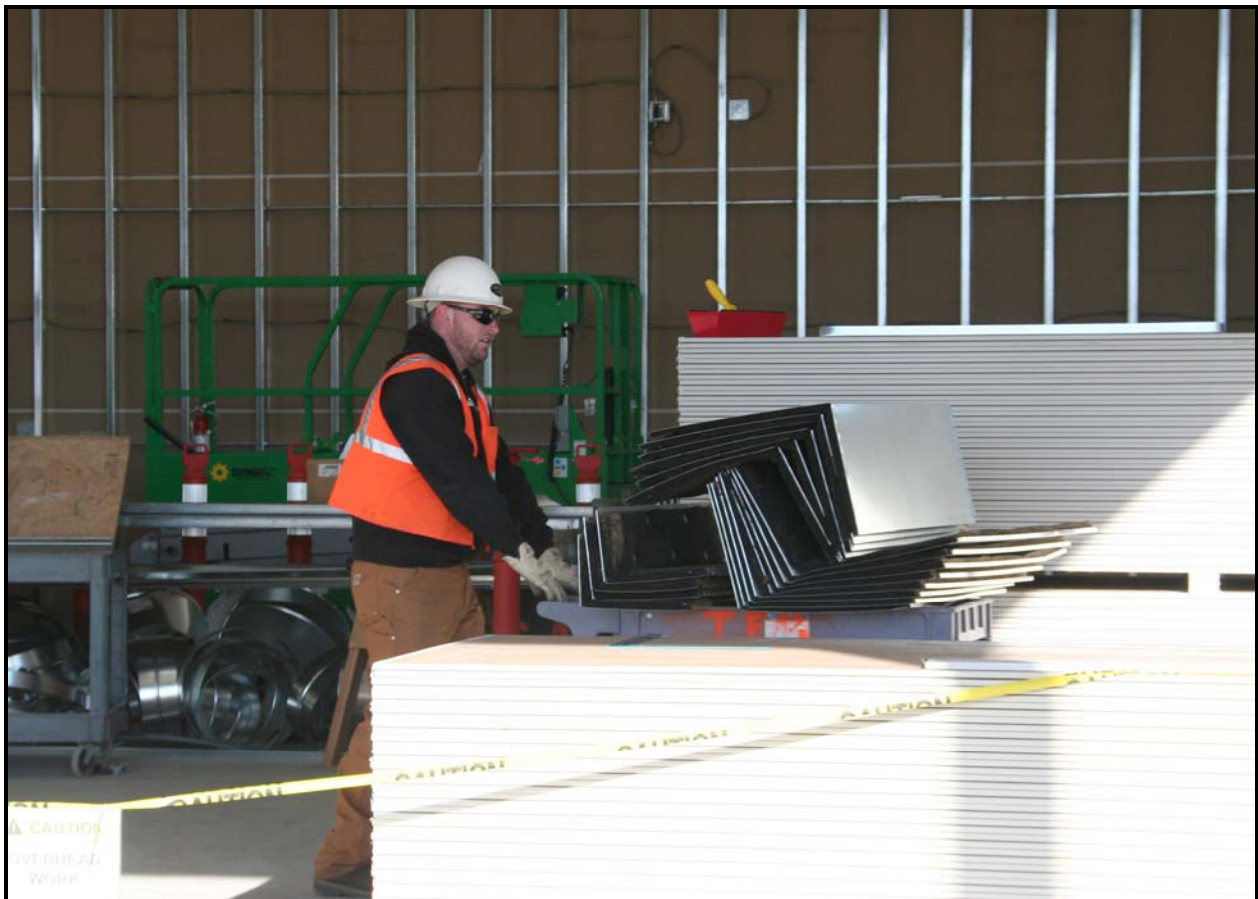
An employee with Washington Closure Hanford subcontractor ELRFowler works to install sheetrock in the new container maintenance facility at ERDF. (Photo 3)

WCH subcontractor ELRFowler continues to make progress with construction of ERDF's new maintenance facilities. At the container maintenance facility, the project team completed the electrical and plumbing rough-in and continued to construct the interior wall frames and install sheetrock. At the equipment maintenance facility/operations center, the project team completed installing the horizontal structures.

The container maintenance facility will include a large container repair line, a maintenance shop, and a weld area. The equipment maintenance facility will include two service lines, an operational storage facility, a large concrete pad, and an exterior awning over a smaller concrete pad. The new operations center will help alleviate severe overcrowding of personnel and also accommodate new employees hired to handle the increasing waste volumes.

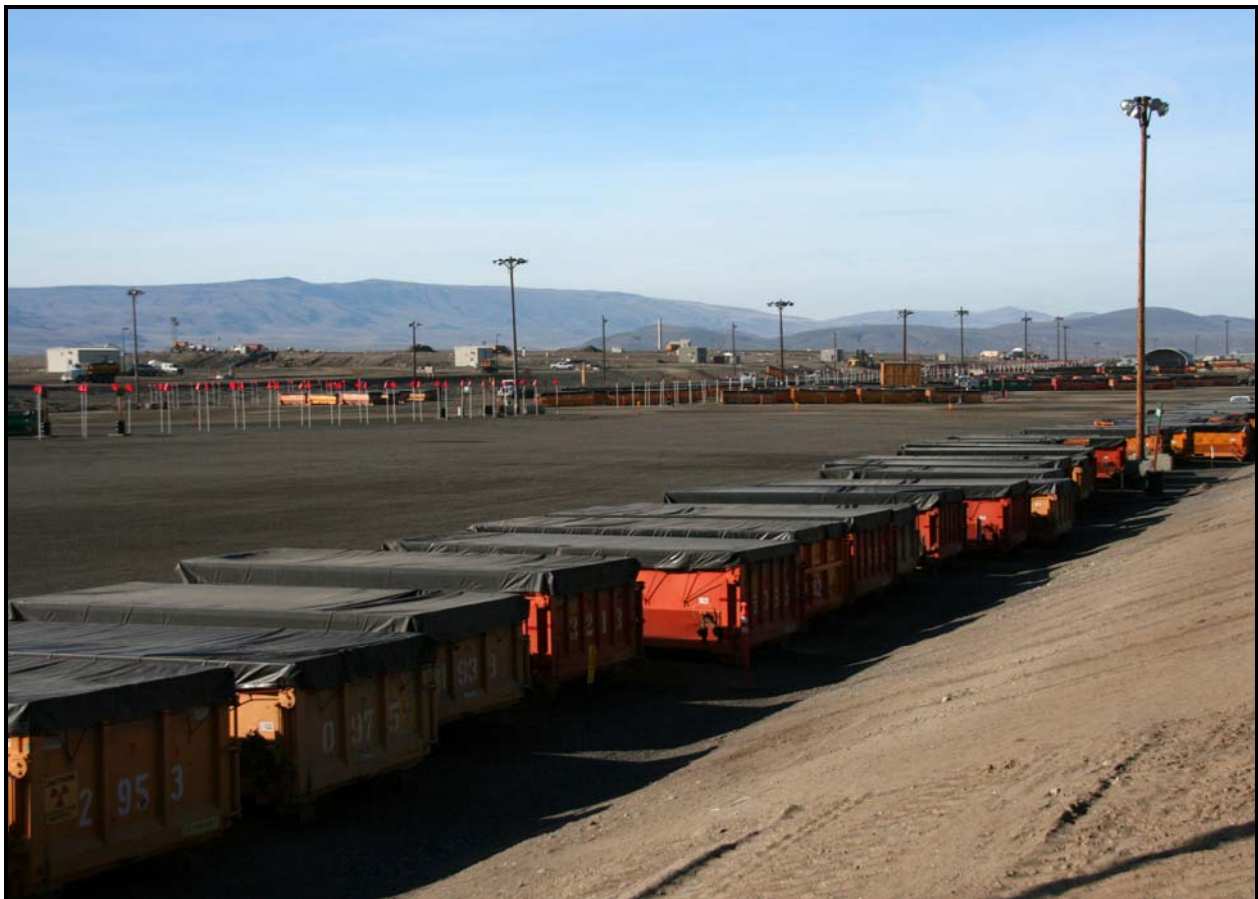
Waste containers occupy the recently expanded container transfer area at the Environmental Restoration Disposal Facility. (Photo 4)

The newly expanded section of the ERDF's existing container transfer area (CTA) is in service. The existing CTA was enlarged 600 feet to provide additional storage for about 300 waste containers.

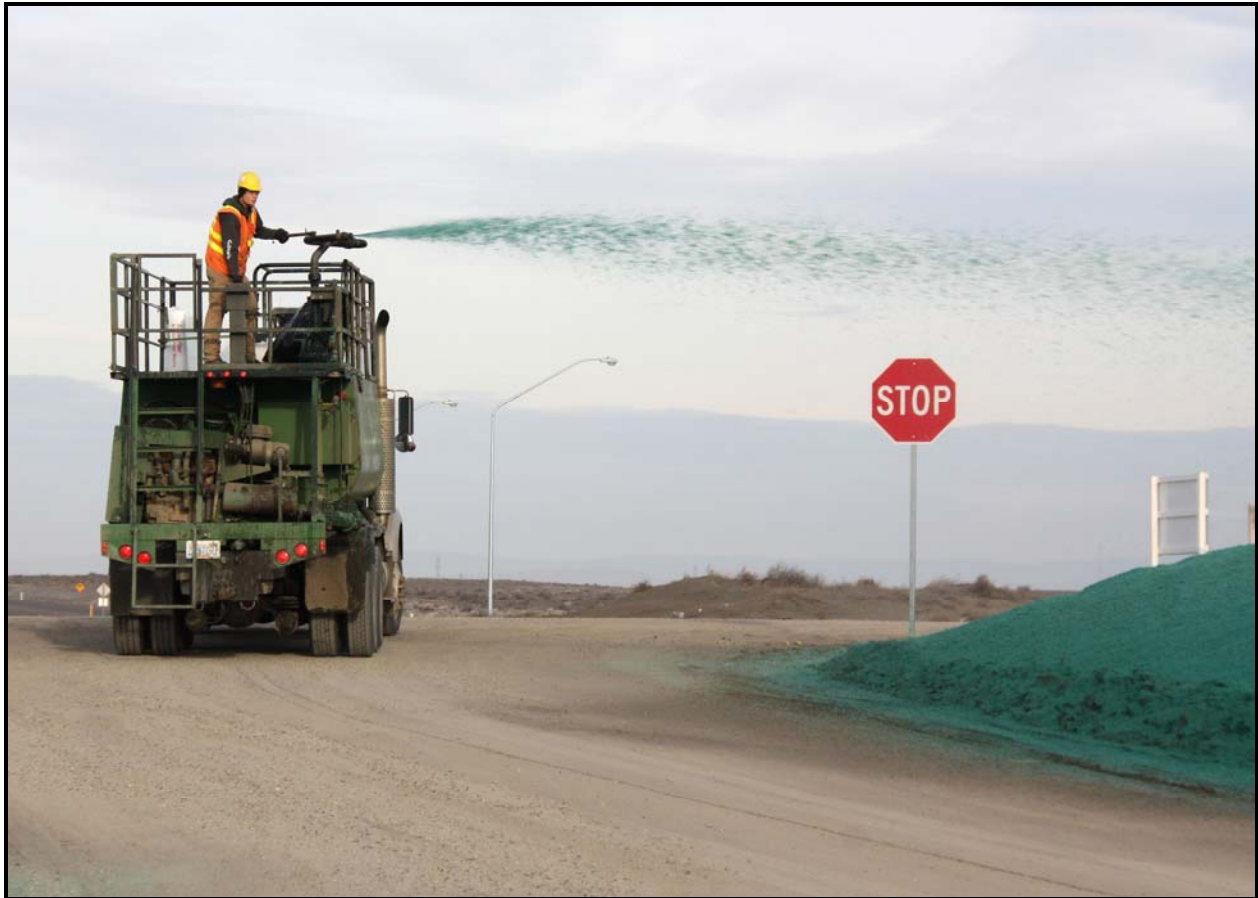
Washington Closure Hanford subcontractor Wildlands spreads hydroseed at the 618-10 Burial Ground. The hydroseed will help with dust suppression and erosion. (Photo 5)

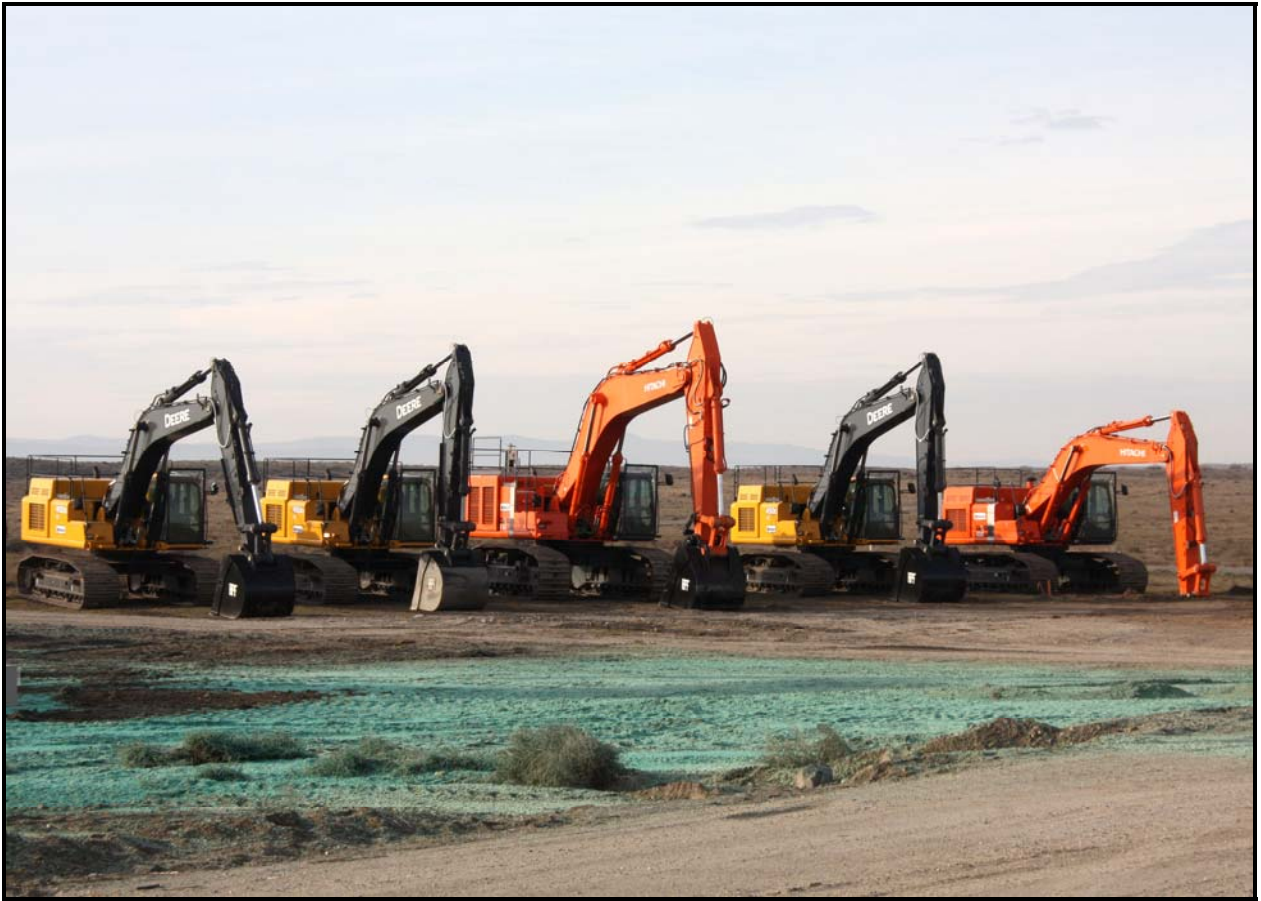
Mobilization of heavy equipment was completed at the 618-10 Burial Ground. Mock-ups are under way and full-scale remediation activities scheduled to begin in March. (Photo 6)

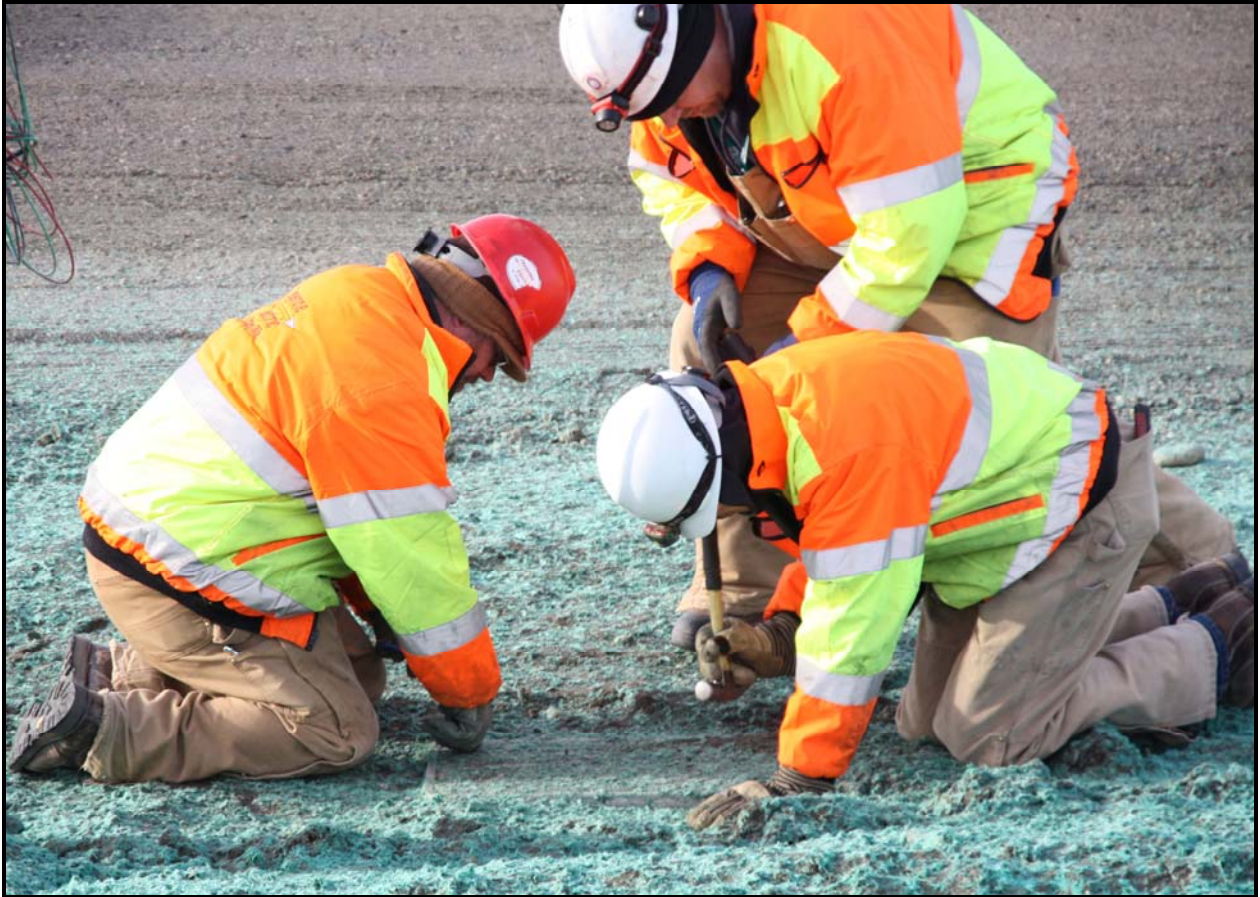
*Workers are close to completing installation of the electrical system at the 618-10 Burial Ground.
(Photo 7)*

WCH subcontractor White Shield/Apollo is close to completing the installation of utilities for trench remediation activities. The project team is installing the electrical system and building site roads in preparation for full-scale remediation to begin in March.

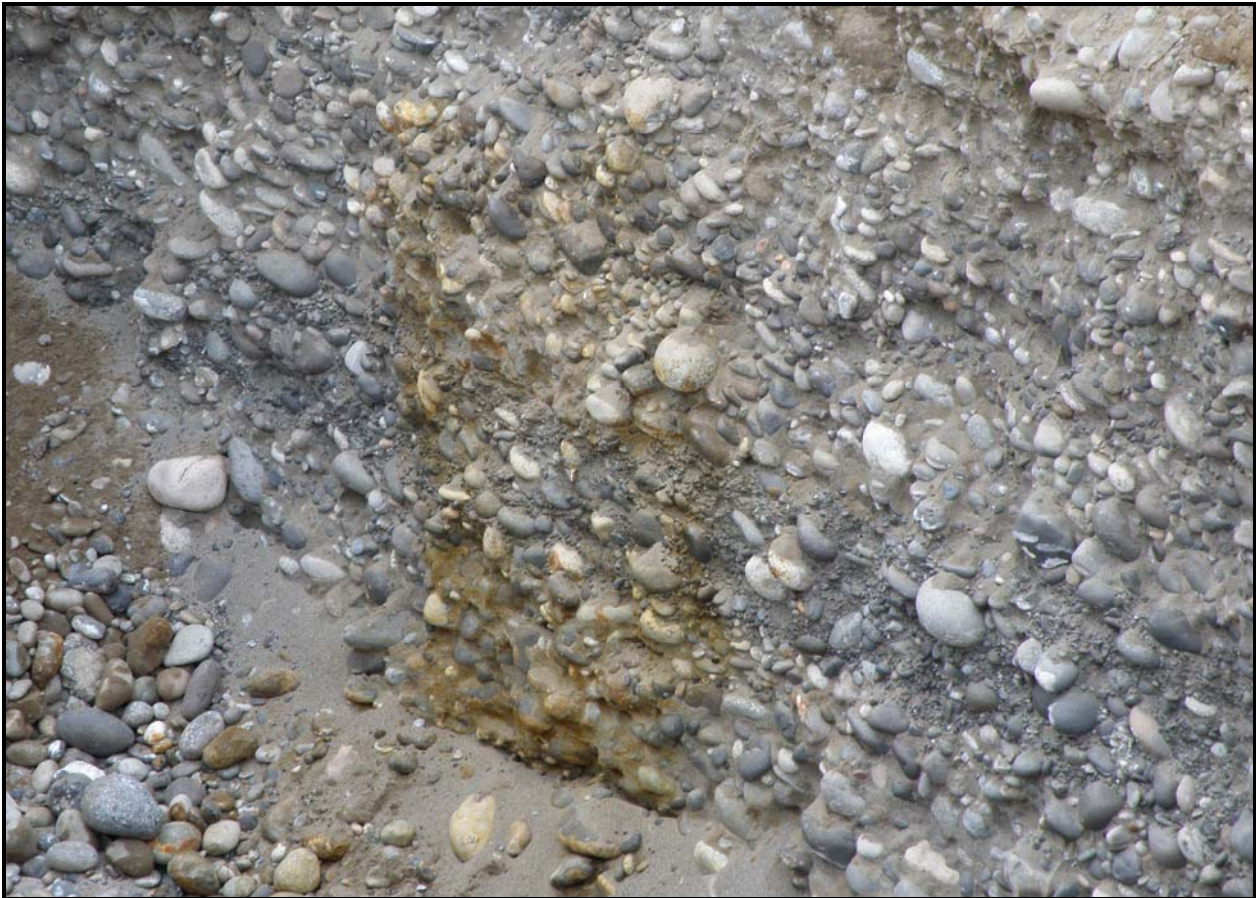
The stained side of a test pit at 100-F-57, where hexavalent chromium was found. (Photo 8)

The project team continued a test pit campaign at 100-F-57, which contains hexavalent chromium in the area of a concrete slab and underlying soil. Work to load out stockpiled asbestos from the site also was completed.

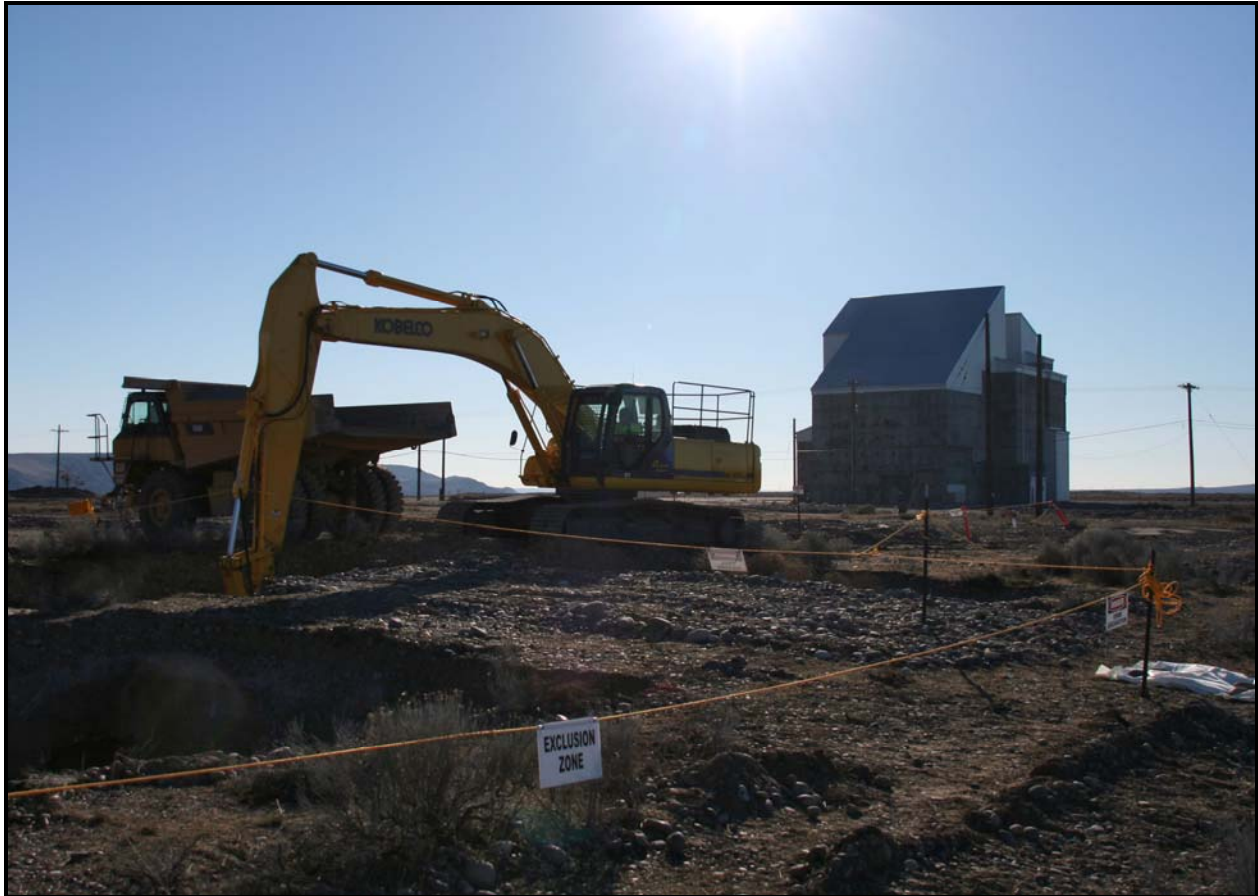
Washington Closure Hanford subcontractor Ojeda Business Ventures began loadout of stockpiled waste at 100-F-49, which contained a maintenance garage lube pit foundation. (Photo 9)

The project team continues to remove pipes and drain liquids at 100-F-26:7, which contains sodium dichromate and sodium silicate pipelines. Excavation and loadout was completed at 100-F-47 (electrical substation foundation), and the loadout of stockpiled waste is under way at 100-F-49 (old maintenance garage lube pit foundation, pipelines, and drywells).

An underground storage tank was discovered at 100-F-49 last month, and sampling of the soil around the tank was performed. The presence of motor oil, gasoline, lead, and other

substances were confirmed to be in the area. A job hazard analysis was conducted for pumping the liquid out of the tank for sampling.

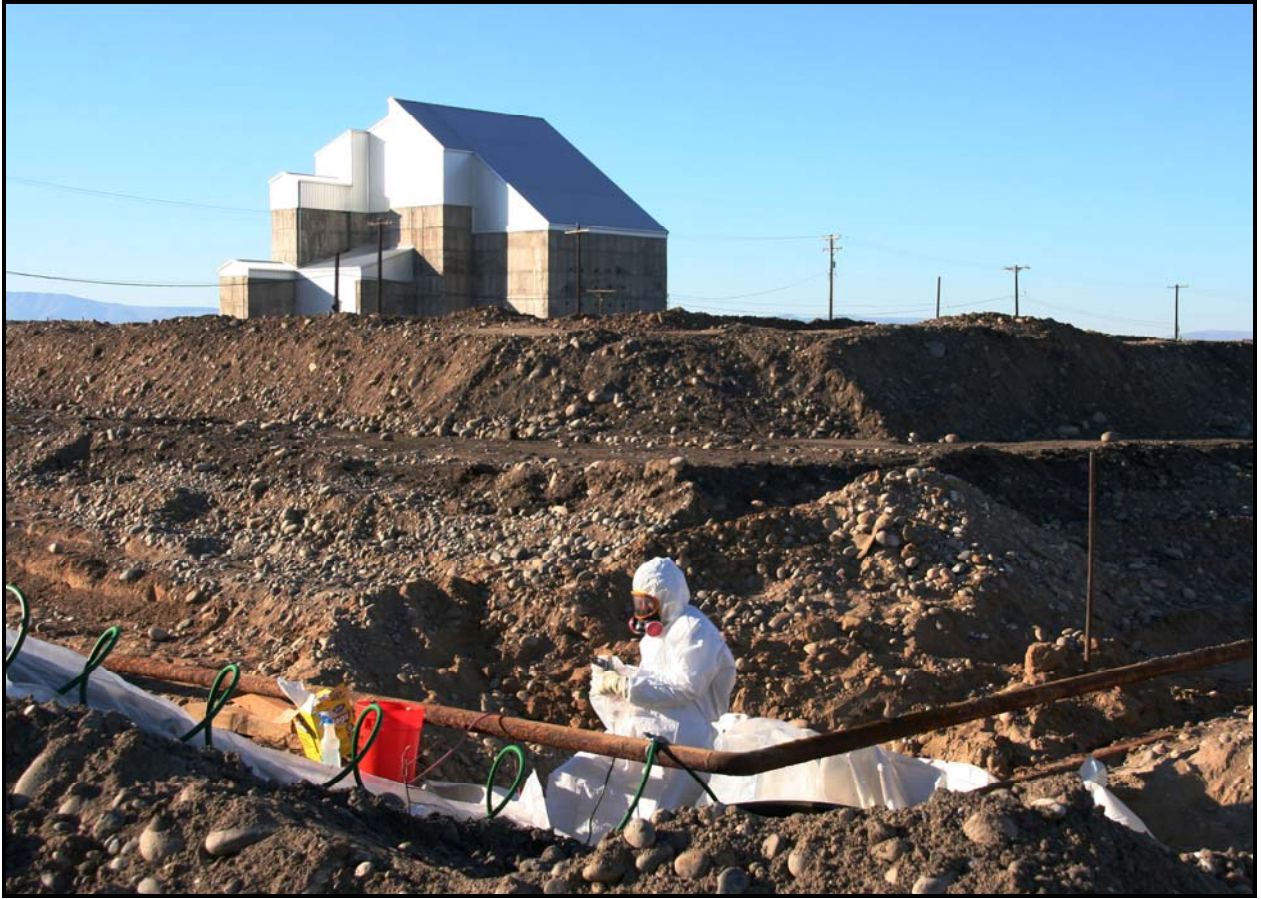
A worker cuts and drains pipe at 100-F-26:7, which contains sodium dichromate and sodium silicate pipelines. (Photo 10)

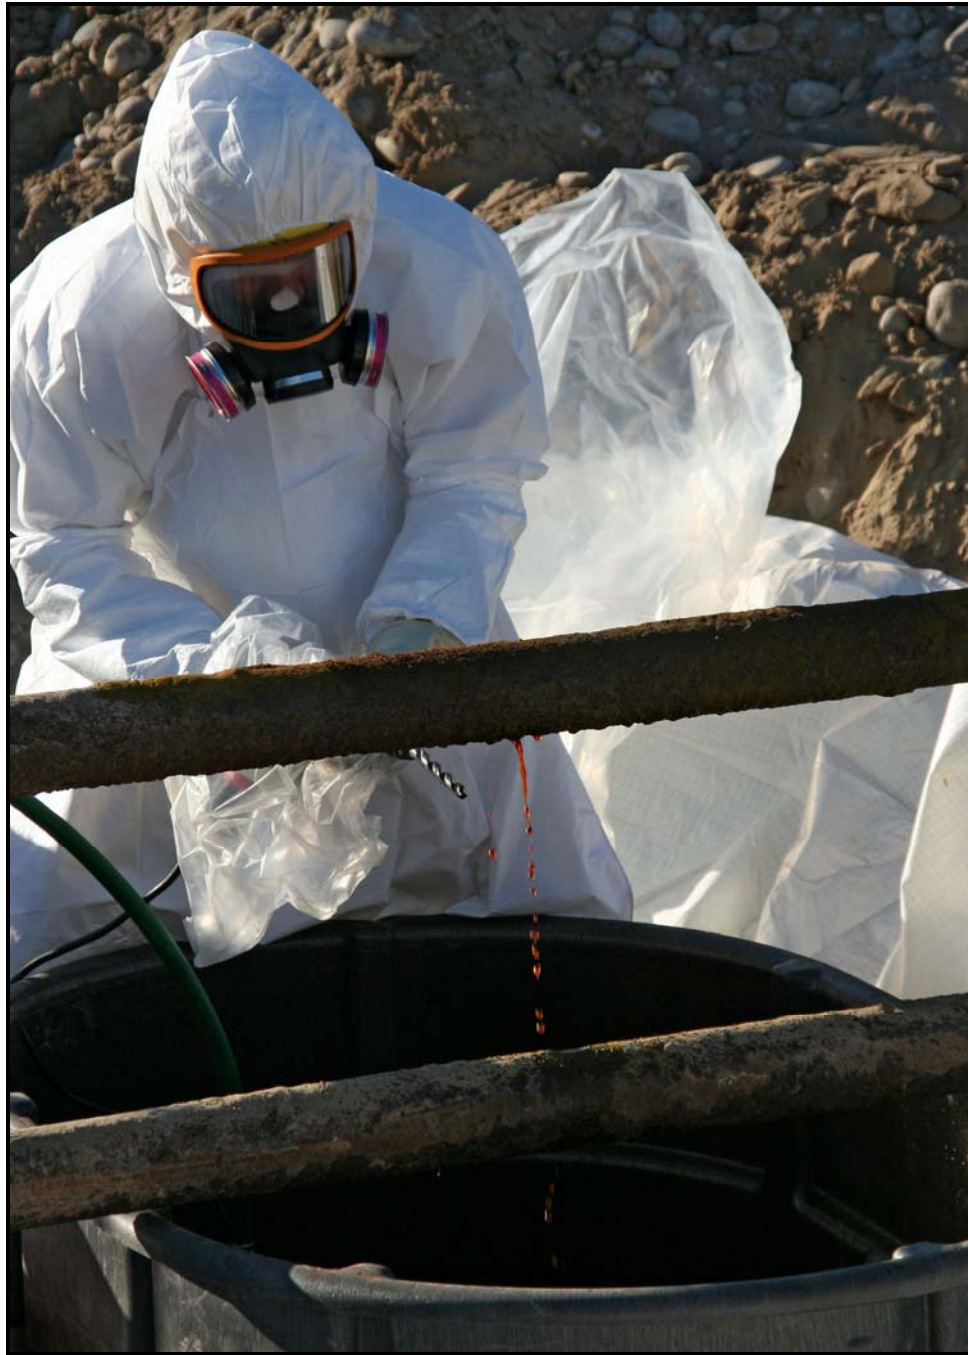
A worker drills a hole to drain liquid from a pipe at 110-F-26:7. (Photo 11)

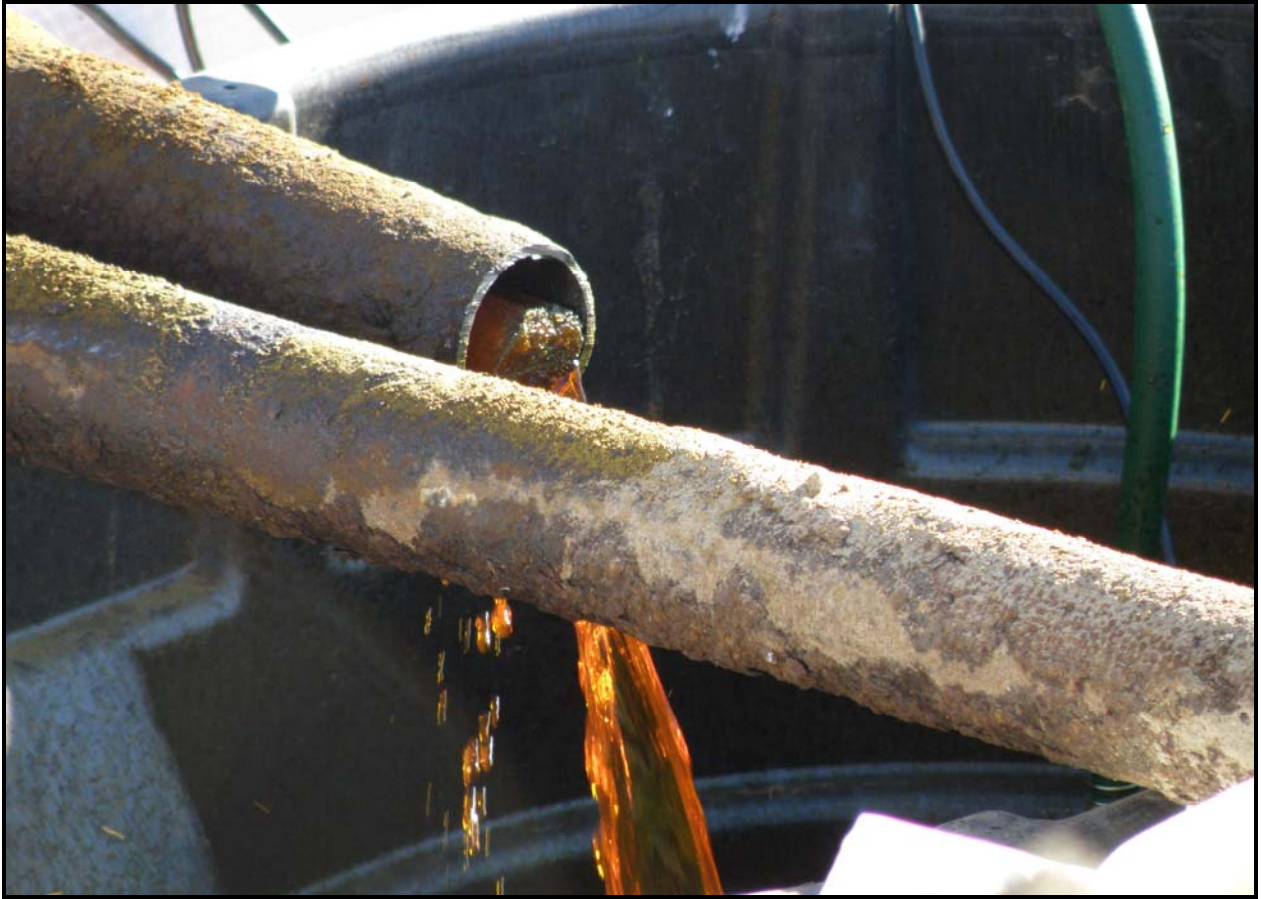
A pipe is cut and liquid drains out at 100-F-26:7. (Photo 12)
