*River Corridor Closure Project*

# Recovery Act Weekly Report

For the week ending June 3, 2011

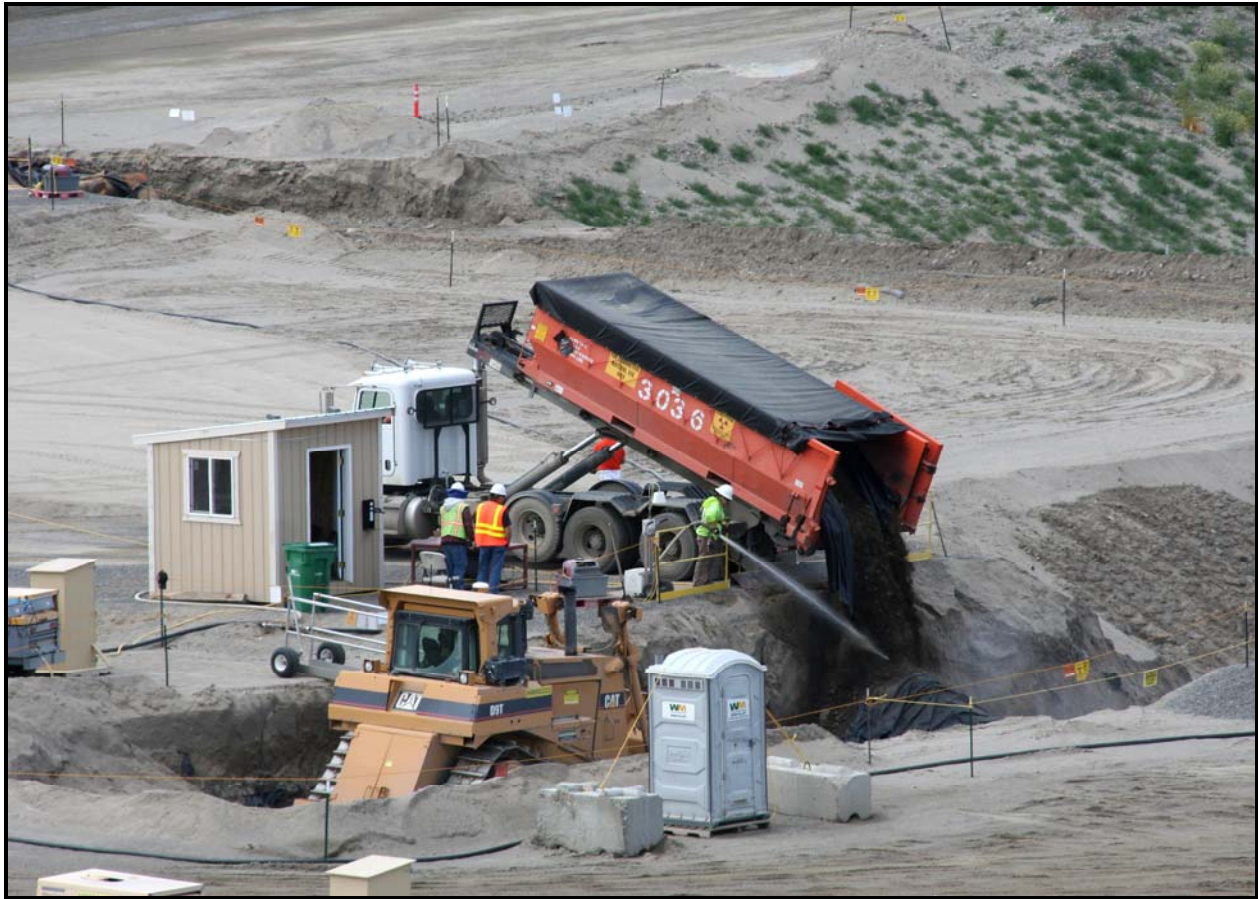
*The waste disposal team used a new dump ramp constructed in super cell 9 at the Environmental Restoration Disposal Facility. (Photo 1)*

WCH and subcontractors TradeWind Services and DelHur Industries completed construction of super cells 9 and 10 in February. Super cell 9 was placed into service in February, and super cell 10 was authorized for use in early May.

The project team used lessons learned from previous cell construction to devise the design for the super cells. A super cell is equivalent to an existing pair of cells – 1,000 feet long, 500 feet wide, and 70 feet deep – and is more cost-efficient because it simplifies the leachate collection system. The super cell design eliminated 12 inches of drainage gravel and requires fewer pumps, motors, crest pads, valves, and other pieces of equipment. The result was a cost reduction of \$1.5 million per super cell.

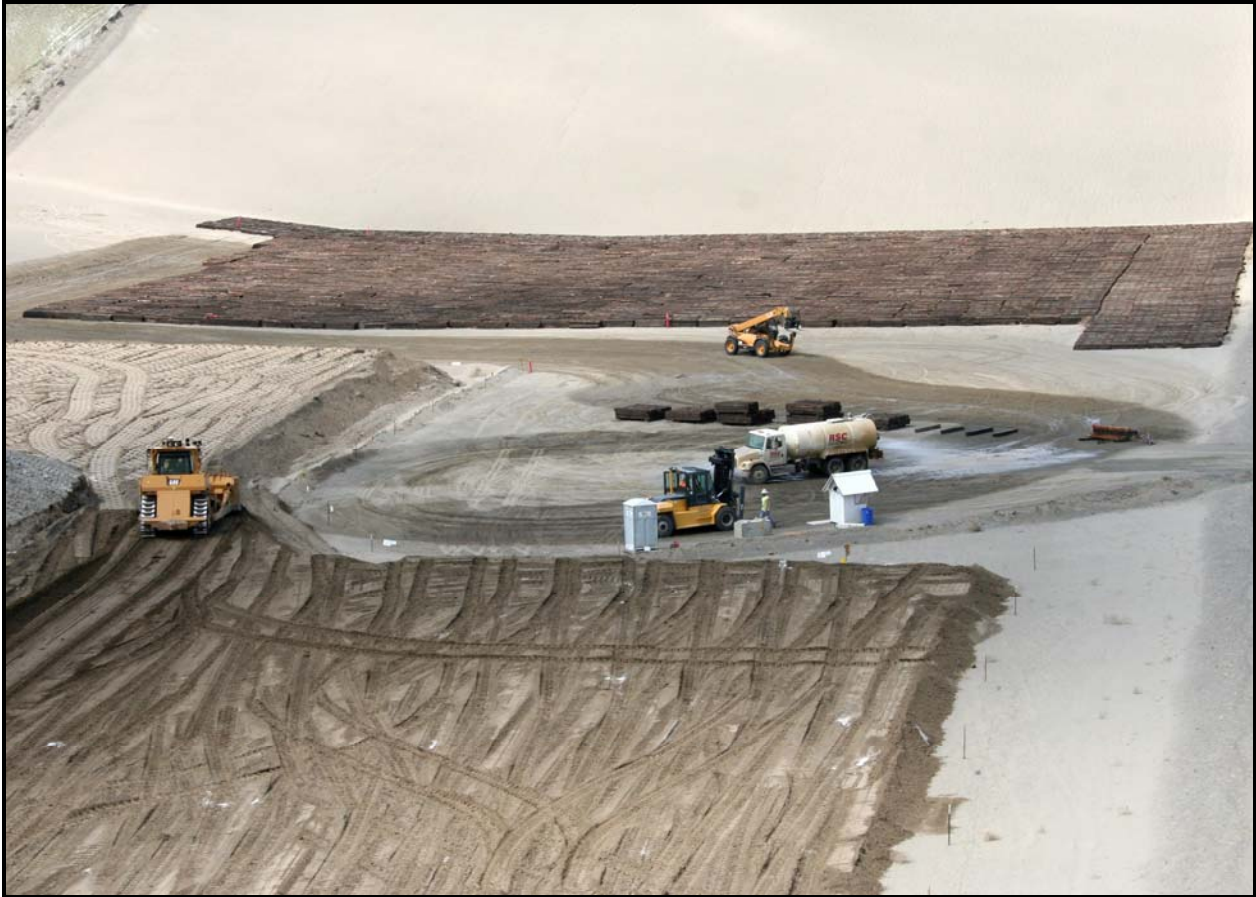
*The waste disposal team spreads contaminated soil on the south side of super cell 9 while disposing railroad ties on the north side. (Photo 2)*

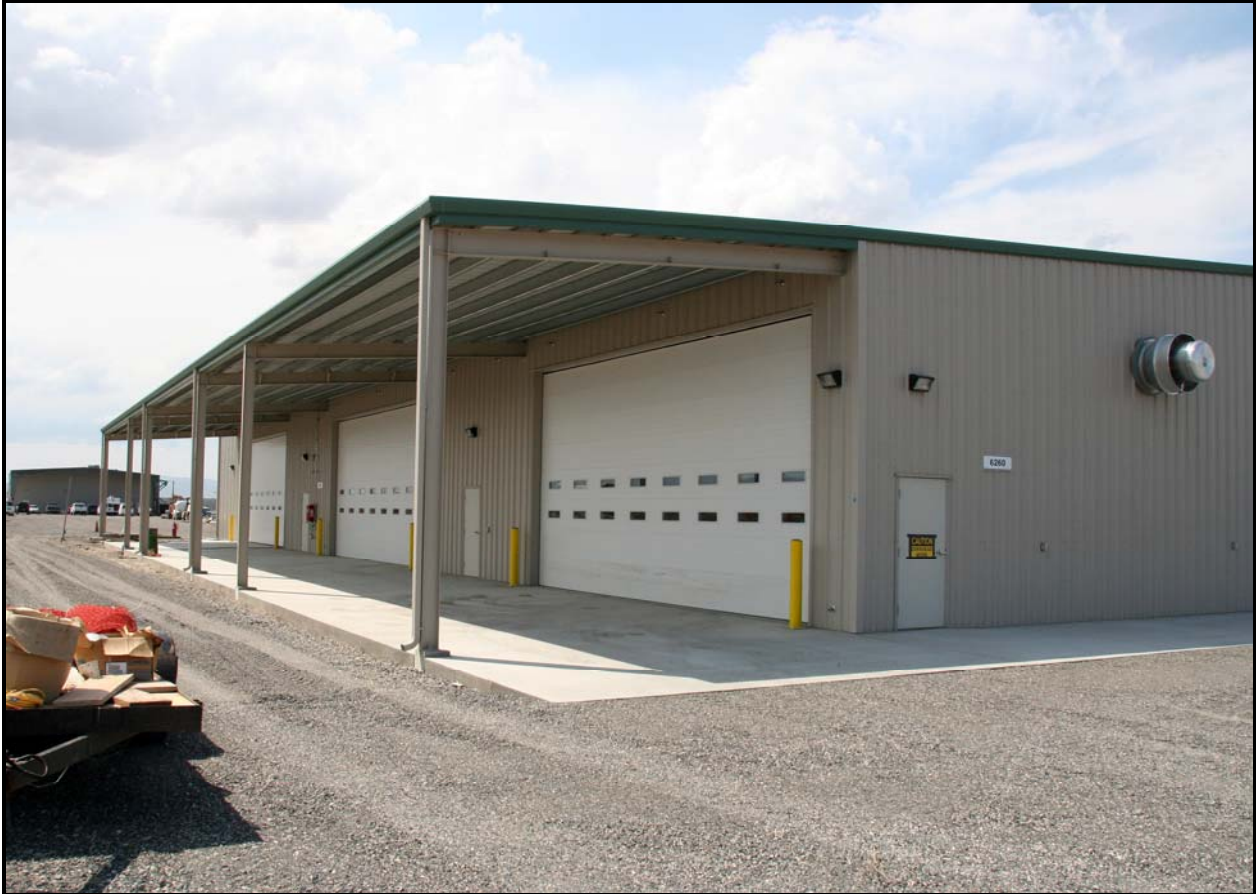
*ERDF's new container maintenance facility includes three stalls, a repair line, a maintenance shop, and a weld area. (Photo 3)*

Progress continued at ERDF's new maintenance facilities. Electrical power was connected to the new container maintenance facility and testing of the HVAC system was conducted. Floor and cabinet installation continued in the operations center, and rough-in electrical and plumbing work continued in the equipment maintenance facility. At the transportation maintenance facility, drywall was completed in the east addition and taping and mudding is under way.

The container maintenance facility will include a large container repair line, a maintenance shop, and a weld area. The equipment maintenance facility will include two service lines, an operational storage facility, a large concrete pad, and an exterior awning over a smaller concrete pad. The new operations center will help alleviate severe overcrowding of personnel and also accommodate new employees hired to handle the increasing waste volumes.

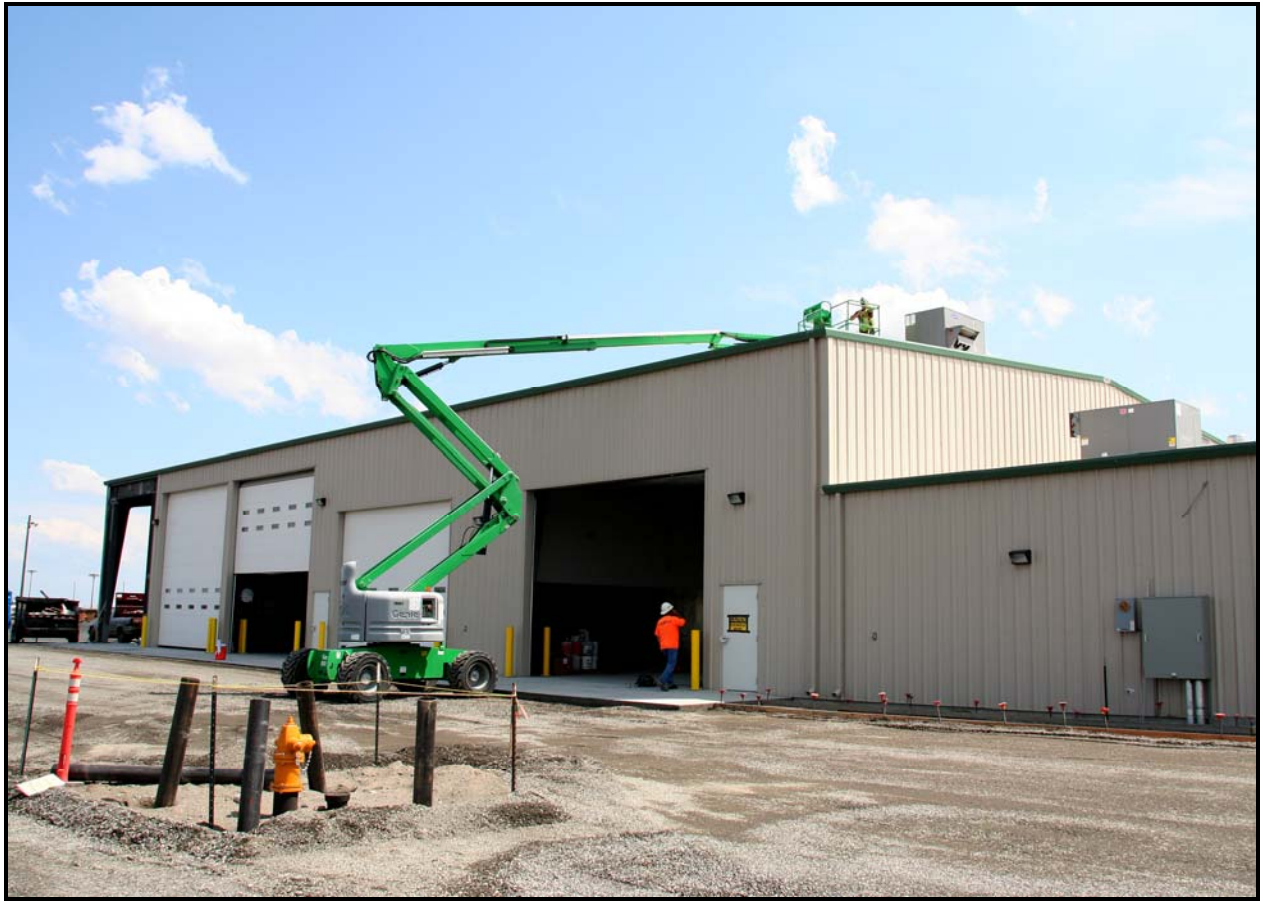
Washington Closure Hanford subcontractor ELRFowler works on an air conditioning unit at the equipment maintenance facility/operations center. (Photo 4)

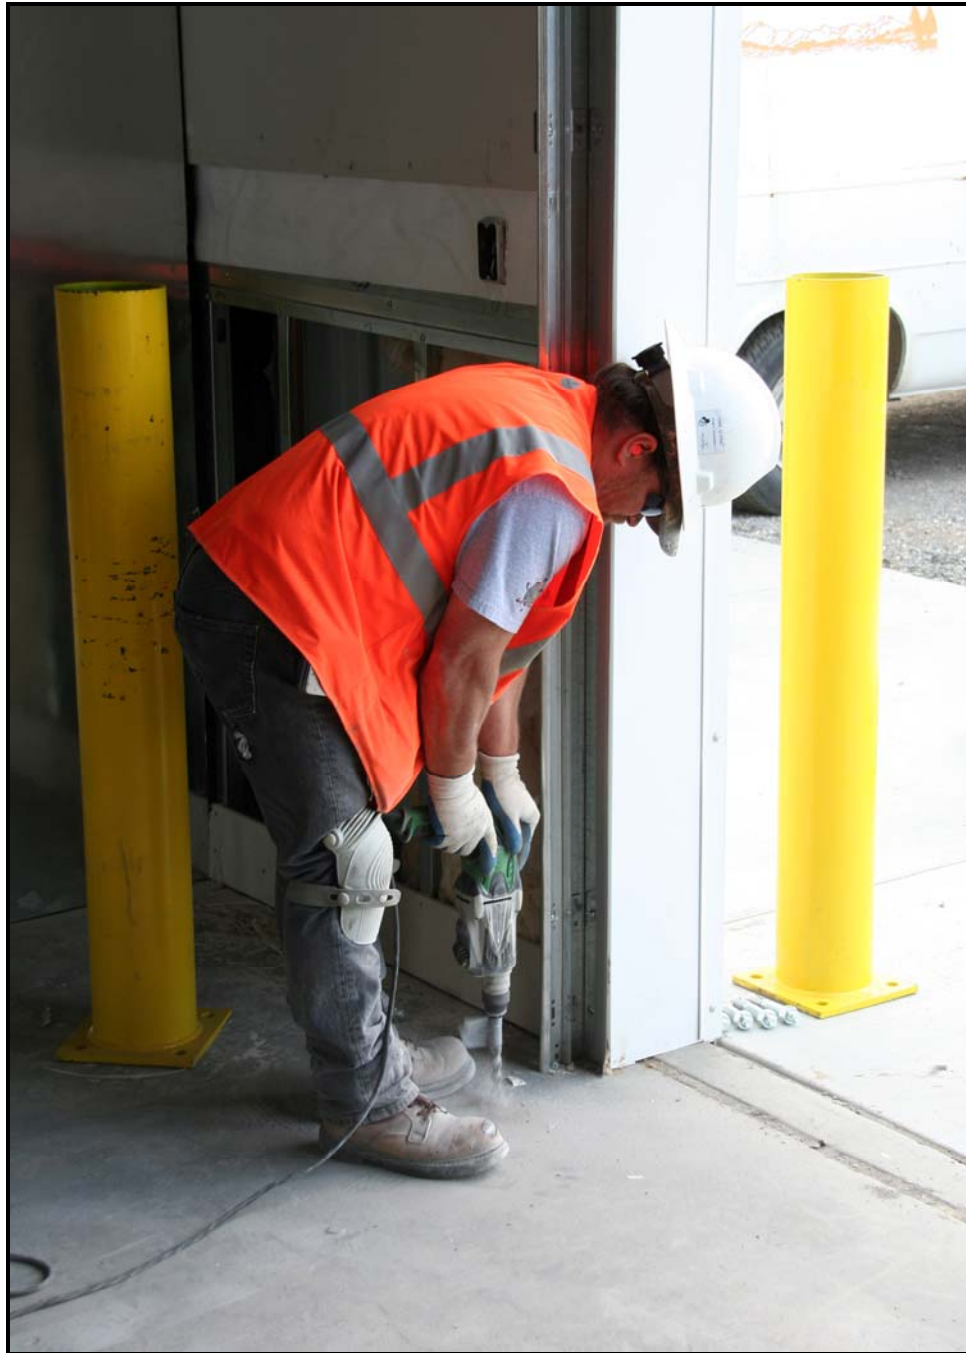
*An ELRFowler employee installs a bollard in the east addition of the transportation maintenance facility. (Photo 5)*

The expanded transportation maintenance facility will include two additional truck bays, a large concrete pad, an exterior awning that will cover two smaller concrete pads, and a conference room. The project began pouring the concrete footers on the east side of the building. WCH continued to install radio-frequency identification tags and began testing the readers for the new waste container tracking system at ERDF. The system will assist the Waste Operations team by providing the location of full and empty containers.

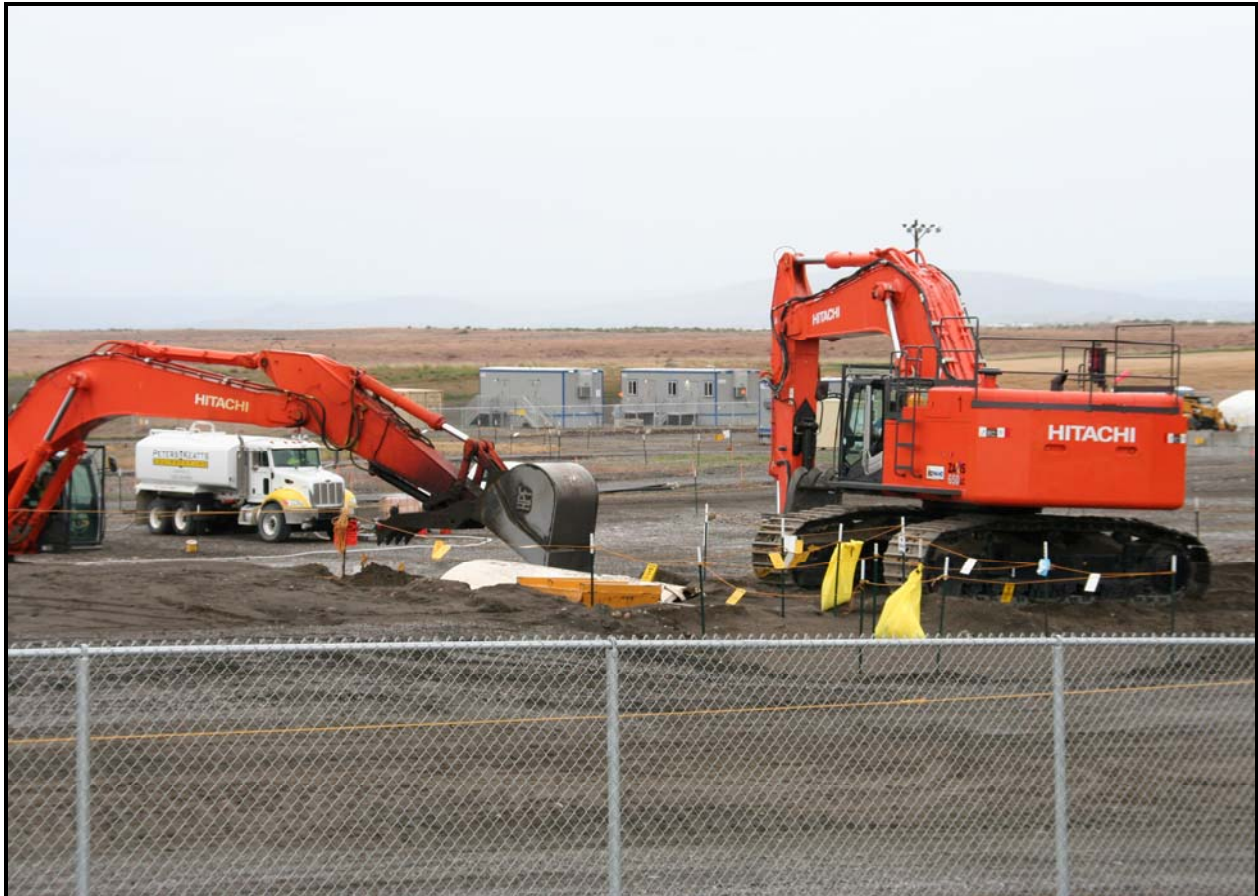
*Washington Closure Hanford workers uncover a large steel tank in the north central section of the 618-10 Burial Ground. (Photo 6)*

WCH continued trench excavation of the 618-10 Burial Ground. As of June 1, a total of 24,400 bank cubic meters has been removed. The project team excavated a large steel tank from the central section of the north excavation front.

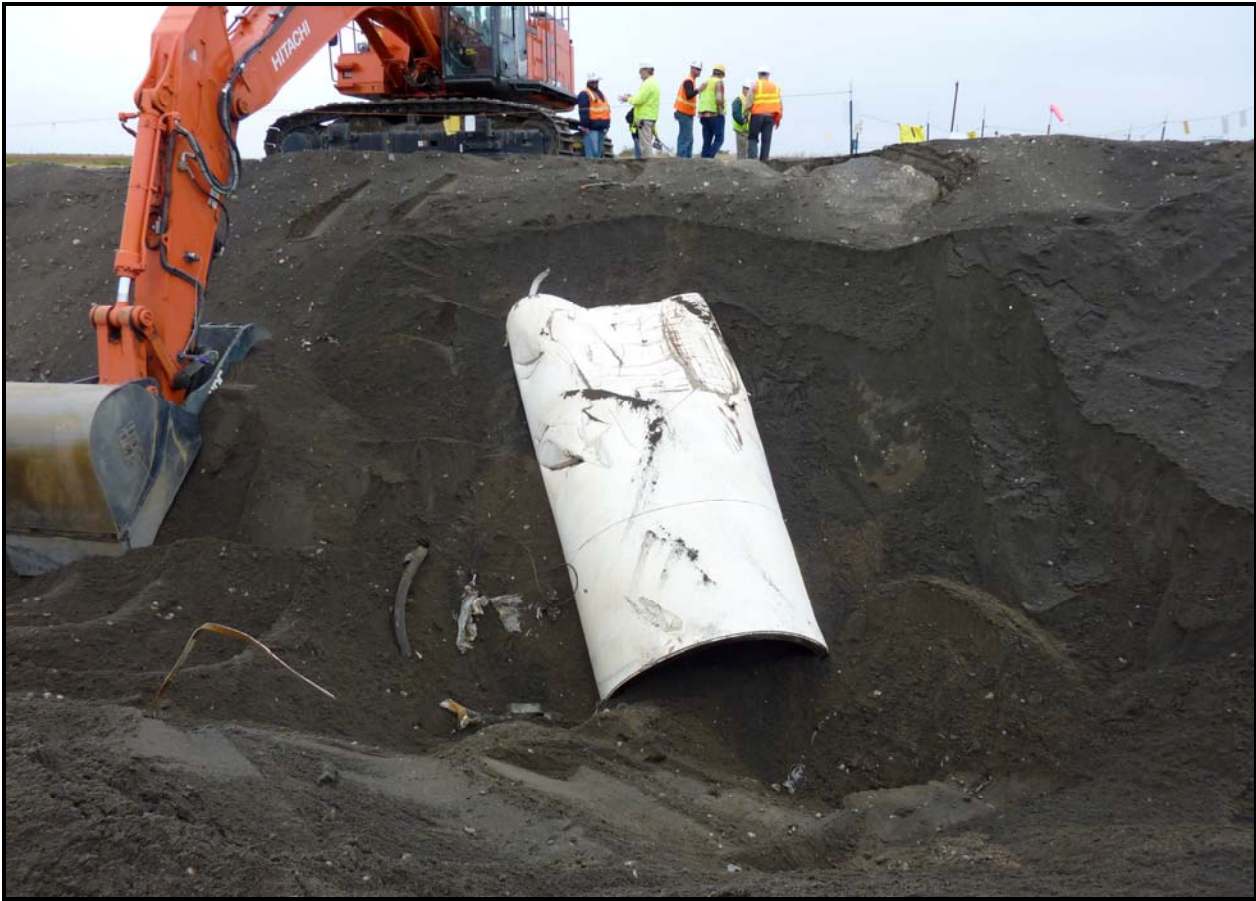
*The steel tank found at the 618-10 Burial Ground contained a ladder. (Photo 7)*

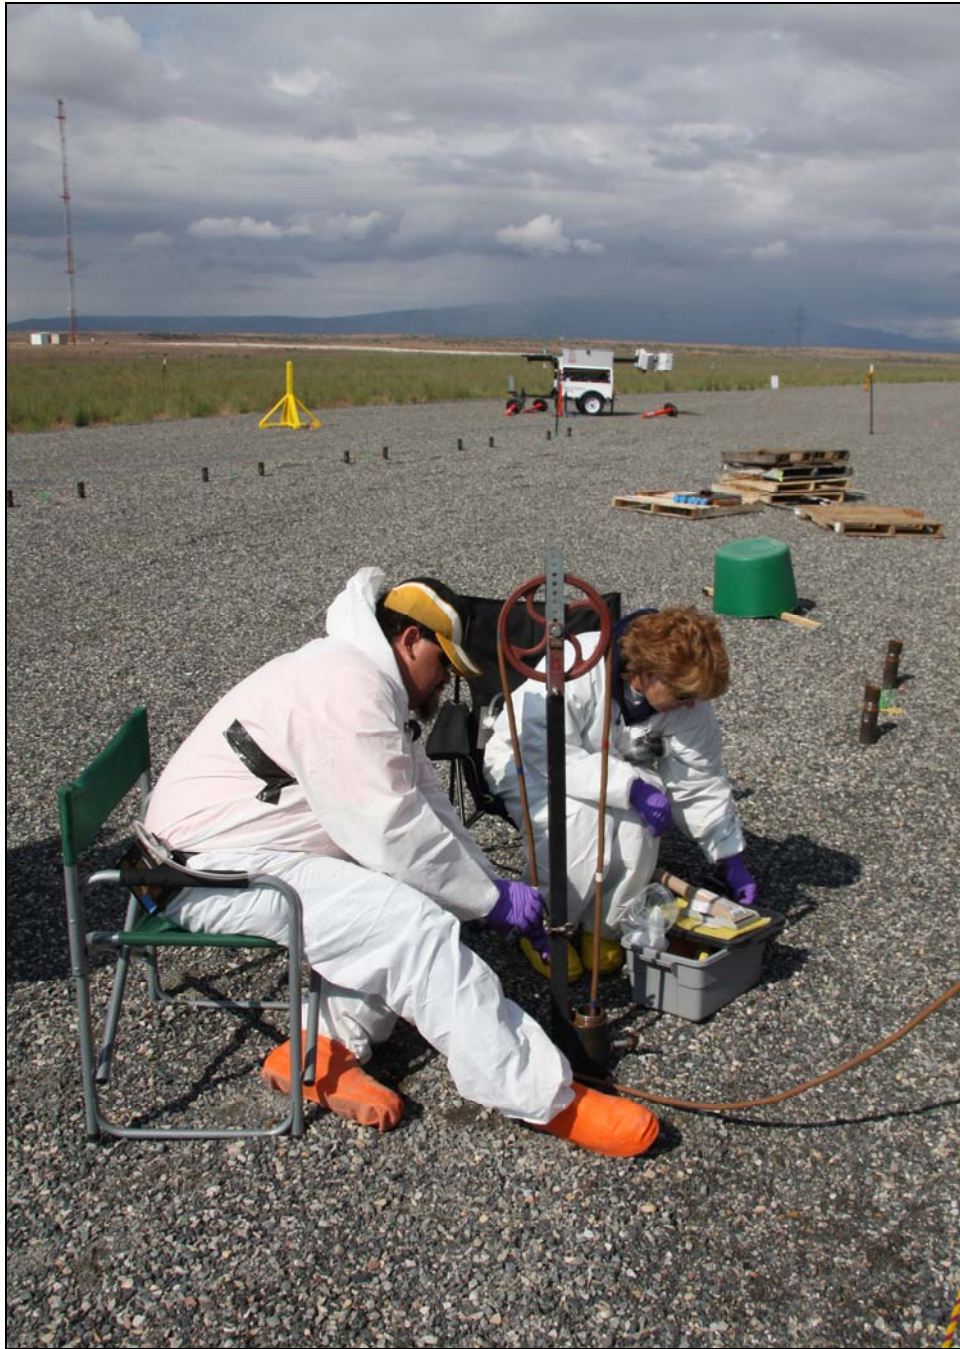
*Employees with Washington Closure Hanford and subcontractor North Wind Inc. retrieve a multi-detector probe from a cone penetrometer during nonintrusive characterization of the 618-11 Burial Ground. (Photo 8)*

The project team is inserting a gamma-logging probe into the cone penetrometers to identify the location of radioactive materials within the VPUs. Prior to characterization activities, North Wind installed two cone penetrometers (narrow steel tubes) about 6 to 8 inches from the exterior of each VPU and to an approximate depth of 6 feet below the VPU.

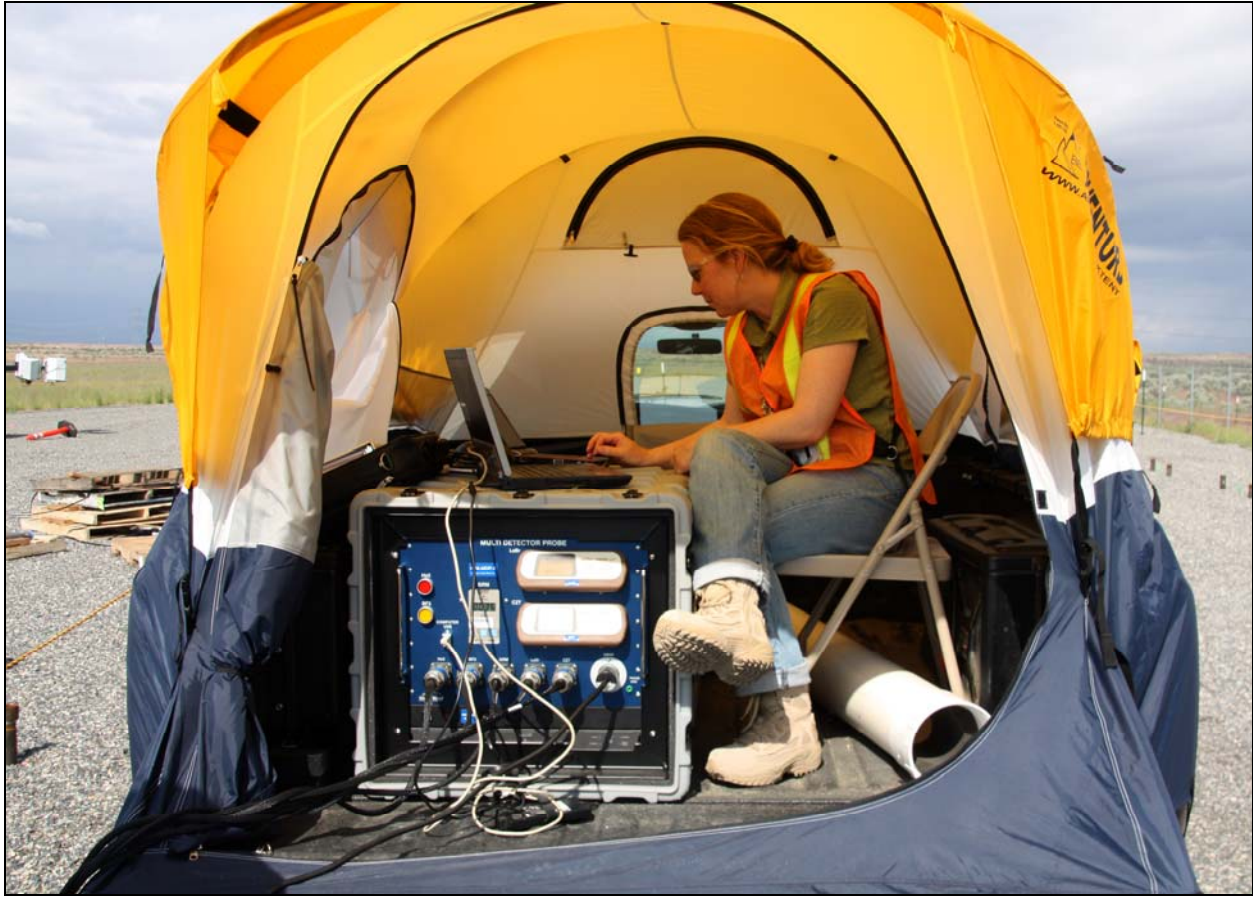
*A North Wind employee takes readings during nonintrusive characterization of the vertical pipe units at the 618-11 Burial Ground. (Photo 9)*

Prior to cone penetrometer installation, the project team conducted geophysical delineation to help locate each of the burial ground's VPU and caissons. The delineation was determined using reconnaissance-level magnetic field survey, detailed-level magnetic and time-domain electromagnetic induction (TDEMI) survey, and ground-penetrating radar (GPR) survey.

The VPUs typically were constructed by welding five 55-gallon bottomless drums end to end. The caissons were constructed of corrugated metal pipe (8-foot diameter, 10-foot long). The top of the caisson was 15 feet below grade and connected to the surface by an offset pipe (3-foot diameter) with a dome-type cap. The trenches are 900 feet long by 500 feet wide and 25 feet deep.

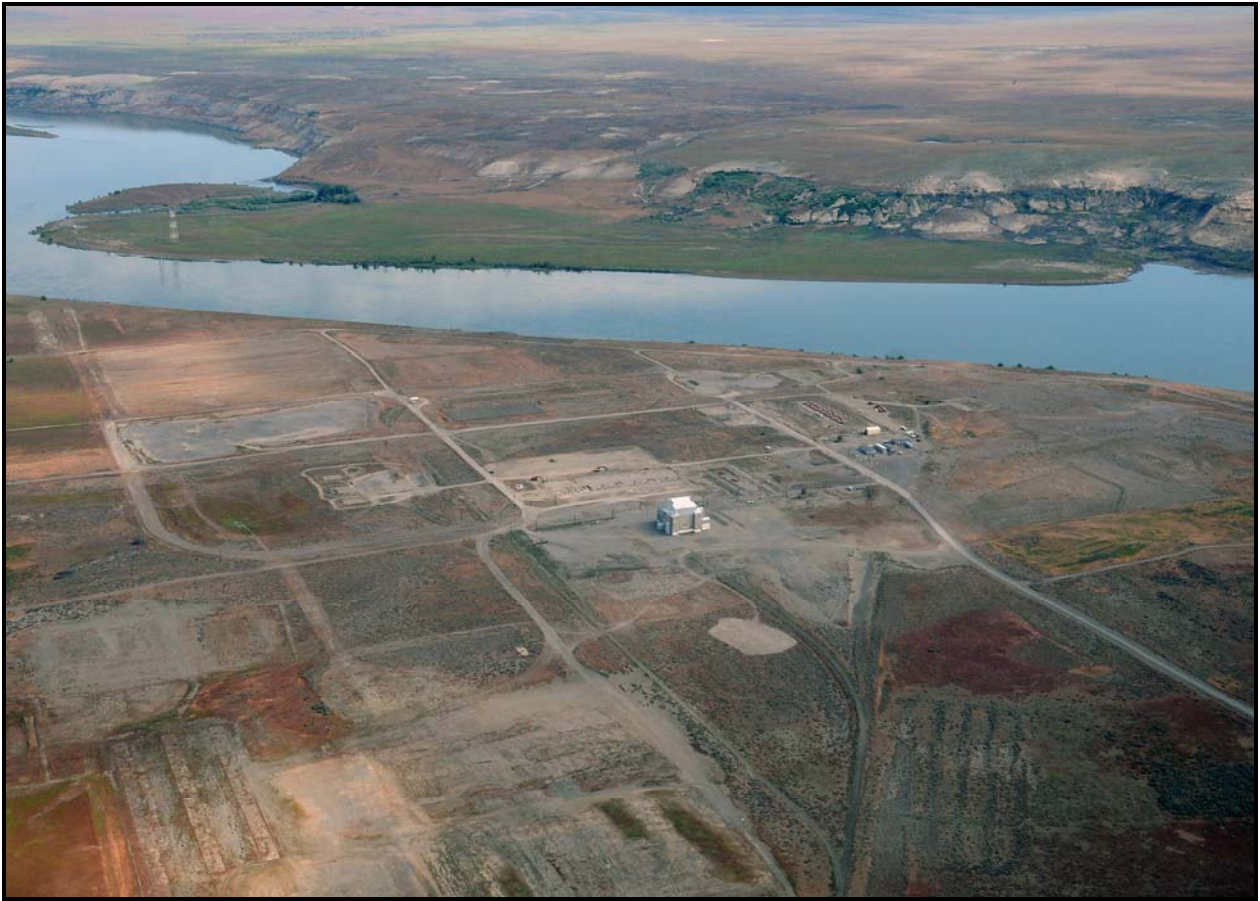
*Washington Closure Hanford is remediating 19 waste sites in 100-F Area, home to the third of Hanford's nine plutonium production reactors. (Photo 10)*

WCH and subcontractor Ojeda Business Ventures continued with the remediation of 19 waste sites at 100-F Area. The project team is demolishing and loading out the western portion of 100-F-57 to the 15-foot level. The site consists of stained concrete and soil containing hexavalent chromium.
