Motorcoach Run-Off-the-Road and Collision
With Vertical Highway Signpost
Interstate 95 Southbound
New York City, New York
March 12, 2011

NTSB/HAR-12/01
PB2012-916201
Notation 8308A
Adopted June 5, 2012

Highway Accident Report

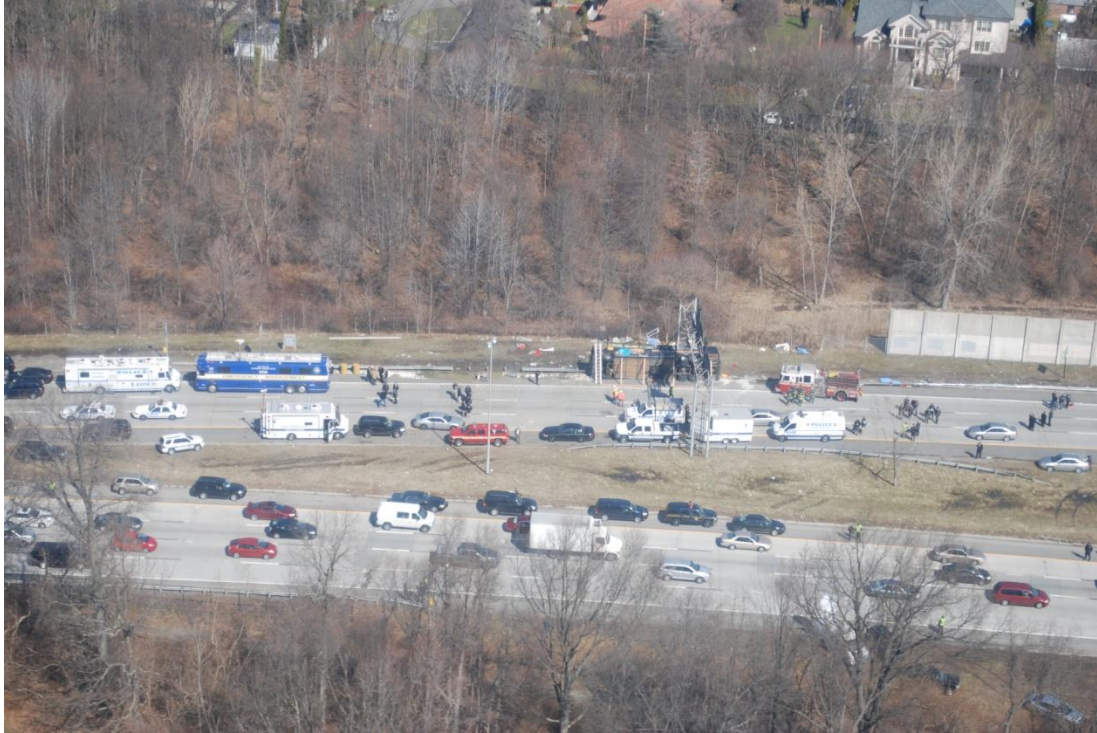
Figure 2. Aerial view of I-95 and accident site. (Source: New York State Police [NYSP].)

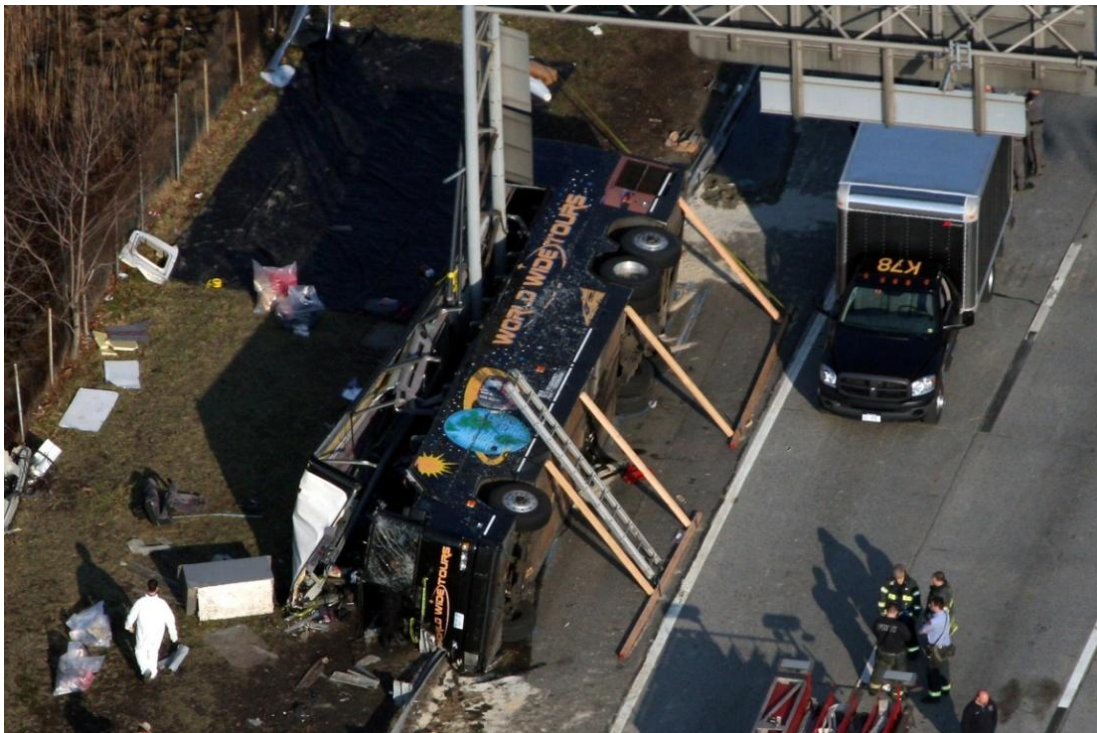
Figure 3. Aerial view of motorcoach. (Source: *The Journal News*, Frank Becerra)

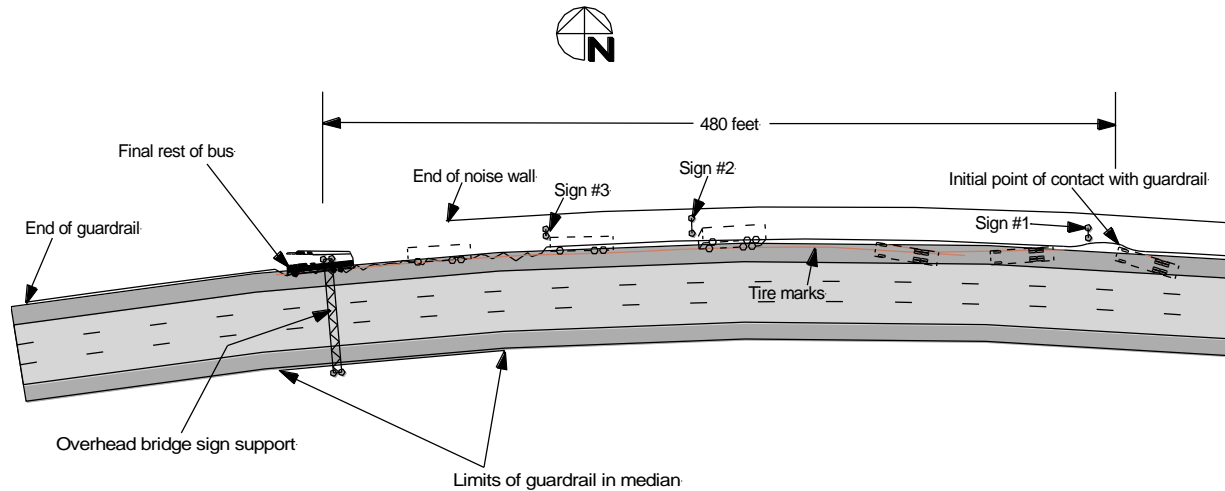
As the motorcoach approached mile marker 3.2, the vehicle left the roadway and crossed the rumble strip on the 10-foot-wide right shoulder, striking a strong-post blocked-out W-beam guardrail² at 64 mph.³ The motorcoach continued forward along the paved shoulder, sideswiping the guardrail, and then overturned to the right 90° on its longitudinal axis, flattening the guardrail as it continued to slide forward. (See figures 4 and 5.)

Figure 4. Accident scene diagram.

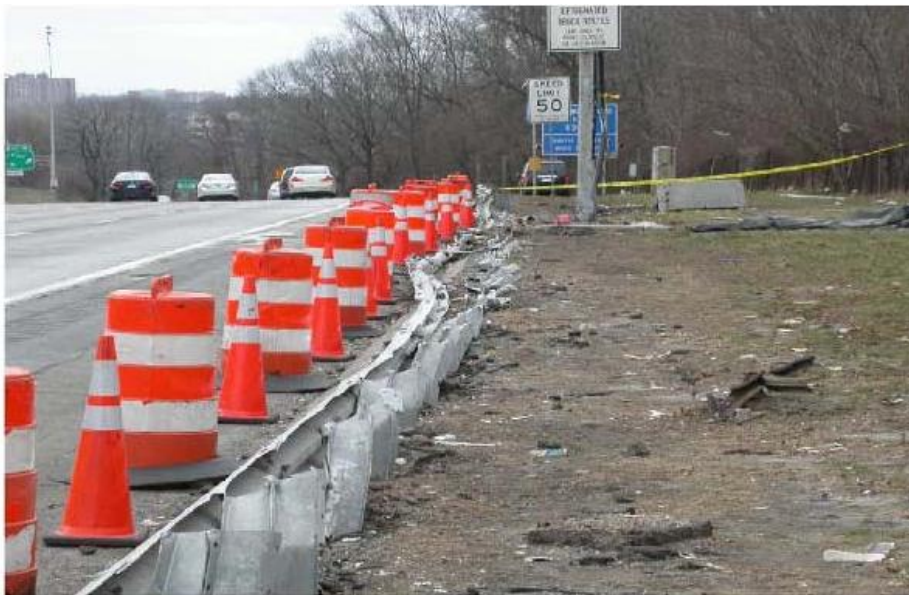
Figure 5. Damaged guardrail at the approach to the vertical highway signpost.

On March 15 and 16, 2011, the NYSTA repaired 256 feet of accident-damaged sections of the strong-post blocked-out W-beam guardrail with new strong-post W-beam guardrail with steel block-outs, remaining a TL-2 barrier. On April 29, 2011, in the immediate vicinity of the accident location and extending from the point at which the bus initially collided with the guardrail to south of the vertical highway signpost, the NYSTA replaced 627 feet, including the 256-foot section repaired in March 2011, of the steel block-outs with plastic block-outs, upgrading the performance of the guardrail from a TL-2 barrier to a TL-3 barrier.

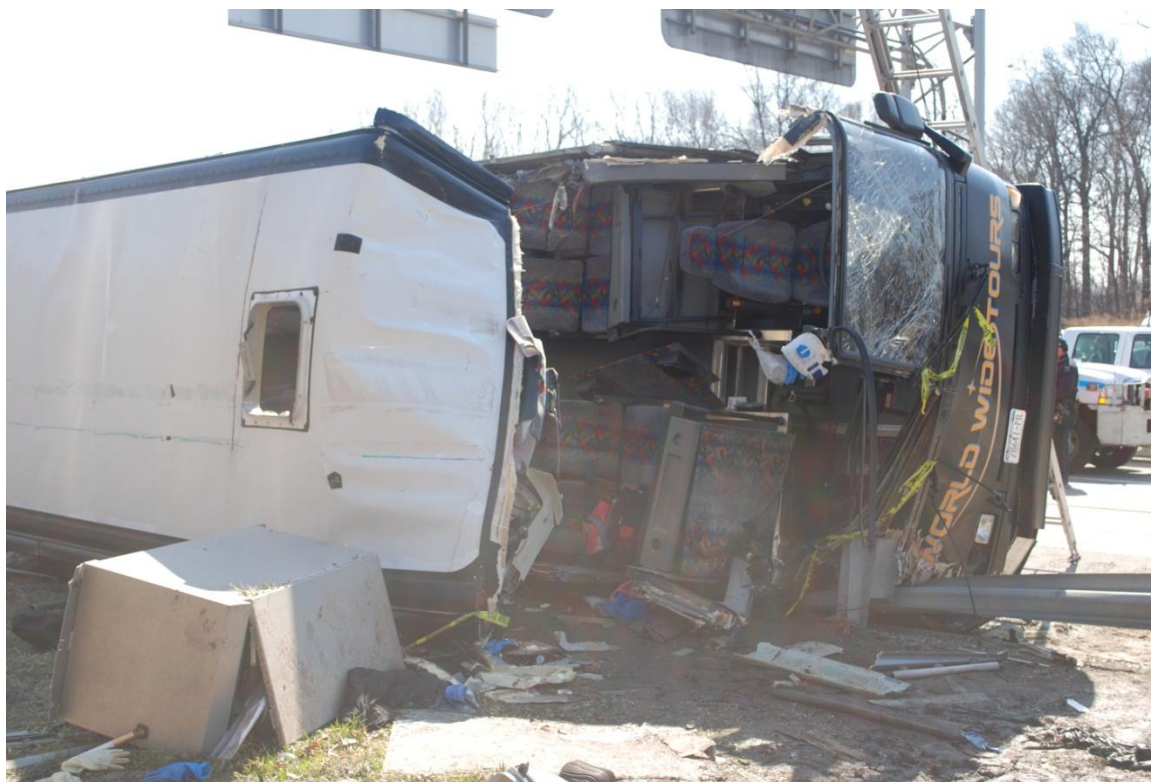
The front of the motorcoach subsequently collided with an overhead vertical highway signpost, consisting of two vertical 8-inch-diameter steel tubular poles linked by cross-beam diagonal metal supports and an attached steel electrical box.

After the motorcoach's windshield struck this support structure and steel electrical box, the two poles making up the vertical highway signpost entered the passenger compartment along the base of the passenger windows, as the motorcoach slid forward. The impact resulted in the vehicle's roof panel being torn from the bus body for almost the entire length of the bus. (See figure 6.) Fifteen passengers were killed, 17 passengers received serious-to-minor injuries, and the bus driver received minor injuries.

Figure 6. Roof separation due to intrusion of the vertical highway signpost poles.

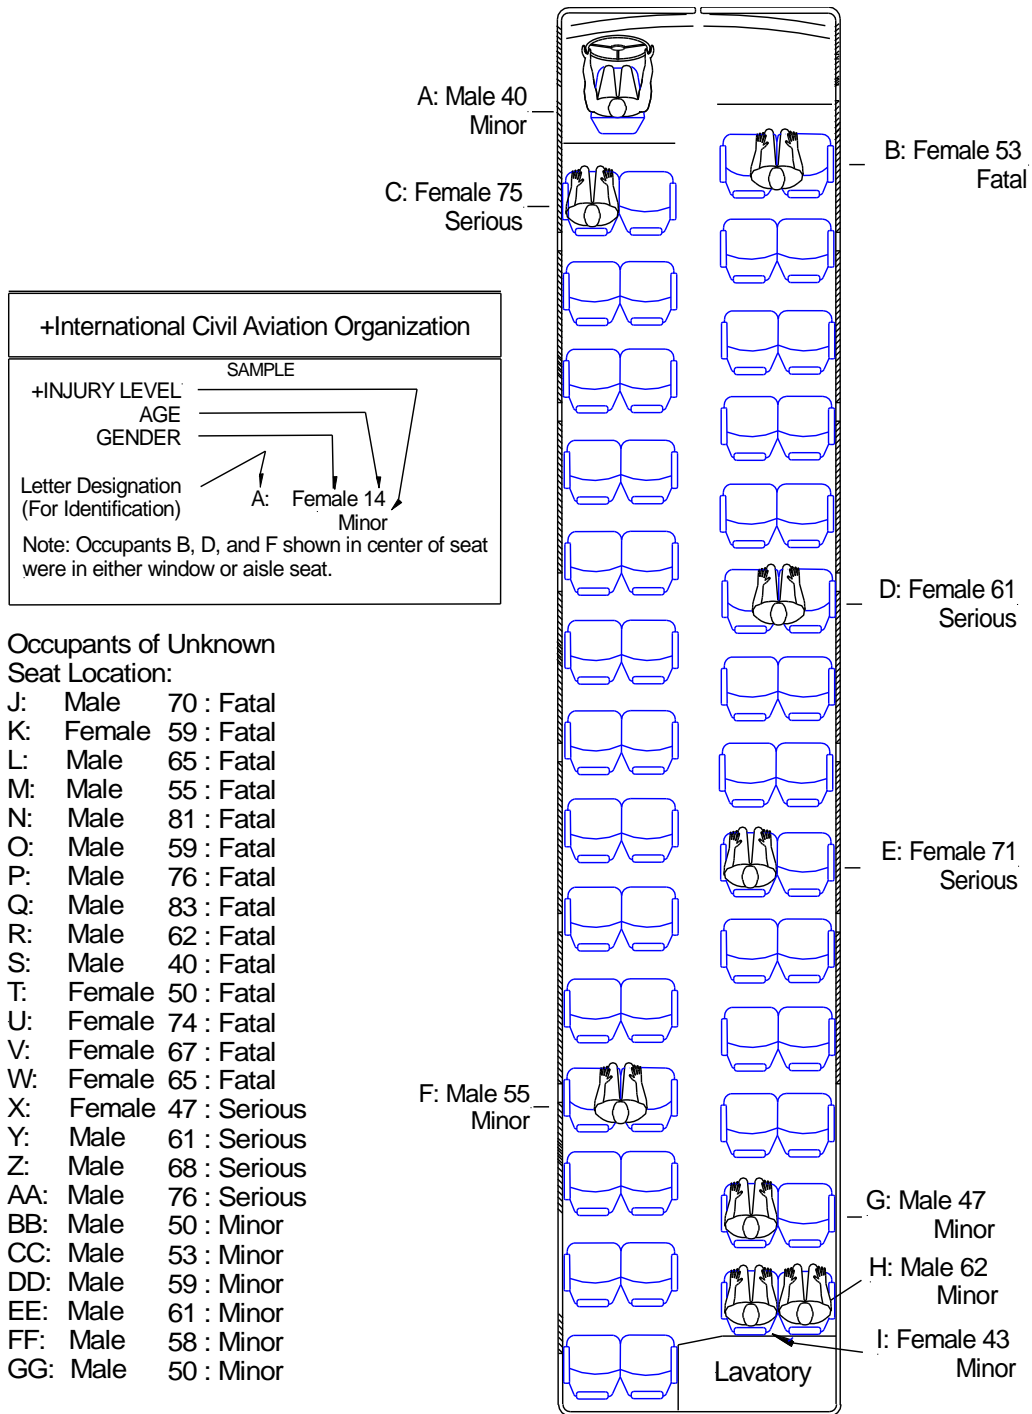
Passenger interviews provided information on seating positions for 8 of the 32 passengers.⁶ (See figure 7.) The partial seating chart contains the known locations of bus occupants obtained through these interviews. All occupants are assigned a letter designation in the chart for reference; occupants whose seating position before the crash could not be determined are listed by letter designation and injury severity.

Figure 7. Passenger seating chart, injury, and demographic information.

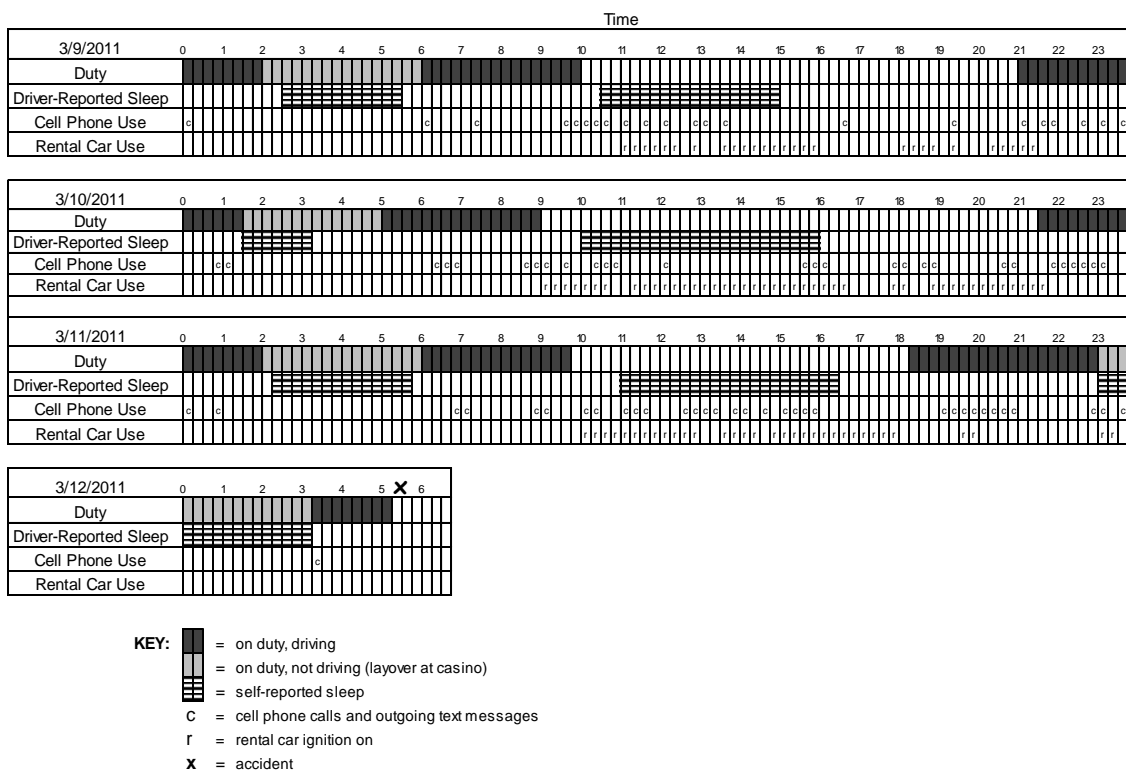
Figure 8 provides a graphical activity history for the 3 days leading up to the accident and includes information about the driver’s driving/duty status, self-reported sleep times, cell phone use, and rental car use. Each block in the figure represents a 15-minute increment, with the letter “c” in a block representing a period in which the driver’s cell phone was used for calls or outgoing text messages and the letter “r” representing a period when the rental car’s ignition was on. The driver’s work duty status did not show a violation of the commercial hours-of-service regulations. Evidence from the driver’s cell phone records suggests that he was using his cell phone frequently during self-reported off-duty or daytime sleep periods over the 3 days before the accident.¹¹ Additionally, cell phone data obtained by the NYSP show that during the driver’s self-reported sleep period, his cell phone was in use at several locations in New York City and Nassau County, New York. Factoring in the driver’s cell phone use, his opportunity for sleep during off-duty periods would have been limited to short periods of approximately 4 hours or less.

Figure 8. Recent driver activity history.

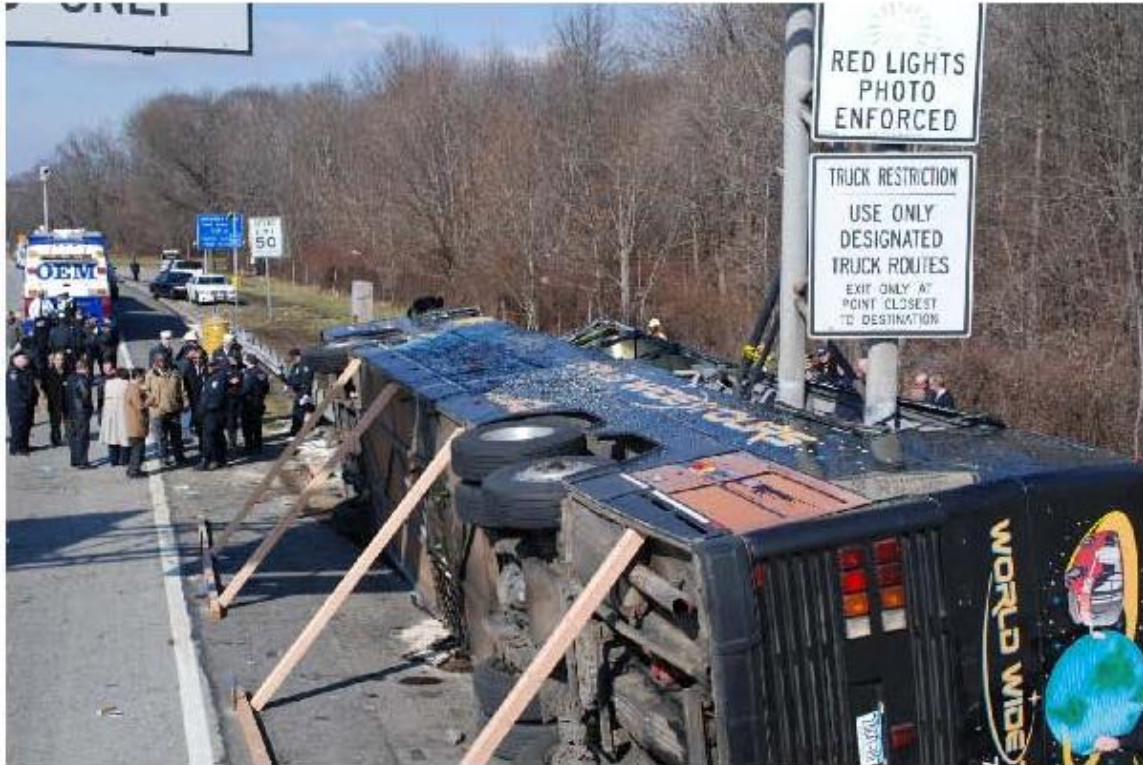
The primary mechanism of physical damage to the motorcoach occurred after the vehicle rolled 90° onto its passenger side and slid forward, striking the vertical highway signpost. The damage was due to the intrusion of the signpost's support poles and cross-beam diagonal metal support and attached steel electrical box, which nearly separated the roof from the motorcoach body at the passenger windows. (See figure 9.)

Figure 9. Southbound view of accident motorcoach at rest.

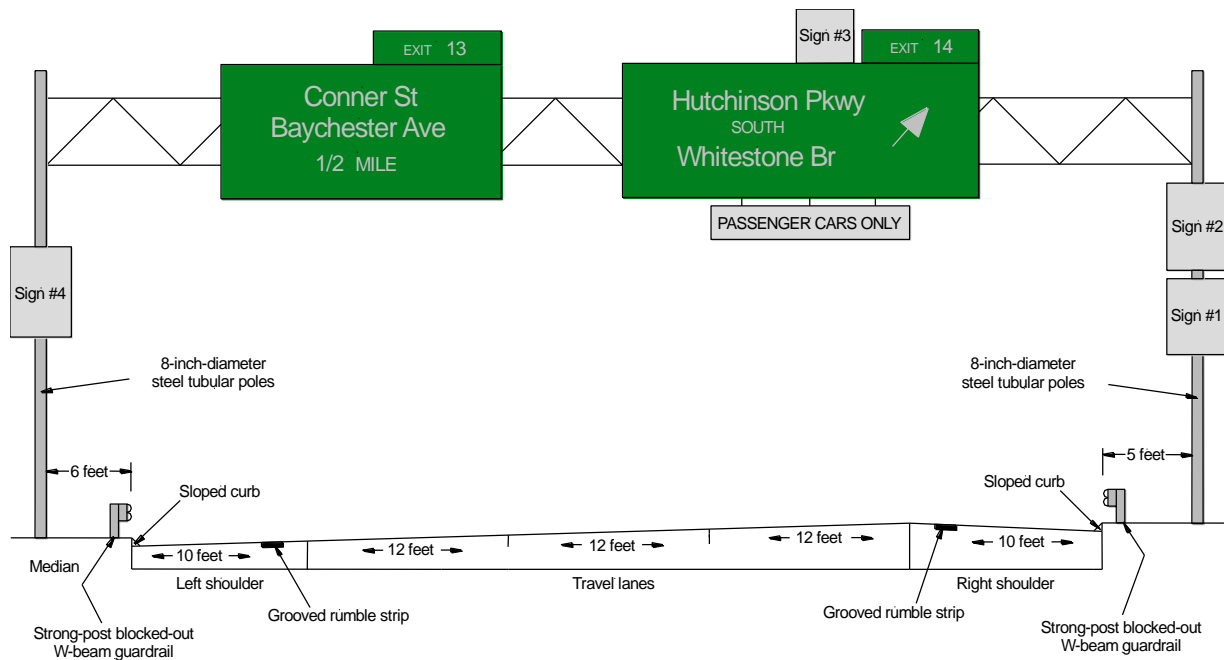
I-95 in the vicinity of the accident, which is classified as an urban principal arterial road, was constructed in the 1950s and reconstructed in 1984. The southbound lanes consist of three travel lanes, each measuring approximately 12 feet wide and separated by evenly spaced white retroreflective pavement stripes 6 inches wide and 10 feet long. A 6-inch solid yellow pavement stripe delineates the inner edge of the roadway from the 10-foot-wide left shoulder, and a 6-inch solid white pavement stripe delineates the outer edge of the right travel lane from the 10-foot-wide right shoulder. (See figure 11).

Figure 11. Typical section of I-95 southbound lanes in the vicinity of the accident.

A sloped (or mountable concrete) curb located at the edge of the 10-foot-wide paved right and left shoulders (see figure 11) had been installed in 1984 to convey stormwater runoff from the travel lanes of I-95 to a closed drainage system. The curb was approximately 5 inches high, as measured from the pavement surface.²³ The strong-post blocked-out W-beam guardrail was offset approximately 3 inches from the back face of the sloped curb. The installation of the curb complied with the NYSDOT *Highway Design Manual* guidance and standard sheet details in force at that time.²⁴

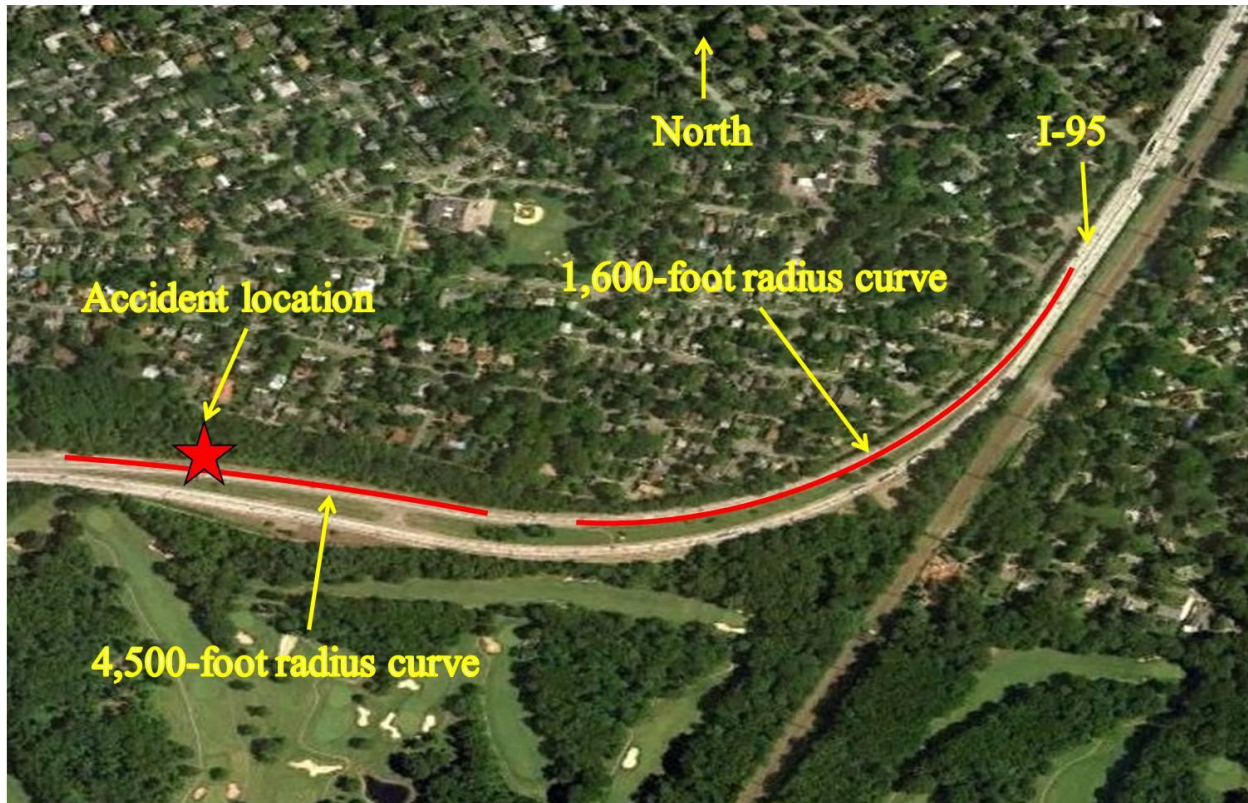
770 feet before the accident location and then transitions to a 4,500-foot radius curve that turns to the left in the direction of travel. The accident location was within the 4,500-foot radius curve. Grooved rumble strips (also called shoulder treatment for accident reduction, or STAR) were located on the right and left shoulders of the southbound lanes, along with a sloped curb at the edge of the right and left shoulders. (See figure 12 illustrating the two horizontal curves.)

Figure 12. Horizontal curvature of I-95 southbound in the accident vicinity.

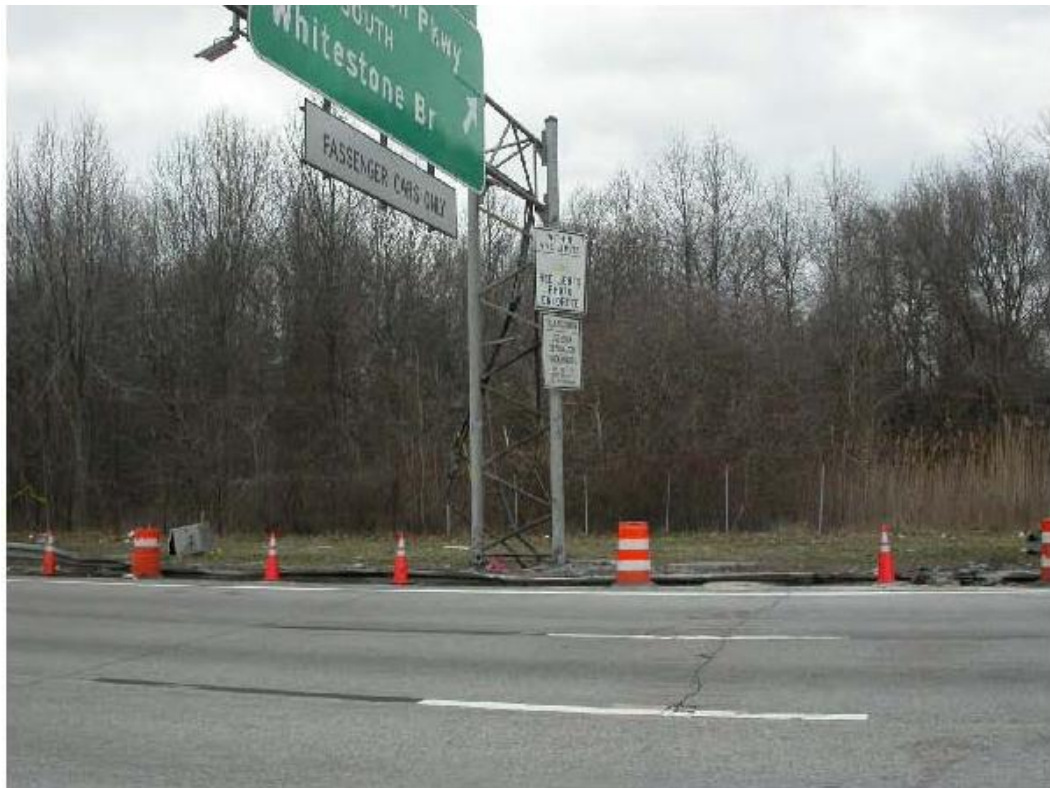
The four poles that supported the overhead vertical highway signpost were part of a fixed-base system and, as such, are not designed to yield or break away on impact. The four vertical support poles, two on I-95 northbound and two on I-95 southbound, were 8-inch-diameter steel tubular poles²⁷ with a wall thickness of 0.3125 inch. Each pair of poles was connected with cross bracing and separated by a lateral (parallel to the travel lanes) distance of 5 feet 2 inches. (See figure 13.) Two E-ZPass tag readers, wired to a metal cabinet installed on the cross bracing, were mounted on the overhead sign structure above the travel lanes. In addition, two wire conduits were attached to the vertical highway signpost to feed a variable message system sign above I-95 northbound. NTSB investigators documented accident damage to the two vertical poles, including a hole at the base and an indentation 9 feet above the base on the west pole and multiple scrape marks on the east pole from its base to a height of 9 feet.

Figure 13. Overhead vertical highway signpost (east and west poles).

The vertical highway signpost support poles were located within the clear zone and offset from the edge of the travel lanes by 15 feet, which consisted of a 10-foot-wide paved shoulder and a 5-foot offset from the face of the W-beam guardrail. (See figure 11.) The clear zone concept, which recommends providing a traversable and unobstructed roadside area beyond the traveled way for use by errant vehicles, is usually set at 30 feet for freeways.²⁸

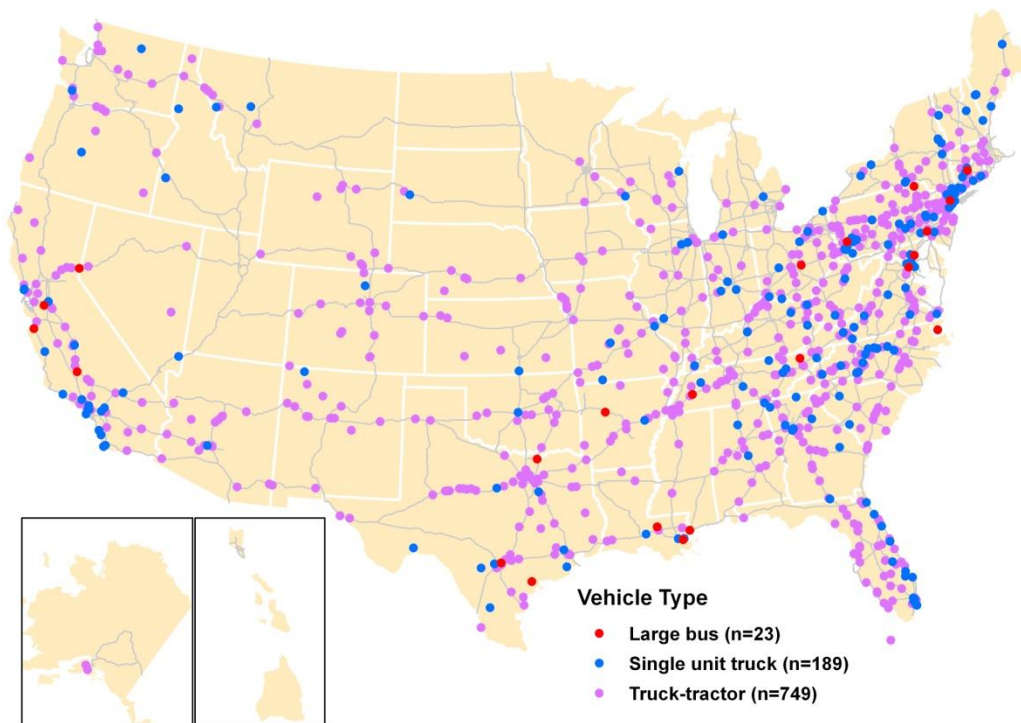
NTSB investigators examined the event sequence of fatal accidents on high-speed roadways involving collisions with guardrails from 2004–2010, using NHTSA Fatality Analysis Reporting System (FARS) data. Figure 14 shows the locations of the accidents involving heavy vehicles. In those accidents, “collision with guardrail” was typically not the first event, indicating that one or more precipitating events led to the interaction with the guardrail. Because most guardrails are set back a distance from the traveling lanes, “ran-off-road” was the event most often cited as the preceding event, similar to the accident described in this report. Also, “collision with guardrail” was rarely recorded as the most harmful event specifically involving large buses and other heavy vehicles. The most likely subsequent event after a vehicle collided with the guardrail was “rollover” for truck-tractors and “ran-off-road” for large buses. On average, very few fatal accidents involved vehicles colliding with guardrails and then subsequently colliding with supports (such as a highway sign, overhead sign, light, or traffic sign).

Figure 14. Fatal accident locations involving heavy vehicles colliding with a guardrail on high-speed roadways (2005–2010).

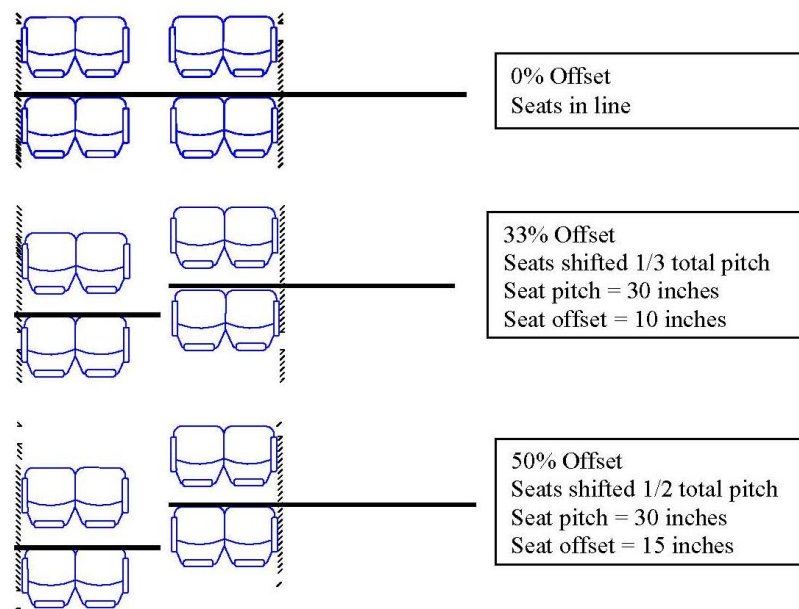
Because restraint installation would redefine occupant kinematics in a motorcoach crash and could reduce ejection, secondary impacts, and intrusion factors, the NTSB undertook a simulation study to characterize occupant kinematics with and without passenger lap/shoulder belts.¹⁸⁹ The study focused on two full rows of passenger seats near the bus's CG and included variable occupant density, restraints, and armrest configurations. Offset rows were identified as a factor greatly affecting occupant kinematics and injury predictions for unrestrained passengers in rollover events. As discussed in section 1.5.2, offset rows refer to the seating rows on the driver side of the bus being offset slightly rearward from the same rows on the opposite side of the bus. (See figure 15.)

Figure 15. Simulation study seat row alignments and offset row configurations.

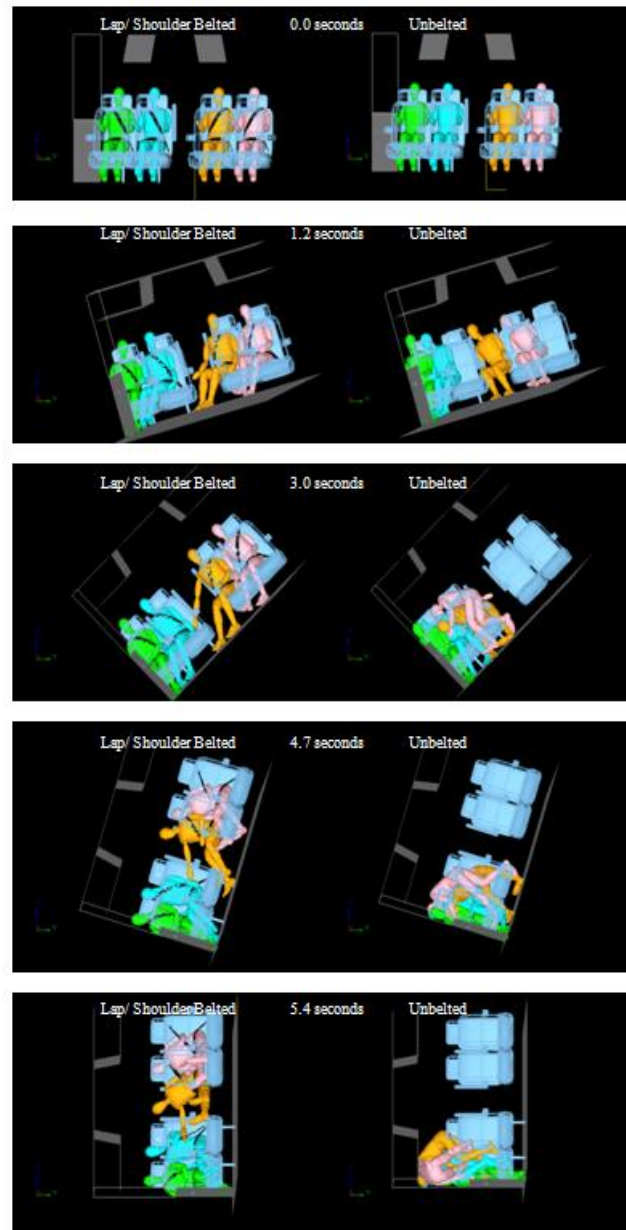
In the simulation, lap/shoulder-belted occupants were contained within their seating compartments. Occupants seated on the far side of the roll (opposite the side near the ground) were able to partially escape the shoulder harness during the roll sequence, which then placed them in a position closer to the floor of the bus than to the luggage racks, reducing their vulnerability during intrusion of the vertical highway signpost at the window level later in the impact sequence. Near side occupants remained in a more upright position during the simulation, making them potentially more vulnerable to impact and intrusion of the signpost's poles. For all lap/shoulder-belted occupants, the simulation resulted in low predicted injury levels for the motorcoach rollover without intrusion. A comparison of unrestrained occupant kinematics and lap/shoulder-belted occupant kinematics is shown in figure 16.

Figure 16. Time history of unrestrained and lap/shoulder-belted occupant kinematics.

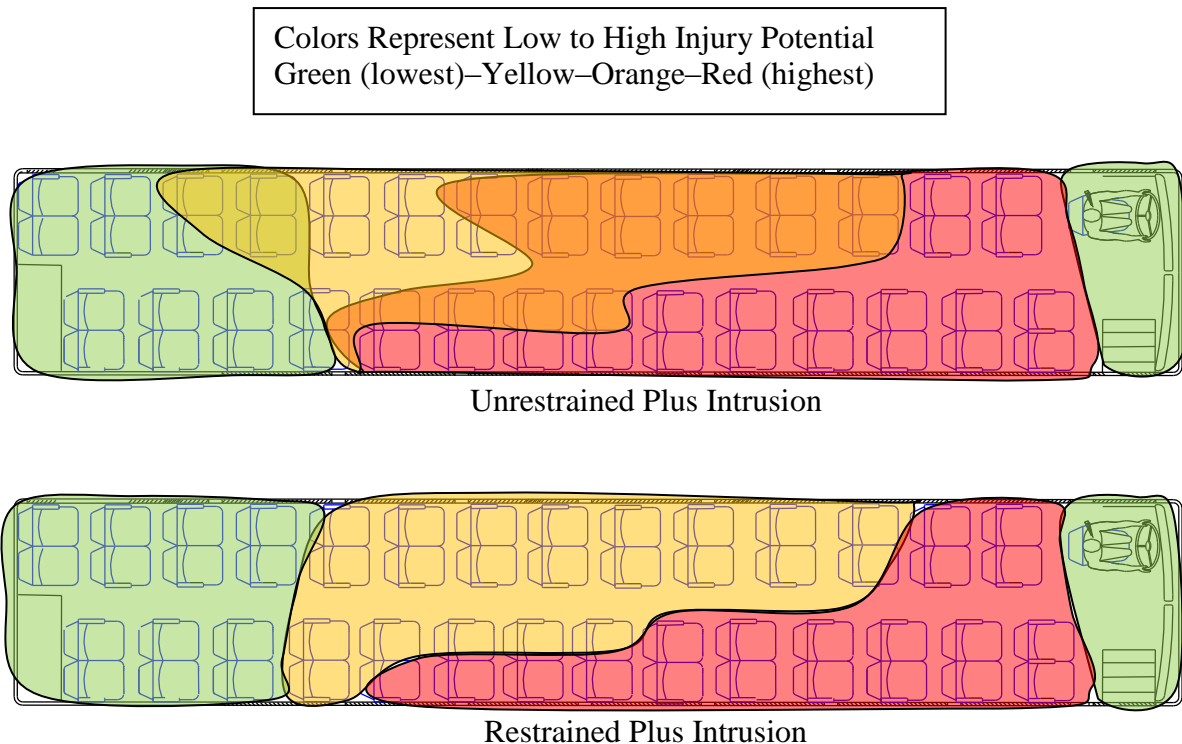
The characteristic motion of the unrestrained occupants compared to the intrusion zone evaluation indicates that the vertical highway signpost's intrusion appears to have caused most of the injuries and all of the fatalities in this accident. The motorcoach's occupant compartment was not compromised before the vertical highway signpost's impact, and the regions of intrusion are clearly identified.

Figure 17. Risk zone approximation using intrusion and occupant study data.
