Appendix D – Plume Calculation Team 2010; Particle Image Velocimetry Report

Deepwater Horizon Release Estimate of Rate by PIV

July 21, 2010

Plume Team - FRTG

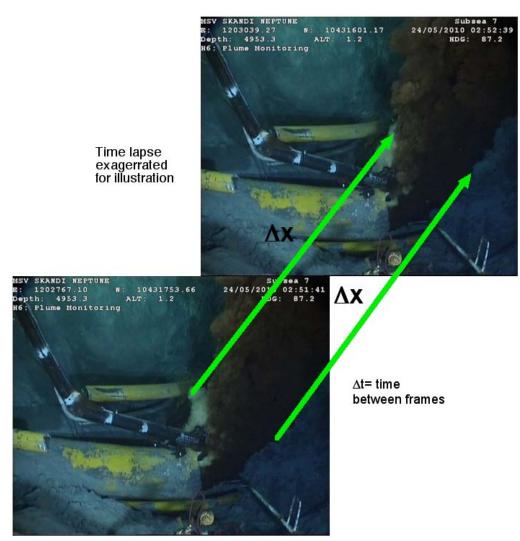
Figure 3: Illustration of Particle Image Velocimetry

Figure 3 illustrates the approach. Because the flow velocity is not uniform throughout the plume, multiple locations, known as interrogation spots, must be sampled to estimate and average velocity. Similarly, the cross-sectional area is time and spatially dependent as well as having diffuse boundaries so that an average cross-section, dependent upon the location of the interrogation spots, needs to be calculated. A further challenge for measuring the flow in this case is that it is not spatially or temporally uniform in mixture of gas and fluid.

For each of the interrogation sites a vector velocity $\Delta X/\Delta t$ is computed. The vector average of these velocities provides an average velocity. Combined with an average cross-section area, this yields a net flux of both gas and oil. A key parameter was this average ratio of gas to liquid. This term seemed to vary over the time period of the spill and during the time of the video clips. Increasing gas increased the velocity of the plume but decreased the mass flow. Analysis of the available short movies of the riser flow shows the existence of periods when the flow oscillates from pure gas to seemingly pure oil. This could be an indication of Slug Flow Regime. These periods of gas-oil flow fluctuation are in the range of minutes. Longer periods may also exist but would require examination of longer clips to determine.

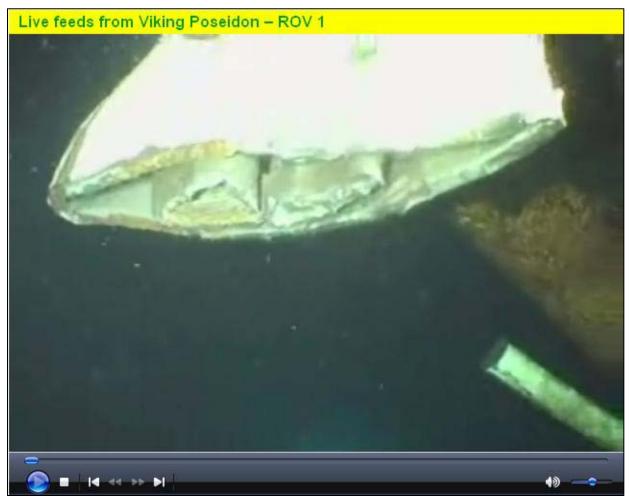
Figure 5: Cut Riser Showing Two Pipes Inside

By June 3, BP had severed the riser just above the BOP. According to the oil company estimates, this was expected to increase the total leak rate by approximately 20%. Surprisingly, the interior of the riser pipe contained not one, but two pieces of drill pipe inside (Figure 5). One team member speculated that the drill pipe snapped during the accident into several segments that would fit side by side inside the riser. The team requested from BP videos of the leak after the cut but before the installation of a dome designed to capture part of the flow. The damage to the riser during cutting complicated the task of estimating flow cross section.
