A Post Occupancy Evaluation of 22 GSA Buildings

## **Re-Assessing Green Building Performance: A Post Occupancy Evaluation of 22 GSA Buildings**

June 2010 – *Published September 2011*

Prepared for the U.S. General Services Administration  
under Contract DE-AC05-76RLO1830 with Battelle Memorial Institute.

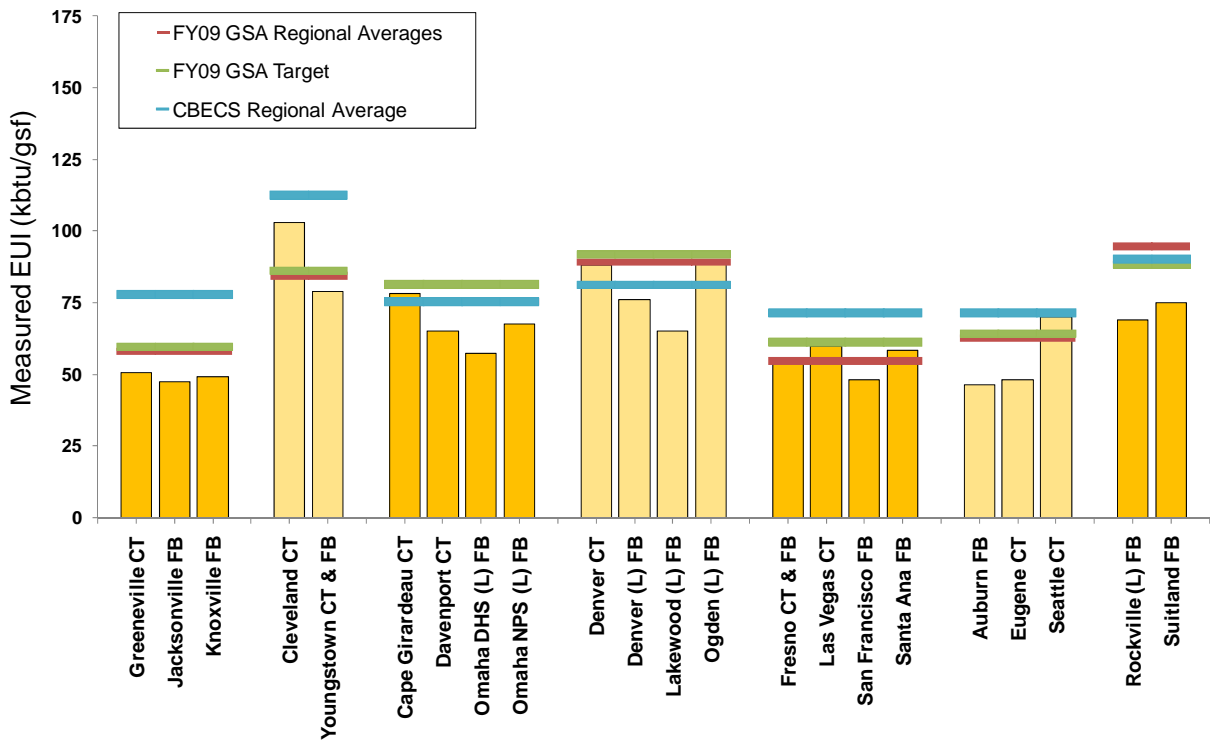
**Figure S4.** Energy performance of GSA buildings is strong when compared to industry averages.

The buildings' energy use intensity (EUI) was compared to multiple different baselines (Figure S4), with the most commonly referenced baseline being the Commercial Building Energy Consumption Survey (CBECS) average EUI for office buildings. The energy performance average of the buildings in the study was 25% better than CBECS, 10% better than fiscal year 2009 GSA Regional Averages, 13% better than fiscal year 2009 GSA Target values, and 18% better than CBECS regional averages. The CBECS national average is for office buildings built from 1990-2003, while the regional averages are for all building types. The GSA Target is the Public Buildings Service goal for energy performance across the agency.

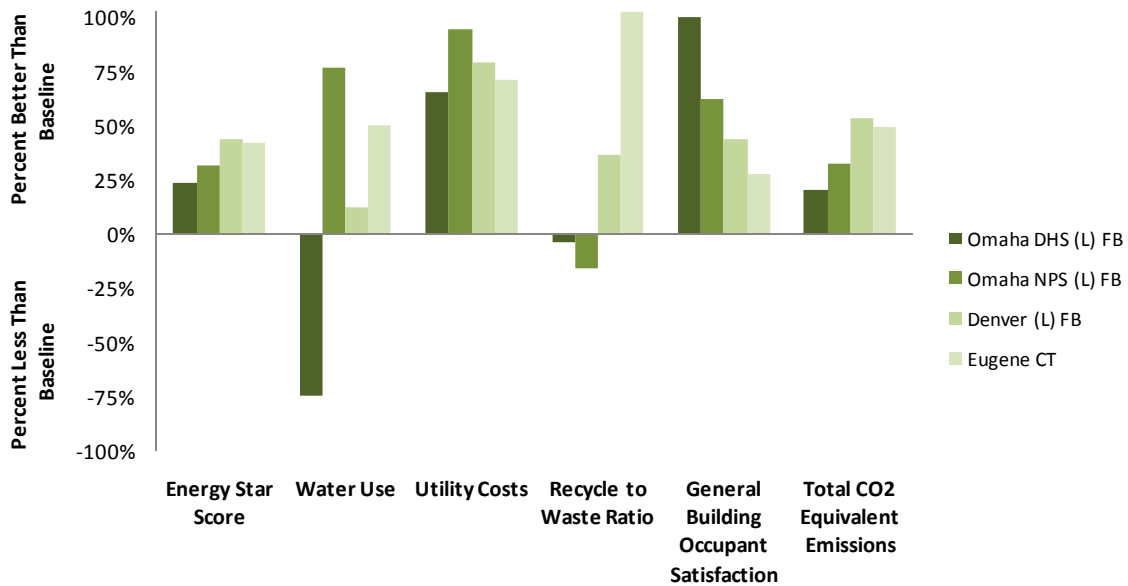
**Figure S10.** LEED Gold buildings show exceptional performance on all of the key performance metrics.

Figure S10 shows that overall the four LEED Gold buildings in the study performed better than the industry baselines. Water use for the Omaha DHS building is not only higher than the industry baseline, but also significantly higher than it was during the first assessment of this building. This change in water use should be investigated to understand if it is a data measurement error, a leak, an unintended use, or an increase in the building occupant related water use. The waste to recycle ratio is worse than the industry baseline for both of the Omaha buildings as well.

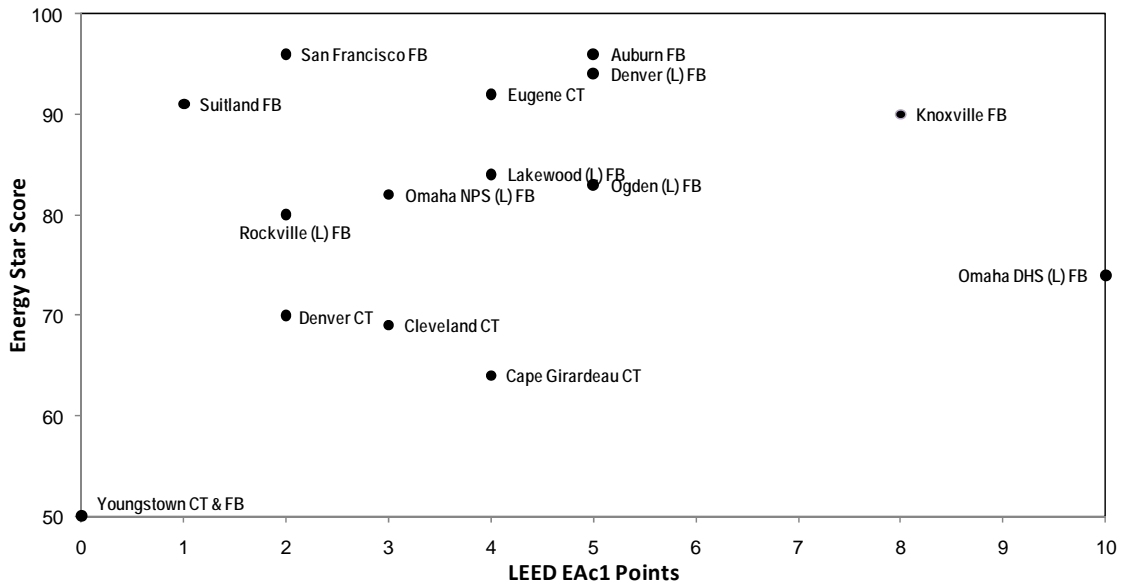
**Figure 10.** Energy Star rating and LEED energy credits

Comparing Energy Star scores with the EAc1 points shows that 4 of the 5 buildings that had five or more EAc1 points had Energy Star scores above 80, with only 50% of the buildings with three points or less scoring 80 or above.

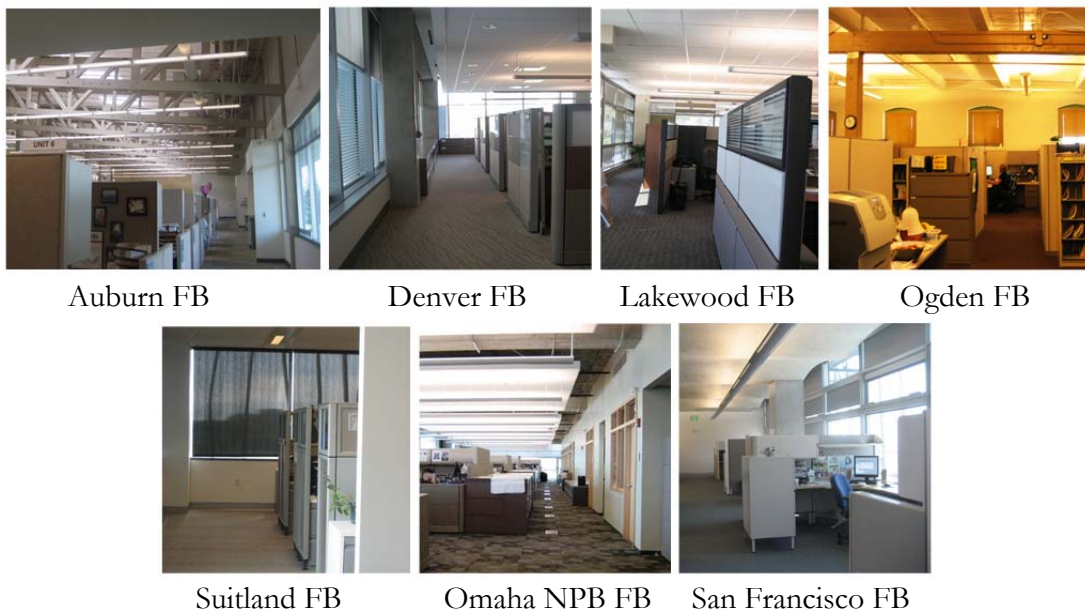
**Figure 31.** Photographs of cubicle workspaces

Photographs of the building workspaces show a variety of cubicle heights and types, which do not offer a consistent reason for the different acoustic satisfaction scores.

information content of the noise causes distraction and dissatisfaction. CBE also compared the acoustic satisfaction levels to the type of office space. Not surprisingly, the highest levels of satisfaction are in private offices and the lowest are in open office spaces and cubicles.<sup>31</sup> For the buildings in this study where cubicle workspaces were predominant the acoustic satisfaction scores are shown in Figure 30. Two of the five buildings with cubicle style workspace, Denver FB and Auburn FB, have a positive acoustic satisfaction scores.

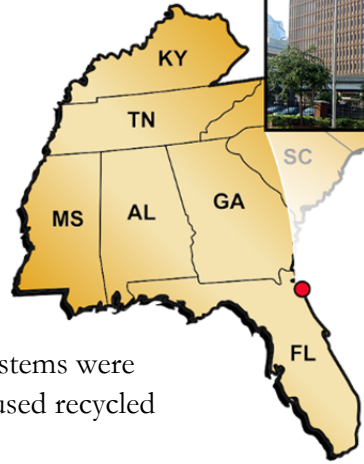
The energy use intensity has reduced by 60% from a pre-renovation energy use intensity of 120 kBtu/SF. The renovation included envelope improvements including better insulation and low-E windows. A smaller “pony” chiller was added during the renovation to cool the

The Chas E. Bennett Federal Building was renovated in 2004 and received Energy Star recognition in 2007. The building was completely gutted during renovation and all of the plumbing, electrical and mechanical systems were replaced. Some of the flooring and finishes used recycled materials.

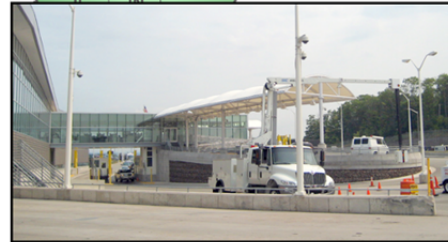
The facility's steel-frame construction with glass curtainwall offers daylighting to the interior space, and the facility sits on top of an at-grade parking garage.

The Sault Ste. Marie Port-of-Entry is located on the U.S. side of the northern international border and operates 24 hours a day, 365 days a year. The building has primary and secondary vehicle inspection bays and two commercial truck lanes and three car lanes for in-bound inspections.

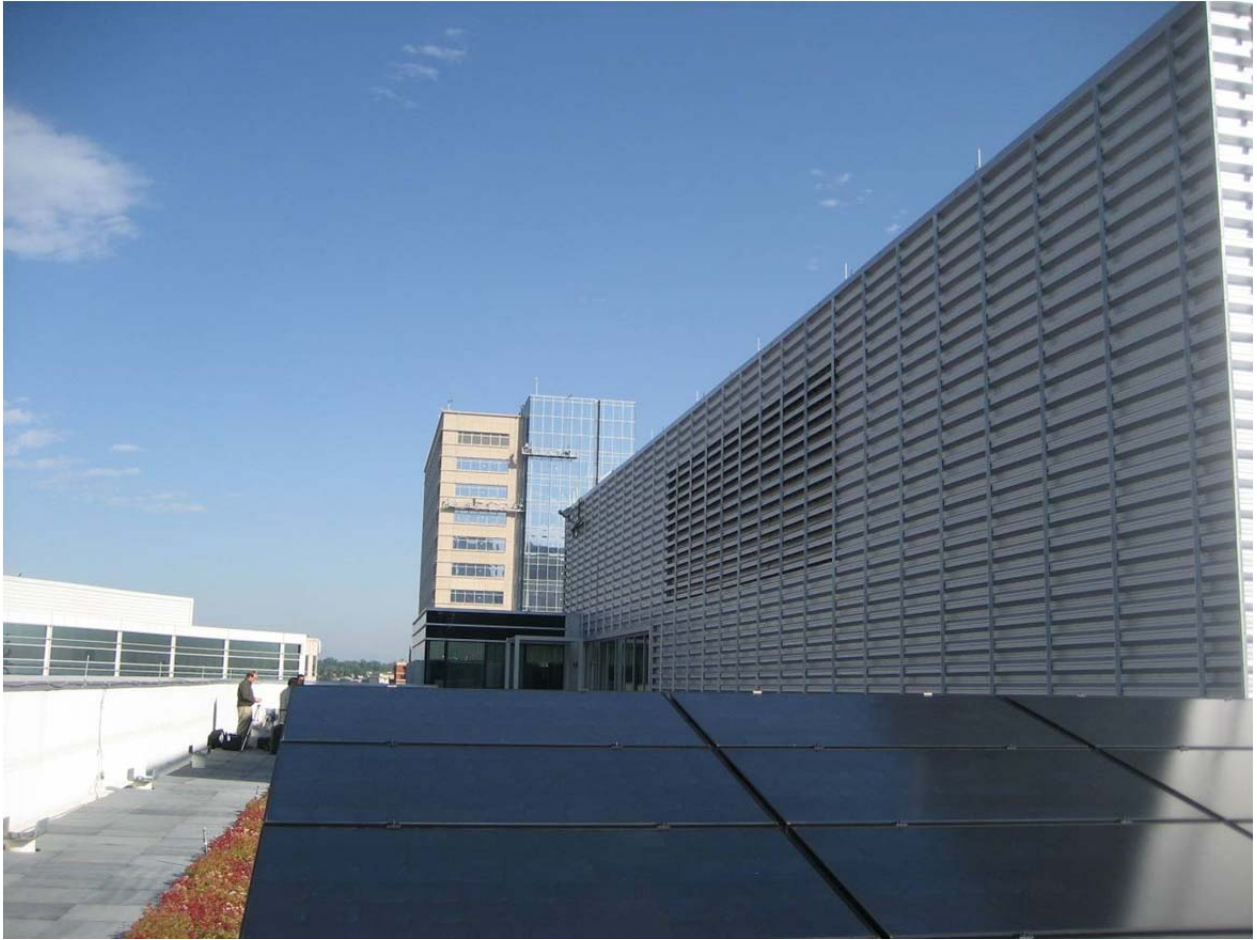
**Figure 1. Roof sampling location.**

Indoor sampling locations were selected throughout the building to characterize the IEQ in the different areas of the building where staff spend the bulk of their time. One location was outdoors on the roof of the building near the air intake for the HVAC system. This location was on a tiled path near the outer edge of the building. The sampling location was on the “green” portion of the roof (vegetation was present in close proximity to the sampling location). Of the five interior locations, four were located in office spaces while one was located in a dedicated copy room. Of the office spaces, two locations were closed offices and two were open offices. One each of the open and closed offices had underfloor ventilation, while the others had overhead ventilation. Table 1 lists the six sampling locations and specifies the location and ventilation conditions present in each. Figure 1 through Figure 6 show each of the sampling locations at various stages in the sampling process.

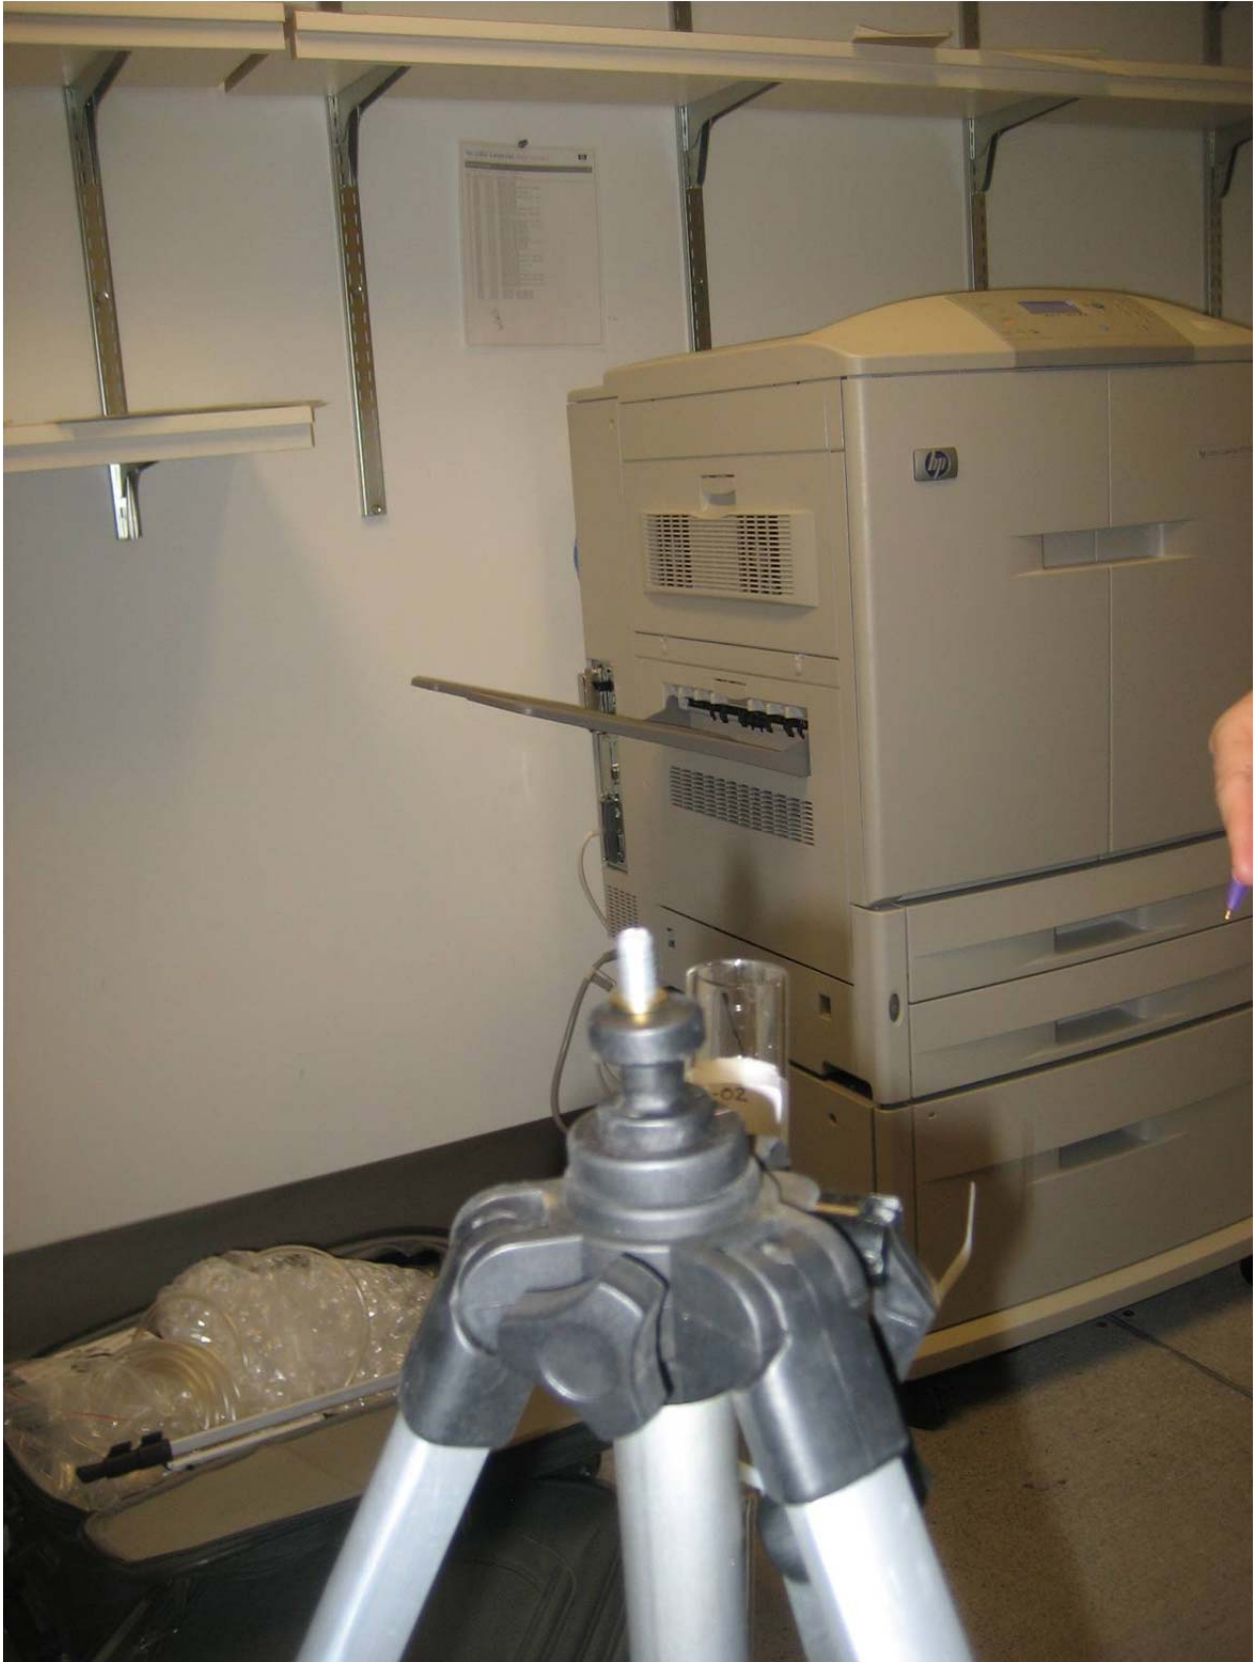
**Figure 2. Copy Room (CR) sampling location and SVOC cartridge.**

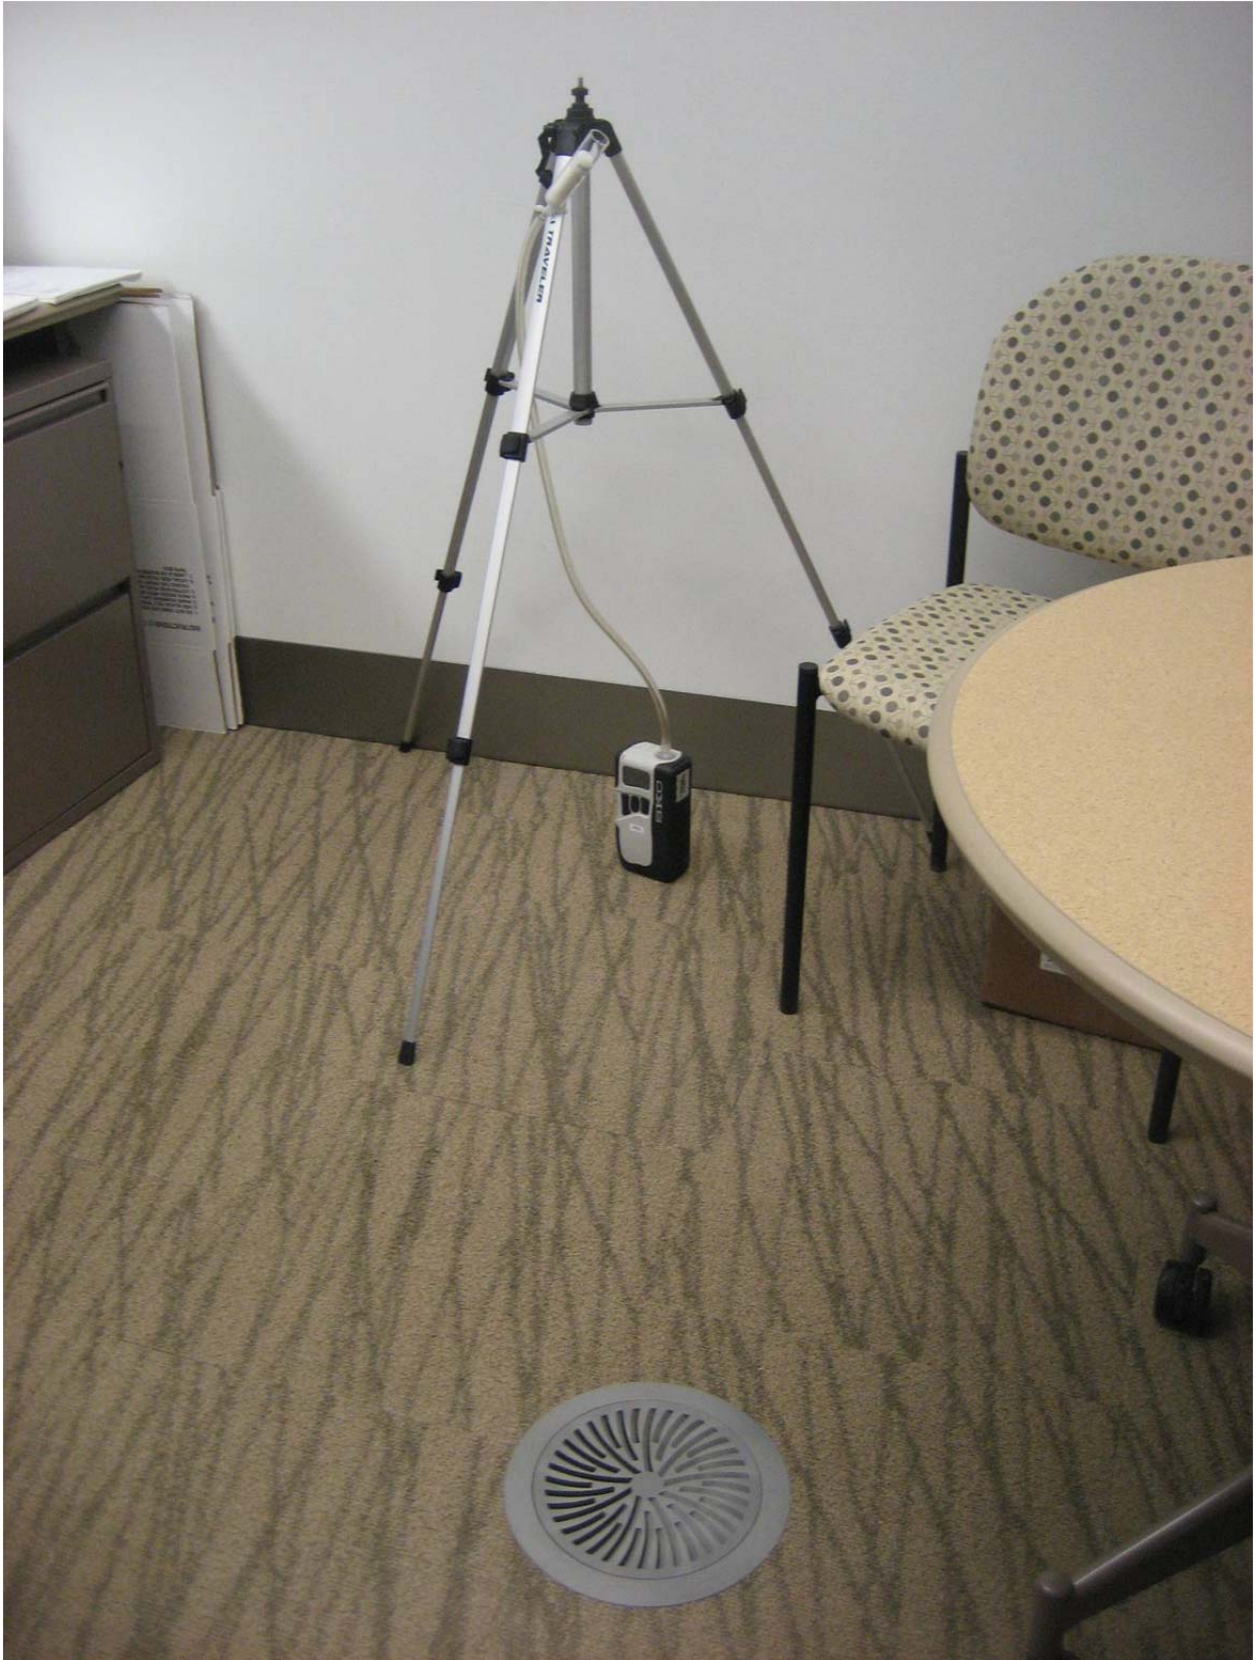
**Figure 3. Office 1 (O1) sampling location and SVOC sampling setup.**

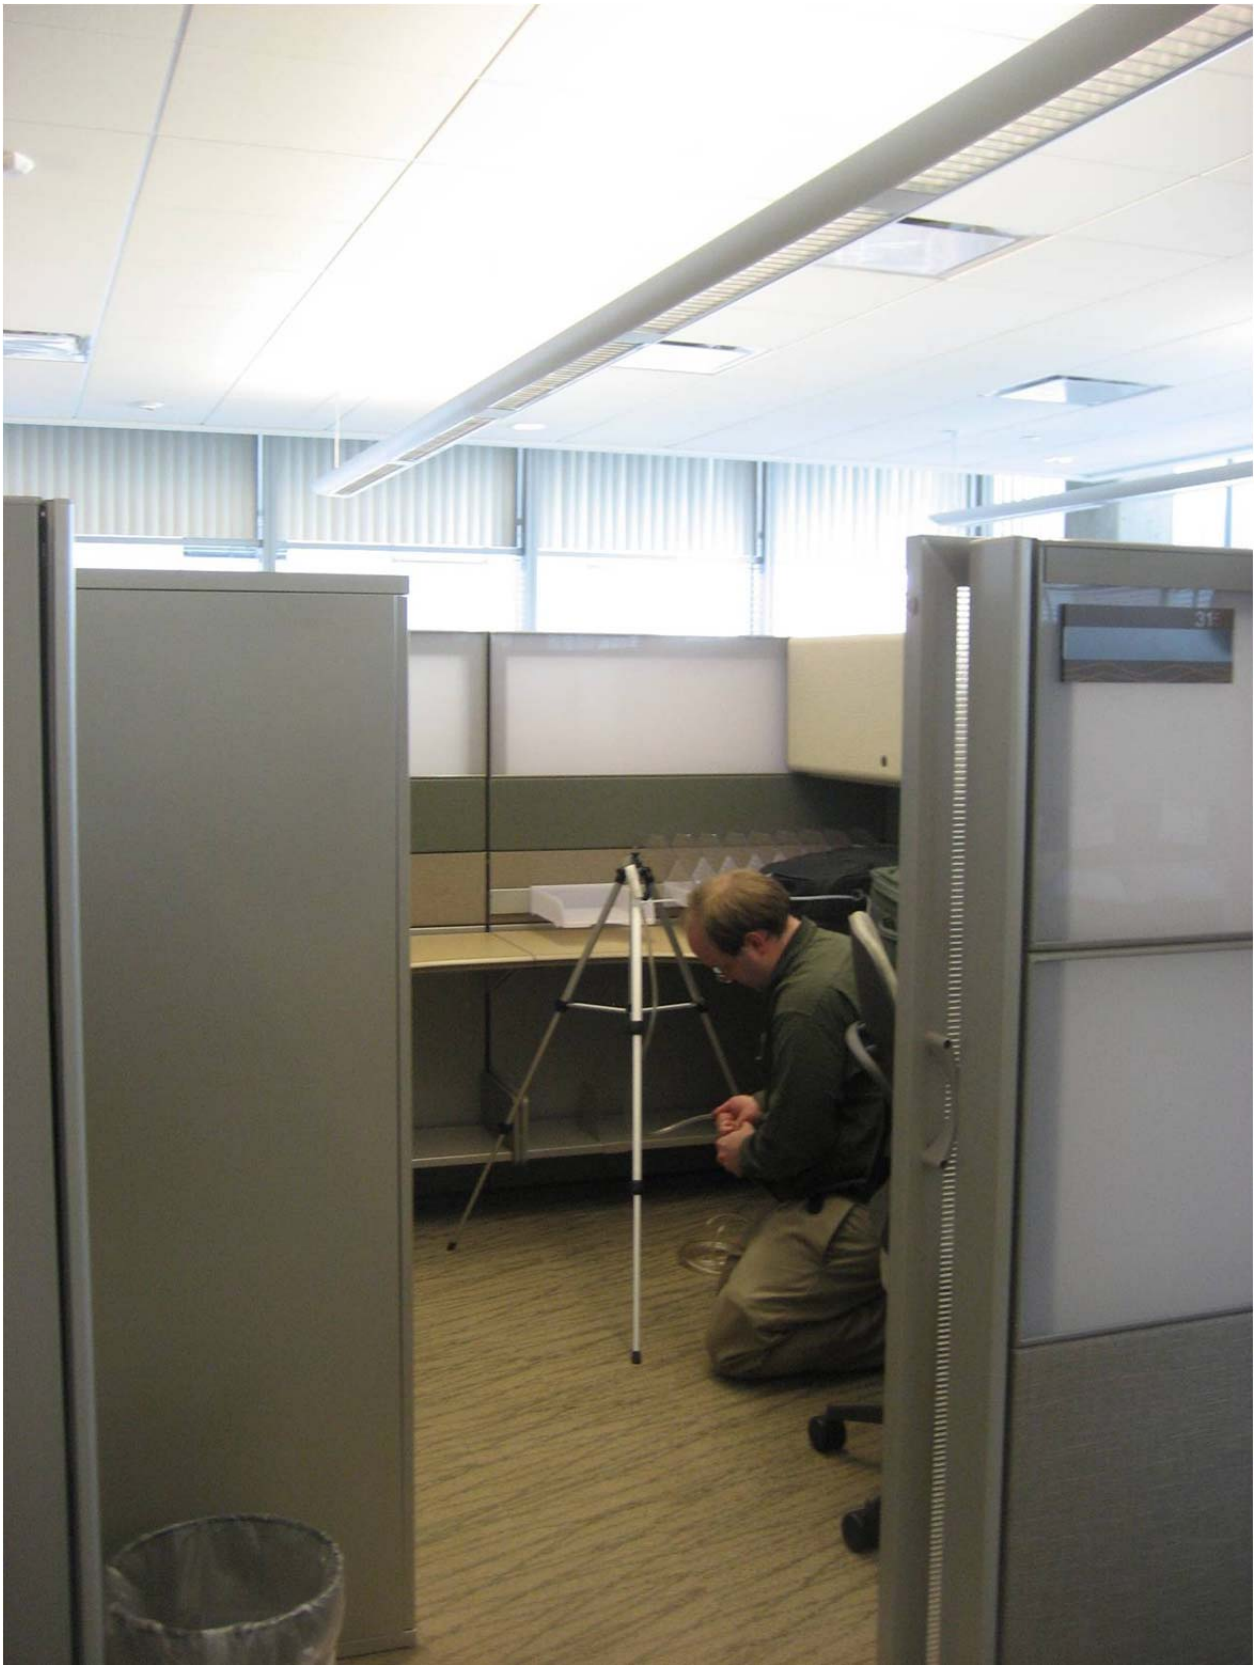
**Figure 5. Office 3 (O3) sampling location.**

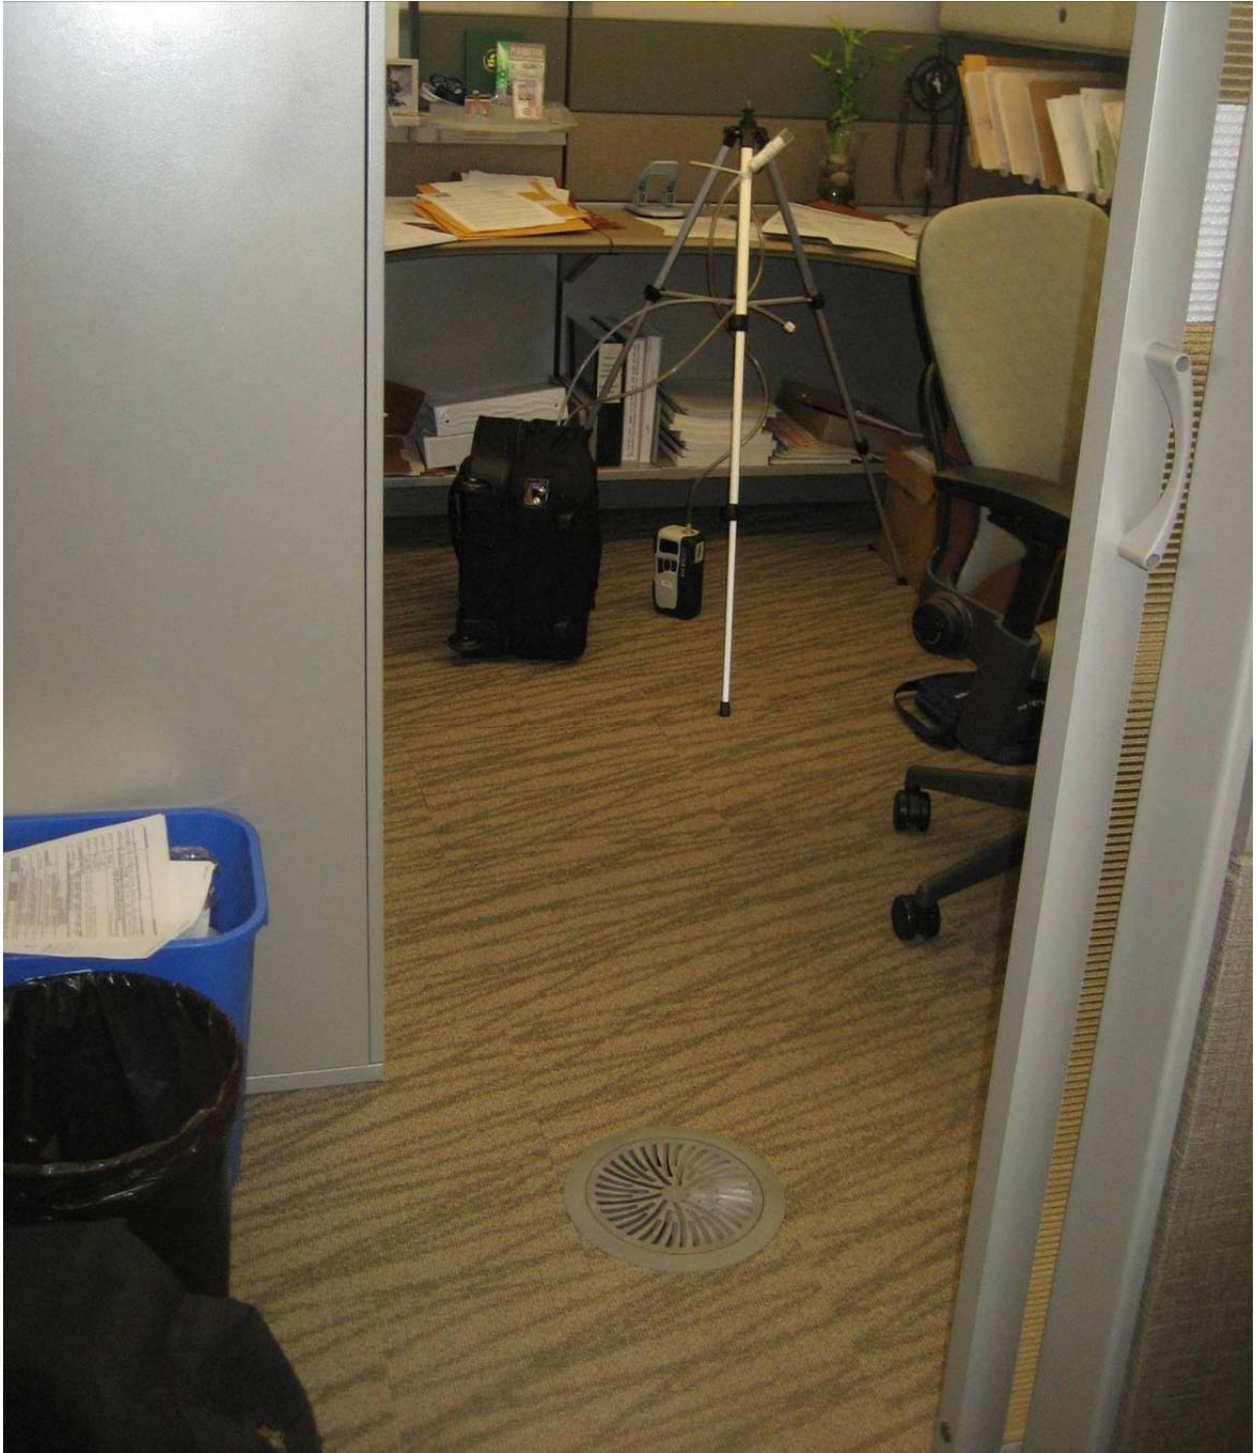
**Figure 6. Office 4 (O4) sampling location with SVOC sampler and continuous instruments.**
