Archaeological Curation-Needs Assessment

Technical Report No. 20

Volume II Non-Military Repositories

**US Army Corps
of Engineers**
St. Louis District

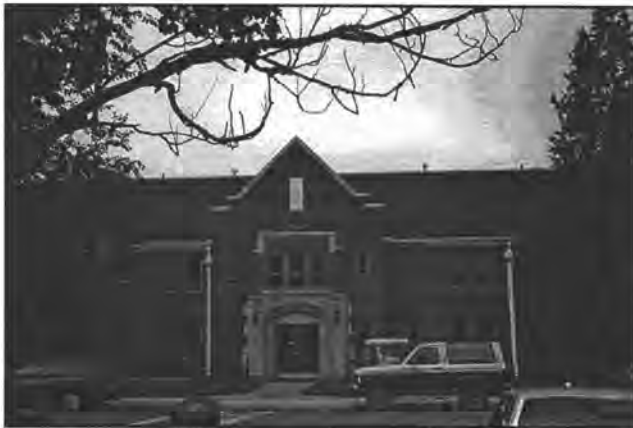
Quay Hall was originally built as a college dormitory in the late 1930s, but was converted to house University offices (in pre-1983) (Figure 34). The entire building encompasses approximately 13,064 ft² of floor space on two levels above grade, of which the ACA project files office occupies an estimated

Figure 34. The office of the Agency for Conservation Archaeology is located in Quay Hall on the campus of Eastern New Mexico University, Portales.

165 ft² on the second floor. The foundation is concrete and the exterior walls are concrete block with brick facing. The flat areas of the roof are composed of tar and gravel while the pitched areas are covered with composite shingles. Roof leaks have occurred, but have not affected the records room to date. There are two windows in the ACA project files office. Both have aluminum frames and are fitted with Venetian blinds. The interior door (Room 220) is wood panel.

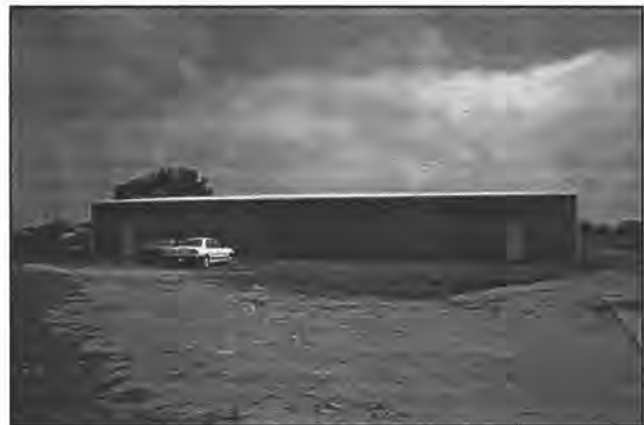
The Anthropology Curation Facility is constructed of wood frame and corrugated metal set on a concrete foundation (Figure 35). The warehouse was built approximately 15 years ago by the University and was used for storage of grounds-keeping equipment. In 1993, the University allocated the warehouse for the sole use of ACA. The roof is original to the building and is also constructed of wood frame and corrugated metal. ACA has conducted some internal renovations such as removing partitions and installing insulation and sheetrock. The warehouse floor has also been treated and sealed to prevent any leaks in the foundation. Plastic-backed insulation has been placed in the ceiling and on the walls. Two small rooms have been created for the storage of records and osteological collections. No windows exist in the building. Electrical and plumbing systems are present, and the lavatory has been renovated. The warehouse is considered structurally sound and provides 5000 ft² of storage space. There are two kinds of exterior doors present (single panel and garage-type).

Figure 35. A corrugated metal and wood warehouse is used for collections storage of anthropological collections at the Agency for Conservation Archaeology, Eastern New Mexico University, Portales.

At the time of the original evaluation in 1994, and the second assessment in 1996, no environmental controls were present in the warehouse facility. A gas-forced air unit provides heat for the building, but there is no mechanism in place for cooling. The dry climate in this part of the state provides generally favorable conditions for the preservation of the collections, so humidity control is not considered a priority. Dust filters and ultraviolet (UV) sleeves were not in place, but these measures are planned for installation. Dust, blown into the warehouse facility by the frequent high winds, presents the greatest challenge. The warehouse facility is currently only cleaned on an as-needed basis by the curatorial staff.

1. Establish basic temperature and humidity monitoring and control measures in the Anthropology Curation Facility as soon as possible.
2. Install a basic security system, if possible, for the Anthropology Curation Facility.
3. Install smoke detectors in both Quay Hall and the Anthropology Curation Facility.
4. Archival box the large ground stone objects, currently sitting loose on open shelving, and integrate them into the main collections storage area of the Anthropology Curation Facility.
5. Records should be removed from current acidic manila and accordion folders and placed in archival quality containers. Duplicate copies of the records should be made and stored at a separate and secure location. All contaminants, such as metal staples and paper clips, should be removed from the records.

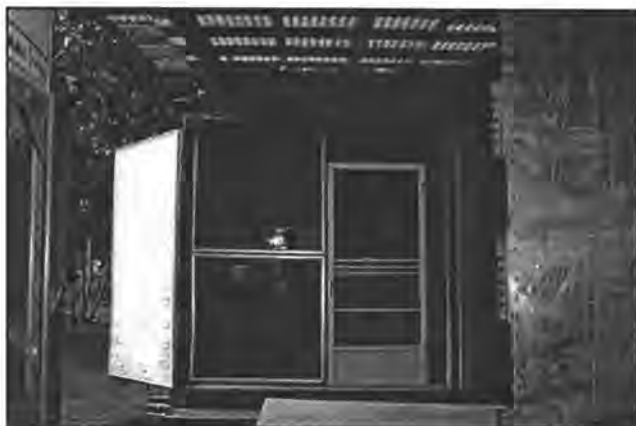
The collections area is a prefabricated metal outbuilding, separate from the main repository, that has been converted into a records archive (Figure 36).

Figure 36. Collections are housed in a metal outbuilding at Archaeological Consultants of the Pacific.

It has metal interior and exterior walls and floors and a concrete foundation. The roof and frame are steel and aluminum. No structural problems have been noted in the archives by any staff members. There are two windows in the building that slide open and have screens and blinds. The building measures 300 ft².

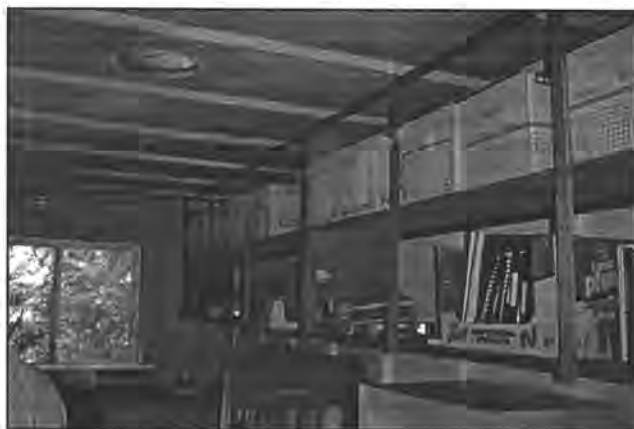
Records are stored in the metal outbuilding on non-movable, wooden shelving units in acidic cardboard boxes (Figure 37). Each box holds approximately 2.8 linear inches of records and is secured with a telescoping lid. Records associated with Department of Defense (DoD) administered land are stored in two such boxes that are labeled directly in marker. Label information includes installation, report numbers, and dates. Records within each box are

Figure 37. Wooden storage units hold boxed collections and supplies in the collections storage building.

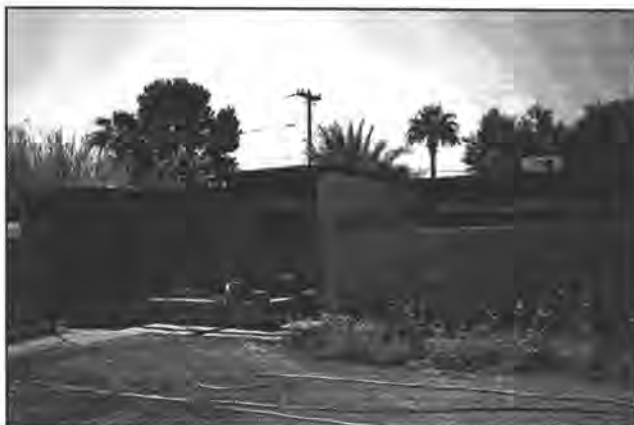
The ARS office is located in a residential neighborhood in Tempe. The office is in a duplex house that was built in 1956 and totals approximately 2100 ft² (Figure 38). The building has a concrete slab foundation and is one floor above grade. The exterior walls are cinder block bricks and the flat roof is composed of tar and paper. At the beginning of 1997, a layer of urethane foam insulation was added to the roof. The building is structurally solid, but does have cracks in both the foundation and the exterior walls. Repairs have been made to leaks that have occurred in the building. The numerous exterior windows have multiple panes of glass in metal frames. At least one of the windows

Figure 38. A building constructed of cinder block with a flat roof houses the offices of Archaeological Research Services.

has a cracked pane that allows for air and water leaks. There are two entrances to the building, one leading into each side of the duplex. Each entrance has a metal screen door, as well as a wooden door. Floors are painted concrete and interior walls are painted wallboard. The ceiling is of varnished wood planks. The office areas and storage areas are not separated and are in close quarters. These areas are cluttered with office equipment and the various paper records and resources.

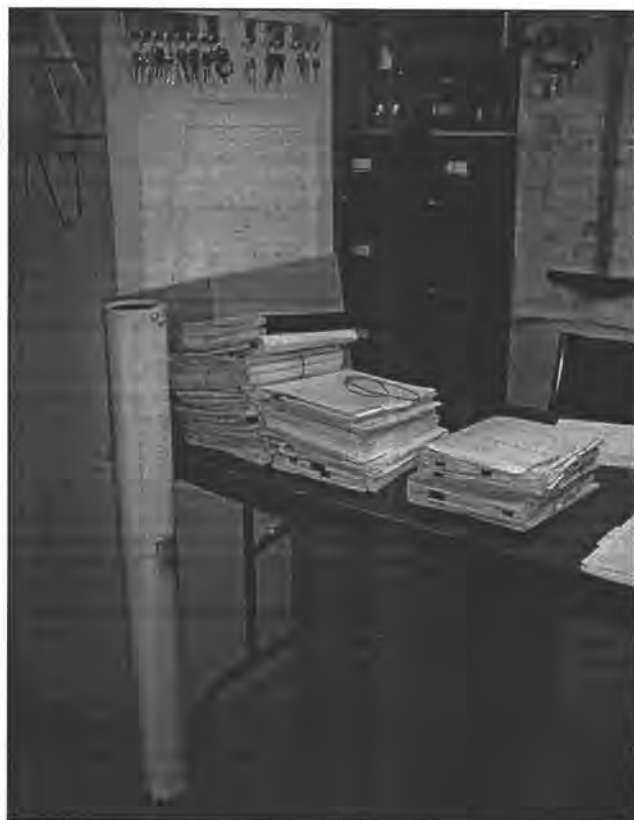
Figure 39. Archaeological Research Services housed associated documentation from projects constructed on several military installations in Arizona.

secondary containers and the records are in fair to poor condition. The containers are overpacked and deteriorating, both the containers and the records are torn and discolored, and the records are fastened together with a variety of contaminants, such as metal binder clips, paper clips, and staples.

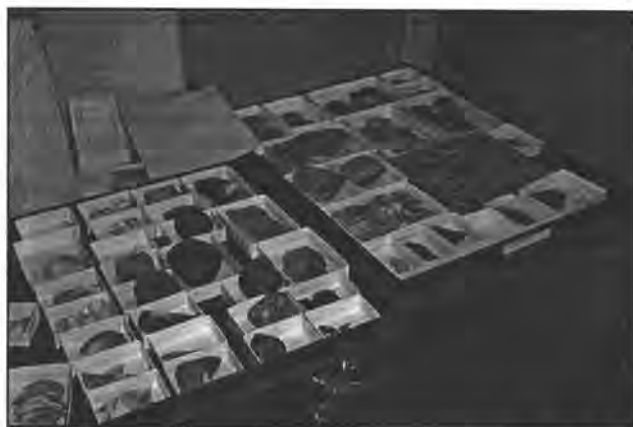
Figure 40. Catalogued collections are housed in the North Building (repository 1). They are marked in ink and stored in acidic cardboard boxes in metal drawers in a metal cabinet. An inventory of each drawer is enclosed.

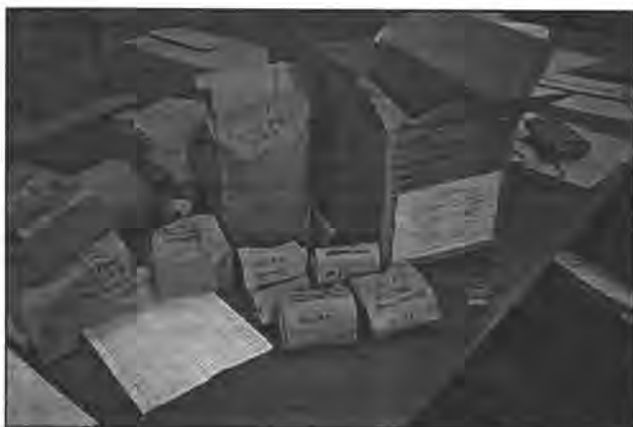
Most of the artifacts in the research collections storeroom are housed in acidic cardboard boxes (Figure 41). A small collection of ground stone is stored directly on a shelf. Box size ranges from 0.04 to 1.3 ft³. A collection from a particular project may be housed in one box size, but there is not a standard

Figure 41. An acidic cardboard box labeled directly in marker and with a printed paper label glued to the box holds collections from Luke Air Force Base. Paper bags serve as secondary containers, many are secured with rubber bands. A box inventory is enclosed.

box size used overall. Many of the boxes have an inventory enclosed. Boxes are labeled with acid-free paper labels glued to the side of each box. Typed label information includes site number, ASM accession number, and material classes enclosed.

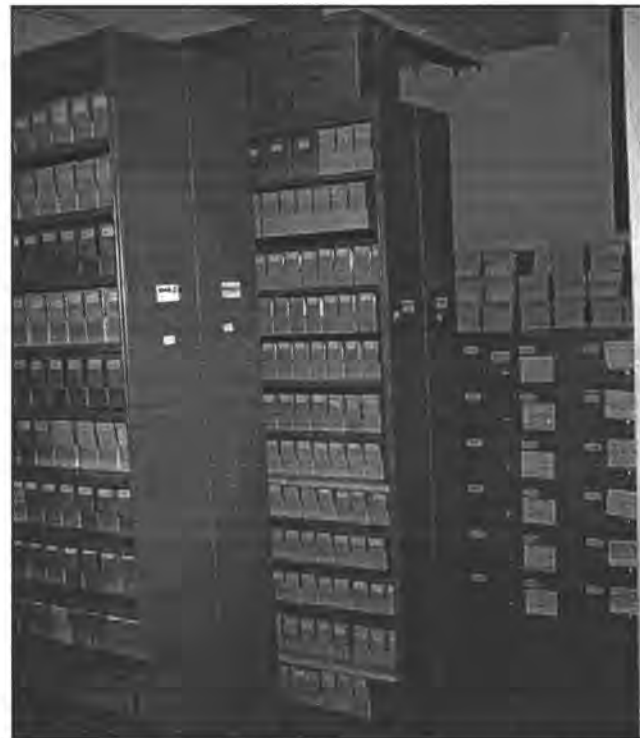
Figure 42. Boxes of negatives are stored on metal shelves in the photograph collection storeroom.

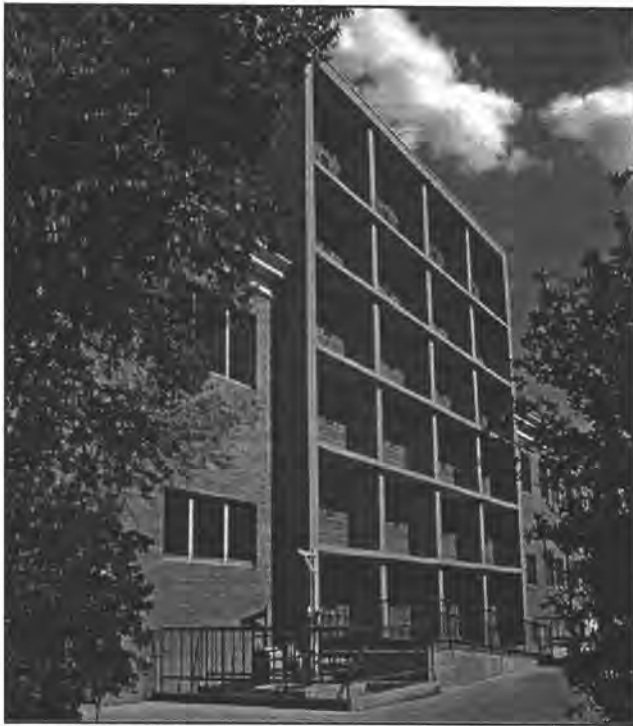
Matthews Center (Figure 43) was constructed in 1930 as the original site of the university library. The U-shaped building has a concrete foundation and yellow brick exterior walls with two floors above grade and one below grade. The building was expanded in 1949 by adding a large section in the center of the original U-shaped building. The entire addition is constructed of concrete including the foundation, exterior walls, and roof. The addition measures approximately 17,000 ft² and is six floors above grade and one floor partially below grade.

Figure 43. The Matthews Center on the campus of Arizona State University houses artifact collections from Williams Air Force Base.

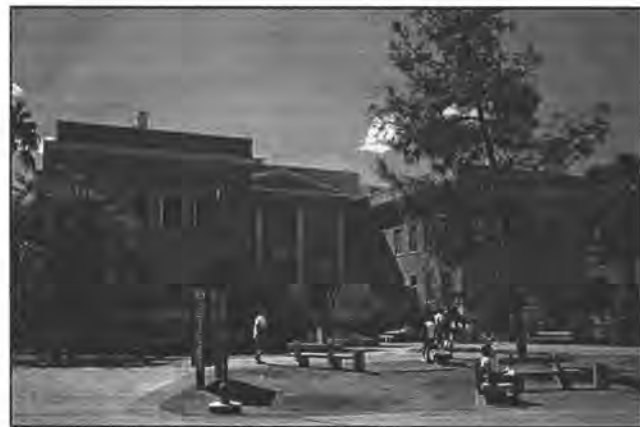
The Anthropology Building (Figure 44) was built in 1914 and is listed on the National Register of Historic Places. The repository was originally occupied by the music and fine arts department until the 1970s. The repository includes a collections facility, classrooms, artifact holding, washing, and processing areas, exhibit area, laboratories, and offices. The Anthropology Building is the repository for archaeological records. The repository has a concrete foundation with brick exterior walls. The flat roof is composed of tar. There are two floors above grade and one floor partially below grade. The facility is structurally sound but is suspected to have cracks underneath the tiled floors. There have been leaks, but those have been repaired. Internal renovations in 1974 nearly gutted the entire building to create new wall configurations. The repository has multiple aluminum framed windows that measure 4 x 5 feet (h x w). The windows are equipped with shades and show no evidence of water or air leaks. Some of the windows have been replaced. The repository has running water, heat, restrooms, telephone lines, computer lines, air conditioning, and electricity. The plumbing, electricity, and heat were renovated in 1974 and the air conditioning was upgraded in the last 10 years. There are always active renovations in the repository.

Figure 44. The Anthropology Building on the campus of Arizona State University houses associated documentation for archaeological work conducted on Williams Air Force Base.

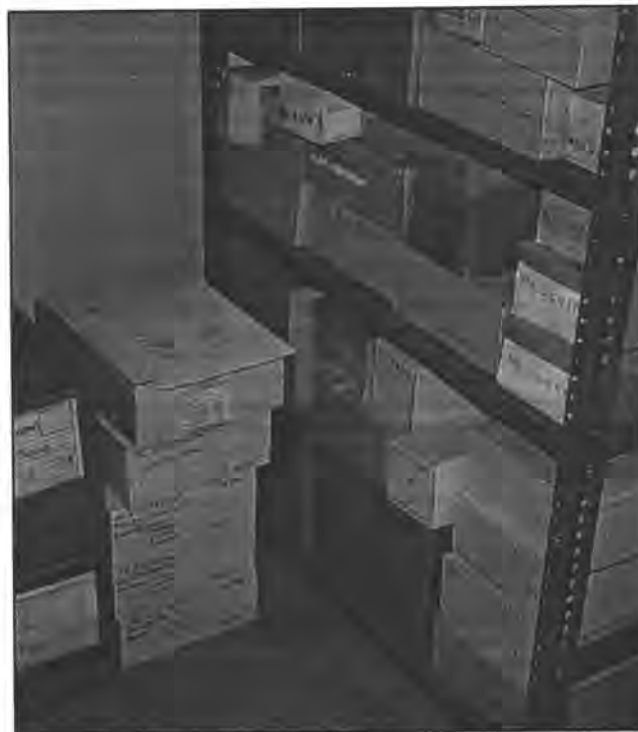
Artifacts for Williams AFB are stored in the 1949 addition of the Matthews Center on the ASU campus. The archaeological materials for Williams AFB are stored in a variety of locations in the collections storage area (Figure 45). Two boxes are stored on a non-movable shelving unit. The unit is composed of metal uprights and shelves that are bolted to the floor and ceiling. There are a total of 133 shelving units with seven shelves per unit. The aisles between the shelving units are approximately 40 inches. The shelving unit was measured from the floor to the ceiling and measures approximately

Figure 45. Artifact collections from Williams Air Force Base are stored in cardboard boxes on the floor and on a steel shelving unit in the Matthews Center.

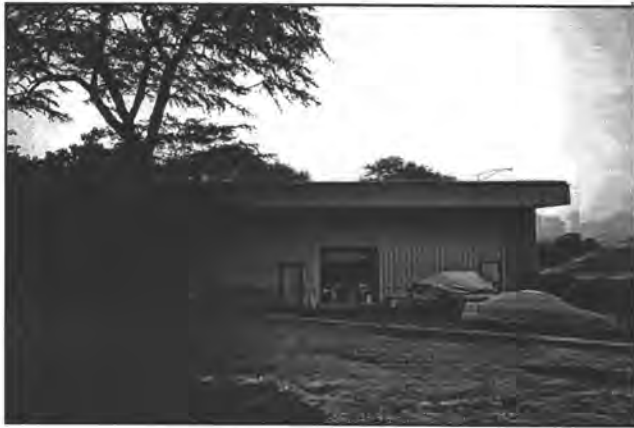
Repository 1 (Figure 46) is a warehouse used for oversized collections storage. Archaeological collections are located on the second floor/loft of the building. Repository 2 (Figure 47) is Konia Hall, which includes space for offices, laboratories, and collections storage rooms. DoD artifact and records are located in three collections

Figure 46. Halekini Hall (repository 1) is a warehouse style building which houses oversized objects as well as archaeological collections.

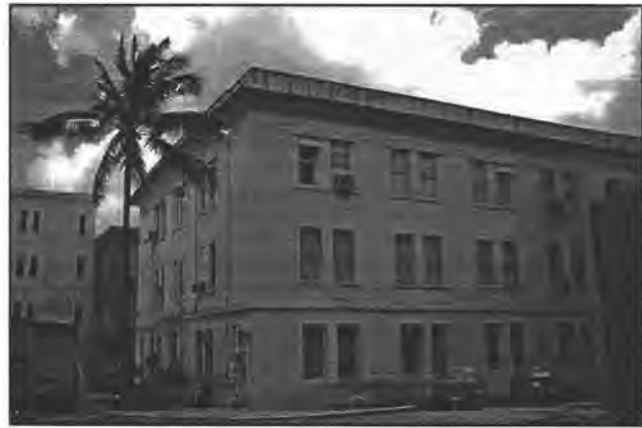
Figure 47. Konia Hall (repository 2) houses offices, laboratories, and collection storage rooms. Department of Defense collections, including documentation and human skeletal remains, are housed in several rooms throughout this building.

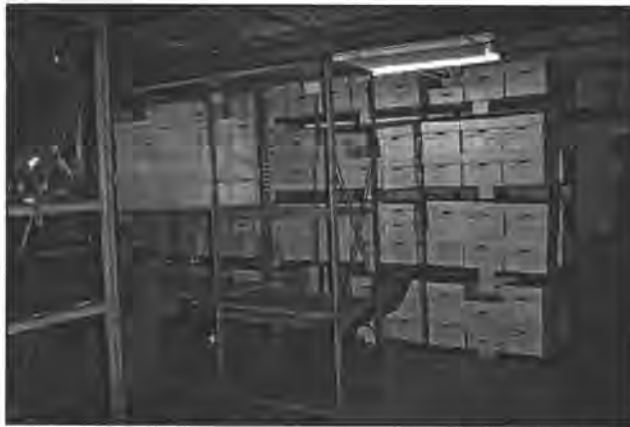
Storage units in Repository 1 consist of adjustable, metal shelving units that have an enamel finish and measure 7 x 3.5 x 2.5 feet (h x w x d). There are approximately four shelves per unit and twelve boxes per shelf (Figure 49).

Figure 49. Collection storage room, units, and primary containers in Repository 1, where federal collections are housed.

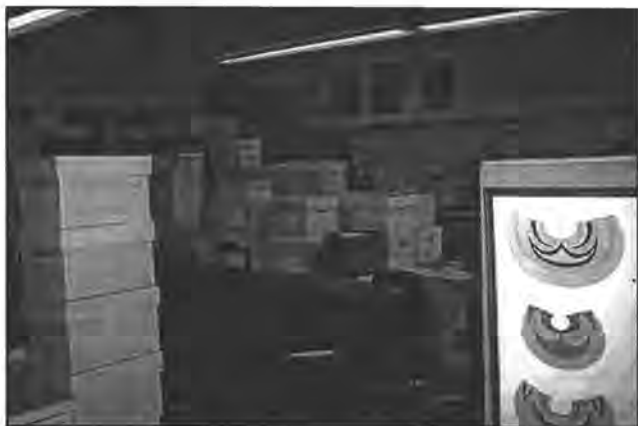
Figure 50. Waianae Army Recreation Center collections are temporarily located in the archaeology laboratory in repository 3.

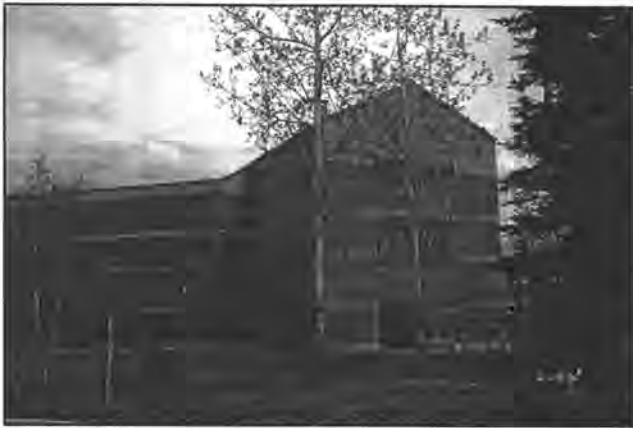
The BLM Northern District Office building was completed in 1988 and dedicated in 1989 (Figure 51). The building, totaling approximately 52,000 ft², is primarily office space, but does have a receiving and loading garage, a multipurpose laboratory for artifact holding, washing, and processing, and a mechanical/utility room.

The building has a concrete foundation with concrete block exterior walls. The flat roof is original to the building and is composed of an insulated roof membrane that was adhesively

Figure 51. Exterior view of the entrance to the Bureau of Land Management, Northern District Office.

applied. The building has two floors above grade and is structurally solid; however, the facility does have some cracks and leaks. There have been minor internal renovations in the building. Multiple exterior aluminum framed windows, which are equipped with shades, are located on all sides of the building. The windows show no evidence of water or air leaks. The building has glass exterior doors with metal frames and wood paneled interior doors.

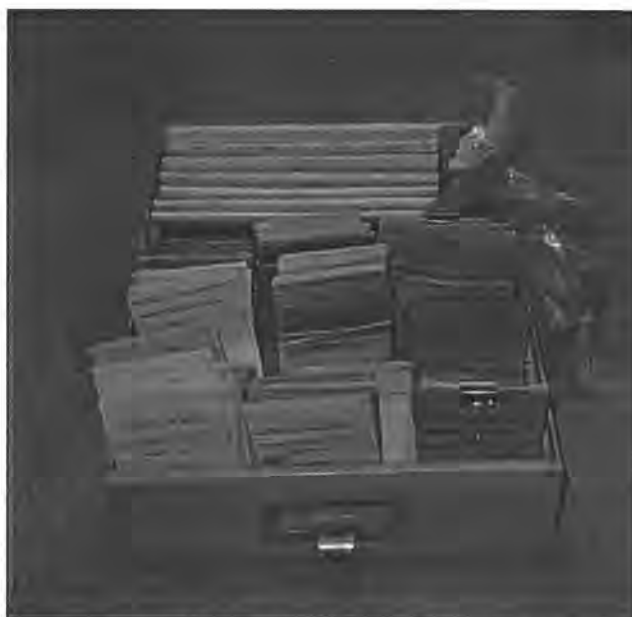
The archaeological materials located at the BLM Northern District Office will not be permanently curated at this facility. The collection is presently being analyzed and will be sent to the University of Alaska Museum in Fairbanks for curation upon completion of the project. Currently, the archaeological materials for Fort Wainwright are stored in the archaeology laboratory. The storage unit has three metal drawers across and 11 metal drawers down to total 33 drawers. There are six of these metal drawer units, but only one has military collections (Figure 52). The unit measures approximately 3.1 x 1.1 x 2.5 feet (h x d x w). The metal drawer units can be secured with a metal

Figure 52. The metal drawer is the primary container for artifacts and associated documentation from Fort Wainwright. Secondary containers for the artifacts consist of manila envelopes and plastic bags.

security plate cover that has a key lock. These plates were not in use at the time of the visit. Percentages of material classes are outlined in Table 35.

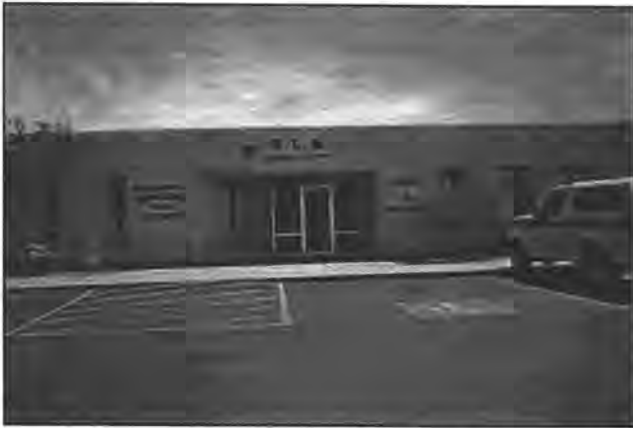
The BLM Phoenix Field Office (Figure 53) includes offices, a warehouse, a receiving/loading dock, an

Figure 53. The Bureau of Land Management, Phoenix Field Office holds several artifacts and associated documentation from Barry M. Goldwater Range.

artifact holding area, a records storage area, and a security monitoring space that totals approximately 33,710 ft². BLM leased the building in 1983 as the original occupants; however, the lease agreement expires in 1998, potentially resulting in a need to relocate.

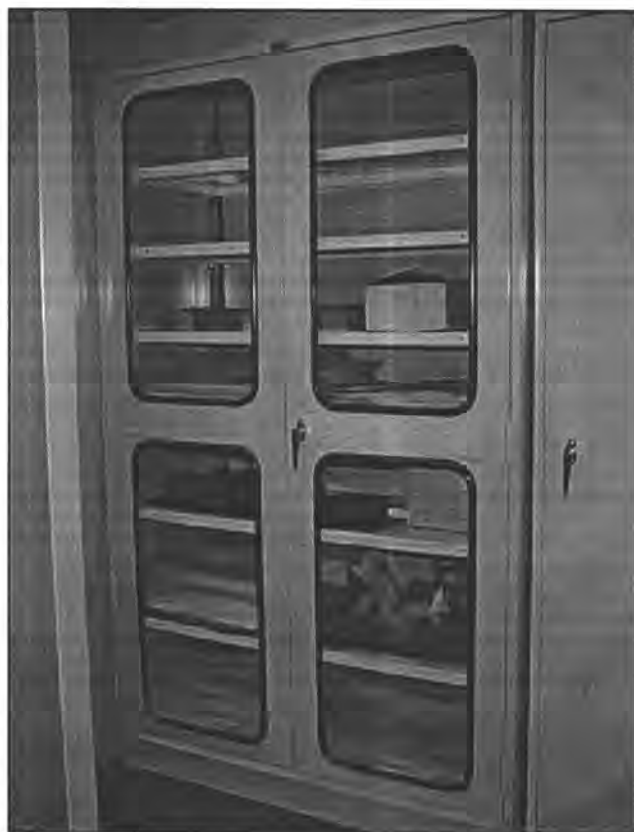
Artifacts from Luke AFB and Yuma MCAS managed land on Barry M. Goldwater Range are stored in the BLM Phoenix Field Office in a museum quality storage unit located in the general office area (Figure 54). The storage unit is a nonmovable, baked enamel, air tight shelving unit. There are glass windows on the doors of the unit.

Figure 54. A projectile point and ceramic vessel collected from Barry M. Goldwater Range are housed in this museum quality cabinet in the office of the Bureau of Land Management, Phoenix Field Office.

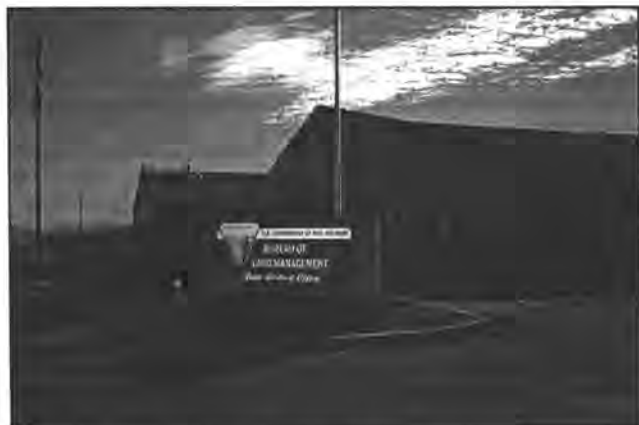
The BLM Yuma Field Office building (Figure 56) was constructed in 1996 specifically for rental to the BLM. The building was approximately nine months old at the time of assessment. The single story structure occupies a total area of approximately 30,300 ft² divided approximately equally between an office area and warehouse space. The building is

Figure 56. The offices of the Bureau of Land Management, Yuma Field Office.

constructed with concrete brick walls on a concrete foundation and has a shingle roof. Both the foundation and the roof are considered to be structurally sound. Building facilities include a loading dock, a hazardous materials storage area, a materials and supply storage area, a library, records storage room, a mechanical/utility room, and a law enforcement evidence room. The facility is not considered to be a permanent repository for archaeological artifacts and storage space is limited to a metal cabinet in the staff archaeologist's office.

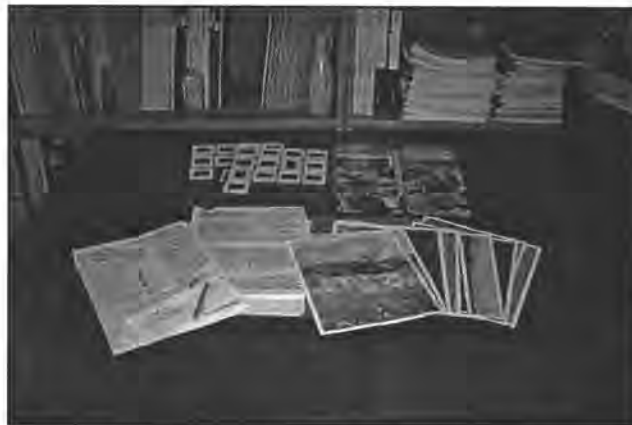
The archaeological documentation records for YPG consist of site file records, field notes, analysis records, photographs, slides, negatives, and site maps (Figure 57). These records are stored in a fireproof, locking filing cabinet. Documentation records consist of approximately 1.5 linear feet of mixed material that is arranged in acidic manila

Figure 57. Records from an archaeological project conducted on Yuma Proving Ground.

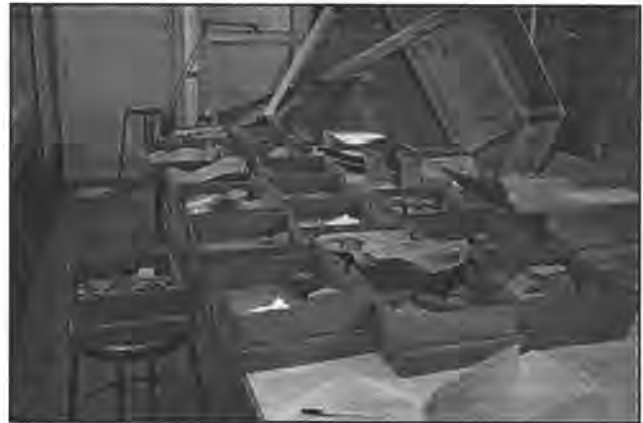
Figure 59. Acidic cardboard boxes serve as primary containers for Fort Bliss collections at the Centennial Museum.

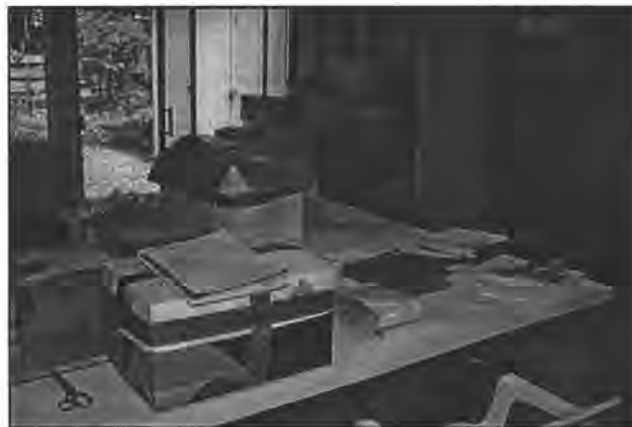
DoD collections (Figure 63) total 7.0 ft³ of archaeological materials from five installations (Table 46) that are currently housed at Cultural Surveys Hawaii. The materials are stored on wooden shelves in large utility closets. The materials are stored by project.

Figure 63. All the collections from Fort Kamehameha and Waianae Army Recreation Center that are housed at Cultural Surveys Hawaii are shown on the table.

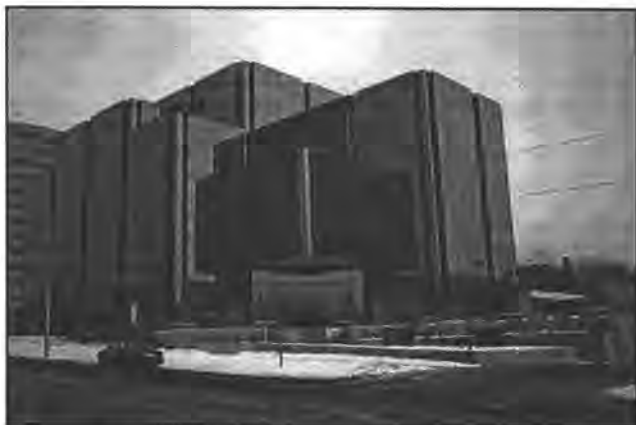
Dames & Moore is located in downtown Salt Lake City, in the Boyer Company office building (Figure 64). The building is very large, and Dames & Moore is one of many tenants. Constructed in the 1980s, the building foundation is concrete, and exterior walls are composed almost exclusively of glass. The roof

Figure 64. View of the exterior of the office building where Dames and Moore is located.

is built-up asphalt and steel, and is original. The structure is solid, with no significant cracks or leaks. A parking garage is located below grade, and six floors are located above grade. Exterior windows are generally equipped with shades.

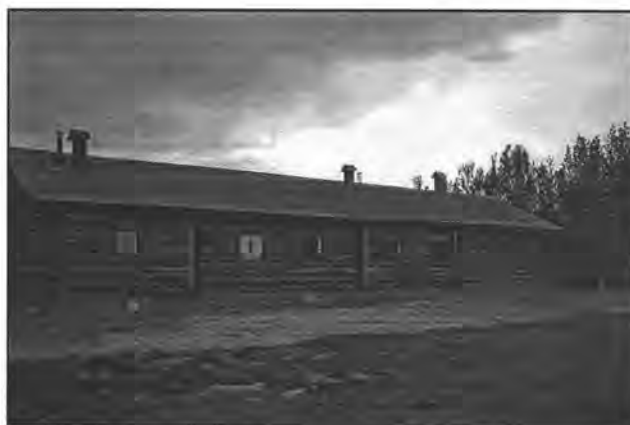
Figure 65. Exterior view of the temporary storage facility for the artifact collections from Fort Greely's Sullivan Roadhouse.

The historic structure is a single story, four room log cabin constructed with indigenous spruce trees. The roadhouse was rebuilt using all of the original wood logs except for the bottom three which had become rotten. Unfortunately, the replacement logs have been infested with insects that bore holes in fresh spruce. A new wooden floor has also been added. The roof is new, and consists of corrugated metal. A plastic sheet between the overhead logs and the metal corrugated roof provides insulation and additional protection from leaks. New features include electricity, a closet to hide the electrical box, and a crawl space under the cabin.

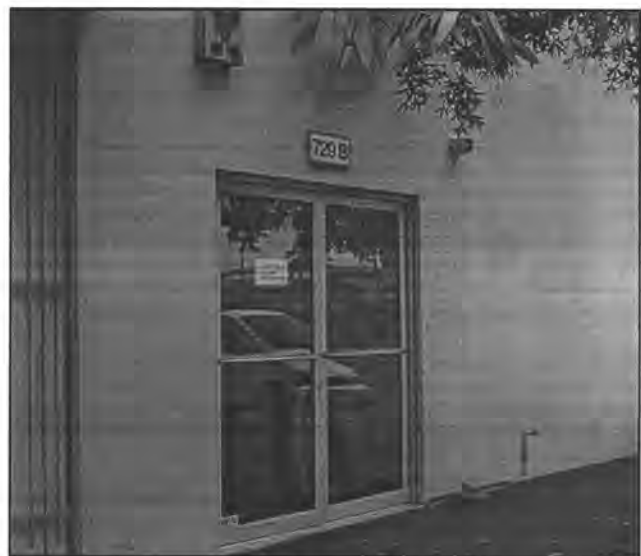
The privately owned structure is approximately 21 years old and encompasses 1393 ft² (Figure 67). The foundation is concrete and the building frame is steel and concrete. The external walls of the repository are

Figure 67. Exterior of the building where Garcia and Associates is located.

constructed of concrete and the built-up asphalt roof is original. No structural problems have been noted in the foundation or the roof. Interior walls are wallboard and floors are concrete covered with carpet. Ceilings in the repository are suspended acoustical tile. Windows in the repository have aluminum frames and are sealed. The repository has space for analysis of artifacts and examination of documents. The majority of the space is used for report preparation and for offices.

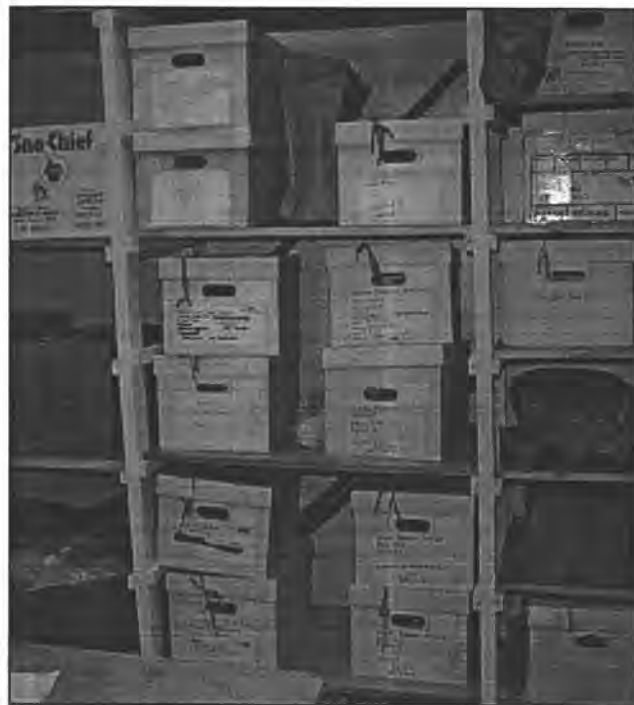
Figure 68. Collections from Department of Defense installations are housed on wooden shelves.

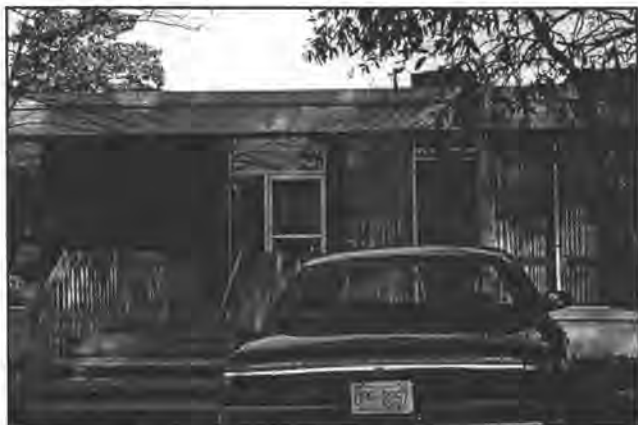
Garrow occupies approximately 2300 ft² of a 9200 ft² single-level brick office building with a partially above ground full basement (Figure 69). The building has a concrete foundation and steel-frame construction. The present roof, which is less than five years old, is constructed of built-up asphalt. There have been no cracks or leaks in the structure

Figure 69. Garrow and Associates has numerous offices including one in Raleigh, North Carolina.

that Garrow staff is aware of, and no upgrades to the building's plumbing or electrical systems.

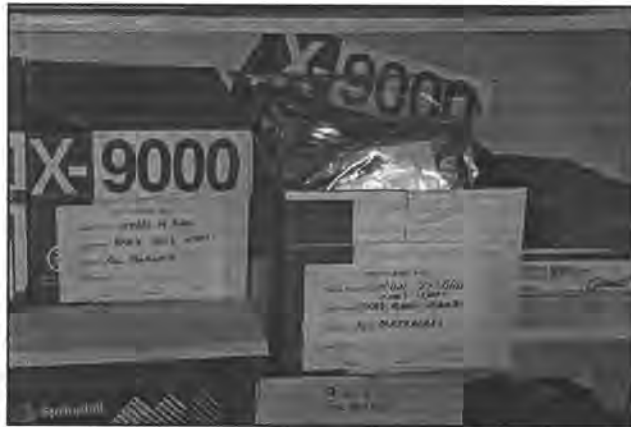
The objects are stored in acidic cardboard boxes (Figure 70) with telescoping lids—approximately 1.15 ft³ each in volume—that are directly labeled in black marker with variable information such as a project number, an installation name, a project phase, a site name, material class, or a series of artifact catalog numbers. A few of the boxes containing sample materials are overpacked, and one ground stone artifact for Fort Bliss is stored loose in an acidic box lid.

Figure 70. Fort Bliss collections housed in acidic cardboard boxes at Geo-Marine.

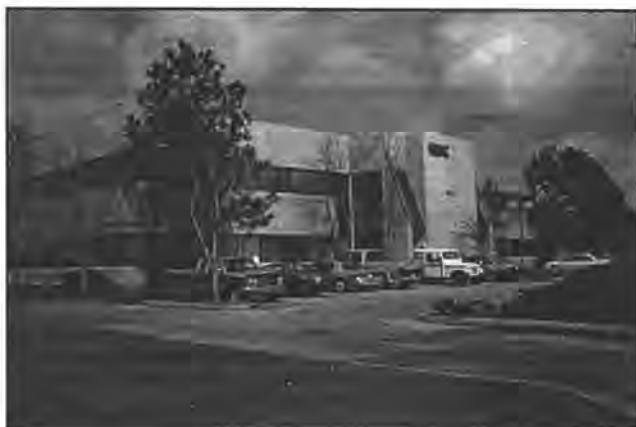
The offices of GSRC are located in a building approximately 15 years of age. The two story structure (Figure 71) is constructed with a steel beam frame and a cement slab foundation. The asphalt roof is original to the building, but was re-tarred in 1995. The laboratory and the shared office of the staff archaeologists are located on the second floor of the building in windowless interior rooms. Collections are processed and temporarily stored in the

Figure 71. The offices of Gulf South Research Corporation, a private engineering firm.

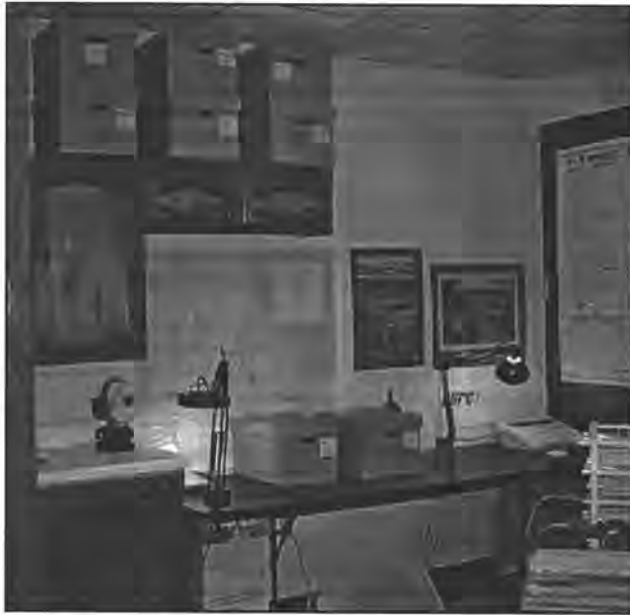
A collection of 5 ft³ archaeological materials from Fort Polk was being processed at the time of the assessment (Figure 72). When the collection is processed and packed to the standards of Fort Polk, they will be transferred to the installation for

Figure 72. Collections that enter the GSRC building are temporarily stored in the laboratory until they are processed and sent to a designated repository for permanent curation.

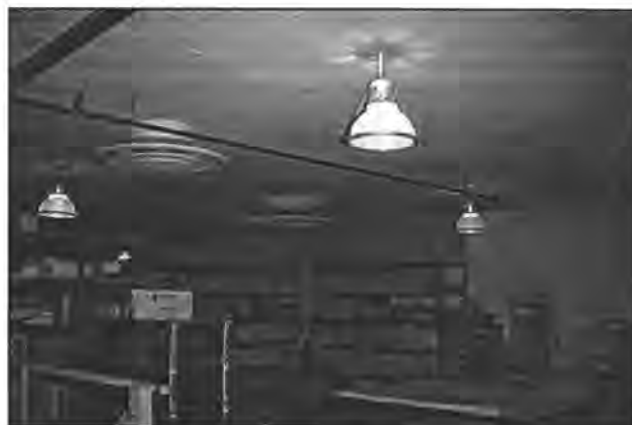
Figure 74. Overview of the collections storage area at the Harry Reid Center for Environmental Studies. Note the ceiling, lighting, and storage units.

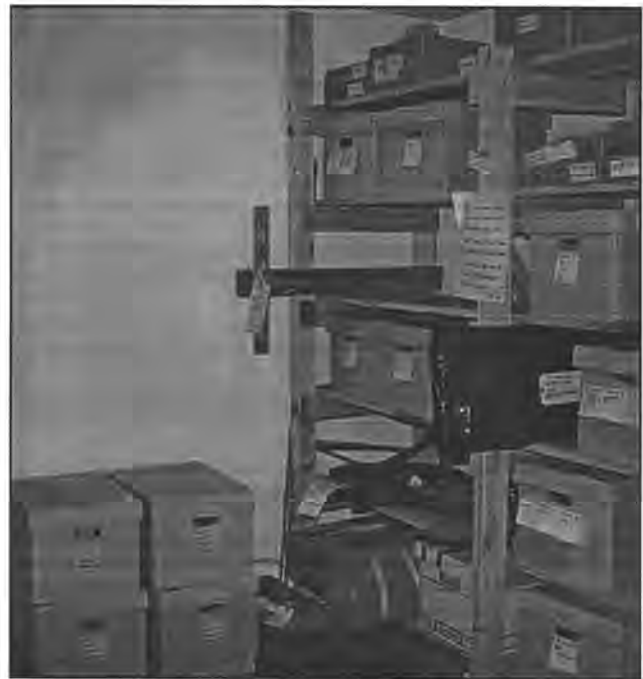
Figure 76. Boxed collections as well as large loose artifacts from White Sands Missile Range are stored on wooden shelves in the offices of Human Systems Research.

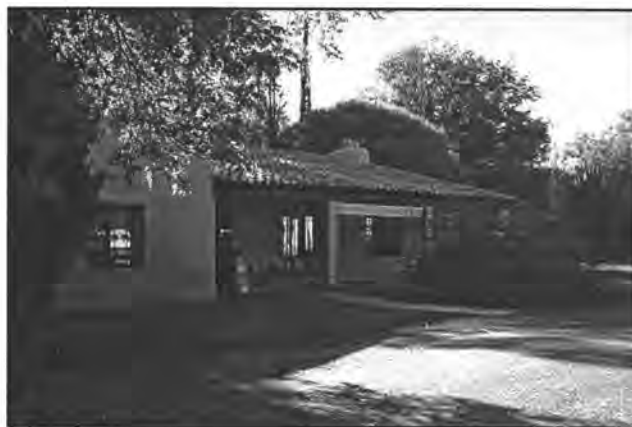
Figure 77. The Human Systems Research office in Tularosa is located in an adobe and stucco building with a clay tile roof constructed around 1900.

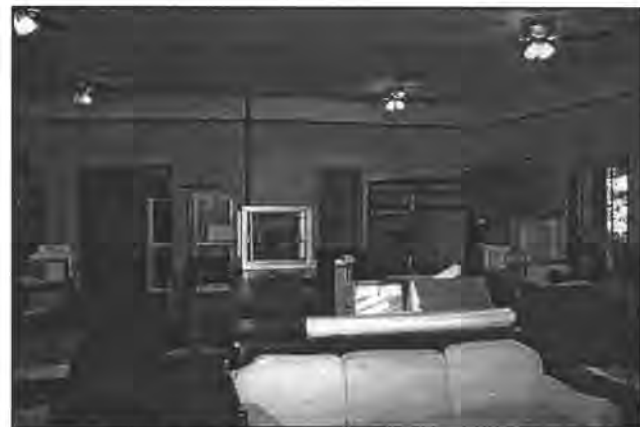
Collections are stored on metal shelving units measuring 8 x 3 x 6 feet (l x d x h) (Figure 78). Two rows of these shelving units in the corner of the processing laboratory are used for the temporary storage of collections. These units provide approximately 80 ft³ of storage space. These collections will be turned over WSMR as soon as an adequate facility becomes available for collections storage.

Figure 78. An interior view of Human Systems Research in Tularosa; the space is used as both an office area and a laboratory area.

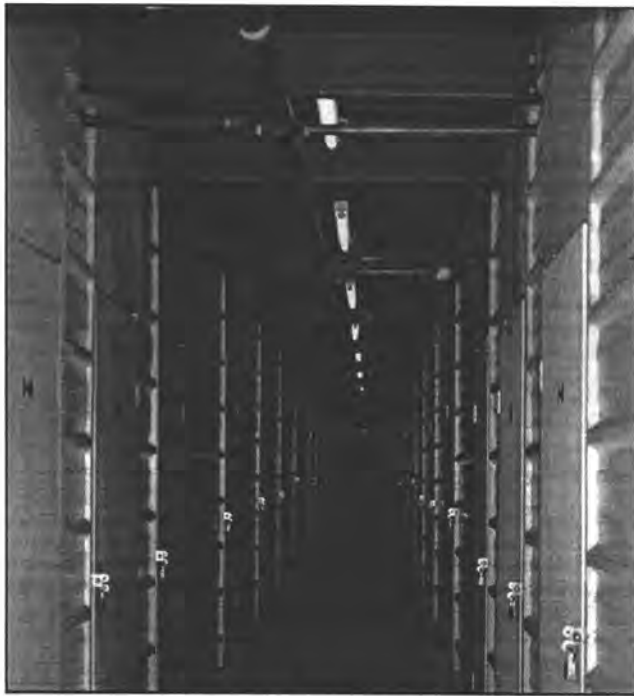
Collections are only stored in Repository 2 on enameled metal adjustable shelving units with pressed board shelves (Figure 81). Each of the seven units measure 2 x 6 x 3 feet (w x h x d). There are three or four shelves per unit, with the bottom shelf raised 4.5 inches above the concrete floor. The shelving units are directly labeled in marker, noting rack number and shelf letter. Strips of masking tape have also been applied to the shelving units with collection information hand written in marker. For percentages of material classes present, refer to Table 63.

Figure 81. A hallway in Building J, the self storage building in which International Archaeological Research Institute, Inc. rents storage space for artifact collections.

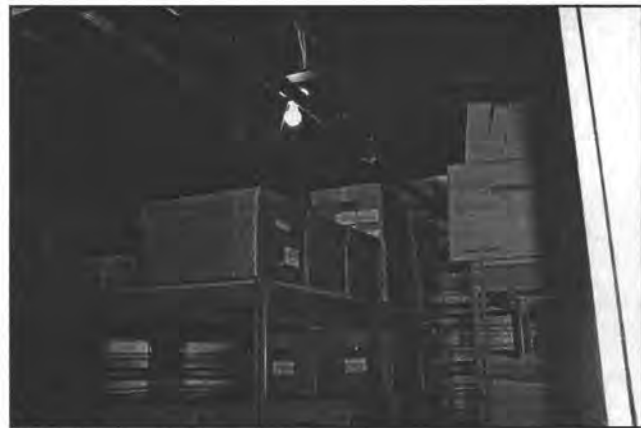
Archaeological materials are housed in folded, archival quality cardboard boxes fitted with telescoping lids (Figure 82). The boxes are labeled with adhesive tags that are handwritten in pen and marker. Label information is legible and typically includes the project name and number.

Figure 82. Archival boxes hold collections.

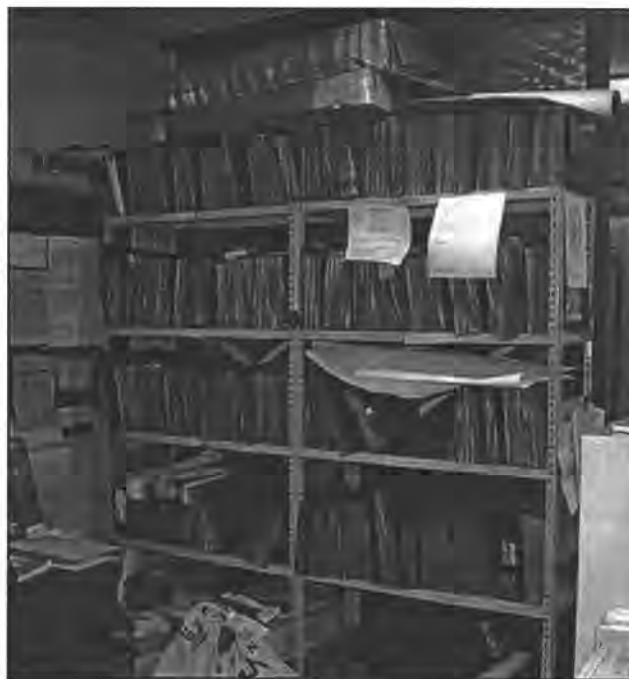
Approximately 7.2 linear feet of associated documentation (Figure 83) are located in the files stored in Repository 1. Records have not been archivally processed and do not have a finding aid or a security copy. Project files, upon completion of a project, are stored in expandable file folders, which have overlapping flaps that are secured with cotton string or an elastic band. These folders are directly labeled with marker. Label information consists of the project area or name and often the project number. For the volume of document types by branch of service and installation, refer to Table 65.

Figure 83. Associated project records are stored on shelving units in the administrative offices on the James M. Chrono Building.

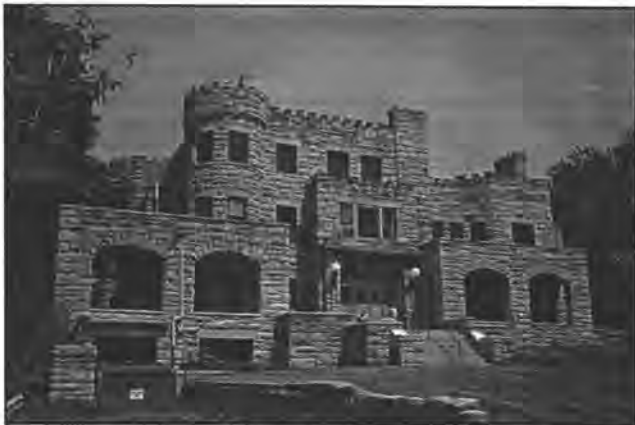
Figure 84. Exterior of the Kansas City Museum's Annex Administration building.

serves as both an office space for the museum, and as a repository for a portion of the museum's collection. The four story building, with three floors above grade and one floor below grade, has a stone foundation, stone and stucco exterior walls, and a rolled-out composition roof. Although both the roof and stone foundation were reported to be structurally solid, it was also reported that water leakage had previously caused some damage to the building structure as well as to some non-federal collection materials. No record of internal or external renovations to the building structure was reported. Annex Building utilities include a telephone, restrooms, air conditioning, electricity, heat, and a dehumidifier.

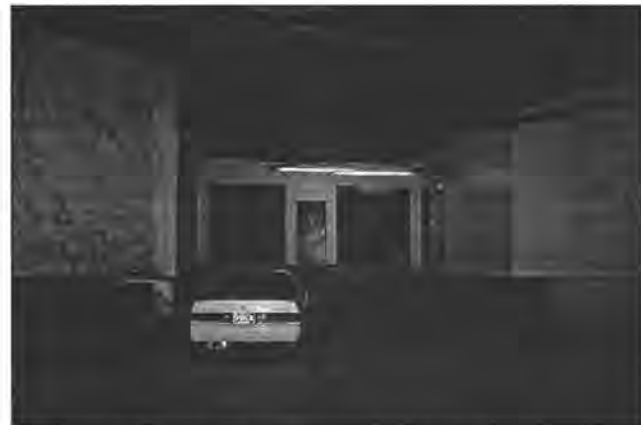
The Downtown Underground Docks (Figure 85) is a single level man-made cave system located approximately 80 feet below ground. The cave system entrance is located at 1501 West 31st Street. The Downtown Underground Docks location was privately developed in the late 1930s and early 1940s for commercial use. The single level cavern is partitioned into individual tenant usage areas by cinder block walls built among the excavated limestone support pillars.

Figure 85. Interior entrance to the storage space within the Downtown Underground Dock "cave" system.

The cave system is entered by a ramp that descends through a cement block and brick wall fronting on West 31st Street. The entrance ramp and floor of the cave are asphalt over limestone, the walls are natural limestone and cement block, and the ceiling is limestone. The facility was reported to be structurally solid with no cracks or leaks.

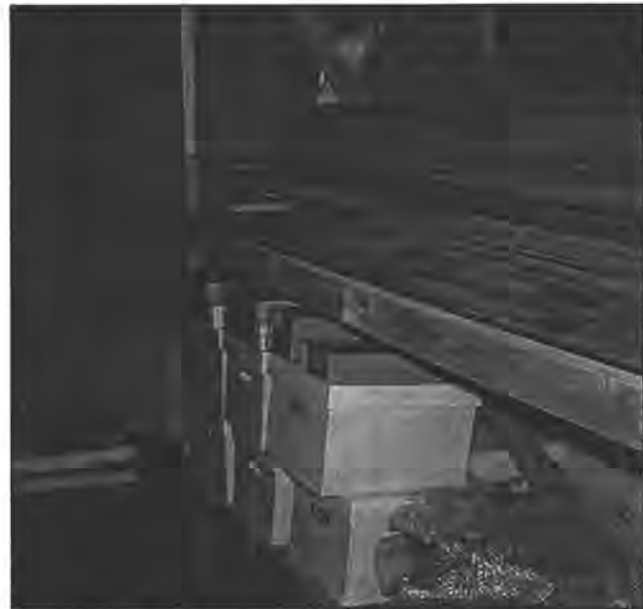
Figure 86. Collections from Sunflower Army Ammunition Plant are stored in cardboard boxes on wooden shelving units in the Downtown Underground Docks.

Storage units include both wood and metal open shelving units (Figure 86). The federal collection is located on a wooden shelving unit.

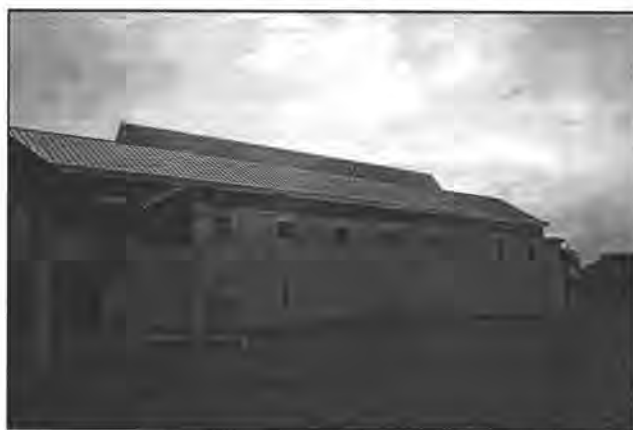
The Kansas Historical Museum Center for Historical Research (Figure 87) curates approximately 2.8 ft³ of archaeological material from Fort Leavenworth. These materials are housed in two separate rooms on the first floor of the Center's repository. The bulk of the collection is housed in the general collections storage room that adjoins the archaeology laboratory,

Figure 87. The Kansas Historical Museum Center for Archaeological Research building is cement with a standing seam roof.

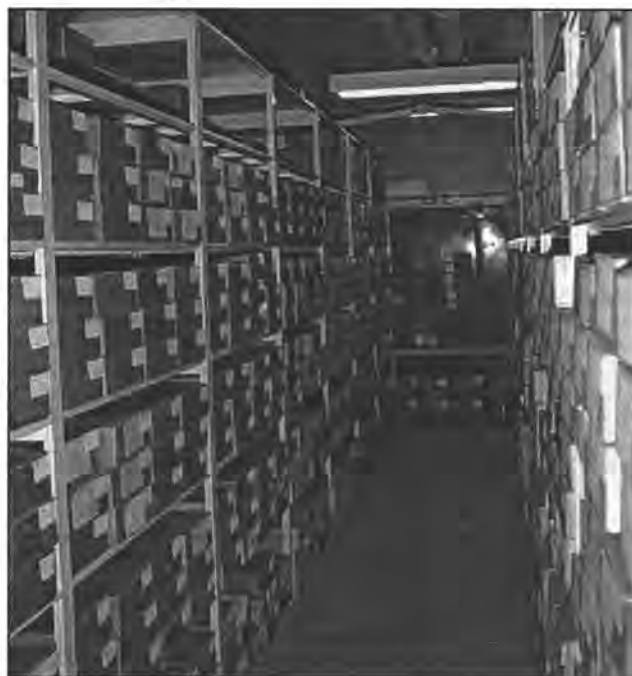
Within the main collections storage room, artifacts are stored on open, enameled metal shelves placed on movable "space saver" shelving units (Figure 88). There is a total of 10 movable units measuring approximately 2 x 8 x 27 feet (d x w x h). There are approximately 1050 ft² of compressed storage in the units, which is equivalent to approximately 2624 ft² of standard shelving. The rest of the space is cluttered with curation supplies and full artifact boxes. In the UBS storage rooms wood boxes are

Figure 88. Shelved boxes of archaeological collections.

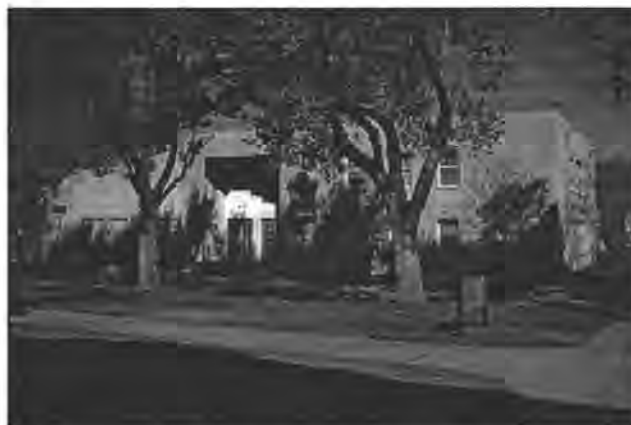
The building that houses the Department of Anthropology at UNM was constructed during the 1930s and 1940s. It originally functioned as office space and classrooms. In 1972, the Maxwell Museum of Anthropology was established. The museum was designed as an addition to the Anthropology building and was constructed specifically for museum exhibits. The addition provided much-needed space for the museum, but eventually many rooms of the Anthropology building were also converted to serve museum space requirements. In 1990, a permanent gallery was constructed, and in 1992, the gift shop was expanded. Activity areas located in the museum include a receiving dock, an artifact holding area, an artifact washing area, an artifact-processing and conservation laboratory, a temporary artifact storage area, collection store rooms, a supply storage area,

Figure 89. Exterior of the Maxwell Museum of Anthropology (repository 1) on the campus of the University of New Mexico. The building houses the museum as well as the anthropology department.
