Archaeological Curation-Needs Assessment

Technical Report No. 20

Volume II Non-Military Repositories

**US Army Corps
of Engineers**
St. Louis District

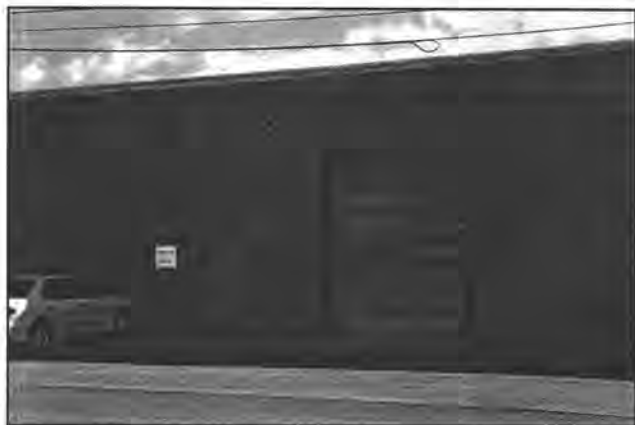
Figure 90. A warehouse (repository 2) that holds collections of the Maxwell Museum of Anthropology has a key locked door and a large metal overhead door, both wired to the campus security.

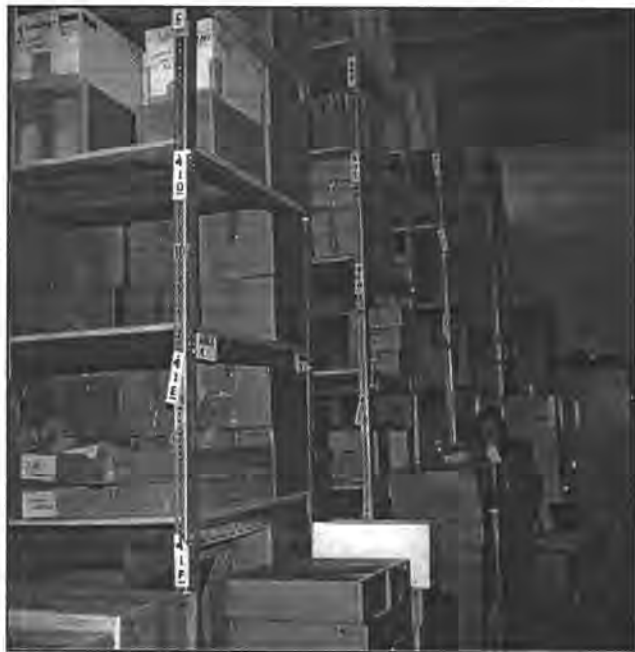
Figure 91. Acidic cardboard boxes are housed on metal and unsealed wood shelving units in the warehouse (repository 2) of the Maxwell Museum. A lift is used to retrieve boxes from upper shelves.

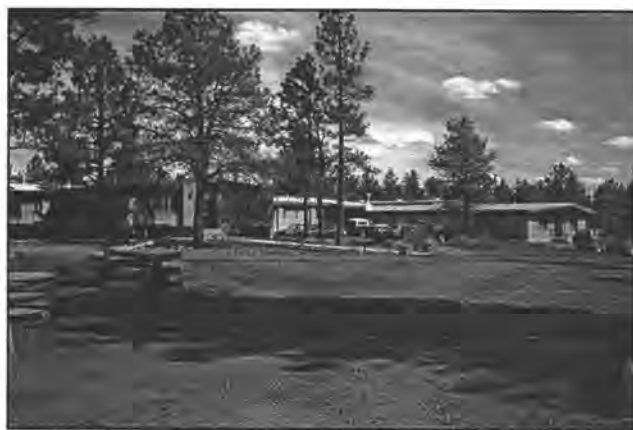
Figure 92. The anthropology building and administrative offices are part of the Museum of Northern Arizona complex.

Built in the 1960s, this single-story butler building has been converted and adapted for use to house the archaeological collections and the offices of the collections staff. The building, encompassing approximately 12,221 ft², has a concrete foundation and painted concrete block exterior walls. The roof is original to the construction of the building. It is composed of tar and tarpaper, covered with a silver, reflective paint. The roof is repaired and maintained as needed. Structurally sound, the staff and assessment team noted no signs of cracks in the foundation or walls. The roof has had water leaks in the past, but has been repaired. There is no evidence of water damage to the building or collections. Metal framed windows surround the building, with the exception of the addition that is used for bulk collections storage, which has no windows at all. None of the windows have been replaced, and occasionally leak water, or are drafty. These problems are repaired as needed. Utilities in the building are original; electrical lines have been updated recently to accommodate the increased use of computers. There is no asbestos in this facility.

Anthropology Building #11 is equipped with gas forced-air heating units, but does not have air conditioning, humidity controls, or dust filters in place. Temperature levels are maintained between 65°-68° F for staff comfort. Collections stored in the bulk collections storage room are considered non-perishable, and are not greatly affected by the lack of environmental controls. Humidity levels are

1. Install an air conditioning system equipped with a dust filtration system in the collections storage room.
2. Place ultraviolet filters on fluorescent lights in collection storage room and archives room.

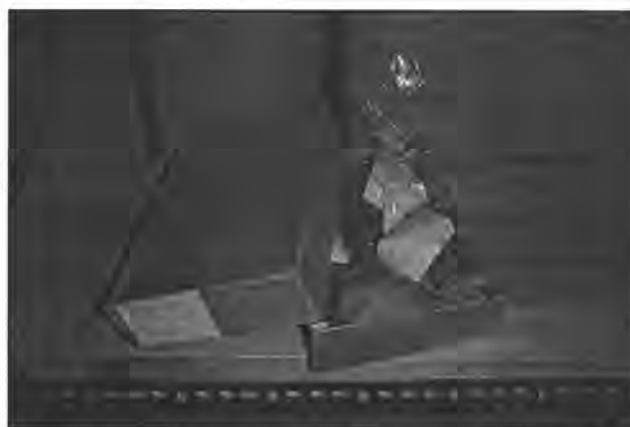
Figure 93. Collections from Williams Air Force Base are stored in plastic bags in a cardboard box.

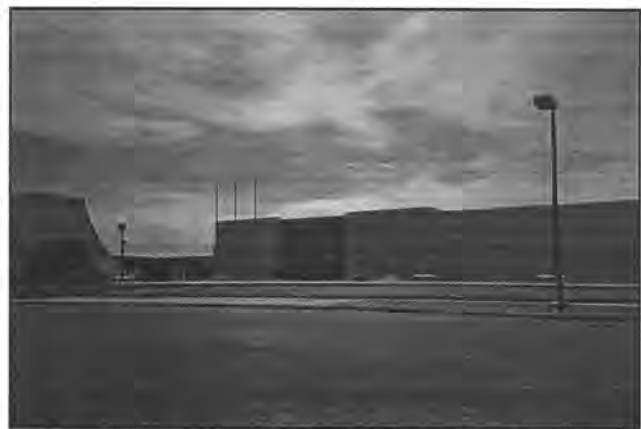
Figure 94. The building that houses the Museum Texas Tech University was originally constructed in 1970 with an addition made in 1990.

The MTTU building has concrete and steel exterior walls with masonry brick aspect, and is seated on a steel reinforced poured concrete foundation. The roof is flat and of wood frame construction with built-up asphalt covering. No cracks or leaks in the foundation have been noticed or reported by museum staff, but the roof has occasionally required repairs. Full utilities are in place throughout the building, and have been upgraded to meet current building codes whenever additions have been made to the building. These upgrades have included asbestos abatement procedures, which continue to be in effect for the original structure.

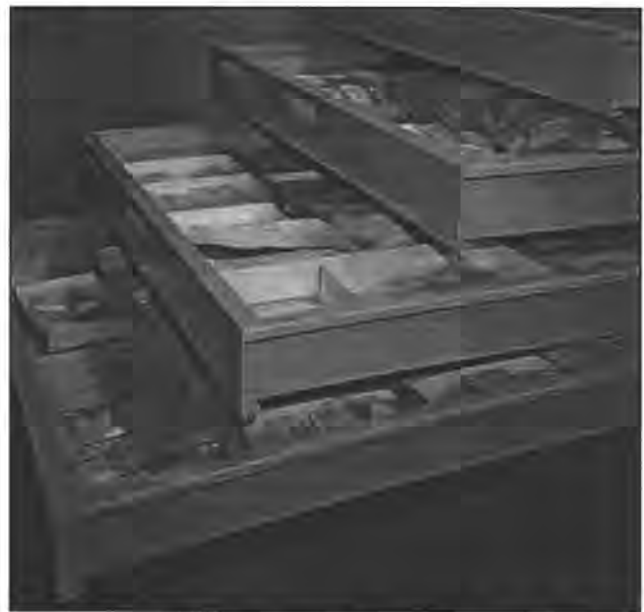
Reese AFB archaeological materials are stored in four enameled metal drawers lined with ethafoam within a non-movable, key-locked, enameled metal storage cabinet measuring 34 x 58 x 76 inches (l x w x h) (Figure 95). This cabinet is in the main archaeological collections room, D-24. Drawers are labeled using an acid-free typed paper tag insert placed into the metal label holder built into each drawer. Information on the labels includes site and accession numbers as well as the drawer and cabinet numbers. Table 76 outlines the material classes present among Reese AFB collections at MTTU. Finding aids are available, and all collections are easily accessible and well organized.

Figure 95. Collections from Reese Air Force Base are stored in three drawers of a metal cabinet, the drawers are lined with ethafoam and collections are housed in plastic zip-lock bags and acid-free cardboard boxes.

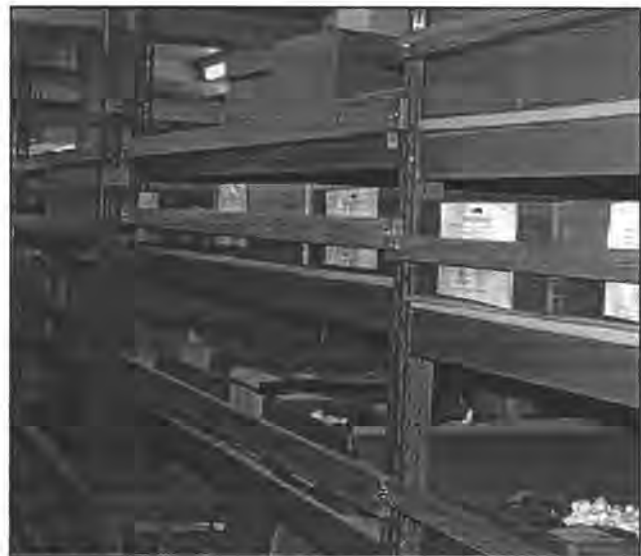
Storage units in Collection Storage Area 1 consist of metal cabinets with wood drawers and an open metal shelving unit each lined with ethafoam (Figure 96). The metal cabinets have permanent, metal label holders on the front of each cabinet. The labels are paper slips that have the accession number, area of origin, and a brief description of the cabinet contents typed or printed in permanent ink. There are open, unlabeled shelving units in both Collection Storage Areas 1 and 3. The shelves in Collection Storage Area 1 have wood boards screwed to the sides of the shelving units for better earthquake security.

Figure 96. Collections from Fort Bliss are housed on open metal shelving in Collections Storage Area 1. Boards are attached across the front of the units as earthquake protection.

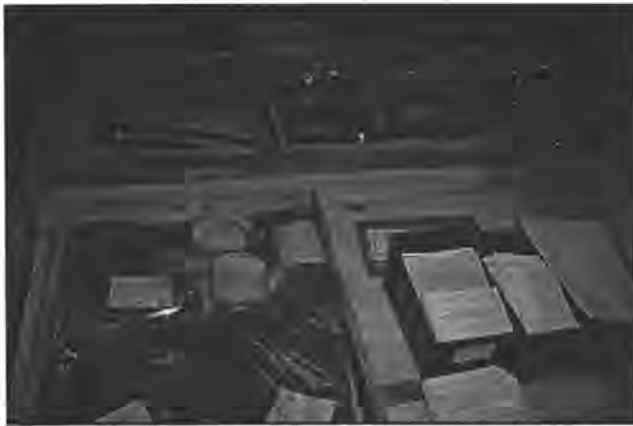
In Collection Storage Area 1 the primary containers are wood drawers lined with a layer of ethafoam with paper labels stapled on the outside (Figure 97). Each label is typed with the accession number, drawer number, a short description, collection name, and area of origin. The oversized artifacts on open metal shelving have no primary or secondary container; however, the shelf is lined with a thick piece of ethafoam.

Figure 97. Wood drawers hold artifact collections from Fort Bliss in Collections Storage Area 1.

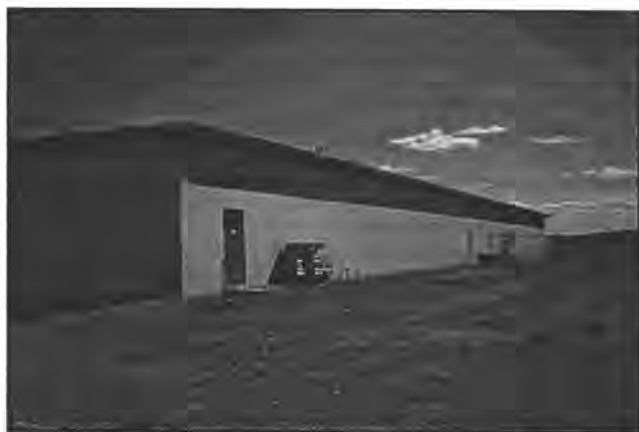
The Indian Hills Annex was built in 1982 and encompasses 15,408 ft² (Figure 98). The single-story building was constructed to house the Anthropology laboratory, the collections storage area, and offices. A wing, identified as the "quarry room," which contains a receiving/loading dock, was added some time after construction of the original building. Multiple activity areas within the annex include a mechanical/utility room, offices, a materials/supplies storage area, an equipment bay, an artifact holding area, an artifact washing area, an artifact processing laboratory, a temporary artifact storage area, an artifact study room, a records study room, a photographic storage room, and a records storage room. The facility's exterior is cinder block and the foundation is concrete. The roof is 15 years old and is without leaks or cracks. Interior walls are cement and concrete block.

Figure 98. The Indian Hills Annex of the Nevada State Museum.

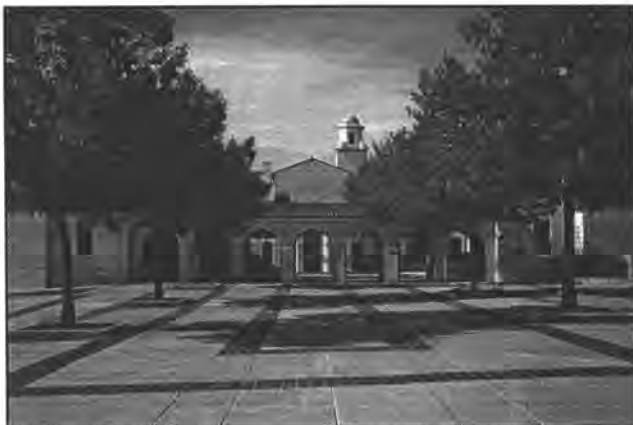
Repository 1 is Kent Hall, a Spanish mission-revival building that houses the museum's exhibit and storage areas, and offices (Figure 99). Kent Hall, built in 1957, was originally used as a dormitory. The Museum moved into the facility in 1980. The horseshoe shaped structure has a concrete foundation

and brick exterior walls covered with plaster. A center courtyard is surrounded on three sides by the building and arched gateways on the fourth side. The building has a red-tiled roof and a brightly colored, mosaic-tiled cupola. The building has proven to be structurally solid, although staff have noticed cracks in the foundation and the roof occasionally leaks during heavy rains. There are two floors above ground and one level below grade. There are many windows on both floors above grade, but no windows in the basement. Asbestos is present in the building. The building is regularly maintained by the university facilities personnel.

Figure 99. Exterior of Kent Hall (repository 1), which houses the New Mexico State University Museum in Las Cruces.

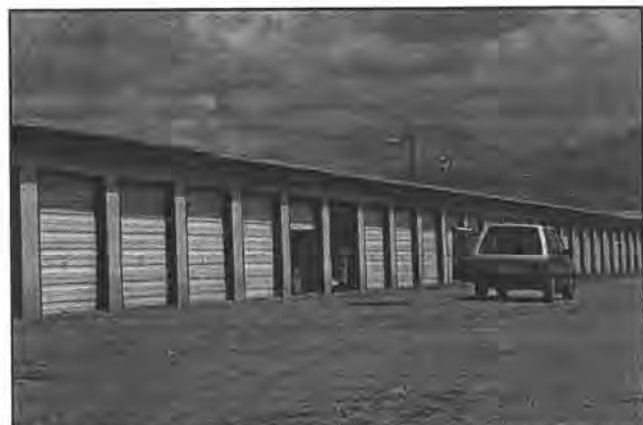
Repository 2 is a row of storage bays used by several departments on campus for surplus storage (Figure 100). Bays 58 and 59 have been allocated to the museum for excess storage of archaeological collections. These bays were constructed during the 1980s. The museum moved some of their archaeological collections into bays 58 and 59 in 1987. Each bay encompasses approximately 200 ft² of space and is connected to neighboring bays on three sides. The structure has a poured cement slab foundation and prefabricated plaster-covered sheetrock exterior walls over a wood frame. There are no windows, only an overhead sliding door that serves as an entrance into each single car garage-type structure. During the time of the assessment, a significant amount of water from a severe storm the night before had leaked into the bays where the collections are housed, causing damage to some of the boxes stored on the floor.

Figure 100. An off-site storage facility used to house collections from New Mexico University (repository 2); the open bays indicate the areas used by the museum.

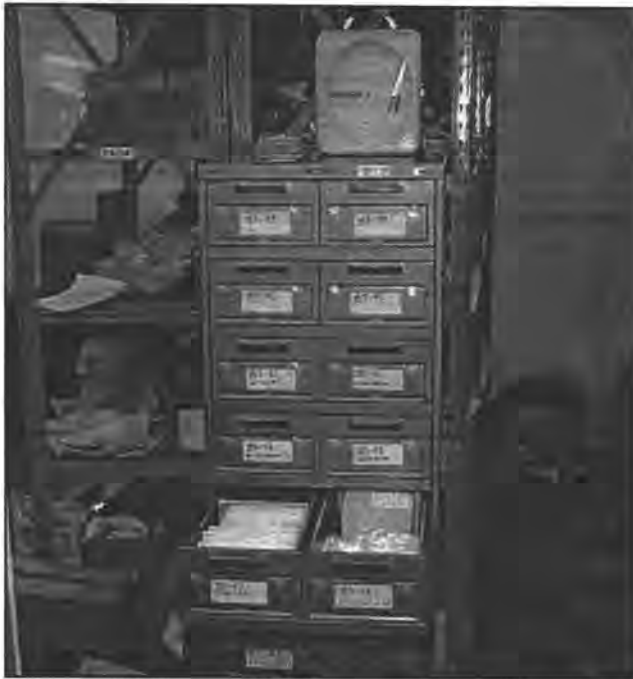
Figure 101. A metal storage unit with drawers houses small artifacts with paper and plastic envelopes as primary containers. A hygromograph on the unit monitors both temperature and relative humidity.

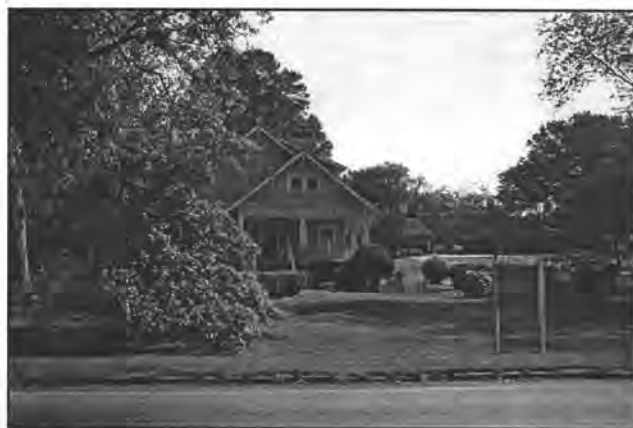
New South Associates, located in Stone Mountain, Georgia, conducts archaeological investigations throughout the United States. A large house (Figure 102) serves as their office, laboratory, and equipment storage areas. Collections from Fort Polk, Louisiana, are stored in two collections storage areas. One collections storage area is located in the laboratory and the other is the attic above the laboratory.

Figure 102. New South Associates offices are located in an 87 year old wooden structure.

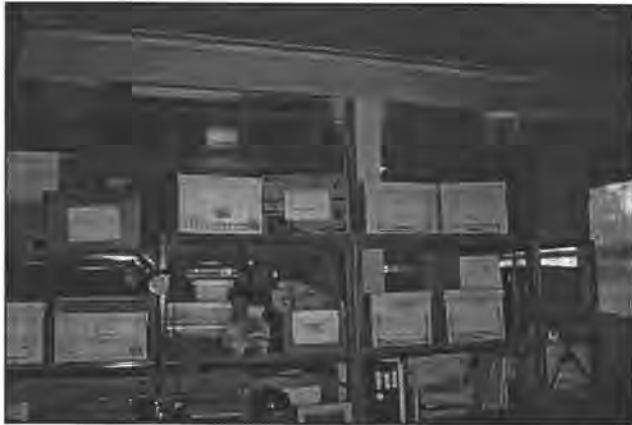
Figure 103. Collections are stored in a variety of secondary containers on steel shelving units.

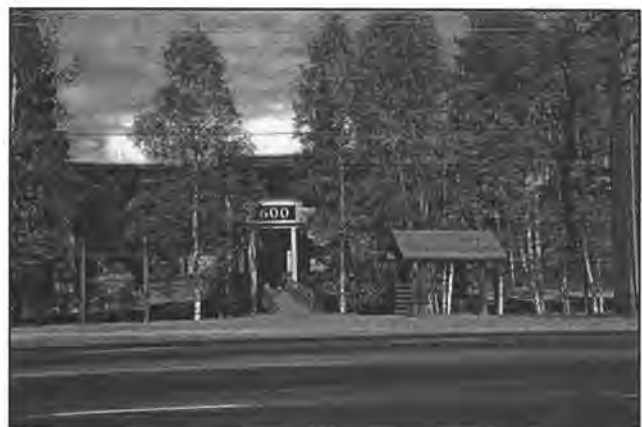
The NLUR offices are located on the second floor of a large office complex called 600 University Plaza (Figure 104). The building was constructed in the

Figure 104. Front view of the exterior of the building where Northern Land Use Research offices are located.

1970s and the second floor originally housed the state law enforcement offices. The building has a concrete foundation with framed wood slate exterior walls. The roof is composed of built-up asphalt and is original to the building. The building has two floors above grade and one below and is structurally solid, with no major cracks or leaks. Internal renovations include periodical reconfigurations of office partitions due to new rental agreements. There are multiple exterior wood framed windows that are equipped with plastic sun shades. These shades do not offer ultraviolet (UV) protection. There are interior wood panel doors in the NLUR office space. The exterior doors, which have combination locks, are metal panels with glass windows. The building is equipped with running water, heat, restrooms, telephone lines, and electricity.

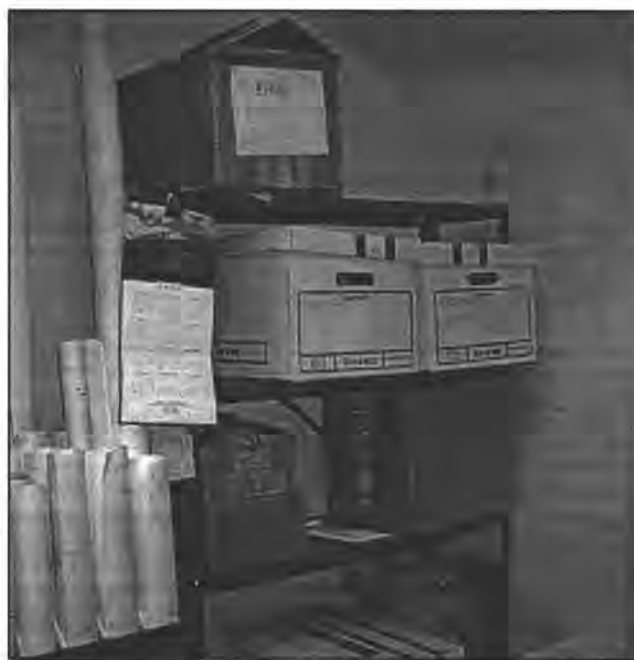
The YPG collection materials are stored on open metal shelves in the office of Steven Dosh, project manager (Figure 106). The collection is organized in primary container boxes by installation and delivery order number. Table 82 summarizes the material classes present in the YPG collection.

Figure 106. Collections from Yuma Proving Ground are housed in acidic cardboard boxes on metal shelves.

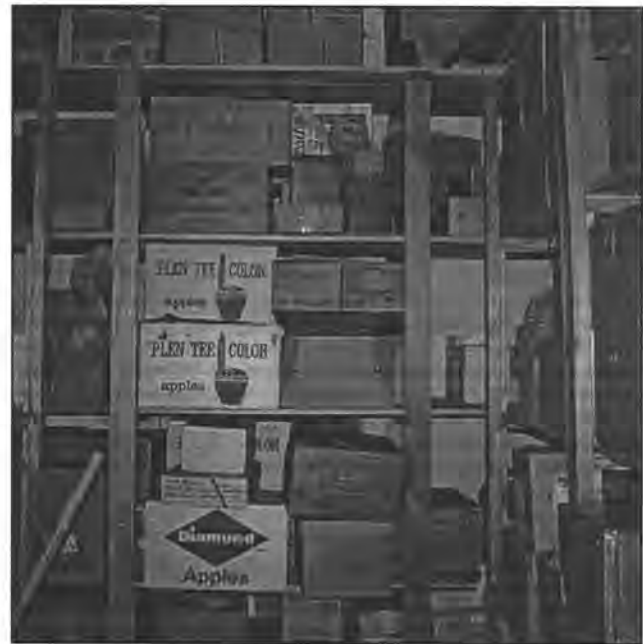
Collections are stored on unsealed wooden shelving units constructed of plywood and two by fours (Figure 108). The units were constructed in the storage rooms and vary in size to fit the dimension of the area.

Figure 108. Artifacts are stored in a variety of acidic cardboard boxes on wooden shelving units in room 215A in Kyser Hall.

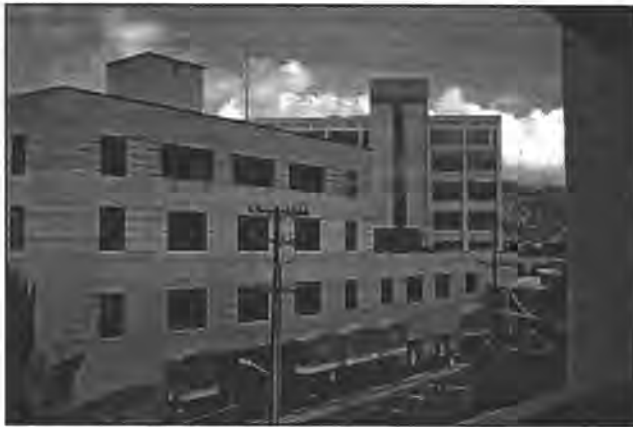
The structure is approximately 60 years old and was originally used as the main processing plant for the Dole Corporation (Figure 112). The foundation is concrete and the building frame type is steel and

Figure 112. Ogden Environmental and Energy Service's main office is located in a building formerly part of the Dole pineapple cannery.

concrete. The building is privately owned. The external walls of the repository are constructed of concrete and the built-up asphalt roof was renovated eight years ago. No structural problems have been noted in the foundation or the roof. Interior walls are wallboard and floors are concrete covered with carpet. Ceilings in the repository are suspended acoustical tile. Windows in the repository have aluminum frames, have shades, and are sealed. The portion of the repository used by Ogden encompasses 10,000 ft². The majority of space in the repository is used for report preparation and for offices. In addition, there is a small kitchen area for employees.

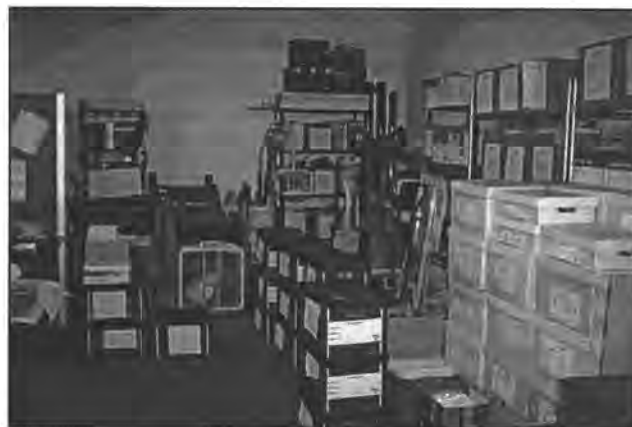
DoD collections total 146.5 ft³ and are stored on the floor of the collections storage area (Figure 113). All collections are stored loosely by project. Percentages of material classes are outlined in Table 89.

All artifacts are stored in acidic cardboard boxes that are glued and folded in construction and secured with a telescoping lid. They are all labeled with paper tags that are tucked under the lid of the box. Label information is written in marker. The information is legible and consistent for all

Figure 113. Boxed collections as well as field equipment are stored collectively in a storeroom.

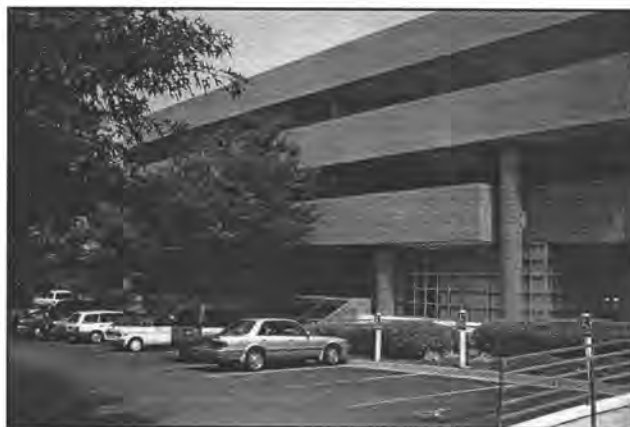
Figure 114. Parsons Engineering Science is a private contract engineering firm that conducts work for various Department of Defense installations.

The repository has a concrete foundation and exterior walls are composed of steel frames and concrete blocks covered with bricks. The roof, which is original to the building, is covered with built-up asphalt and has occasionally required repairs. Currently there are no cracks or leaks. There have been no major renovations or upgrades to the building, only minor interior wall restructuring to accommodate changes in office staffing. There are multiple exterior windows and doors throughout the building.

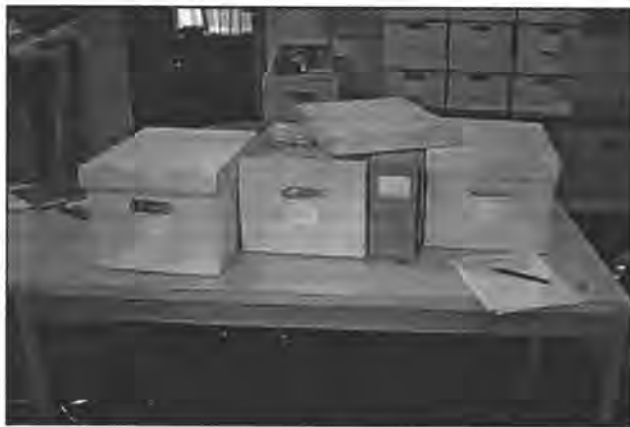
Archaeological materials are stored in acid-free cardboard boxes with a telescoping lids, about 1.2 ft³ in volume (Figure 115). This primary container is labeled (typed) on an acid-free adhesive label with the project and installation name. Archaeological materials are well packed.

Figure 115. Collections from Lackland Air Force in Texas are housed in acid-free cardboard boxes in the laboratory at Parsons Engineering Science.

2. Produce multiple copies of all documentation on acid-free paper and store in separate, secure locations. Documentation should be placed in acid-free folders, and lightly packed into fire-resistant file cabinets. If a box is used, it should be labeled by attaching a stainless steel or polyethylene label holder with an acid-free paper insert—printed or typed in indelible ink and encapsulated in a polyethylene plastic sleeve—to the front of the box.

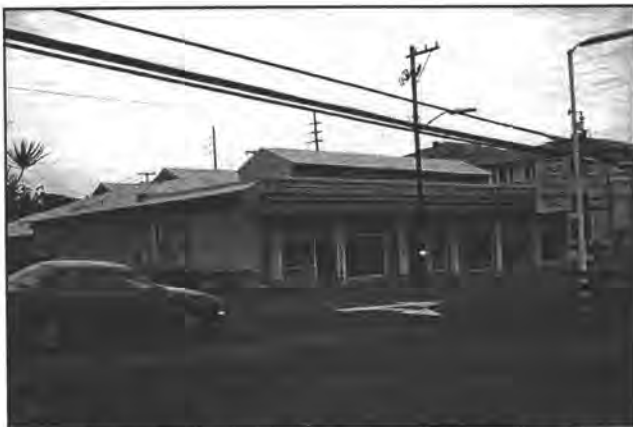
PHRI rents office space in what was originally a furniture store, and the staff refer to it as the Tropical Sleep Center building. PHRI moved into the facility in October 1993 and occupies almost 65% (9444 ft²) of the 14,616 ft² building (Figure 116). There is one other tenant in the building, with more space available for rent. The two-story building has a concrete foundation, painted concrete block walls, and a corrugated metal roof which is original to the construction of the building. It is structurally solid, with no visible cracks in the foundation or walls; however, the east wall leaks water during heavy storms.

Figure 116. The building (repository 1) in which PHRI rents office space.

Records and archaeological materials undergoing processing in the laboratory are located in the various offices in the building. Significant internal renovations have been performed and wallboard/sheetrock walls were added to create the offices. Wood framed windows are located on three of the four sides of the building and measure either 6.25 x 7.3 feet (w x h) or 2.3 x 7.3 feet (w x h). Windows are partially shaded and show no evidence of water or air leaks. The concrete floor is carpeted.

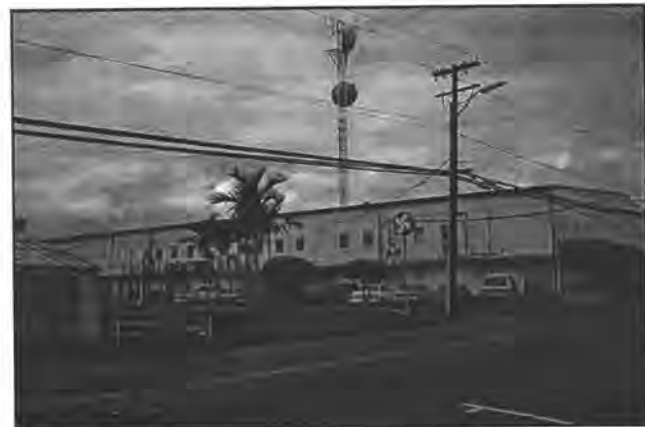
PHRI rents storage space in a partially below grade level underneath the Hilo Shopping Center, which was rebuilt in the early 1960s after the 1960 tsunami destroyed the area. PHRI rents approximately 13,400 ft² of the 70,000 ft² building for collections and field equipment storage (Figure 117). The shopping center has a concrete foundation and painted concrete block walls with a steel frame. The

Figure 117. PHRI rents office space in this building (repository 2), which is part of a shopping mall.

original metal roof is supported by metal beams and covered by a five-layered roof of tarpaper and EPDM. There is no asbestos present in the structure. DoD archaeological materials are housed in a 900 ft² area where the floor, walls, and ceiling are concrete. Doors in the collections storage areas are wood paneled. The entire building was renovated and brought up to code in 1985.

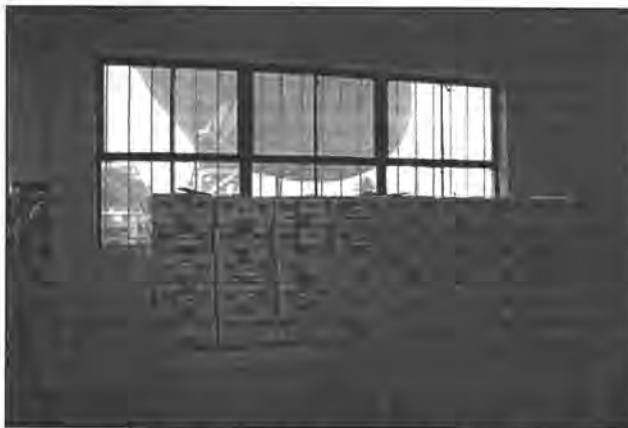
All federal collections have been stored separately from the rest of the collections in a 900 ft² room on a wall-length, unsealed wood shelving unit which measures 8.8 x 2 x 23.3 feet (h x d x w) (Figure 118). This open shelving unit is 2.5 inches off the floor and has four shelves. The shelves are labeled with pieces of paper taped to the edge of the shelf,

Figure 118. Collections in repository 2 are stored on wooden shelves. The windows in this repository have steel bars on the outside and are not filtered against ultraviolet radiation.

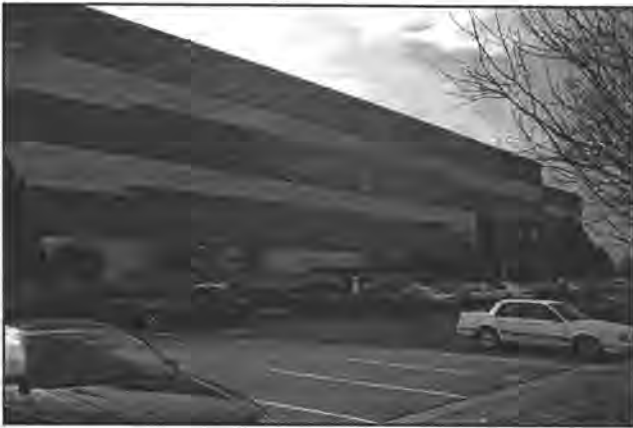
Central Place 1 is an office complex located in Aurora, Colorado (Figure 119). The entire building encompasses an estimated 50,000 ft² of office space, storage areas, a mechanical/utility room, and a security monitoring area. Powers Elevation Company offices occupy only about 4863 ft² of this space. The space Powers Elevation

Figure 119. Exterior view of the building where Powers Elevation offices are located.

Central Place 1 was originally constructed in 1984-1985 as an office complex. Powers Elevation Company moved into this building in 1988. The foundation of the building is concrete, and the exterior walls are concrete block. The roof is made up of built-up asphalt and is original to the building. The repository has three floors above grade and is solid, with no major cracks or leaks. Individual office space within the repository has been renovated by the various occupants. There are multiple aluminum framed windows in the building, all equipped with shades.

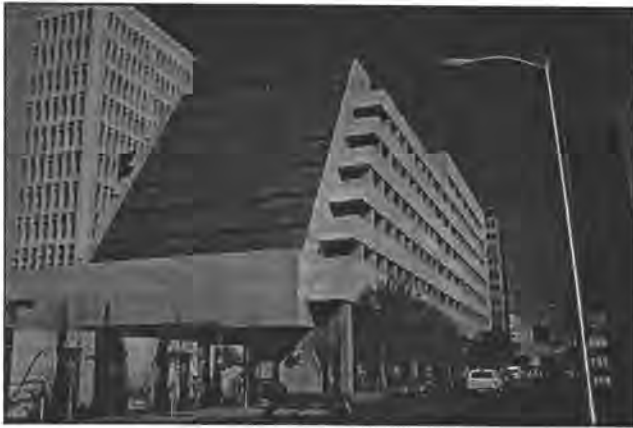
PNM is headquartered in a two city block area of downtown Albuquerque (Figure 120). This building has an overhead pedestrian walkway that connects with the Alvarado Square Building on the other side of the street.

Figure 120. Public Service Company of New Mexico headquarters building is located in downtown Albuquerque.

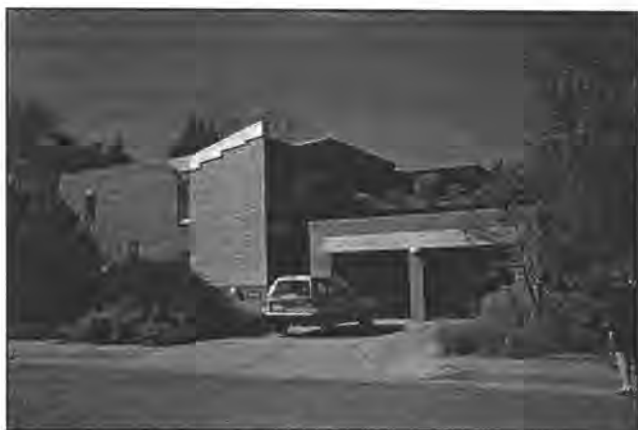
The 3200 ft² structure was built in 1975 as a residence, and is maintained as a residence (Figure 121). It has a concrete foundation with slump block exterior walls. The roof of the house is a built-up gravel-surfaced roof that is original to the home. The land on which the structure is built is sloping, with half a floor below grade, and one and a half floors above grade. Eight hundred square feet of office space is on the lower level. Ms. Condie has an office with a desk

Figure 121. Quivera Research Center is operated from a private residence.

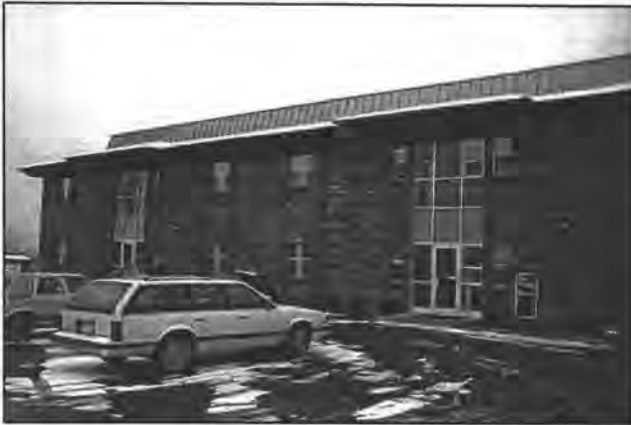
Sagebrush occupies three suites of an office building (Figure 122). The building was constructed in 1972, consists of two floors and a basement area, and encompasses approximately 50,000 ft² of space. The foundation is concrete and the exterior walls are brick. The roof is composed of tar and is less than two years old, but it is still subject to occasional

Figure 122. Exterior view of Sagebrush Archaeological Consultants' office building.

leaks. Interior walls are comprised of wallboard, and the ceiling is composed of suspended acoustical tiles. The floor is wood covered with carpet. Doors to the exterior of the suite are solid glass panel, while doors within the interior of the suite are wood panel. The building has multiple aluminum framed exterior windows, all equipped with locks and blinds. Within the offices, the firm utilizes space for artifact holding and temporary storage, for records and photograph storage, and for artifact and records study.

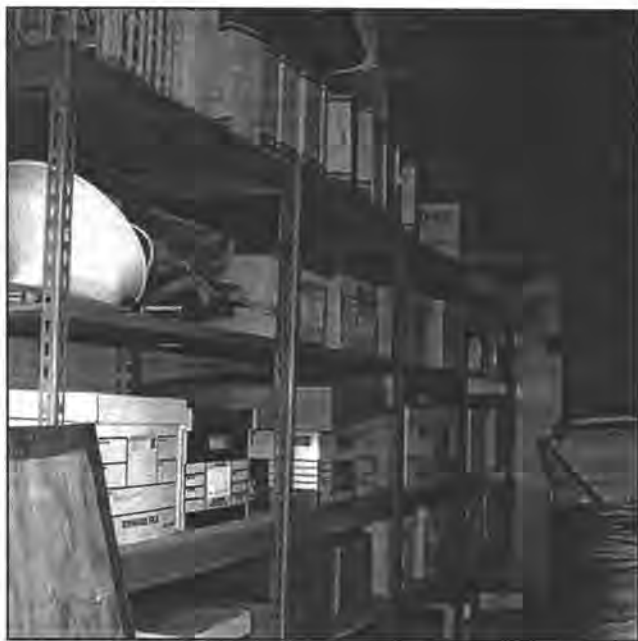
Sagebrush Archaeological Consultants houses approximately 3.2 linear feet of documentation associated with archaeological work performed on military installations (Table 96). Records are stored in the main suite of offices, the basement storage room, and the off-site storage facility. In the main offices, storage units consist of standard letter-sized metal file cabinets, and acid-free cardboard boxes stored on the floor in various individual offices. In Collections Storage Area 2, the Basement Storage Area, storage units consist of metal uprights with particle board shelves (Figure 123). In Repository 2, storage units are again metal uprights with particle board shelves.

Figure 123. Shelving units housing military record collections at Sagebrush Archaeological Consultants' off-site facility. The off-site facility has corrugated metal walls.

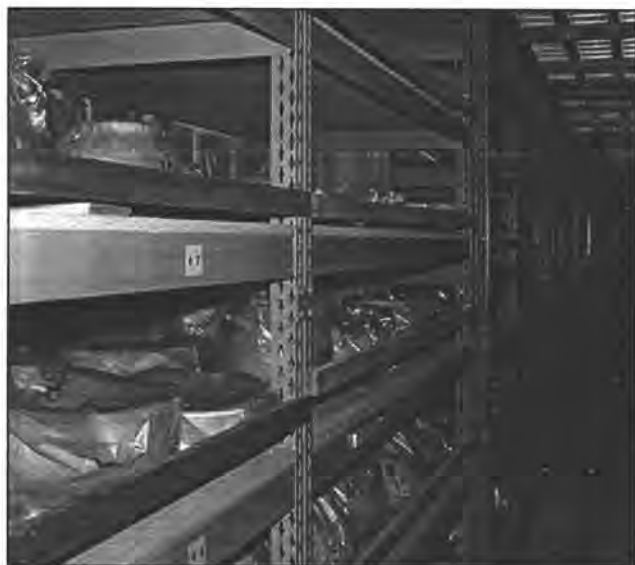
The artifacts are stored in four different locations. In CSA 1, ceramic sherds, some shell and small lithic materials are stored in wooden drawers built into the wall. Additional drawer storage is located in the center of the room, taking most of the available space. A counter top above this cabinetry is used for staging exhibits and general work space. In preparation for an upcoming exhibit, nearly all of the counter space was taken by baskets. Downstairs in CSA 2, whole and reconstructed ceramic vessels are stored on open metal shelving units (Figure 124). In

Figure 124. Whole vessels are housed on metal and pressed wood shelving units in Lab 4 (Collection Storage Area 2).

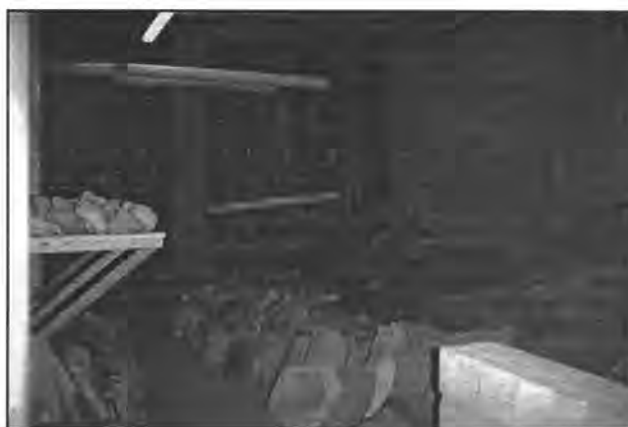
a small corner section of the same room, boxes of sherds are stored on open metal shelving units. The third collection storage area is primarily an archaeological storage area. Both sides and the entire back section of the room are devoted to ceramics, lithics, and general archaeological collections; the middle area is shared with ethnographic collections temporarily housed there pending funding of a renovation of ethnographic collection storage space. The fourth and final storage location is adjacent to the third. Oversized ground stone is stored on a small wooden plank deck built over the dirt floor. These large metates are placed in rows with the row number painted directly on the wood panels. The metates are placed side-ways leaning on each other like dominos (Figure 125). The percentages of materials classes included in the collection are given in Table 97.

Figure 125. Large ground stone artifacts are housed in Lab 5 annex (CSA 4).

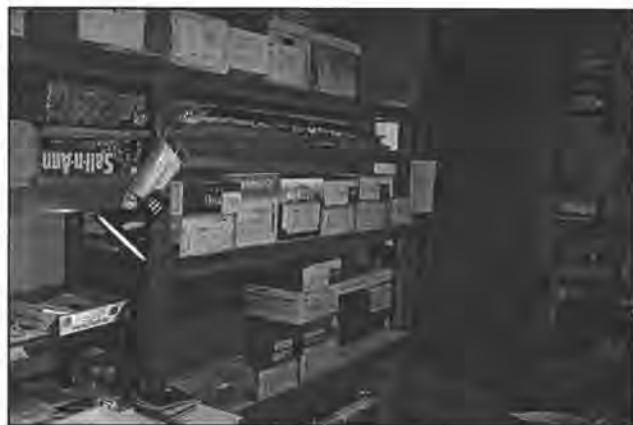
DoD collections total 9 ft³ of artifacts from six installations (Table 99). The materials are stored on nonmovable, metal shelving units measuring 5 x 1.5 x 5 feet (h x w x d). The shelving units are not labeled and are not secured (Figure 126).

Figure 126. Department of Defense collections are housed on steel and wood shelves in the offices of Scientific Consultants Services.

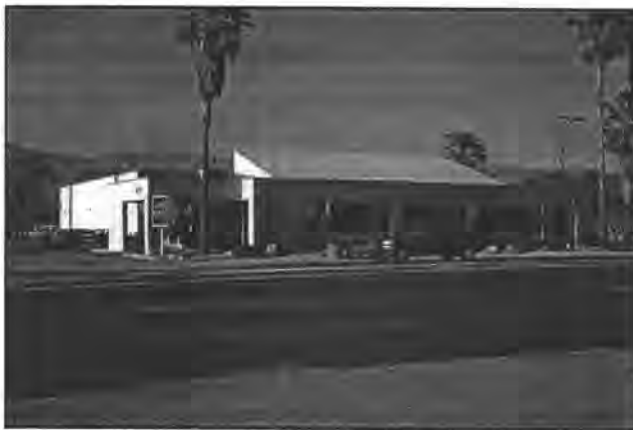
SRI leases space in a building constructed in 1973, which housed a home health care provider company prior to renovation for use by SRI (Figure 127). The structure has a concrete foundation and concrete block exterior walls. The roof, which was completely renovated in 1996, has shingles in the front and built-up asphalt in the rear of the building. There are no reported cracks or leaks, and the building appears to be structurally solid. Activity areas present in this 12,000 ft² facility include offices, report production areas, a laboratory with collections storage space, materials/supplies storage space, a reception area with a display case, and a dark room. The one-story facility has multiple windows of varying dimensions; no windows are in the collections storage area, but there are skylights present. The aluminum framed windows in the rest of the building are sealed, have

Figure 127. Statistical Research has offices, a laboratory, and a warehouse.

partial shades, and have never been replaced. There is no evidence that the windows are drafty or leak water. Exterior doors are metal framed with glass panes. Maintenance of the building is the responsibility of SRI.

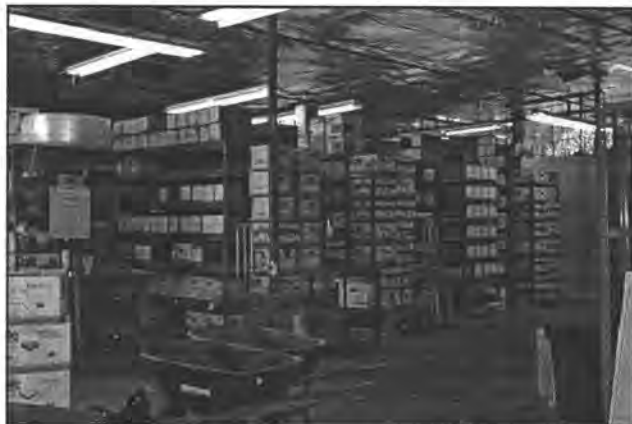
Archaeological materials (27.2 ft³) recovered from Fort Huachuca and Navajo Army Depot are housed in the collections storage area of the SRI laboratory. Percentages of material classes are provided in Table 102. Boxed collections are stored on adjustable metal shelving units (Figure 128) that measure 8 x 4 x 8 feet (w x d x h). There are four units with seven pressed wood shelves per unit. The shelves are not labeled.

Figure 128. Archaeological collections are boxed and housed on metal shelving units; processing and field equipment share the space.

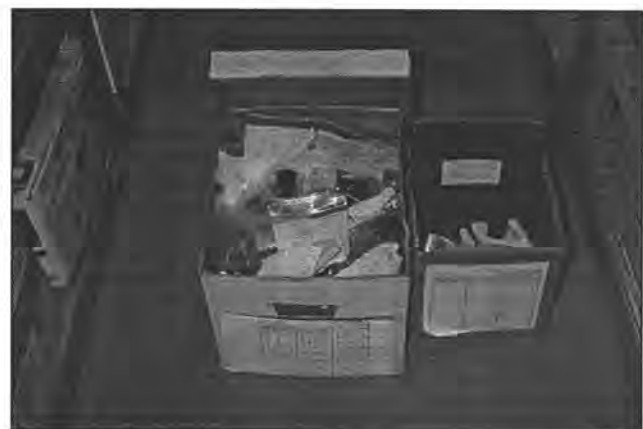
Archaeological materials, not currently undergoing processing and analysis, are housed in acidic cardboard boxes that vary in size and volume ranging from 0.3 ft³ to 2.5 ft³. The boxes have a folded, glued, stapled, or taped construction (Figure 129). Some of the boxes assessed for DoD

Figure 129. Collections generated from Fort Huachuca are stored in plastic zip-lock bags in acidic cardboard boxes.

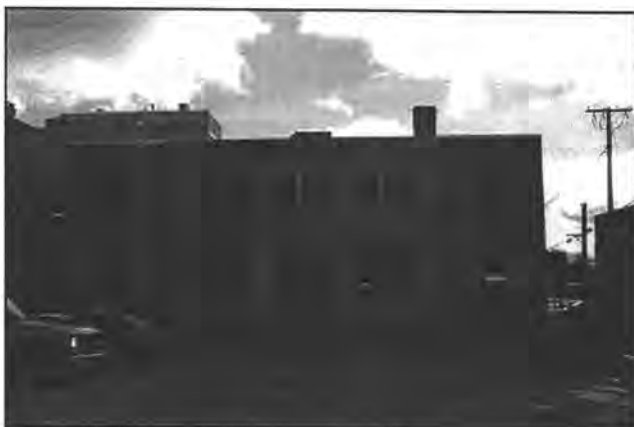
The building housing SWCA was constructed in 1927 and functioned originally as a post office (Figure 130). It is still referred to as "the old Federal Building." SWCA moved into the building in 1993-1994. The facility has a total of three stories, with two above grade and one below grade. The total area for the facility is approximately 17,000 ft². The building has a concrete foundation, concrete block and sandstone exterior walls, and a built-up asphalt roof. Both the foundation and roof are considered to be structurally solid without cracks or leaks. The roof was replaced in 1986 and some minor repairs were made in 1994.

Figure 130. The offices of SWCA, Inc. are located in Flagstaff in a former federal building.

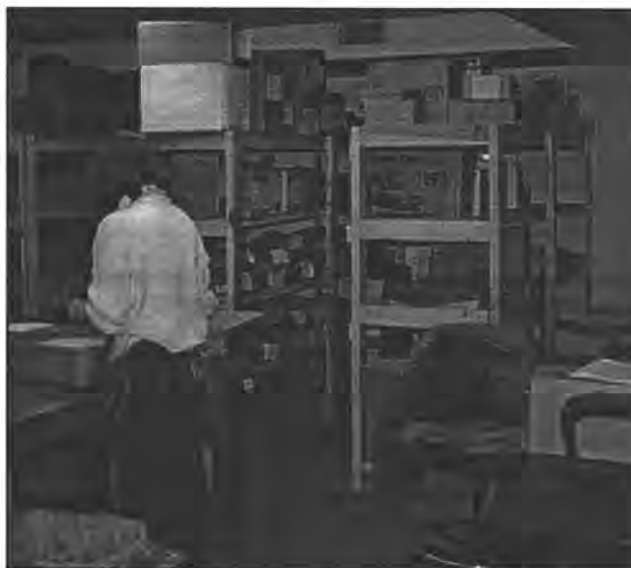
The collection materials held by SWCA are stored on large, unsealed wood and press board shelving units (Figure 131). Table 105 summarizes the material classes present in the Navajo Army Depot collection.

Figure 131. Collections are stored in acidic cardboard boxes on wooden shelves in the archaeological laboratory.

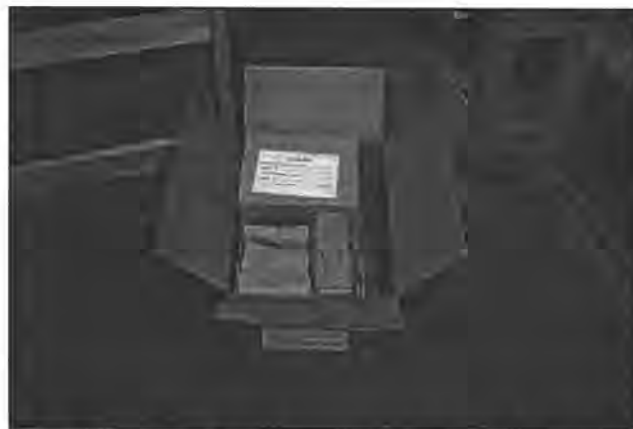
Figure 132. Artifact packaging at SWCA, Inc., includes cardboard boxes and nested acidic paper bags secured with rubber bands.

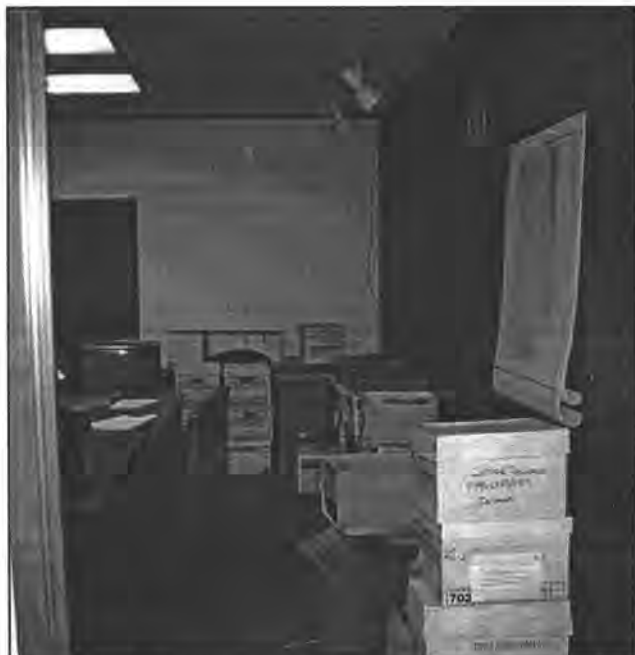
The documentation for on-going projects is kept in the offices of Susan Bupp and Evelyn Chandler where it is stored in metal file cabinets. Other documentation is stored in acidic cardboard boxes on the floor of the office conference room (Figure 133). Although the storage boxes have recently been labeled directly in marker with box content information, the materials inside are arranged with no specific order. Project records and photographs are mixed within these boxes. For amounts and types of documentation by installation, refer to Table 106.

Figure 133. A conference room is temporarily used to house associated documentation.

2. Replace acidic cardboard boxes with acid-free boxes. Apply adhesive polyethylene plastic label holders, with acid-free inserts, to the boxes. Labels should no longer be applied directly to the boxes. When label information or box contents changes, inserts are replaced, thus reducing the chance for conflicting and confusing information.

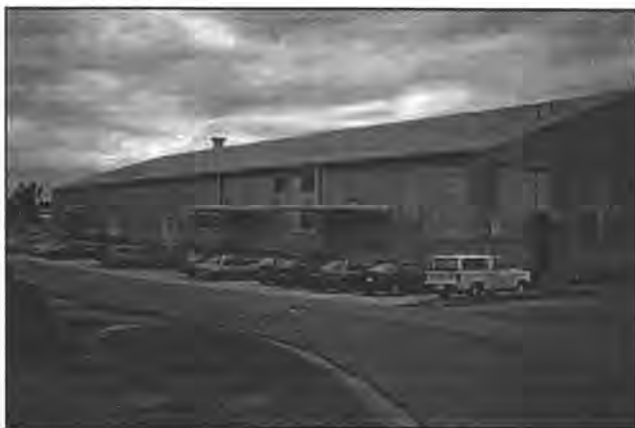
Building 5 is approximately 42 years old and was previously used as a munitions factory for magnesium processing (Figure 134). Offices for faculty and staff are located throughout the facility, but the majority are on the second floor. Most of the central portion of the structure is devoted to collection storage and laboratory space. The facility has undergone internal and external renovations for its current configuration.

Figure 134. Building 5 (repository 1) is located on the campus of the University of Texas at Austin; it formerly served as a munitions factory.

The structure has a concrete and rubble core foundation with brick and corrugated transit exterior walls. The roof is composite (transit/concrete) and is only three years old. The shingles are asphalt. No active cracks in the foundation or active leaks in the roof have been noticed by staff members. The building functions as office space, collection storage, laboratory and classroom areas. The structure possesses three floors above grade. Internal renovations include the addition and removal of walls (sheet rock) to better facilitate current usage. Some windows in repository have steel frames and have either been covered over with walls or been painted over. According to TARL staff, some of these windows have shown evidence of air or water leakage. Most windows in the repository are original.

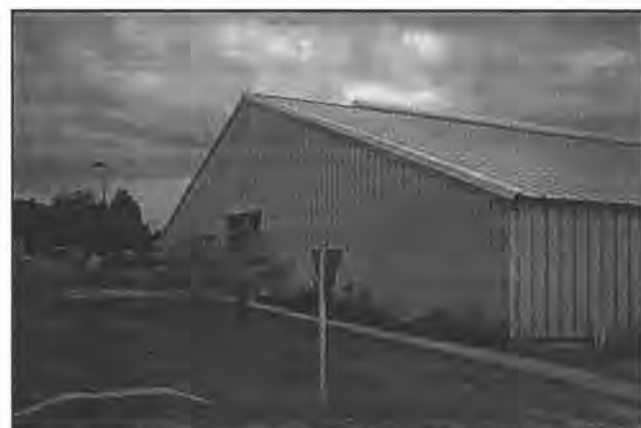
Figure 135. Building 33 (repository 2) on the J. J. Pickle Research Campus is a corrugated metal building devoted to artifact and equipment storage.

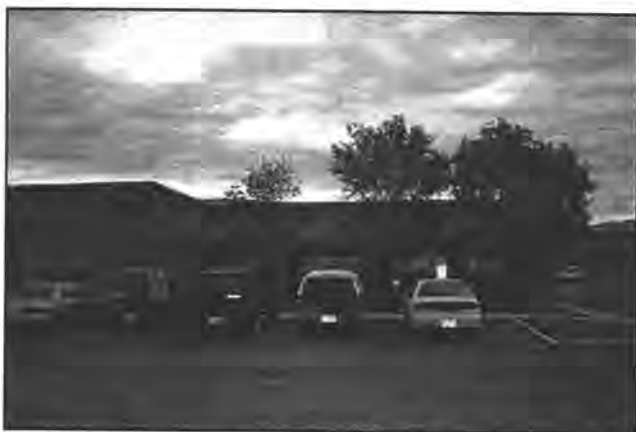
TRC-Mariah Associates, an archaeological contracting firm, are tenants of an industrial park complex located on the northeast side of Albuquerque (Figure 136). The entire 5185 ft² office building is occupied by TRC-Mariah. The single story structure was constructed in the 1980s with a cement foundation and exterior walls of stucco over a wood frame. The building has a flat, composite gravel roof, with the exception of a porch area on the

Figure 136. The offices of TRC-Mariah Associates are located in an industrial park on the northeast side of Albuquerque.

front of the building, which has a tile roof. Utility systems are original to the building. A reception area and offices occupy the front of the building. Artifact washing, processing, and analysis are conducted in a large room in the center of the building. This area has partitioned work spaces, counters with overhead cabinets, a sink, movable drying racks, a microscope, and computer terminals. A storage room houses shelved collections along with equipment and some records. This room is accessible through a door from the processing area, a door from the office area, a

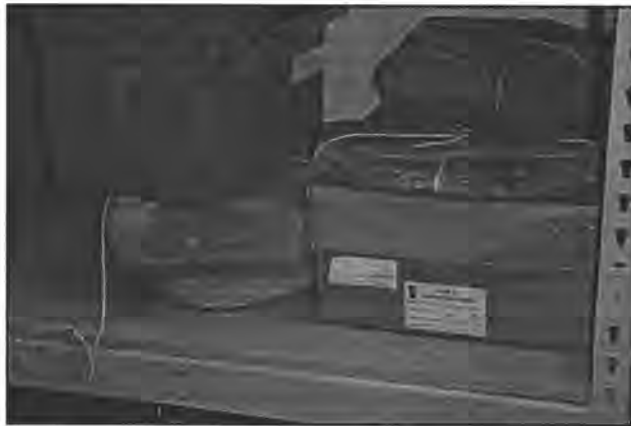
The storage room has two types of shelving units. The processed collections are on units with wood shelves on a metal frame (Figure 137). Each unit measures approximately 7 x 7 x 2 feet (h x w x d) with four shelves spaced approximately three feet apart. A unit constructed of unsealed two by fours and plywood hold collections being processed, as well as, equipment and supplies. This unit measures 6 x 6.5 x 1.5 feet (h x w x d). Boxed collections in the processing room are stored on the counter and a folding table.

Figure 137. Large ground stone and boxed collections are stored on metal and pressed wood shelving units in the storage room of TRC-Mariah Associates.

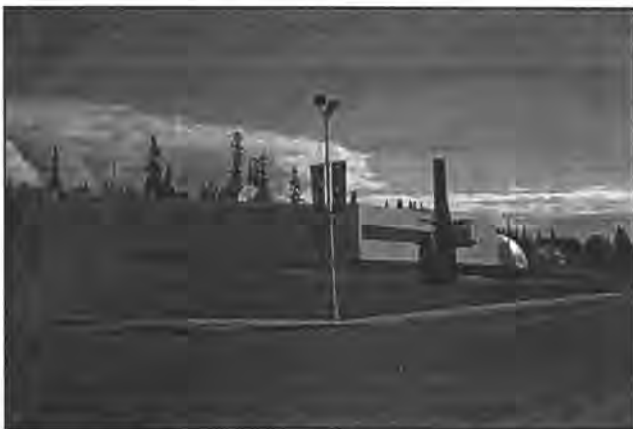
The Otto Geist Building, measuring approximately 40,000 ft², was originally constructed in 1979 for use as a museum (Figure 138). The museum has collection storage facilities, classrooms, office space, artifact holding, washing, and processing areas, temporary artifact-storage areas, materials/supplies storage areas, exhibit areas, artifact study rooms, photographic storage rooms, records storage rooms, laboratories, a receiving/loading dock, a walk-in refrigeration unit, and a security monitoring space. Many of these rooms are multi-purpose.

The repository has a concrete foundation with steel exterior walls and concrete with sheet rock interior walls. The roof is made of concrete and steel and is original to the museum. The building has two floors above grade and one below grade. It is structurally solid, with no major cracks. There have been some minor leaks in both the overhead pipes and in the concrete. The pipes were repaired, but the concrete cannot be mended. There have been external renovations to the building. There are

Figure 138. Exterior view of the University of Alaska Museum in Fairbanks.

multiple exterior steel framed windows located on the east and west sides of the building. Windows are located in the lobby and the administrative offices, but not in the collection storage or exhibit areas. All of the windows have Venetian blinds. There is no evidence of water or air leaks in the windows. There are numerous doors throughout the museum. The entrance/exit doors to the museum are glass. The interior doors are hollow metal fire doors and frames. Utilities in the repository include running water, heat, restrooms, telephone lines, air conditioning, humidity control, and electricity. The plumbing and electricity are original to the museum, however, the HVAC system was rebuilt in 1993.
