Archaeological Curation-Needs Assessment

Technical Report No. 20

Volume II Non-Military Repositories

**US Army Corps
of Engineers**
St. Louis District

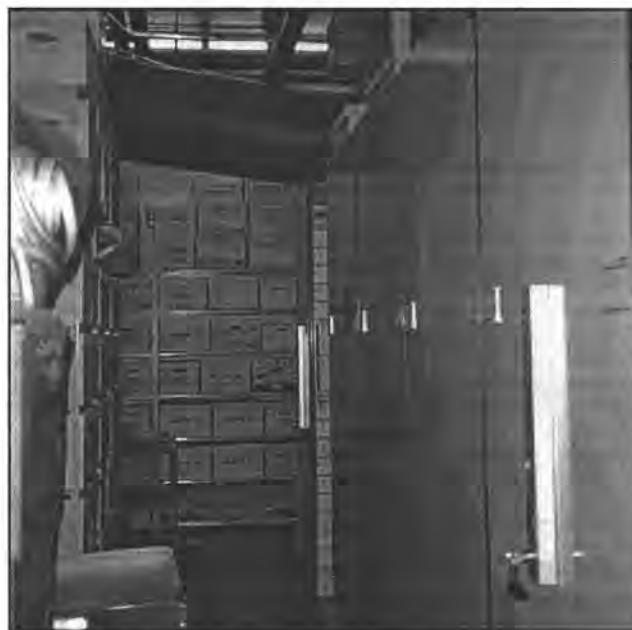
Figure 139. View of the archaeology collections storage area showing both the stationary shelving units and the front panels for the five rows or nine ranges of electric sliding-track compact storage unit.

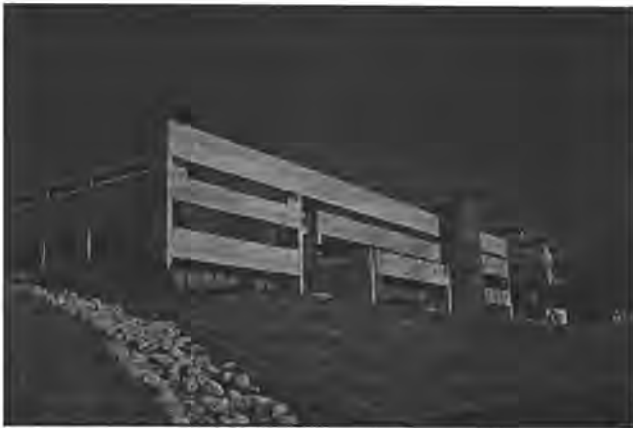
The Anthropology Department is located in Dwire Hall (Figure 140) on the UCCS campus. Dwire Hall is a large university classroom building that was originally constructed in 1971-72. Facilities include classrooms, laboratories, offices, a computer center, and a library spread throughout a structure three floors above grade. The foundation is concrete, and the exterior is composed of prefabricated concrete. The roof is built-up asphalt and has been replaced at

Figure 140. Exterior view of Dwire Hall, the location of the archaeology department at the University of Colorado, Colorado Springs.

some point since the building was constructed. Some cracks in the foundation and ceilings were reported by the UCCS staff. Dwire Hall is located on the side of a large hill, the Austin Bluffs in Colorado Springs, and the foundation is slipping gradually down slope. Approximately five years ago, cracks in the roof had to be repaired.

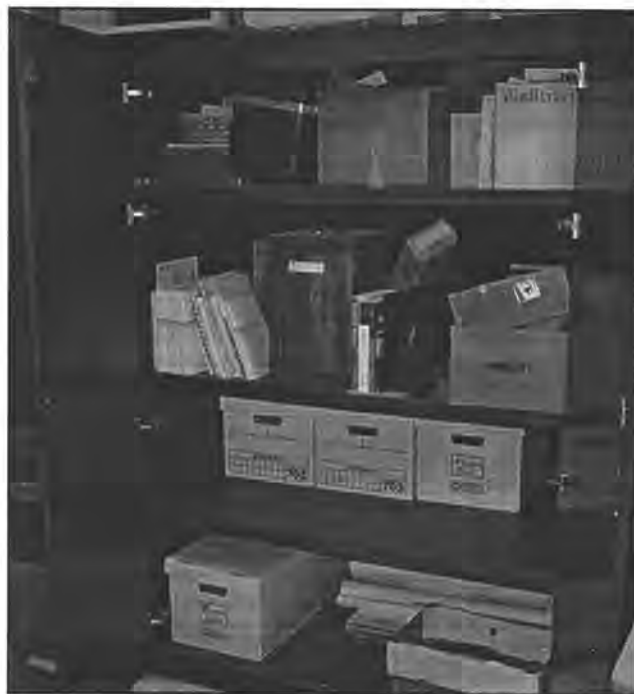
Storage units for artifacts and documentation consist of three particle board wood cabinets with locking doors (Figure 141). The cabinets, which are equipped with four interior shelves, measure 72 x 34 x 48 inches (h x w x d). Military archaeological collections are housed on the bottom two shelves of one cabinet. Table 116 outlines the types of materials present in the USAF Academy archaeological materials.

Figure 141. Wooden shelving storage unit for
artifact and record collections from the
U.S. Air Force Academy.

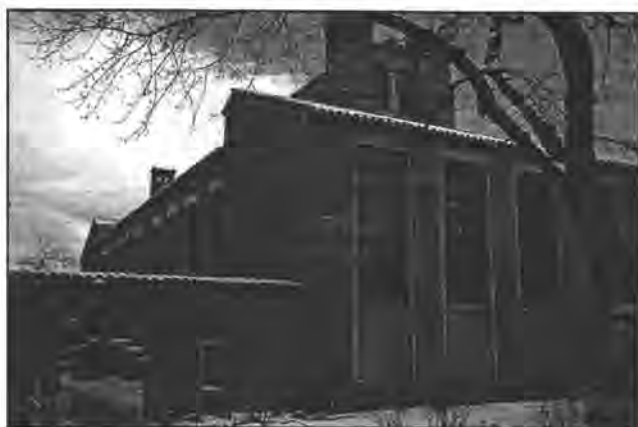
Figure 142. Exterior view of the Henderson Building used for the University of Colorado Museum.

The Henderson building, measuring approximately 22,000 ft², was originally constructed in 1935 for use as both a museum and as classroom space (Figure 142). Today, it is totally a museum facility, including four exhibition galleries, museum administrative offices, museum public education offices, and the curatorial divisions of Entomology and most of the Division of Anthropology. The museum is broken into 5-6 departments, which have different curators and administrative guidelines, and these additional curatorial divisions are housed in two additional museum buildings on campus, which include one further portion of the Anthropology Division as well. This summary focuses on the Anthropology Section of the Museum. Within the Anthropology Section, the military collections were curated under the guidelines and standards for the Cultural Resource Management (CRM) Repository Program. The Anthropology Section encompasses 11 rooms in the Henderson building, which are all multi-purpose.

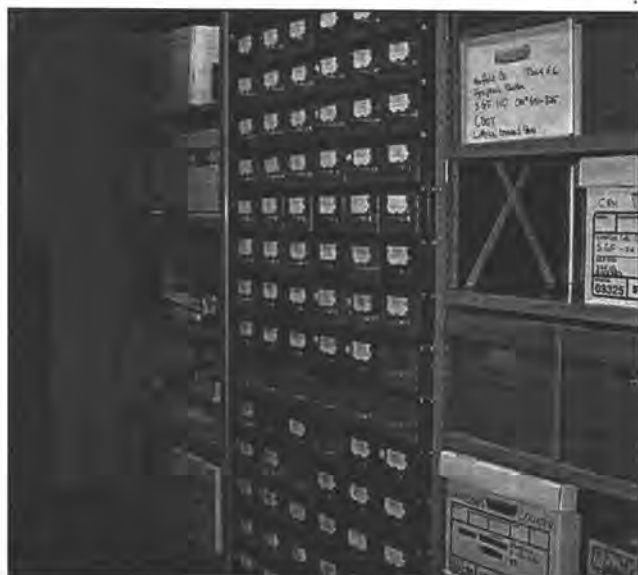
Primary containers consist entirely of metal sliding drawers that are riveted, stamped, and bolted. The drawers measure 17 x 5.5 x 4 inches (l x w x h).

Figure 143. Artifact collections for multiple military installations are stored in metal drawer storage units.

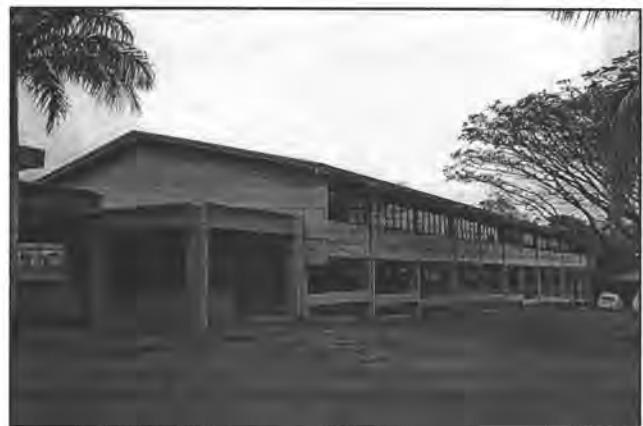
The anthropology department and collections storage room is located in the Edith Kanakaole Hall (EKH), Building 333 on the UHH campus (Figure 145).

Figure 145. Department of Defense collections are housed in Building 333 on the campus of the University of Hawaii at Hilo.

EKH was constructed in 1982 as a university classroom and office building. It has a concrete foundation with painted concrete block exterior walls. The corrugated metal roof has a concrete sub-

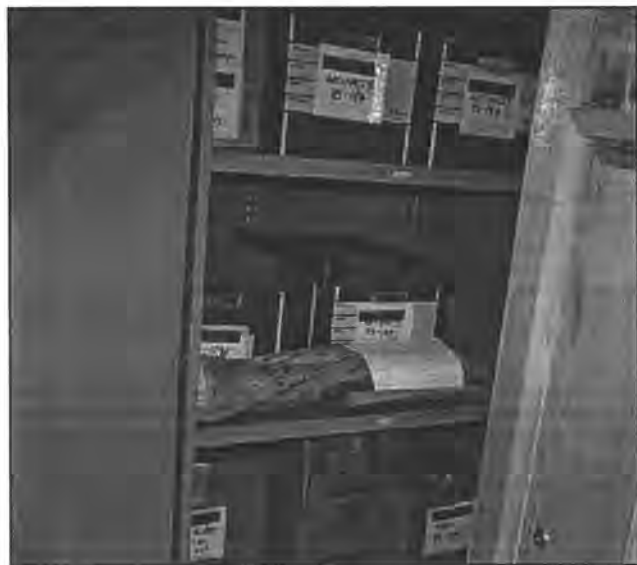
Primary containers consist of acidic cardboard boxes and an acidic brown paper bag with volumes ranging from 0.5 ft³ to 4.5 ft³ (Figure 146). Most of the boxes have a volume of 1.2 ft³. The boxes are of a glued, folded, and taped construction with either folding flap lids, some of which have been taped shut, or telescoping lid security. Labels are either paper

Figure 146. Collections from Pohakuloa Training Area are stored in a variety of acidic cardboard boxes and paper bags in a metal storage unit.

inserts in adhesive plastic holders or are written directly on the surface of the container. Label information is consistent and legible and includes the project number and box number. Some labels include the material contents.

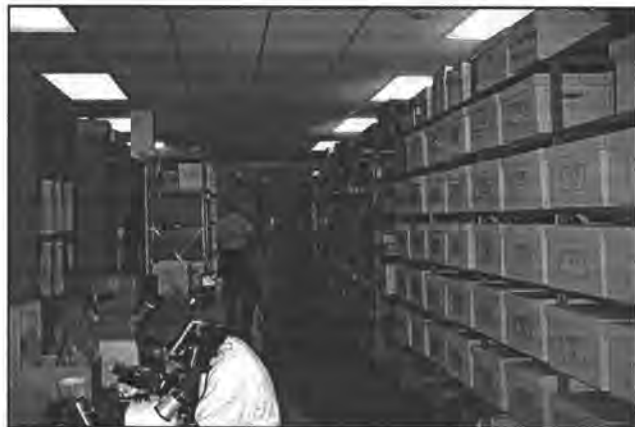
Primary containers are housed on fixed, open, metal shelving units. Individual shelving units measure approximately 85 x 35 x 24 inches (h x w x d) and each unit contains a total of six shelves with approximately 15 vertical inches between shelves (Figure 148). There is an aisle distance of

Figure 148. Artifacts are processed in the storage room.

approximately 54 inches between the rows of shelving units. A total of eight shelves on shelving units number 109 and number 110 was utilized to house DoD collections from Fort Leavenworth, Kansas. One of these shelves was noted as being bowed under the excessive weight of the heavily packed collection boxes. For a breakdown of material classes see Table 125.

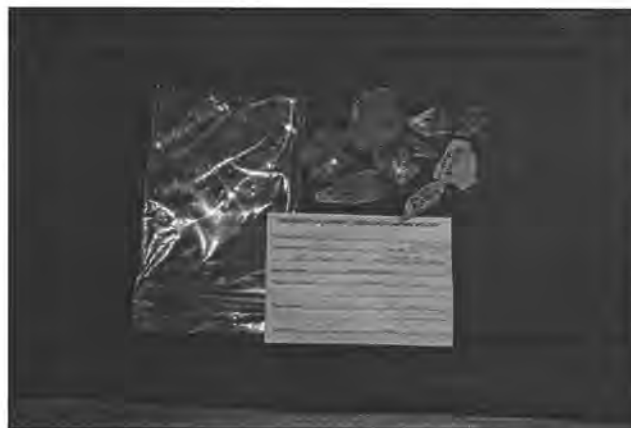
Secondary containers are 1- and 2-mil non-archival quality plastic bags with a zip-lock closure (Figure 149). Frequently, there are additional containers nested within the secondary containers. Secondary containers are not labeled externally, but contain acidic paper insert tags with information about the site and container contents written in pencil.

Figure 149. Artifacts are labeled directly in ink and housed in a plastic zip-lock bag; a label is also inserted in the bag with the artifacts.

items such as limestone, sandstone, and quartzite were generally packaged without cleaning. Only larger items in the collection have direct labeling in indelible ink. Small items are not individually labeled. Over 90% of the collection materials were sorted by material type.

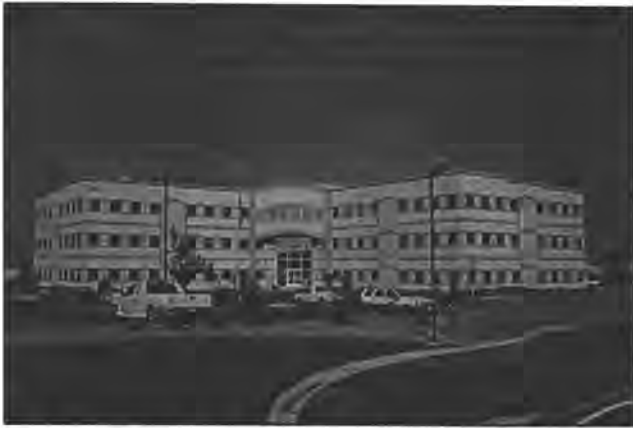
The new building is located in the northeast section of Albuquerque in an industrial park and was completed in the summer of 1995 (Figure 150). This building encompasses approximately 58,800 ft² of space and has three floors all above grade, a concrete foundation, and exterior walls constructed with a steel frame faced with stucco. The roof is a single-ply roof with a ballast. The building is structurally sound and has shown no evidence of leaks or cracks in the structure. All of the

Figure 150. The U.S. Army Engineer District, Albuquerque headquarters building was constructed in 1995.

windows, which measure 5 x 5 feet, have aluminum frames shaded with Venetian blinds. Windows are sealed shut and have been covered with film that has a mirror effect from the outside. No significant internal or external renovations have occurred. The bank of exterior doors are glass in metal frames, while all of the interior doors are solid wood.

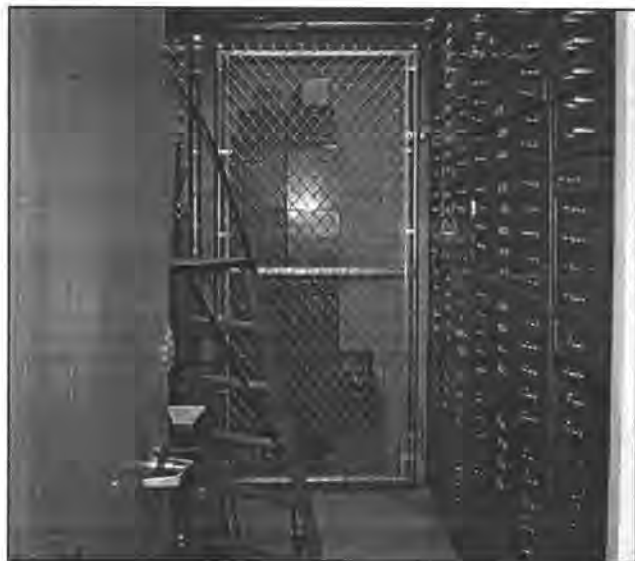
Approximately 9.5 linear feet of associated documentation were assessed during this visit. All associated documentation was generated from work conducted on Fort Wingate for environmental compliance surveys under the Base Realignment and Closure Act (BRAC). Records present include paper records, report records, maps and oversized documents, photographic records, and computer records. Approximately two linear feet of associated documentation is located in Room 122, the Environmental Section offices, and 7.5 linear feet of records in Room 107, the excess records storage room (Figure 151).

Figure 151. Project records for Fort Wingate are stored within a fenced and locked area of an excess storage room.

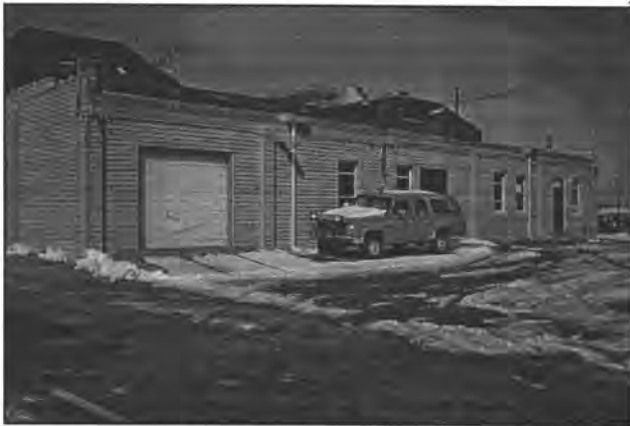
The storage facility is used for a variety of storage purposes, only one of which is archaeological collections. It was constructed during the 1950s and encompasses approximately 5000 ft² of floor space in one floor (Figure 152). The building has areas for artifacts, materials storage, and offices. The foundation of the building consists of concrete, and exterior walls are composed of concrete block. The roof is tin, and is original to the building. The roof

Figure 152. Archaeological collections, including ones generated from Walter Reed Medical Center, are housed in a storage facility constructed circa 1950.

has leaked in the past. Interior renovations have consisted of additions and rearrangements of plywood partitions for interior walls. There are four exterior windows on the east side of the building, all with aluminum frames, and not equipped with shades.

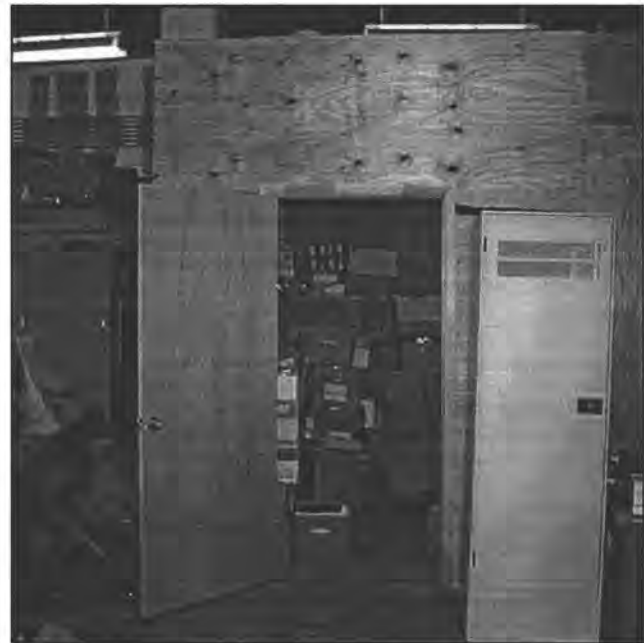
Artifact primary containers were stored on the floor of the storage facility adjacent to Fort McHenry (Figure 153). Table 127 outlines the types of material classes present in the Walter Reed Army Medical Center housed at the USAED, Baltimore.

The primary container is an acidic cardboard box with a telescoping lid. The box is labeled directly in

Figure 153. The collections storage area is partitioned off from the rest of the building with plywood walls and a locking door.

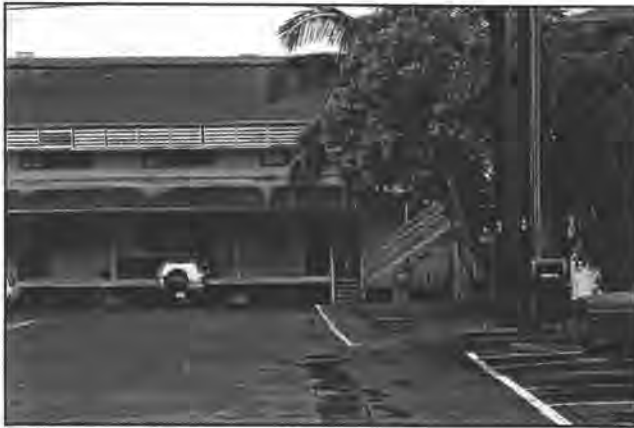
The Pacific Ocean Division offices are temporarily located in Building T-1 on Fort Shafter (Figure 155). A new building to be used by the USAED was under construction at the time of this assessment and was not evaluated; however, the temporary office space allotted to the Environmental Division was assessed. Building T-1 is thought to have been constructed

Figure 155. Office of the U.S. Army Engineer District, Pacific Ocean Division are temporarily housed in Building T-1 at Fort Shafter.

during the 1920s-30s. Built with a concrete foundation on raised wood pier and pilings, it has a wood frame with wood siding exterior walls. The wood roof is covered with asphalt shingles. There is a significant amount of mold and rust stains evident on the building, a result of the tropical, humid environment.

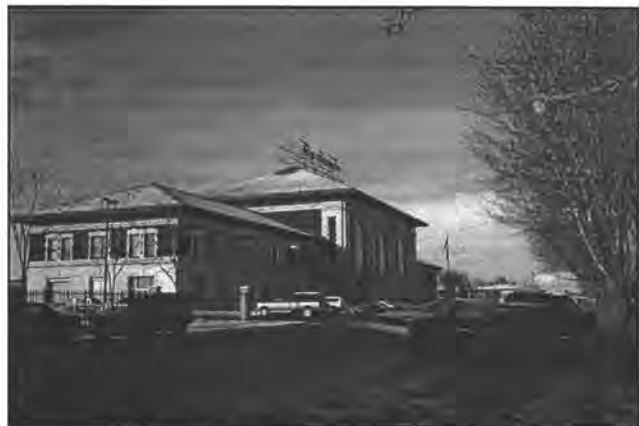
The Utah Division of State History (UDSH) is located near central downtown Salt Lake City in a partially converted historic railroad station (Figure 156). The UDSH has several missions including acting as state archaeology records' repository, issuing and regulating permits needed to conduct archaeological research, operating public education and outreach programs, conducting archaeological research—coordinated through the Utah Geological Society

Figure 156. Utah Division of State History exterior view looking northwest.

The Rio Grande Railroad Depot is a two-story, 480,000 ft² wood frame structure with granite block and masonry exterior walls seated on brick and cement conglomerate foundation pillars. During utility upgrades in 1979, the original 4-foot high crawl space under the building was dug out around the foundation pillars into a full basement that was lined with cement. The repository's plumbing was upgraded in 1995. The single gable wood frame roof, which is original to the building, is covered with Italianate style red slate tiles. There are no cracks or leaks in either the roof or the foundation, but due to the high water table in Salt Lake City, the foundation does occasionally have seepage problems during seasonal changes. In addition to the seepage, heavy rains sometimes cause water buildups to spill into the basement, the direct result of an old storm drain

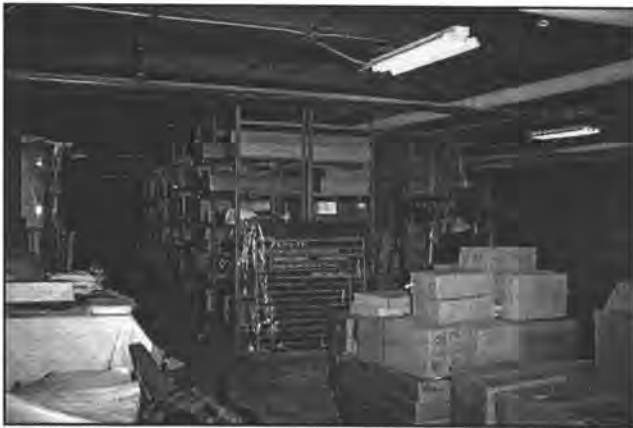
Utah Test and Training Range/Hill Air Force Base archaeological materials are stored on multiple sets of open, adjoining, non-movable, enameled metal shelving units (Figure 157) measuring 3.5 x 3.5 x 8.2 feet (h x l x w), one free standing pedestal display case with a Plexiglas cover, and one standard size domestic upright freezer. Table 130 outlines the material class types present among Utah Test and Training Range/Hill Air Force Base collections at UDSH.

Figure 157. Overview of collections storage area. Enameled metal shelving units house some of the Utah Test and Training/Hill Air Force Base collections.

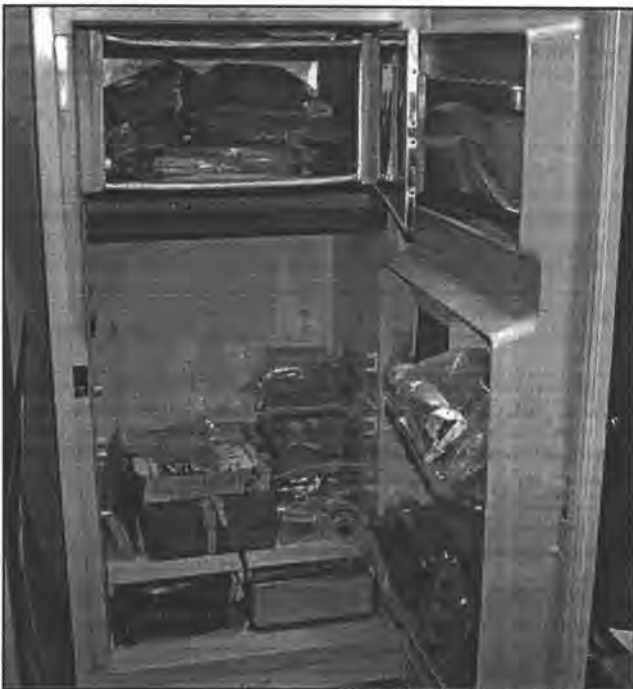
Archaeological materials for Utah Test and Training Range/Hill Air Force Base are stored in both acidic and non-acidic cardboard boxes. There are two sizes of primary containers in use: one acidic box 2.2 ft³ in volume, and four non-acidic boxes 1.4 ft³ each in volume encompassing a total volume of 7.8 ft³ in boxed materials. An additional 3.5 ft³ of salt water affected materials are being housed in an upright freezer in the curator's office (Figure 158). All

Figure 158. View of the freezer interior showing primary and secondary containers for artifacts from Utah Test and Training/Hill Air Force Base.

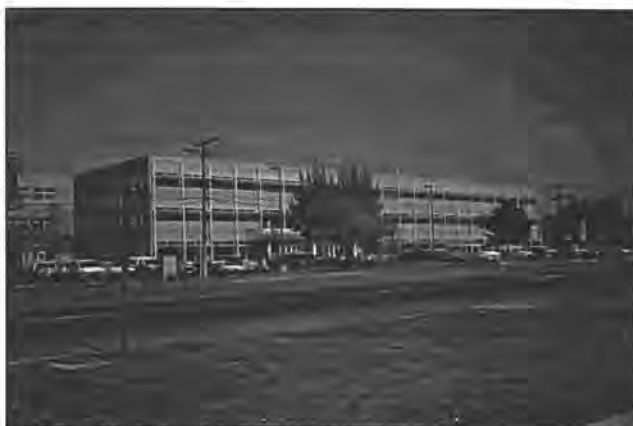
The Department of Natural Resources building (Figure 159) was completed in 1996, and was occupied for only approximately four months prior to the assessment team's visit. Facilities consist primarily of multiple offices and laboratories, and public assistance counters. The foundation is concrete, with concrete block exterior walls. The

Figure 159. Exterior view of the Utah Department of Natural Resources building. The building has natural light reflectors located above the windows.

roof is built-up asphalt. There are multiple windows and doors, and three floors above grade. There are two collections storage areas within the archaeology section on the third floor.

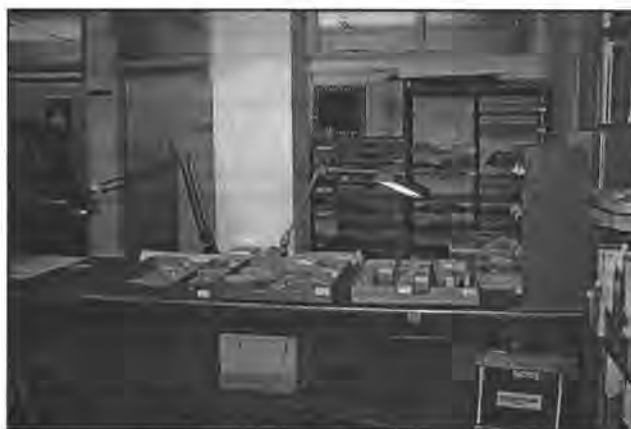
Storage units in both collections storage areas consist of metal uprights and sliding wood drawers. Uprights measure 44 x 22 x 71 inches (w x d x h) (Figure 160). Neither uprights nor drawers are consistently labeled.

Figure 160. Collections storage area 1 and the artifact processing area. Artifacts for Dugway Proving Ground are located in this area.

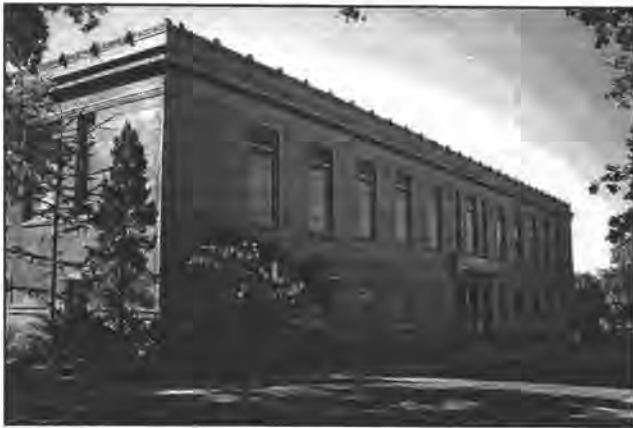
The building was originally constructed as a library in 1935 and since then the interior of the Museum has undergone several renovations (Figure 161). The exterior of the building has a concrete foundation and brick walls. The roof is made of built-up asphalt

Figure 161. View of the exterior of the Utah Museum of Natural History.

and has been redone several times. The Museum has multiple exterior windows. All of these windows are aluminum framed with ultraviolet protective screens and show no evidence of water and/or air leaks. There are no doors to the exterior of the repository from any collections storage area.

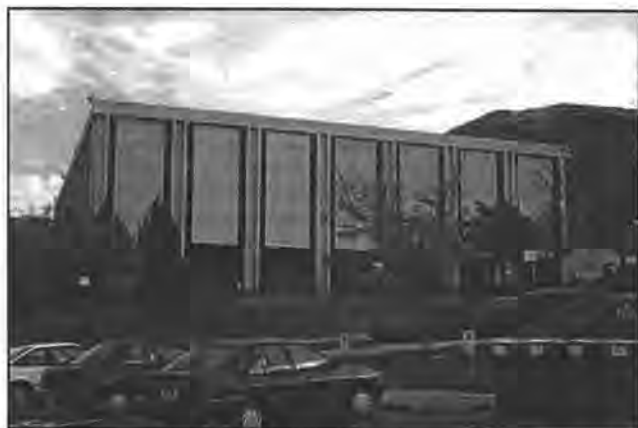
The building was originally constructed in 1972 as the Social Sciences Building (Figure 162). The WSU archaeology laboratory consists of three rooms. One room is devoted to office space and two large rooms serve as the processing and collections storage area, as well as equipment storage.

The building has a concrete foundation and brick exterior walls. The roof is made of built-up asphalt. The building has three floors above grade and one below grade. The WSU archaeology

Figure 162. Exterior view of the Social Sciences building on Weber State University, which is the location of the archaeology laboratory.

laboratory is located in the floor below grade. The building is solid, with no major cracks or leaks. There are multiple exterior windows.

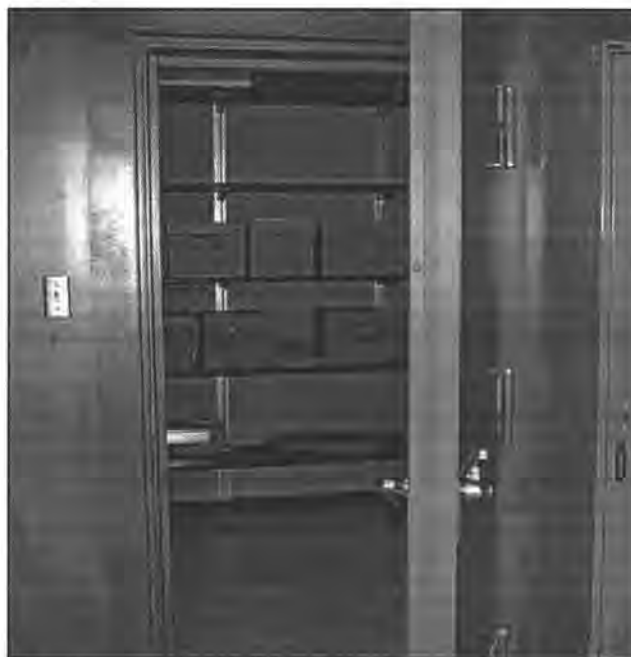
Archaeological materials for Utah Test and Training Range/Hill Air Force Base are stored in collections storage area 1, which is the vault (Figure 163). Storage units for the archaeological collections consist of plywood/particle board shelves with a veneer finish. There are five shelves that measure 6.7 x 1.5 x 7.3 feet (h x w x d). Utah Test and Training Range/Hill Air Force Base artifacts are located on two of the five shelving units. The boxes are not overstacked or cluttered. The storage area also contains some equipment.

Figure 163. Artifact collections for Utah Test and Training/Hill Air Force Base are located in the collections storage area 1, a large vault.

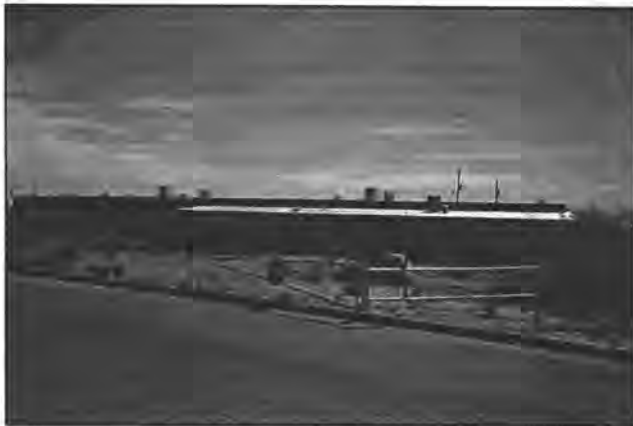
Wilderness Park Museum (WPM), (Figure 164), which is owned and operated by the city of El Paso, has donated space to EPAS for their headquarters and laboratory. In exchange for space, EPAS provides assistance to WPM in the form of volunteer labor, research, exhibit development, and publication support. EPAS occasionally acted as a contracting organization in the past and was responsible for conducting several archaeological projects on Fort Bliss lands in the 1960s and 1970s. EPAS is

Figure 164. The El Paso Archaeological Society has offices and laboratory space at the Wilderness Park Museum.

presently holding 158.7 ft³ of boxed artifacts, including the skeletal remains of at least two individuals (2.3 ft³) and two bedrock mortars currently incorporated into an outdoor exhibit, and 5.1 linear feet of documentation for Fort Bliss, Texas. Collections storage is presently overflowing, with nearly half of the boxed materials at EPAS currently stacked on the floor.

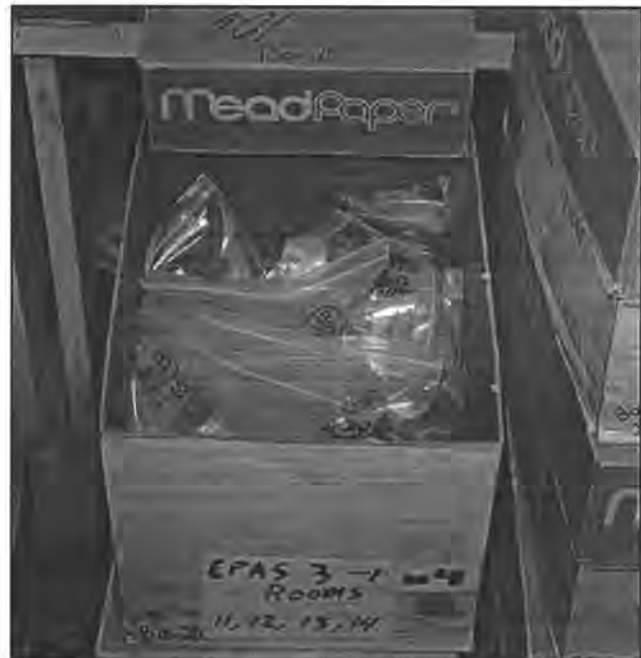
Figure 165. Collections from Fort Bliss have acidic cardboard boxes as primary containers and plastic zip-lock bags as secondary containers.
