Cape Romain National Wildlife Refuge

Climate Change Impacts

How will the Refuge be Affected by Climate Change?

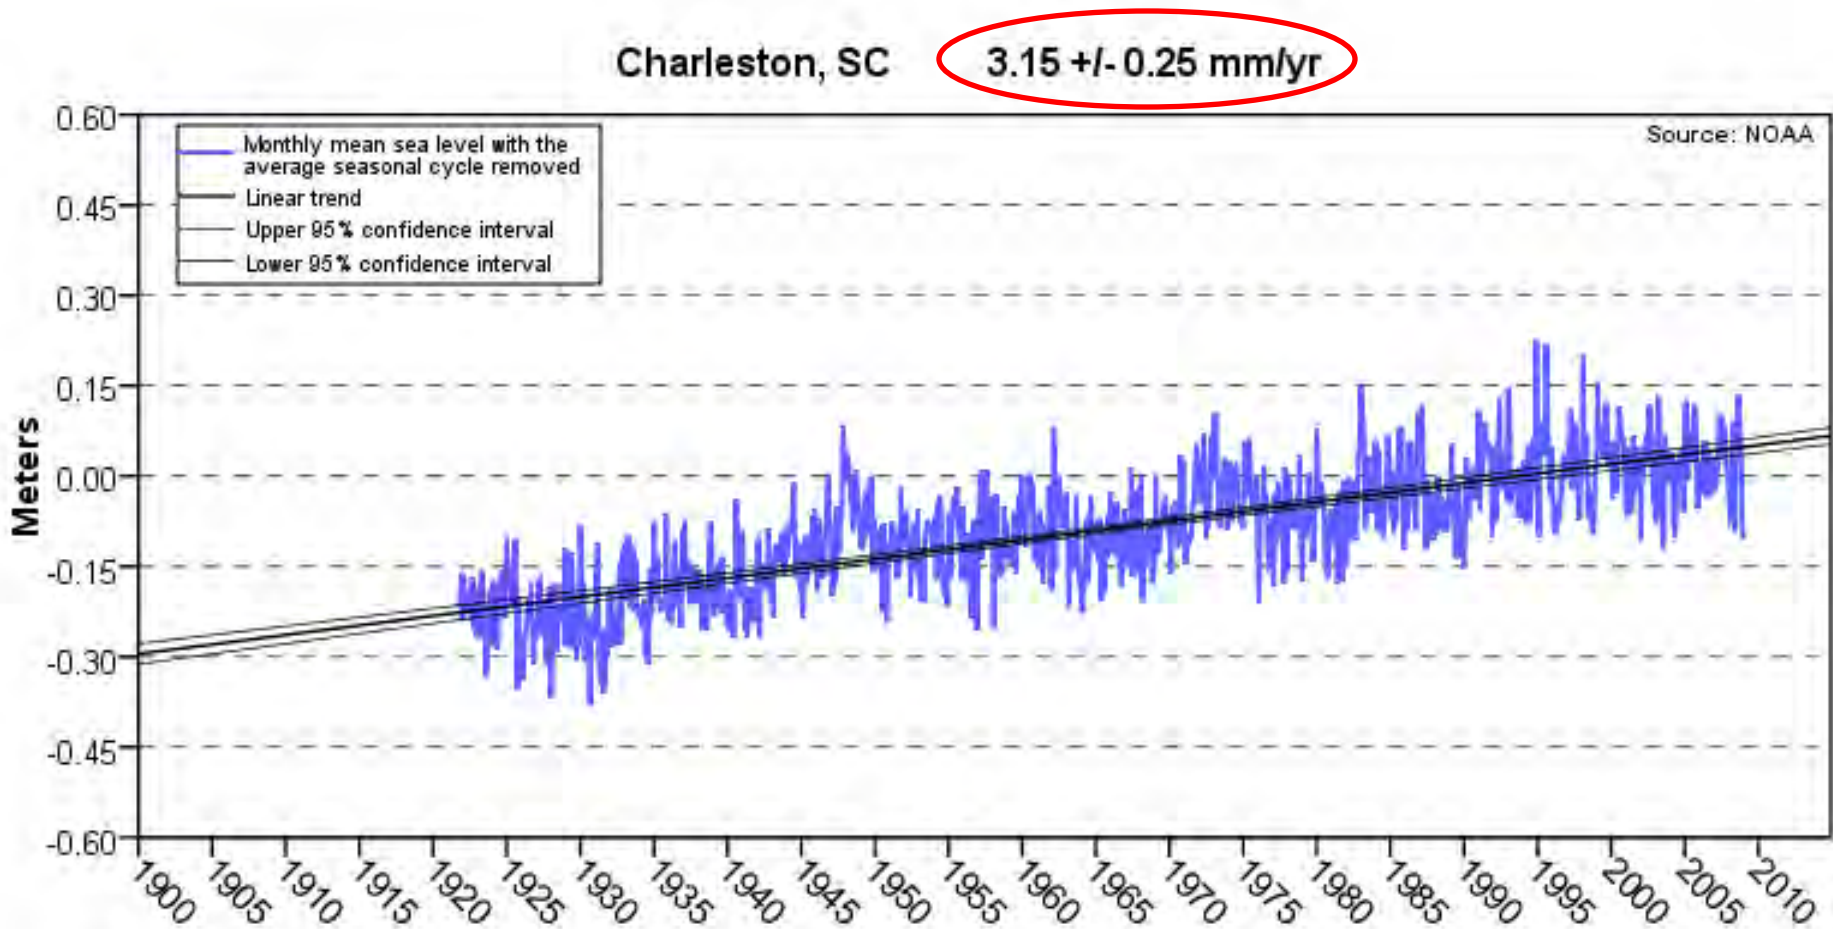
Sea Level Rise Charleston Harbor Since 1923

In the past 100 years - sea levels have risen 3.15 mm/year = 1 foot 4 inches
In the past 20 years - 4.6mm/year = 3.6 inches in 20 years, 1 ½ feet in 100 years)

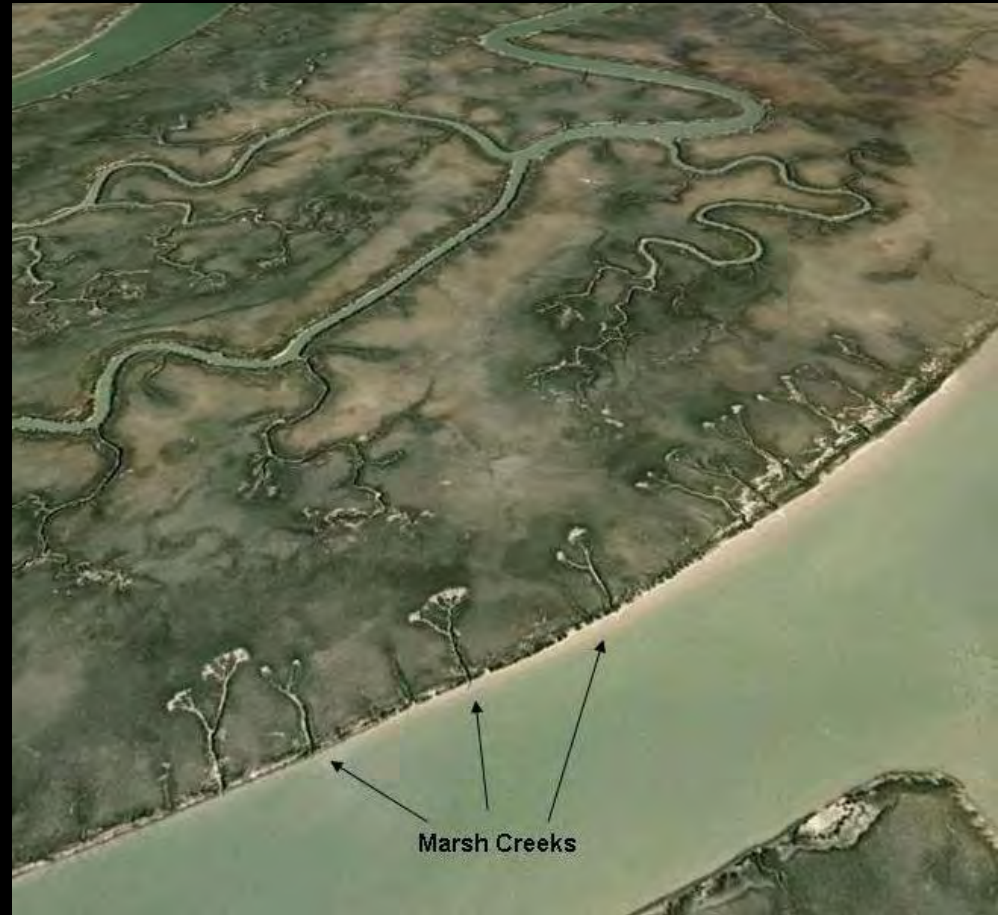
Can the Salt Marsh Keep Up?

- The Capacity of the Marsh to raise and keep up with rate of Sea Level Rise.
- Rate of Erosion of the Seaward boundary of the marsh
- The availability of space for the marsh to migrate inland.
- Amount of head ward erosion in marsh creeks. *Currently 6.2 feet/year*

Hughes et al (2009), Rapid headward erosion of marsh creeks in response to relative sea level rise, *Geophys. Res. Lett.*, 36, L03602, doi:10.1029/2008GL036000.

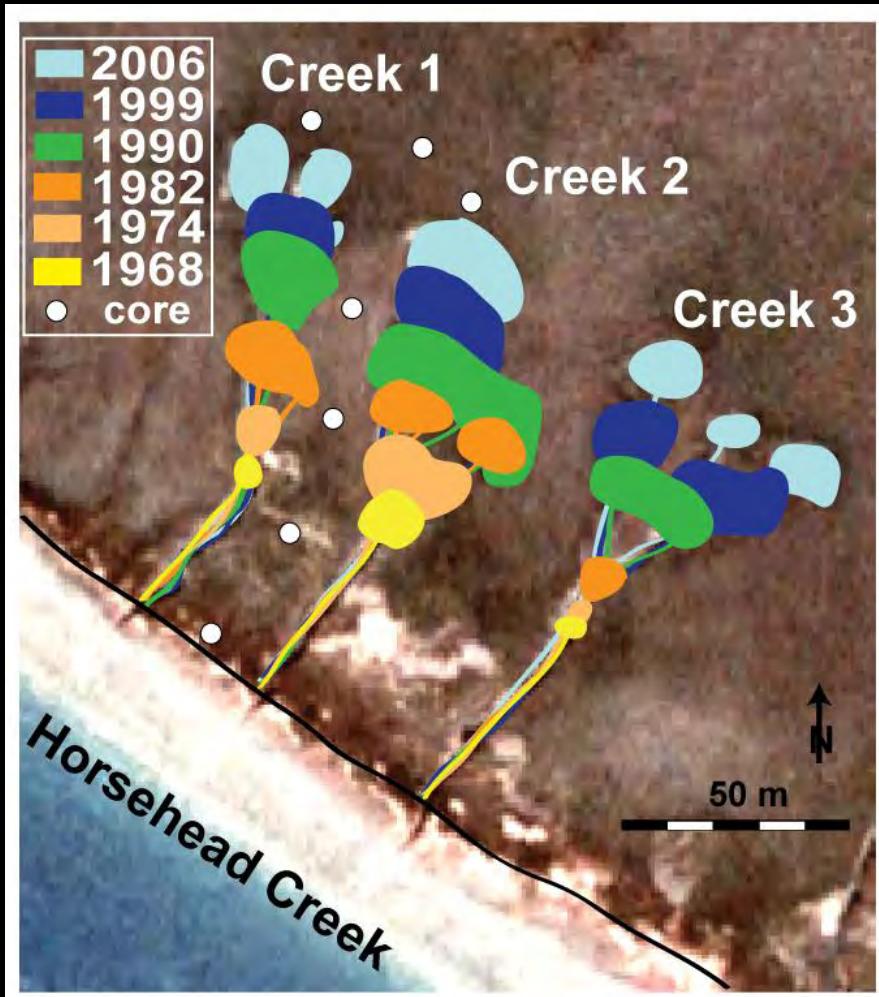
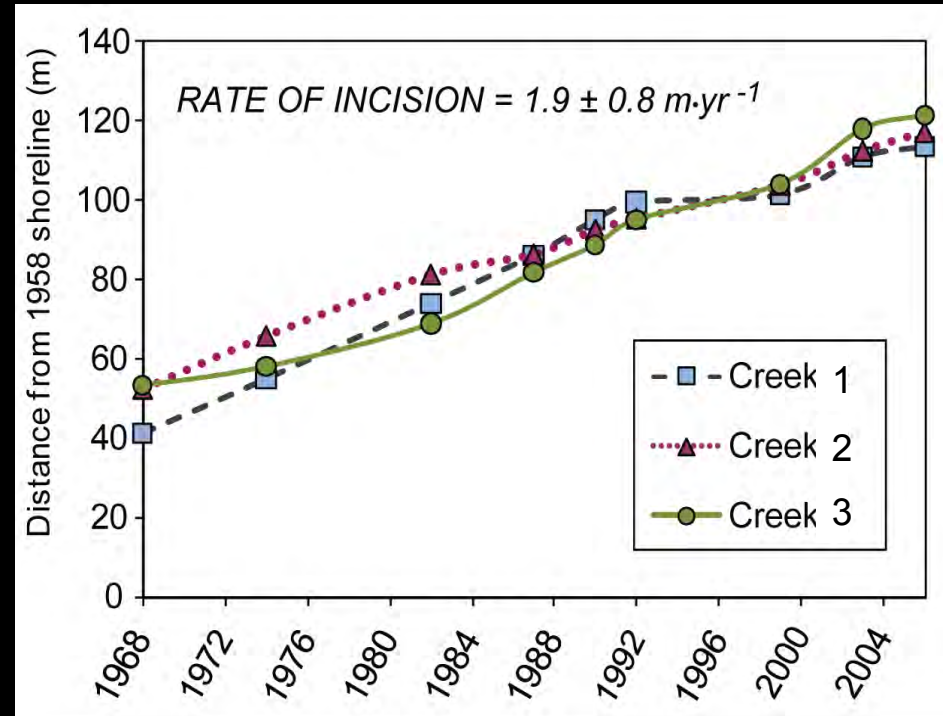
RAPID DEVELOPMENT SINCE 1940's

1968 – 2006

RATE OF INCISION = $1.9 \pm 0.8 \text{ m/yr}$

- Straight, evenly spaced channels forming rapidly
- Area of high regional SLR and very local SLR due to damming (increased hydro period).
- Accumulation limited by dams
- Channel network expansion relates to increased tidal prism
- Ability to erode the marsh facilitated by vegetation removal and bioturbation (crabs).
- In areas where sediment has sufficiently low strength and high RSLR may respond the same way?

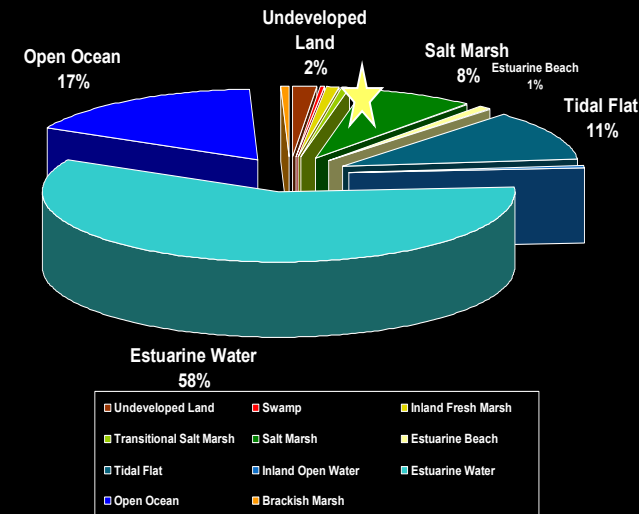
5,301 Salt Marsh Acres by 2100. A loss of 24,519 Acres

* Based on 2.26 Feet SLR over next 100 years

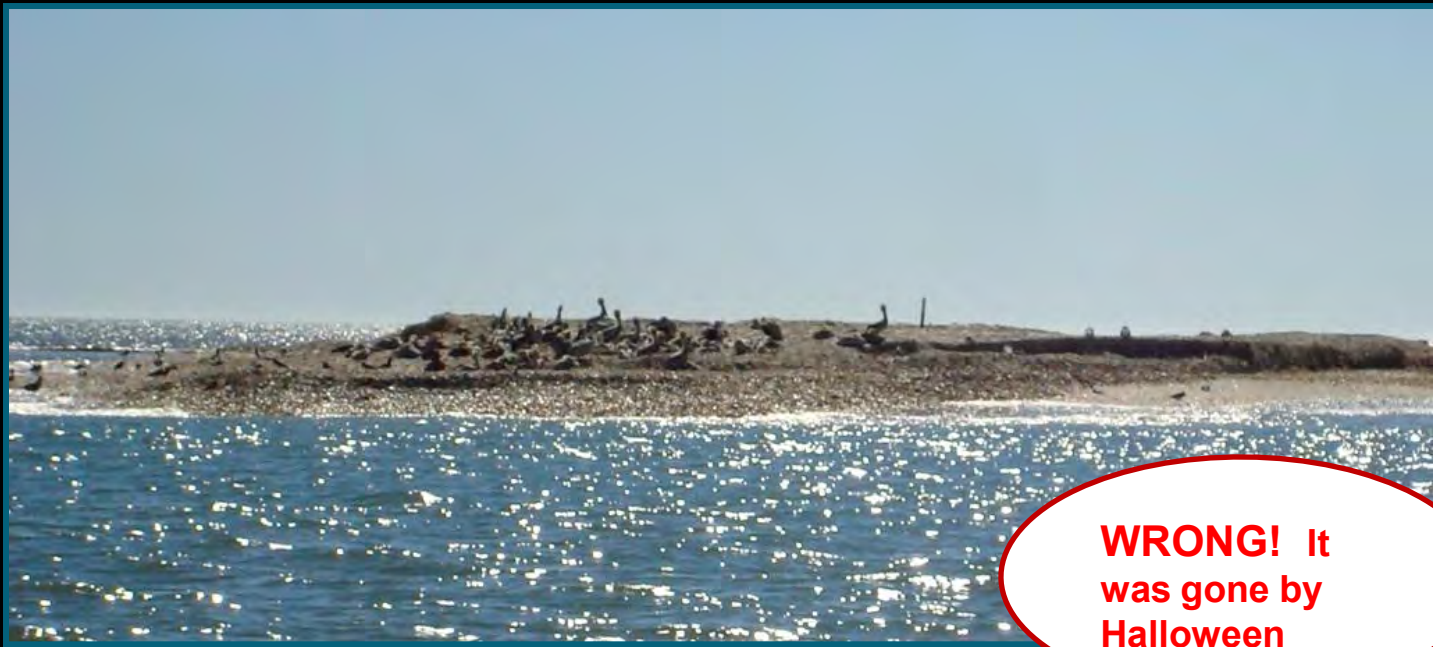
All That Remains of Sandy Point February, 2009

Prediction - Gone by Christmas, 2009

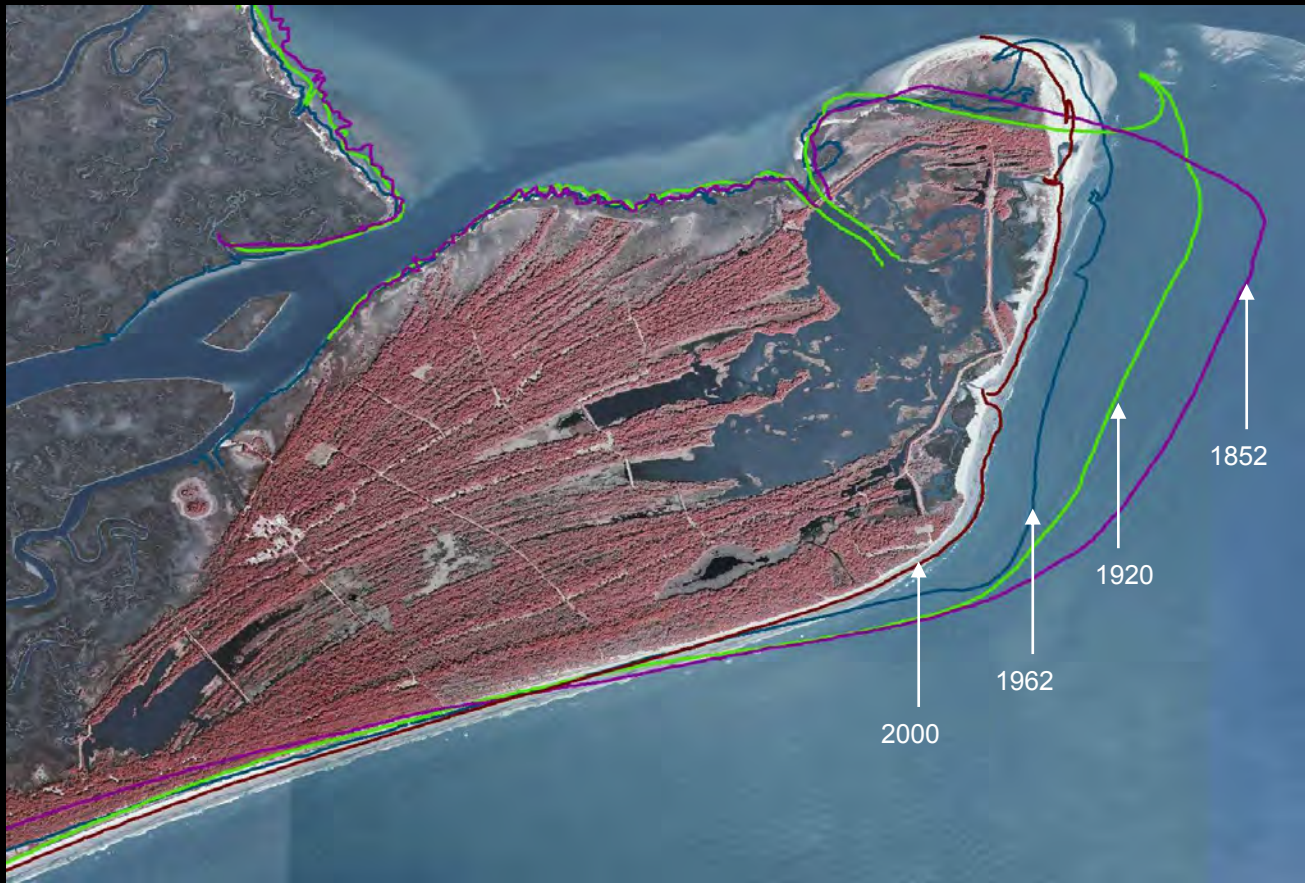
Bulls Island Historic Shorelines

Compared to today's shoreline:

1852: 2,950 ft

1920: 1,885 ft

1962: 870 ft

2000: 225 ft

Average rate of erosion:

20 to 25 ft/yr

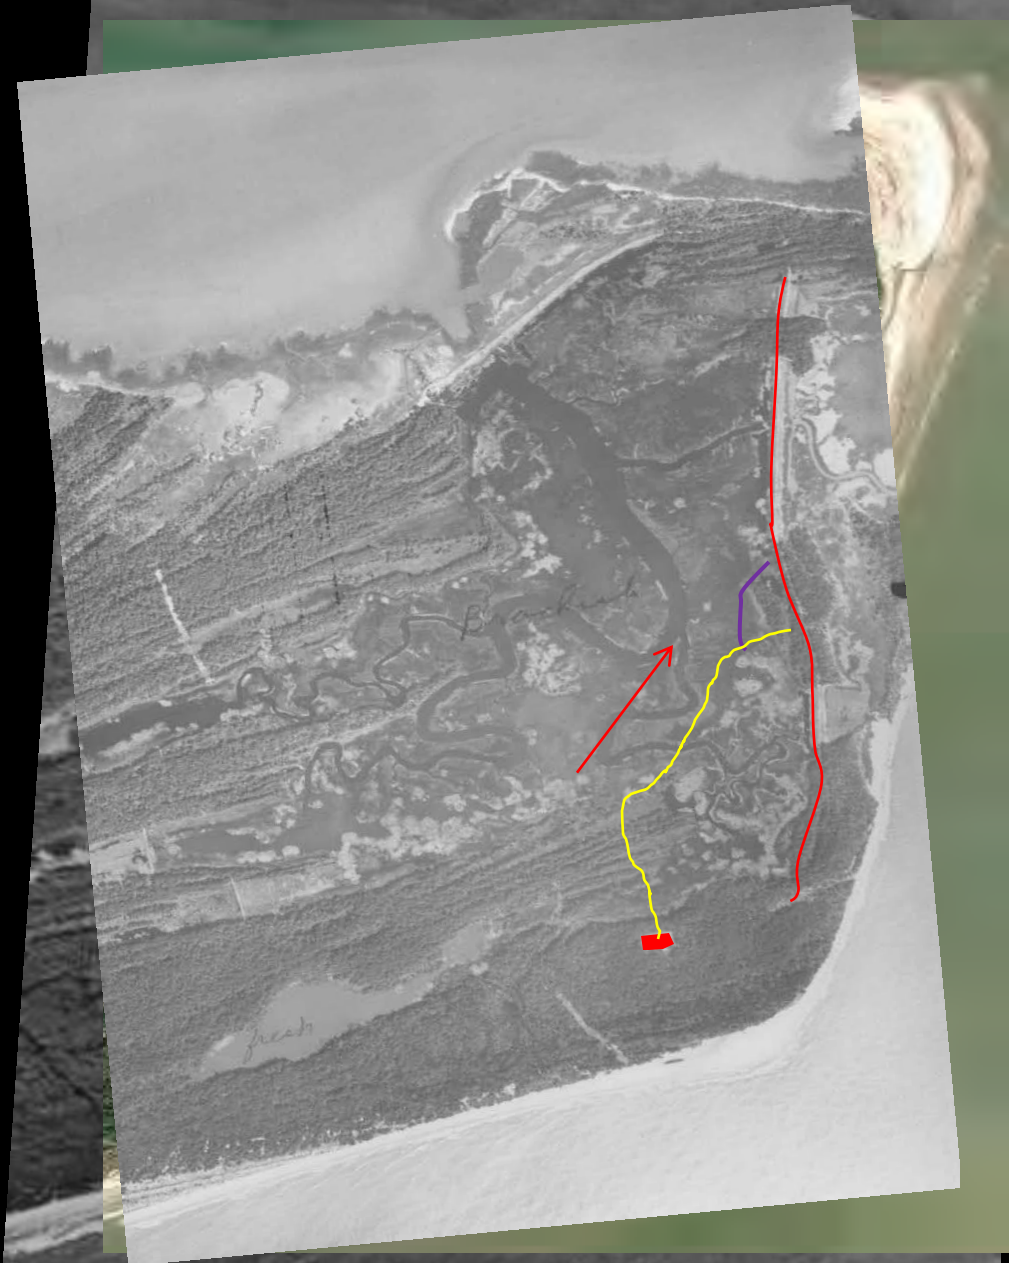
Jack's Creek

- Position of Levee in 1949
- Current Levee constructed 1988
- Redirected levee 2006

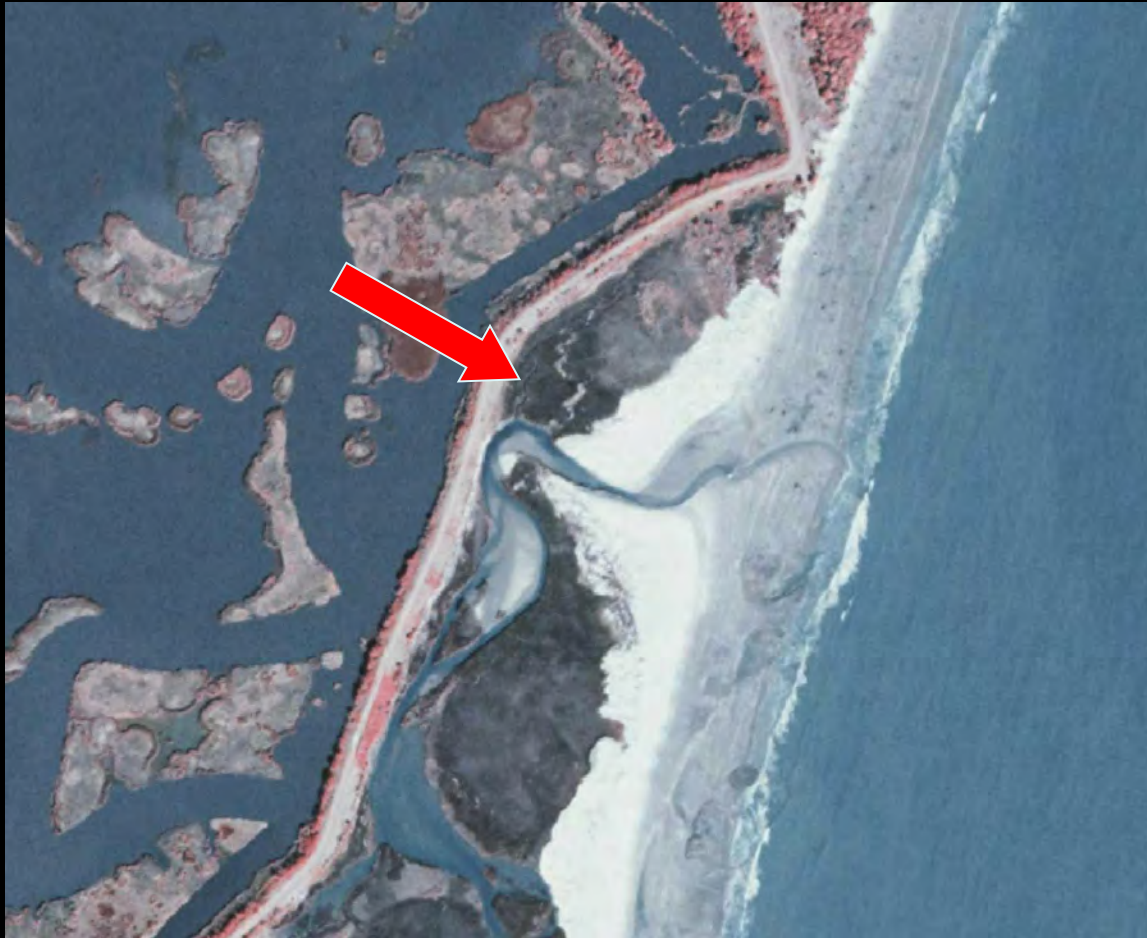
Future Breach

How long before the next breach in the Levee?

± 5 years

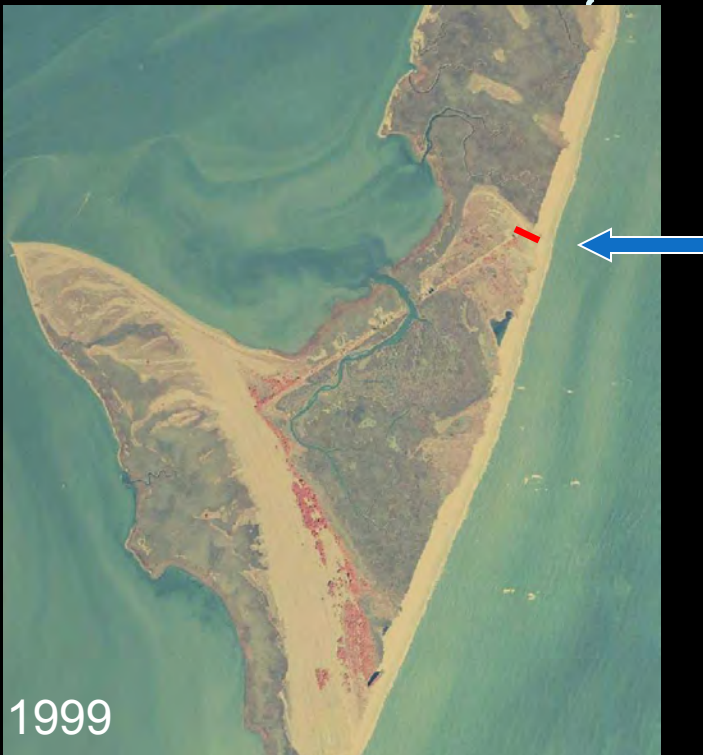
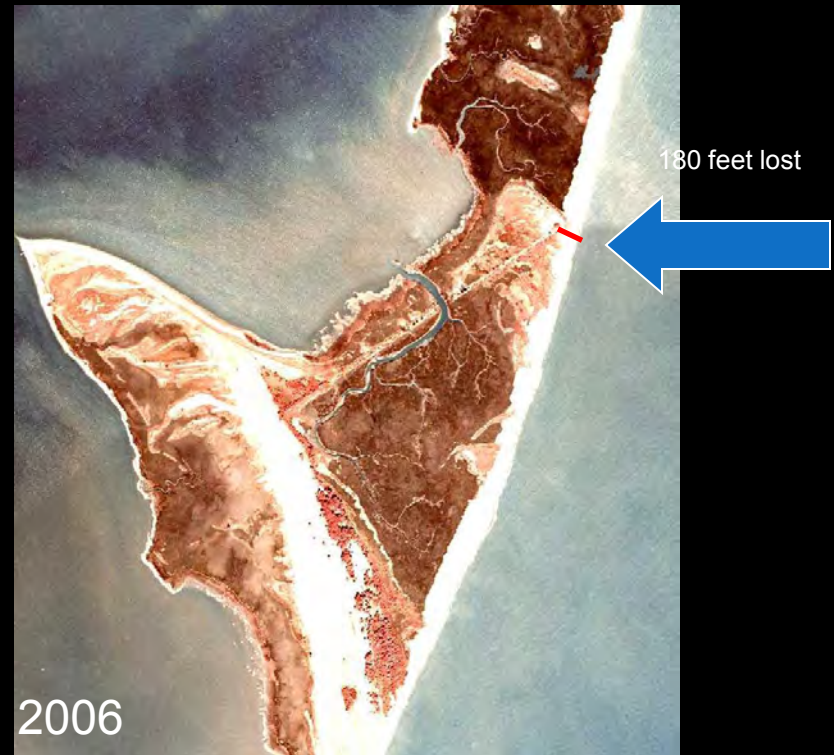
Cape Island

Between 1999 and 2006, approximately 180 linear feet of beach shoreline width was lost to erosion.

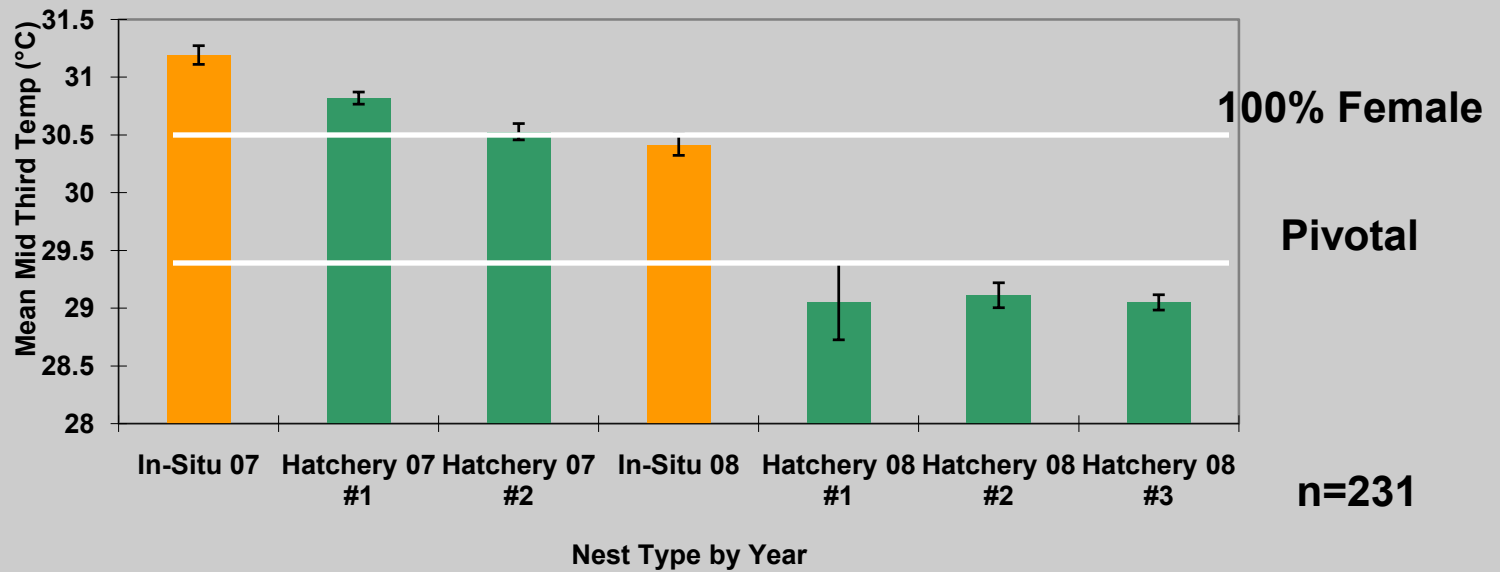
Temperature determines Sex Ratio

Increase in temperature could skew sex ratios.
