River Corridor Closure Project

Recovery Act Weekly Report

For the week ending May 20, 2011

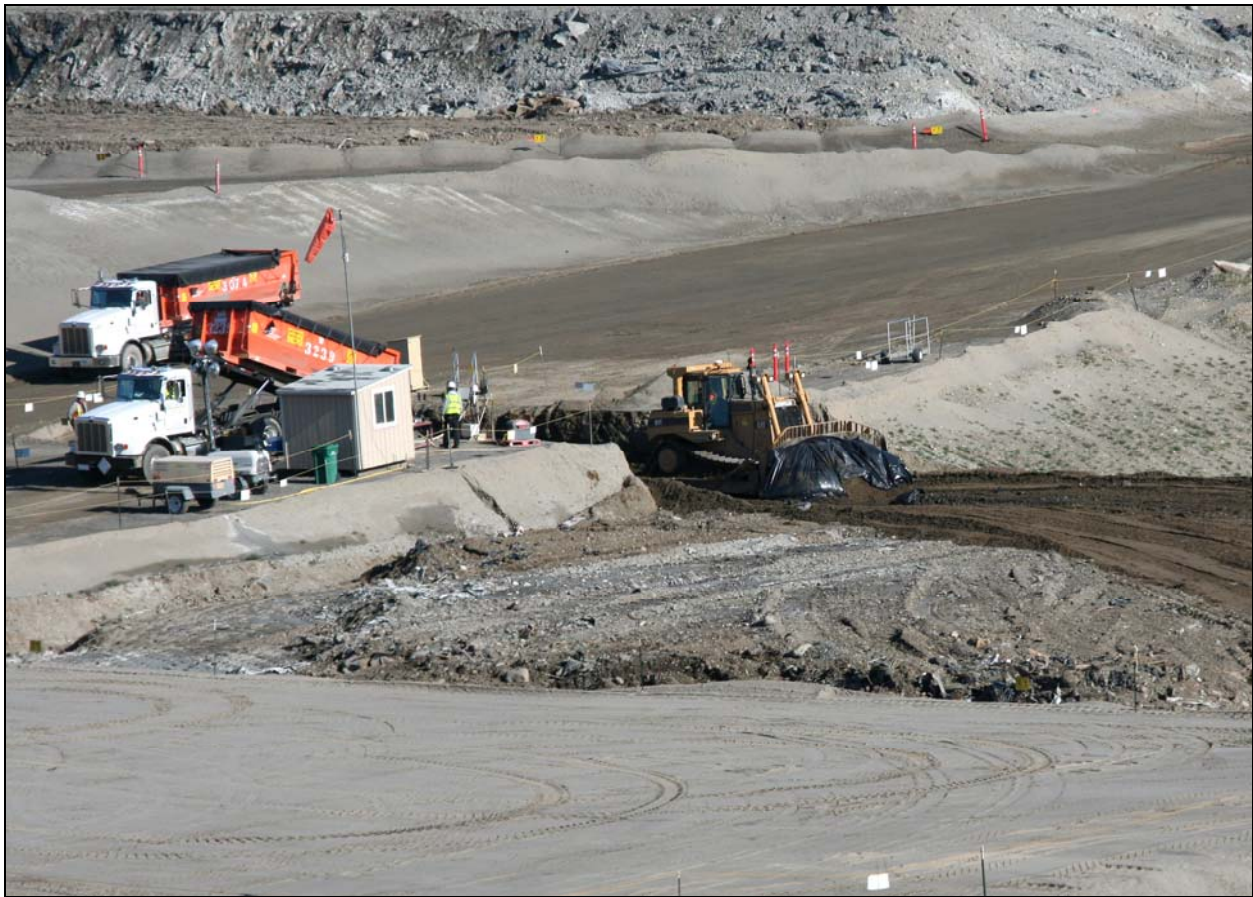
Waste is disposed in super cell 9 at the Environmental Restoration Disposal Facility. (Photo 1)

WCH and subcontractors TradeWind Services and DelHur Industries completed construction of super cells 9 and 10 in February. Super cell 9 was placed into service in February, and super cell 10 was authorized for use in early May.

The addition of the super cells increased ERDF's capacity by 5.6 million tons to a total of 16.4 million tons. The expansion project, initially scheduled to be completed by September 30, 2011, was finished 7 months ahead of schedule and nearly \$16.4 million under budget. The construction of super cell 10 included upgrades to the leachate transmission pipe and construction of two new leachate storage tanks.

The project team used lessons learned from previous cell construction to devise the design for the super cells. A super cell is equivalent to an existing pair of cells – 1,000 feet long, 500 feet wide, and 70 feet deep – and is more cost-efficient because it simplifies the leachate collection system. The super cell design eliminated 12 inches of drainage gravel and requires fewer pumps, motors, crest pads, valves, and other pieces of equipment. The result was a cost reduction of \$1.5 million per super cell.

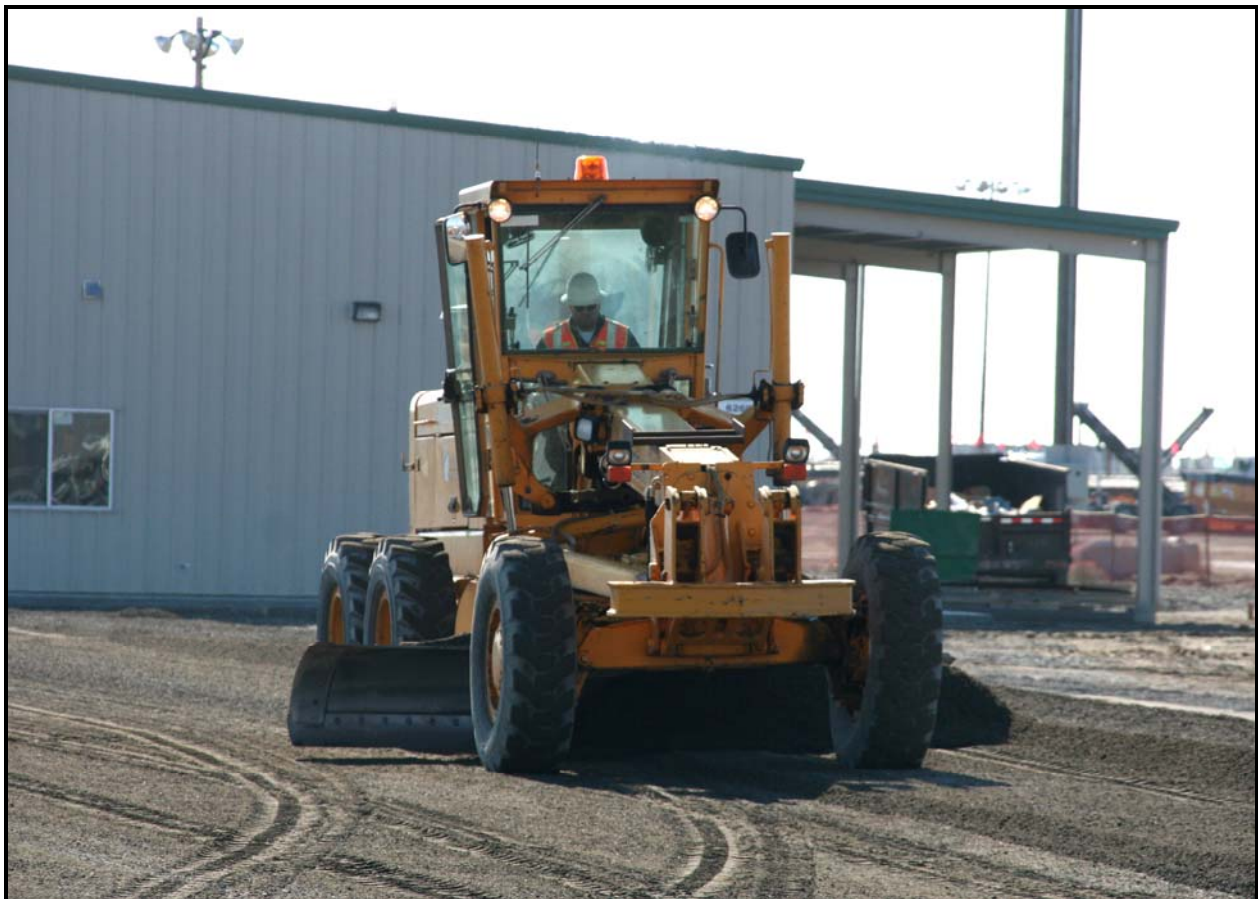
Washington Closure Hanford subcontractor ELRFowler grades the area between the container maintenance facility and the equipment maintenance facility/operations center. (Photo 2)

WCH continued to make progress with construction of the new maintenance facilities at ERDF. The project team is installing electrical, plumbing, HVAC, and fire sprinklers in the transportation maintenance facility and the equipment maintenance facility/operations center. Finish work continued at the container maintenance facility.

The container maintenance facility will include a large container repair line, a maintenance shop, and a weld area. The equipment maintenance facility will include two service lines, an operational storage facility, a large concrete pad, and an exterior awning over a smaller concrete pad. The new operations center will help alleviate severe overcrowding of personnel and also accommodate new employees hired to handle the increasing waste volumes.

The expanded transportation maintenance facility will include two additional truck bays, a large concrete pad, an exterior awning that will cover two smaller concrete pads, and a conference room. The project began pouring the concrete footers on the east side of the building.

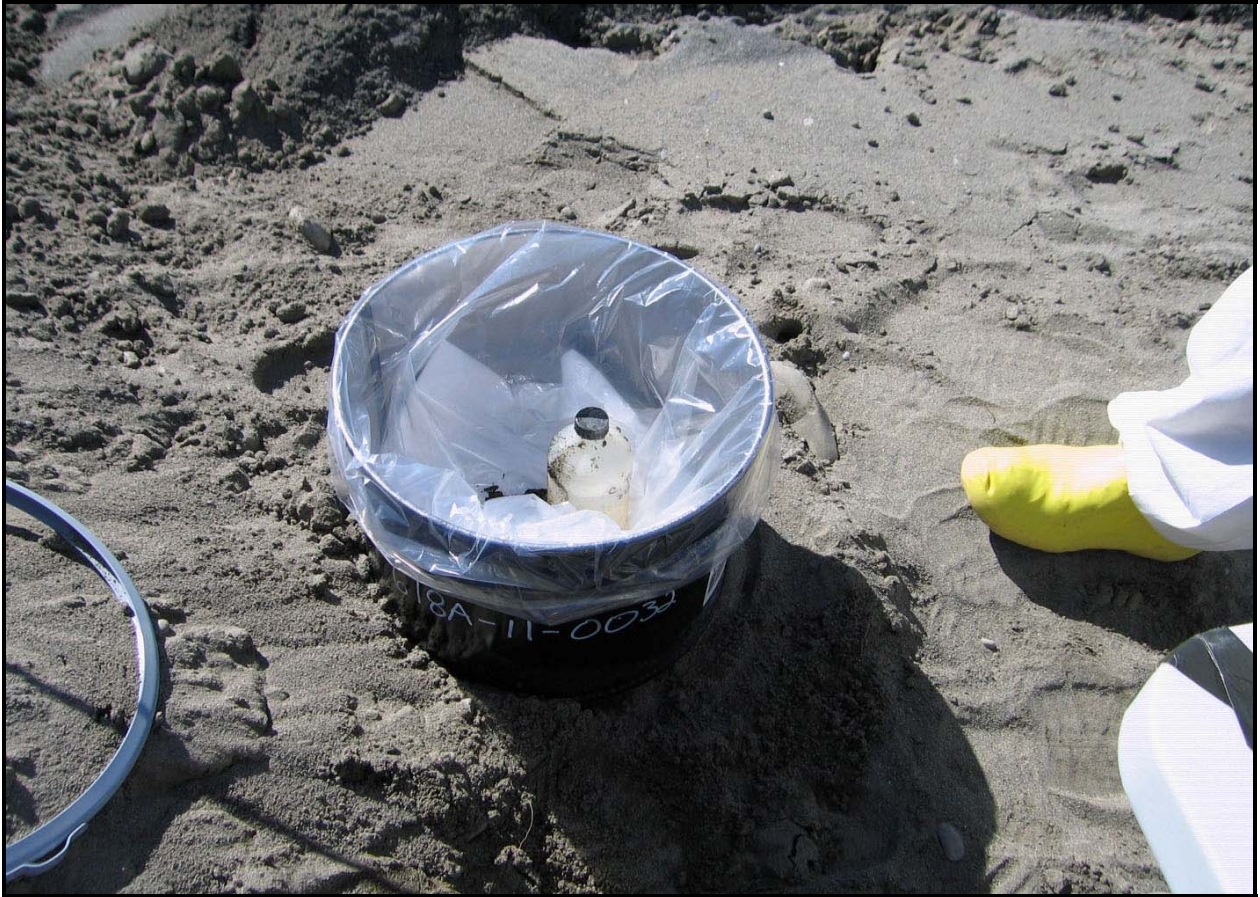
One of numerous bottles found during trench excavation on the north side of the 618-10 Burial Ground. (Photo 6)

WCH continued trench excavation on the north and south sides of the 618-10 Burial Ground. The project team continues to encounter bottles in the north trench. As of May 18, a total of 21,900 bank cubic meters has been removed.

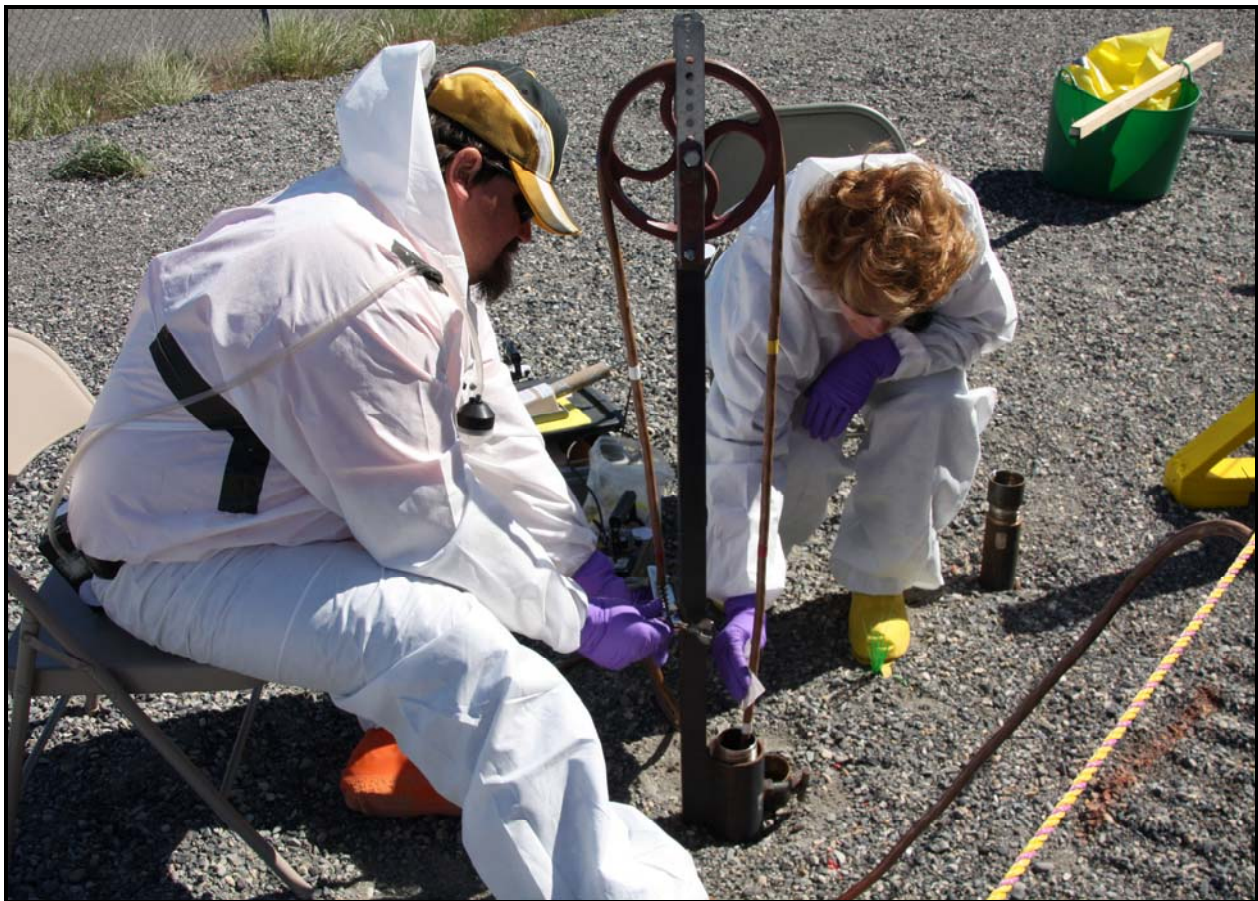
Employees with Washington Closure Hanford and subcontractor North Wind Inc. retrieve a multi-detector probe from a cone penetrometer during nonintrusive characterization of the 618-11 Burial Ground. (Photo 7)

Nonintrusive characterization continues at the 618-11 Burial Ground. WCH subcontractor North Wind Inc. is performing radiological characterization of the vertical pipe units (VPUs).

The project team is inserting a gamma-logging probe into the cone penetrometers to identify the location of radioactive materials within the VPUs. Earlier this month, North Wind installed two cone penetrometers (narrow steel tubes) about 6 to 8 inches from the exterior of each VPU and to an approximate depth of 6 feet below the VPU.

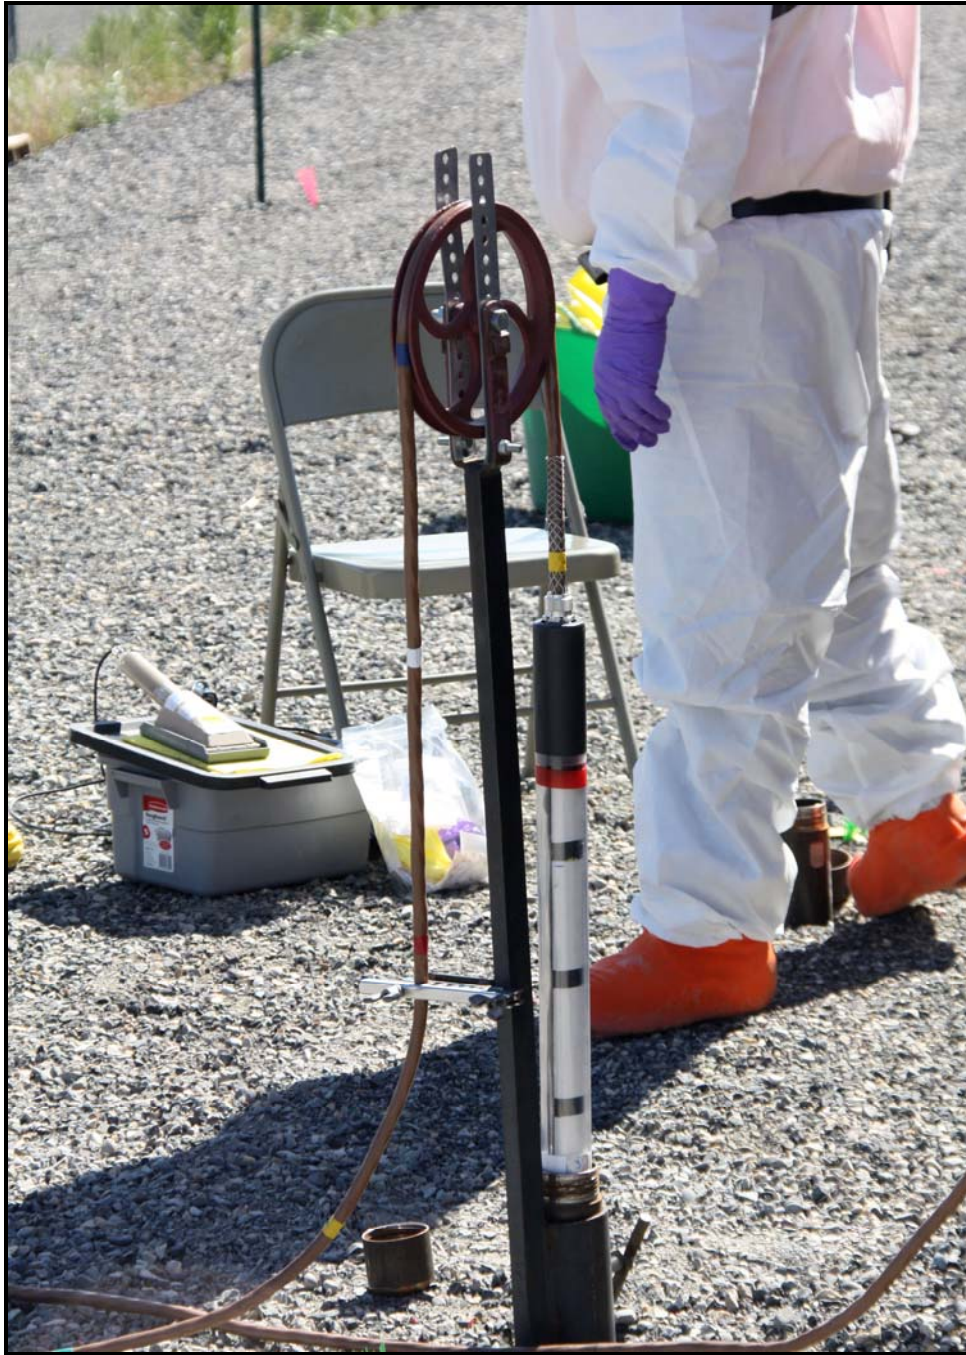
A multi-detector probe is a gamma-logging instrument used to determine the location of the radioactive materials within a vertical pipe unit. (Photo 8)

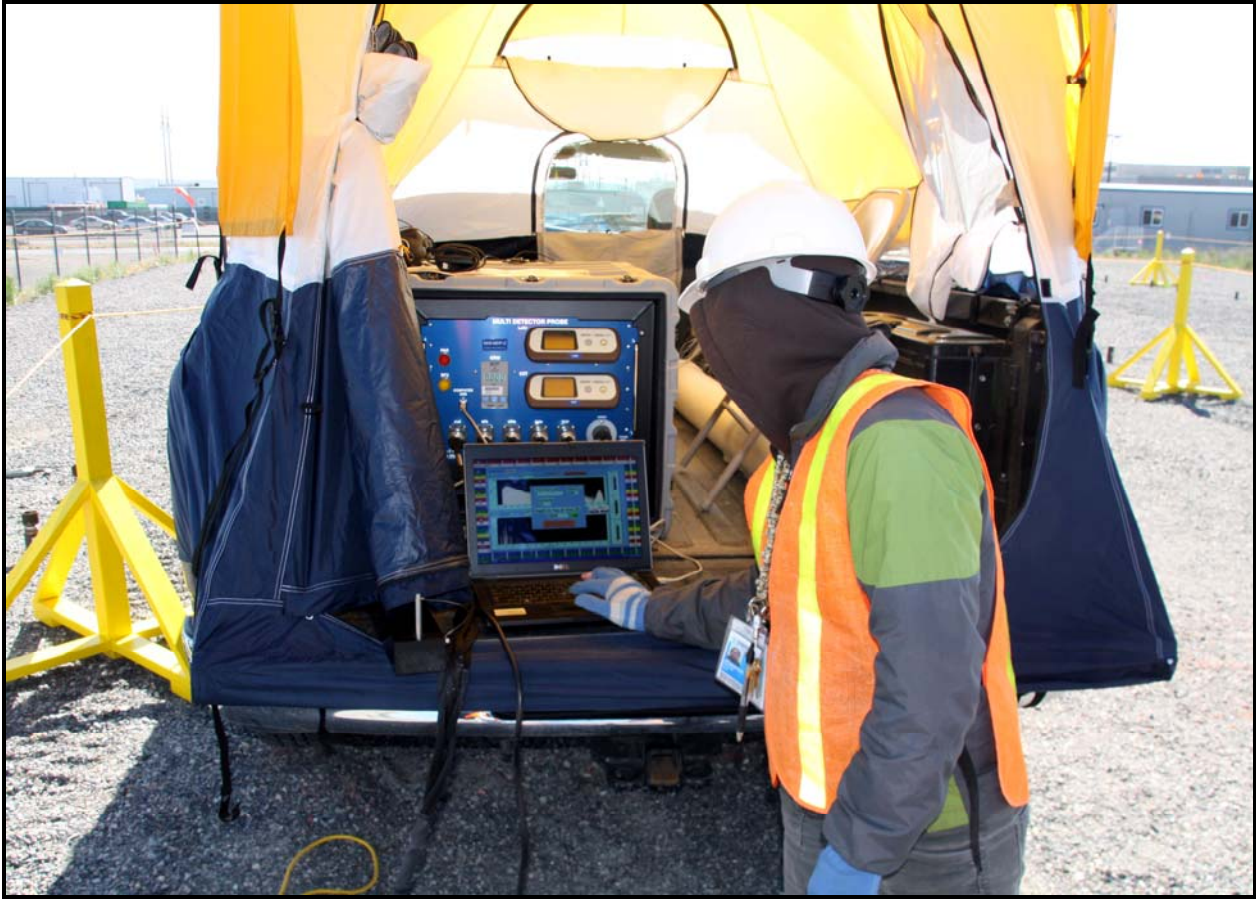
A North Wind employee takes readings during nonintrusive characterization of the vertical pipe units at the 618-11 Burial Ground. (Photo 9)

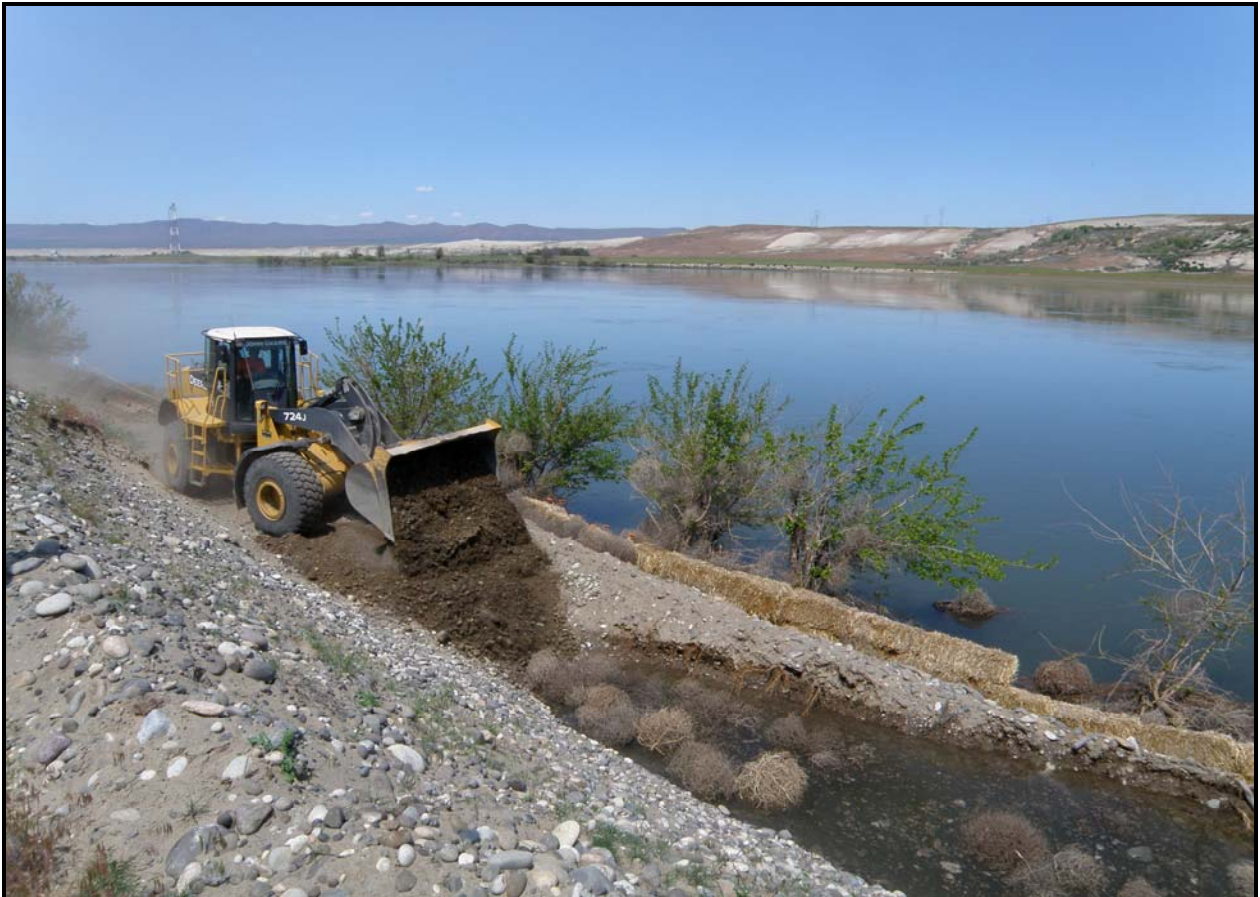
Washington Closure Hanford subcontractor Ojeda Business Ventures backfills site 100-F-45. (Photo 10)

At 100-F-45, very high spring runoff from the Columbia River threatened the excavated waste site. Consequently, closeout sampling design and sample collection proceeded on an expedited basis, rapid laboratory analysis was performed, and the results were shared with the U. S. Environmental Protection Agency. Based on a review of the laboratory data, an expedited approval to backfill the site was received, and subcontractor personnel mobilized and backfilled the site.
