*River Corridor Closure Project*

# **Recovery Act Weekly Report**

For the week ending May 27, 2011

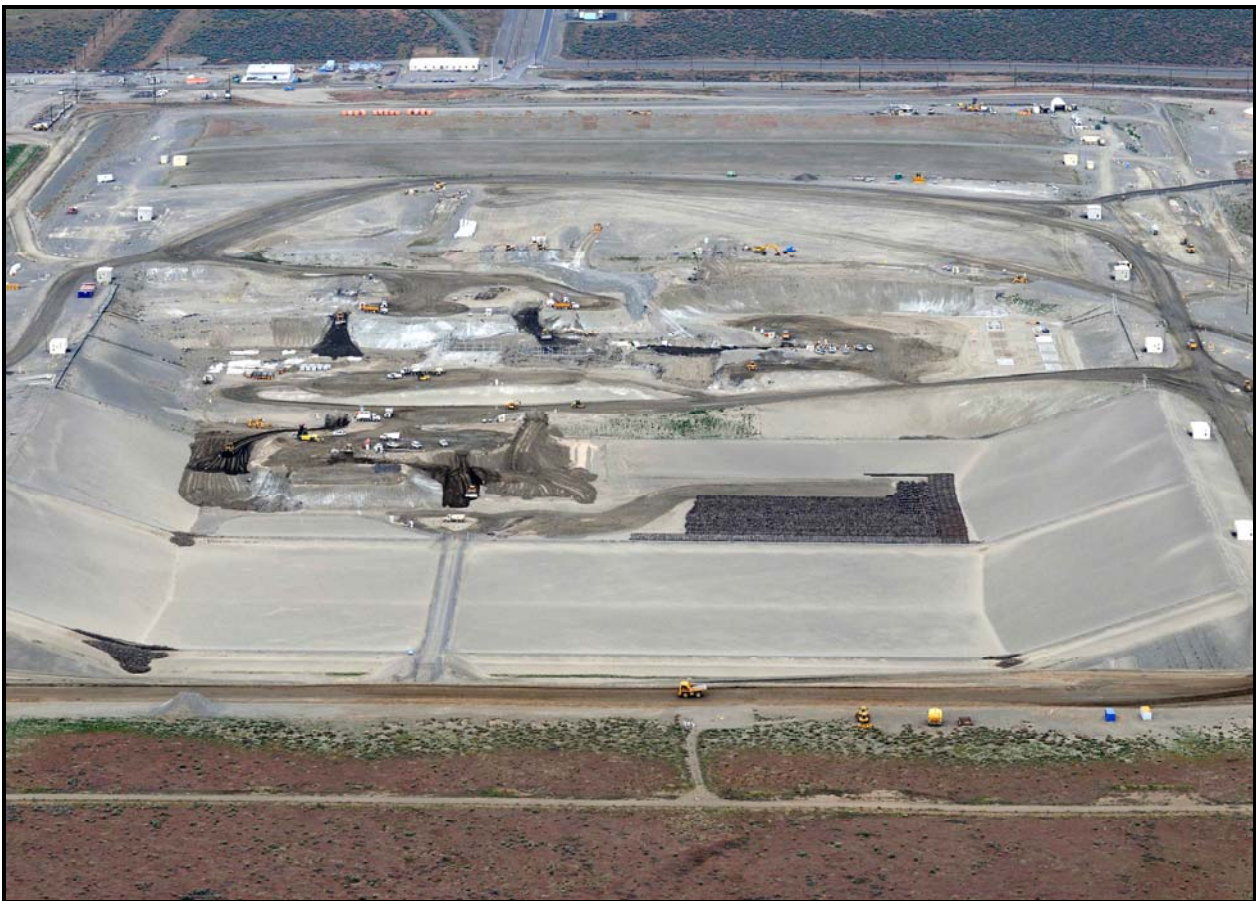
*Super cell expansion increased the capacity of the Environmental Restoration Disposal facility to 16.4 million tons of waste material. Construction was completed ahead of schedule, below budget, and with zero injuries. (Photo 1)*

WCH and subcontractors TradeWind Services and DelHur Industries completed construction of super cells 9 and 10 in February. Super cell 9 was placed into service in February, and super cell 10 was authorized for use in early May.

The addition of the super cells increased the Environmental Restoration Disposal Facility's (ERDF) capacity by 5.6 million tons for a total of 16.4 million tons. The expansion project, initially scheduled to be completed by September 30, 2011, was finished seven months ahead of schedule and nearly \$16.4 million under budget. The construction of super cell 10 included upgrades to the leachate transmission pipe and construction of two new leachate storage tanks.

The project team used lessons learned from previous cell construction to devise the design for the super cells. A super cell is equivalent to an existing pair of cells – 1,000 feet long, 500 feet wide and 70 feet deep – and is more cost-efficient because it simplifies the leachate collection system. The super cell design eliminated 12 inches of drainage gravel and requires fewer pumps, motors, crest pads, valves, and other pieces of equipment. The result was a cost reduction of \$1.5 million per super cell.

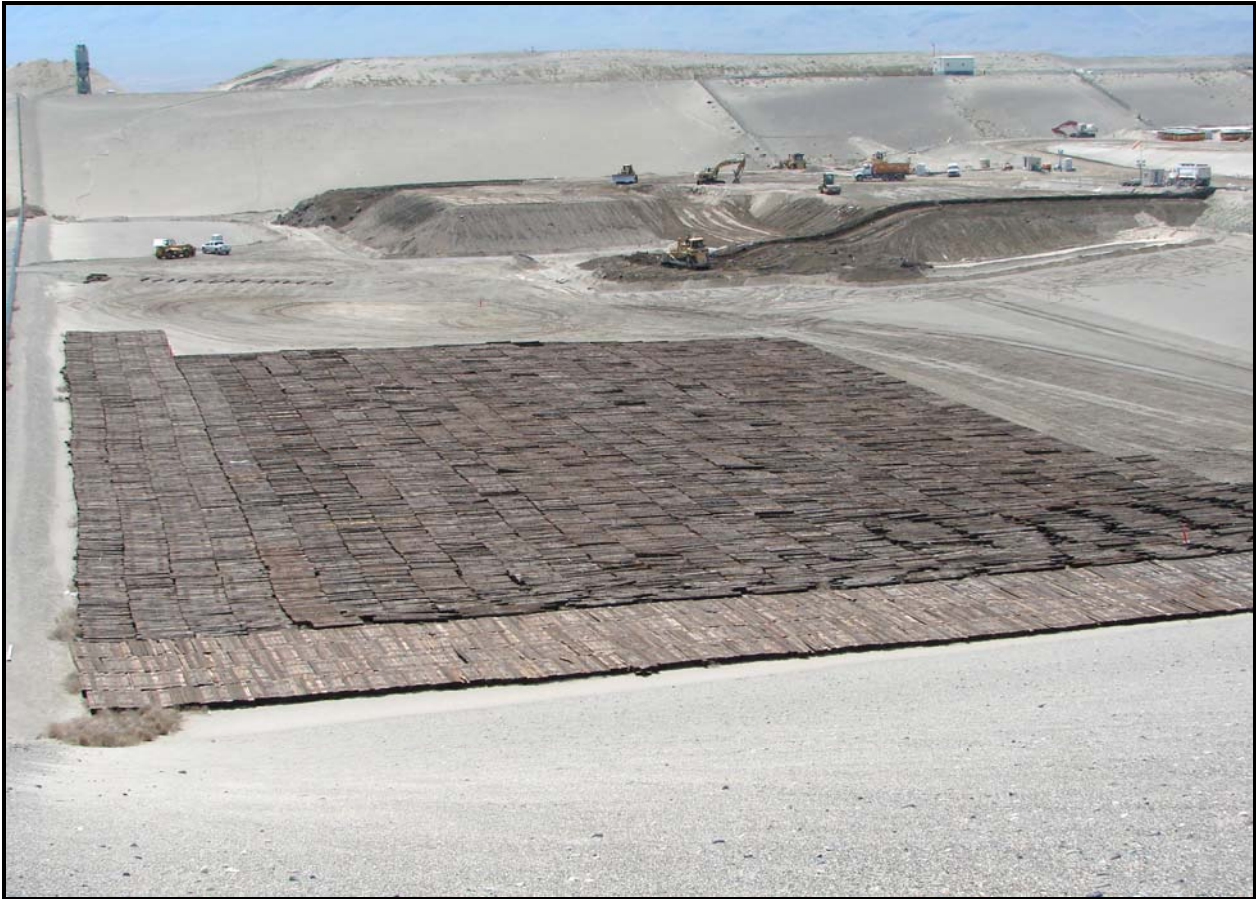
*The Waste Operations team continues to dispose Hanford Site railroad ties in the north end of super cell 9 at ERDF. The facility is expected to receive more than 58,000 ties. (Photo 2)*

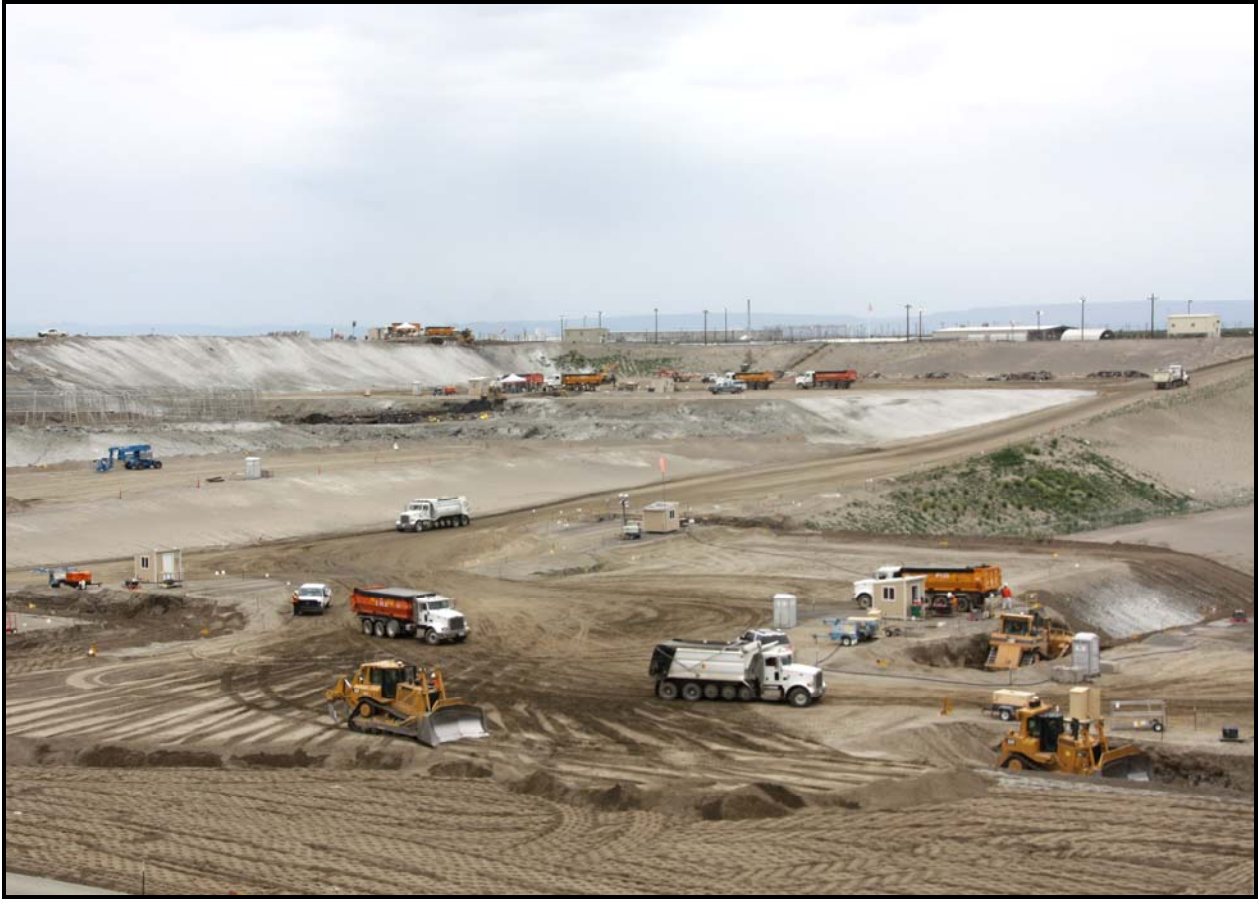
*Two new dump ramps (bottom right) have been constructed in super cell 9 at the Environmental Restoration Disposal Facility. (Photo 3)*

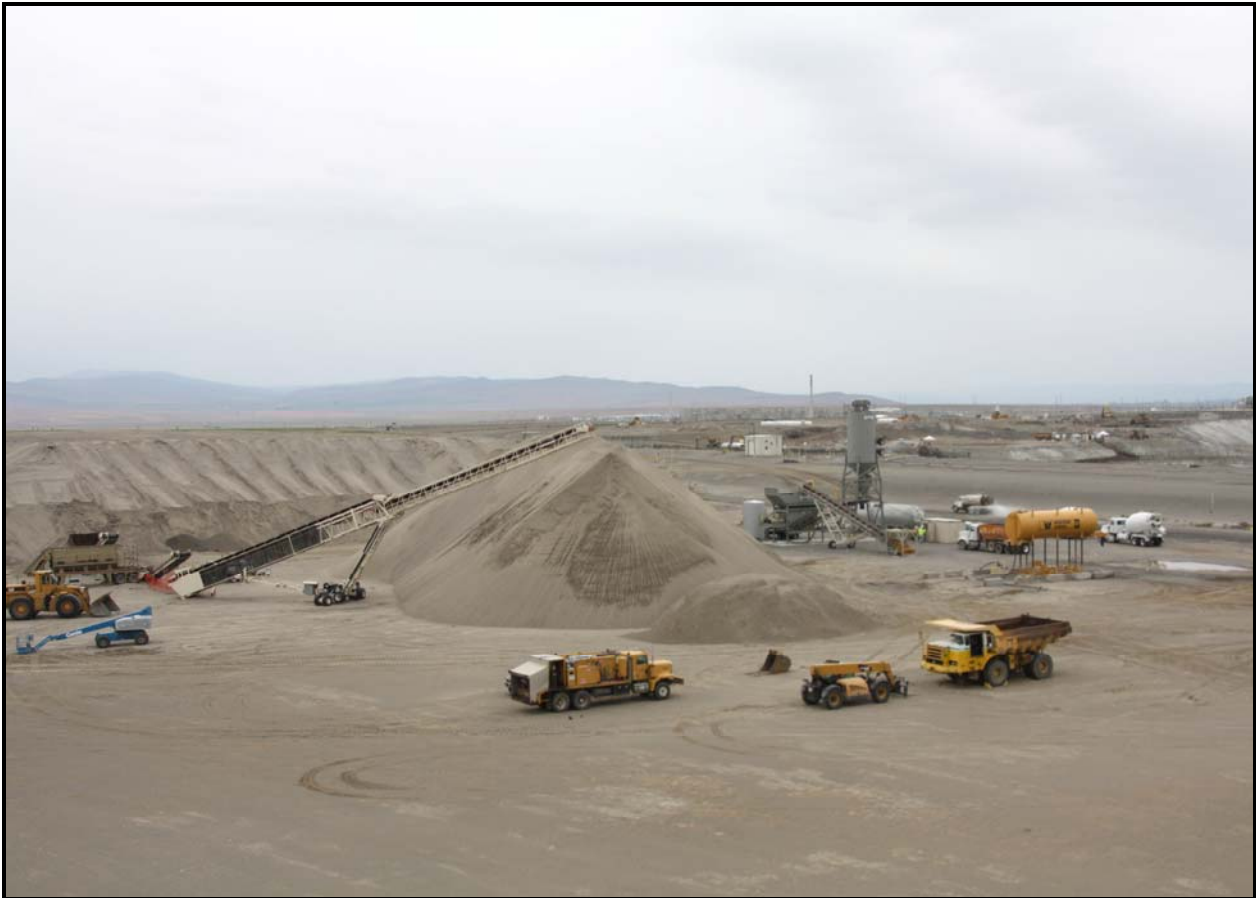
*Washington Closure Hanford subcontractor TradeWind Services began operational testing of ERDF's new batch plant. The plant will be placed into service next month. (Photo 4)*

WCH began operational testing of ERDF's new batch plant. The batch plant will produce concrete used to mix with debris, ensuring no void space during disposal operations. It is expected to be placed into service next month.

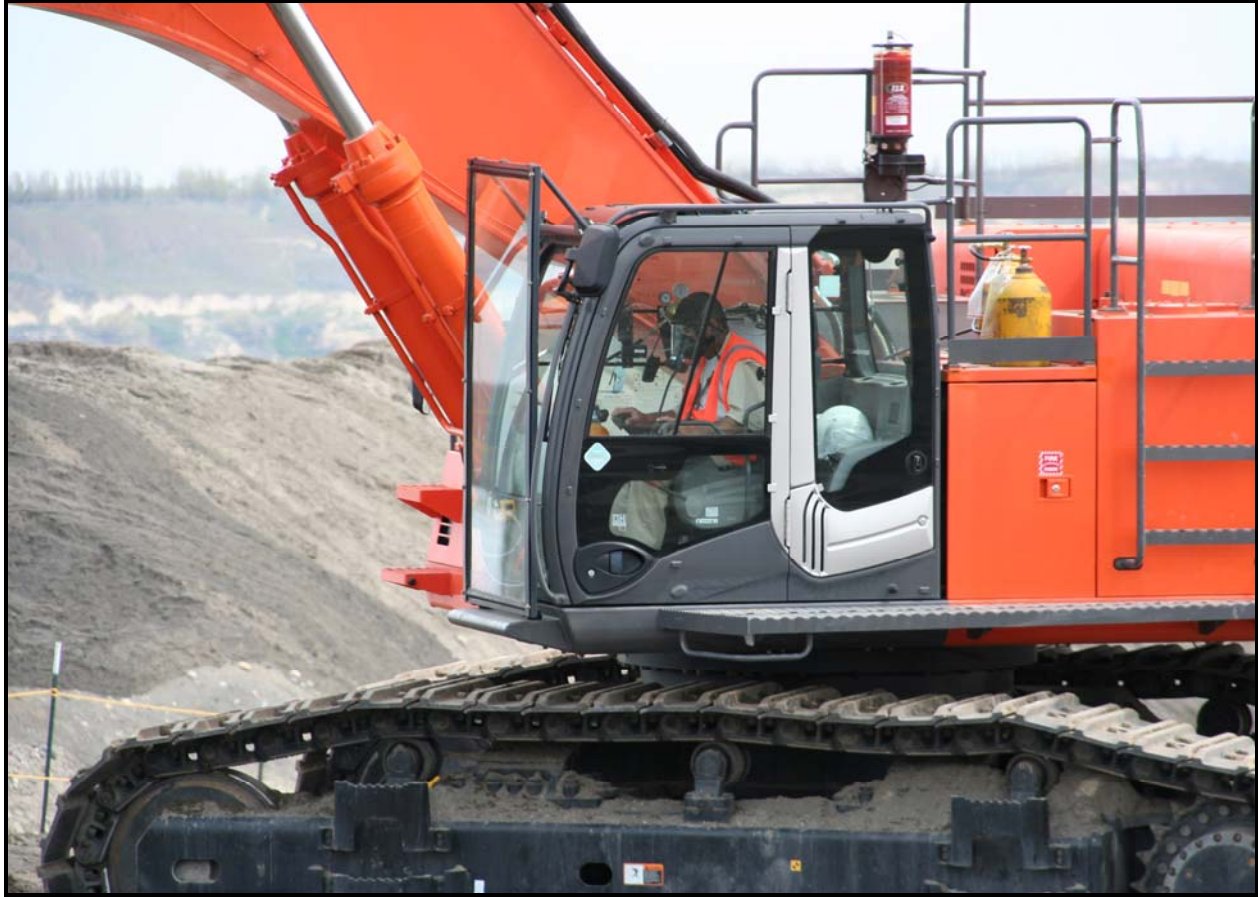
*Washington Closure Hanford continues trench excavation at the 618-10 Burial Ground. The project team has started to encounter drums. (Photo 5)*

WCH continued trench excavation on the north and south sides of the 618-10 Burial Ground. The project team began encountering more drums on the west end of the north trench. As of May 25, a total of 23,400 bank cubic meters has been removed.

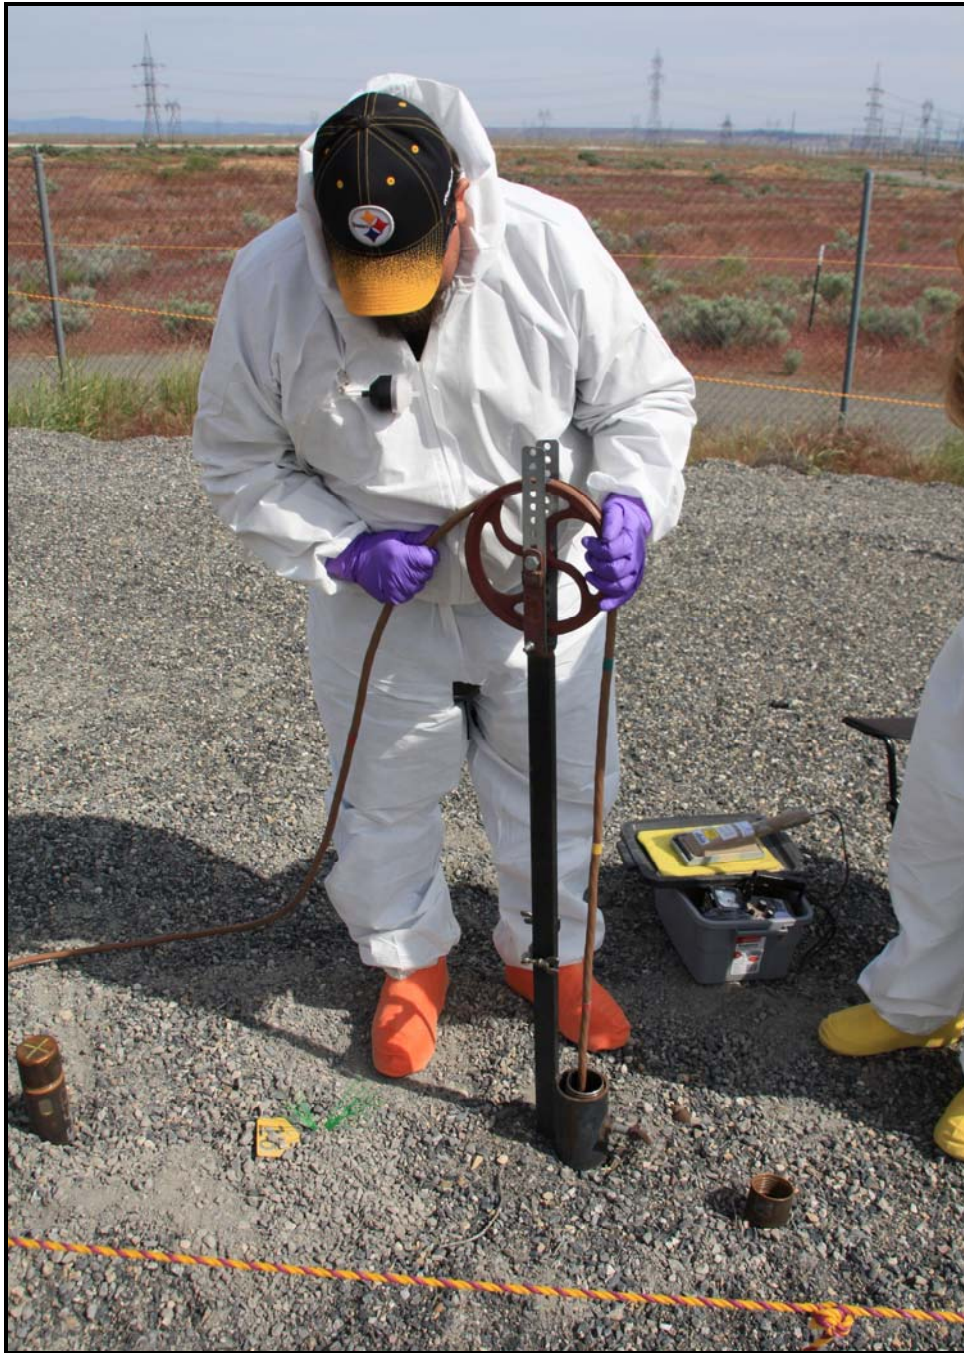
*An employee with Washington Closure Hanford subcontractor North Wind Inc. lowers a multi-detector probe into a cone penetrometer to characterize a vertical pipe unit at the 618-11 Burial Ground. (Photo 6)*

During the characterization process, the project team inserts a gamma-logging probe into the cone penetrometers to identify the location of radioactive materials within the VPUs. Earlier this month, North Wind installed two cone penetrometers (narrow steel tubes) about 6 to 8 inches from the exterior of each VPU and to an approximate depth of 6 feet below the VPU.

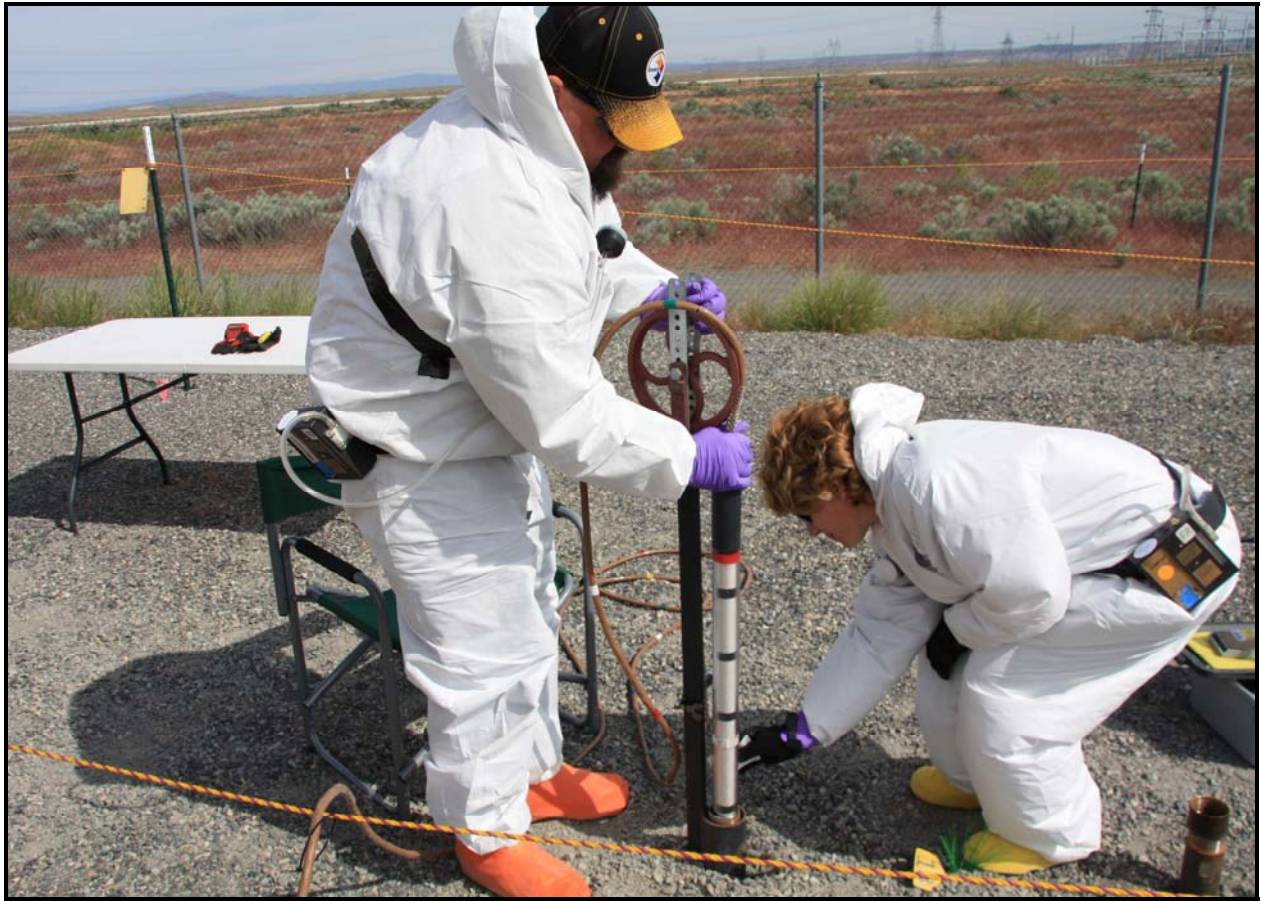
*North Wind employees retrieve a multi-detector probe from a cone penetrometer of a vertical pipe unit during noninvasive characterization at the 618-11 Burial Ground. (Photo 7)*

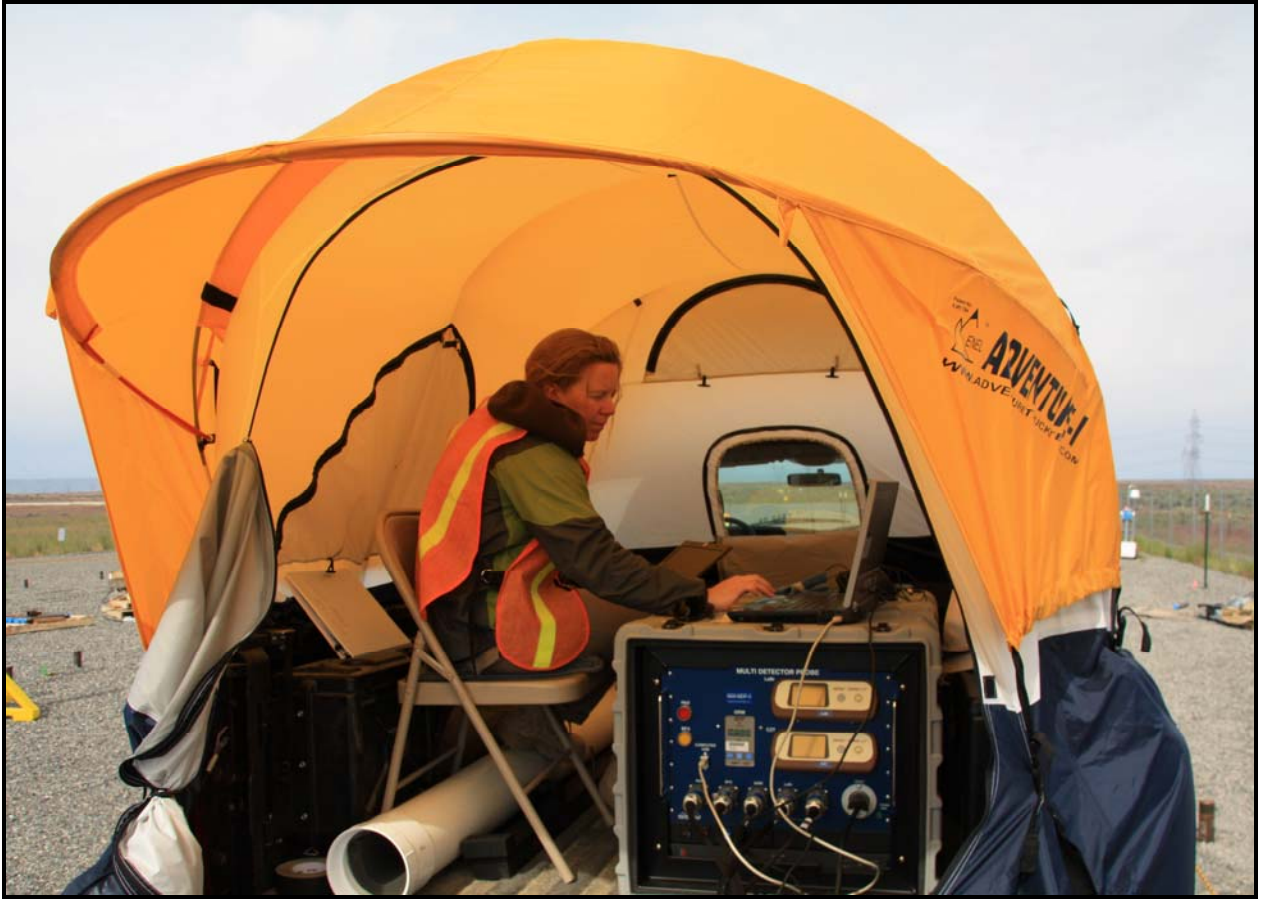
*A North Wind employee takes readings during nonintrusive characterization of the vertical pipe units at the 618-11 Burial Ground. (Photo 8)*

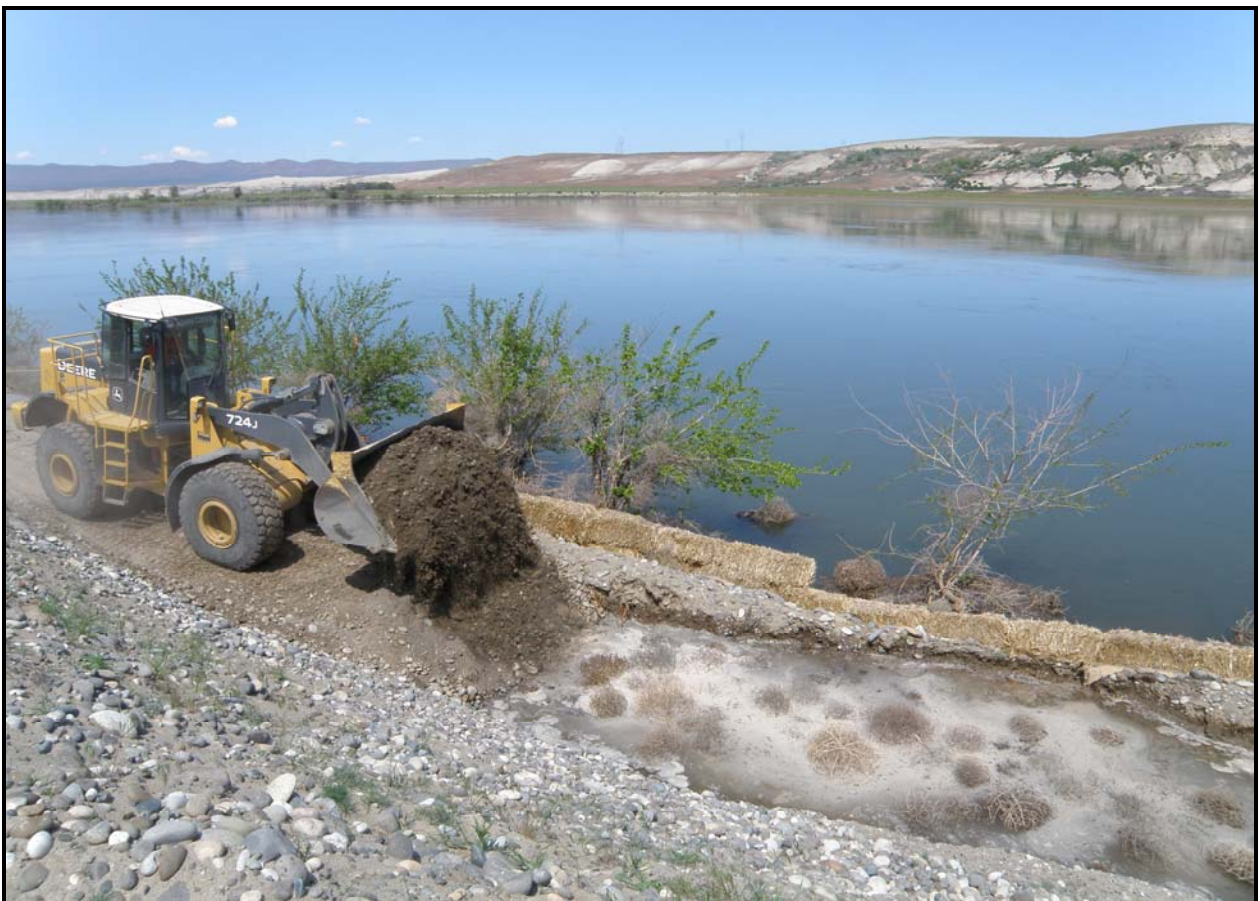
Washington Closure Hanford subcontractor Ojeda Business Ventures backfills site 100-F-45 to protect it from the Columbia River. (Photo 9)

Late last week, the project team backfilled 100-F-45 on an interim basis to protect the site from spring runoff from the Columbia River. Prior to backfilling the site, sample collection was completed, laboratory analysis was performed, and the results were shared with the U.S. Environmental Protection Agency.
