**PHASE I
ENVIRONMENTAL SITE ASSESSMENT**

**Hero Pump Station
Jefferson Parish, Louisiana**

April 2007

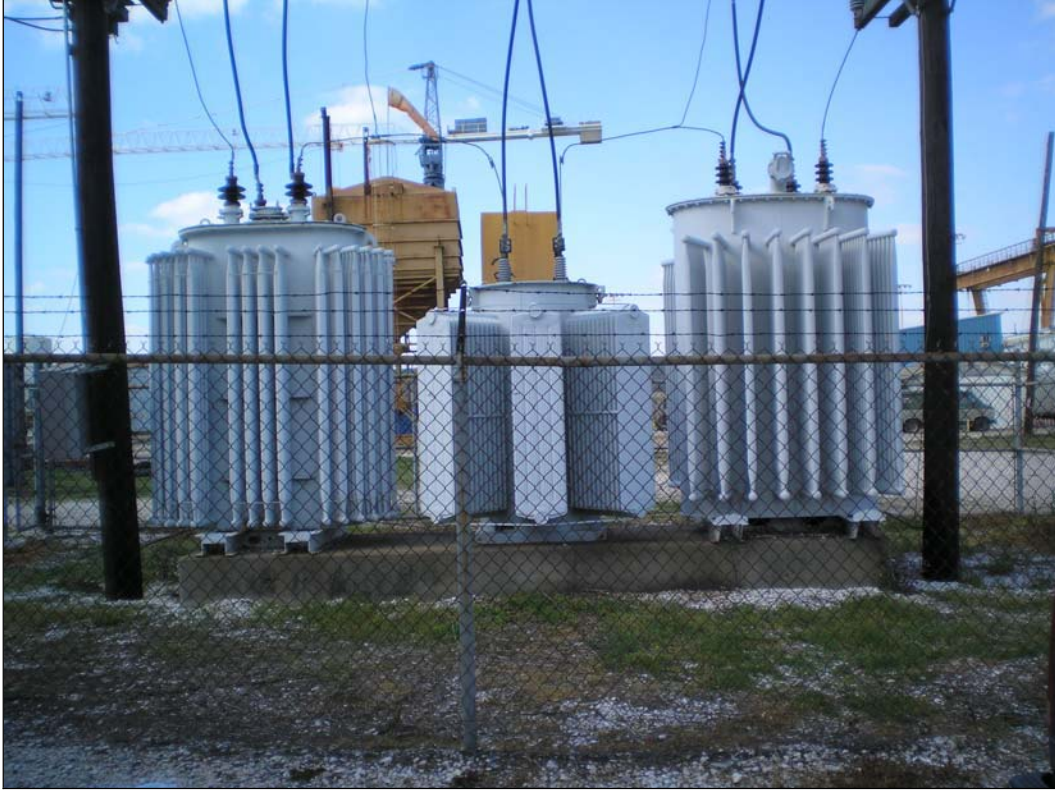
Transformers with unknown PCB content were observed in a fenced and locked enclosure on the property. They appeared to be in good working condition with no visible leaks. A septic tank and drain field was observed on the property, but it appeared to be functioning properly. Sumps are present in the pump building around the motors and pumps, and abundant trash and some oil sheen was observed in the water near the pump intake pipes.

Photograph 5. Transformer station adjacent to pump station

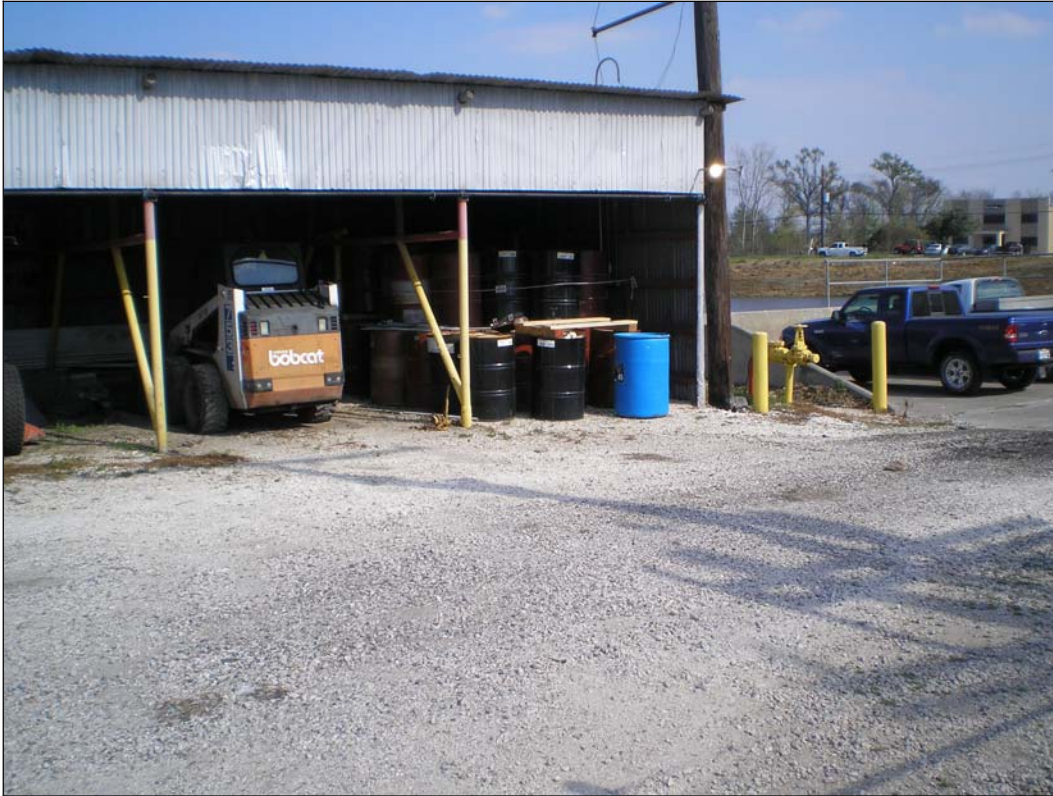
There were numerous old empty 55-gallon oil drums stored in the maintenance shed on the property, and no evidence of spilled contents was visible (Photograph 7, Appendix B). There were also several pieces of maintenance equipment and fuel containers located under cover in the maintenance shed (Photograph 6, Appendix B). There was an empty diesel storage tank adjacent to the north side of the pump building, which was described as being under repair for a leak (Photograph 15, Appendix B).

Photograph 7. Maintenance shed with empty oil drums

GSRC recommends that the empty oil drums stored under cover on the property be disposed of in accordance with state and Federal regulations. The observed oil spills around the generator station should be mitigated by removing and disposing of contaminated soils and modifying the existing generator relief exhaust piping to collect future oil mist discharged from the motors. No *recognized environmental conditions* were indicated on the subject property that would require further environmental studies or assessments.

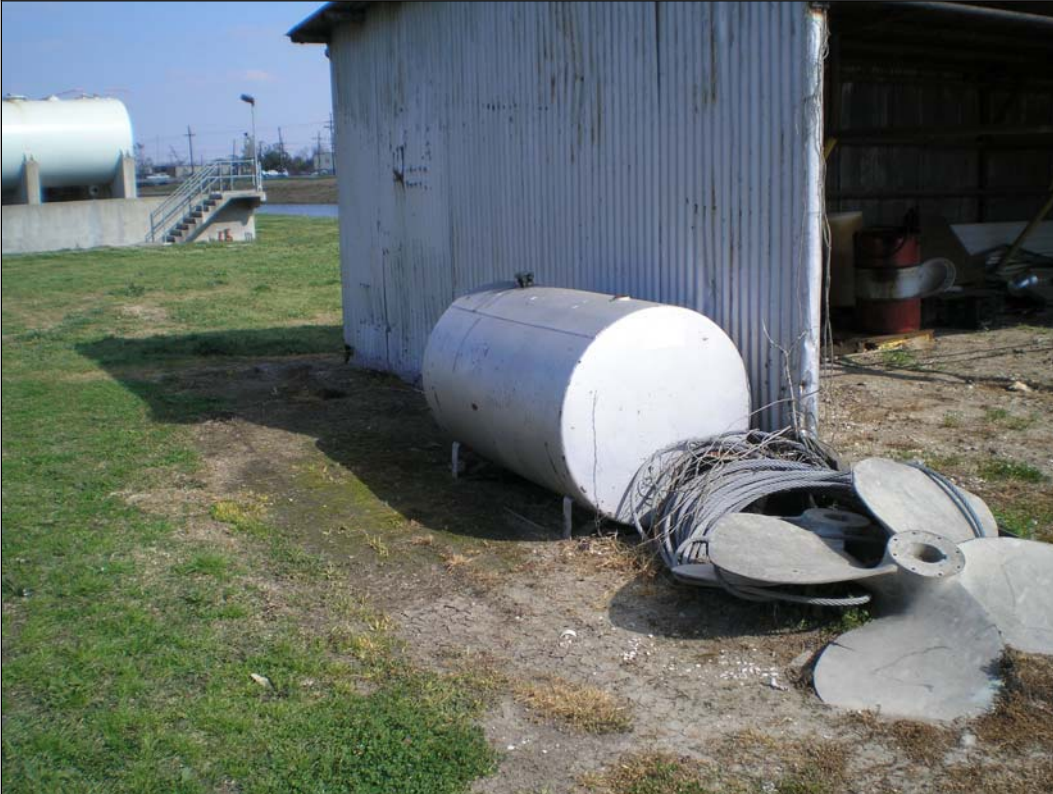
Waste oil is stored in a waste oil tank adjacent to the maintenance shed (Photograph 8, Appendix B), and the oil is recycled by a licensed transporter. Paint, lubricating oil and other fluids are stored under cover in the main pump building (Photographs 1 and 2, Appendix B). There is a current Spill Prevention Control and Countermeasures Plan kept on site, and a spill containment and cleanup kit is also stored on site. Day tank diesel is stored in two 500-gallon tanks adjacent to the intake sump (Photograph 4, Appendix B). Abundant trash and an oil sheen was observed in the intake water sump.

Photograph 8. Waste oil tank adjacent to maintenance shed

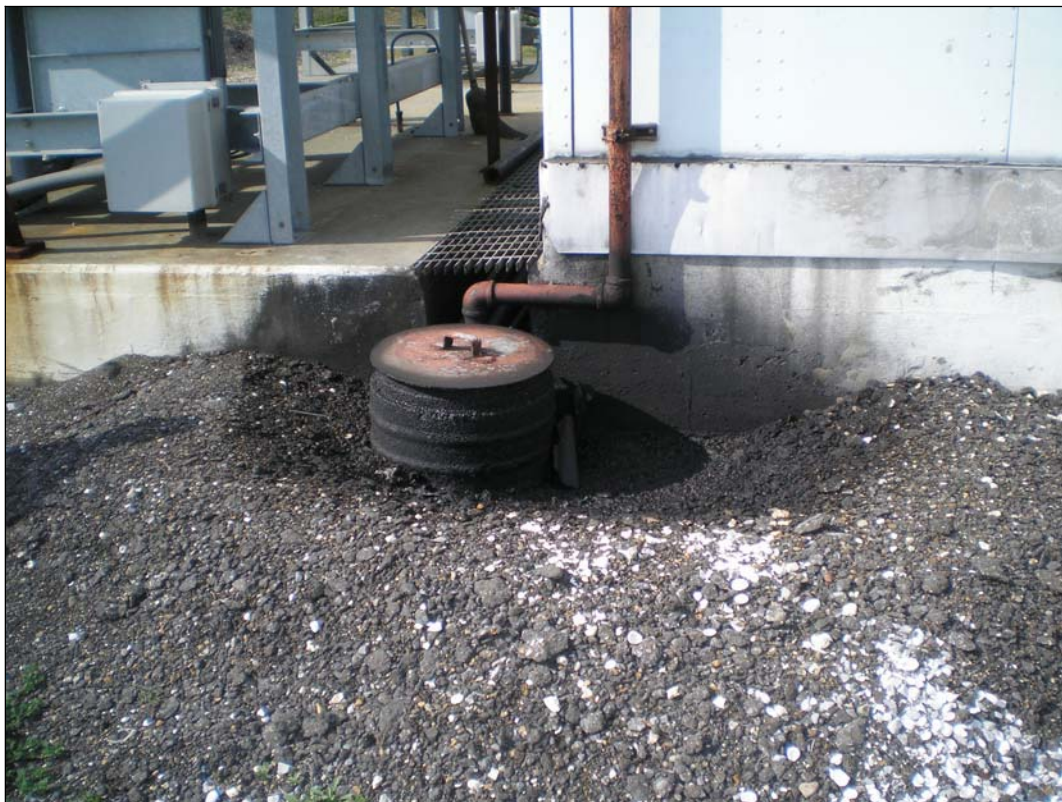
There was a stack of used tires and wheels adjacent to the intake canal on the subject property (Photograph 14, Appendix B). The motor vent pipes from the generator station were routed to the ground in two places, and oil staining was evident around the discharge pipes (Photographs 12 and 13, Appendix B).

Photograph 12. Oil stained gravel adjacent to generator station

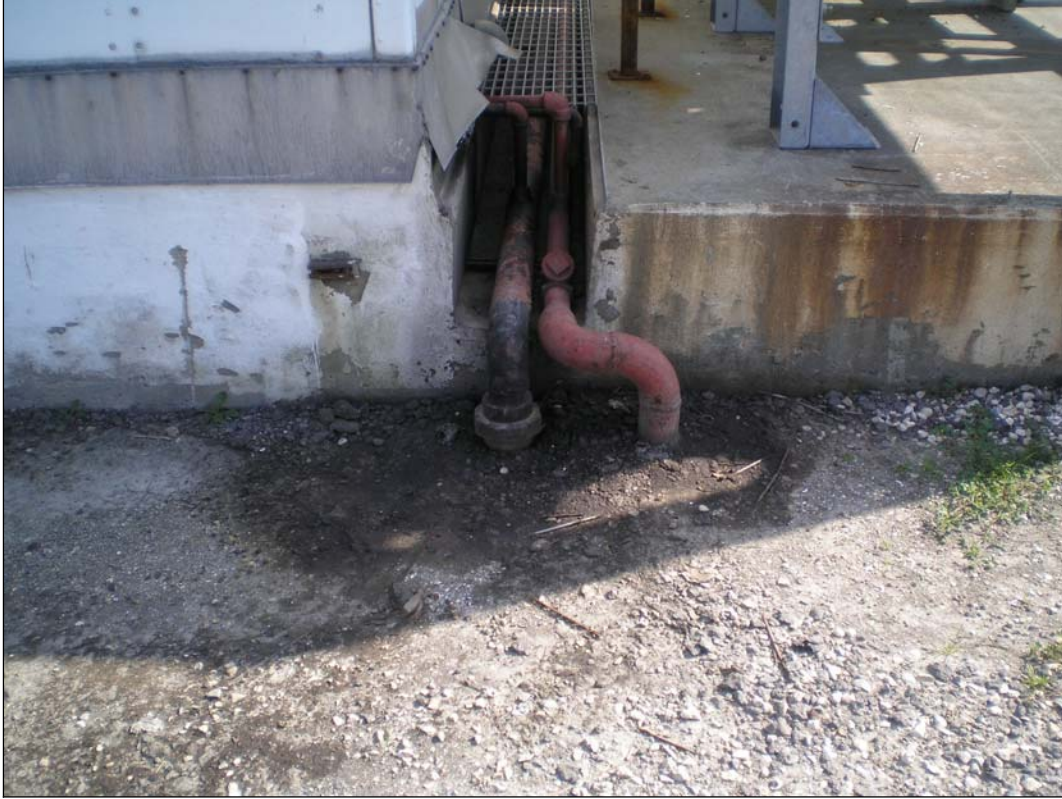
Photograph 13. Oil stained soil adjacent to generator station

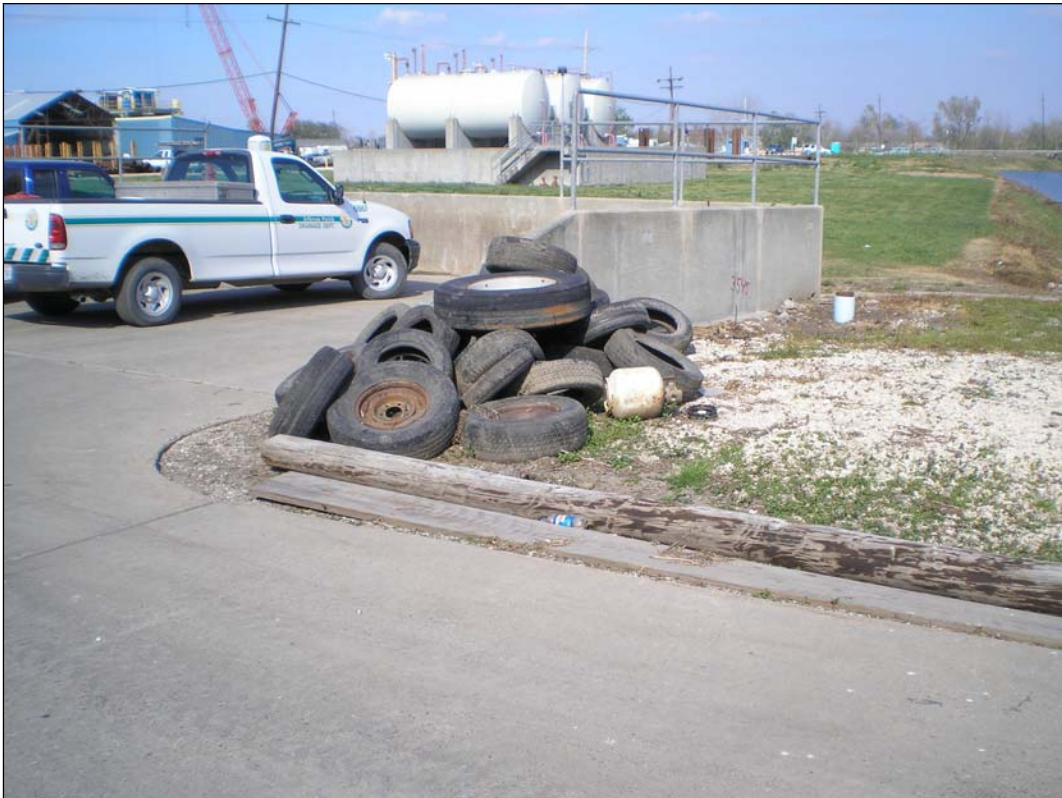
Hazardous materials observed on the subject property included waste oil and fluids in an outside storage tank and 5-gallon buckets of used oil, lubricants, paint and thinners stored under cover in containers and in the main pump building. Several indications of small ongoing petroleum product spills were noted around the generator station. None of the observed spills seemed to indicate a great business environmental risk, but they appeared to be larger than *de minimis* in size. The stack of used tires observed on the property does not constitute a business environmental risk, but disposal should follow state guidelines for used tires.

Photograph 14. Old tires on subject property

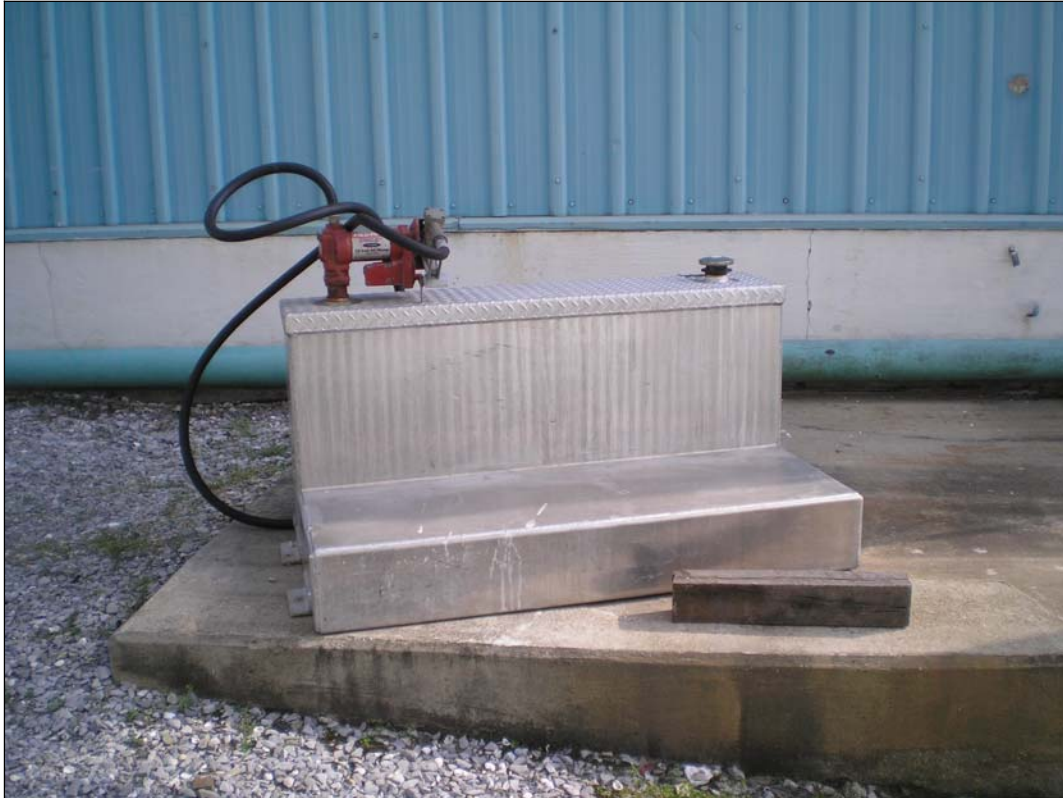
Photograph 15. Diesel truck tank adjacent to pump station building

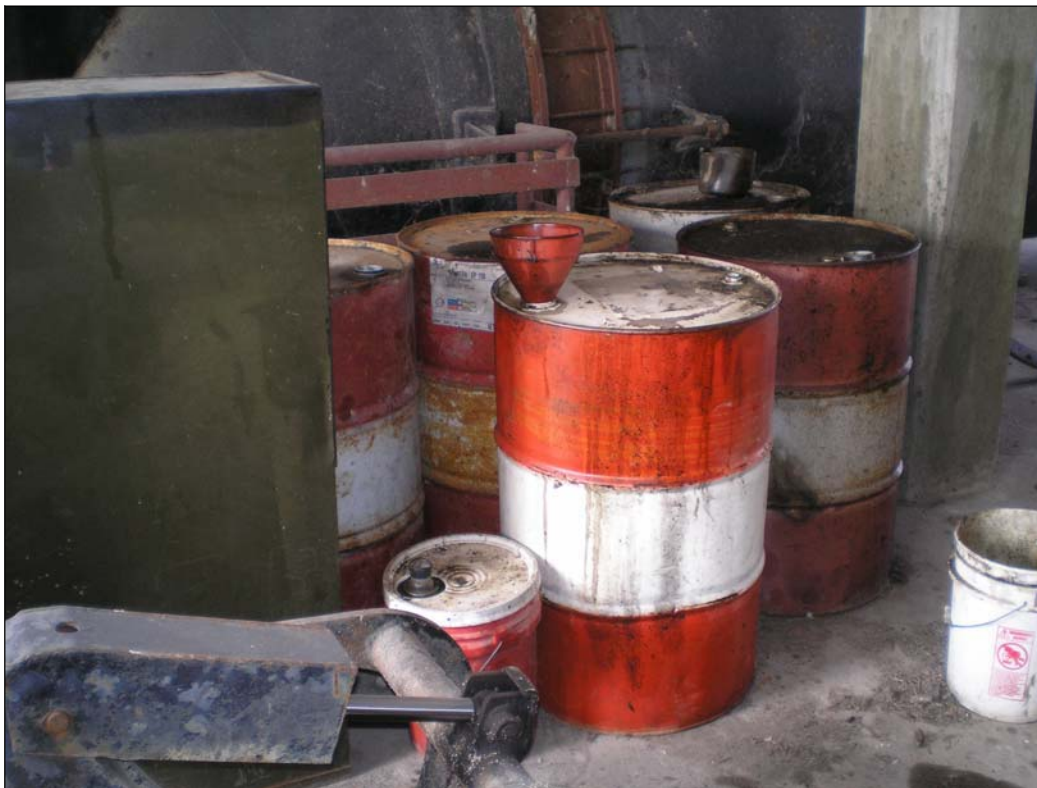
Photograph 4. Oil drums and spills inside old pump station building

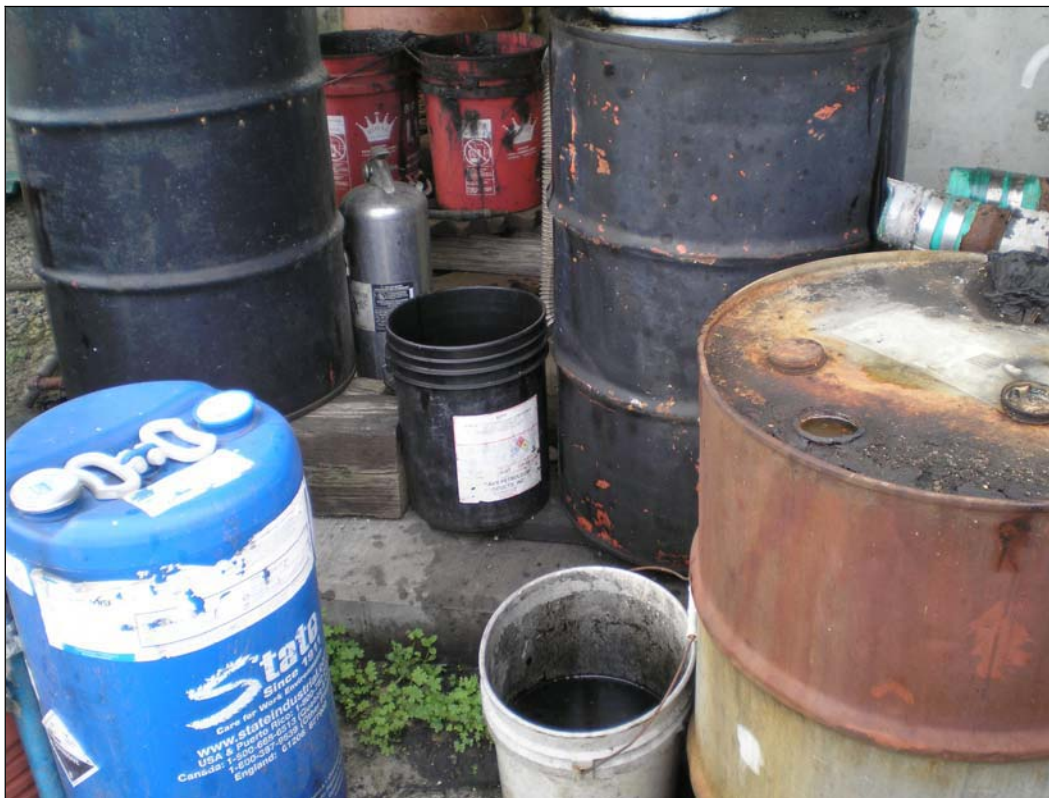
Photograph 14. Open oil containers and spills adjacent to the pump building
