## **Special Inspector General for Iraq Reconstruction**

#### **SIGIR PA-05-002**

March 15, 2006

## Al Wathba Water Treatment Plant in Baghdad, Iraq

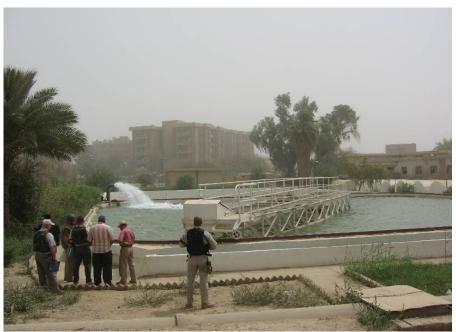
Site Photo 1: Train 1 clarifier tank

The SOW required the clarifier tank to be drained, cleaned, repaired, and painted. Discussions with the Iraqi Plant Manager and review of the quality assurance (QA) documentation disclosed that the clarifier tank work was not completed as required in the SOW. The quality of work performed at train 1 clarifier tank (Site Photo 1) could not be determined visually because the tanks were filled with water and in operation. During the site assessment, the Iraqi Plant Manager said that the clarifier tank was drained and cleaned, but not repaired (sealed). He said he believed the clarifier tank would continue to leak if the repairs were not completed. The

FluorAMEC, LLC Project Manager confirmed that the clarifier tank was cleaned but not sealed because of plant operational shutdown issues and stated that the sealing of the cracks was no longer planned as part of this project.

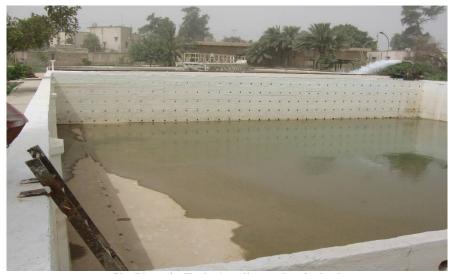
Site Photo 2: Train 1 settling tank – drained

The SOW required the settling tank to be drained, cleaned, repaired, and painted. Visual observations (Site Photo 2) and review of the QA documentation found that the clarifier tank work was not completed as required in the SOW. Although it appears that the clarifier tank was drained, cleaned, and painted as required, the effluent weir wall collapsed during tank re-filling operations, rendering the tank unusable until repaired (Site Photo 3). The failure of the tank can be directly attributed to work performed under this task order. Several rows of bottom drain holes were filled in during repair procedures resulting in an increased hydraulic load on the effluent weir wall, which contributed to its collapse. Filling in the bottom drain holes was not in the Scope of Work and it is unclear why they were filled in during the repair.

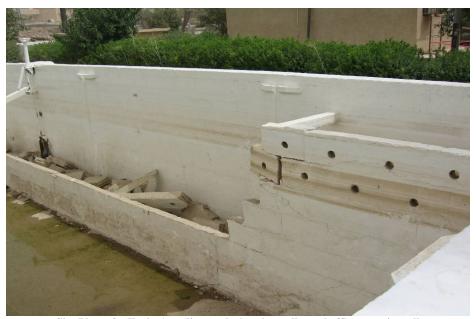
Site Photo 3: Train 1 settling tank showing collapsed effluent weir wall

The rehabilitation work on the clarifier and settling tanks, the chemical building construction, the administration/laboratory building construction, and pressure building construction meet a substantial portion of the standards of the design. However, the collapse of the train 1 effluent weir wall, poor concrete finishing of the chemical building floor, and corrective actions taken during the interrupted concrete pour are all areas of concern.

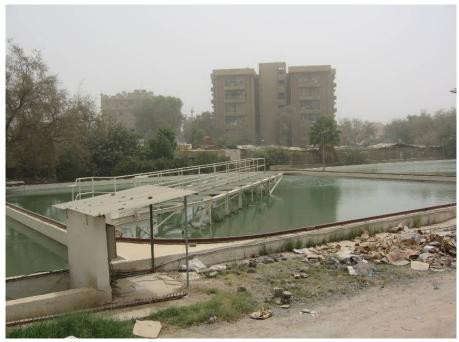
Site Photo 4: Train 2 clarifier tank (foreground) & settling tank (background)

The SOW required the clarifier and settling tanks to be drained, cleaned, repaired, and painted. The QA documentation and site assessment disclosed that the clarifier and settling tanks (Site Photo 4) had been drained, cleaned, repaired, and painted. The quality of work performed could not be determined, however, because the tanks were filled with water and in operation. During the site assessment, the Iraqi Plant Manager said he was satisfied with the rehabilitation of the train 2 clarifier and settling tanks.

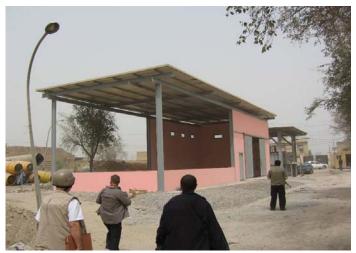
Site Photo 5: Chemical building – new construction

The original SOW called for an 18.3 meter (m) by 9.2 meter new chemical building to house the new alum system equipment and storage for a 10-day supply of alum. The site assessment disclosed that the construction of the chemical building (Site Photo 5) had been completed. The concrete floor of the building was observed to have a rough uneven surface which may be attributed to the concrete setting up before finishing could be completed. The building appeared to be constructed properly and to meet task order requirements; however, the quality of the concrete could not be verified.

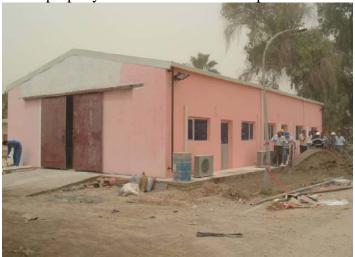
Site Photo 6: Admin/Lab building - new construction

The original SOW called for a new administration building for office and laboratory space. Our site assessment determined that construction was almost complete (Site Photos 6 & 7). Construction, mechanical, and electrical tasks had been completed, with only minor cosmetic work remaining. Final work required to complete the building was being accomplished at the time of our site visit. The building appeared to be constructed properly and to meet task order specifications.

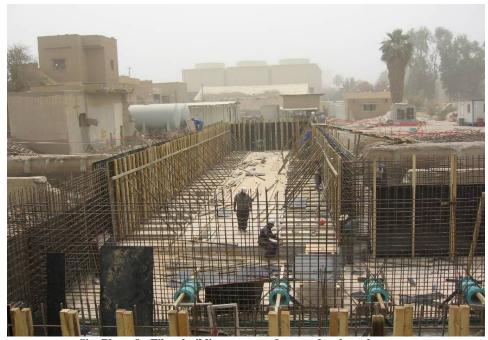
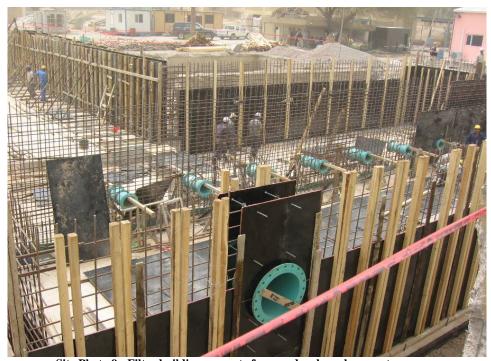
Site Photo 8: Filter building concrete form and re-bar placement (Wet well foreground – dry well background)

The original SOW called for the construction of a pressure filter building to house the new pressure filters and all associated valves, pumps, and instrumentation. Our site assessment determined that the construction (Site Photos 8 & 9) was approximately 25% complete. The foundation footers and interior concrete pad were in place and the forming activities for the walls of the wet well and dry well were in progress. The form work appeared to be consistent with the task order design.

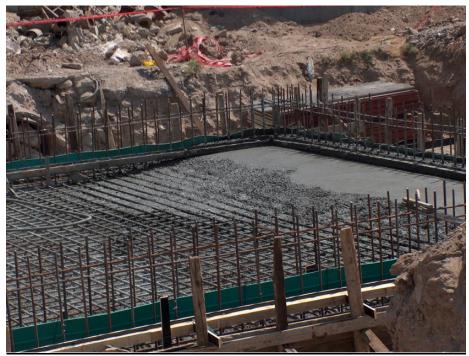
There are concerns regarding the quality of the interior concrete pad of the wet well section. Review of the QA documentation and discussions with the Government QAR identified problems during the placement of the concrete in the wet well section. This concrete pour on 31 May 2005 was interrupted due to equipment failure and the concrete setting before the pour could continue (Site Photo 10, which was provided by the Government QAR). This interruption could cause bonding problems between the old and new concrete, which would decrease the strength of the concrete.

The contractor said he followed the procedures in contract specification "FA 000 215 033000: Specification for cast-in-place concrete," which calls for the use of a bonding agent between the old and new concrete. The Government QAR said the contractor did not use a bonding agent or follow specification FA 000 215 033000. A copy of the contractor construction deficiency log and daily quality control reports were requested to determine actual events, but they had not yet been provided at the time of this report.

Site Photo 10: Filter building, interrupted concrete pour, dated 31 May 2005 (Provided by the Government QAR)

The contractor recommended taking core samples and testing to determine if the floor is within specifications. Relying on the Government QA reports and in the absence of information to the contrary, it would be prudent to obtain a core sample to determine if the concrete is within specifications.
