POLICE STATION – SAFWAN IHP
404
BASRAH, IRAQ

PROJECT NUMBER SIGIR-PA-06-051
JULY 24, 2006

SUBJECT: Report on Project Assessment of the Safwan Iraqi Highway Patrol
Construction, Safwan, Iraq (Report Number SIGIR-PA-06-051)

Police Station – Safwan IHP 404, Basrah, Iraq

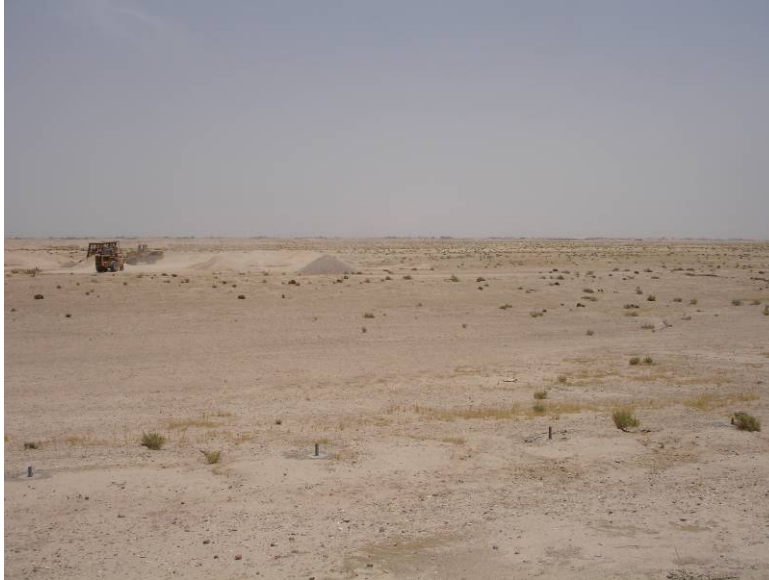
The description of the facility (preconstruction) was based on information obtained from the contract and the USACE project file. The site is located approximately 60 kilometers (km) south of the city of Basrah near the Iraq – Kuwait border, and adjacent to a major highway running from Kuwait through Iraq. Modification 001 moved the initial location of the project 3.4 km before work had begun. The current location was an undeveloped level area of 180 meters (m) by 100 m and is offset from the major highway by 131 m. Community electricity, water, and waste water systems were not readily assessable at the current location. Site Photo 1 shows the project location during initial construction.

Site Photo 1: IHP Barracks project site during initial construction (Photo courtesy of the USACE)

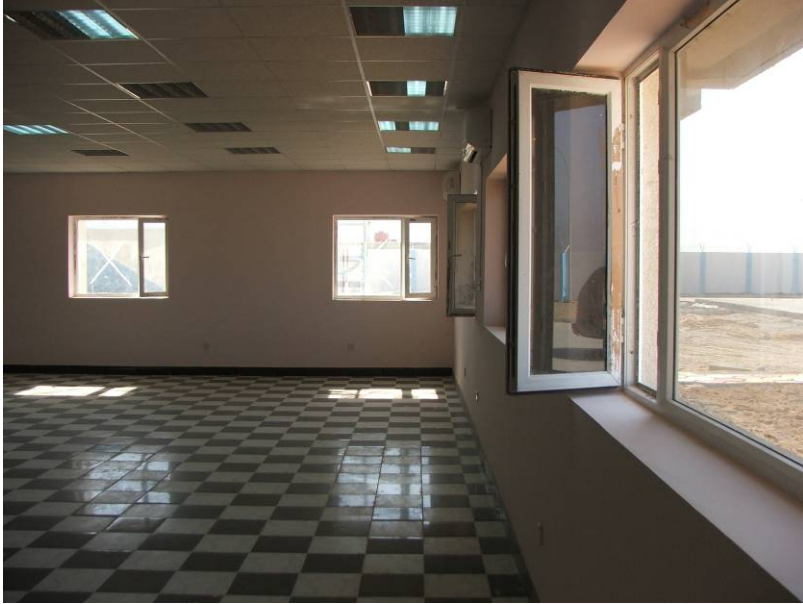
Site Photo 3: Dining facility

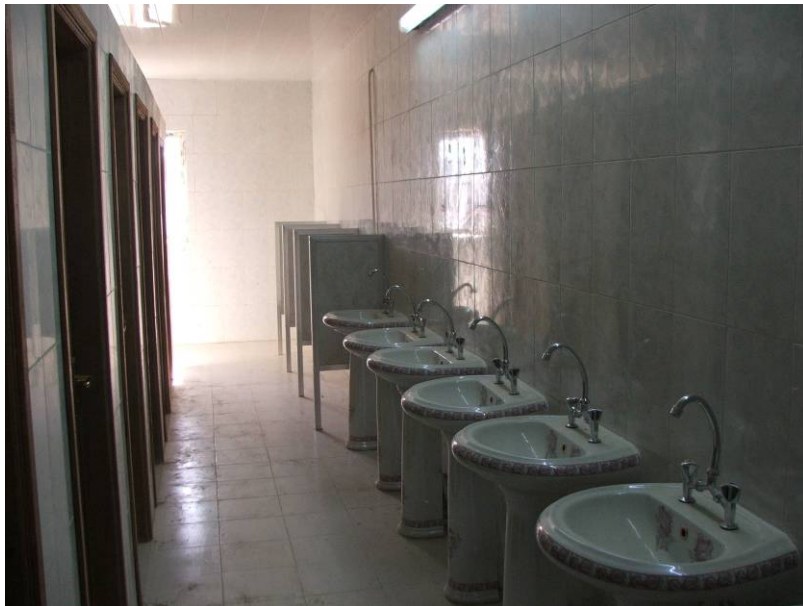
Site Photo 4: Bathroom facility

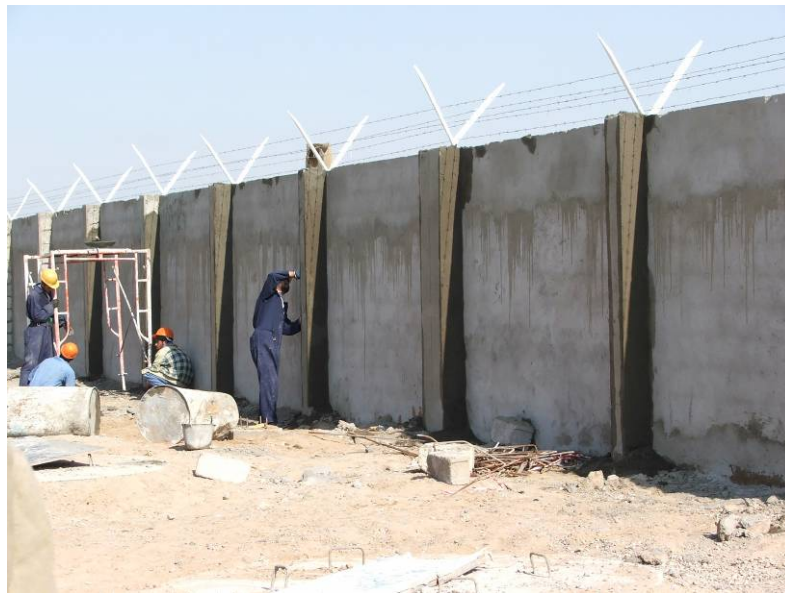
Site Photo 7: Finishing work of section of perimeter wall

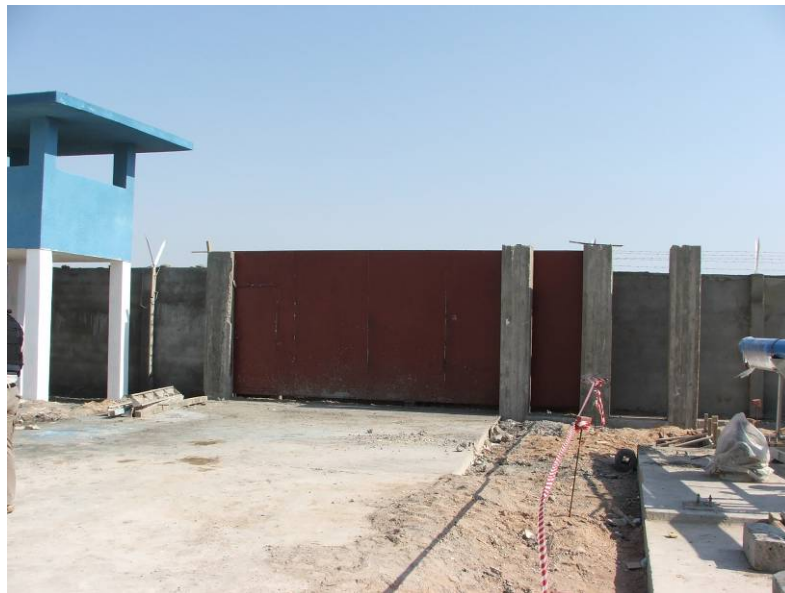
Site Photo 8: Rear entrance gate

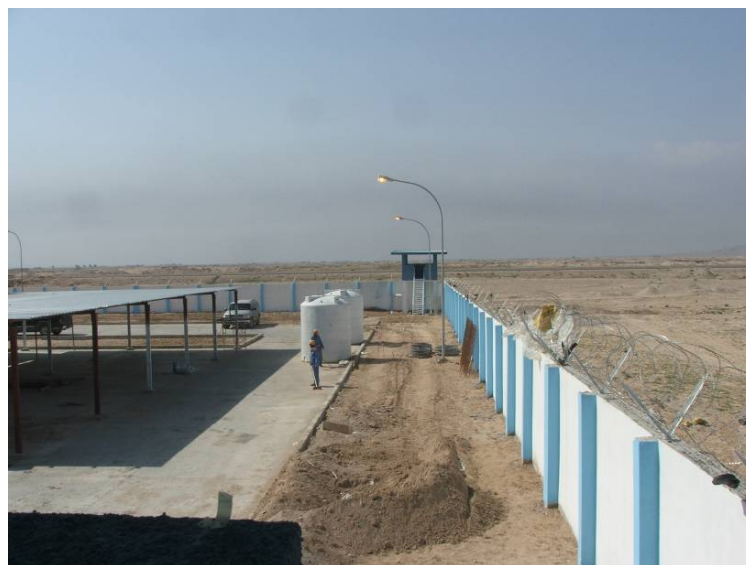
At the time of the assessment, three 8-meter light poles and none of the 4-meter light poles were observed installed. During the site visit electrical testing was being conducted with the use of a portable generator and the light poles were observed to be operational. Exterior building wall mounted lights were observed at entry ways. The guard tower outward orientated lights were not evaluated. Site Photo 9 shows installed 8-meter light poles with the lights illuminated, and Site Photo 10 shows the installed exterior building lights.

Site Photo 9: 8-meter light poles

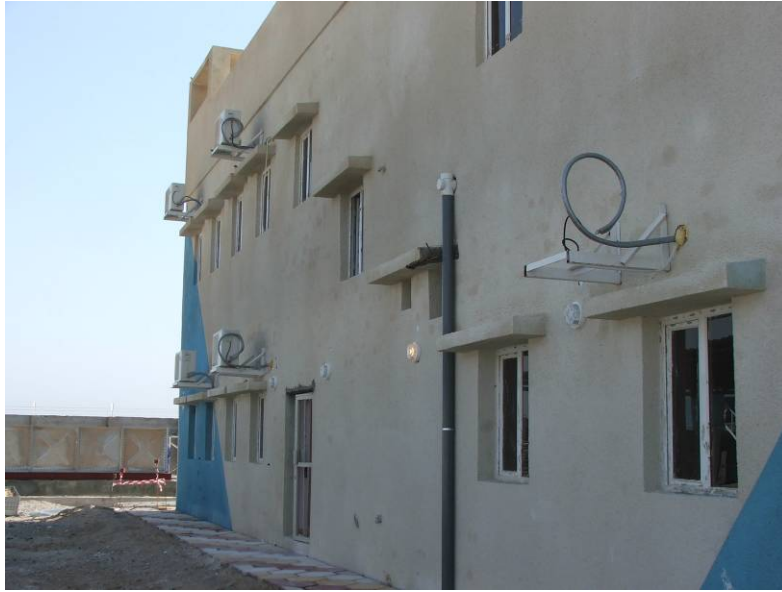
Site Photo 10: Exterior building light

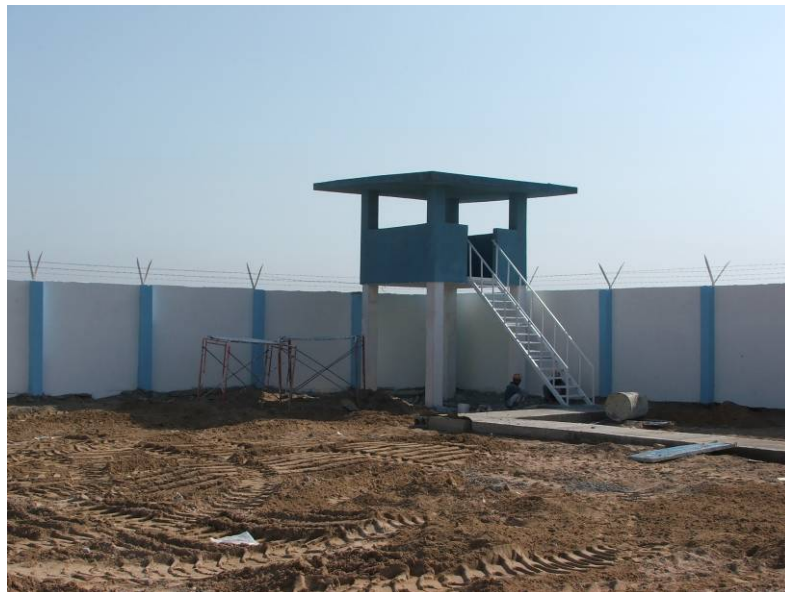
The contract required four corner guard towers, with dimensions of 3 m by 3 m, to be constructed of concrete and CMU and sited along the interior perimeter fence at the corners. The guard towers were required to be anchored to a reinforced concrete pad providing a view of the exterior of the camp with a clearance of 1.5 m above the wall. The design drawings required elevated guard towers on reinforced concrete footings and columns, with reinforced concrete floor slab, parapet, and angled roof slab. In addition, interior lighting and steel access ladders were to be installed. At the time of the assessment, construction of all four guard towers was complete, exteriors were painted, and access ladders were installed. The construction appeared consistent with the contract and design requirements. Site Photo 11 shows an exterior view of one of the guard towers.

Site Photo 11: Exterior view of corner guard tower

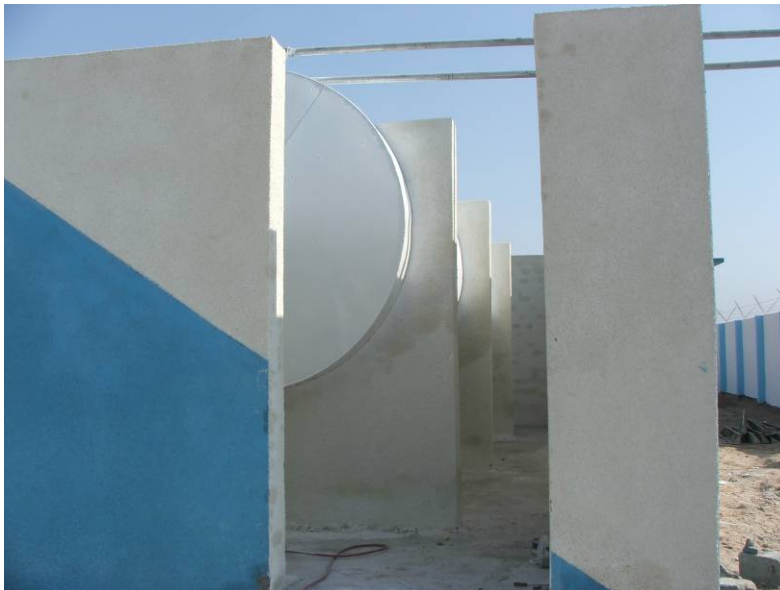
At the time of the assessment, the fuel tanks and the fuel dispensing units were in place, although these items had not been completely tied in. Two steel horizontally mounted fuel tanks were observed located within an enclosed wall system. The fuel tanks were supported by a concrete cradle system and also by steel supports. Piping had been installed and two fuel dispensing units were located on a concrete pad. The framework for a steel framed cover was complete over the fuel dispensing units, although the roof had not been installed. The fuel tanks and piping were consistent with the contract and design requirements. Site Photo 12 shows the end of one of the fuel storage tanks and wall enclosure, and Site Photo 13 shows the fuel dispensing units.

Site Photo 12: Fuel storage tank with wall enclosure

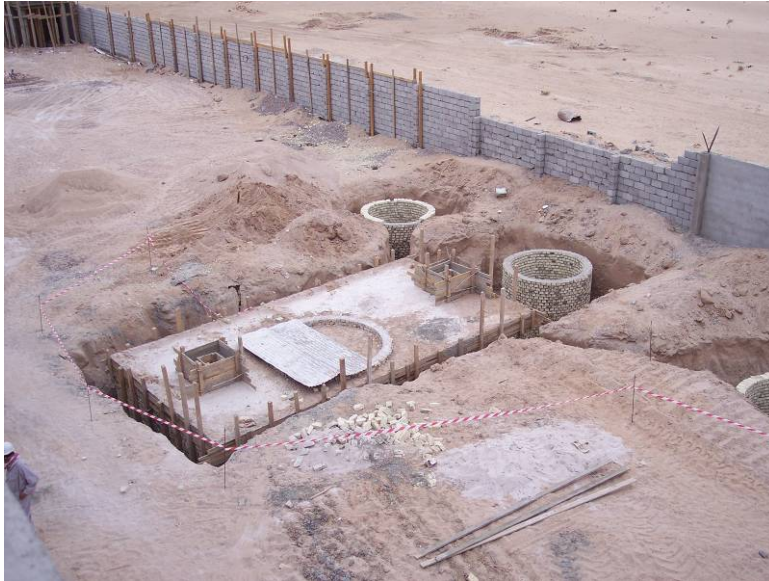
At the time of the assessment, the septic system had been installed, and could not be evaluated because it was located below grade. The manholes were visible at the

surface where the septic system was installed. Site Photo 16 shows the septic system during installation (courtesy of USACE) and shows tank and leech pits.

Site Photo 16: Septic system during installation (Courtesy of USACE)

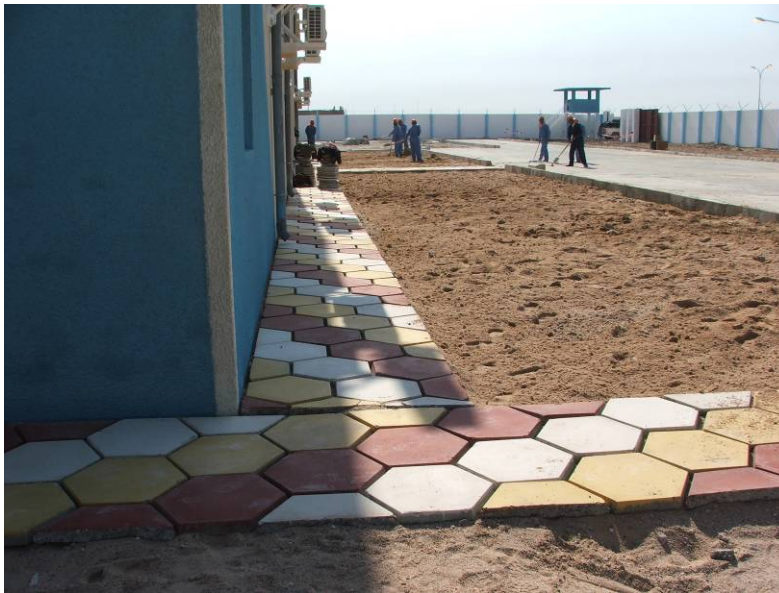
At the time of the site visit, the roadways were constructed and sidewalks installed. Site Photo 18 shows the sidewalks along the perimeter of the barracks facility and roadway. The sidewalks appeared to be consistent with contract and design requirements. Although tile on the walkway was not included in the original design, the substitution enhanced the appearance of the facility. The roadways were constructed of concrete and were complete at the time of the site visit.

Site Photo 18: Sidewalks along the perimeter of the barracks facility (foreground) and roadway (background)

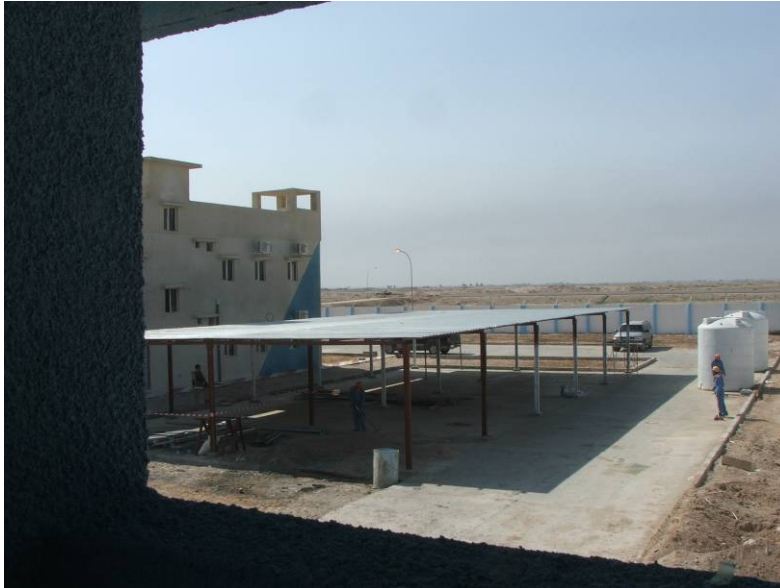
At the time of the assessment, the uncovered parking area was complete and the covered parking area was under construction. The covered parking area design required steel I-beam columns and I-beam cross members. Although steel I-beams

Site Photo 19: Covered parking area

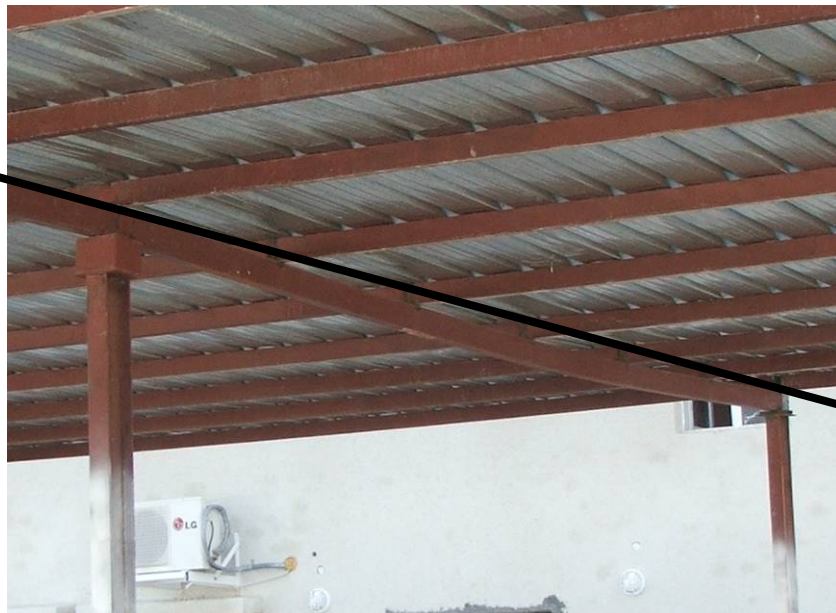
were used for the columns, rectangular tubular steel was used for the cross member supports. The cross members were noticeable deflecting under the weight of the roof. The USACE project manager and contractor were aware of the deflection. The USACE project manager stated that he has coordinated with the contractor to install additional columns to correct this issue. Site Photo 19 shows the covered parking area. Site Photo 20 shows the deflection of the rectangular tubular steel cross member supports in contrast to a straight line between support points.

Site Photo 20: Deflection of the rectangular tubular steel cross member in contrast to a straight line between support points
