THI QAR BEE FARM
THI QAR, IRAQ

SIGIR PA-09-188
APRIL 1, 2010

Summary of Report: PA-09-188

SUBJECT: Report on the Thi Qar Bee Farm, Thi Qar, Iraq (SIGIR Report Number
PA-09-188)

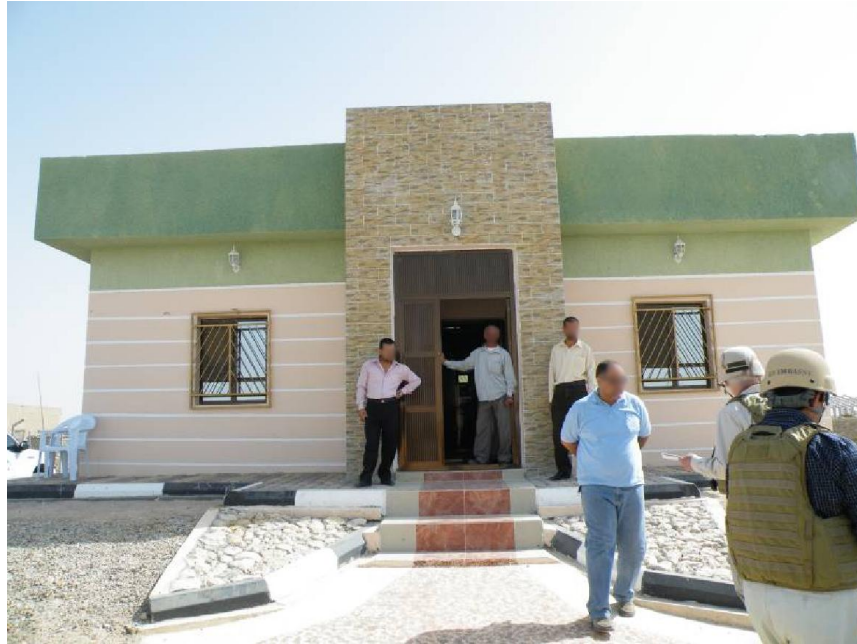
Site Photo 4. Building front exterior

The building was square in shape with a prominent entry. The exterior of the building was finished with plaster and painted in a decorative, horizontal-striped pattern. The horizontal stripes were inset into the plaster finish creating a permanent architectural feature on the exterior of the building. The entryway to the building was finished with ceramic tile to create a contrasting pattern to the building finish (Site Photo 4). The exterior walls were in good condition with no evidence of cracking or settlement. Corners appeared true and plumb and the overall structure appeared sound.

A continuous sidewalk was constructed adjacent to the building and along the exterior wall. Since the building was constructed on approximately one meter of fill material, steps and curbing were constructed at the entrance. Stone was laid behind the curbing and forms a protective surface that prevents erosion of the slopes adjacent to the steps.

Downspouts were constructed along the exterior walls to drain runoff from the roof. The downspouts were in good condition. The downspouts discharge directly onto the perimeter sidewalk adjacent to the building. With the discharge directly onto the sidewalk, the facility will require long-term maintenance.

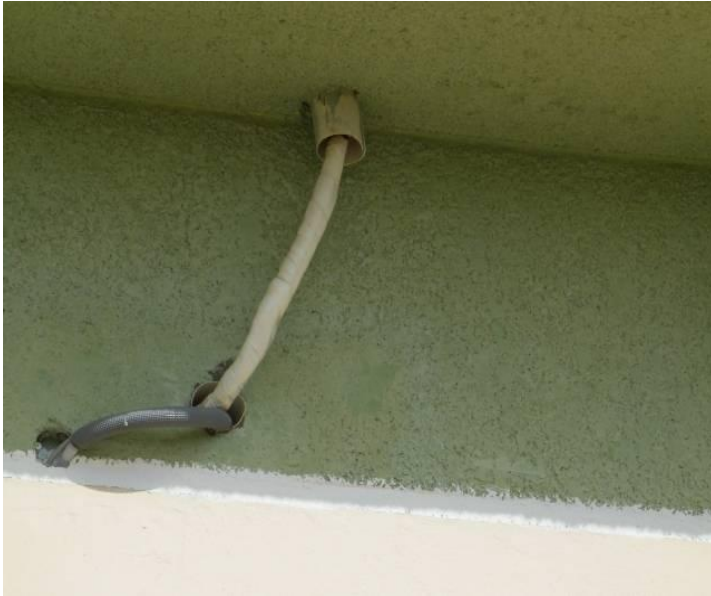
Site Photo 5. Coolant line penetrating roof and wall

The building was constructed with a flat roof. The roof held several of the utilities for the building—including the water storage tanks and the compressor units for the split unit air conditioners. Coolant lines for the air conditioning units were run through the roof overhang and through wall penetrations to the condensers on the interior of the building (Site Photo 5).

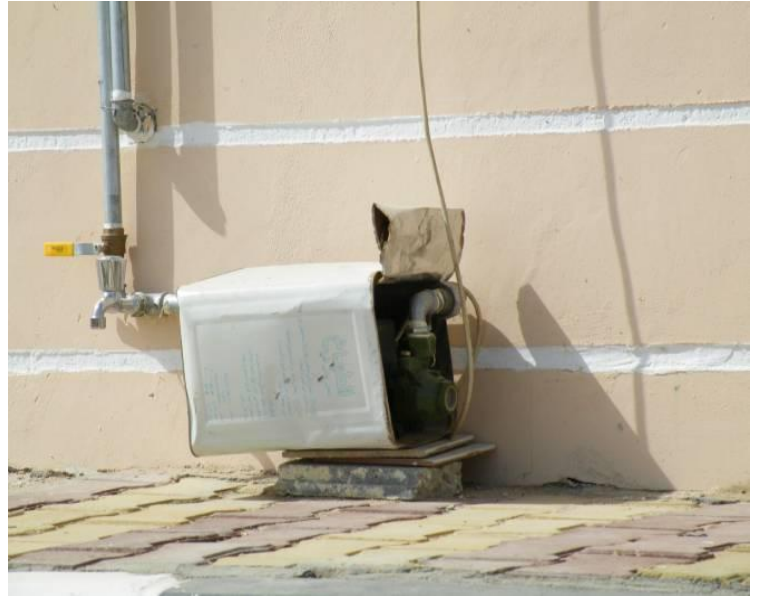
Site Photo 6. Water transfer pump

A transfer pump was located along the exterior wall of the building (Site Photo 6). Instead of connecting to the municipal system, as detailed on the design drawings, the contractor installed a transfer pump to convey water to the rooftop storage tanks. Based on this configuration, water can be supplied by tanker trucks. Due to the multiple connections and handling that must be performed to supply water to the facility, proper hygiene is critical to ensure that contamination is not introduced into the water supply at any point in the delivery cycle. This is especially important if the water is to be used to process honey.

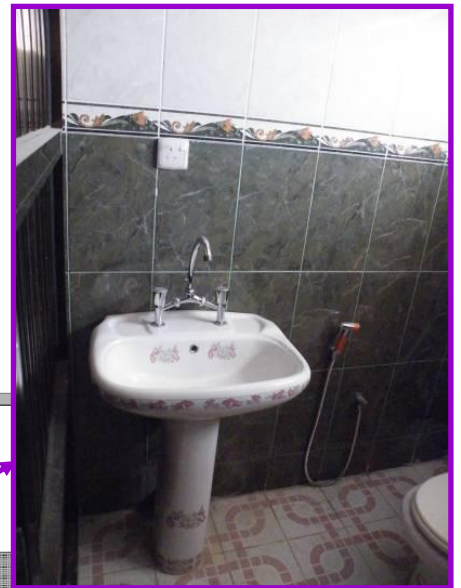
Site Photo 8. Restroom

The restroom was located immediately ahead of the front door to the facility. The restroom appeared functional at the time of the site assessment, and SIGIR observed no apparent defects with the construction (Site Photo 8). The restroom was clean and maintained by the current occupants.

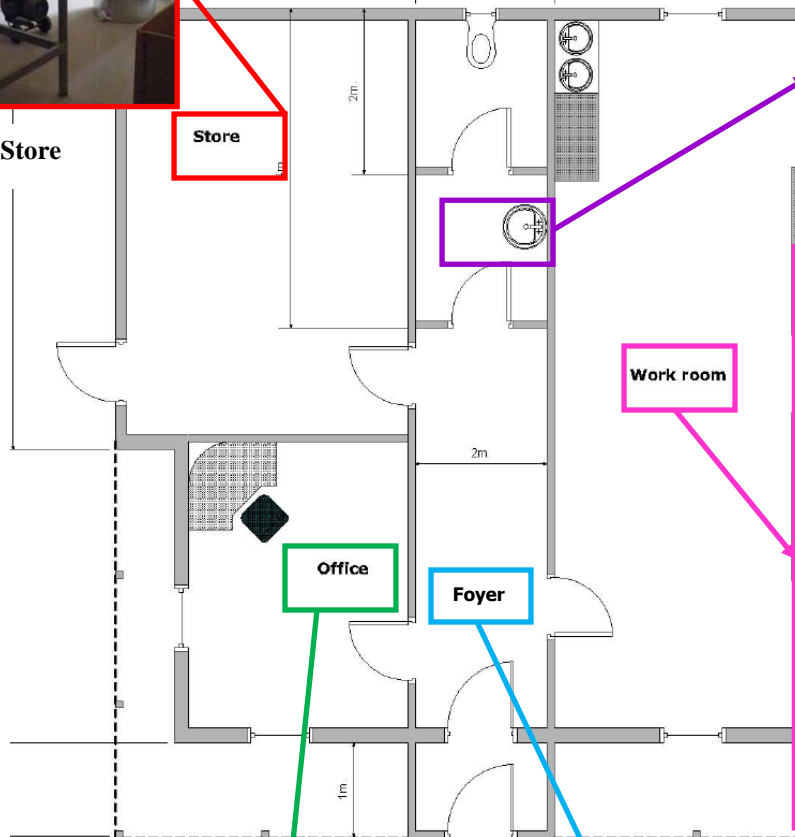
Figure 1. Conceptual design of honey processing facility (Courtesy of GRS)

The building was constructed with three primary rooms and one restroom (Figure 1). The finish in all of the rooms was similar—plaster and painted finish for the walls, and ceramic tiles for the flooring. The finishes appeared well applied and in good condition.

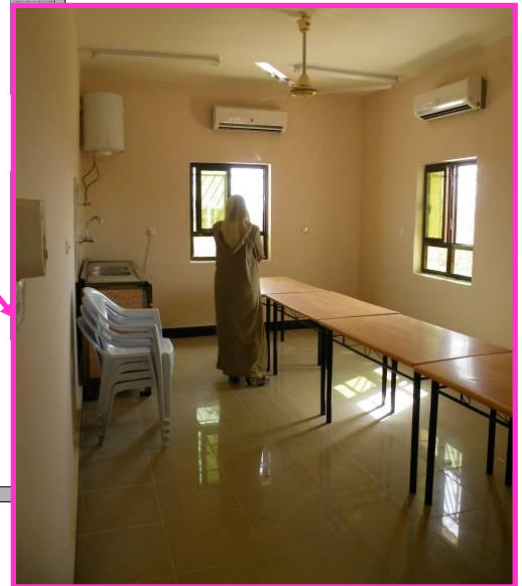
Site Photo 9. Work room

Also, a work room was located to the right of the front entrance. At the time of the site assessment, the work room contained materials and equipment for the facility (Site Photo 9).

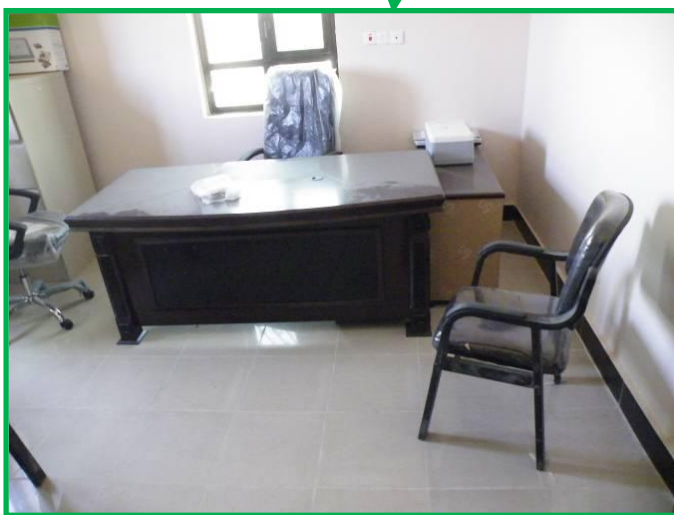
Site Photo 10. Office

An office for the facility manager was located to the left of the front entrance. At the time of the site visit, the office was furnished (Site Photo 10) and the foyer was adequately sized for the building (Site Photo 11).

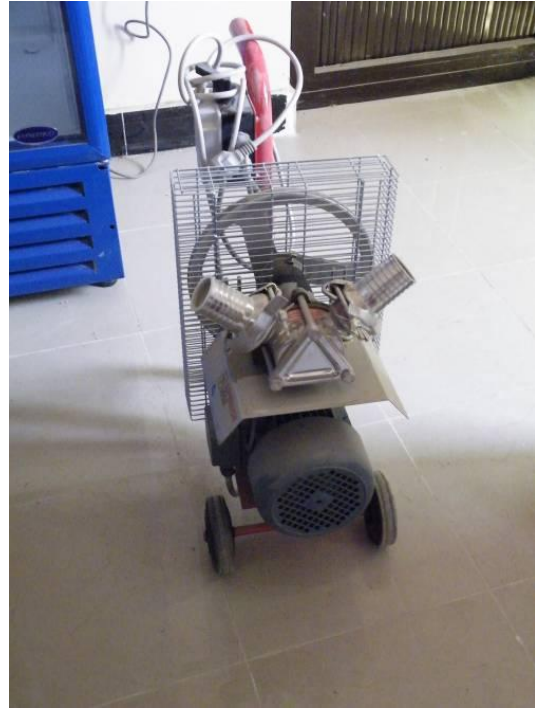
Site Photo 13. Transfer pump

⁷ Transfer pumps are used to transfer processed honey from various containers.

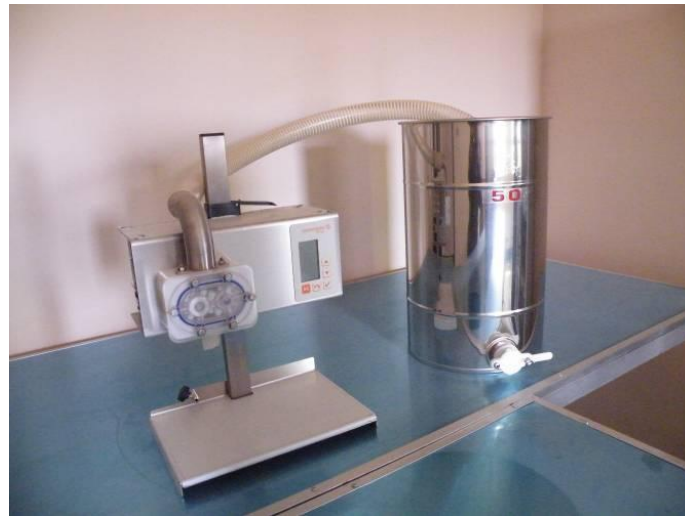
Site Photo 14. Filling machine

SIGIR was able to verify that the equipment required by the contract was present. Specifically, SIGIR observed the extractors⁵ (Site Photo 12), stainless steel decanters⁶, transfer pump⁷ (Site Photo 13), filling machine⁸ (Site Photo 14), and a refrigerator to store the honey.

⁸ A filling machine is used to bottle honey for final delivery to the market for sale.
