# ***Structural Failures Cost Lives and Time***

# Structural Inspection of Processing Plants

PowerPoint prepared by Terry Taylor, P.E.,  
Senior Civil Engineer, PSHTC

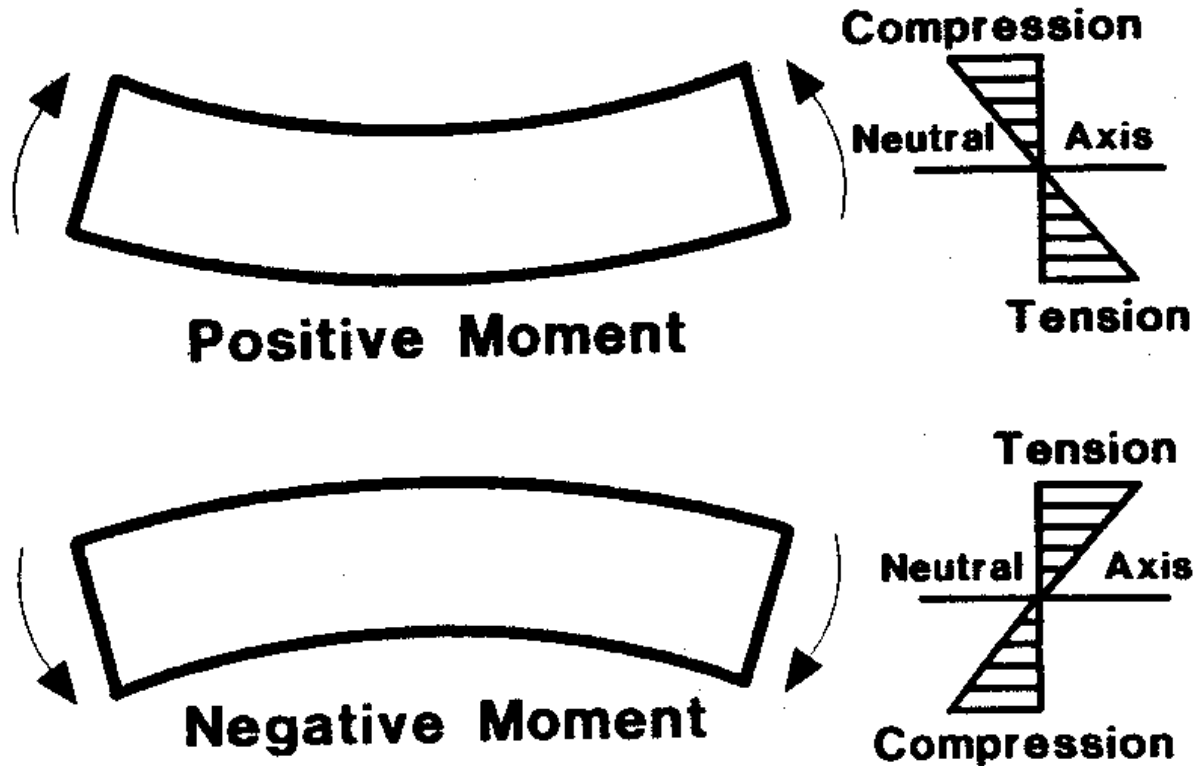
# Bending Moment

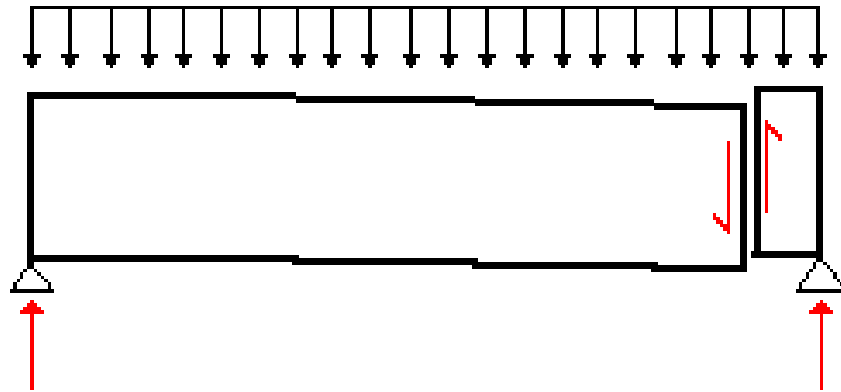
# Shear Force

- Equal (magnitude) but opposite (direction) forces which tend to slide one section of a member past an adjacent section.

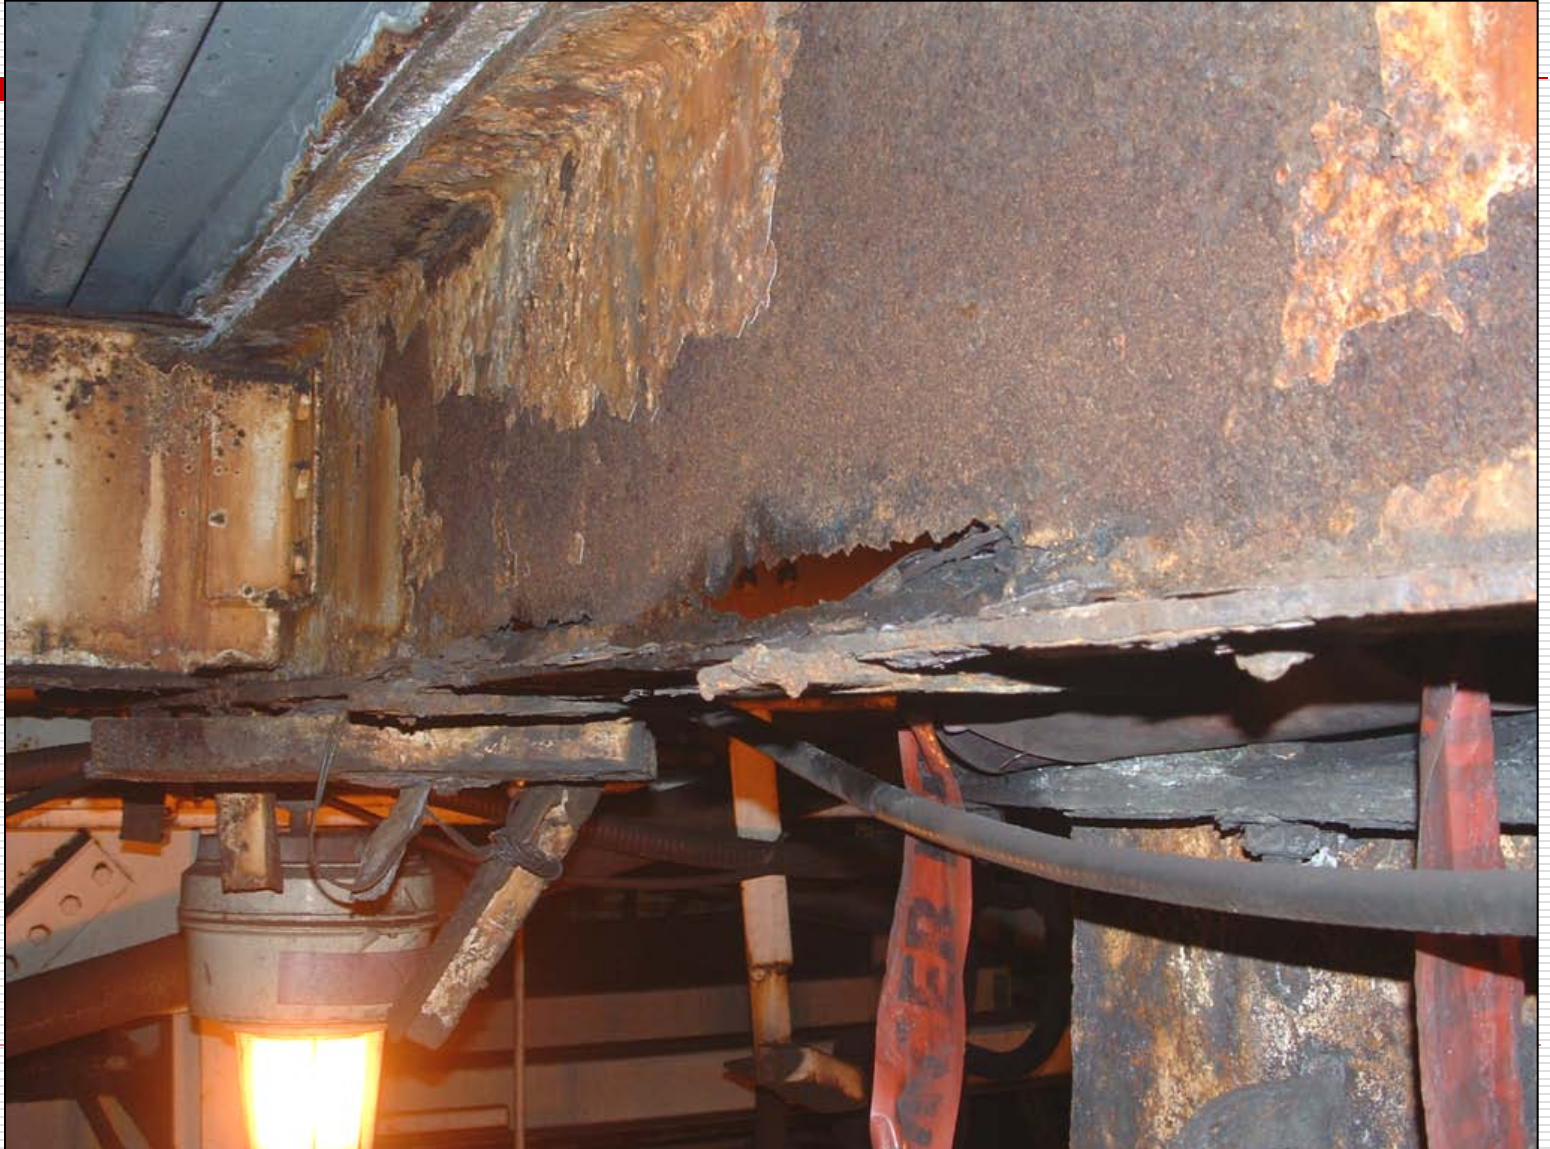
# Long corrosion hole at web to flange interface

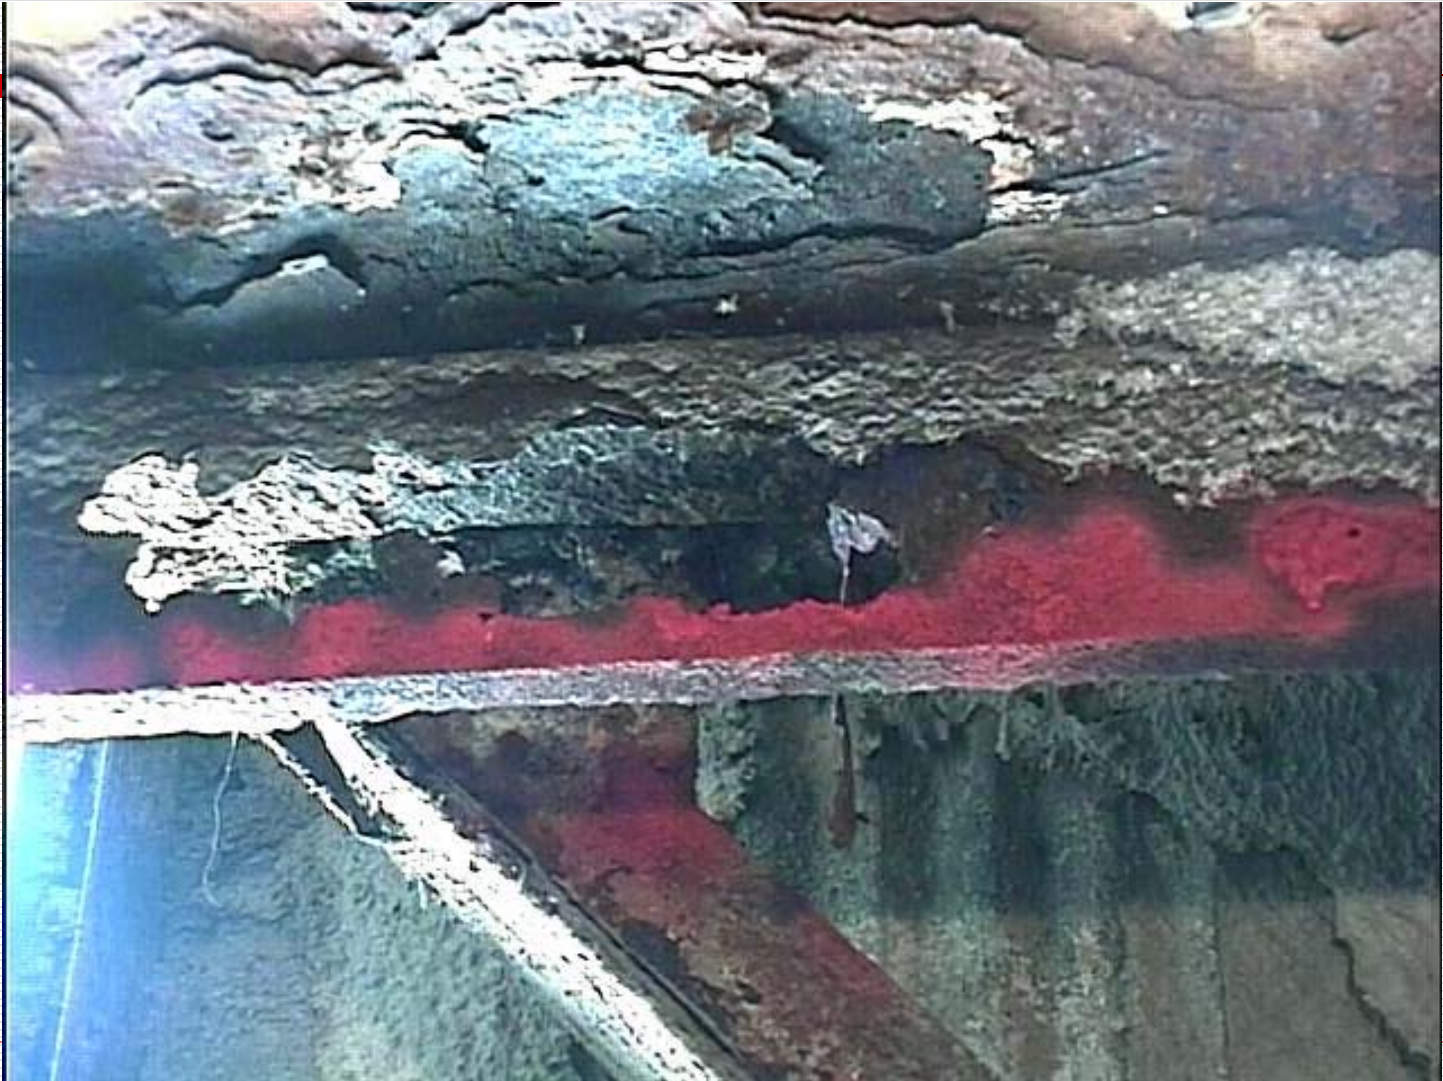
This beam was still standing (?)

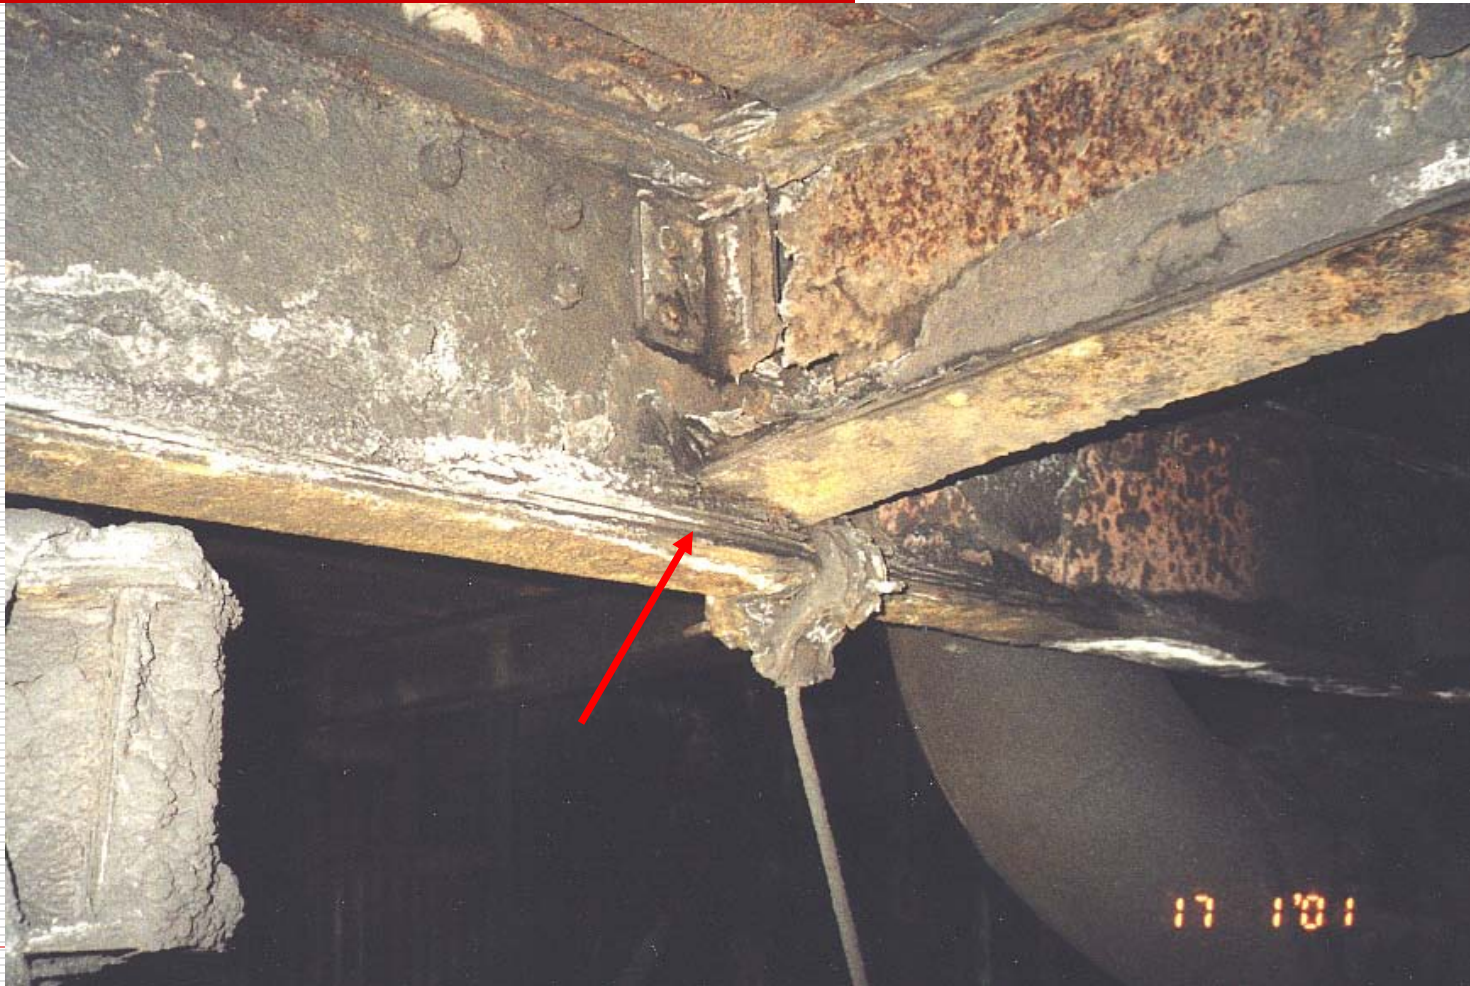
# Heavy delamination of bottom flange

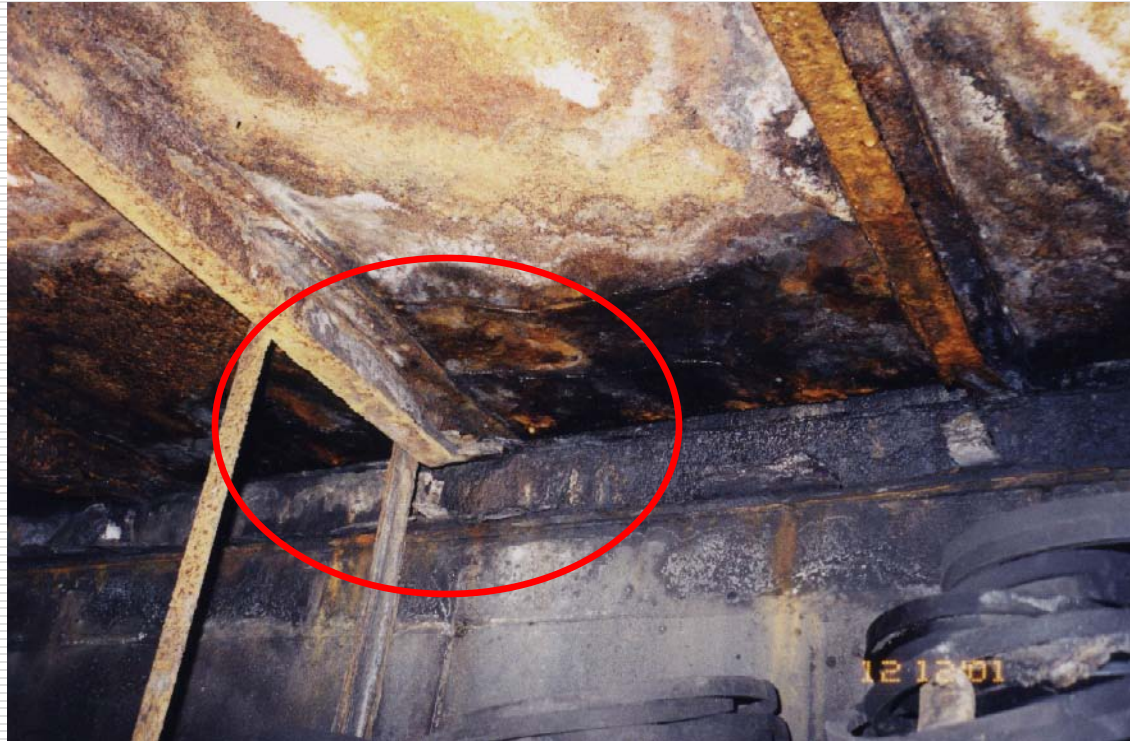
# Buckled webs of corroded channels

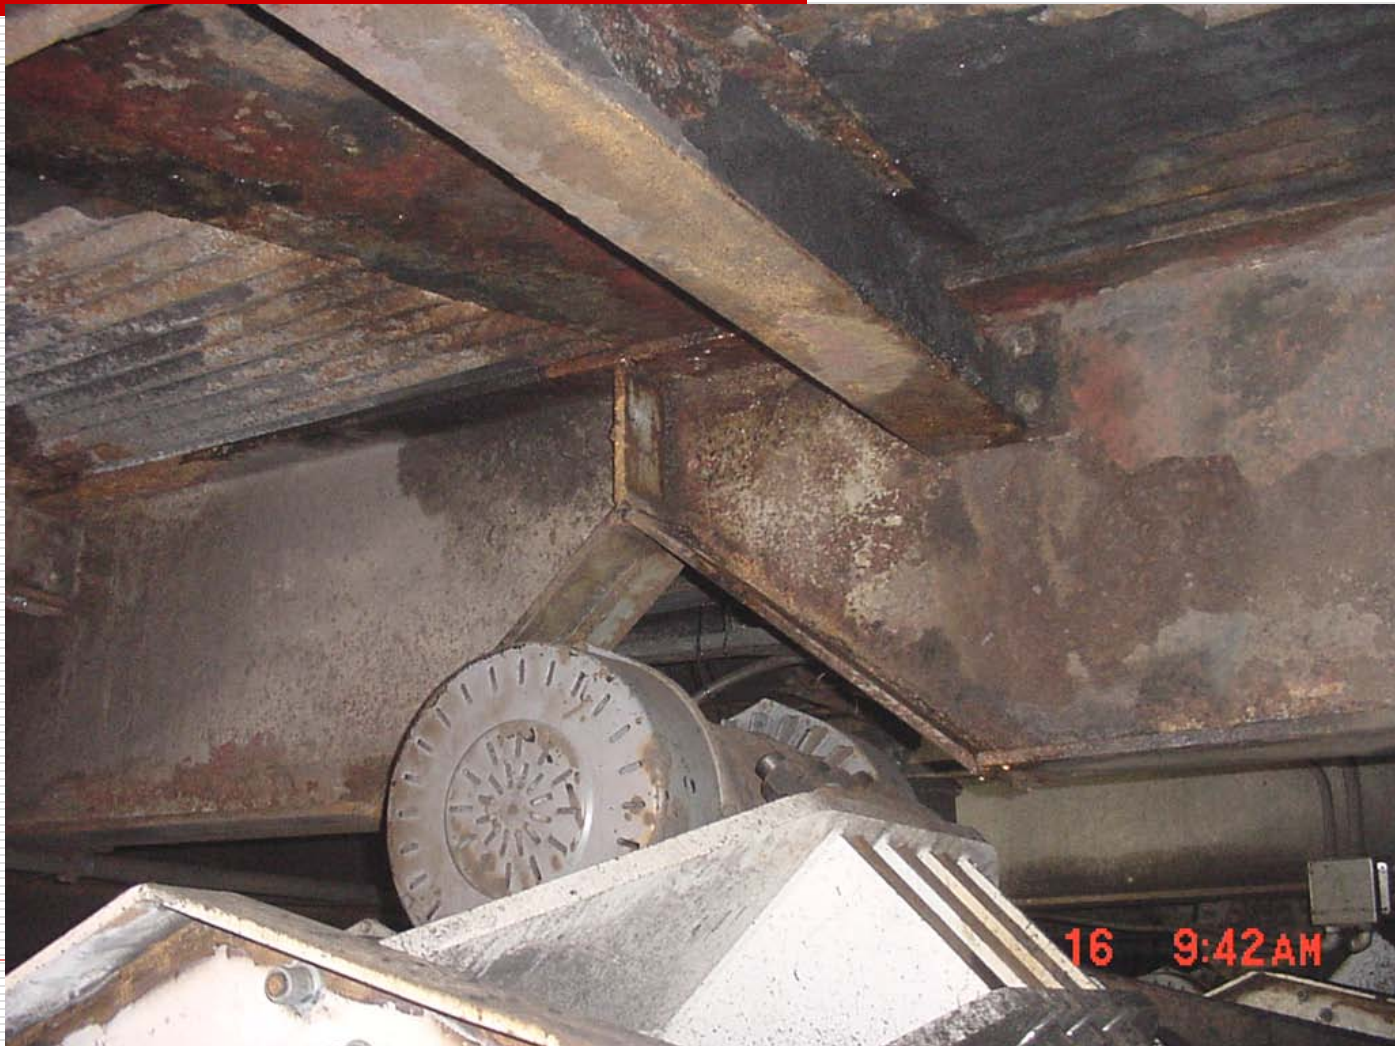
# Beam modifications need engineered!

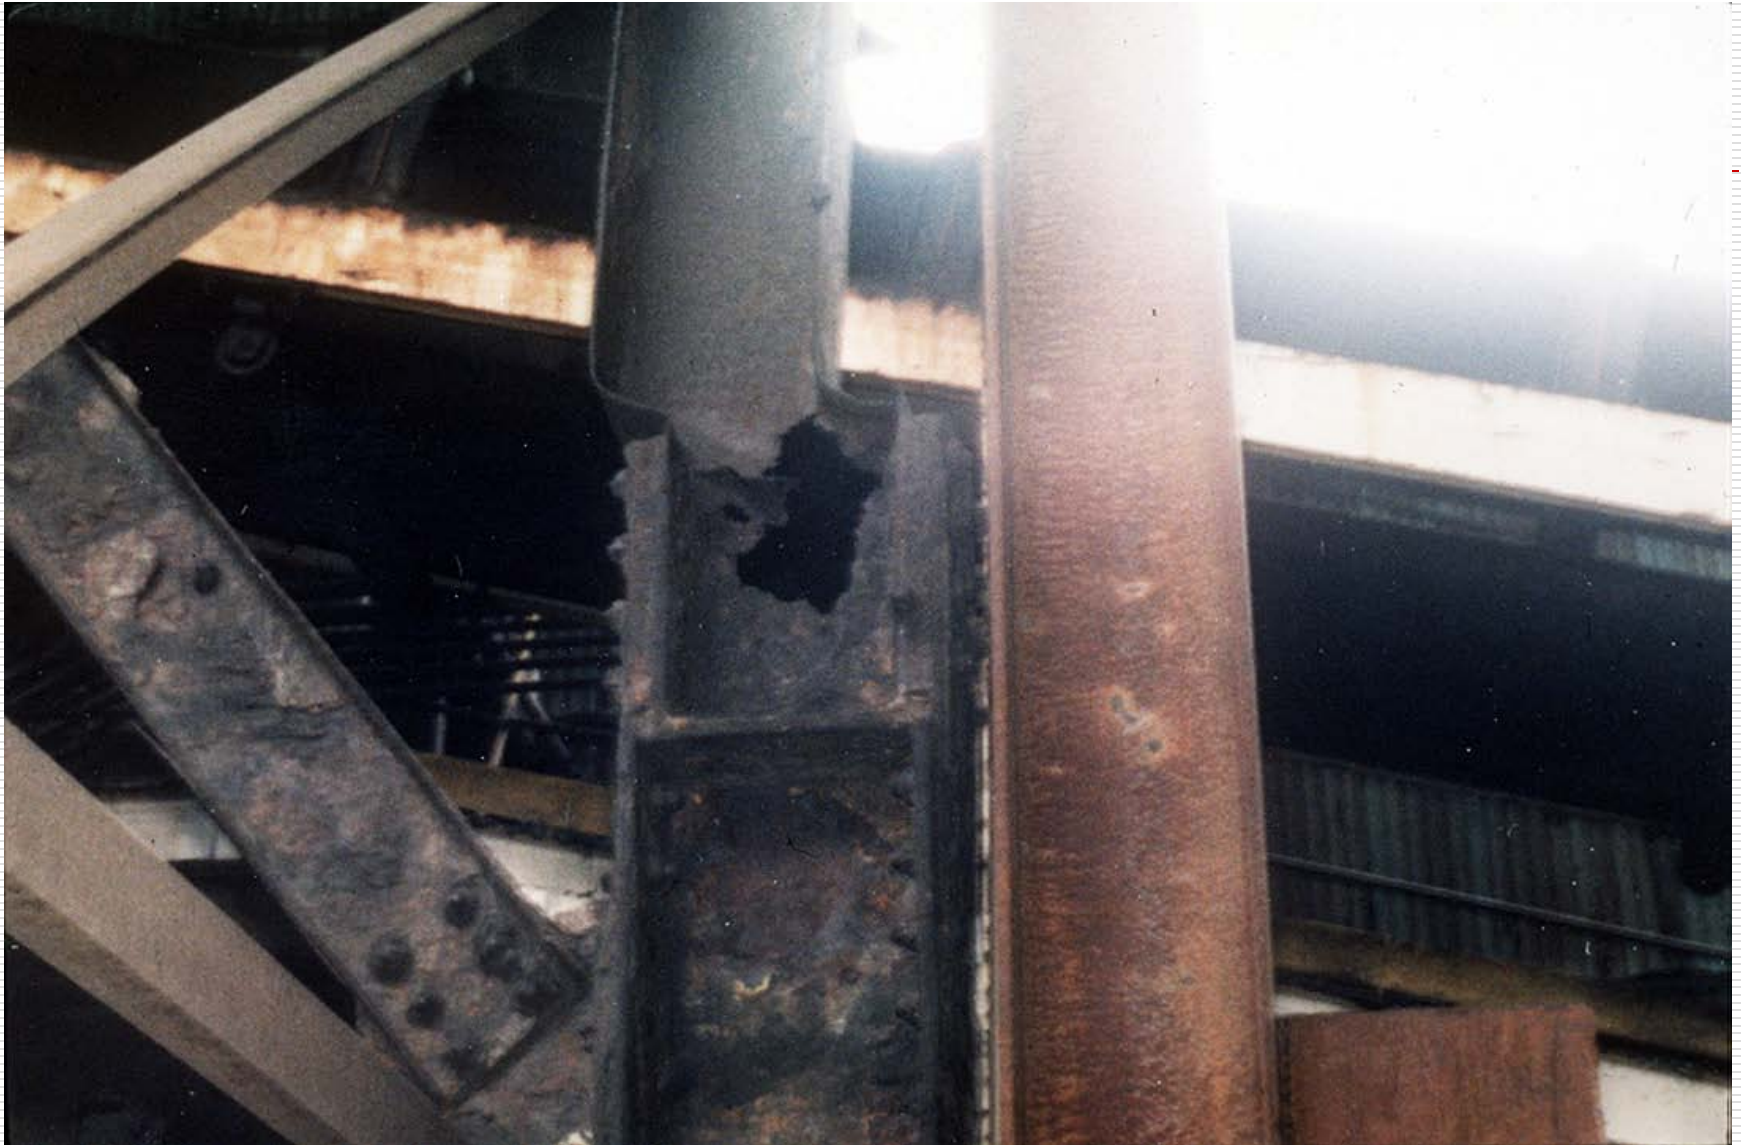
Buckled column flanges @ web corrosion hole 29

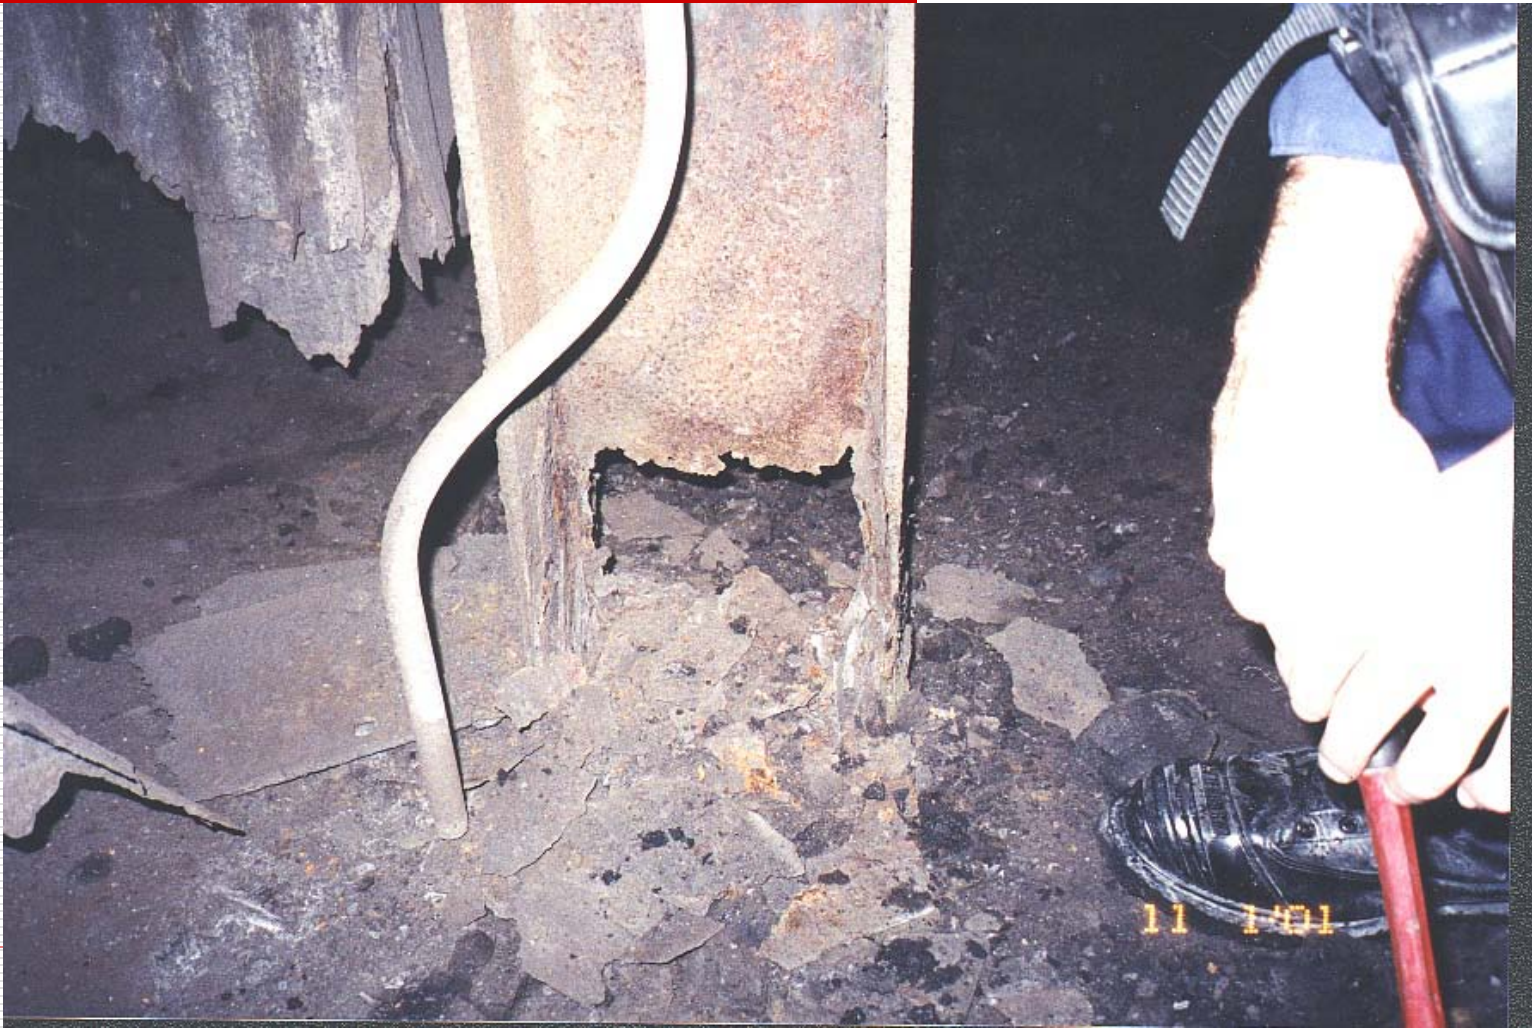
# Corrosion hole in web of column

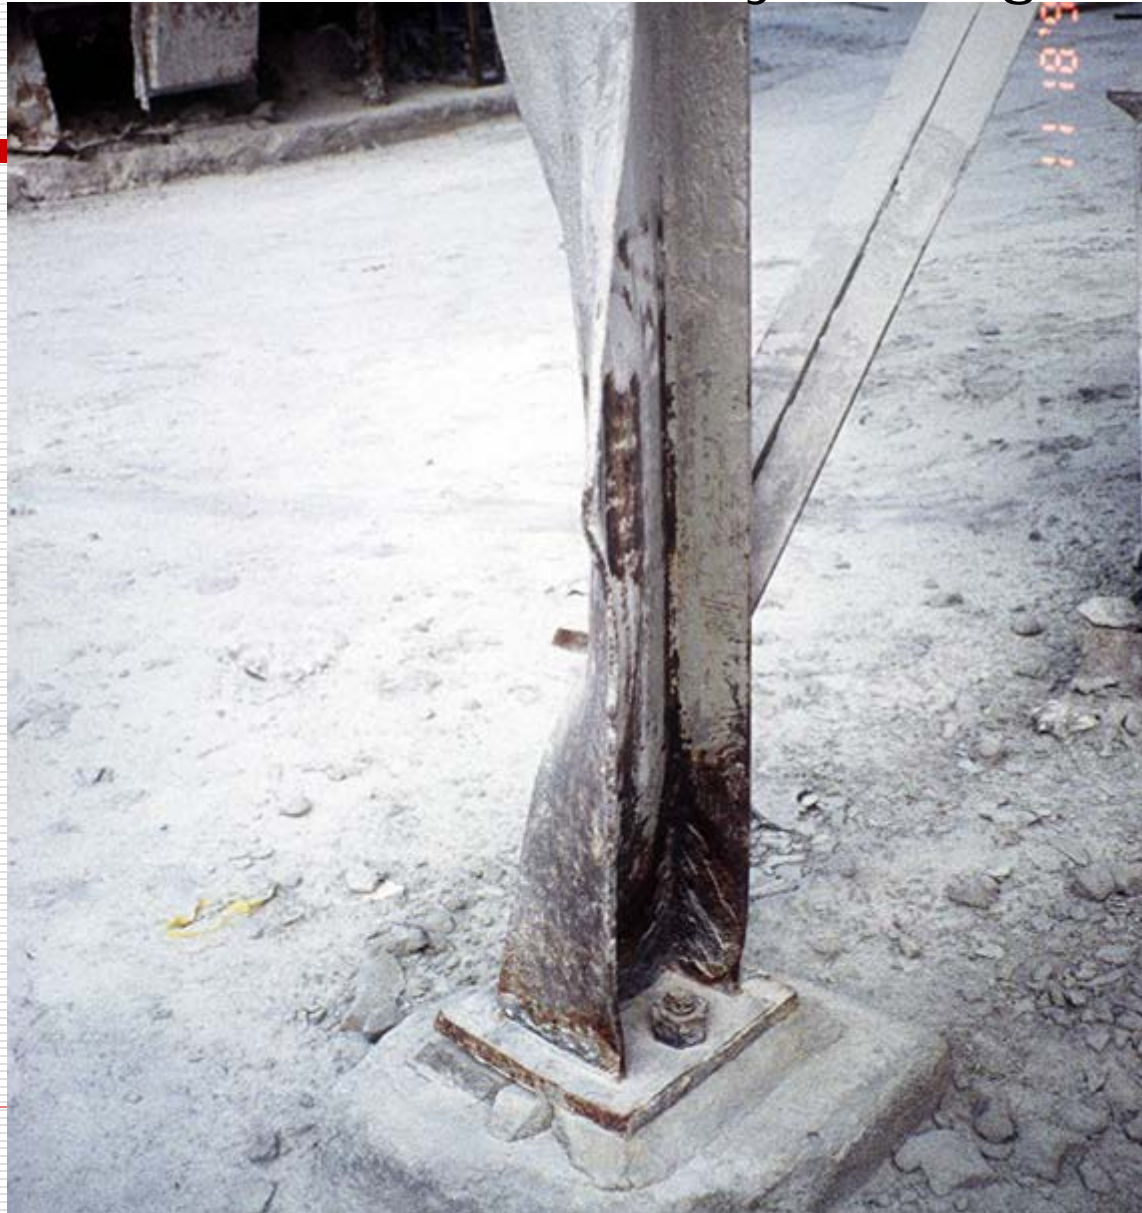
An equipment mishap – these types of repairs can be evaluated by an engineer

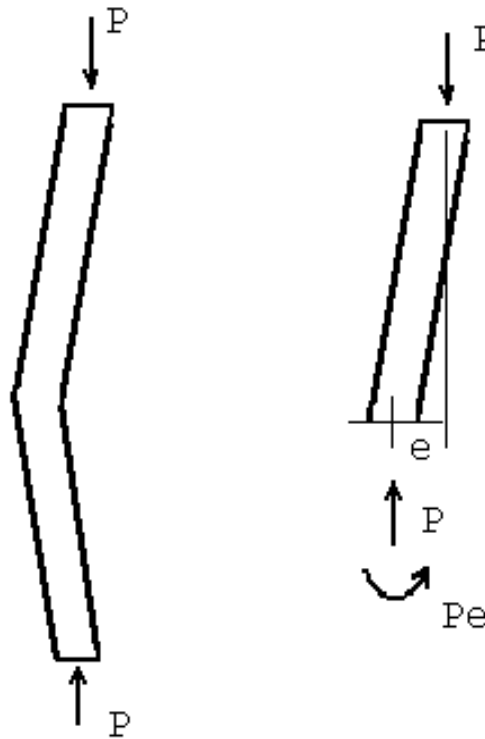
# Crooked Column (creation of moment)

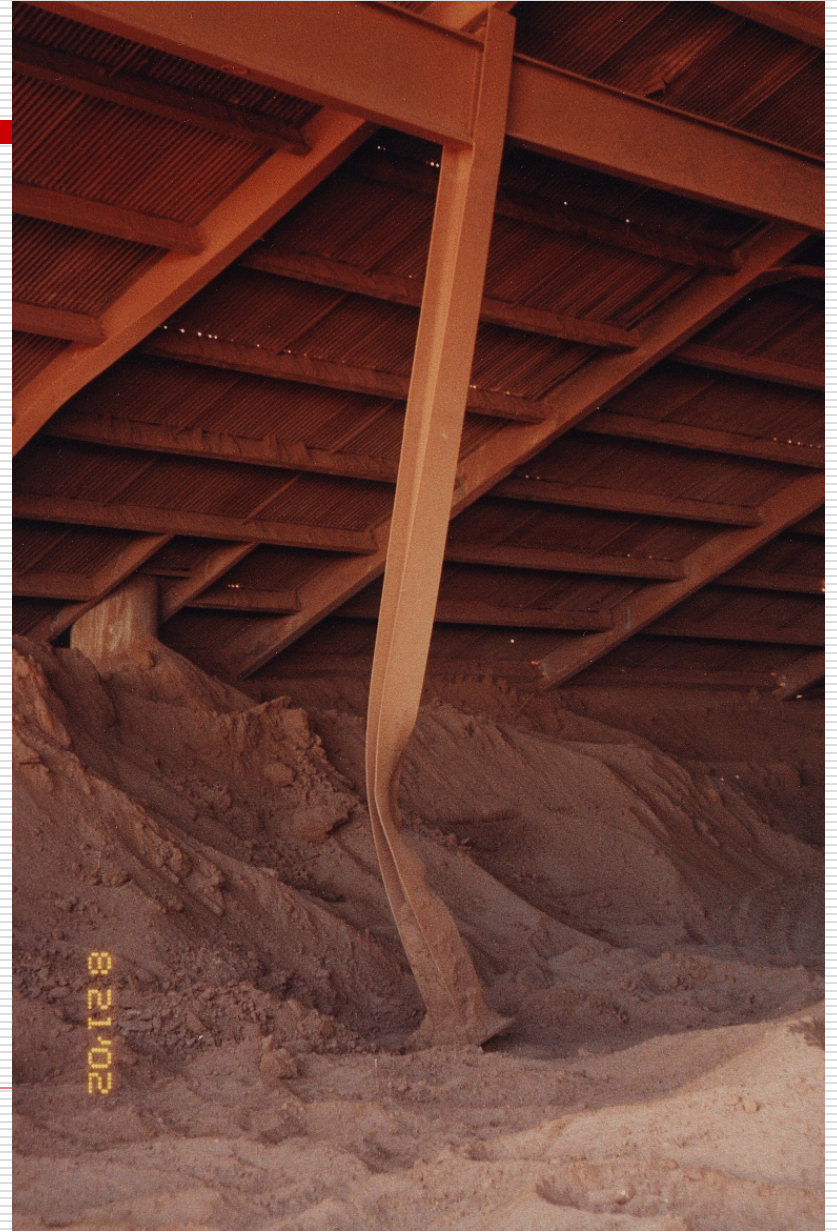
# Severe equipment damage

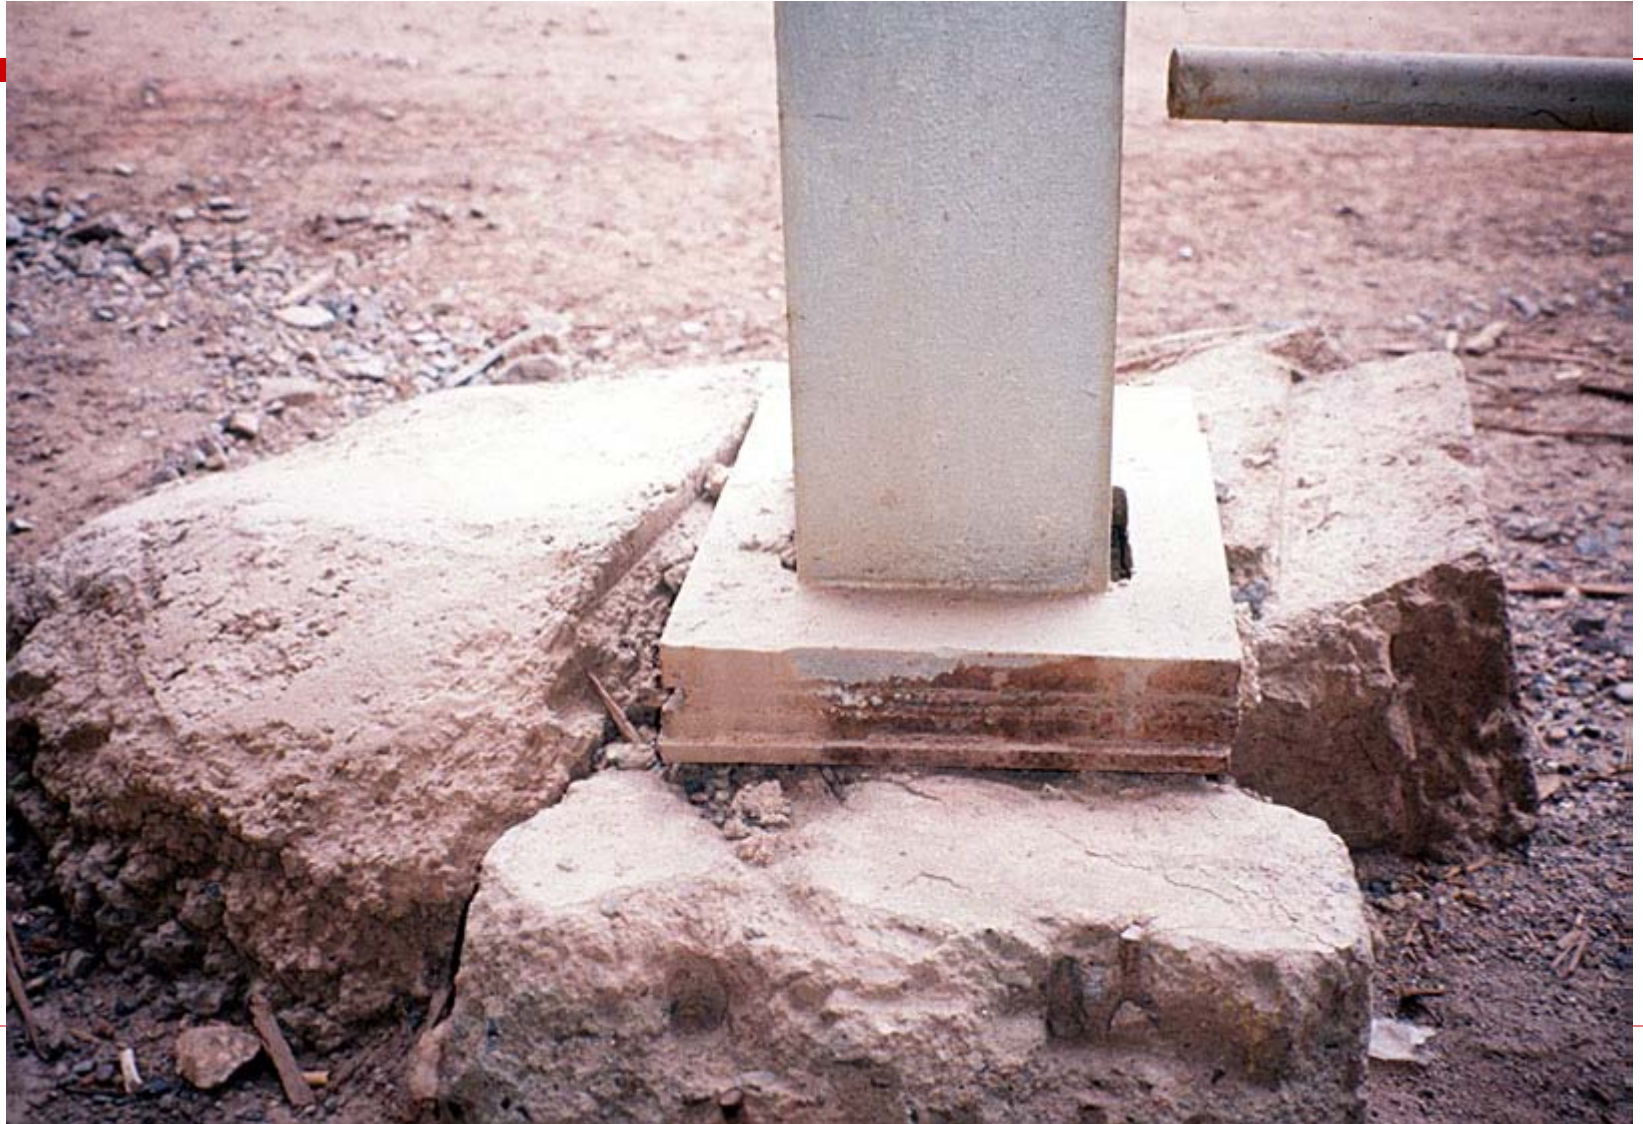
# Inspect the column foundations

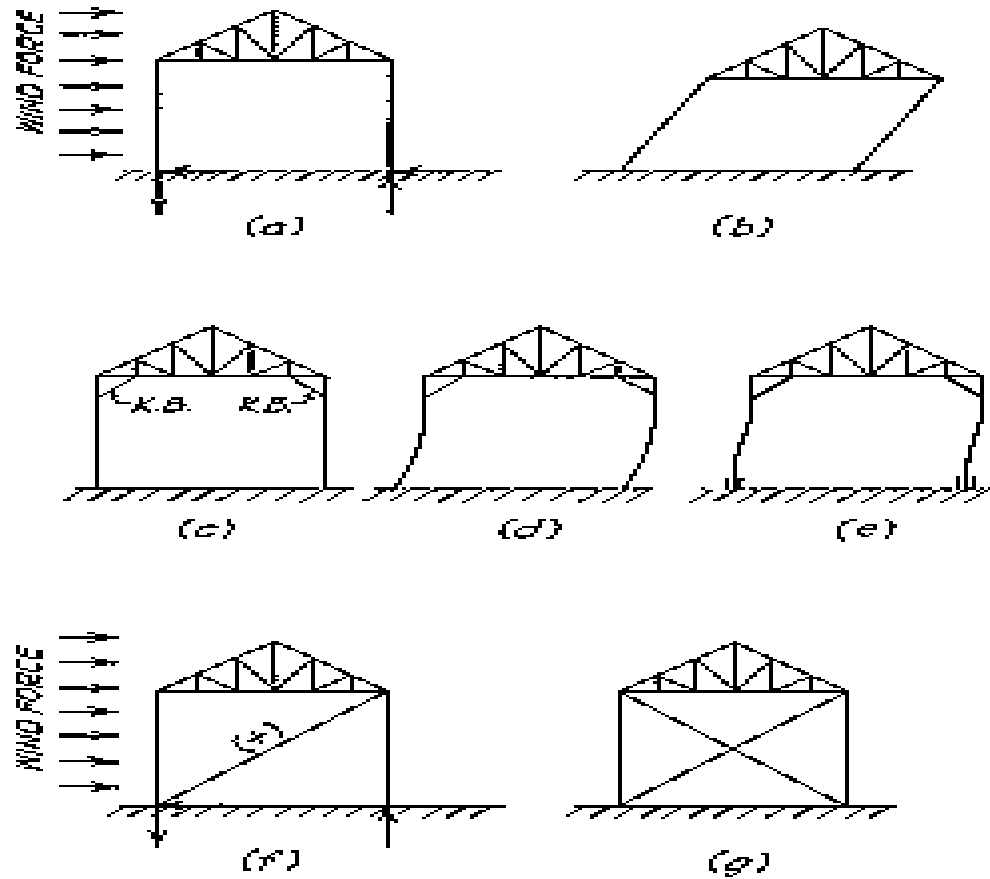
# Don't take the bracings out!

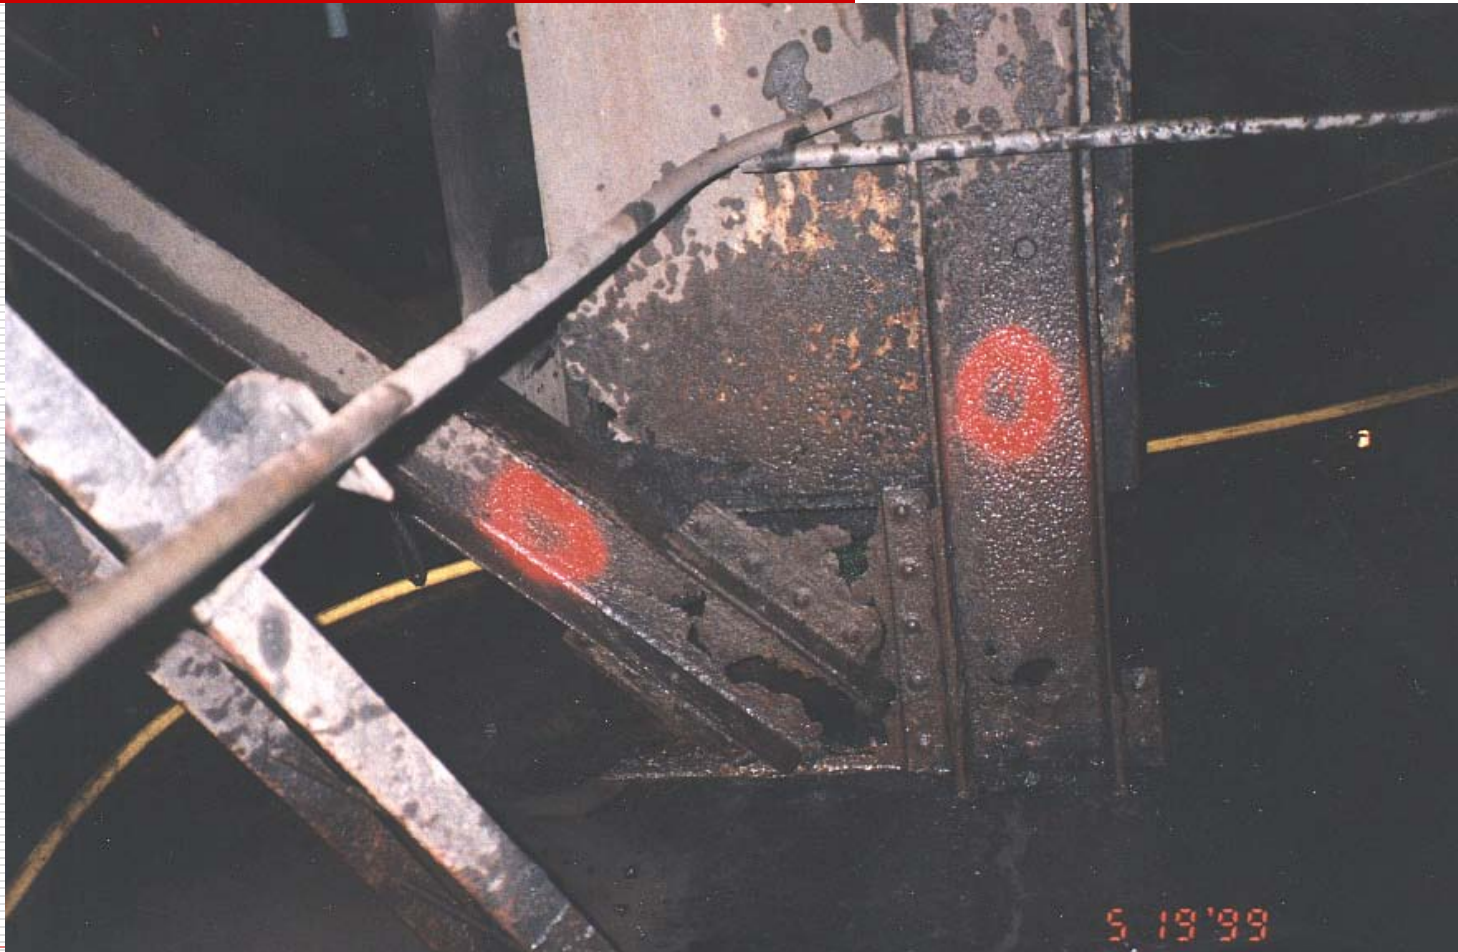
# Corroded diagonal and gusset plate

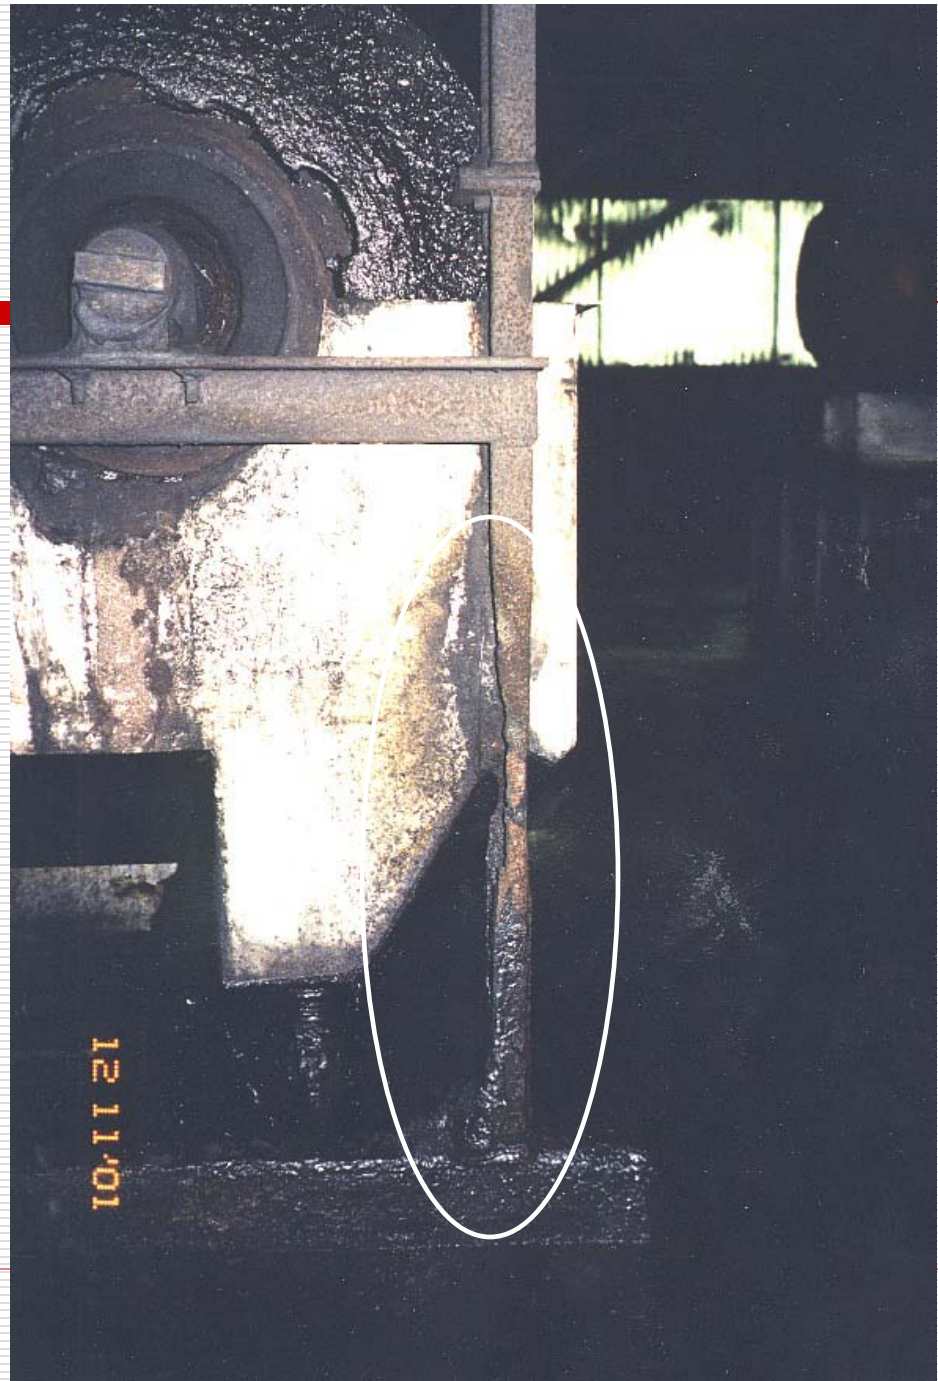
Corroded channel  
post support for a  
magnetic  
separator

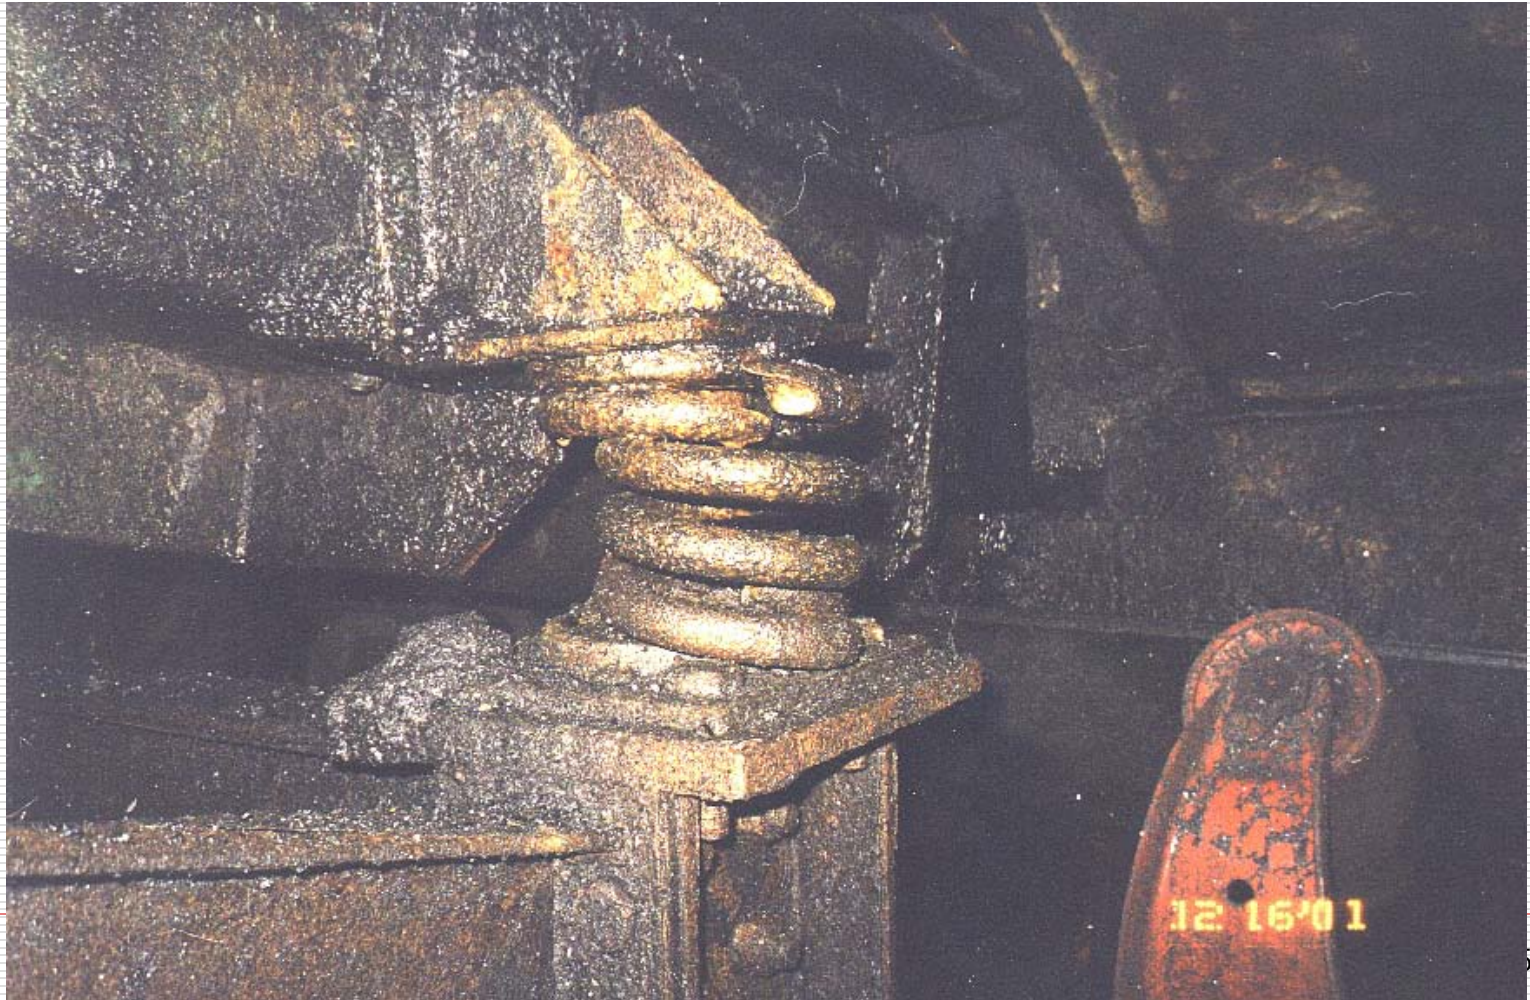
# Fractured spring support for vibrating equipment

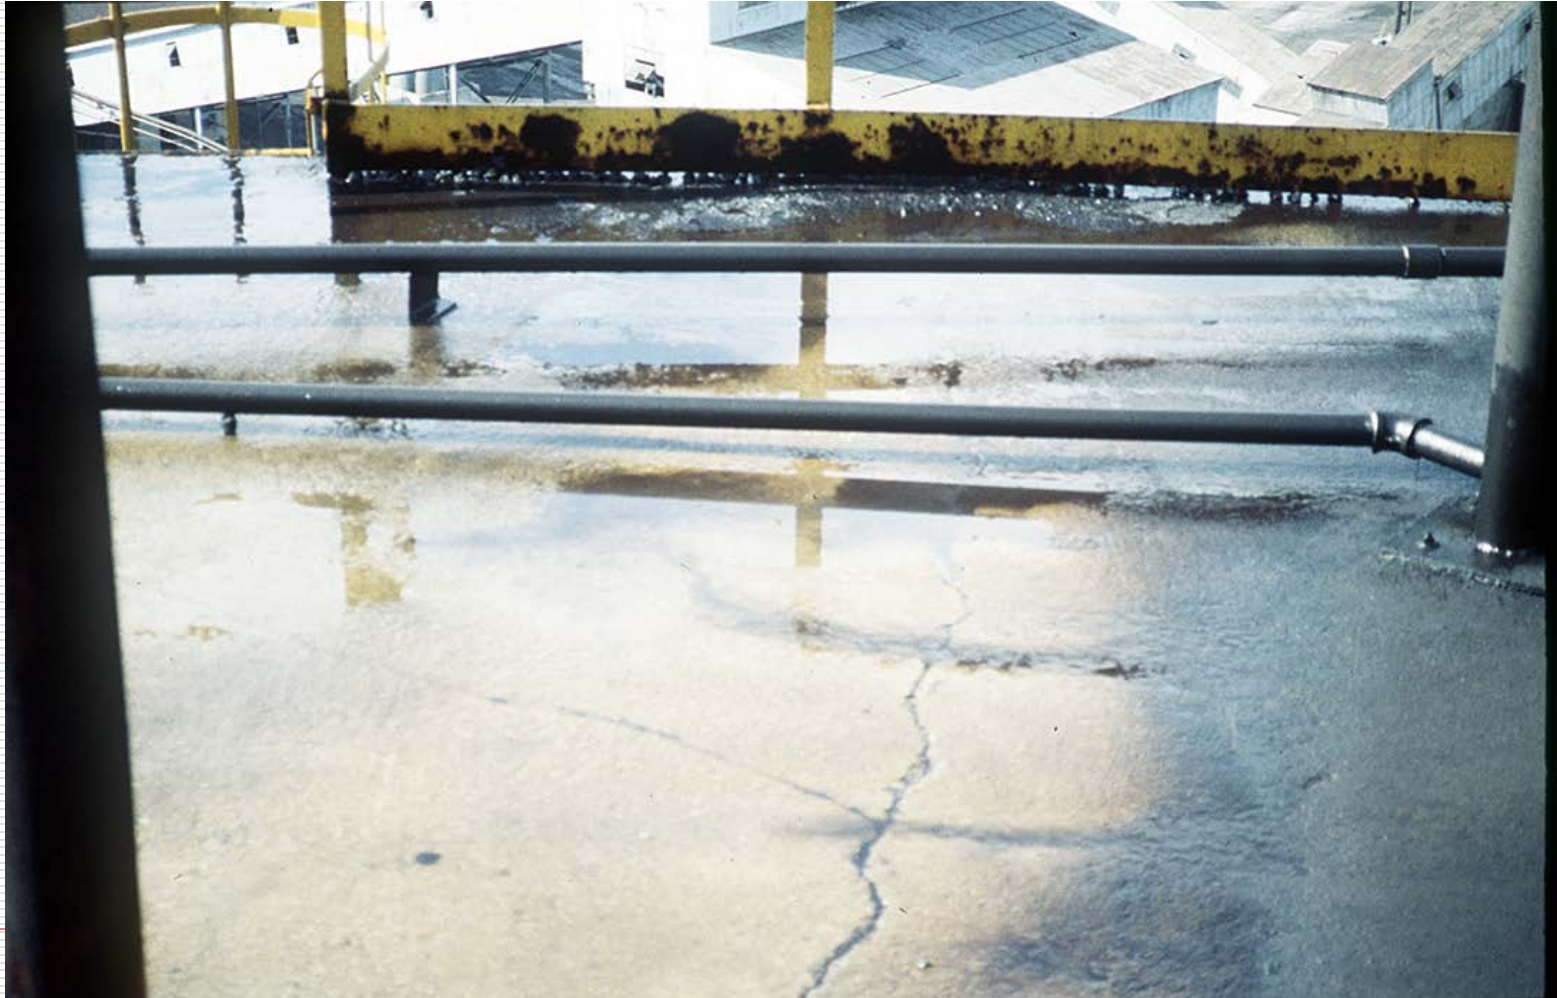
# Floor slab cracks - a potential source of rebar corrosion
