# ***Structural Failures Cost Lives and Time***

# Structural Inspection of Processing Plants

PowerPoint prepared by Terry Taylor, P.E.,  
Senior Civil Engineer, PSHTC

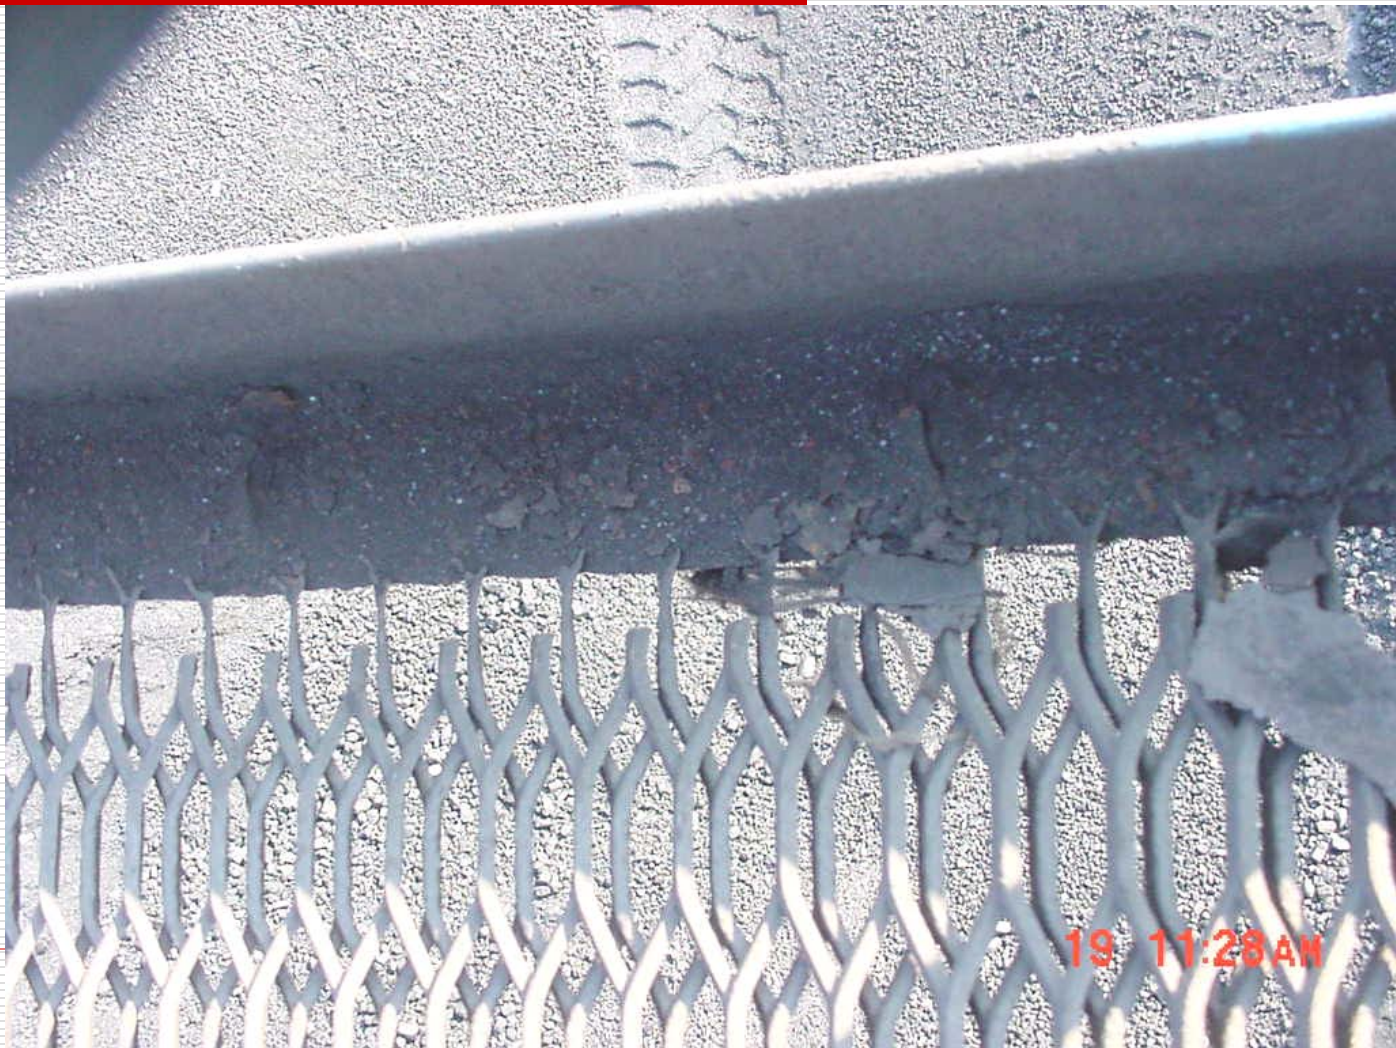
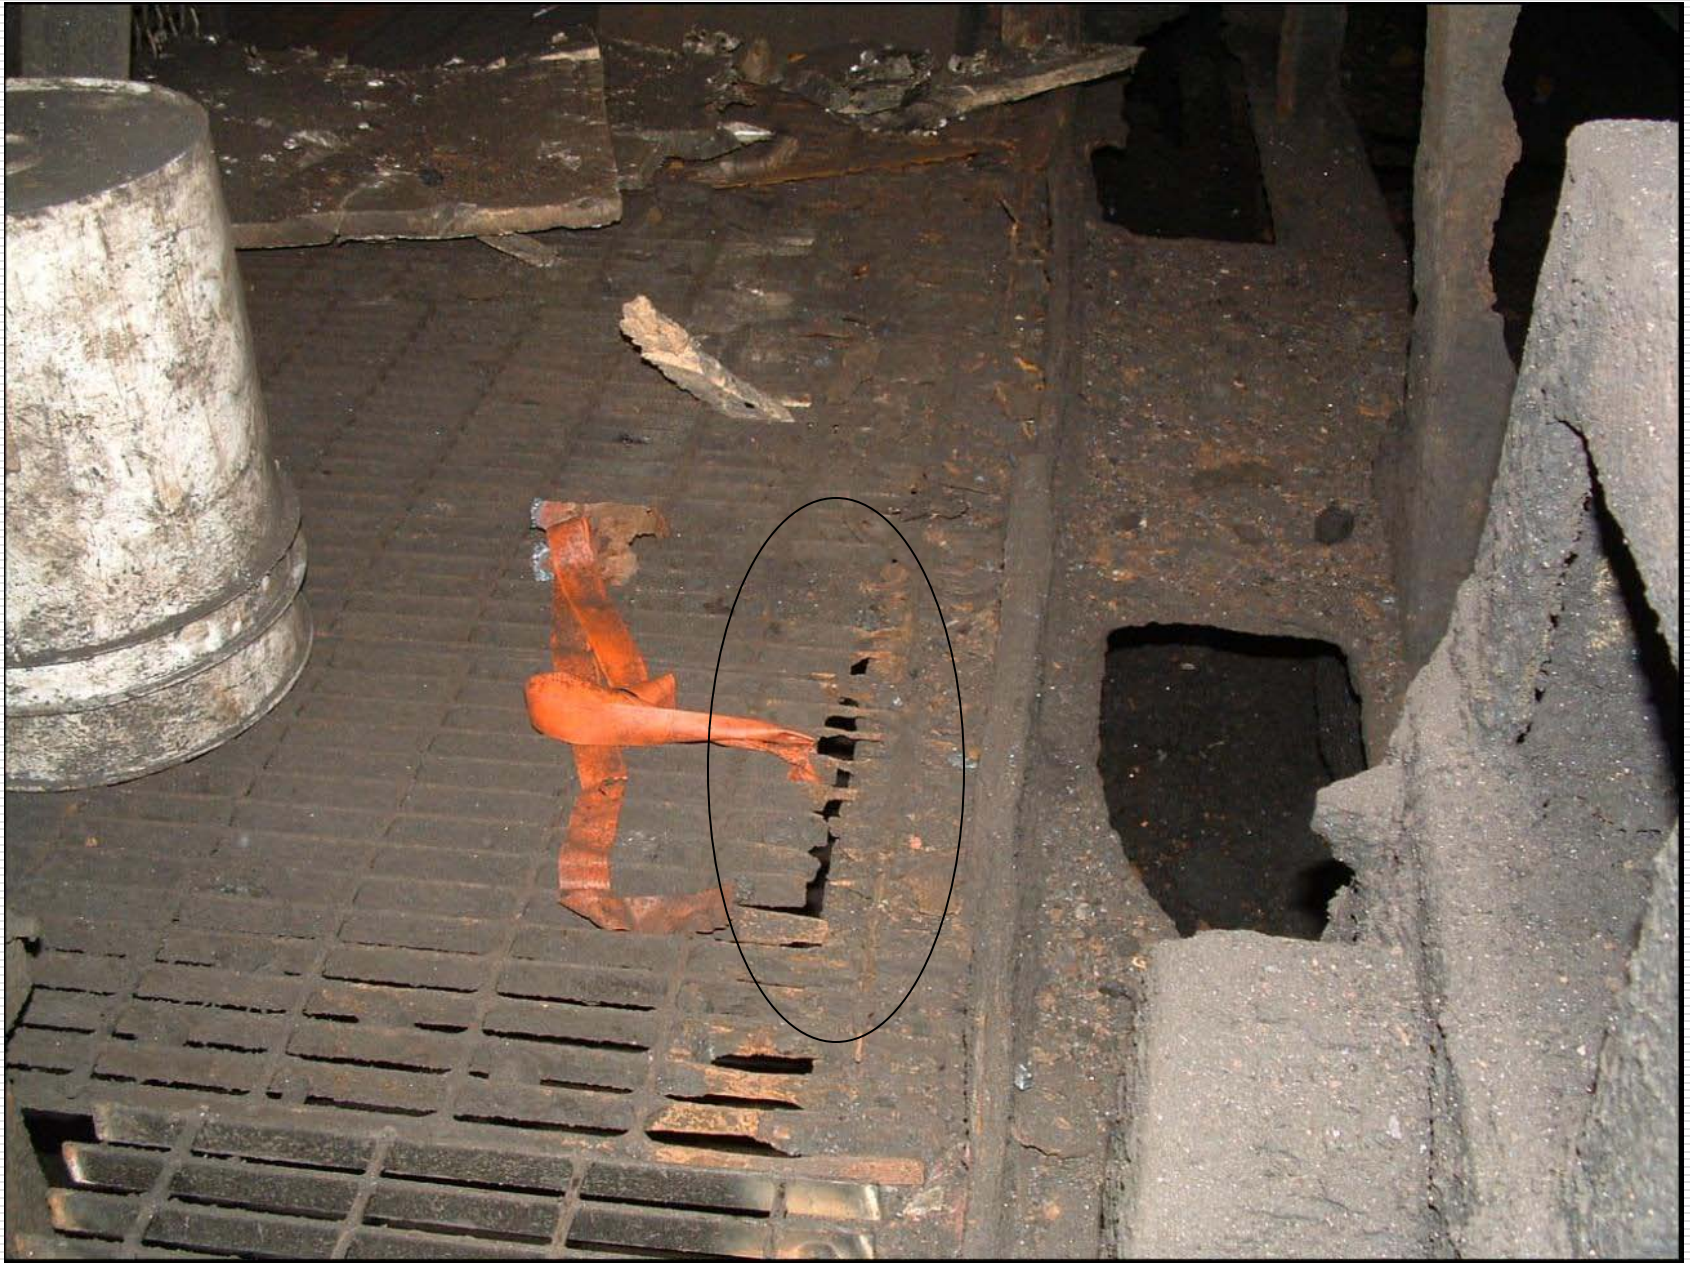
# Corrosion at support edge of grating

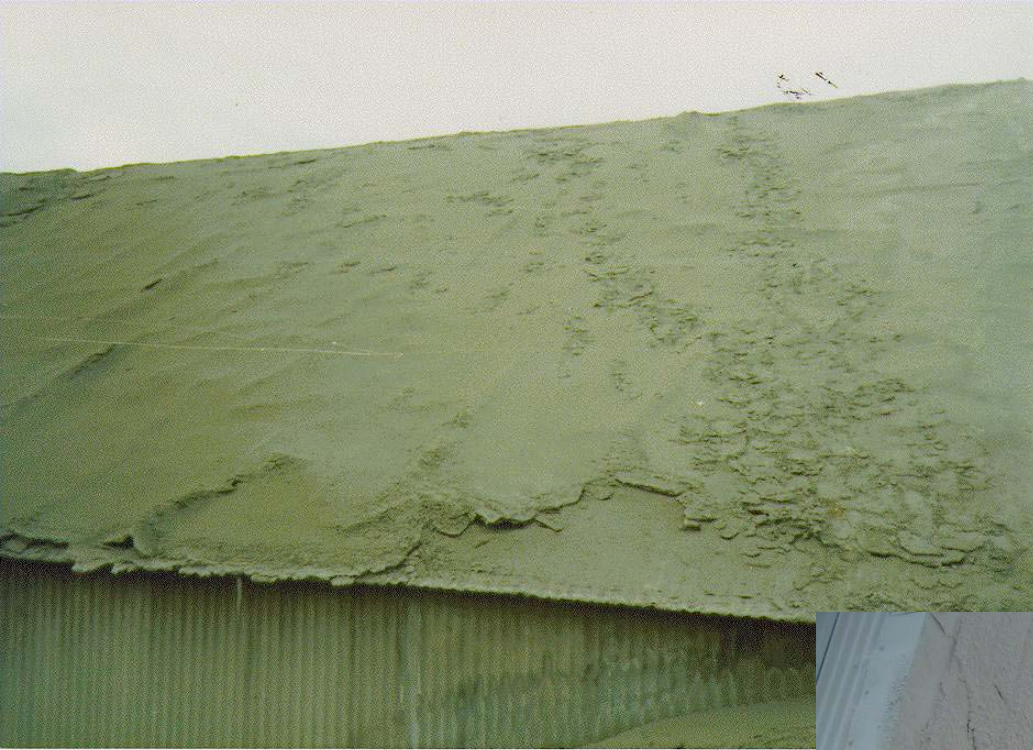
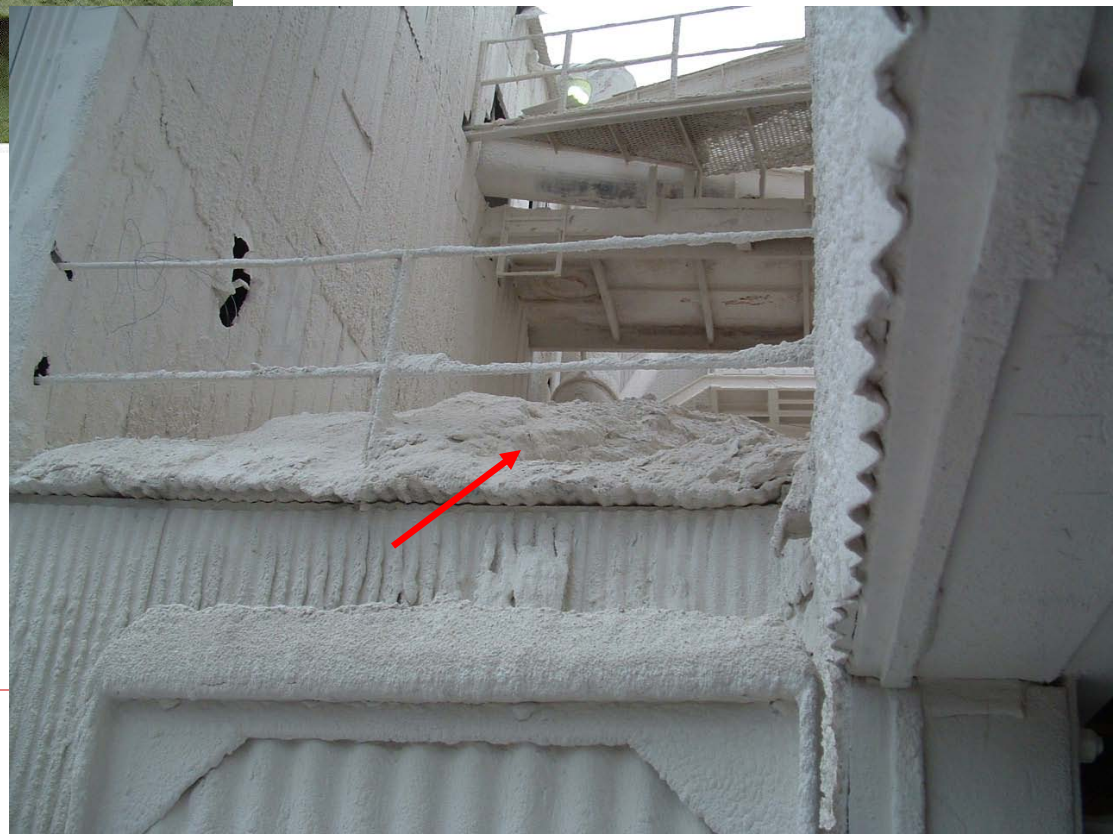
# Heavy Roof Loading

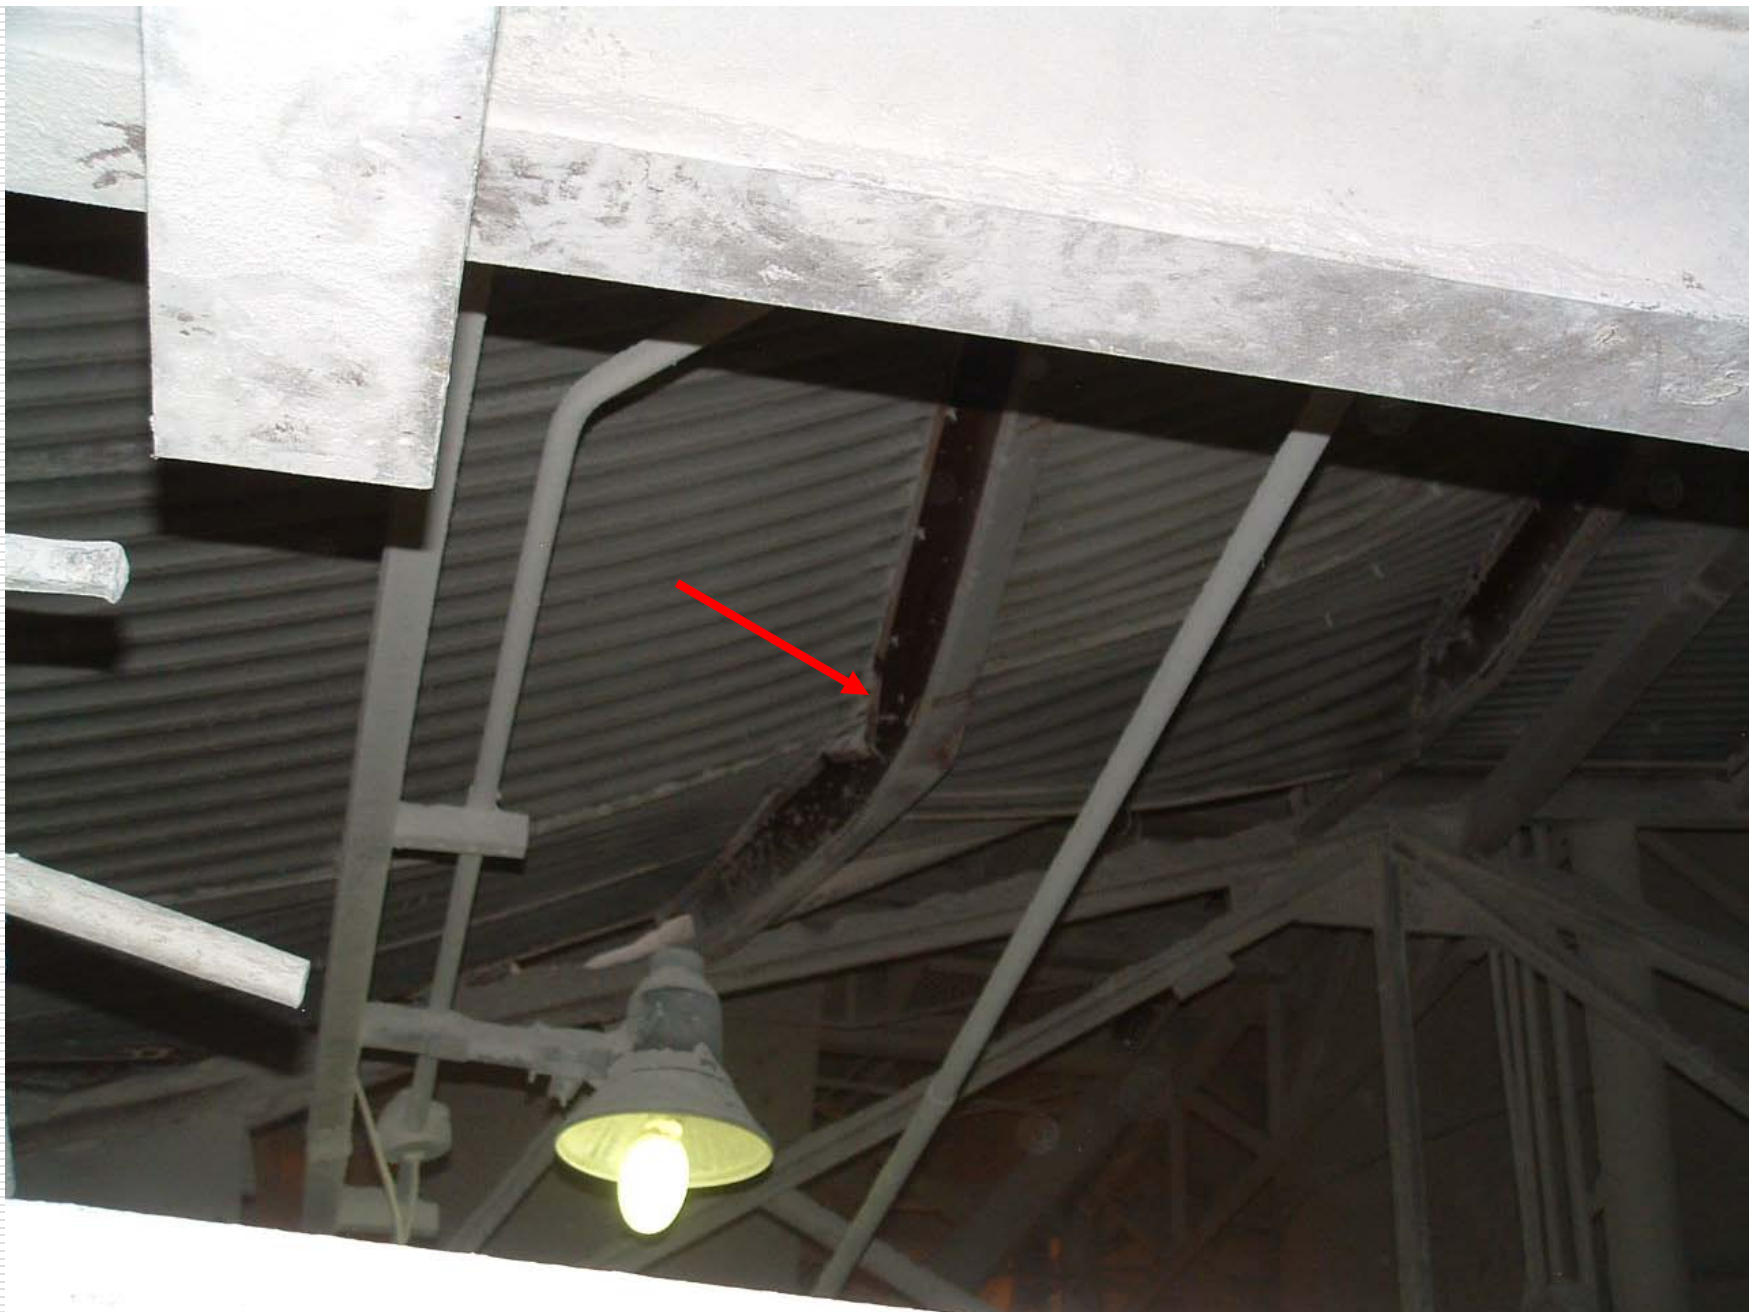
Collapsing Roof Support Purlins

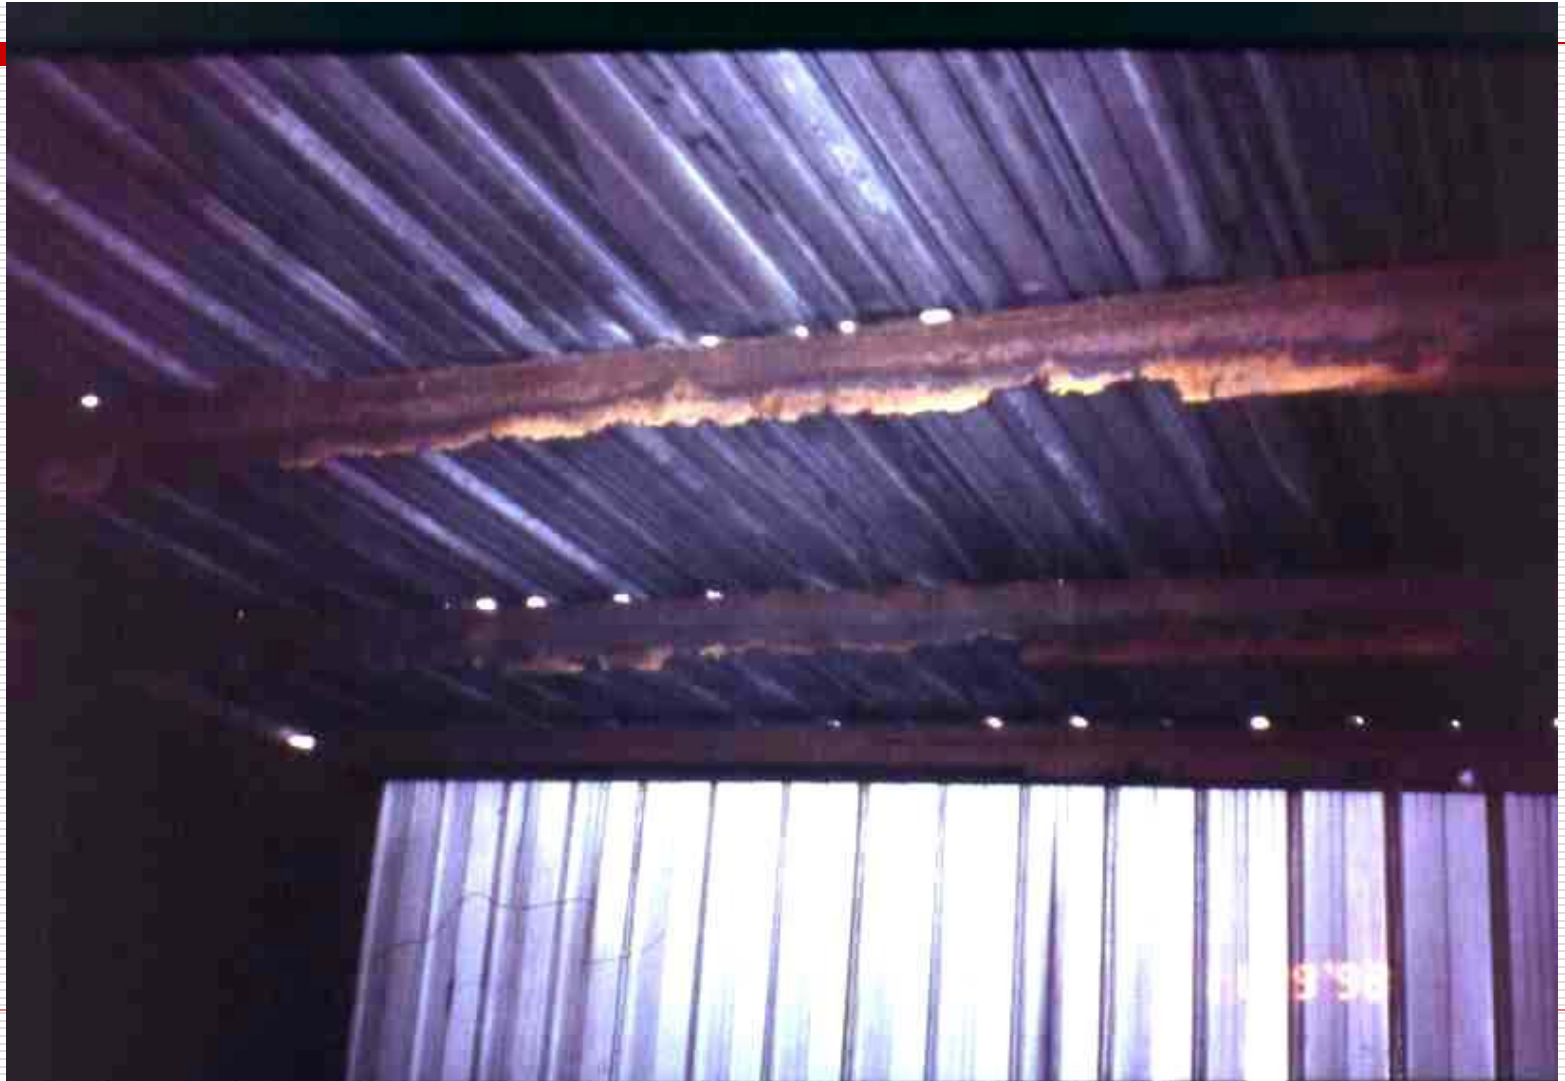
# Corrosion of bottom flange of roof support channel

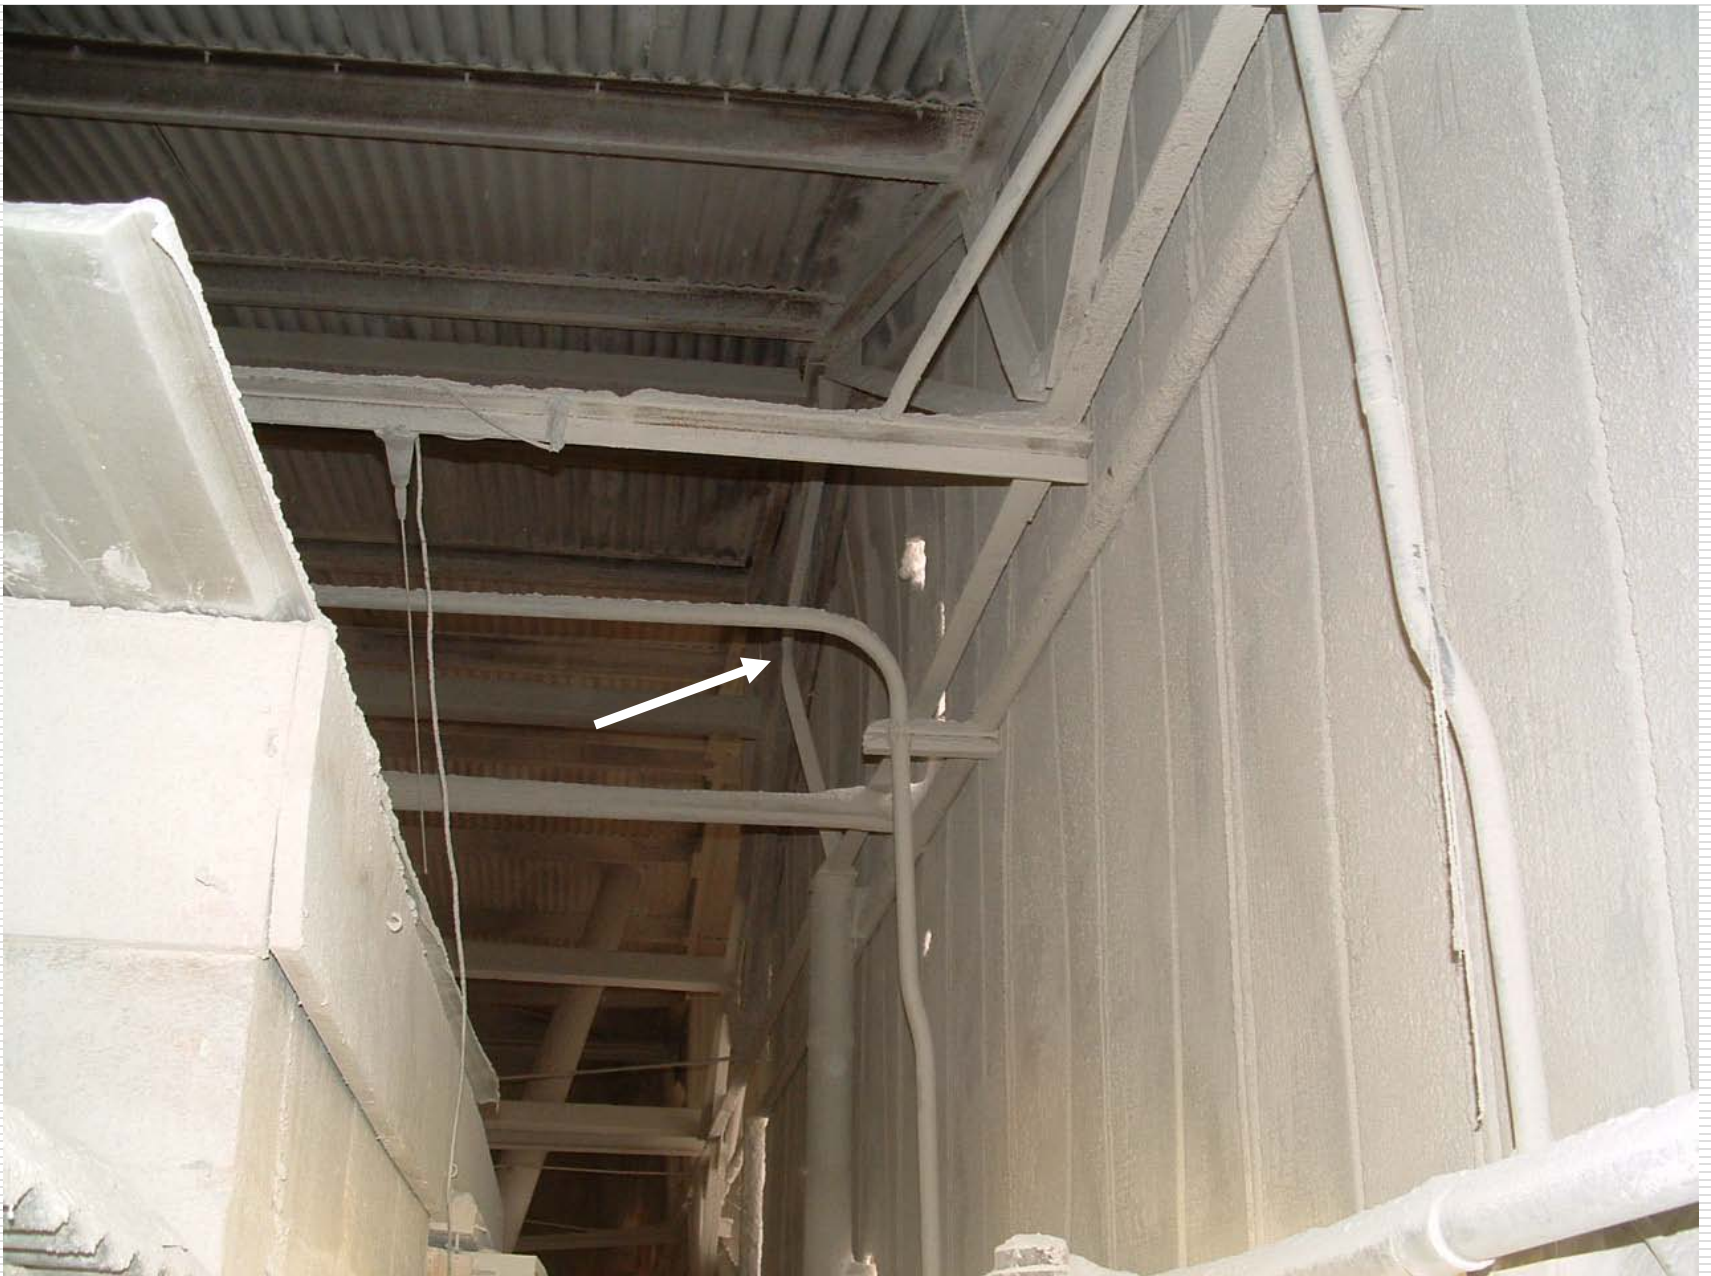
Buckled Vertical Roof Truss Member

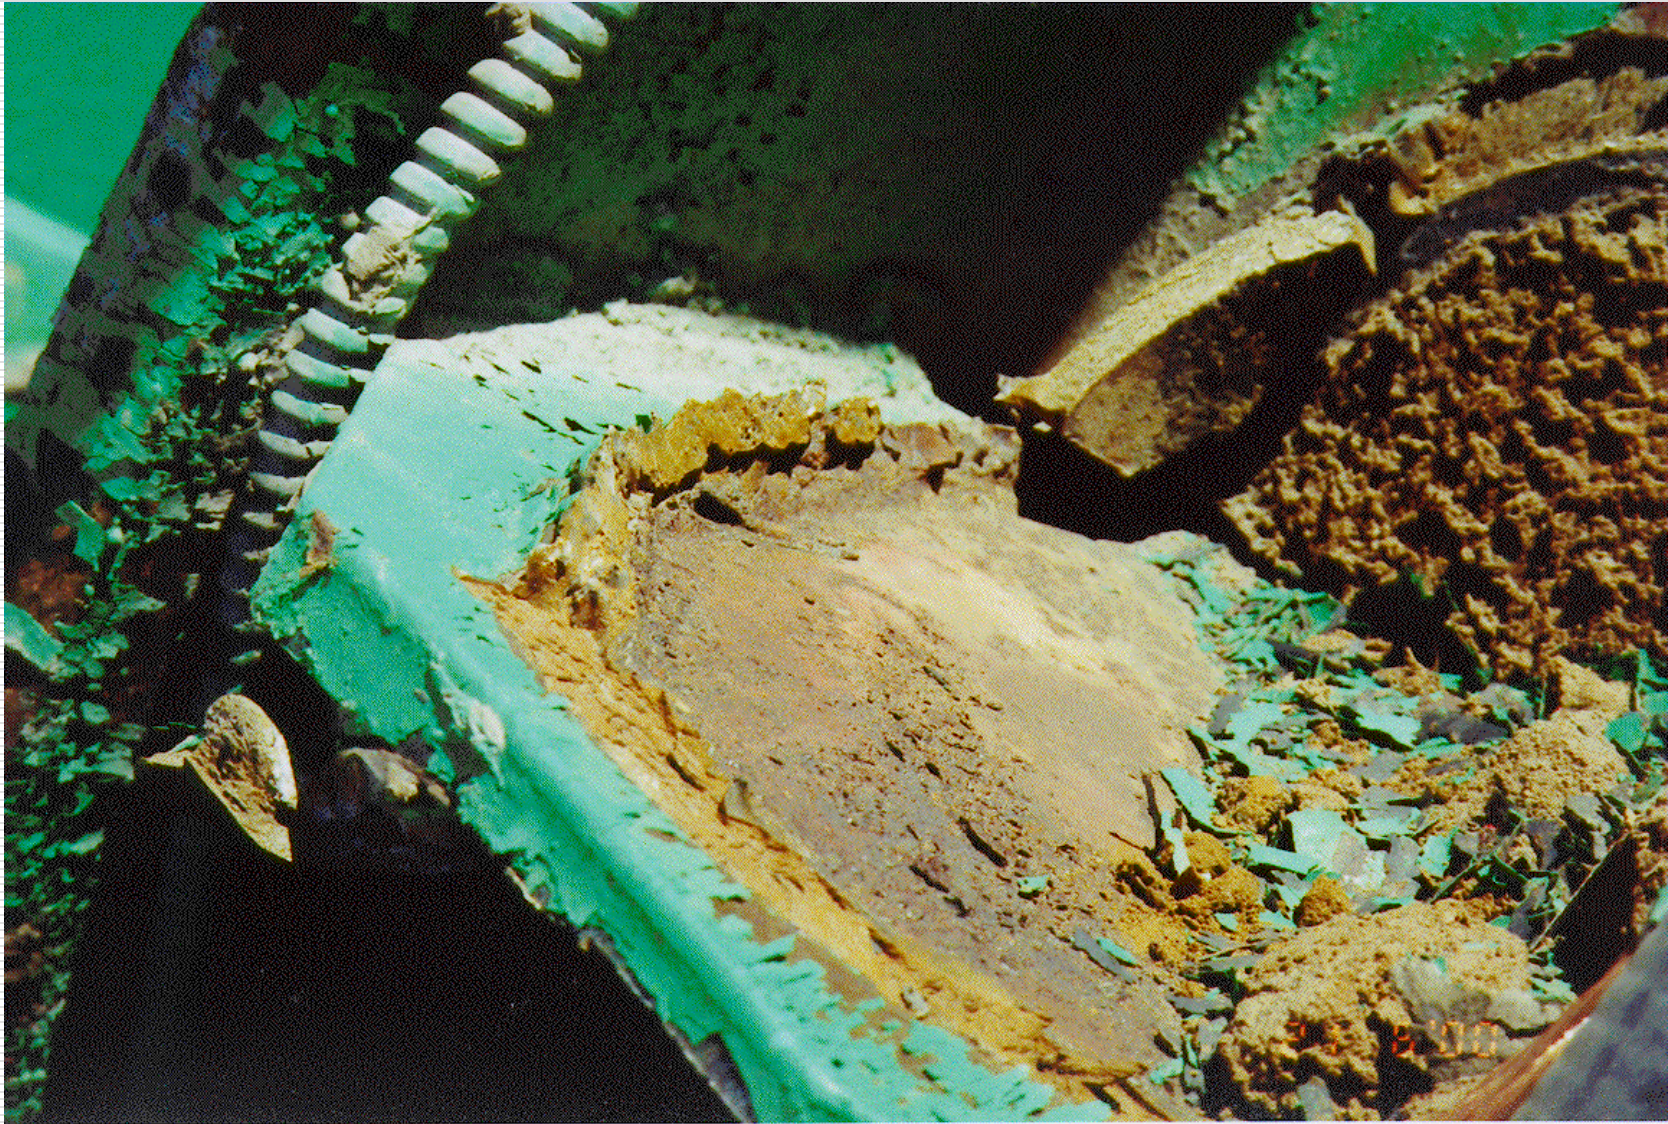
# Irregular weld surface w/porosity

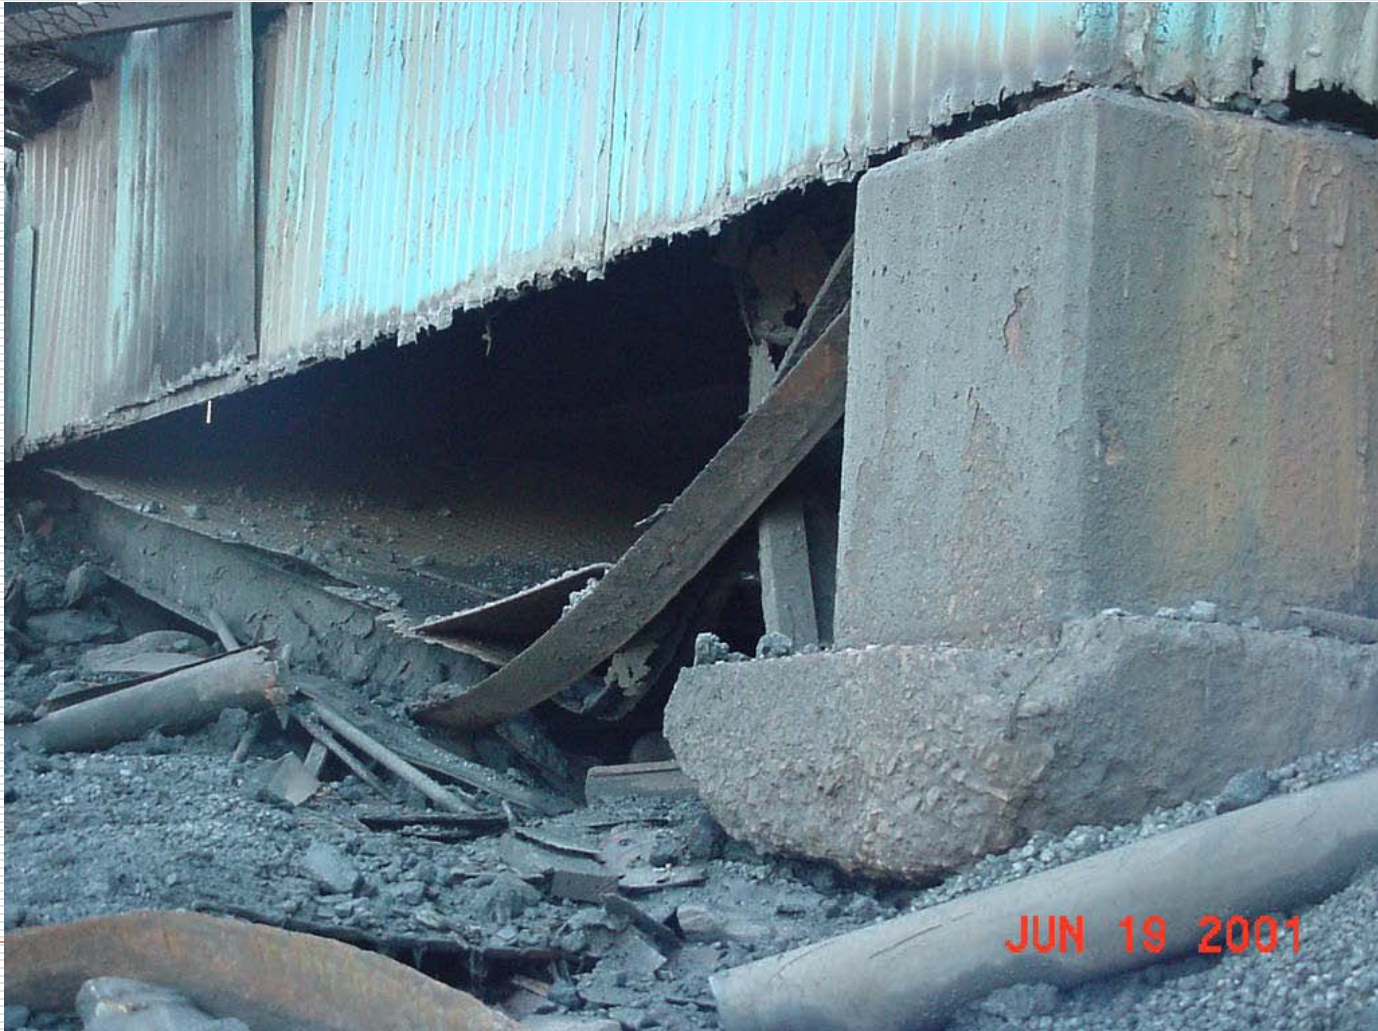
# Collapsed floor – Avoid this!
