# **EPA CHEMICAL ACCIDENT INVESTIGATION REPORT**

**Accra Pac Group, Inc.  
North Plant  
Elkhart, Indiana**

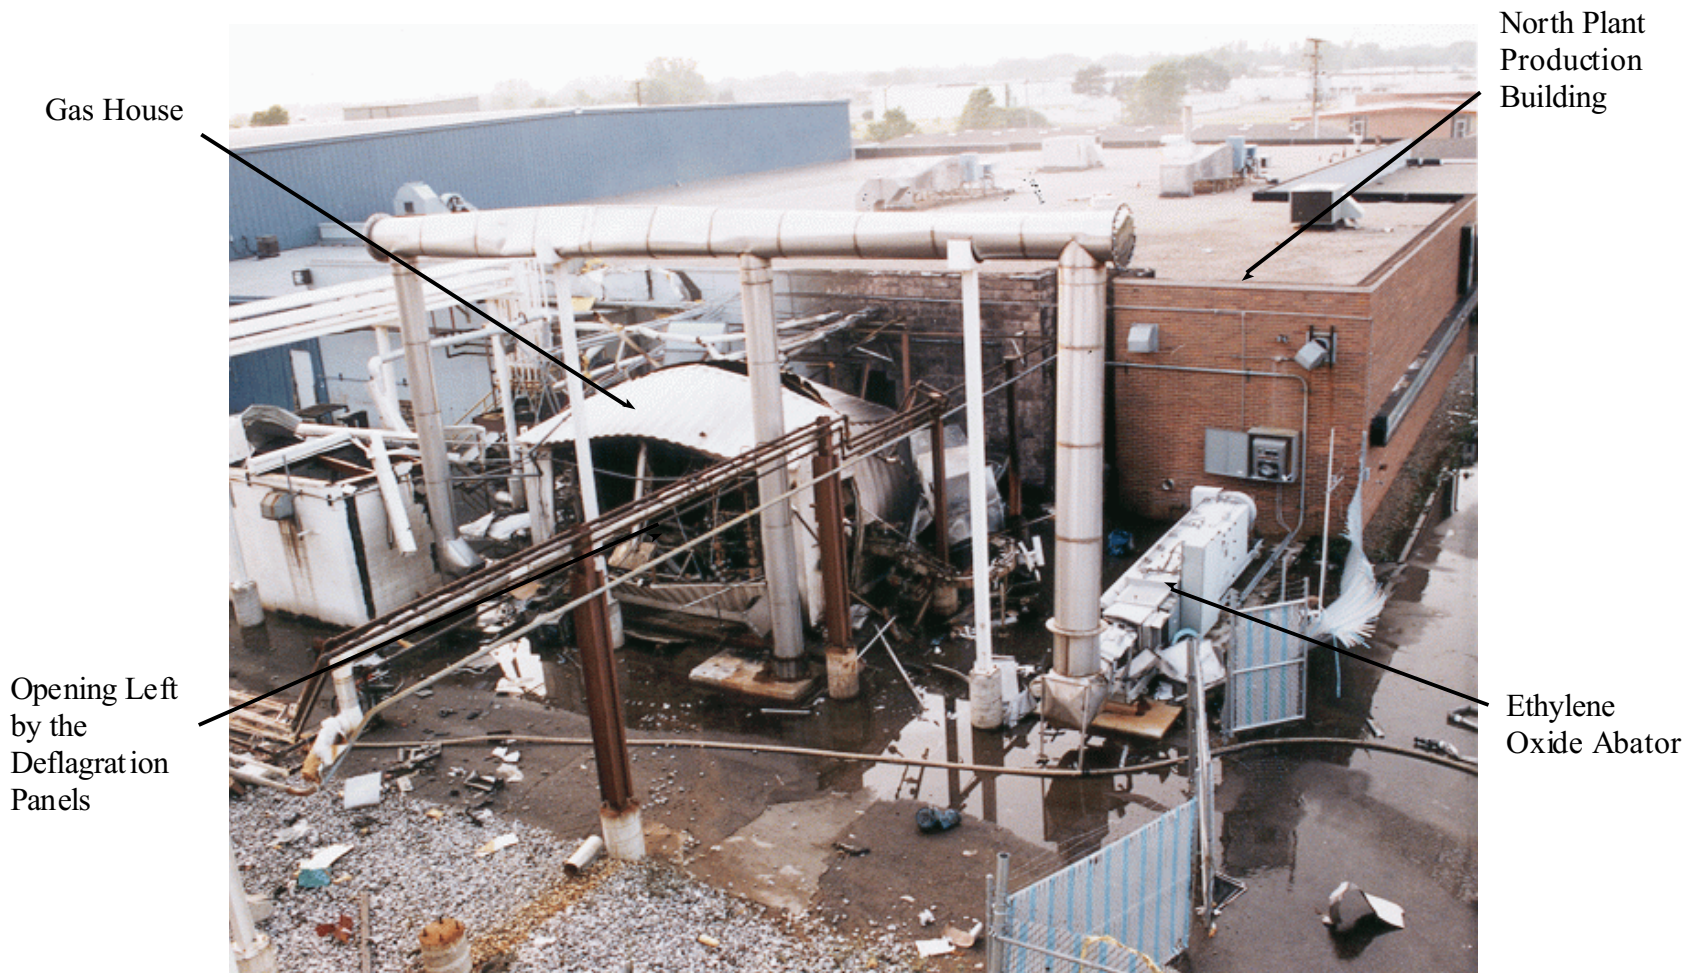
An Accra Pac employee working in the Production Building across from the Gas House was killed as a result of the explosion. When the Gas House doors were blown off, the door facing the Production Building impacted the Production Building door and caused that door and its frame to be dislodged and blown into the Production Building where it struck and killed the employee.

**A-1: The Gas House and the Production Building after the explosion and fire.**

- **Properly locate and provide sufficient barriers between units that have a potential for explosion from other processes in accordance with NFPA 30, 5-3.2.2.** Units that are recognized as hazardous with a potential for explosion should be sufficiently spaced away or provided with blast walls between units such that if an explosion occurs, employees in other locations are not harmed.
