Structural and Foundation Response Measured During the Site Specific Load Test on the London Avenue Outfall Canal I-Wall/Levee

Contract No. W912P9-05-D-0514, Task Order 6

United States Army Corps of Engineers

November 20, 2007

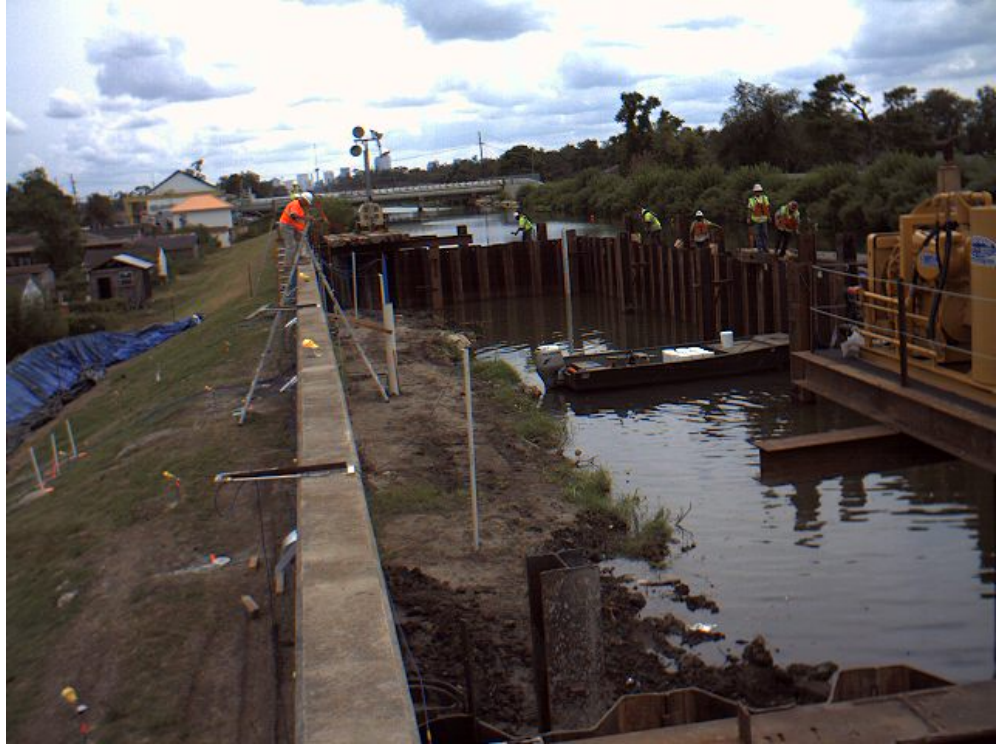
Cofferdam With Water at Elevation 1.0 ft

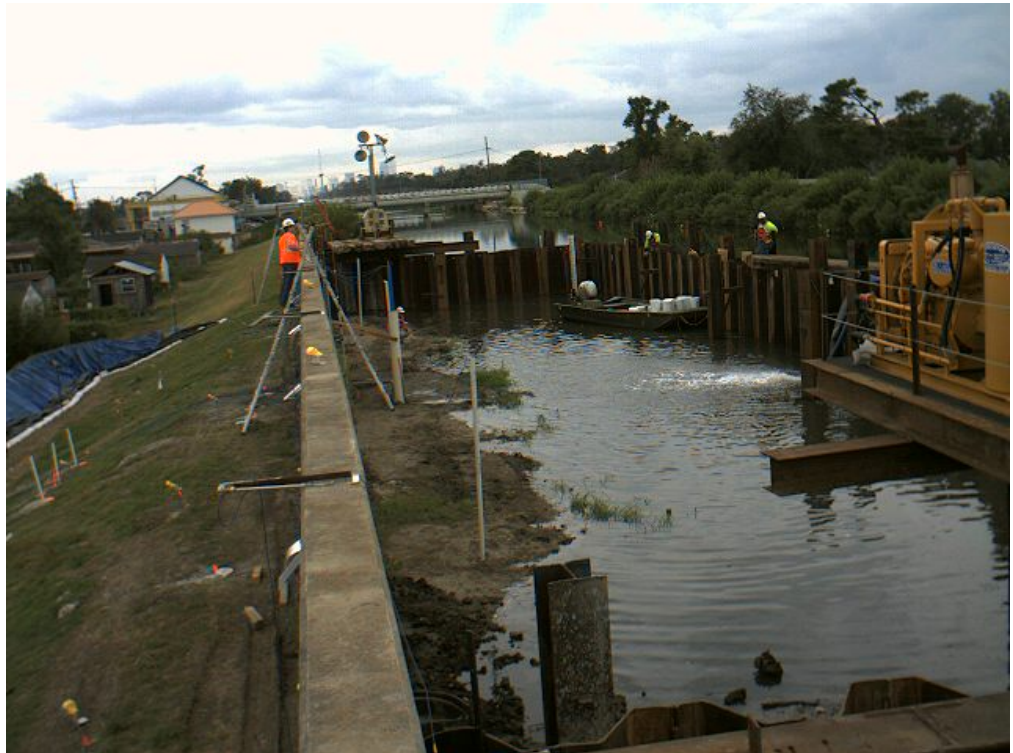
Cofferdam With Water at Elevation 2.0 ft

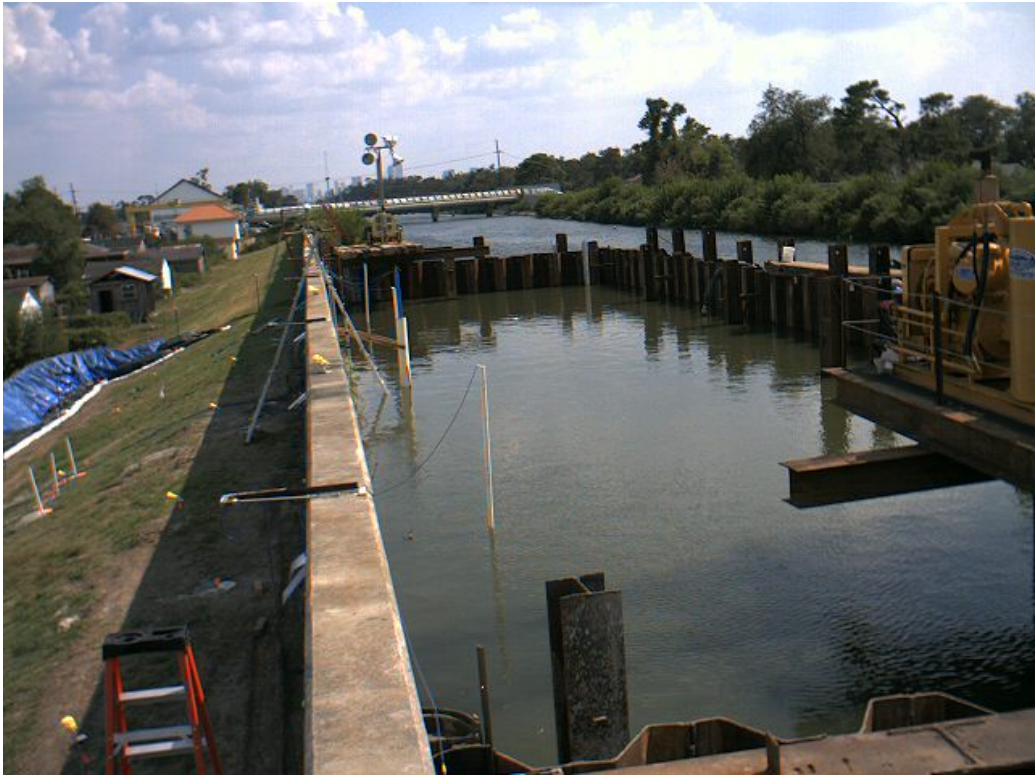
Description: Cofferdam With Water at Elevation 4.0 ft

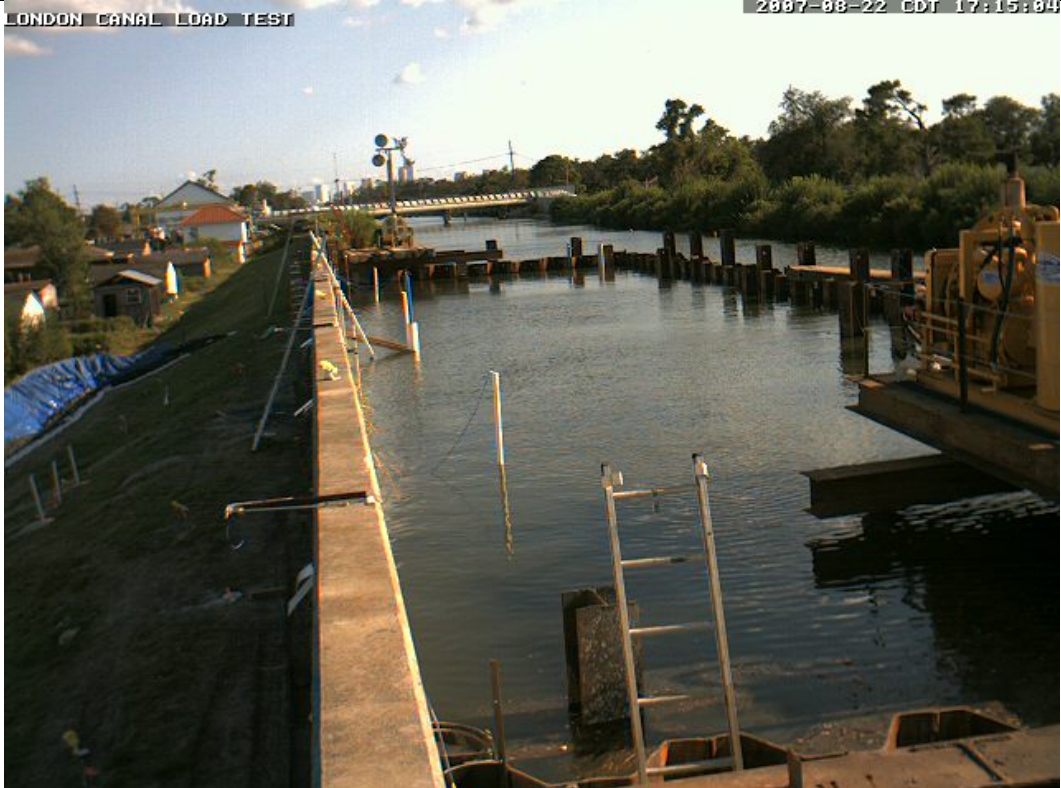
Description: Cofferdam With Water at Elevation 7.0 ft

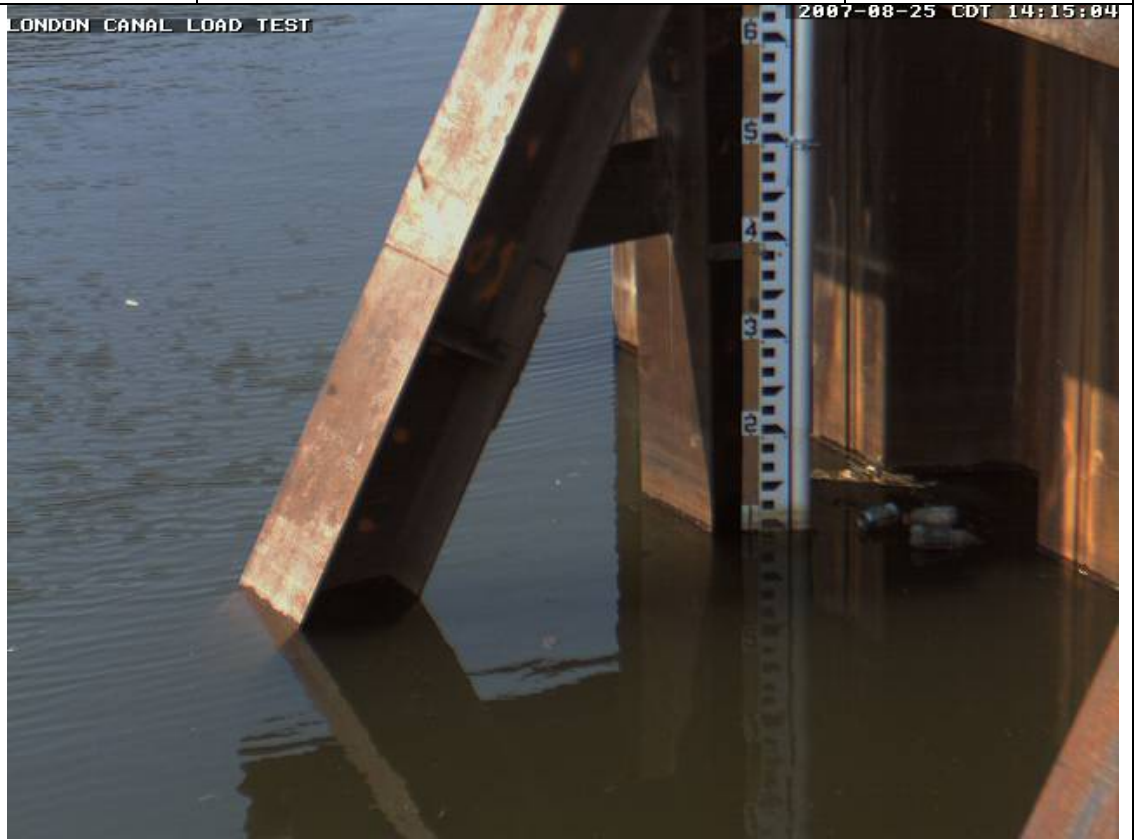
Description:
Photograph of Surface Water Level Gages (Staff Gage and Adjacent Casing for Transducer)

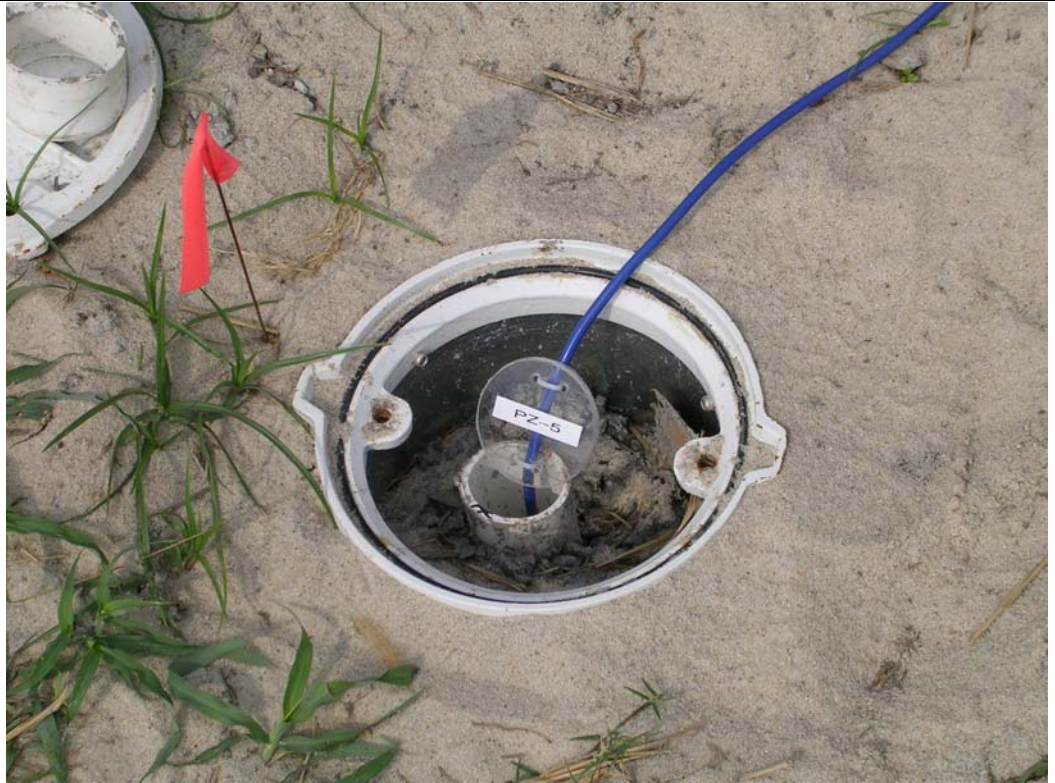
Typical Piezometer Installation.

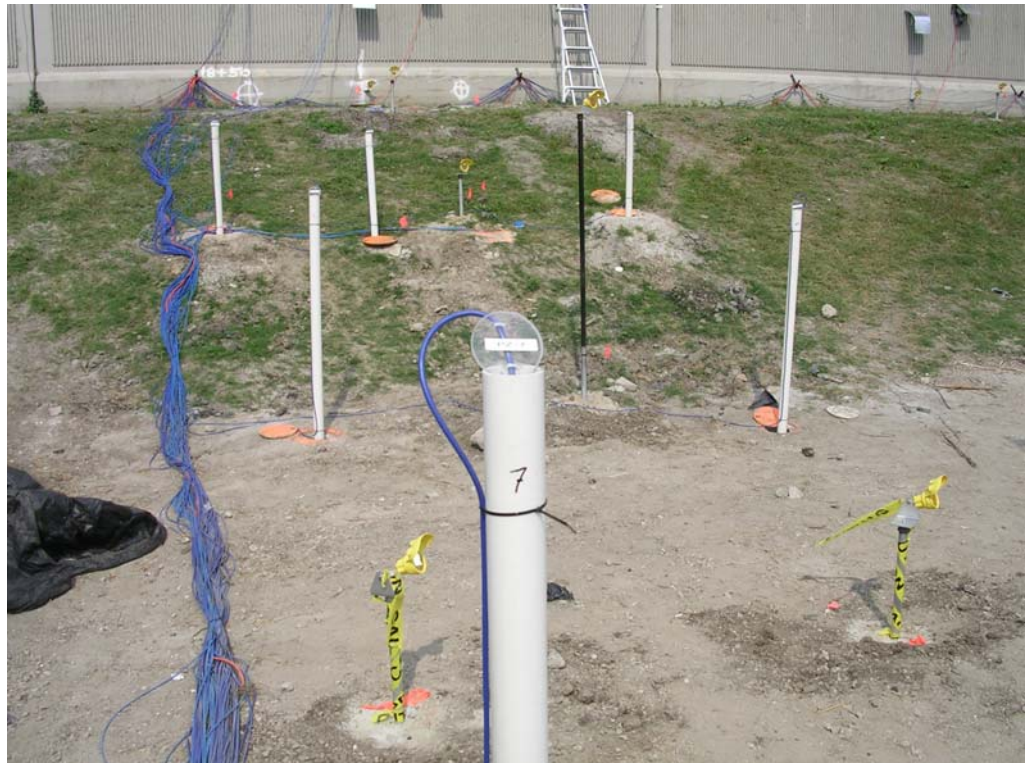
Piezometers with Riser Pipes Above Grade.

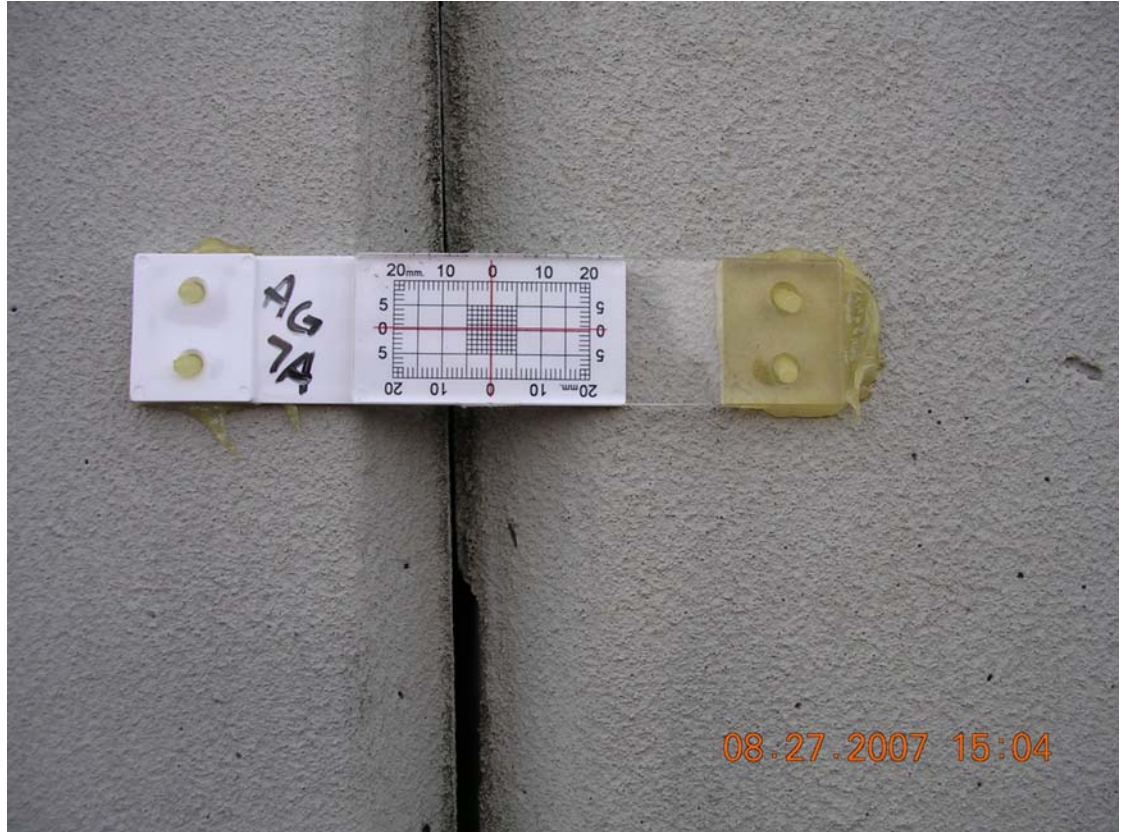
Photograph of Manual Crackmeter

Avongard Gages were installed as a manual backup to the vibrating wire crackmeters. The Avongard Gages had an added benefit of enabling measurement of movements in two dimensions. The manual gages were mounted across the I-Wall panel joints at each electronic crackmeter location. In addition, manual gauges were installed mid-height of the panel face on the protected side of the I-Wall on the joints. Manual gages were not installed with the canal side electronic crackmeters. The manual gages were usually read once per load increment.

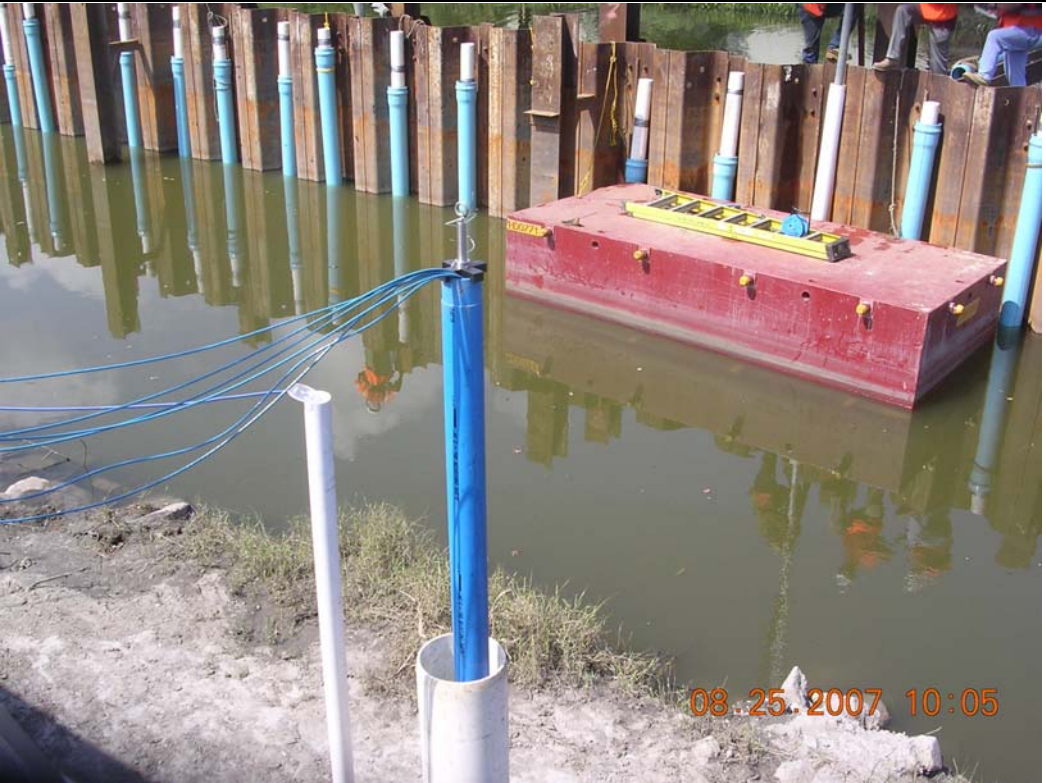
<p>08.25.2007 10:05</p>	
Description: Photograph of Incliner IPI-1. (Incliner is inside the cofferdam. The inclinometer is adjacent to Piezometer PZ-14.)

There was observed movement in the plots of the data for IPI-1. The instruments were being read at a fine resolution. Factors such as moon/earth tides, canal tides, wave action, vibrations from pumps, etc., likely influenced the readings. This inclinometer was subjected to more influencing factors (noise) than IPI-2 and IPI-3 since it was within the cofferdam. It is inconclusive as to the overall cause of the fluctuations in data. It is likely that had more movement occurred, then an actual trend in the data might have become apparent.

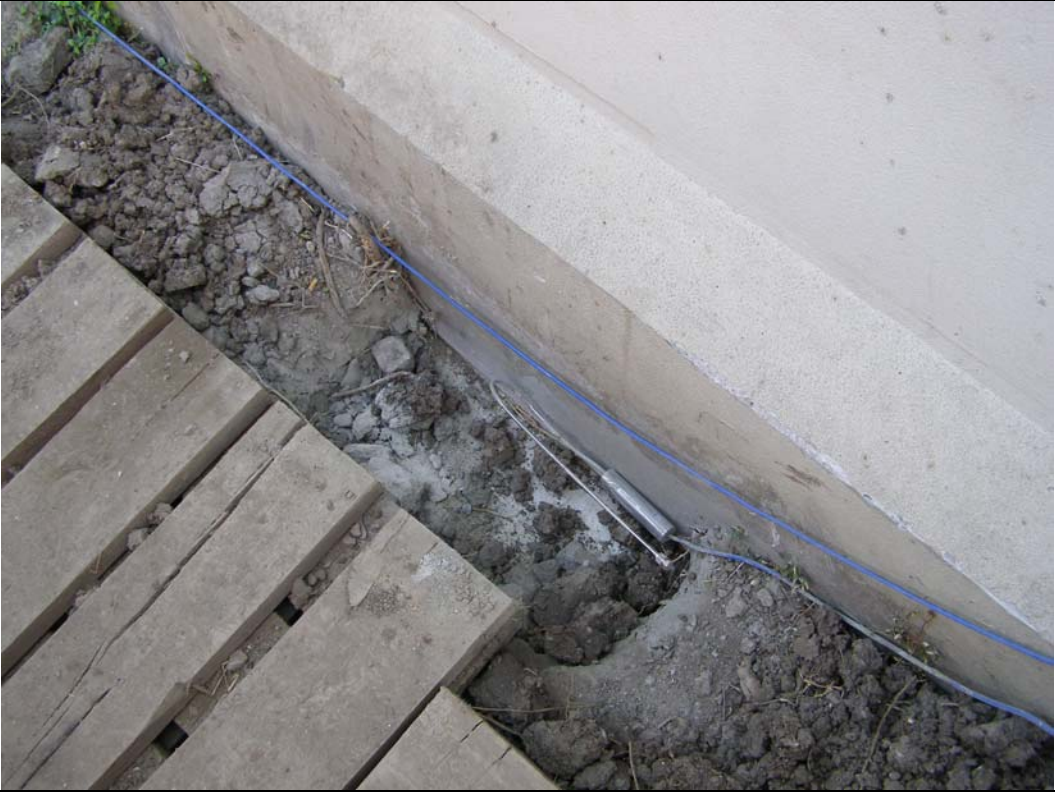
Description: Installation of PC-3 prior to completion of backfilling.

The intent of the design was to detect a loss of contact between the soil and the I-Wall. The plastic sheet was installed to prevent the sand cement from bonding to the I-Wall. (The plastic sheet was inadvertently omitted from the PC-3 installation, but a loss in pressure was still observed in this device.) The increase in the water level would increase the pressure reading from the pressure cell. The formation of a gap should drop the pressure reading to the hydrostatic pressure.

Before the test, and after the installation of the pressure cells, the water level in the canal and the cofferdam was raised to approximately El. +2 feet. It was observed that one of the pressure cells (PC-3) was indicating a drop in pressure from 5 psi to 1.5 psi. The closest telltale (TT-5) also showed a drop of 2.5 feet.

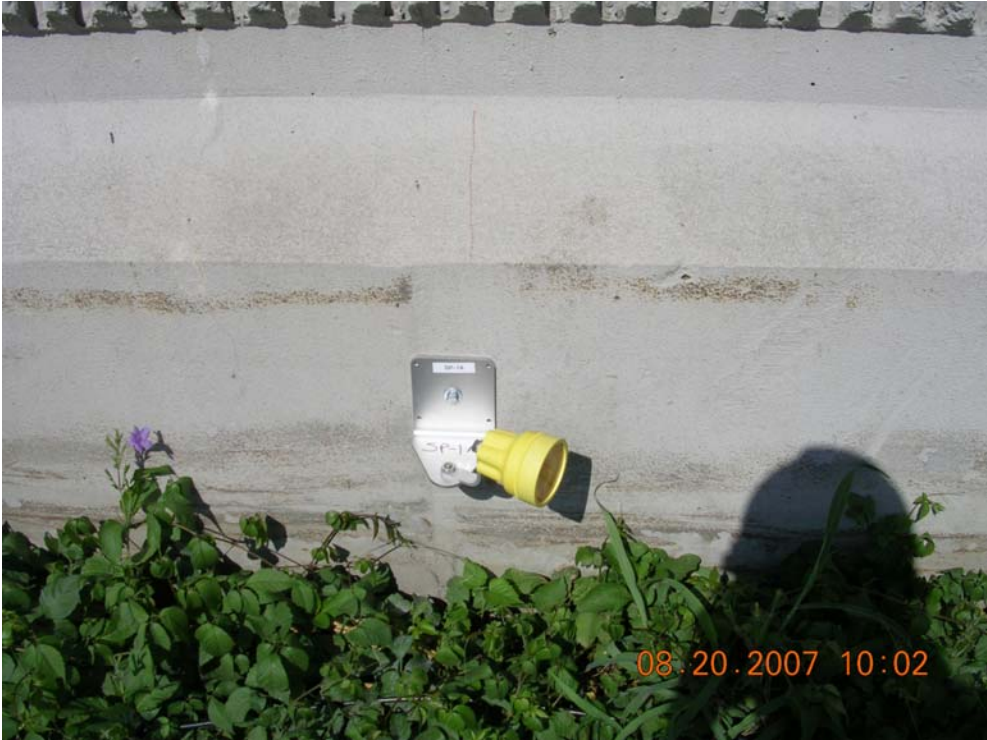
Description: Typical Prism Installation on I-Wall

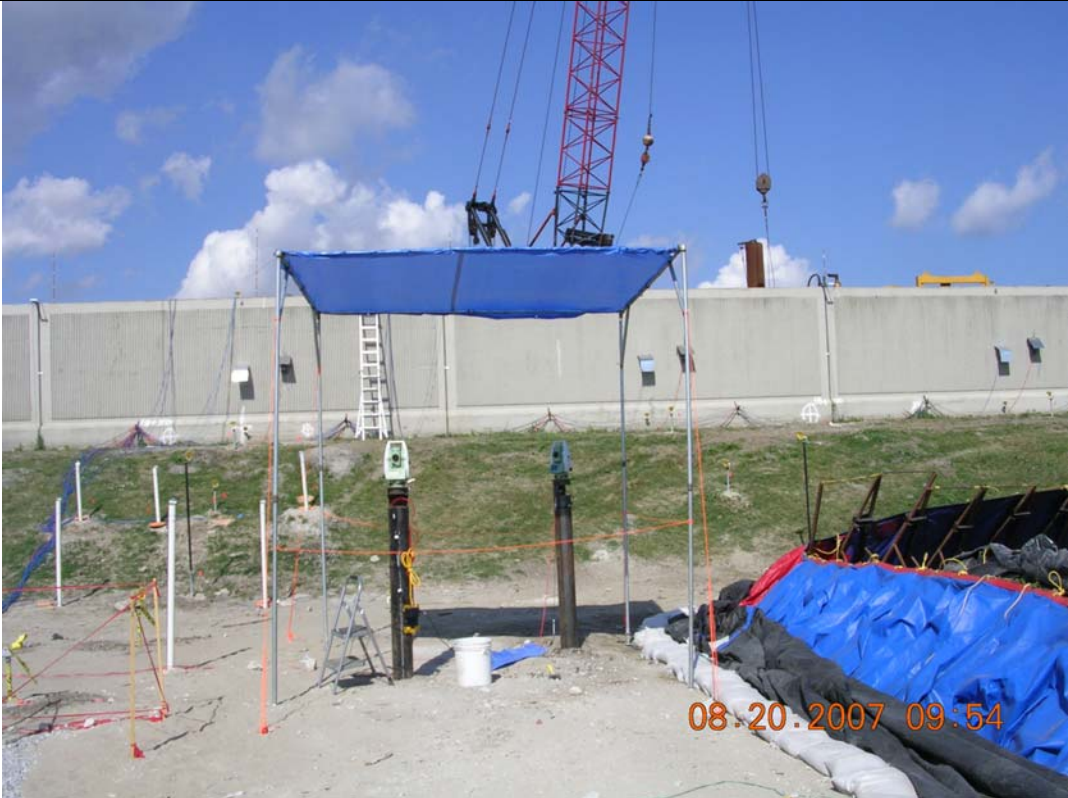
Description: Robotic Survey Devices

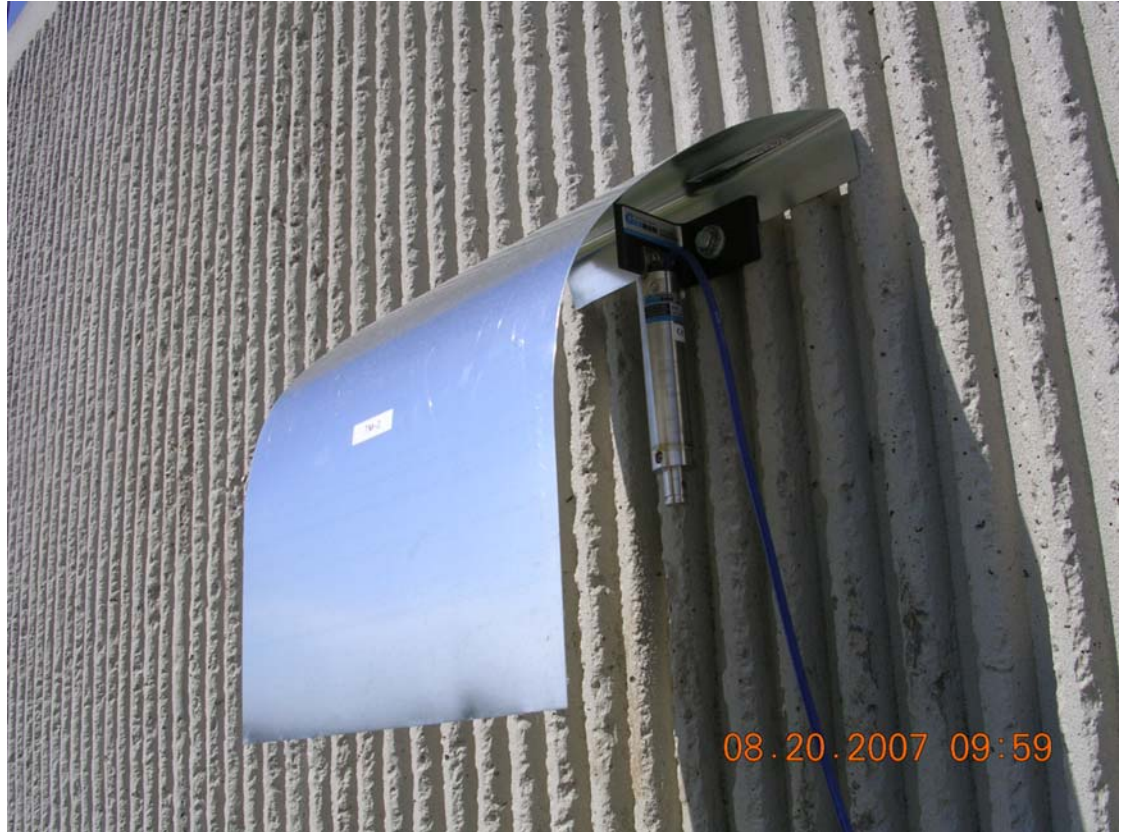
Photograph of Vibrating Wire Tiltmeter

Vibrating wire tiltmeters were attached to the I-Wall in the center of each panel at the locations shown in Figure 3.1. Initially during the test, alarm levels were being reached sporadically. After discussions with the manufacturer, the excitation voltage used to read the instruments was adjusted. This change eliminated the problem. The data for the tiltmeters was consistent with that obtained by the prisms and is shown in Figure 4.27. Tiltmeter data was also plotted with crackmeter and surface water levels in Figure 4.17.

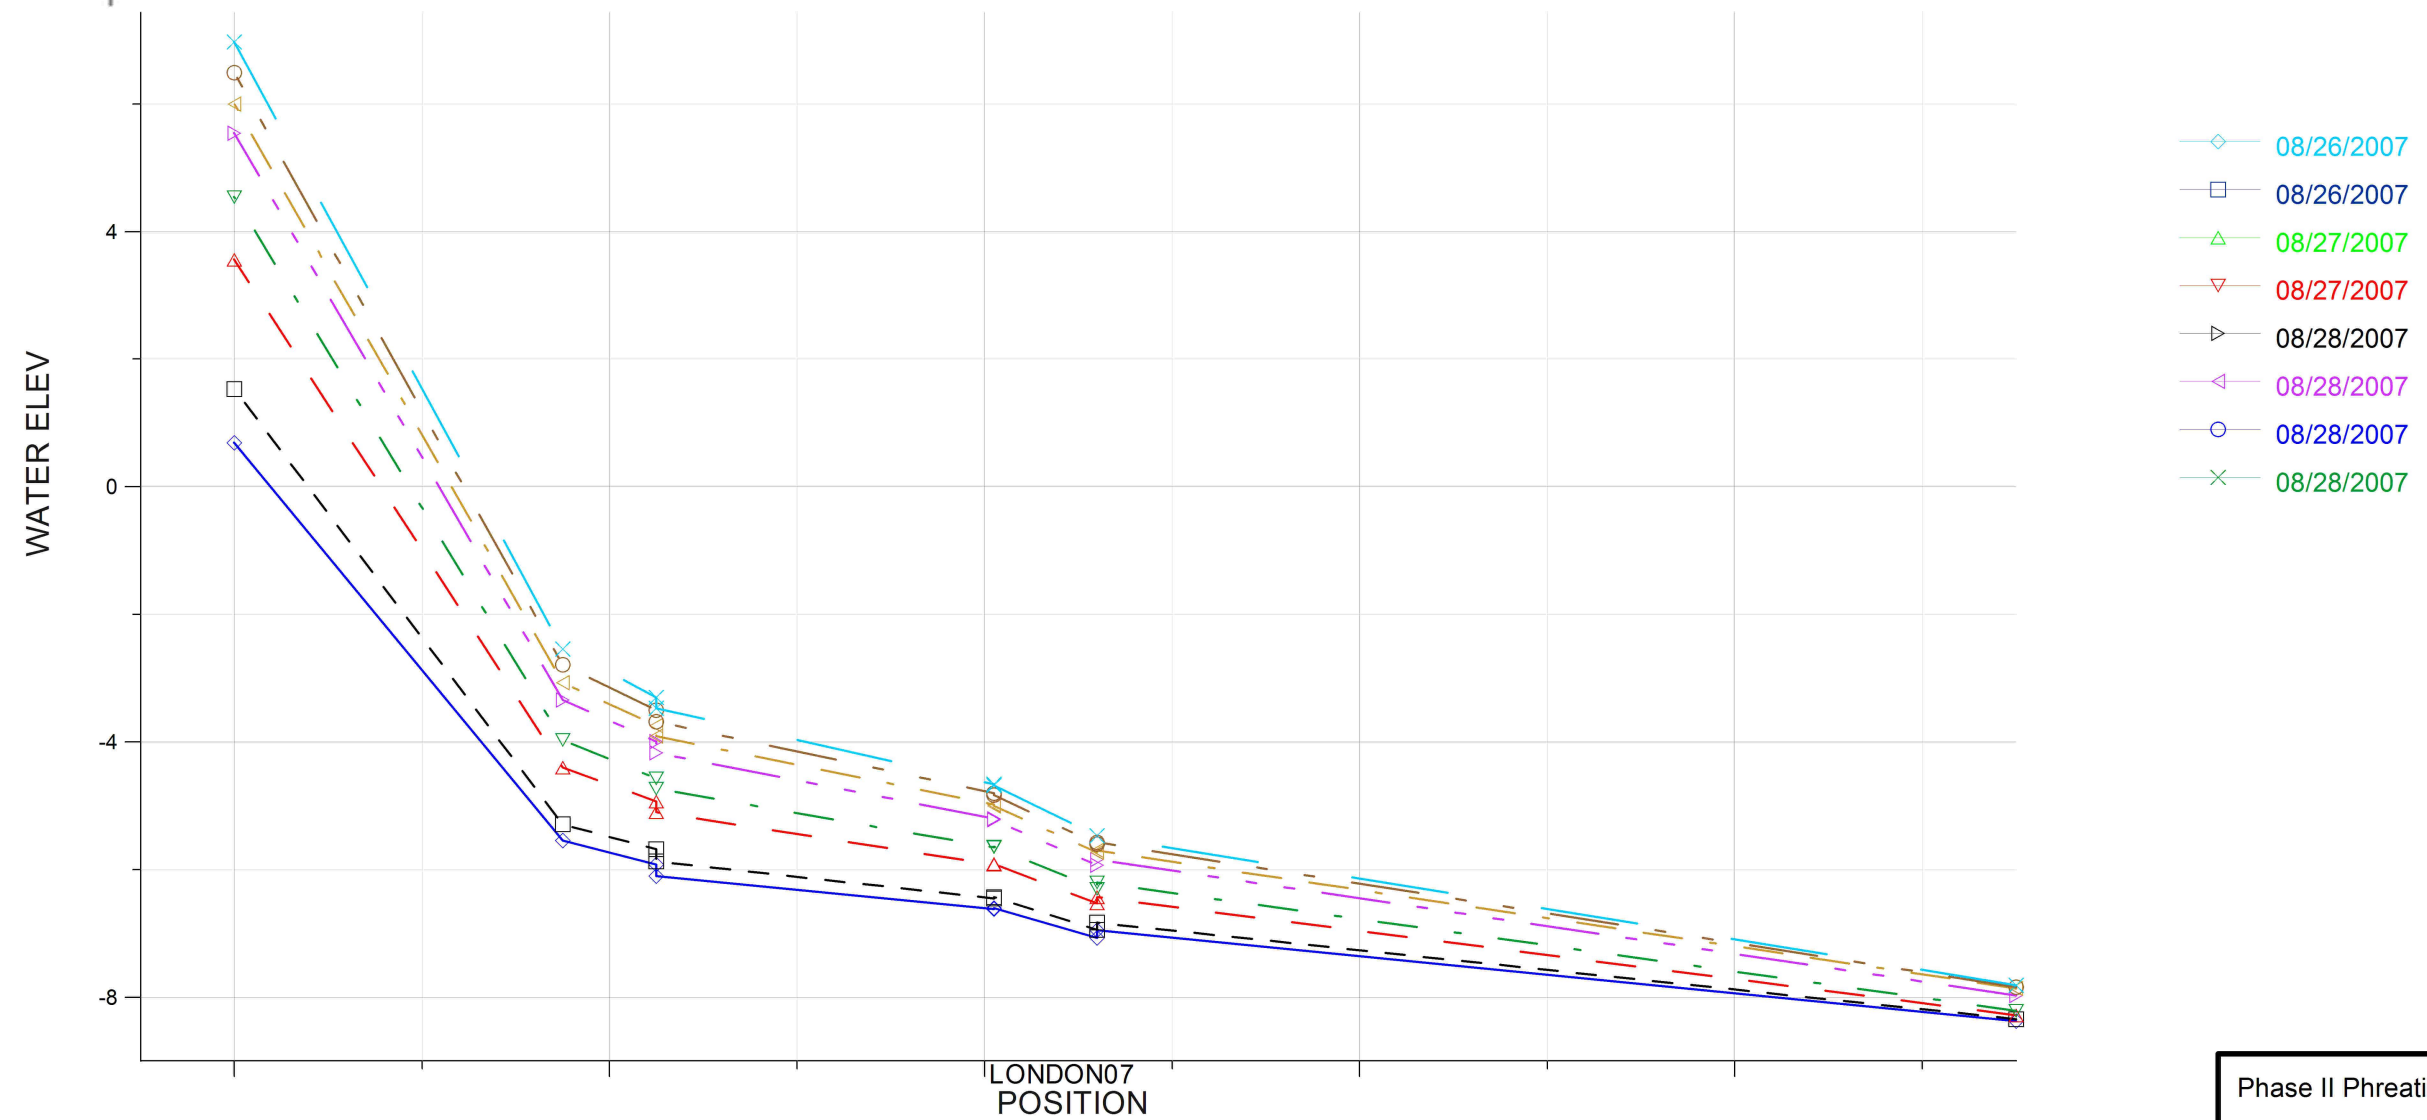
Phase II Phreatic Surface Profile
 London Canal Load Test
 FIGURE 4.16

PHASE II - PHREATIC SURFACE PROFILE CENTER LINE

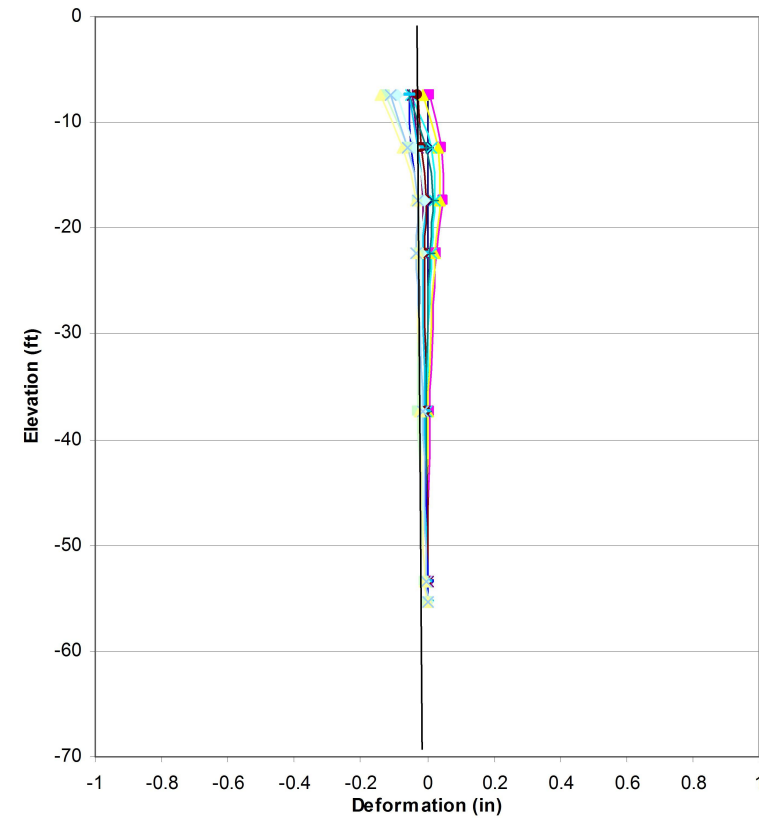
IPIs Phase I
London Ave Canal Load Test
Figure 4.19

IPI-1, IPI-2, and IPI-3 Phase I
Deflection (Inches) vs Elevation (Feet)

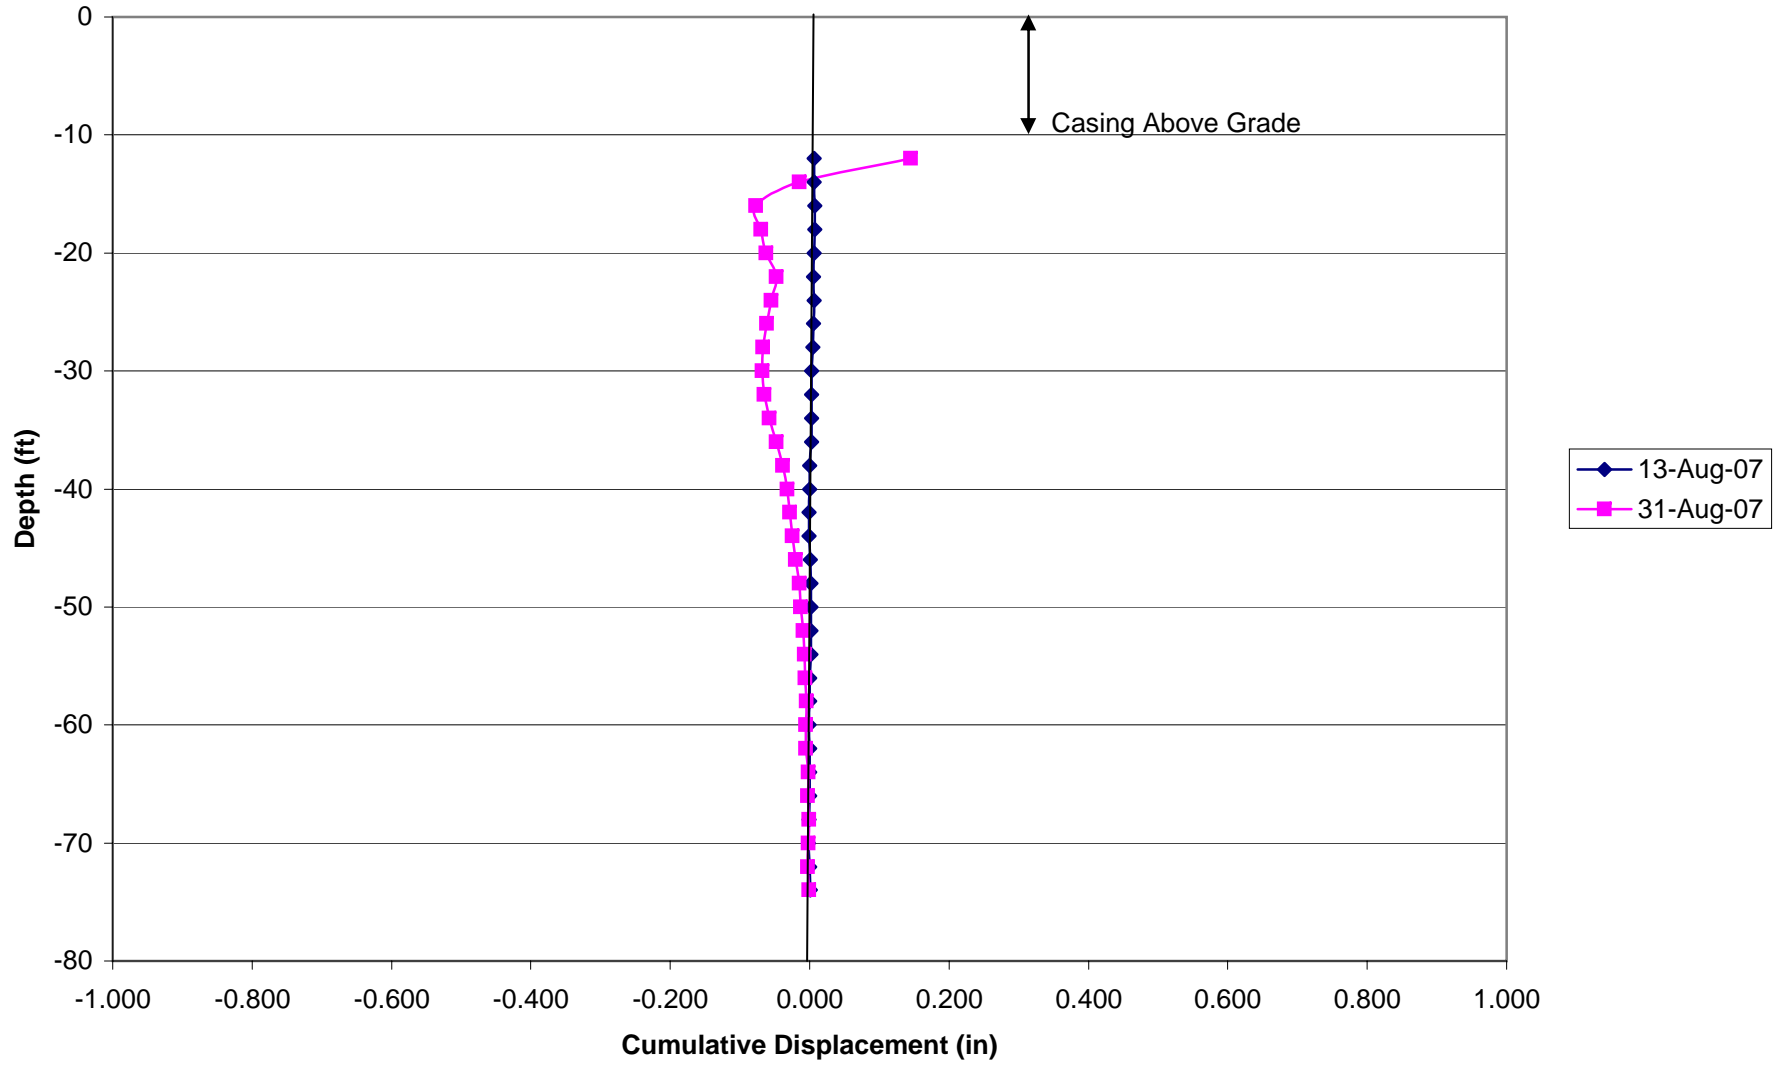
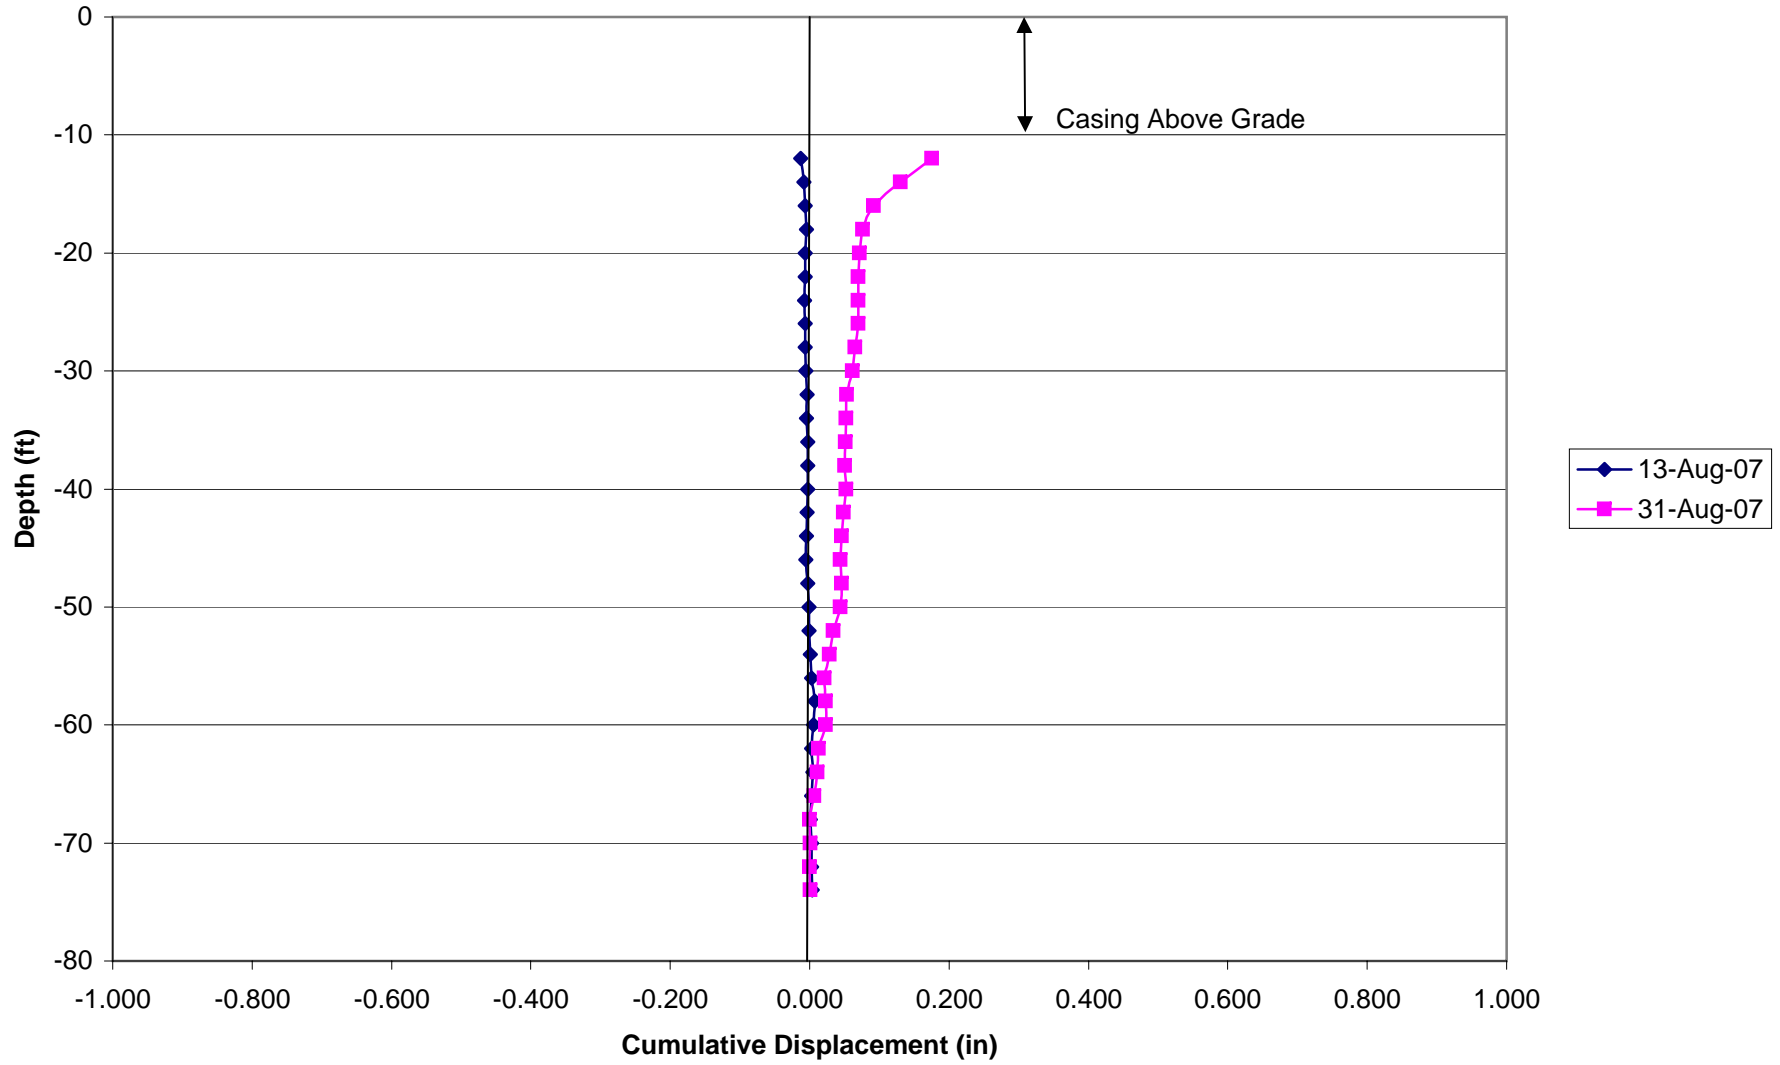
The raw inclinometer data and cumulative displacement plots for each inclinometer are attached. One data set for IPI-2 baseline readings had some data missing. The plots attached have a deflection curve of the second baseline readings and the post-test readings. Since IPI-2 only has one useful set of baseline readings, the plots for IPI-2 only have a deflection curve for the post-test data.
