THE LONDON AVENUE SITE SPECIFIC LOAD TEST

A Report by the Hurricane Protection Office
of the US Army Corps of Engineers
and
The St. Louis District Corps of Engineers

Final Version, August 2008

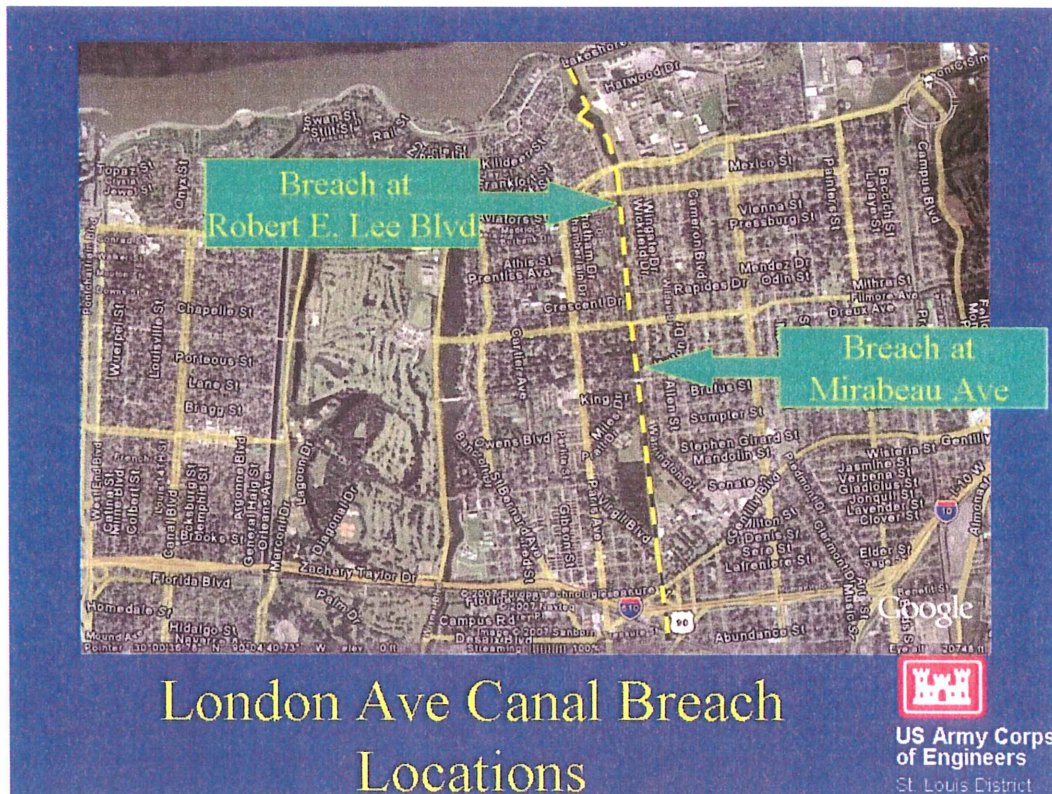
Figure 1.1 – London Avenue Breach Locations.

Hurricane Katrina caused failure of the hurricane protection system in two locations along the London Avenue Outfall Canal (hereafter referred to as 'the Canal'). The first of these was the I-wall on the west side of the Canal immediately South of Robert E. Lee Boulevard. The second was at the I-wall located on the east side of the Canal immediately North of Mirabeau Avenue. The Final Report of the Interagency Performance Evaluation Task Force (IPET) dated June, 2007 and titled '*Performance Evaluation of the New Orleans and Southeast Louisiana Hurricane Protection System; - Volume V- The Performance - Levees and Floodwalls*' discusses the forensic investigations related to these two sections and the extent of these failures. Figure 1.1 indicates the locations of these failures.

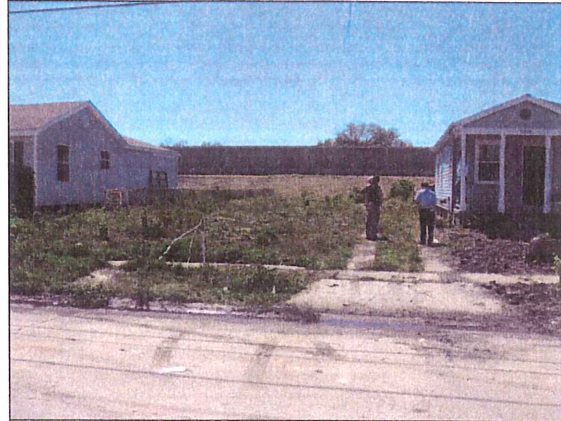
Figure 2.3 – Protected Side View of I-Wall Figure 2.4 – Protected Side Vacant Property

Cofferdam Location. The cofferdam was sited at the critical location described by the site location study. The cofferdam's centerline lay on the center of an existing I-wall monolith and was located approximately 1000-feet south of Robert E. Lee Boulevard on the east bank of the canal and approximately 100-feet south of boring B-59 shown on Figure 2.1. This location placed the centerline of the cofferdam within the vacant property at 5772 Warrington Drive shown on Figure 2.4.

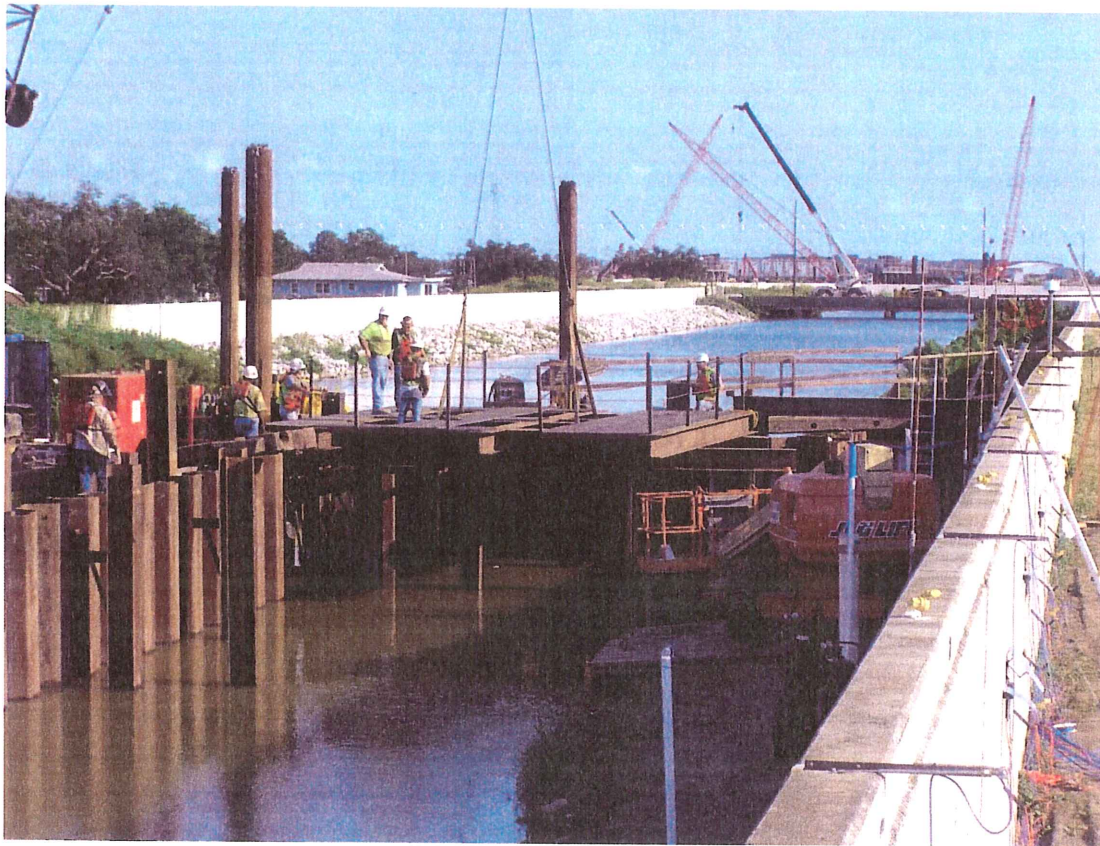
Figure 2.7 – View of Partially Completed Cofferdam (Looking north)

Size of Cofferdam. The as-built configuration of the steel sheetpile cofferdam was nominally 150-feet (parallel to the canal centerline), by 35-feet (perpendicular to the canal centerline), and designed to withstand water to +7.5-feet NAVDD-88. The structural and geotechnical analyses/design of the cofferdam was done assuming the use of PZ-35 sheetpile and HP 14 x 73 H-piles. Adequate quantities of these piling were owned by the government (previously used on other Corps of Engineers projects) and were provided to the contractor as government furnished property.

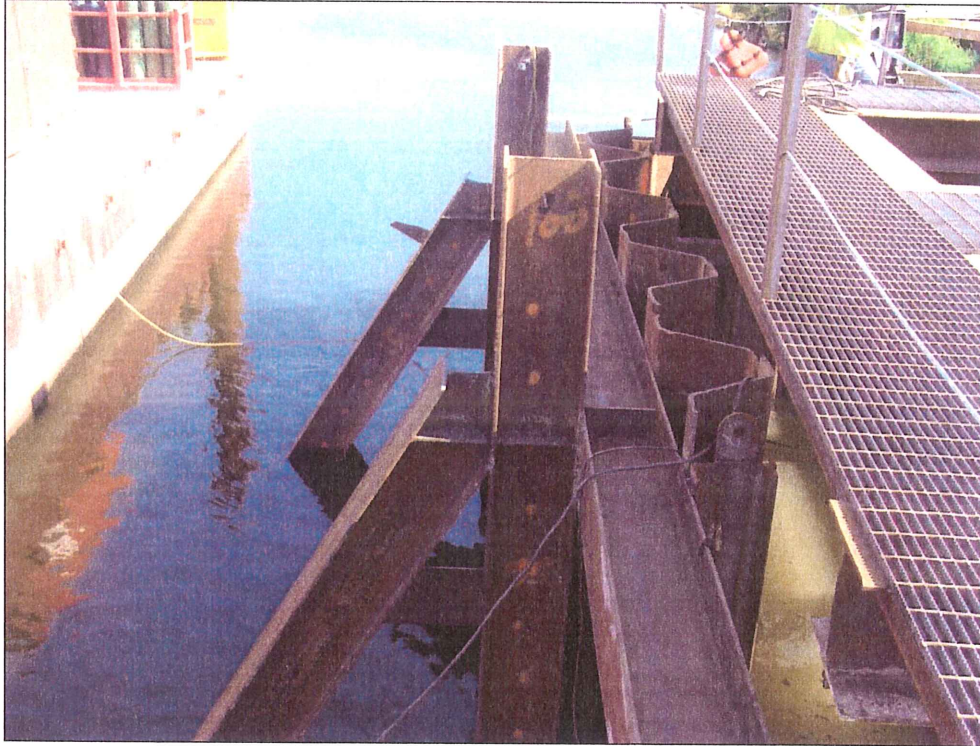
Figure 2.8 – Pile Bent and Waler

The connection between the cofferdam and the existing I-wall was considered to be a critical detail with two functions: It should cause limited impact on the response of the I-wall to the water loads imposed on it during the test and it should be water-tight. The need for a structurally transparent, yet water tight, connection was achieved in the design by embedding the web of the last PZ-35 cofferdam sheetpile into the construction joint between the adjacent monoliths. As shown by Figure 2.9, the contractor did not embed the sheetpile web into the monolith joint. Rather, he chose to weld a flat piece of steel to the last sheetpile and embedded this into the monolith joint to achieve the same result. This joint was strengthened by backing it up with a partial circumference of pipe welded onto the canal-side of the sheet and filling it with non-shrink grout. Water-tightness was achieved by bolting neoprene sheets on both sides (i.e., canal side and interior) of the joint. These details are illustrated in Detail 1 of Sheet 5/8 in the construction drawings found in Appendix G. Figure 2.9 is a photograph of the completed joint at the north tie-in.

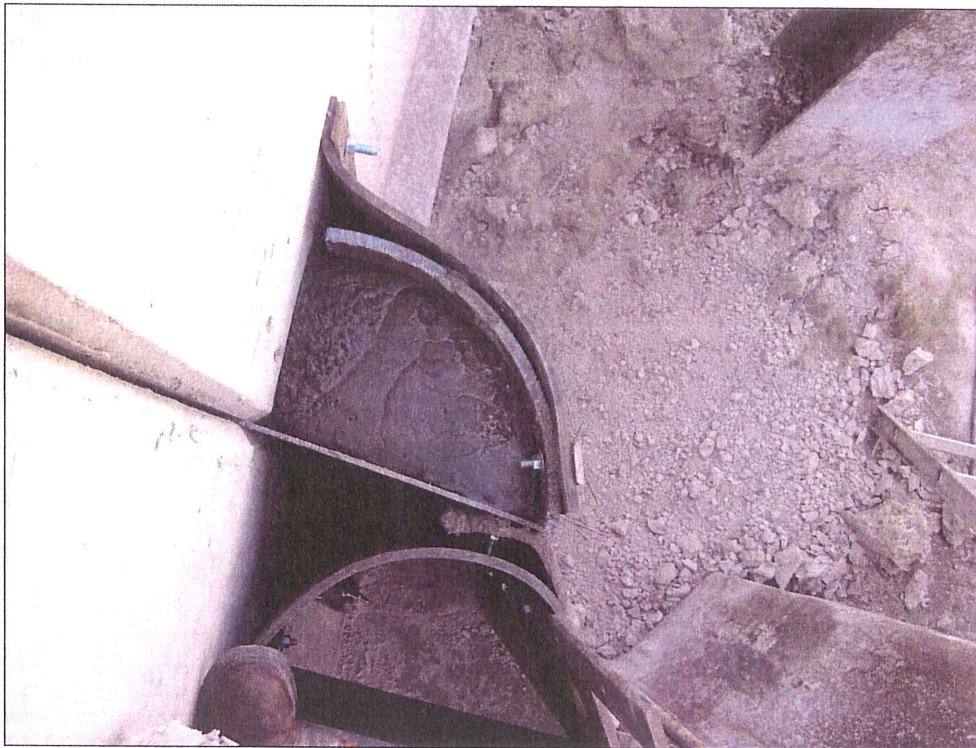
Figure 2.9 – Connection Between Cofferdam and I-Wall

Jet Grouting. Although the contractor was able to connect the sheetpile cofferdam to the concrete I-wall, there was no practical way to establish a structural connection between the cofferdam sheetpile and the existing CZ-101 sheetpile under the I-wall at the

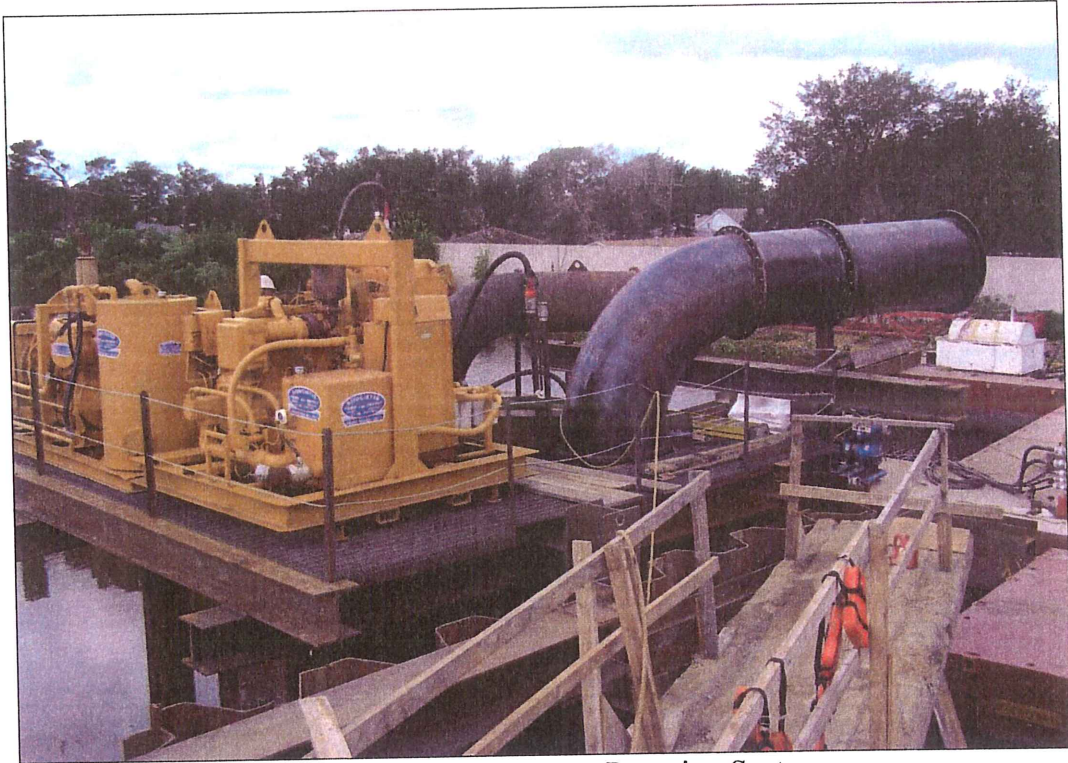
Figure 2.10 – Emergency Pumping System

Emergency Dewatering - Pumping. The contractor was required to pump water into the cofferdam during the load test. As a part of the contract, the Corps also required that the contractor be able to dewater the cofferdam on an emergency basis during the load test, should the need exist. The Corps analyses involved determining a required pumping capacity to empty the cofferdam (from maximum elevation of +7.5-feet NAVD88 to +2.0-feet) in two minutes, evaluating a range of pumping systems that a contractor might install, sizing a supporting structure (pump stand) for a typical pump, and then including that information on the drawings (in limited detail) with the caveat that the final details were to be “contractor designed”. The “Pump Support Plan” is shown on construction drawing 6/8 in Appendix G. Figure 2.10 shows the contractor-designed emergency pumping system. The contractor set two hydraulic driven pumps (30 and 40-inch diameter) on one pump stand in the north end of the cofferdam. The total capacity of the contractor emergency pumping system was 77,000 gpm which met the design requirement.

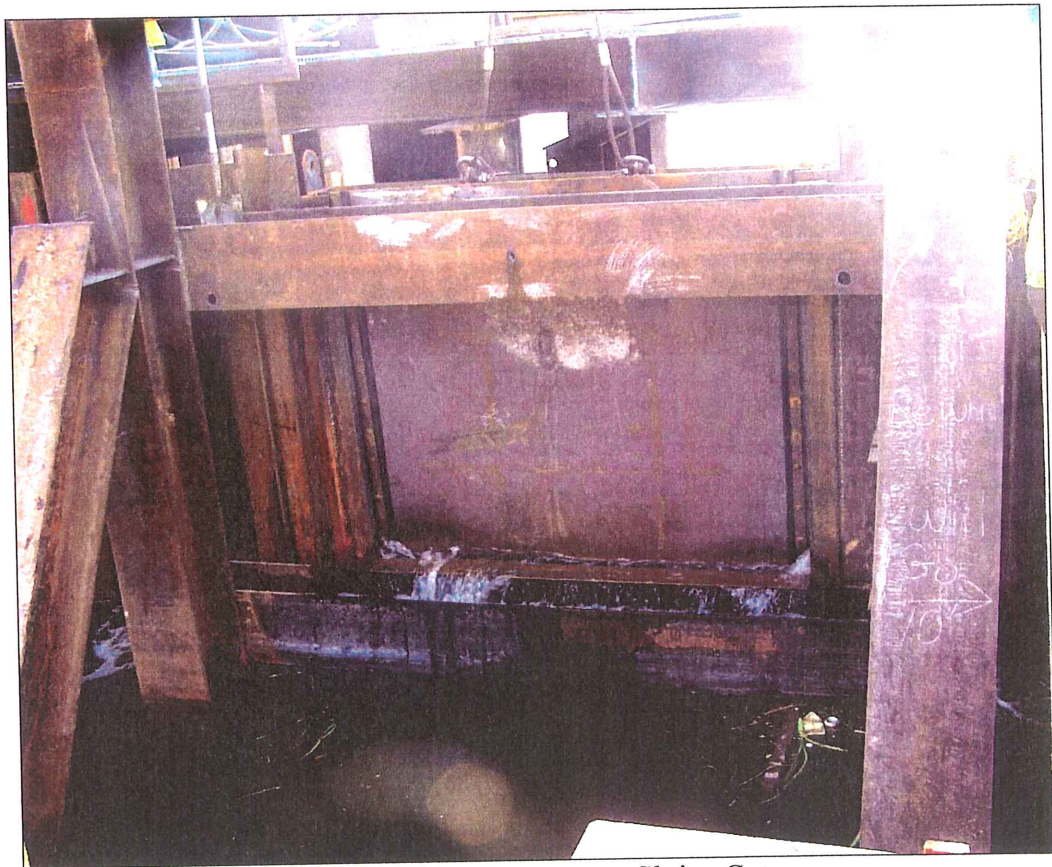
Figure 2.11 – Emergency Sluice Gate

Emergency Dewatering - Sluice Gate. The stakeholder’s desire for redundant safety measures prompted the Corps to include a second emergency dewatering system in the cofferdam to supplement the emergency pumping system. The Corps included a 7.75-ft wide by 6-ft tall sluice gate into the 150-foot long cofferdam wall that could be pulled to hasten the emergency dewatering of the cofferdam. Drawing 3/8 shows the gate location near the emergency pump stand and the gate is detailed on drawing 7/8. Figure 2.11 shows a picture of the sluice gate installed in the cofferdam. During the load test, an operator was at the controls of a crane ready to pull the sluice gate if directed to do so by the Officer in Charge.

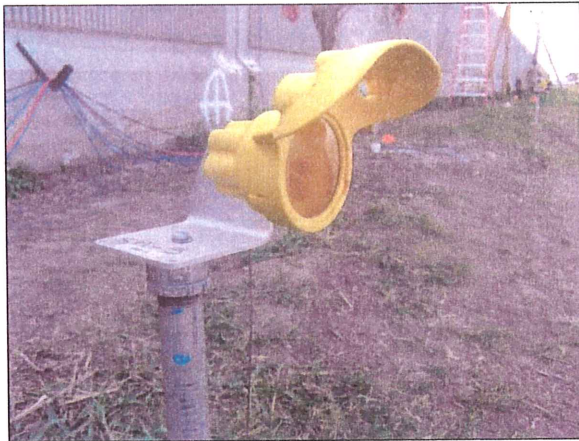
Figure 2.13 - Survey Prism

monuments associated with each I-wall monolith. Additional monuments were installed just beyond the levee toe and at the edge of the street on the protected side. Three additional monuments were installed to function as “control” backsights. Two backsights were installed adjacent to the I-wall at distances of 200 and 400-feet away from the test site and the third was installed at the edge of the street. Figure 2.13 shows a typical survey prism..

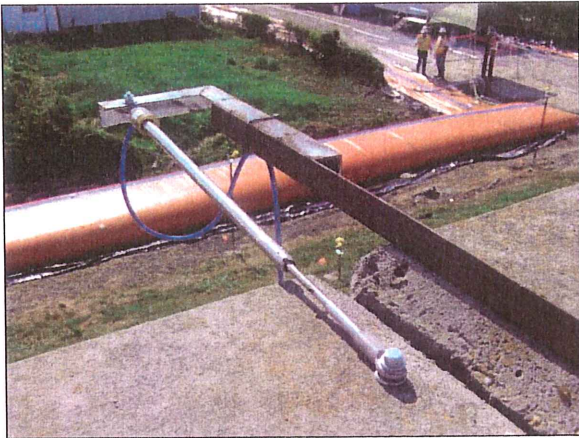
Figure 2.15 - Crackmeter

- Vibrating-wire, uniaxial crackmeters and manually-read Avongard gages were used to detect and measure differential movement between adjacent I-wall monoliths, between the I-wall and the cofferdam tie-ins, and between the I-wall and the protective casing surrounding the canal side in-place inclinometer. Figure 2.15 shows a typical crackmeter installation on top of the concrete I-wall.

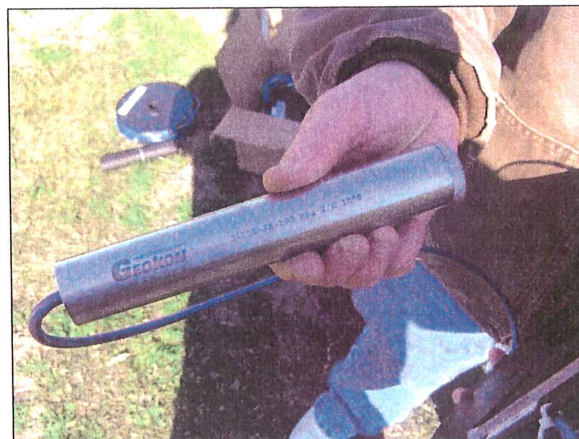
Figure 2.17 – Piezometer Pressure Transducer

- Electronic pressure transducers installed in open system piezometers to measure the piezometric response in the barrier beach sand. The same pressure transducers were used to measure the canal and cofferdam water surface elevations. Figure 2.17 shows the Geokon pressure transducers used in this test.

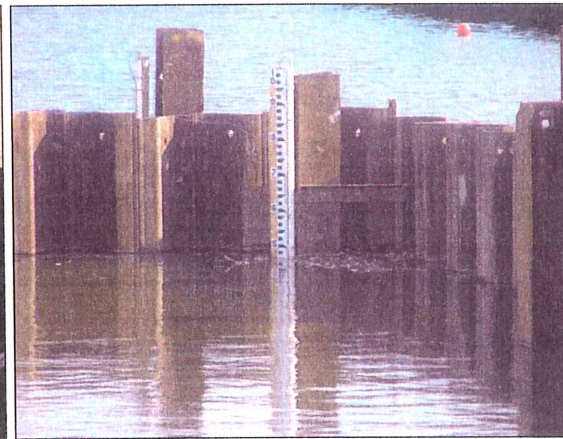
Figure 2.18 – Staff Gage

- Staff gages were placed in the canal and in cofferdam interior. These devices were manually read. Figure 2.18 shows the staff gage installation for instrument SG-2 located on the cofferdam interior. SG-1 is located opposite SG-2 on the cofferdam exterior to monitor the canal water level during the test.

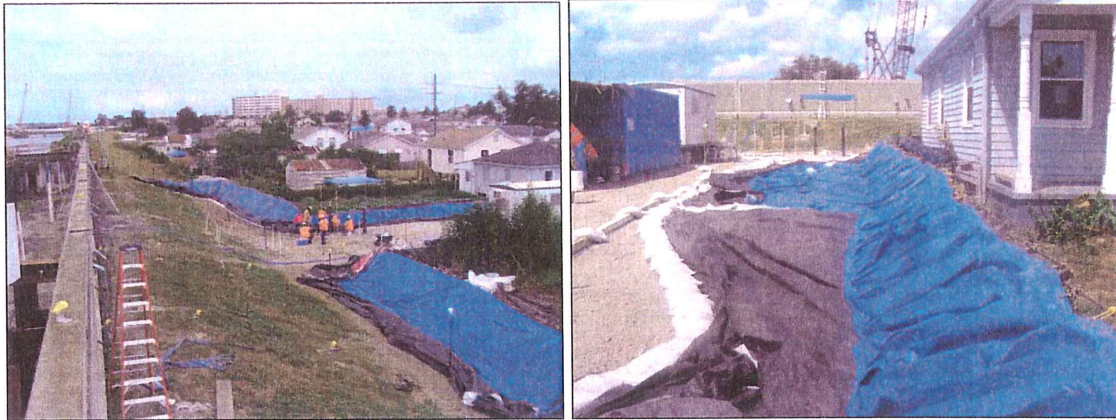
Figures 2.19 and 2.20 - Landside PortaDam™ System

damage to the I-wall system during the load test. The Corps met this requirement by erecting a 4-foot tall PortaDam™ system on the edge of the landside property and tying it into the landside levee slope. The PortaDam was built 2-feet taller where deployed immediately opposite and parallel to the floodwall at the protected side embankment toe. This extra height was included to contain wave runoff in the unlikely event of a monolith failure. Figures 2.19 and 2.20 show the deployed PortaDam.

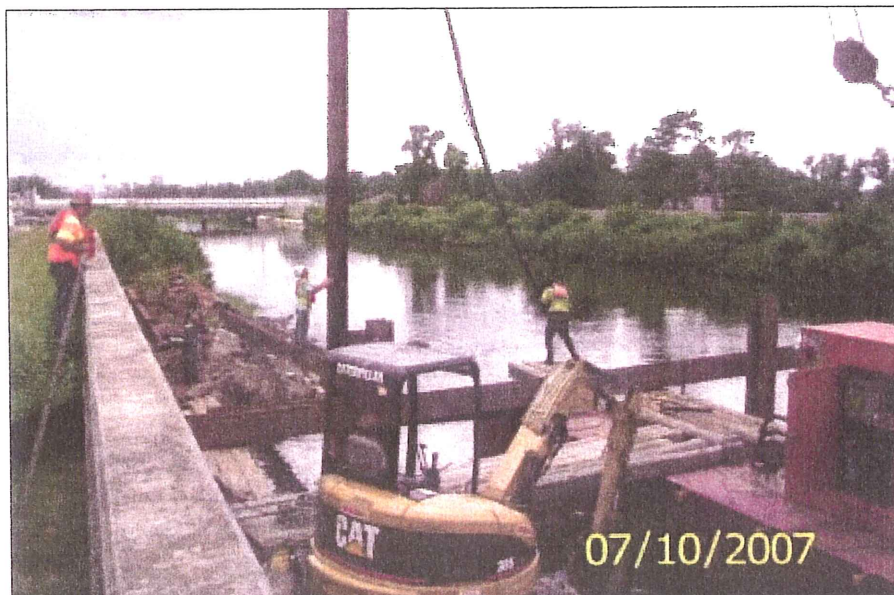
Figure 3.1 – Establishing Sheetpile Template

- **Sheetpile Installation.** The contractor installed the sheetpiles using an MKT V-20B vibratory hammer powered by an HP 325B power pack. The contractor fashioned various driving templates by driving vertical H-piles and attaching horizontal guide beams across them. To ensure successful installation, the contractor completed a narrow, 2-foot deep excavation along the path of the sheetpile to clear all debris that might impede sheetpile installation. Significant amounts of heavy debris were cleared by this operation. Only two sheetpiles were unable to be driven to the design depth due to deep, underground obstacles. Figures 3.1 shows the contractor beginning to drive sheetpile on the established template. And Figure 3.2 shows the sheetpile cofferdam well underway.

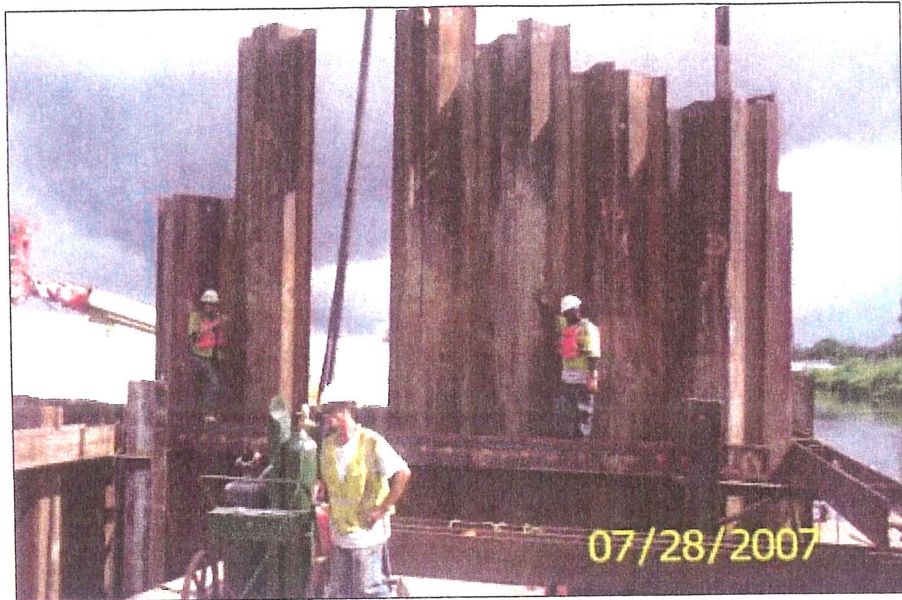
Figure 3.2 – Sheetpile Cofferdam Underway

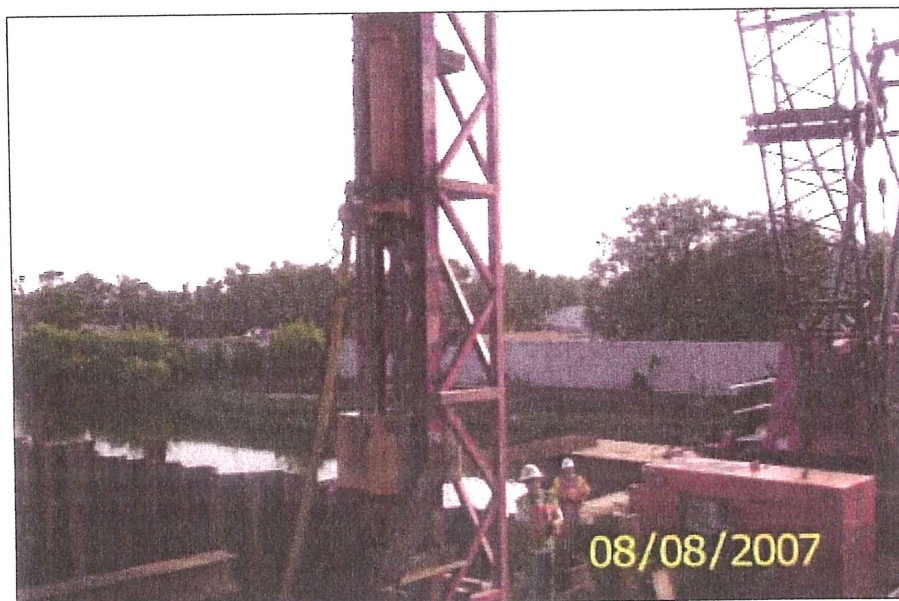
Figure 3.3 – H-Pile Driving Hammer in Swinging Leads

- **H-Pile Installation.** The contractor used a Vulcan-06 and a Conmacco 65E5 hammer to drive the H-piles. The H-piles were supported in swinging leads. Figure 3.3 shows the contractor's pile driving system.

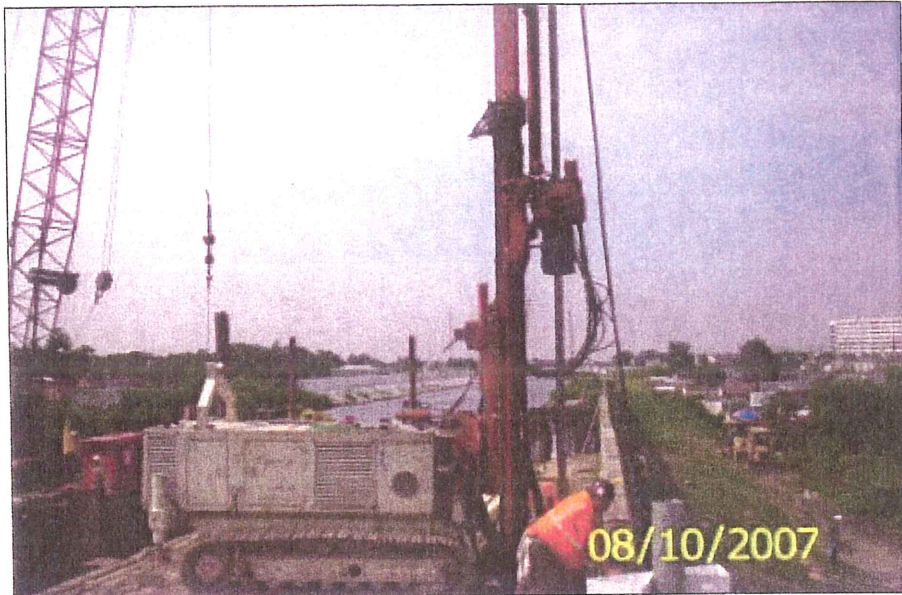
Figure 3.4 – Jet Grouting Operation

- Sluice Gate Details. The contractor provided detailed shop drawings of the sluice gates, its supporting frame and sealing mechanisms.
- Cofferdam Emergency Emptying System. The contractor submitted a plan that provided a total pumping capability of 77,000 GPM using two individual pumps (i.e., 42-inch diameter with 54,000 GPM, and 30-inch diameter with 23,000 GPM). These pumps were hydraulic, vertical turbine pumps driven by diesel engines.
- Jet Grouting Procedures. The contractor submitted plans and procedures to install jet grout columns on the cofferdam interior where the primary sheetpile cofferdam was joined to the existing concrete I-wall construction joint. Figure 3.4 shows the jet grouting system installing jet grout columns at the southern end of the cofferdam.

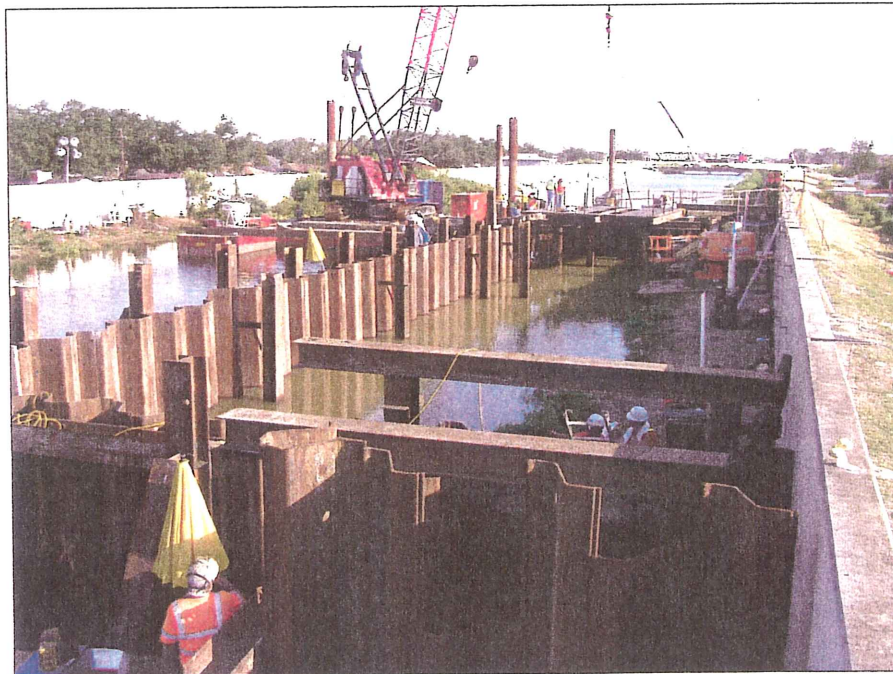
Figure 3.5 – Almost Completed Cofferdam

Cofferdam Completion. The contractor completed the cofferdam and all attendant features per the contract schedule. Figure 3.5 shows the substantially completed cofferdam.

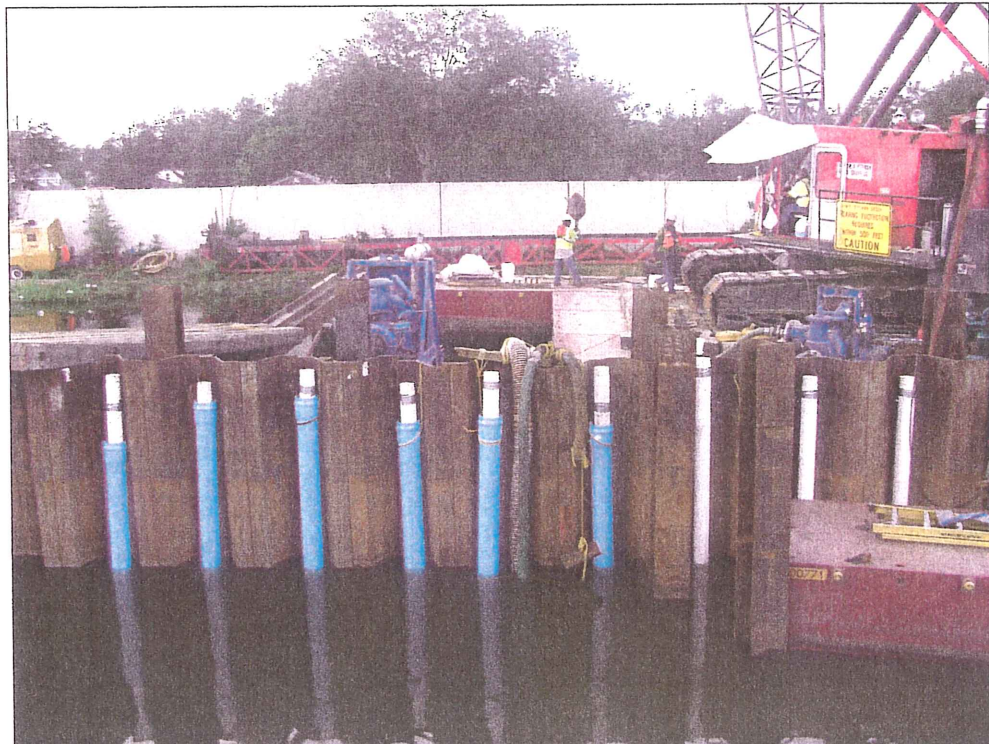
Figure 3.9 – Partially Completed Array of Slotted Pipes.

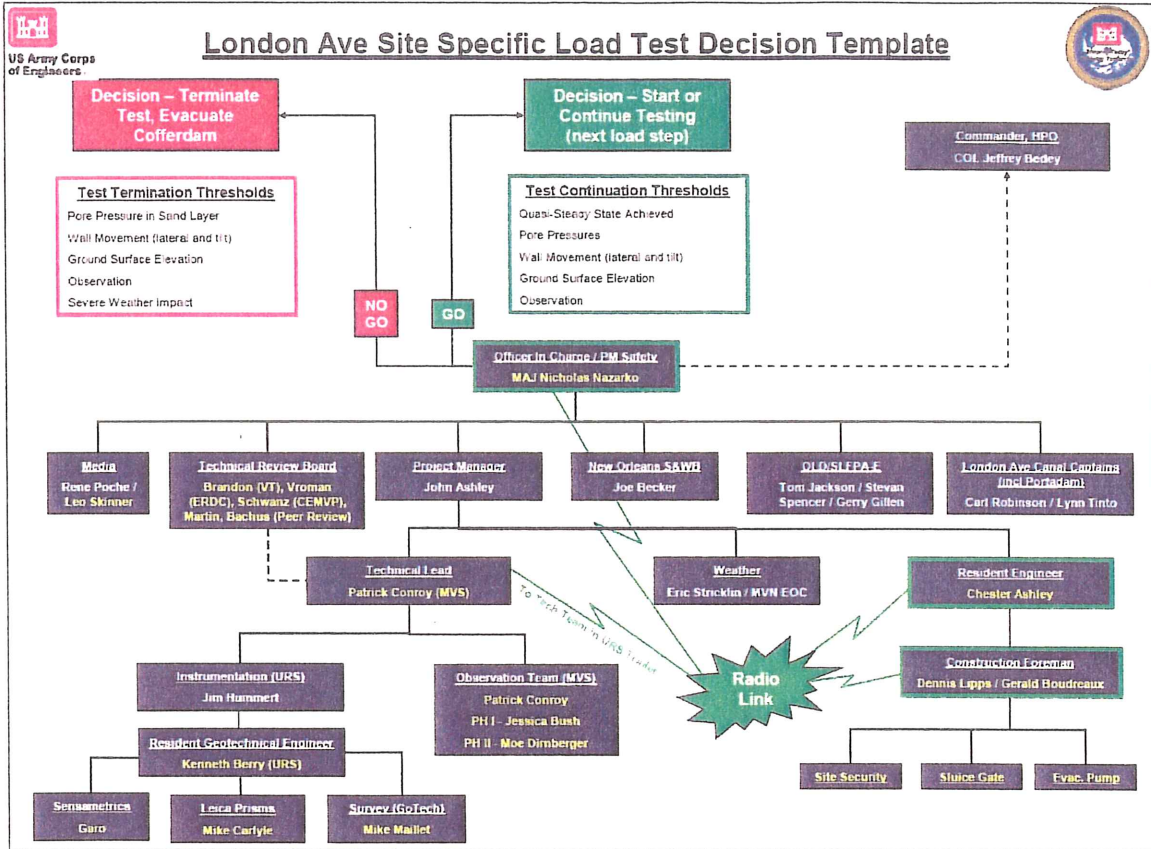
Figure 4.3 – Load Test Decision Template

Load Test Decision Template. The Corps, the Peer Review Team, and the Technical Review Team developed a decision template that established “explicit responsibilities” for all individuals involved in the load test. This template is shown on Figure 4.3. As shown by the decision template, all recommendations from the contractor, the Technical Review Team, the stakeholders, and all other teams identified on the template would be funneled through the “Officer-In-Charge” who would make the final decision on whether or not the next load increment should be added to the wall.

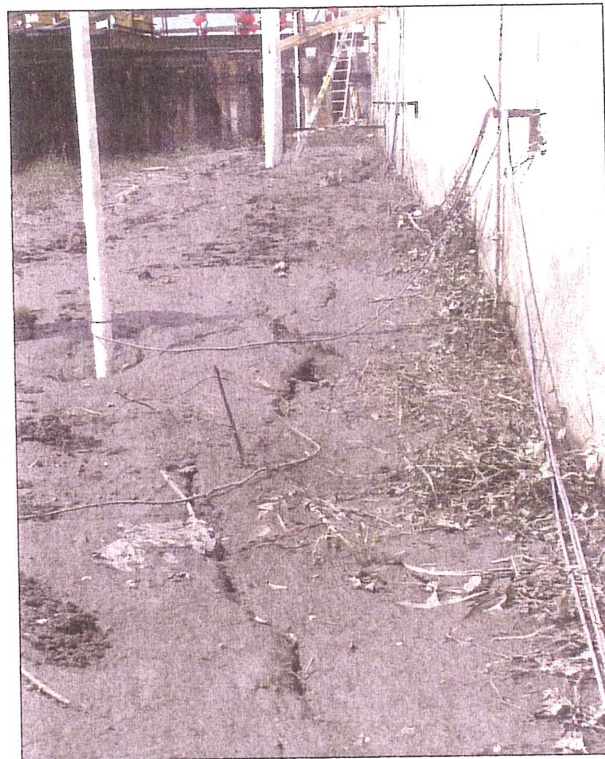
Figure 6.13 – Crack in Canal Side Embankment After Phase I Load Test.

Observed Transverse Crack in Canal Side Embankment. After the Phase I test was completed and the cofferdam drained, the Technical Review Team inspected the canal side I-wall embankment and observed a crack in the top of the embankment that runs roughly parallel to the wall. Figure 6.13 shows the crack. This crack was not present at the beginning of the load test. This picture shows that the top of the soil mass between the crack and the wall is lower indicating that the soil has collapsed against the wall. There is no information that defines the orientation of neither the crack nor the shape and size of the soil mass. It is impossible to tell when the soil mass moved, but given the fact that vertical cuts in clay will stand for some time before collapsing, it is likely that the soil mass stayed intact for some time following the beginning of wall deflection. .

Distance from South Tie-In (FT)	Distance from Wall to 1 st Crack (FT)	Distance from Wall to 2 nd Crack (FT)	Crack Depth (IN)
14.6	Begin Crack		
19.6	2.5	-	0
24.6	2.6	-	0
29.6	2.7	-	1
34.6	2.25	3.6	0
39.6	2.25	3.33	0
44.6	1.75	-	0
48.6	2.7	-	0

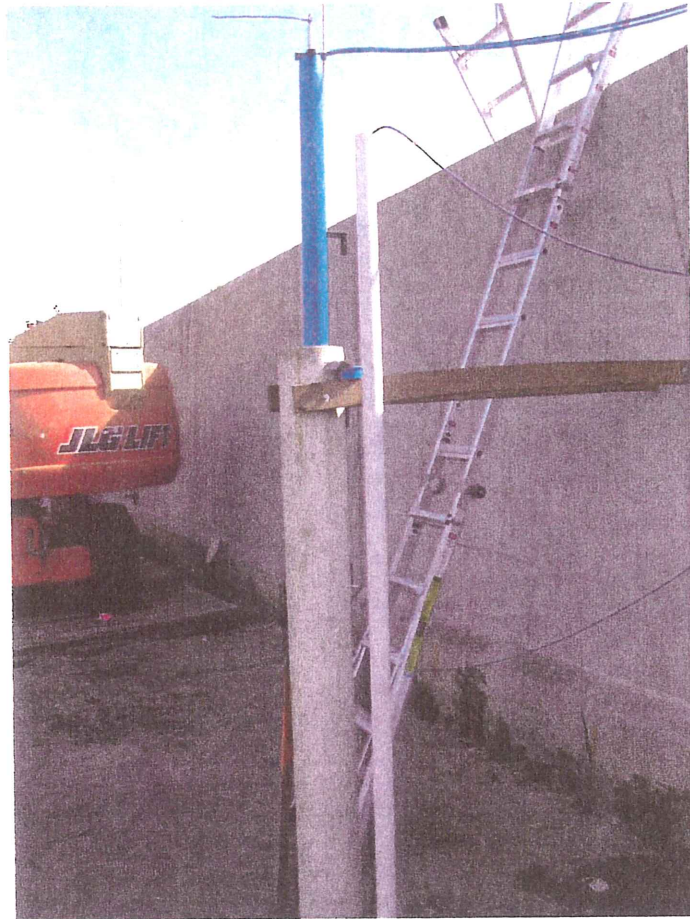
Fig 7.2 – IPI-1 Installation

Note: The timber supports were removed prior to beginning the test.
(Note: The adjacent small white PVC casing is piezometer PZ-14.)

The in-place inclinometers consist of steel rods of varying length that are linked together end to end and hung from the top of the inclinometer casing. Any disturbance (shaking or vibration) of any part of the in-place inclinometer will be translated to other parts of the instrument. Inclinometer IPI-1 was located on the canal side of the I-wall in the cofferdam pool and would be subject to surface disturbances and vibrations created when the contractor was filling the cofferdam with water, running diesel motors, or moving equipment. In anticipation of this, the AE placed a larger diameter PVC pipe (white pipe in Figure 7.2) over the inclinometer casing (blue pipe) above the canal-side grade to shield it from surface disturbances. The data indicates that this external casing was ineffective in preventing construction related vibrations from affecting the canal side in-place inclinometer IPI-1.

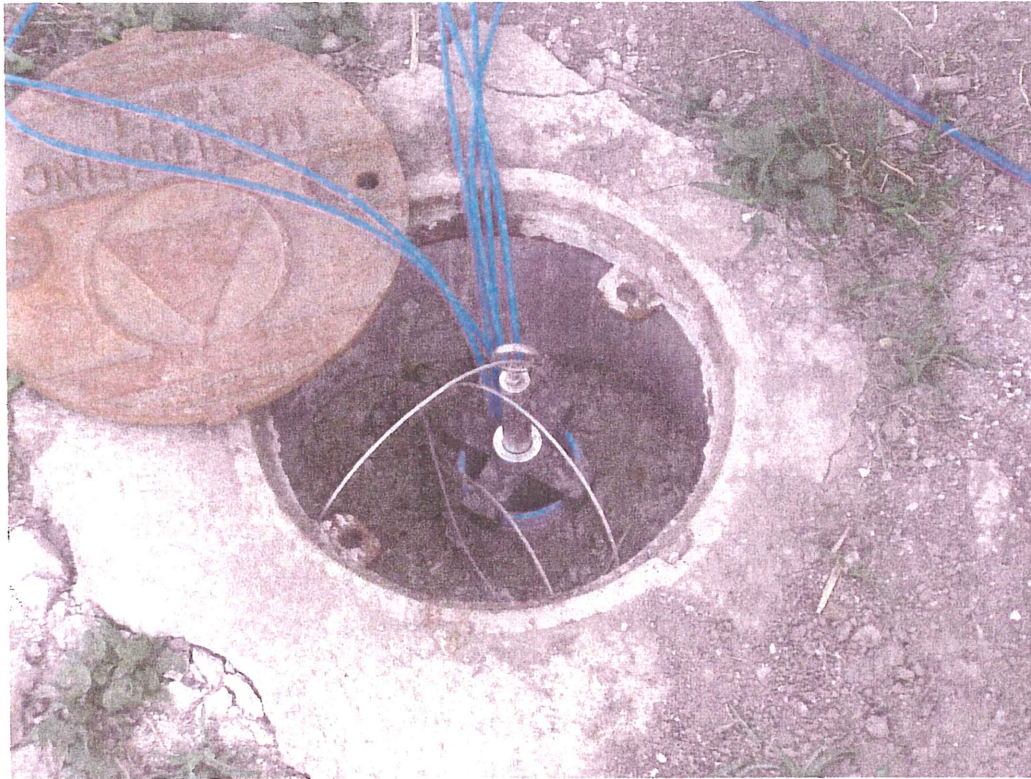
Figure 7.5 - Flush Mount Installation Typical of IPI-2 and IPI-3
