October 3, 2012

Subject: **Docket No. 50-361**
Confirmatory Action Letter - Actions to Address Steam Generator Tube Degradation
San Onofre Nuclear Generating Station, Unit 2

SONGS 2C17 Steam Generator Condition Monitoring Report

SONGS U2C17 Steam Generator Operational Assessment for Tube-to-Tube Wear

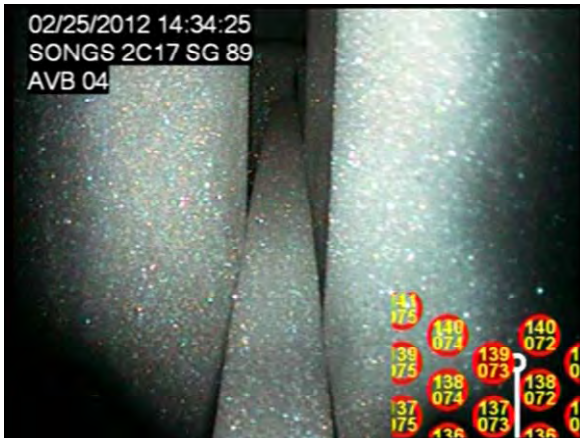
Sample from SG-2A

Pattern 2 wear seen in Unit-3 was also seen on the tubes with the Type 2 wear tubes.

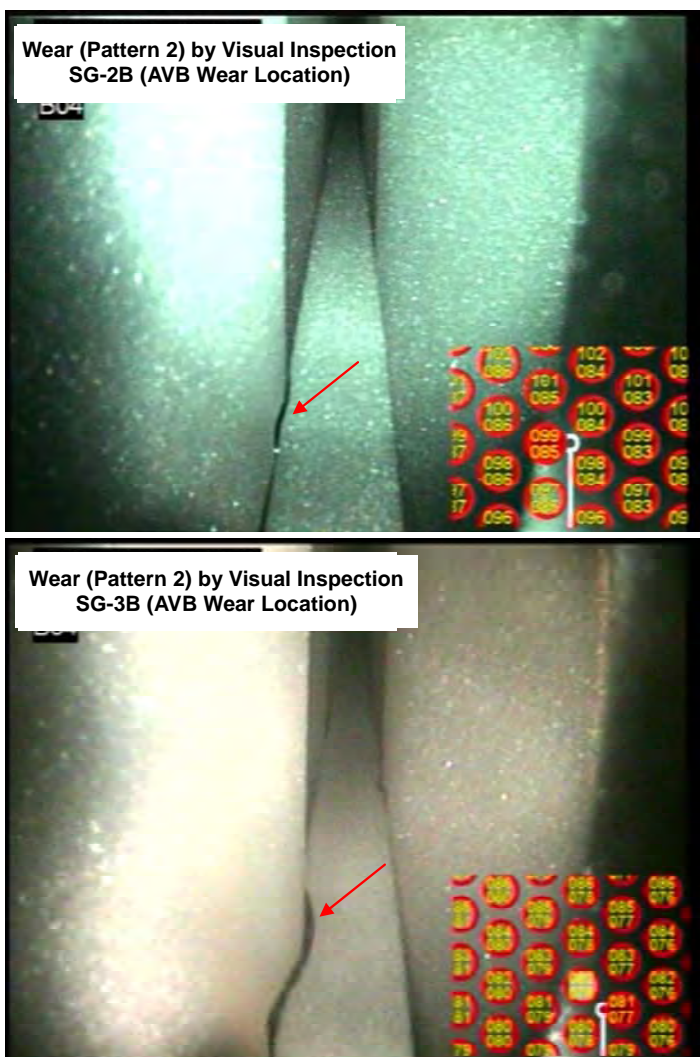
Fig.4.2-3 Illustration of Tube Wear Pattern 2

Pattern 1 wear indicating high amplitude in-plane motion of the tube, as shown in Fig 4.2-2, was seen on the tubes with Type 1 wear. Pattern 2 wear, as shown in Fig 4.2-3, was seen on the tubes with the Type 2 wear.

The AVBs, end caps, and retainer bars were manufactured according to the design. It was confirmed that there were no significant gaps between the AVBs and tubes which might have contributed to excessive tube vibration because the AVBs appear to be virtually in contact with tubes as shown in Fig.4.2-1, Fig.4.2-2 and Fig.4.2-3. ECT wear indications are identified as the Type 1 and Type 2 wear.

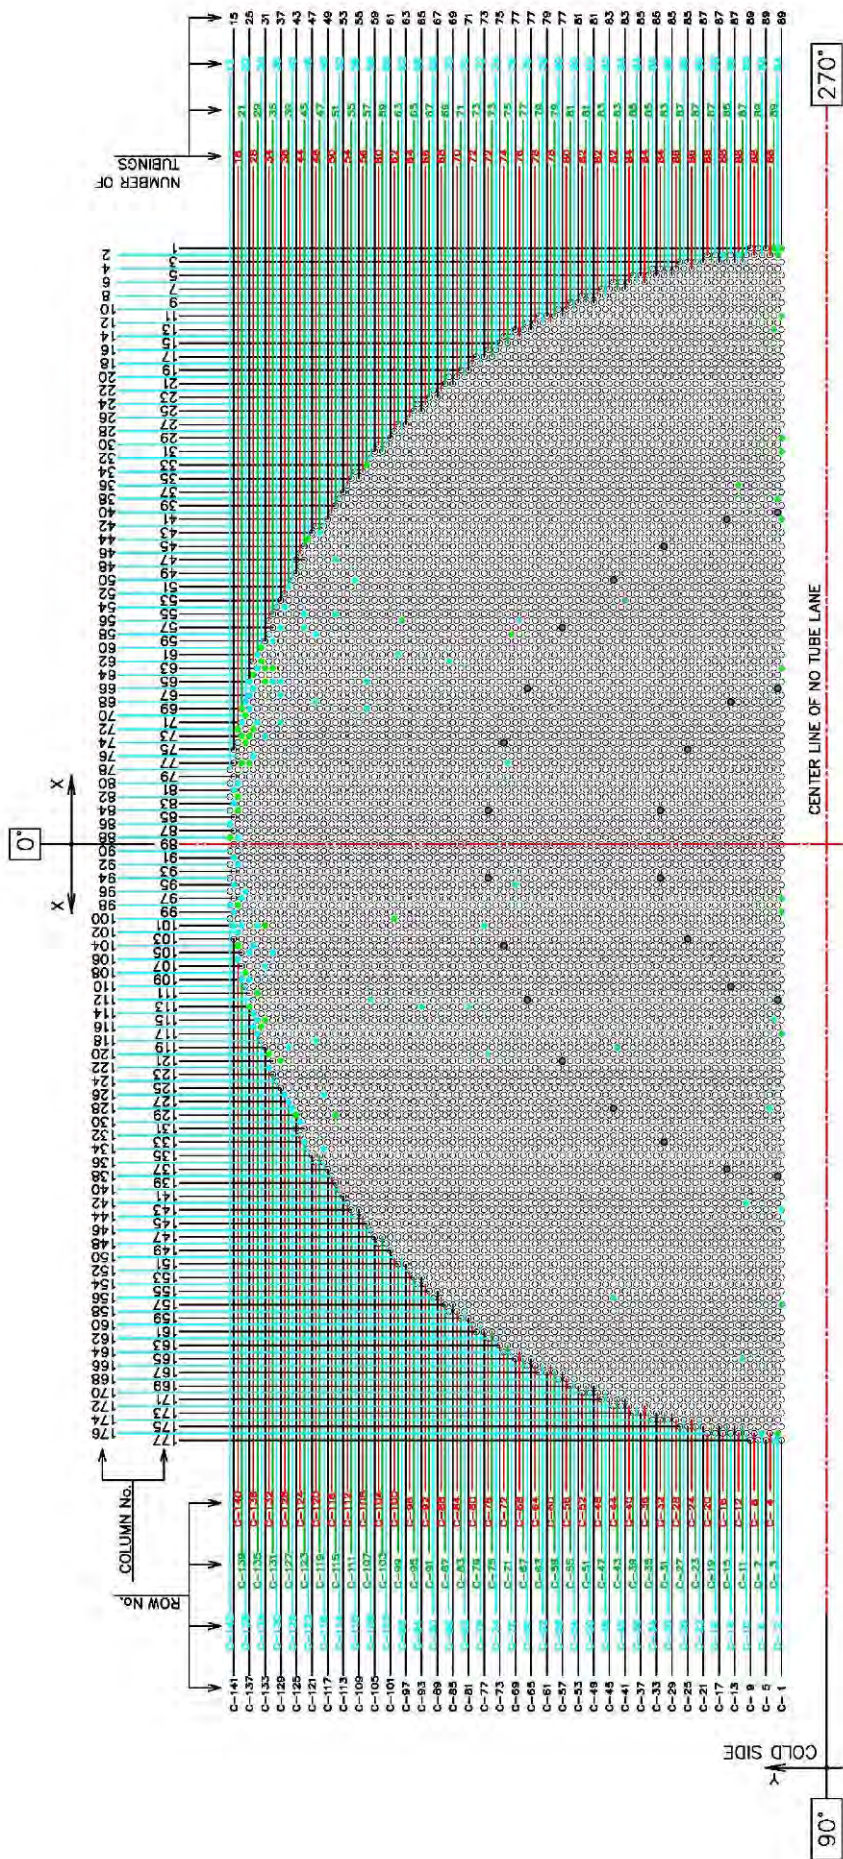
Fig. 6.5-2 Tube-to-TSP wear in 2B-SG

- : 0%
- : TSP 1~10%
- : TSP 11~20%

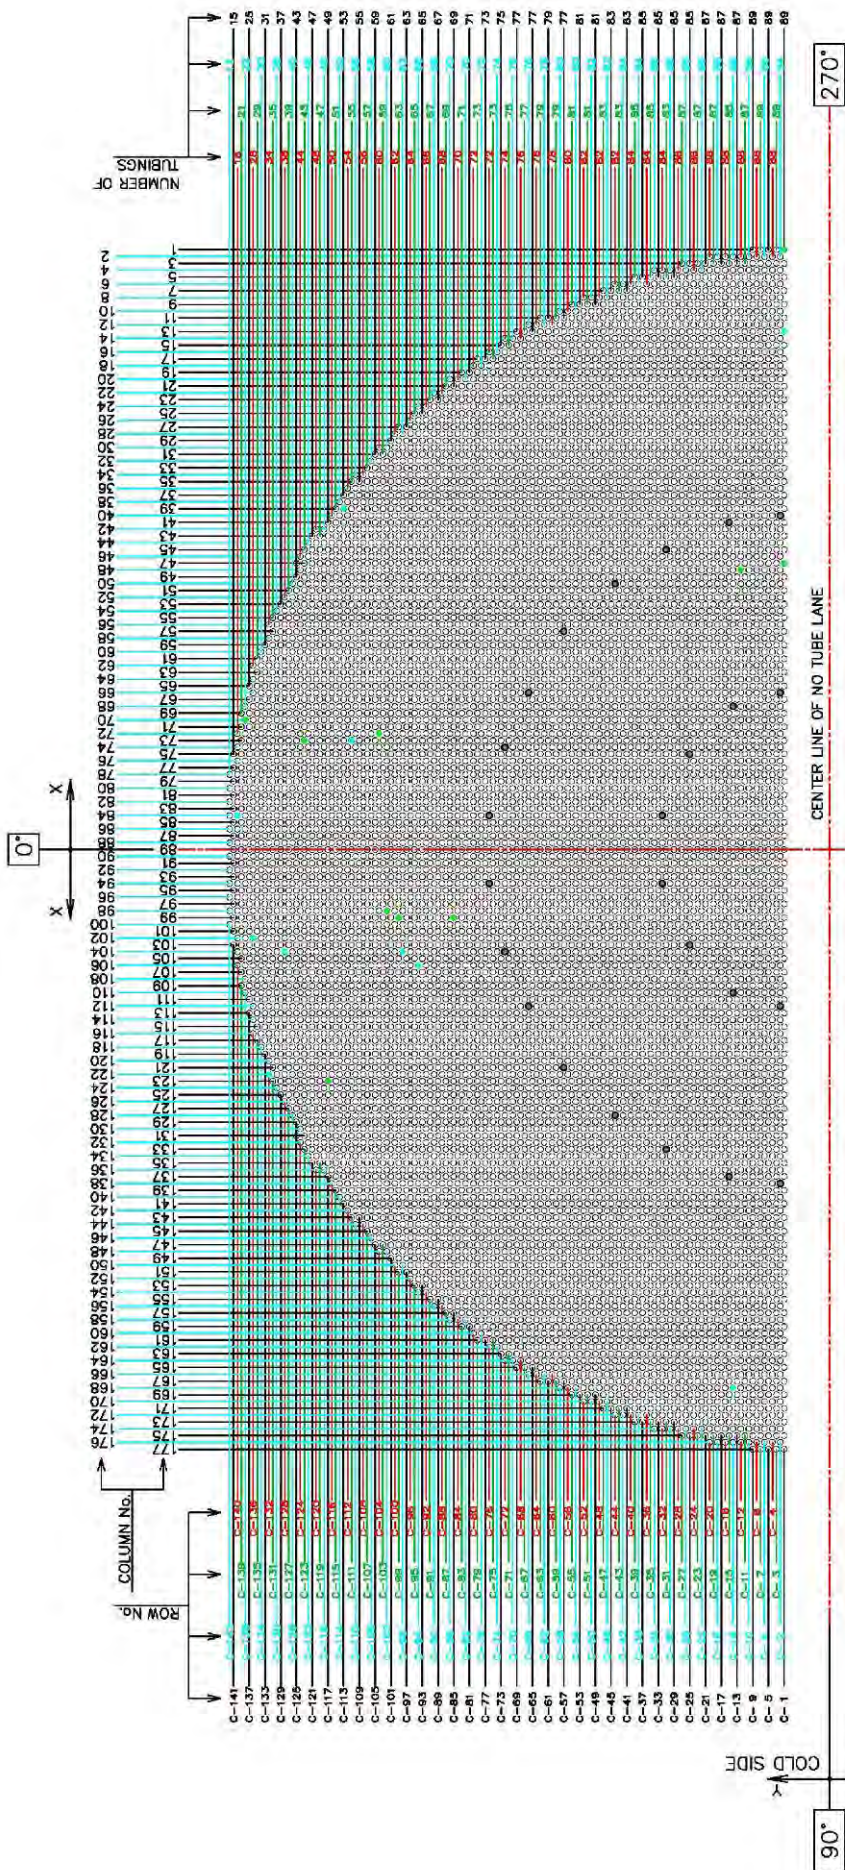
Fig. 6.5-4 Tube-to-TSP wear in 3B-SG

- : 0%
- : TSP 1~10%
- : TSP 11~20%

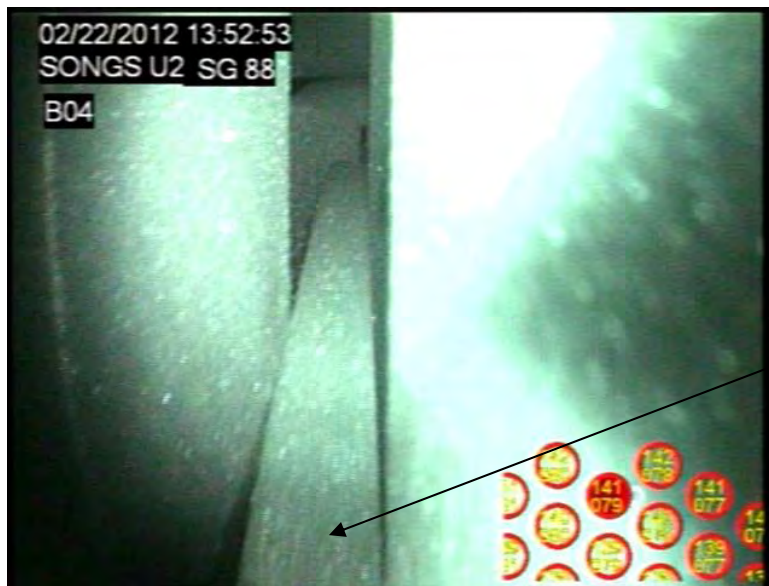
Photo-3 Visual Inspection Image of Outermost Tube Region [Unit-2B]

Image of Unit-2B Col. 78/79 tubes at AVB 04

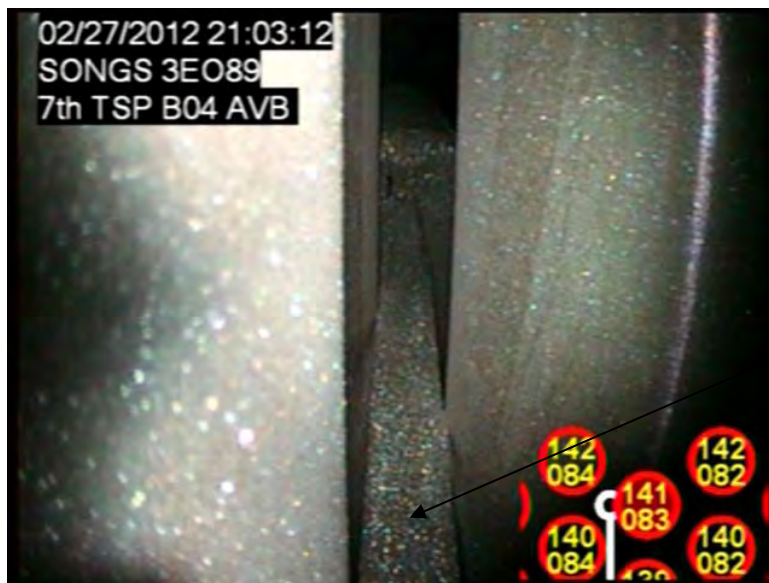
Photo-5 Visual Inspection Image of Outermost Tube Region [Unit-3A]

Image of Unit-3A Col. 84/83 tubes at AVB 04

Left side's far end is Row 142, right side is Row 141 and left side's closer end is Row 140.

The bottom of the End Cap is seen over the outermost tube.

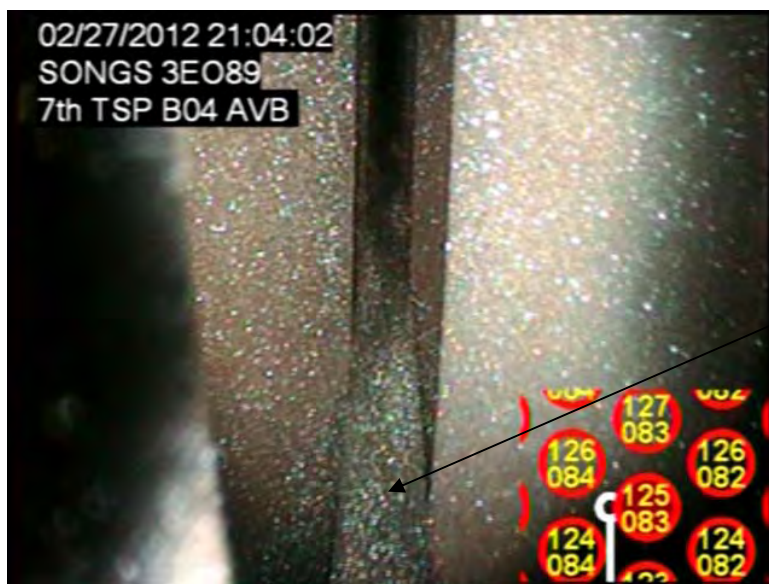
Photo-6 Tube Bundle Visual Inspection Image [Unit-3A]

Image of Unit-3A Col. 84/83 tubes around Row 125 at AVB 04 (Sample).

No gaps between the tube and AVB beyond 0.1mm and no twisting and bending on the AVB are observed.

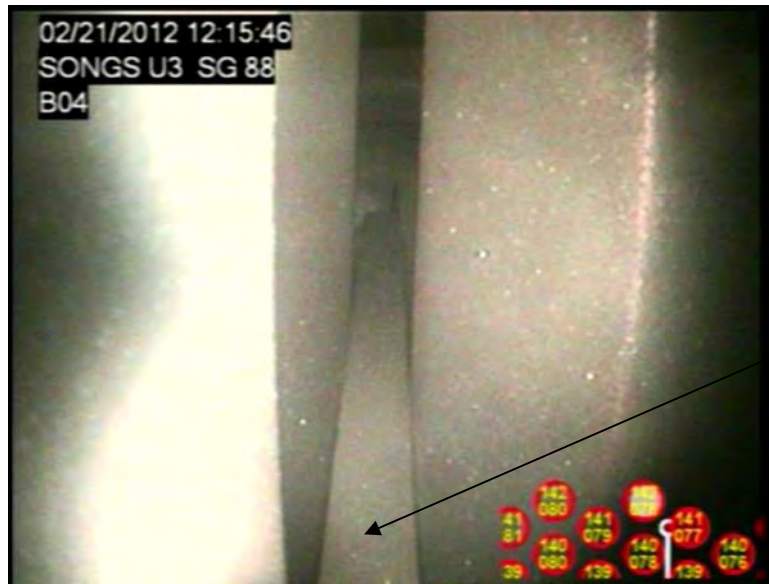
Photo-7 Visual Inspection Image of Outermost Tube Region [Unit-3B]

Image of Unit-3B Col. 78/77 tubes at AVB 04

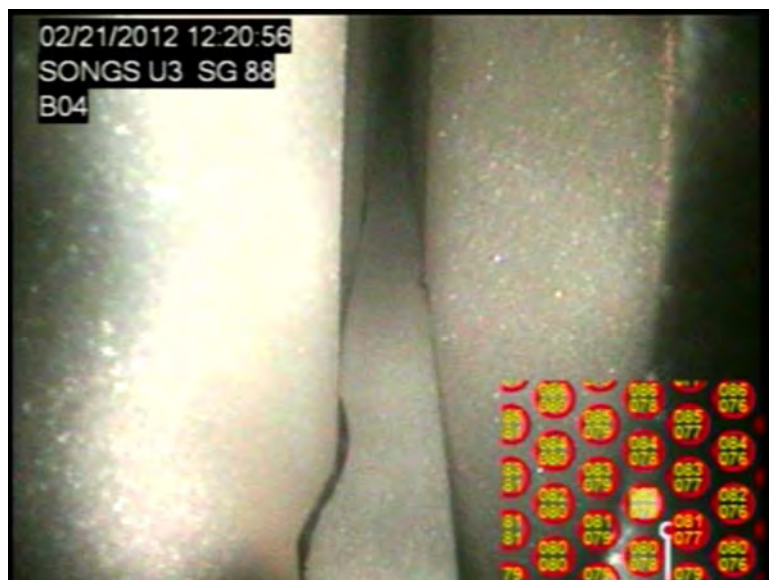
Photo-12 Sample of Pattern-2 [Unit-3B]

- Pattern-1 wear due to high amplitude in-plane vibration, as shown in Photo-9 and Photo-10, were found in the free span region.
- Pattern-2 wear as shown in Photo-11 and Photo-12 was found near where Pattern-1 occurred.
- There is some Pattern-1 wear identified by visual inspection, for which Bobbin ECT was not able to detect as this type of wear. (See Table-1~Table-4)

Image of Unit-3B Col. 78/77 shows a sample of the most typical Pattern-2 wear, where wear between the tube and AVB cannot be distinguished.

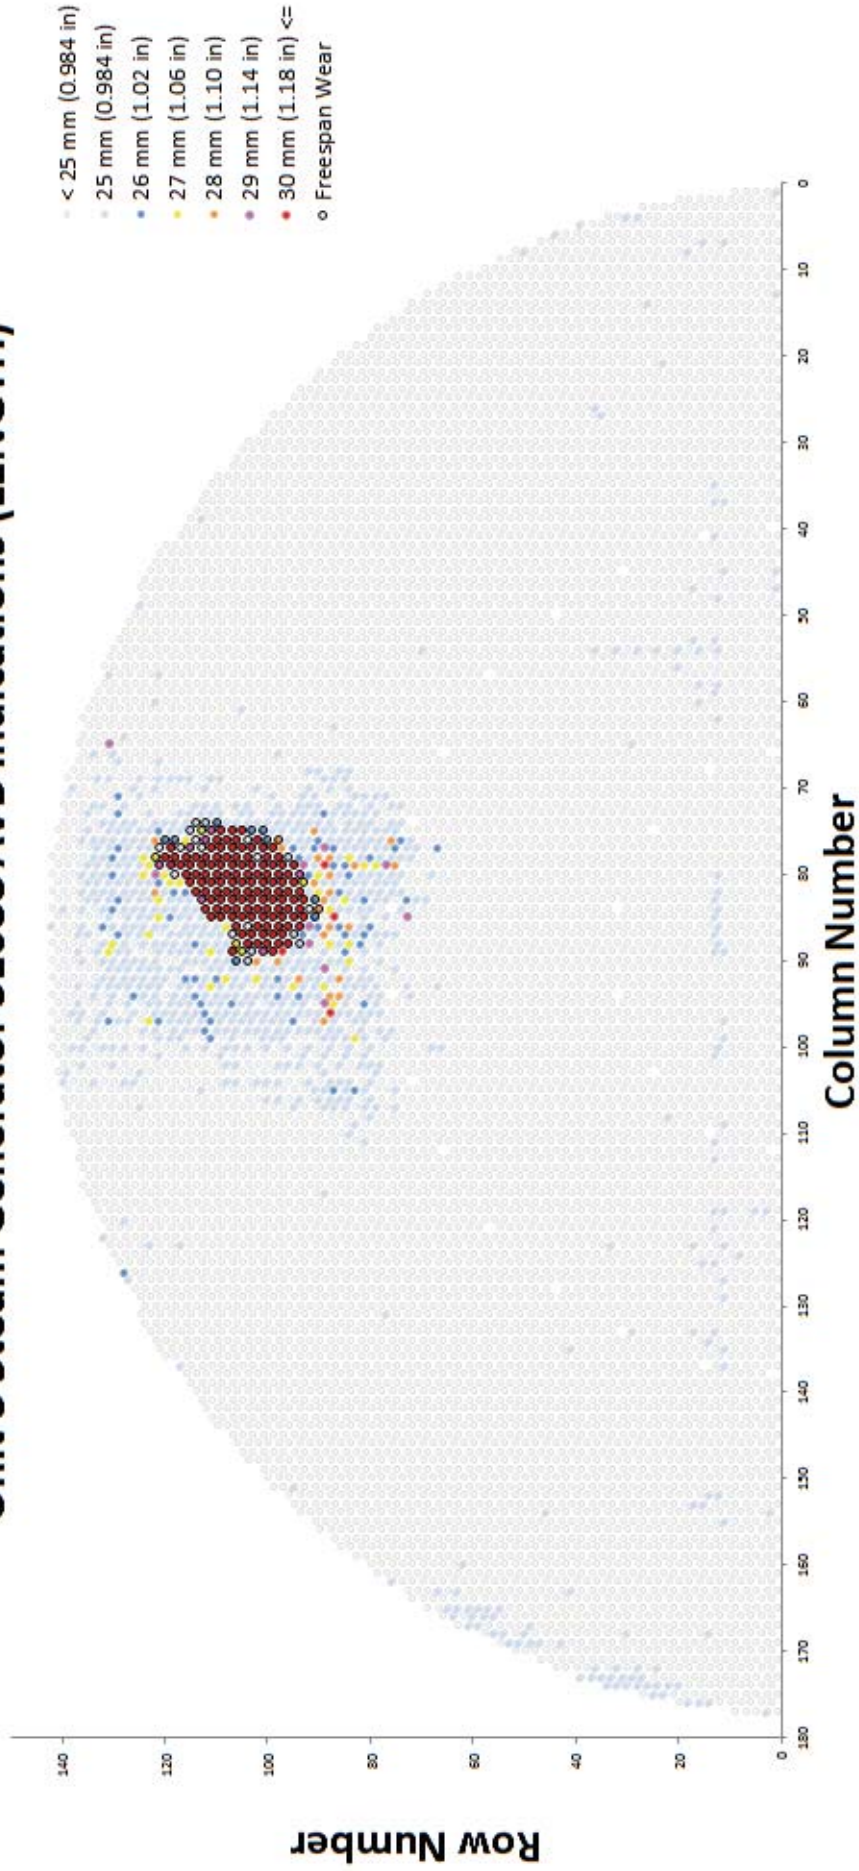
Figure 4-13: Tube Wear Length at AVBs for Unit 3 SG E-088

Unit 3 Steam Generator 3E088 AVB Indications (LENGTH)

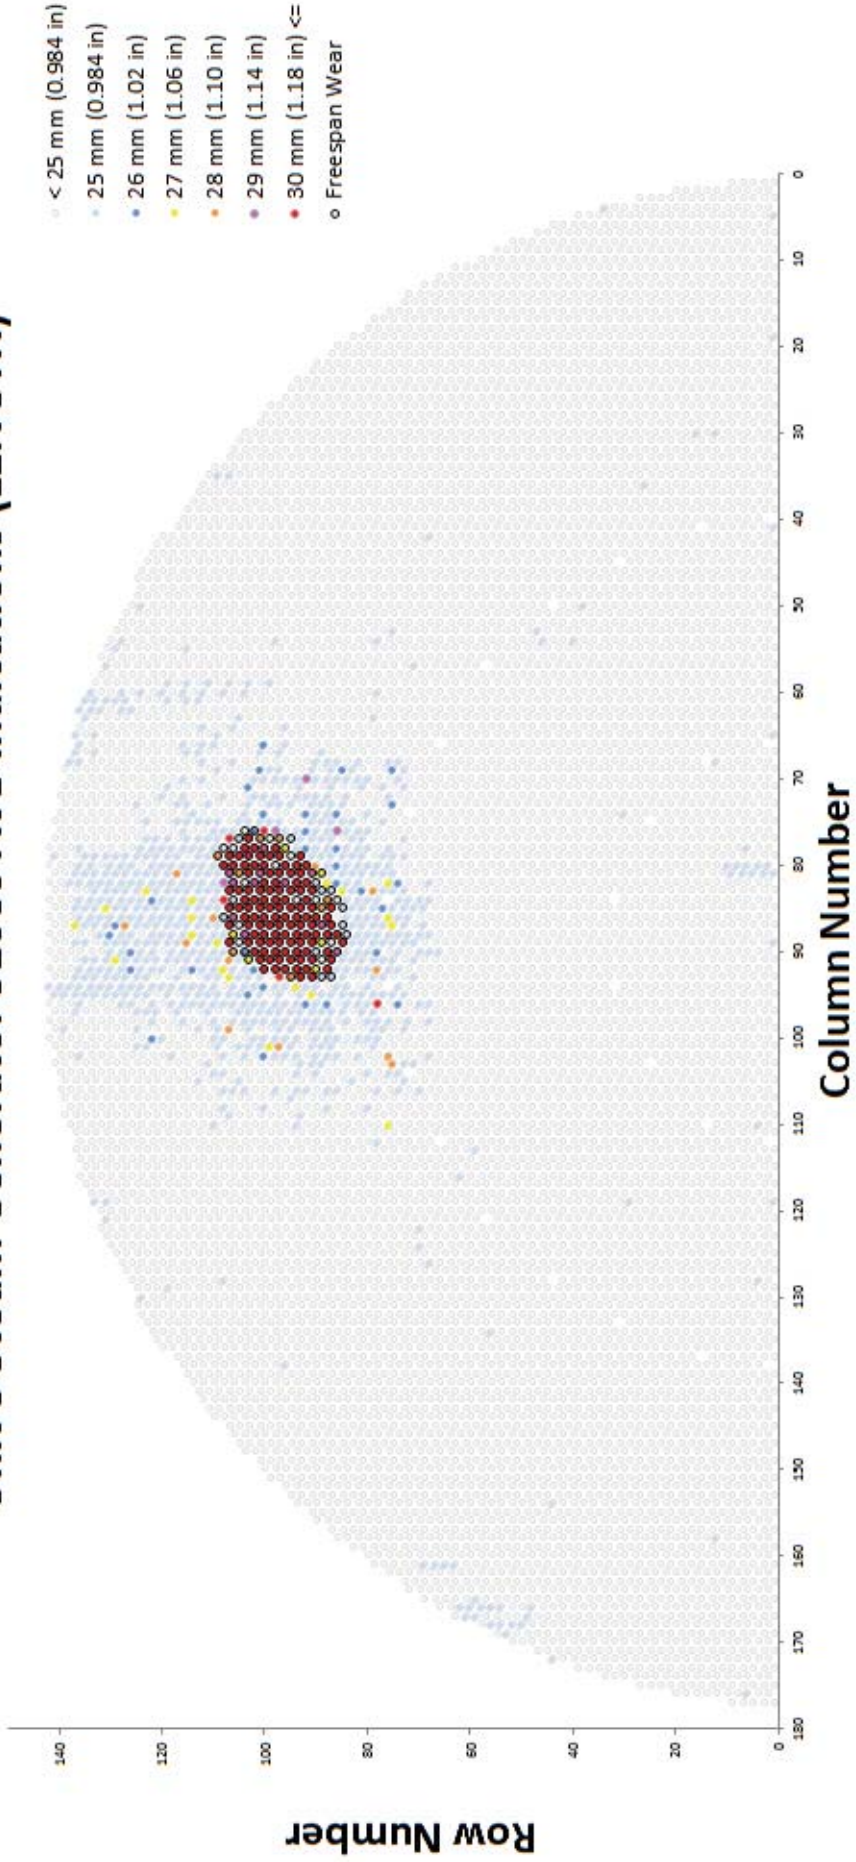
Figure 4-14: Tube Wear Length at AVBs for Unit 3 SG E-089

Unit 3 Steam Generator 3E089 AVB Indications (LENGTH)

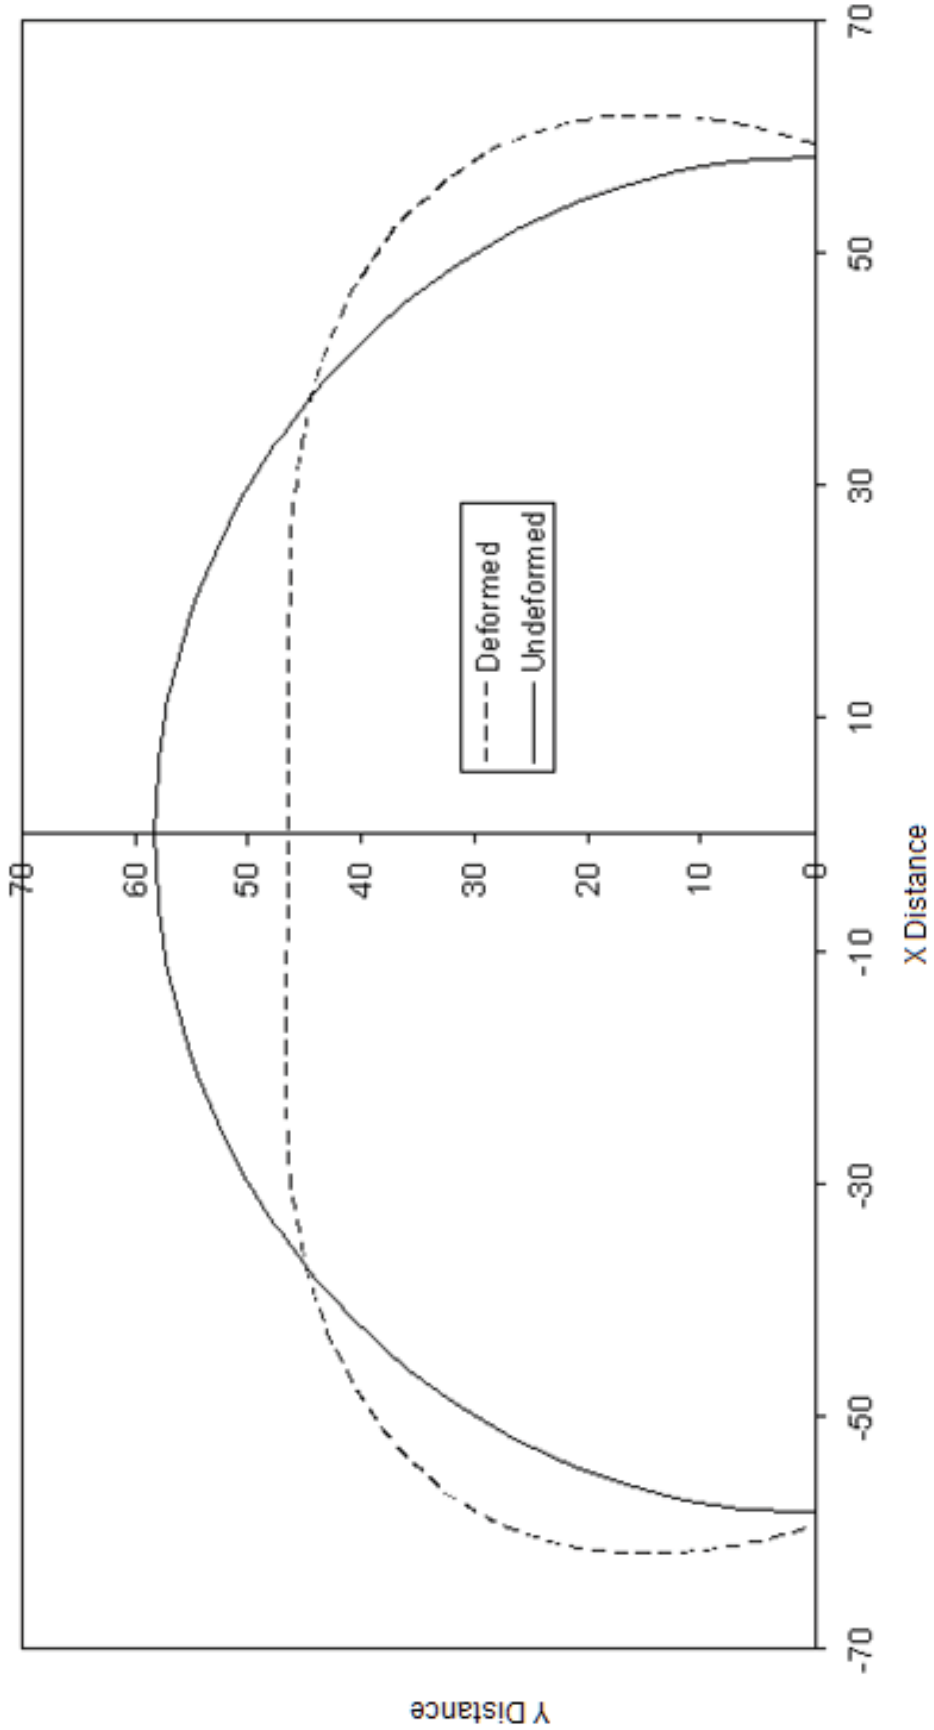
Figure 4-18: Mode 2 Displacement Pattern

Deformed and Undeformed U-Bend Row 106 Mode 2

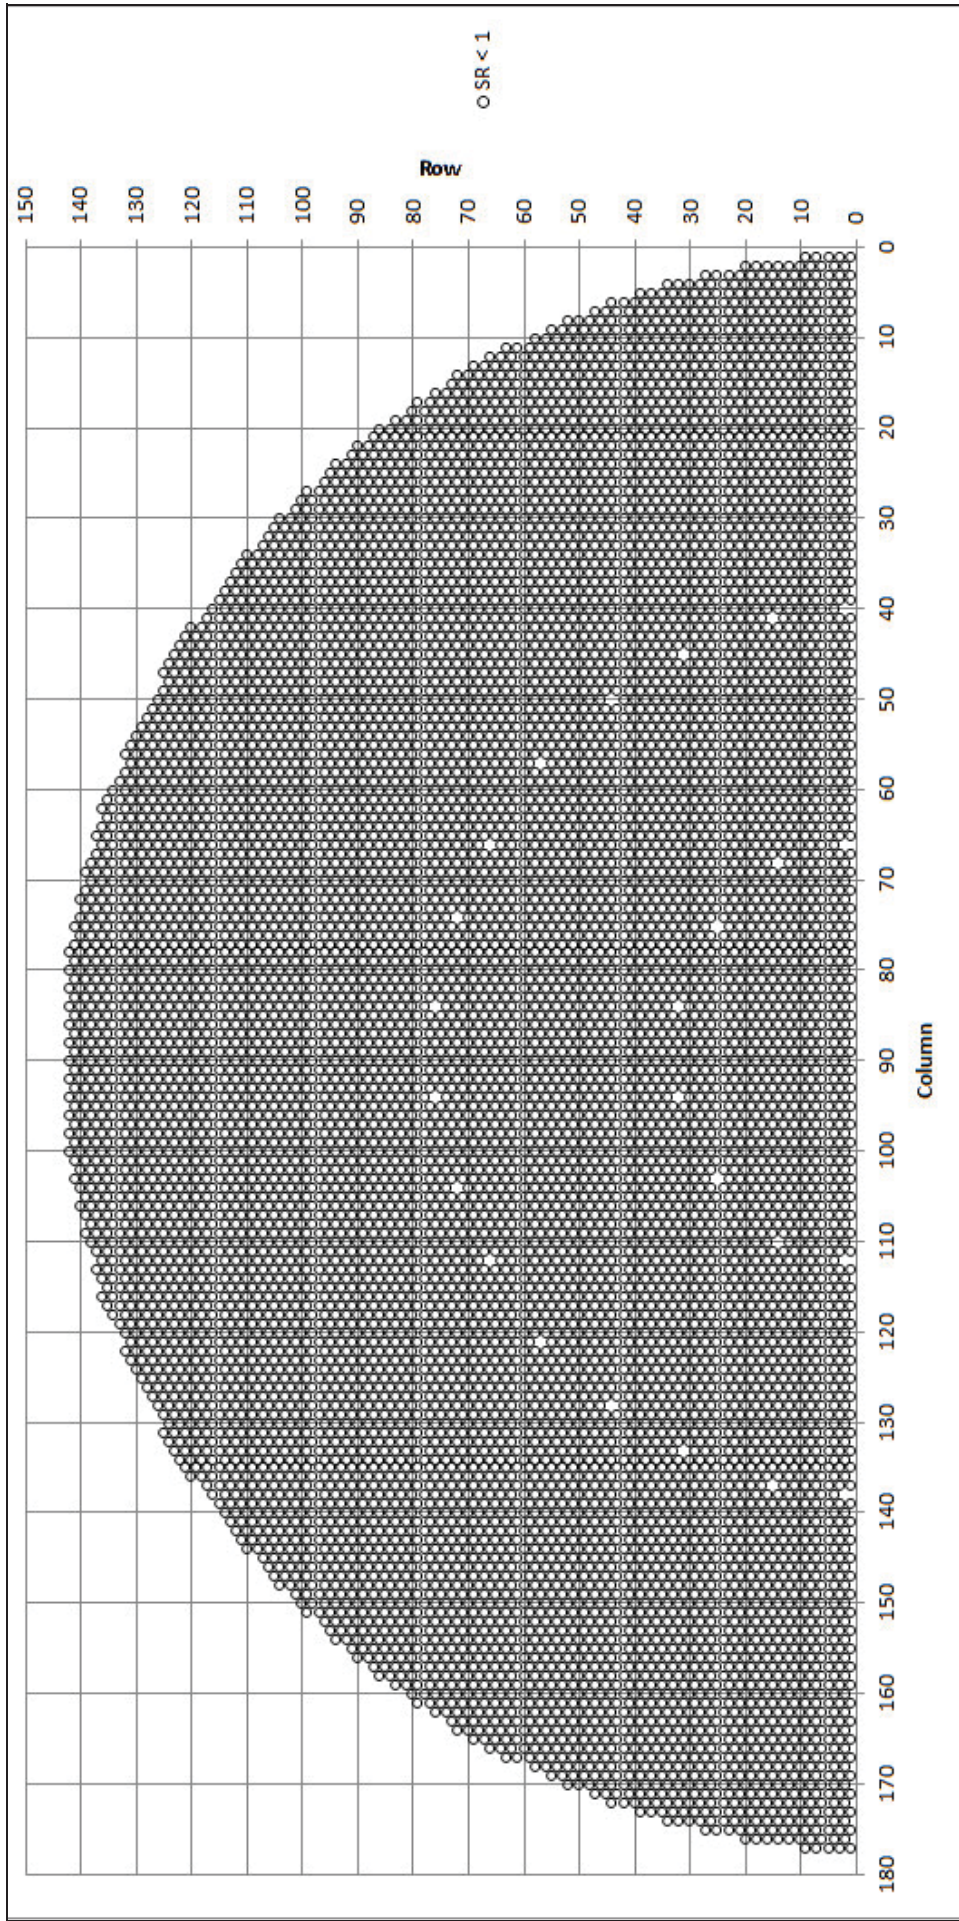
This blank figure is not an error. Even with no effective in-plane supports there are no unstable U-bends at 70% power
