Innovative Methods Save Vermont Recreation Area

By Dr. JoAnne Castagna

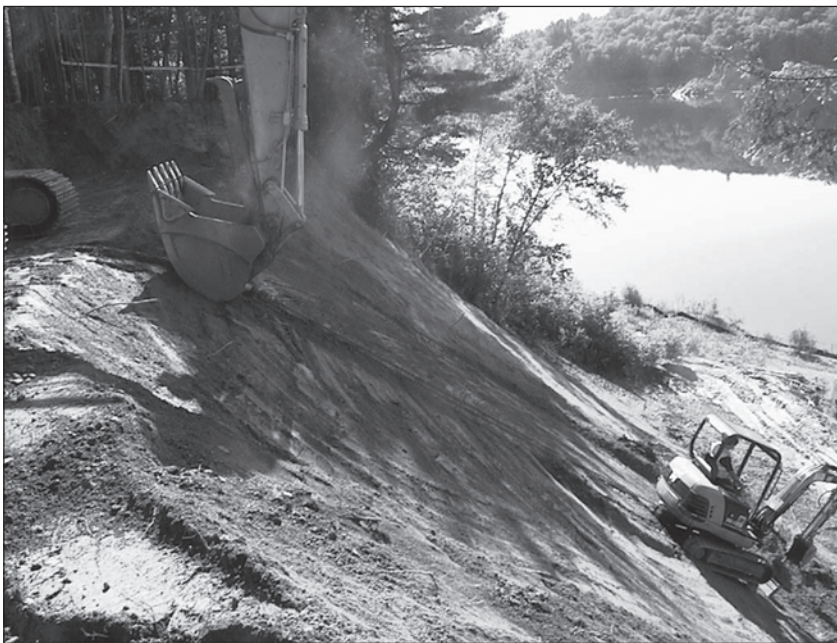
The slope was regraded prior to placing riprap for stabilization.

Traditional techniques, using stone or riprap, stabilized the bottom of the slope. The weight of the stone prevents wave action from moving or removing the stone and prevents scoring or erosion. This part of the slope must remain stable for the upper areas (stabilized using bioengineering techniques) to remain in place and function properly.

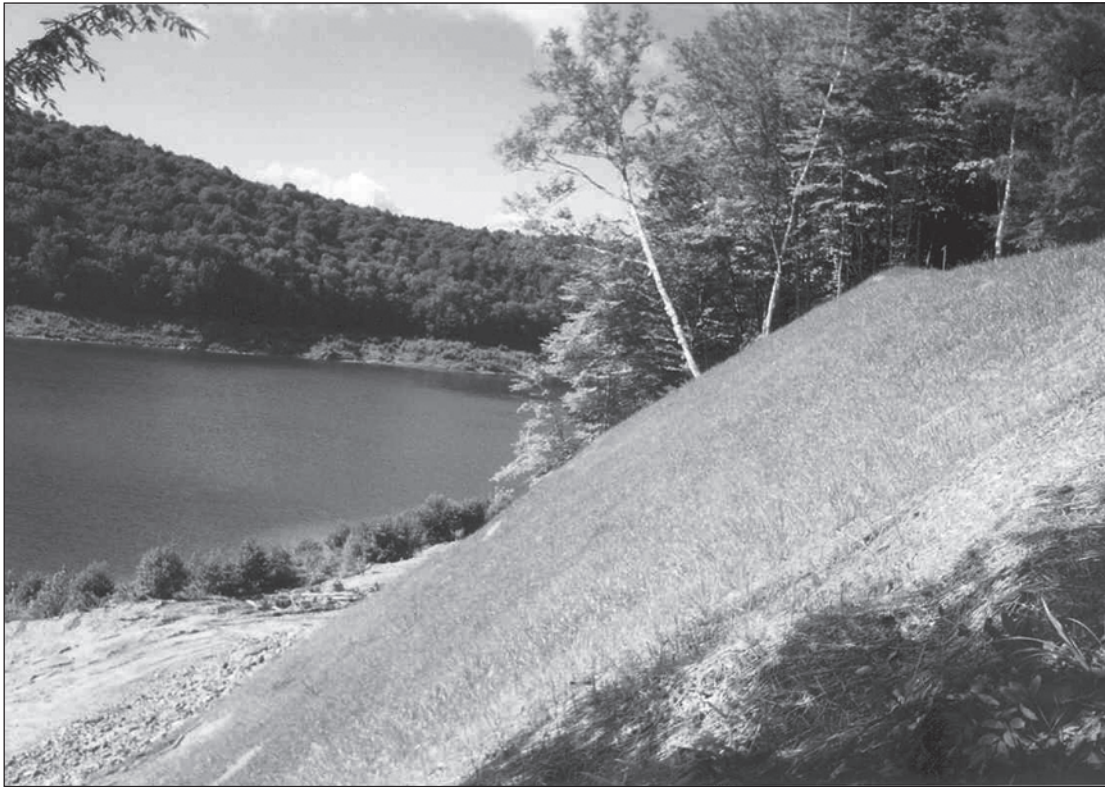
Riprap was placed at the bottom of the slope for stabilization, and the regraded slope was covered with grass seeding prior to fall plantings.

With the stabilization at the bottom of the slopes completed, grass seed was sown at the top of the slopes for immediate slope stabilization. In the fall, a mix of live cuttings and containers of woody vegetation, such as shrubs and trees, were planted on the slopes for long-term stabilization. Planting in the fall is more conducive to plant survival than planting during the summer.
