Nationwide Context, Inventory, and Heritage Assessment of Works Progress Administration and Civilian Conservation Corps Resources on Department of Defense Installations

**CCC-WPA Resources Legacy Grant Case Study:
Fort Riley, Kansas**

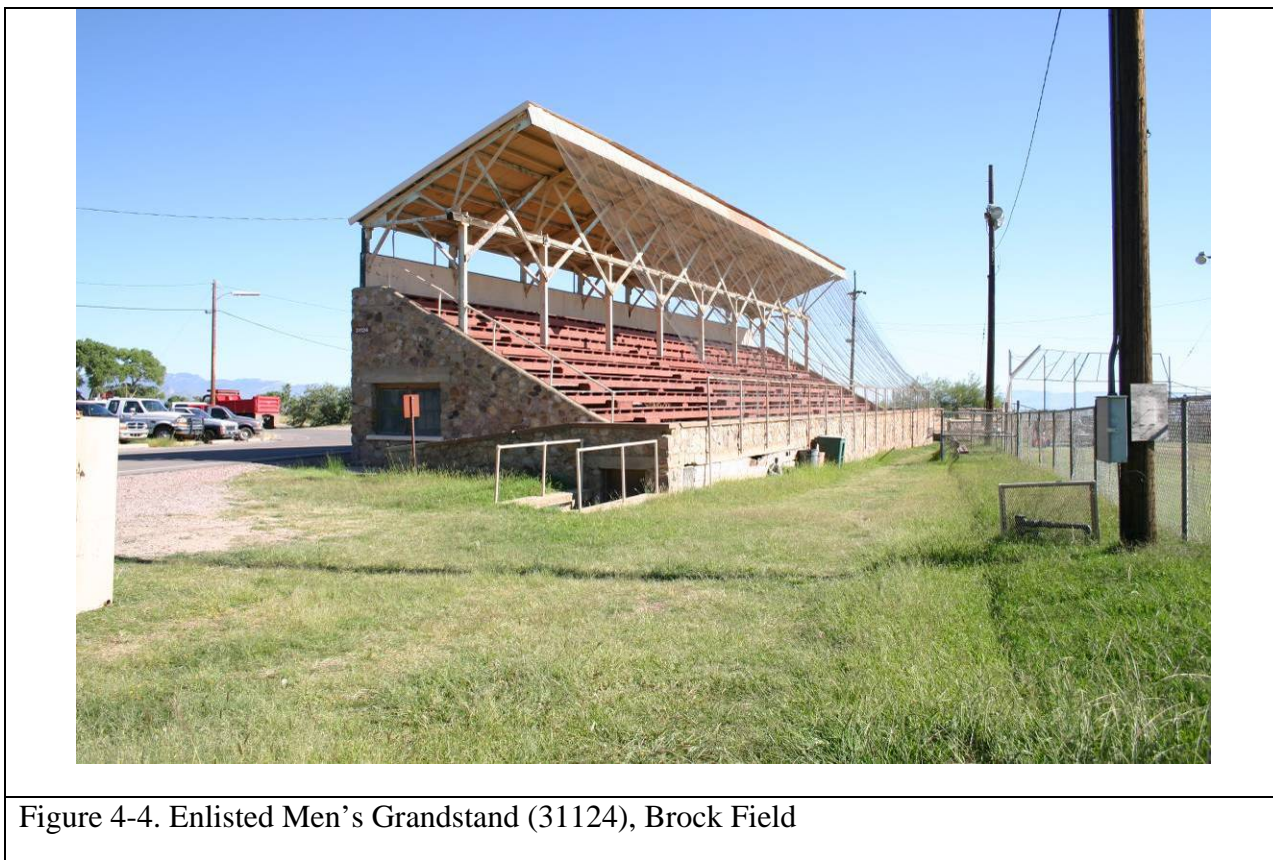
Figure 4-5. Officers' Grandstand (31123), Brock Field

the period of significance that would associate them with the notable baseball teams of the 25th Infantry and 9th Cavalry. Evaluating integrity based on its architectural significance only, the Officers' grandstand is evaluated not eligible for NRHP listing due to alterations and missing features. Historic photos show a canopy structure over the Officers' grandstand similar to the extant structure on the Enlisted Men's grandstand, stadium-style folding seats, and hand railings. The original railings are extant though modified where originally connected to canopy supports and neither the canopy nor the seats are extant.

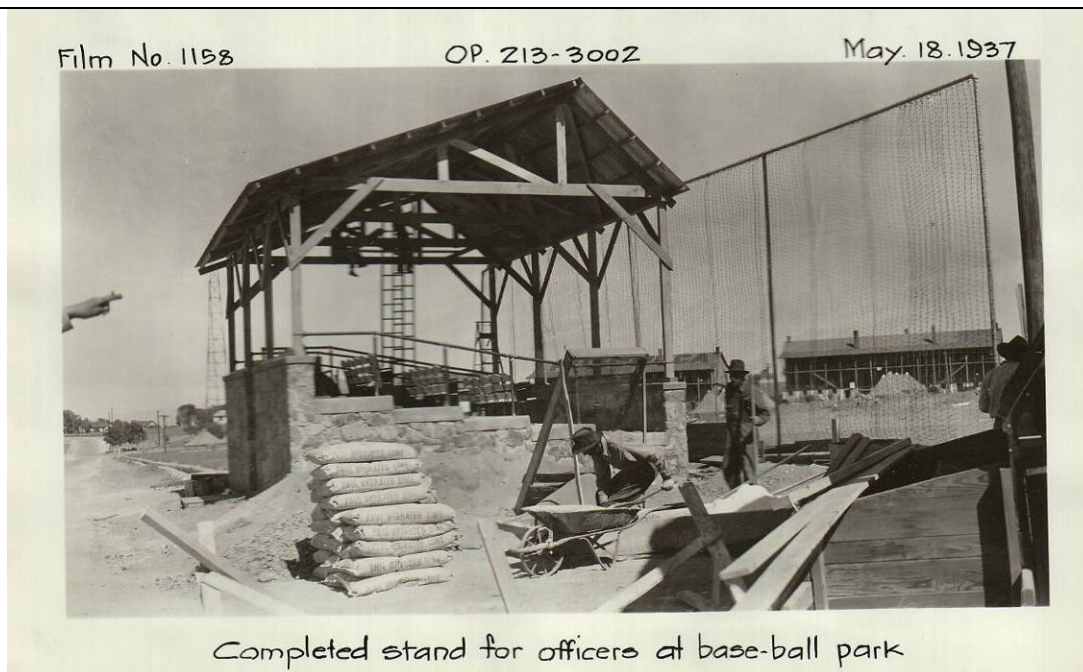
Figure 4-6. Officers' Grandstand under construction. From WPA Photo Album, Fort Huachuca Museum and Archives.

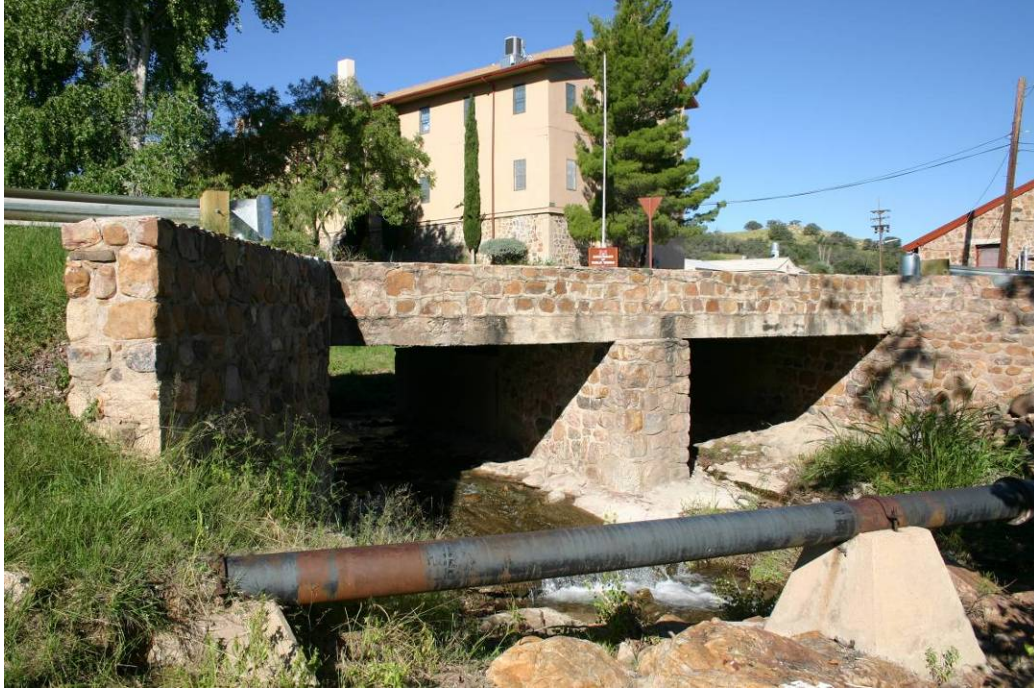
Figure 4-7. Bridge over Huachuca Creek.

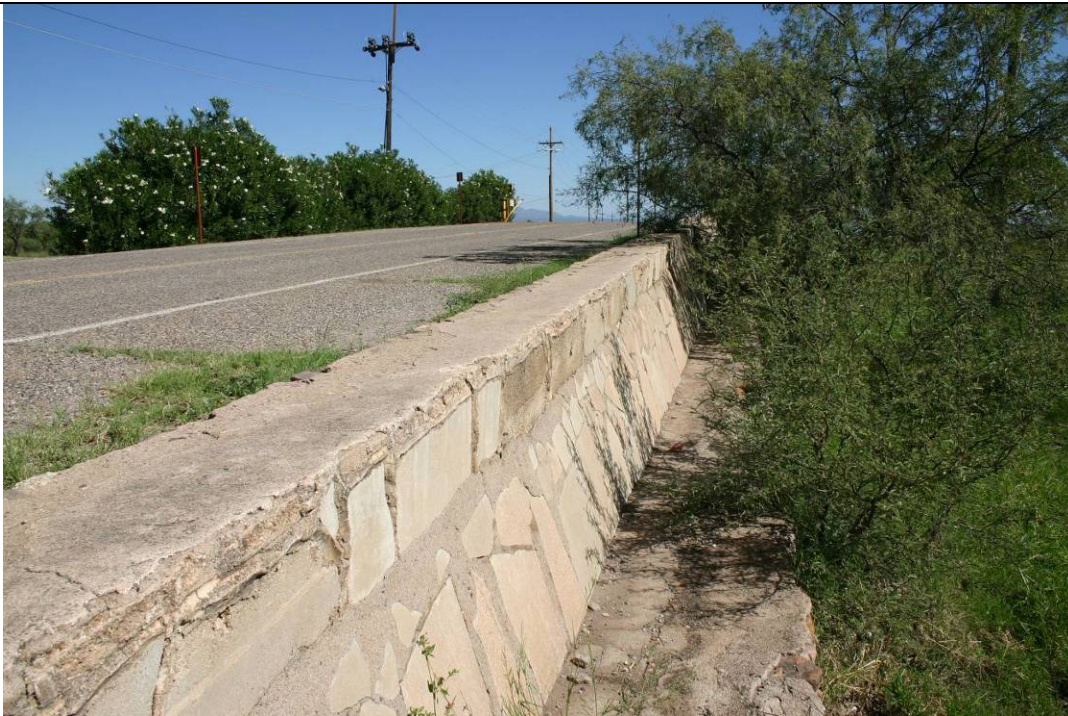
Figure 4-8. SPRR Embankment.

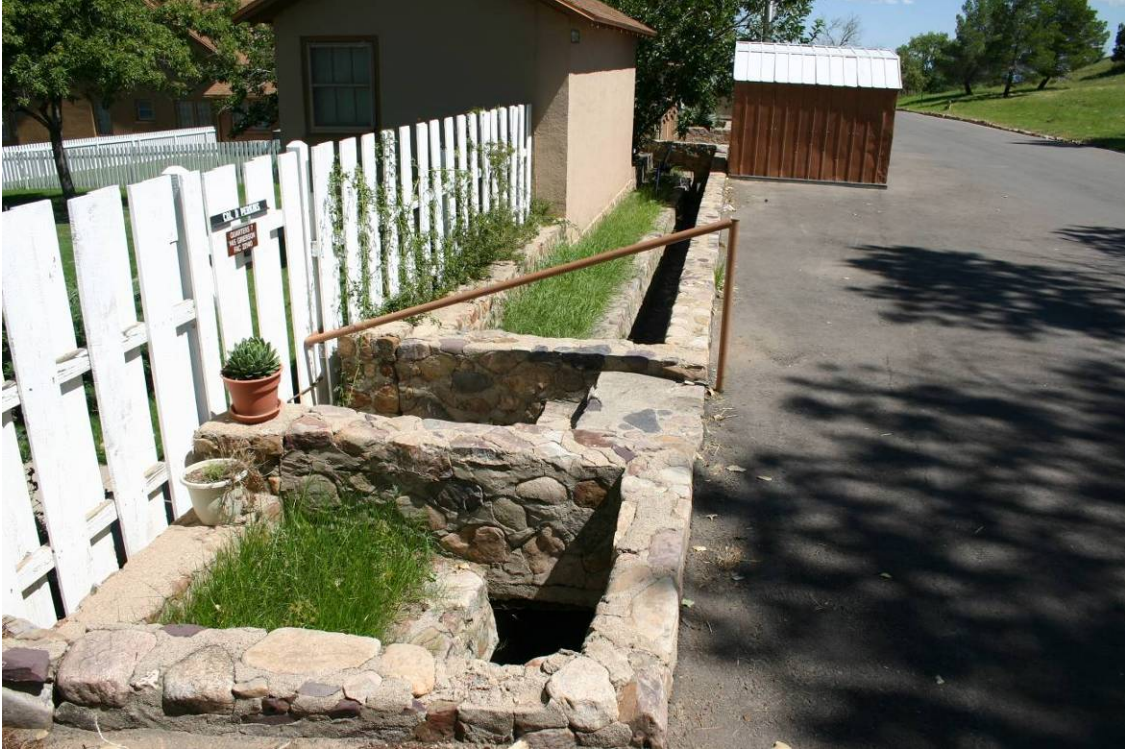
Figure 4-10. Ditches along Grierson Street

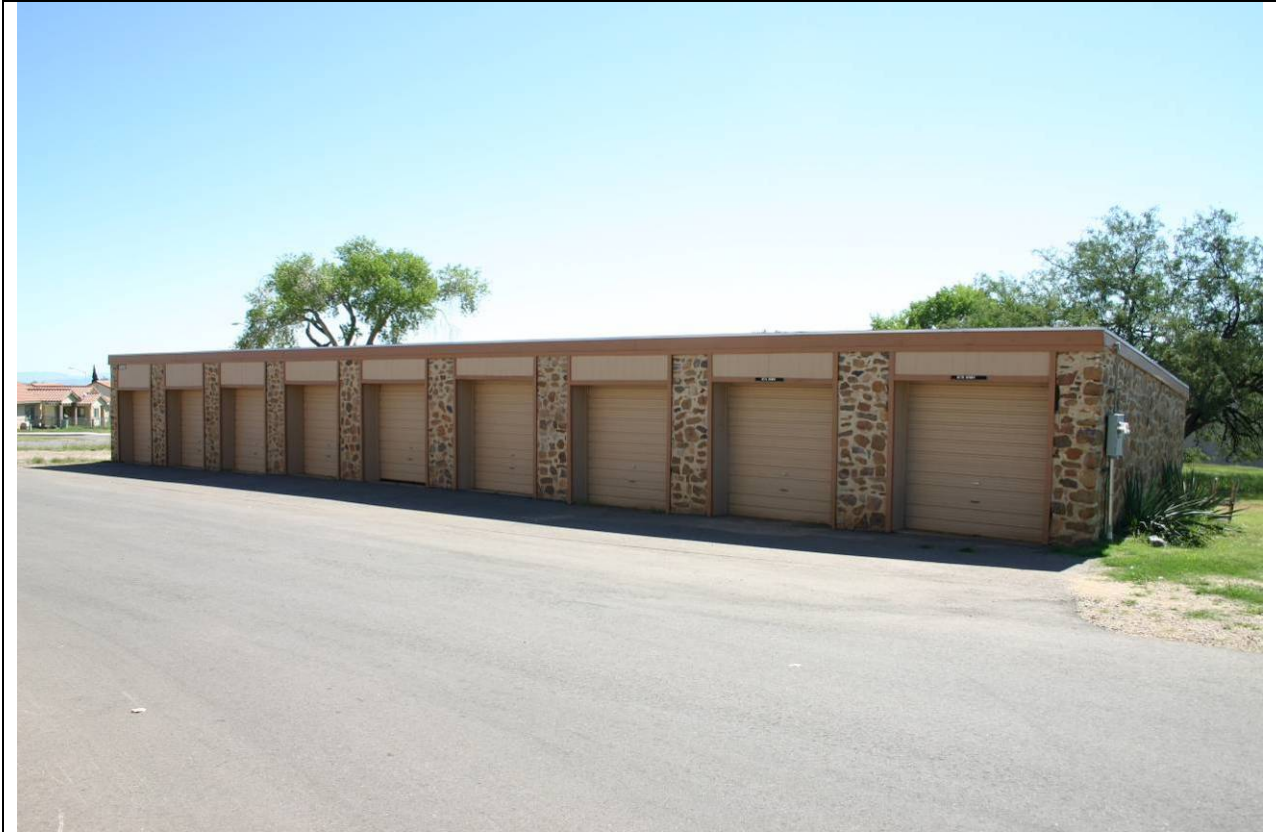
Figure 4-11. Nine bay garage (42021) behind Allen House.

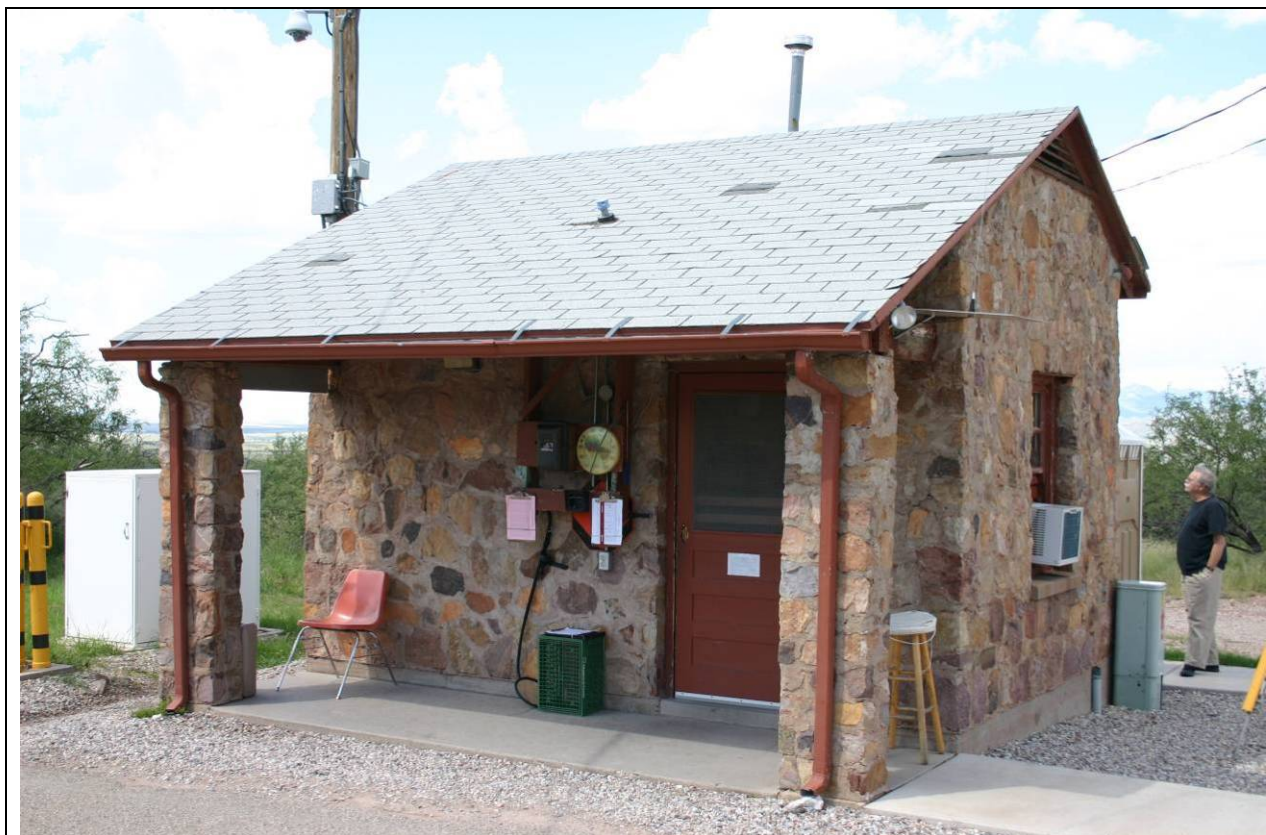
The WPA also provided funding for a new guardhouse at the Canelo Gate, the west entrance into the post. The guardhouse is a rectangular stone masonry structure with a side gable roof and shed roof porch supported by two stone masonry columns. From the “as built” description of the guardhouse in a 1941 WPA completion report, the only major alteration is the replacement of the slate roof with one of composition shingles. The Canelo guardhouse retains high integrity of location, design, workmanship, setting, feeling, and association and is significant under Criterion A for its associations with the WPA and CCC era at Huachuca and under Criterion C as a typical representation of the style and level of workmanship exhibited in WPA and CCC projects at the post. It is recommended eligible for the NRHP.

Figure 4-13. West (Canelo) Gate Guardhouse (11510)

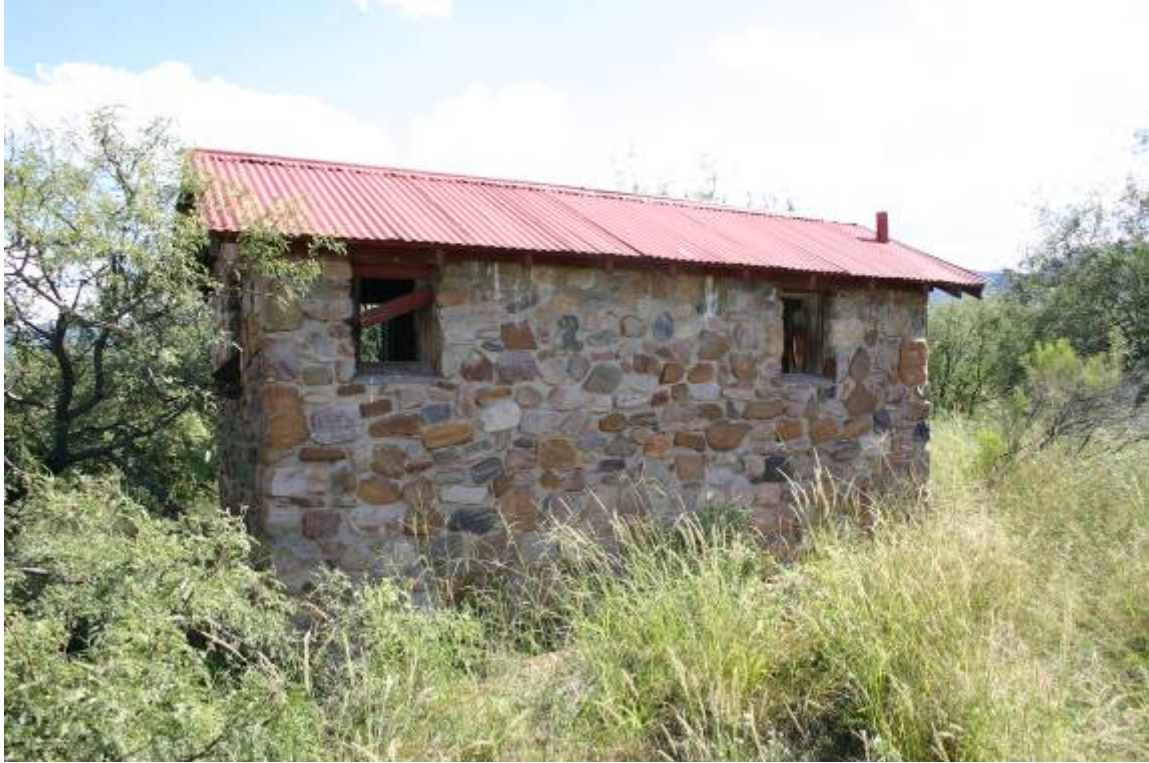
Another new construction project under the WPA at Huachuca is a double latrine at the firing range. The building has stone masonry construction on a slab concrete foundation and a side gable roof. While the double latrine retains high integrity of location, design, materials, and workmanship, it has been abandoned for a number of years as demonstrated by the deteriorated wood elements and surrounding overgrowth of vegetation. The building is also exposed to the elements with no doors or windows extant and the plumbing has been capped. The double latrine does not hold sufficient significance and is recommended not eligible for NRHP listing.

Figure 4-14. Range Latrine

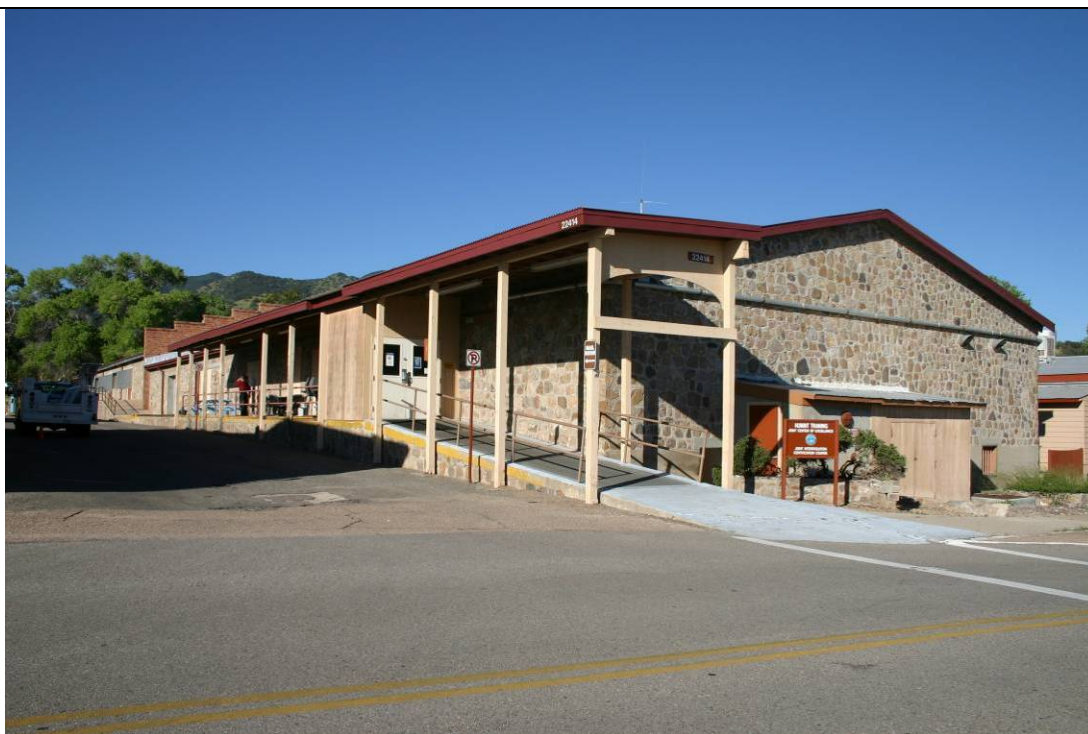
dock bay doors have been bricked-in or replaced with single modern metal pedestrian doors. The interior has also been modernized and sub-divided for use as training classrooms. These cumulative later alterations have significantly impacted the building's integrity of design, materials, workmanship, and feeling; while the removal of the railroad spur and change in use have impacted the building's integrity of setting and association. The Utilities Warehouse, despite its significance as representing WPA renovations to existing buildings at Huachuca, is recommended not eligible for the NRHP due to loss of integrity.

Figure 4-15. Former Utilities Warehouse (22414)

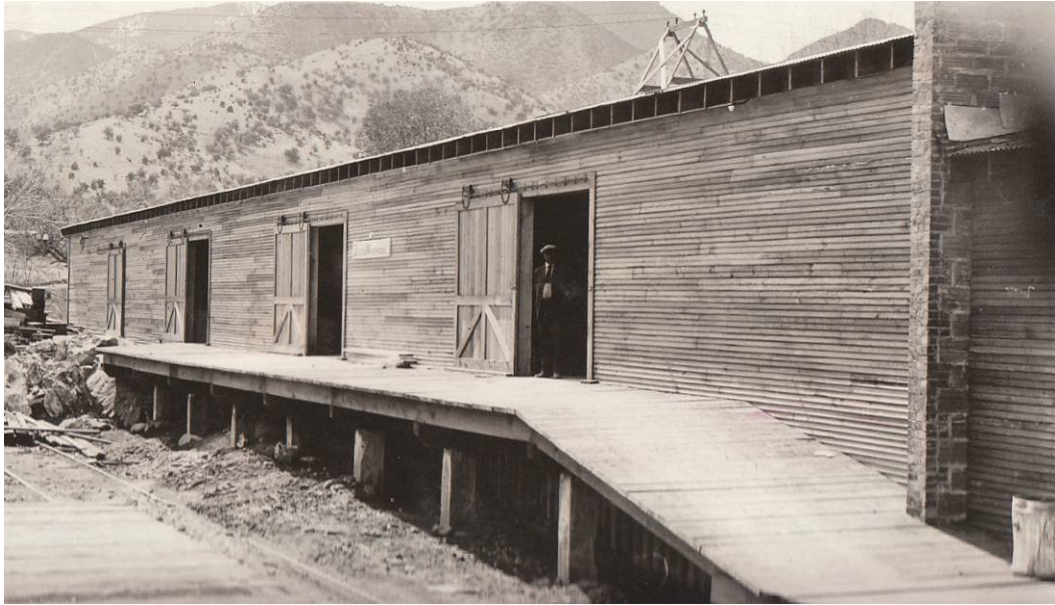
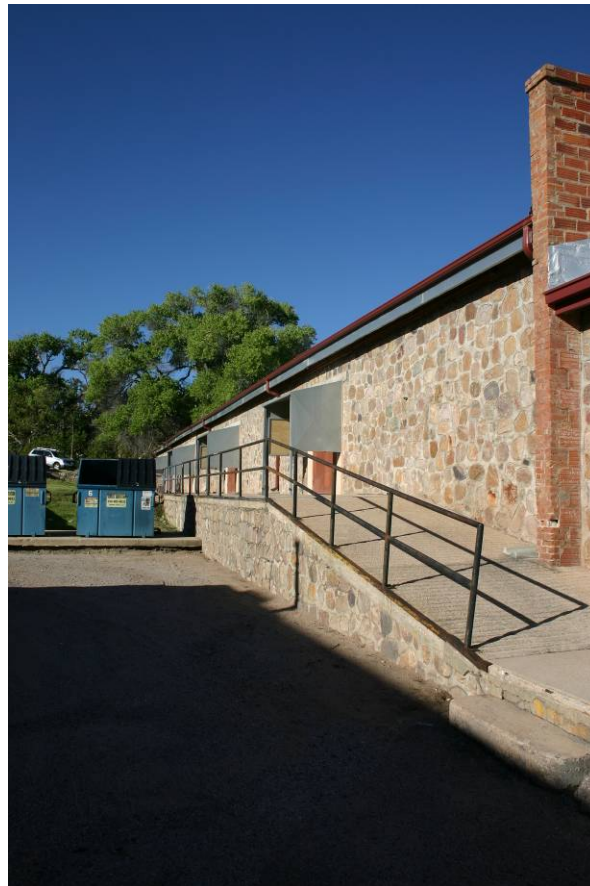
Figure 4-16. Utilities Warehouse before and after WPA renovations.

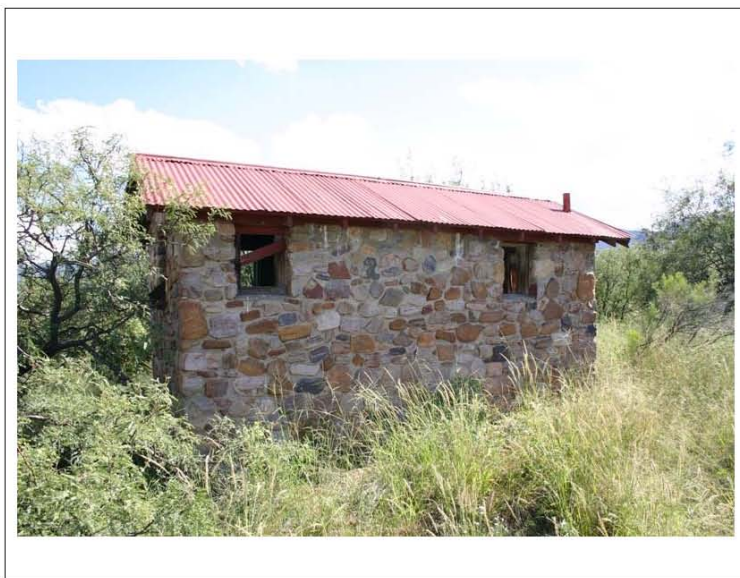
Describe: doors/windows missing, exposed to elements, roof appears sound

The latrine is currently abandoned and the plumbing has been capped. The surrounding setting is still currently used as a target range, however the immediate setting has changed due to overgrowth of shrubs and trees. Doors and windows are missing, leaving the interior exposed to the elements. However, the roof appears sound.

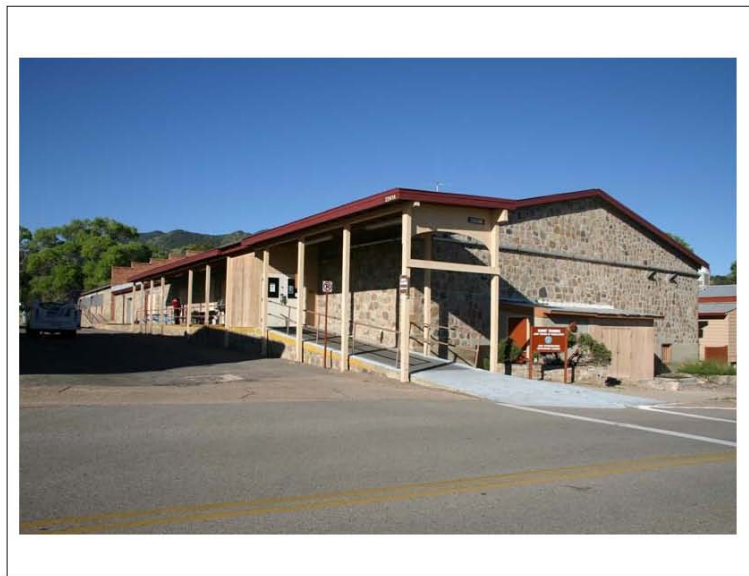
Although the WPA-CCC era additions and renovations are historic, more recent modifications have significantly impacted the historic integrity. Most notable is the replacement of the sliding warehouse doors with metal single and double doors with galvanized steel awnings.

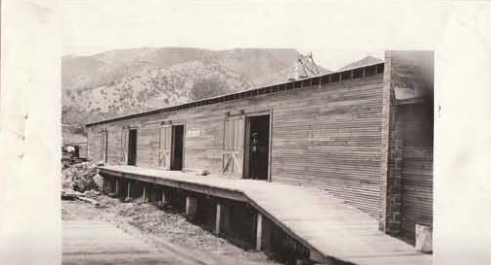
Real Property card with construction date of 1920 and photo before WPA renovations and improvements.

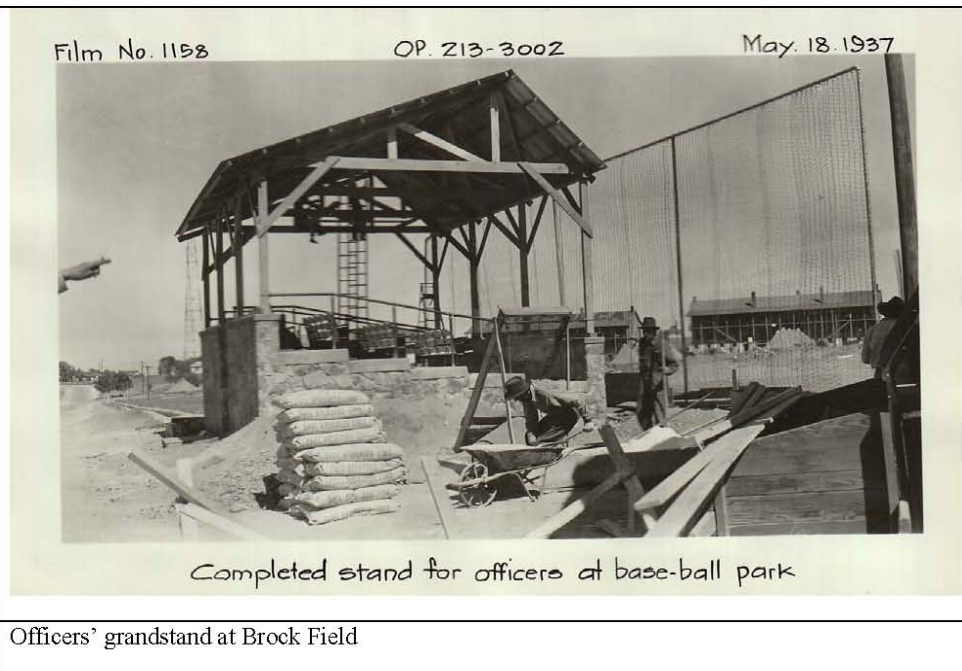
The enlisted men's grandstand is significant under Criterion A for its association with WPA projects at Fort Huachuca and particularly its representation of a WPA project relating to recreation and under Criterion C for its combined use of steel riveted trusses in conjunction with the WPA-CCC rustic aesthetic of ashlar masonry walls.

The original canopy has been removed from the officers' grandstand, impacting the historic integrity of feeling, workmanship and materials.

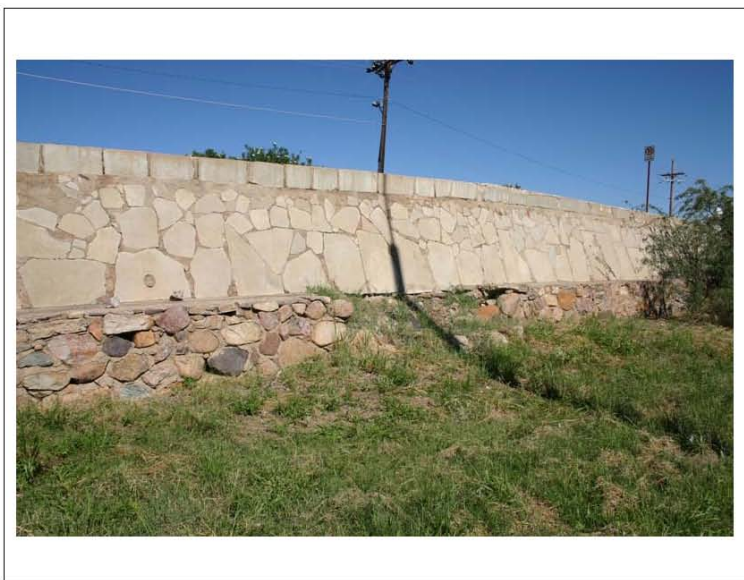
Describe: deteriorated mortar and concrete, but appears structurally sound

5. WORKMANSHIP (Describe the distinctive elements, if any, of craftsmanship or method of construction)
Faced with flagstones on bottom edge, finished side faces southeast, roadbed wall has bricks in places, possible repairs, sidewalk has concrete cap over stone wall foundation

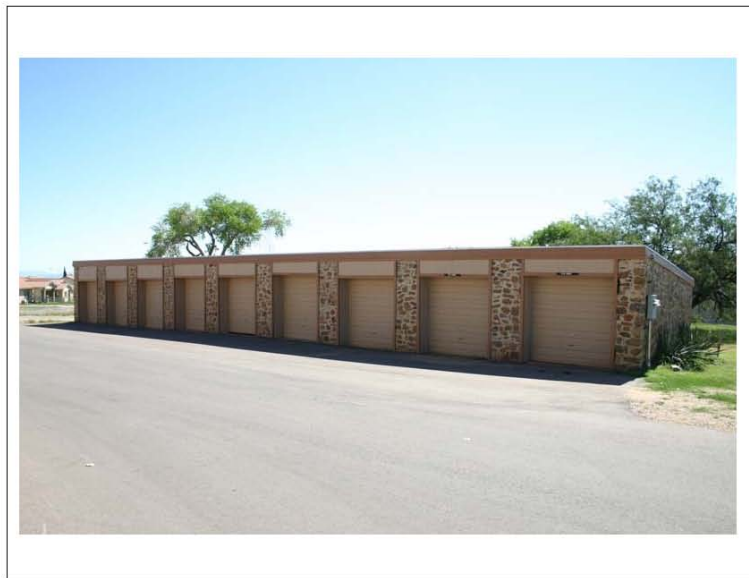
Fair *(some problems apparent)* Describe: cracked mortart along rear façade

The garage located behind Allen House retains the rubble masonry walls, but the garage doors have been updated with modern equivalents. A metal coping has been added, presumably at the same time as a new roof was added. The integrity of setting feeling and association all remain high as Allen House is still used for housing bachelor officers and the garage still houses their vehicles.

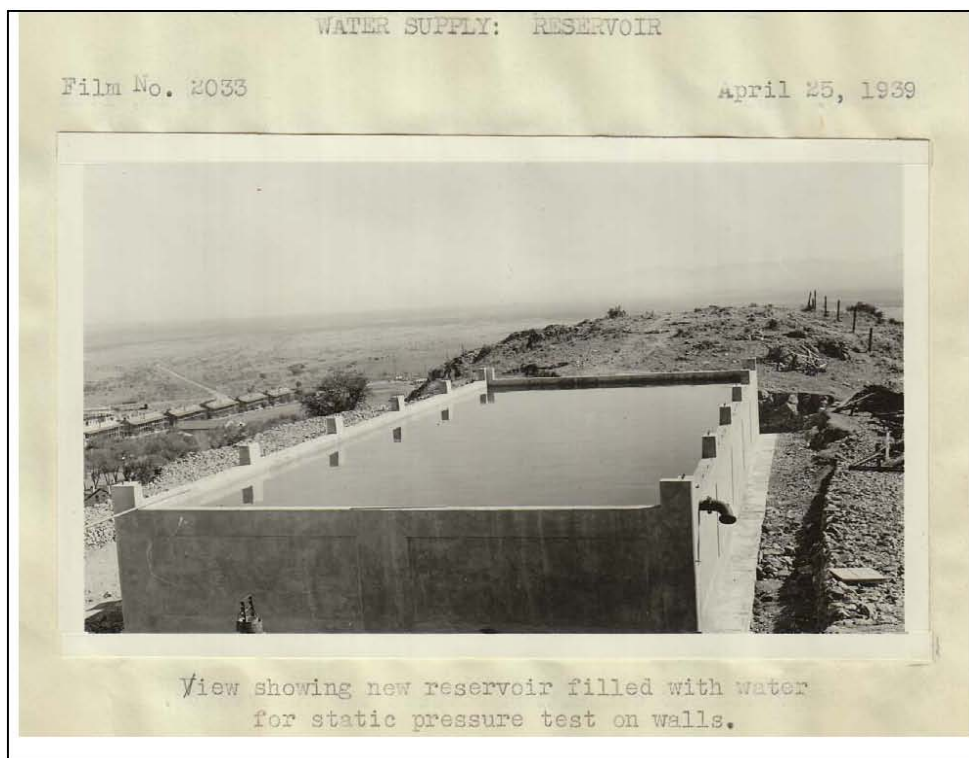
Reservoir No. 2 atop Reservoir Hill was constructed in 1939 to hold the extra water capacity being pumped by the newly drilled wells at the East Gate. The structure is built of poured concrete walls with no wall sheathing, a departure from similar WPA-CCC era structures at Huachuca. Other structures from the same period with the same bare poured concrete walls are Well Nos. 1 and 2, also utilitarian structures associated with water supply and storage at Huachuca.

Reservoir No. 2 is significant under Criterion A for its association with the WPA-CCC era at Fort Huachuca and particularly for its representation of a utility works from that era and under Criterion C for its use of poured concrete walls, one of only three structures at Huachuca from this period exhibiting such construction.

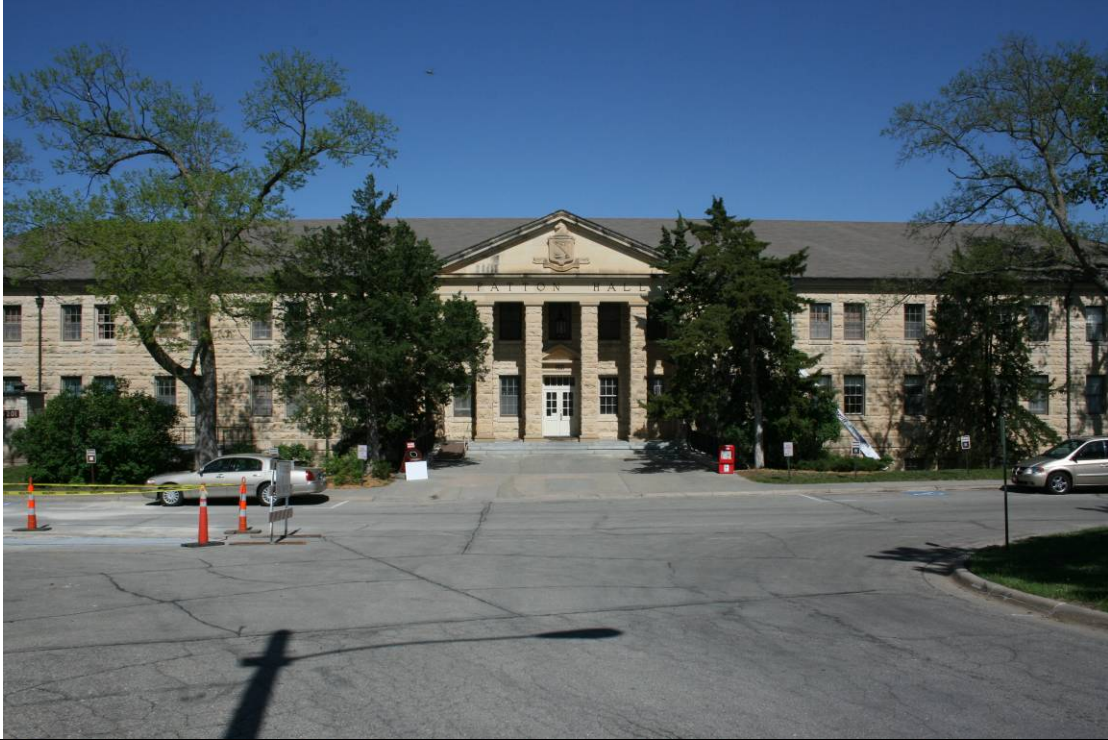
Figure 3-1. WPA-built academic building, later renamed Patton Hall.

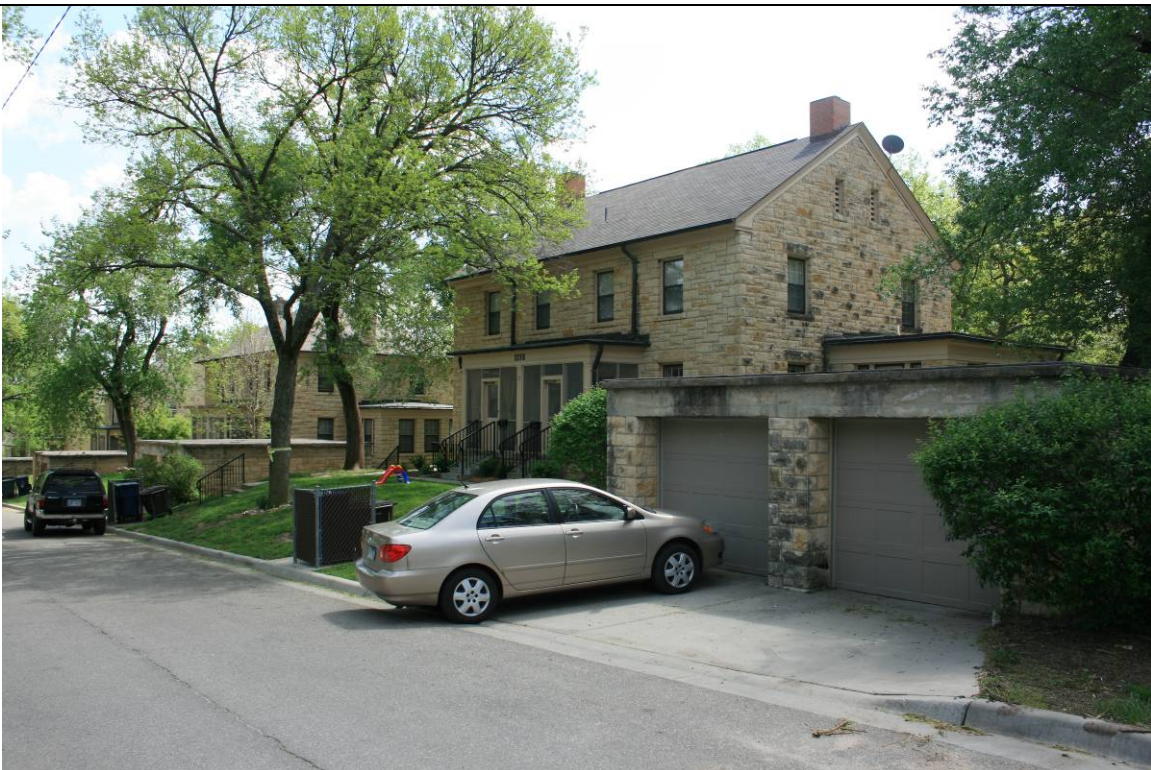
Figure 3-2. WPA-built Officers' Quarters and garages on Stone Court.

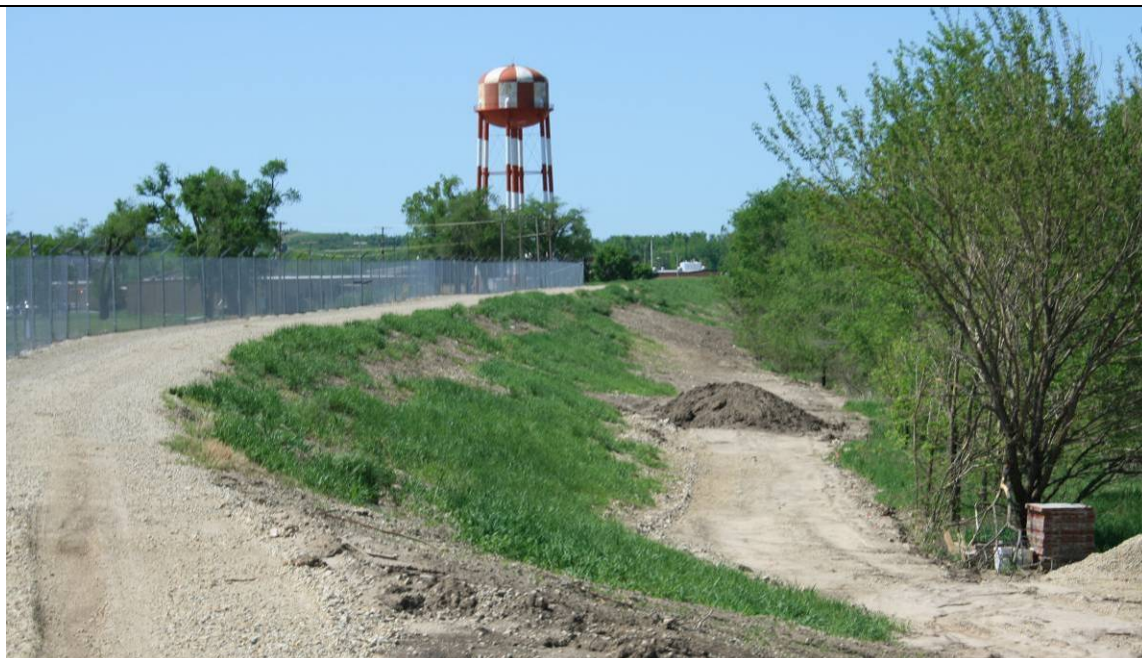
Figure 4-2: Marshall Field Levee with Marshall Field behind fence at left. Kansas river off picture to right.

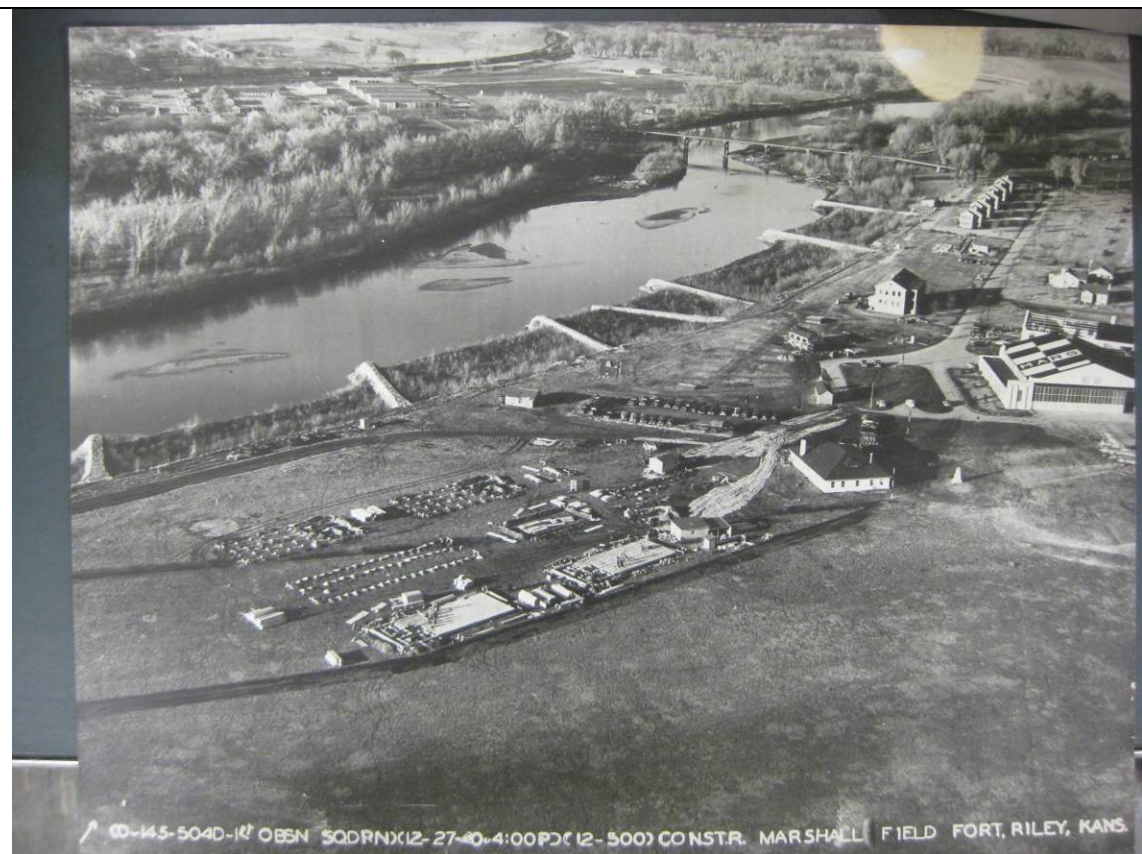
Figure 4-3: Photo of Marshall Field cantonment area showing WPA rock dikes along Kansas River, December 1940. Levee now rests along inland base of buried rock dikes. Photo courtesy of the Fort Riley Museum Archives.

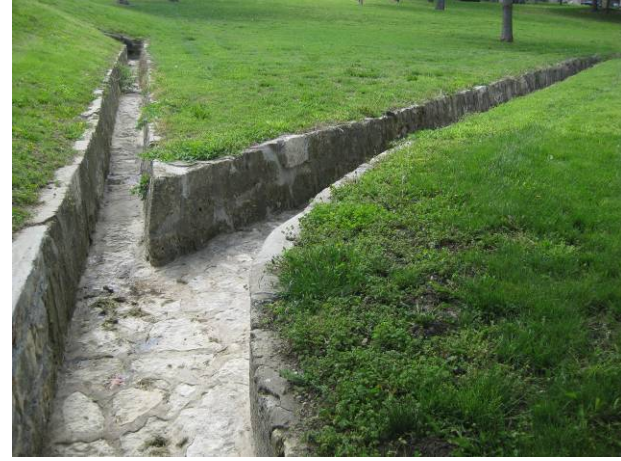
Figure 4-5: Y-junction of the rock-lined ditch. Terminus of the south arm of the ditch at upper left.

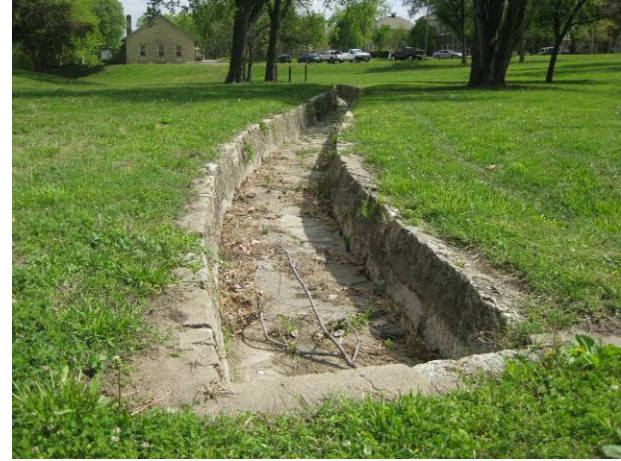
Figure 4-6: North arm of ditch. Building 430 at upper left.

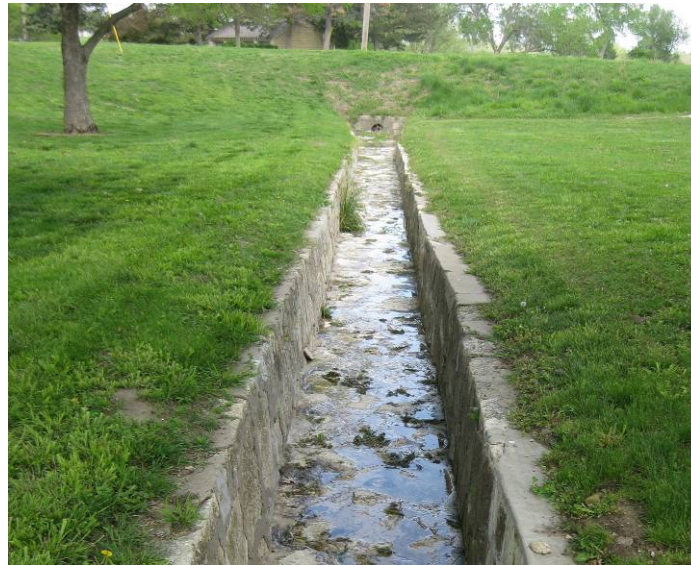
Figure 4-7: Stem of ditch which terminates in the drain under Godfrey Avenue.

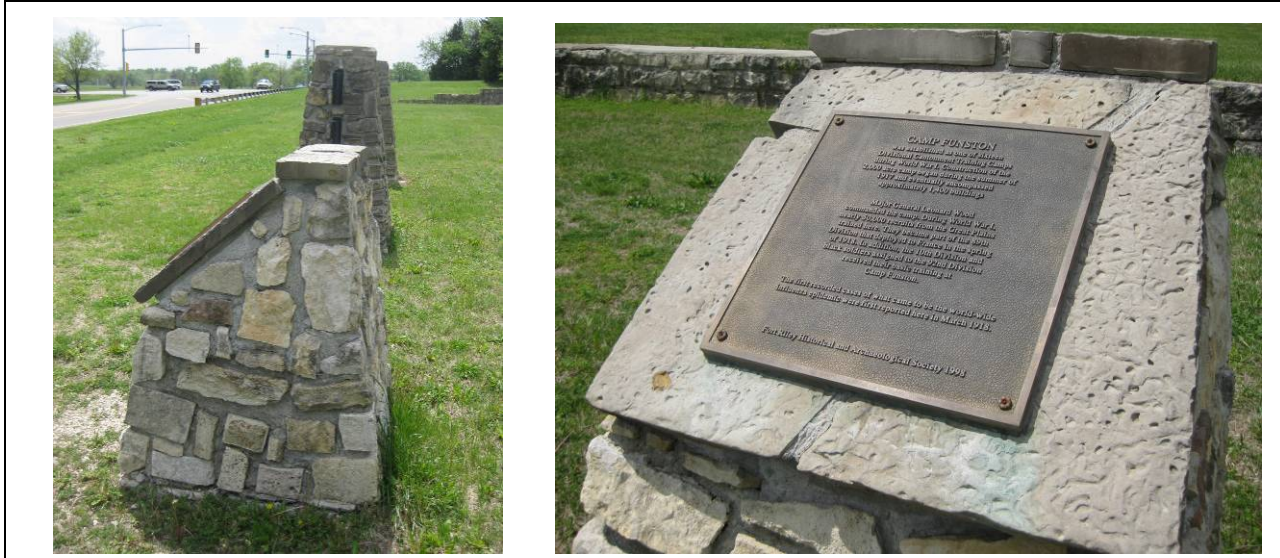
Figure 4-9: Monument and sign at General Leonard Wood Headquarters site.

Today the site consists of a sign and historical limestone marker with a brass plaque describing the history and significance of the site (Figure 4-9) surrounded by a lower curved stone terrace wall, an upper stone terrace wall, concrete stairs from the historical marker to the foundation, and the stone foundation bulk where the chimney, sidewalks, and bench are located. Both terrace walls are capped with concrete along their full length. The lower terrace wall is approximately two feet high, 200 feet long, and is oriented northeast-southwest with a short curved section at the southwest end. The concrete CCC inscription is immediately next to the curve on the straight portion of the lower terrace wall (Figure 4-10). The inscription (Figure 4-11) reads:

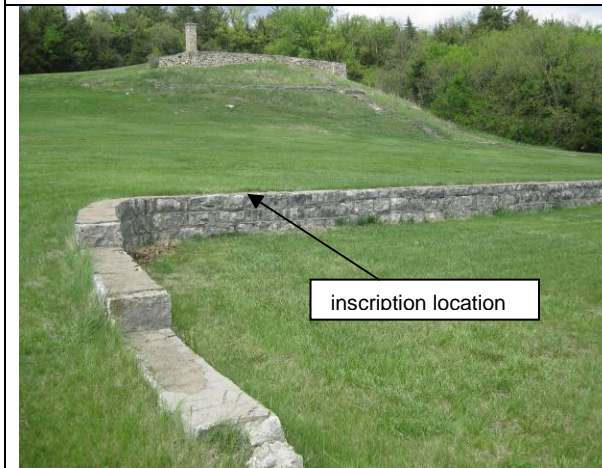
Figure 4-10: Lower terrace in foreground, upper terrace and foundation wall in background.

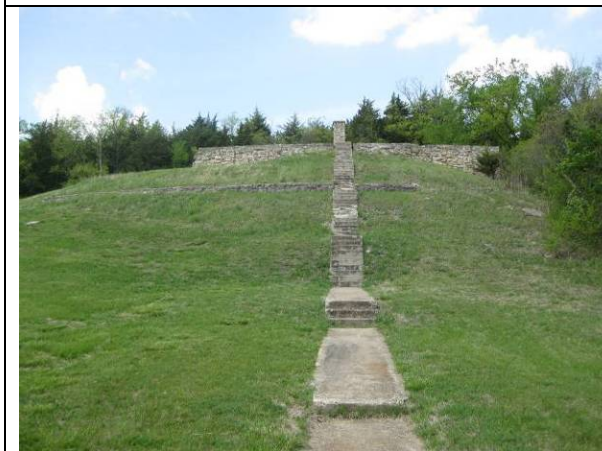
Figure 4-12: Concrete stairs to foundation. Upper terrace is visible just below foundation wall.

The upper terrace is also approximately two feet high, 90 feet long, and (Figure 4-12) parallels the lower terrace just below the foundation wall. The three-foot wide northwest-southeast trending concrete stairs begin at the lower terrace and end at the top of the foundation wall, a distance of 160 feet. The foundation platform at the top of the stairs is 65 x 60 feet, oriented northeast-southwest. The foundation wall is approximately eight feet high at its highest point at the southeast corner. Two parallel sidewalks run along the long axis of the foundation. One sidewalk continues in the center of the foundation along the path of the concrete stairs,

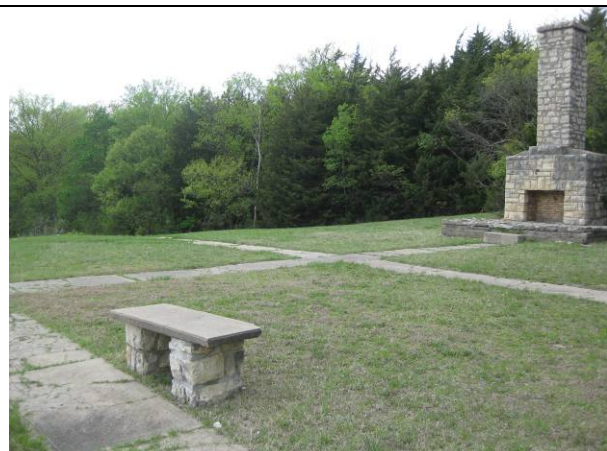
Figure 4-13: Foundation with sidewalks, bench and rebuilt fireplace/chimney.

perpendicular to the two parallel sidewalks. The limestone and concrete bench rests in the southeast quadrant of the foundation platform (Figure 4-13).
