LTPP Pavement Maintenance

Materials: SPS-4 Supplemental Joint Seal Experiment, Final Report

PUBLICATION NO. FHWA-RD-99-151

OCTOBER 1999

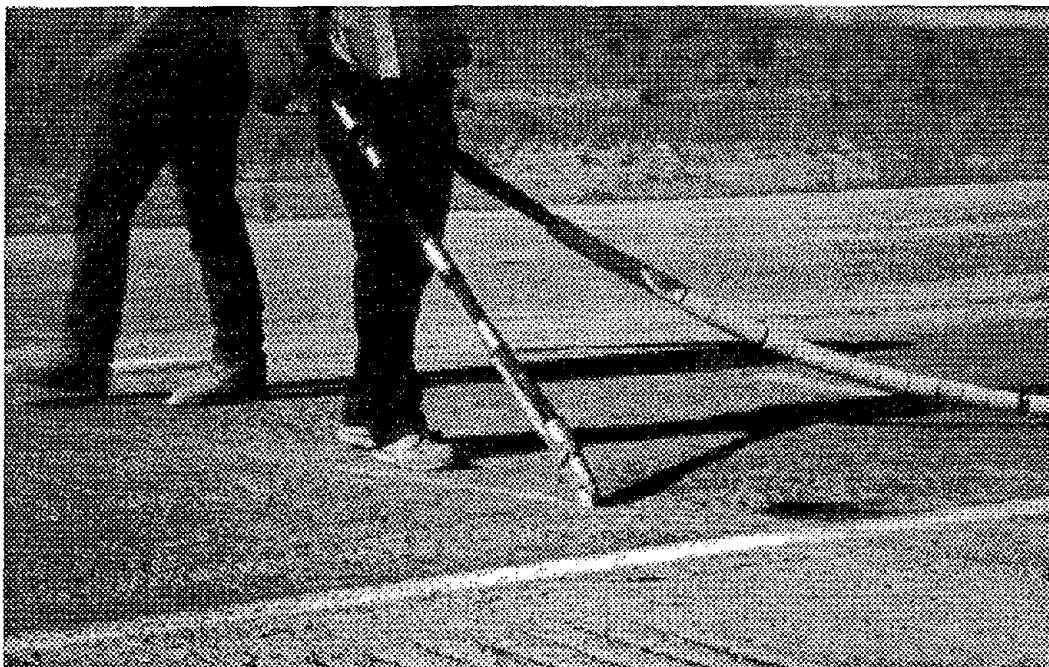
Figure 16. Sandblasting operation at Wells, Nevada test site.

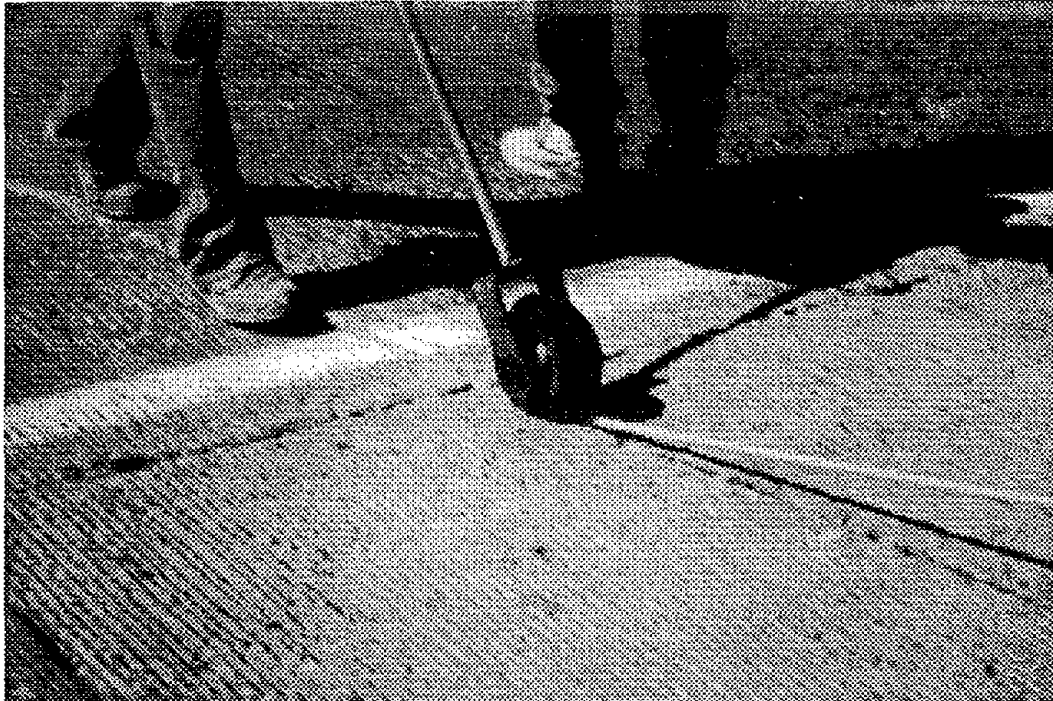
Figure 17. Backer rod placement at Campo, Colorado test site.

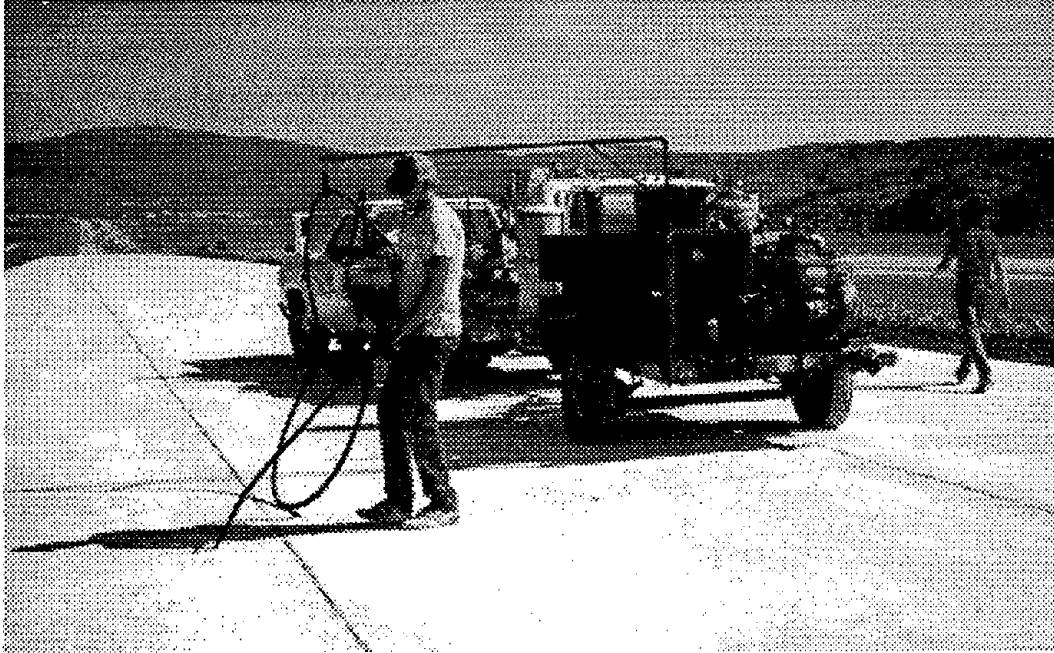
Figure 18. Hot-applied sealant installation at Heber City, Utah test site.

Experimental hot-applied sealants were heated in asphalt kettles to temperatures ranging from 123 to 210°C. To prevent burning of sealant material and to promote uniform heating, each hot-applied sealant was mechanically stirred with agitator paddles located within the heating vats of the asphalt kettles. Once the recommended melting temperature of a particular sealant was reached, the sealant was pumped through a hose-and-wand unit into the bottom of the prepared joints, as illustrated in figure 18.

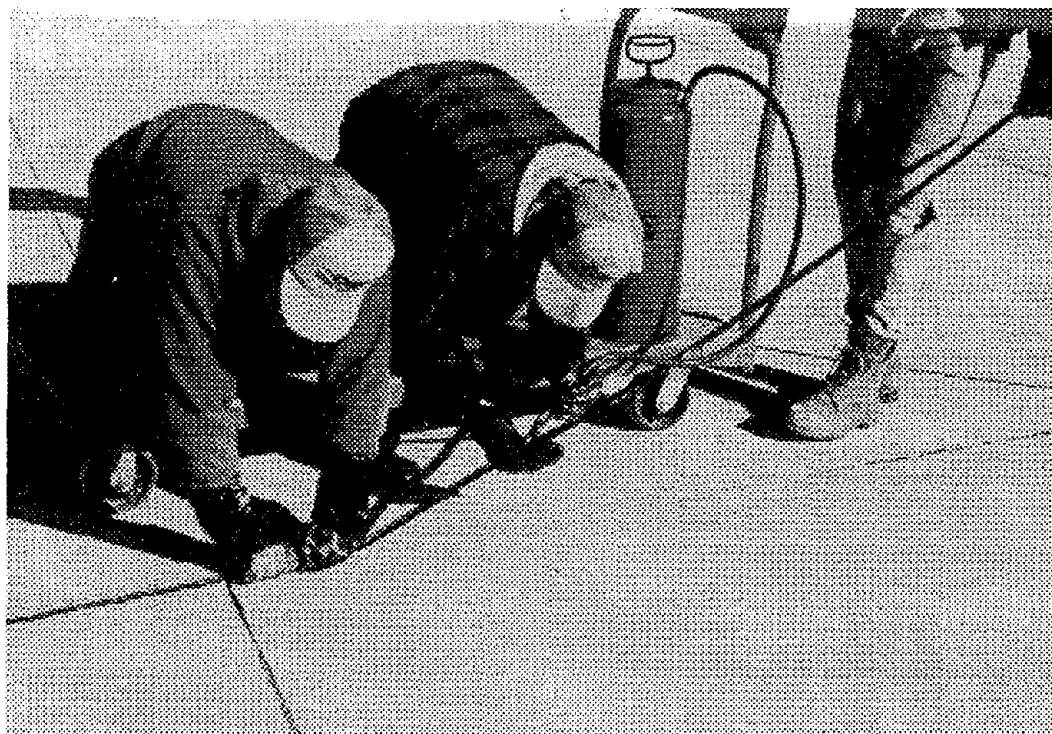
Figure 21. Manual installation of neoprene compression seal at Tremonton, Utah test site.

The Esco PV-687 seals at the Tremonton site were installed by hand, as shown in figure 21. In addition, because of an improperly functioning installation machine, the two compression seals selected for use at the Campo site were also installed by hand using putty knives. The result at the Campo site was several twisted and sunken seals, especially in the 6-mm-wide joints.

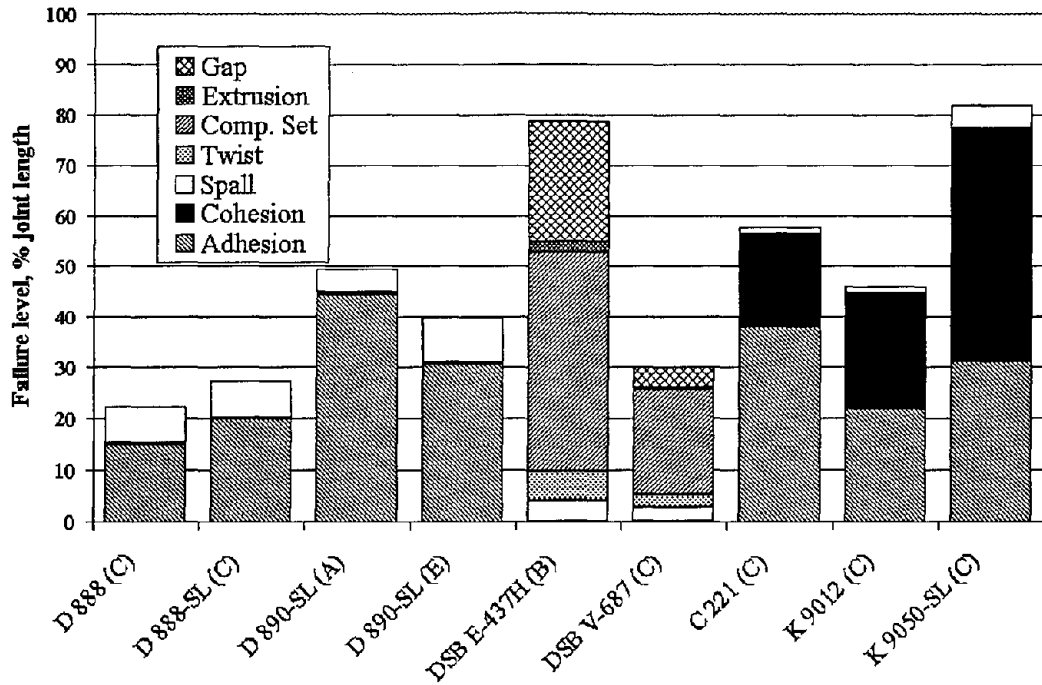
Figure 24. Overall failure of transverse joint seals at Mesa, Arizona test site.

Figure 25. Overall failure of transverse joint seals at Campo, Colorado test site.

Figure 26. Overall failure of transverse joint seals at Wells, Nevada test site.

Figure 27. Overall failure of transverse joint seals at Tremonton, Utah test site.

Figure 28. Overall failure of transverse joint seals at Salt Lake City, Utah test site.

Figure 29. Overall failure of transverse joint seals at Heber City, Utah test site.

Figures 24 through 29 show, by test site, the overall percentage of failure that each treatment exhibited at the time of the 1997-1998 field inspections. These figures also show the types and percentages of individual failure modes contributing to the overall failure percentage. As can be seen, the predominant modes of failure varied by sealant type and by test site. Generally speaking, the main mechanism of failure in hot-applied seals (e.g., Crafcro RS 221, Koch 9012) was adhesive failure, as illustrated in figure 30. Cohesive failure, which can also be seen in figure 30, was significant in some of the seals.

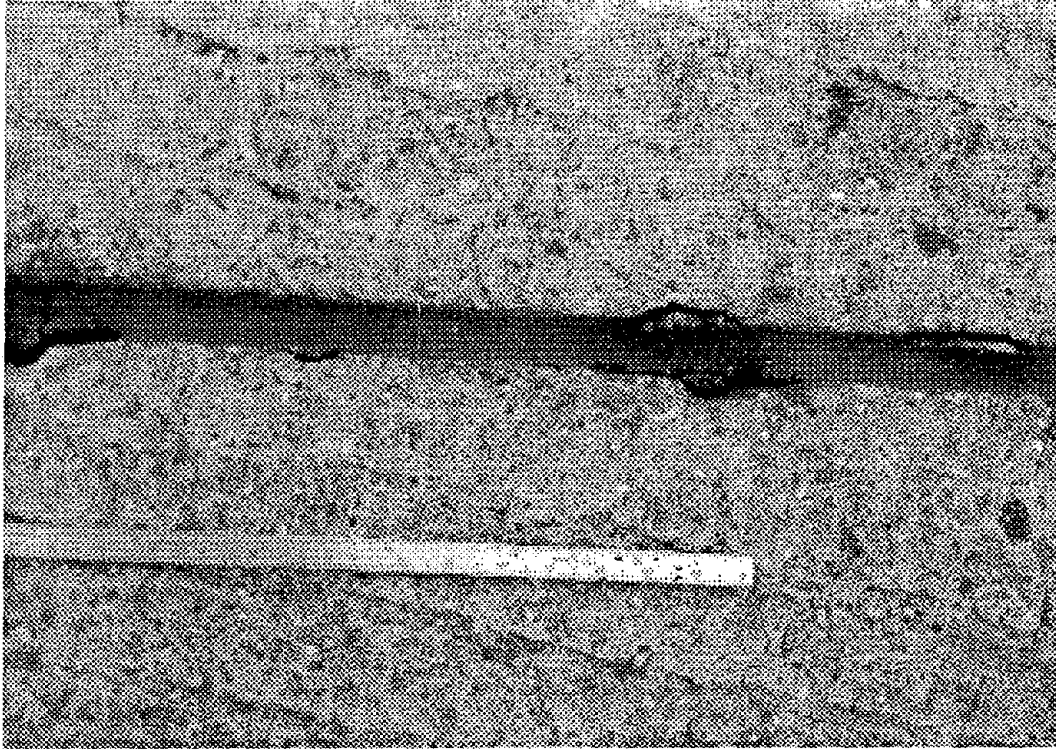
Figure 31. Spall failure in self-leveling silicone seal.

For the non-self-leveling silicone seals, the primary failure mode varied. At a majority of the sites, spall failure (figure 31) comprised most of the failure in these seals, whereas at other sites, adhesive failure was the controlling mechanism. Similar performance characteristics were observed with the self-leveling silicone sealants, except that adhesive failure was predominant at the majority of sites.

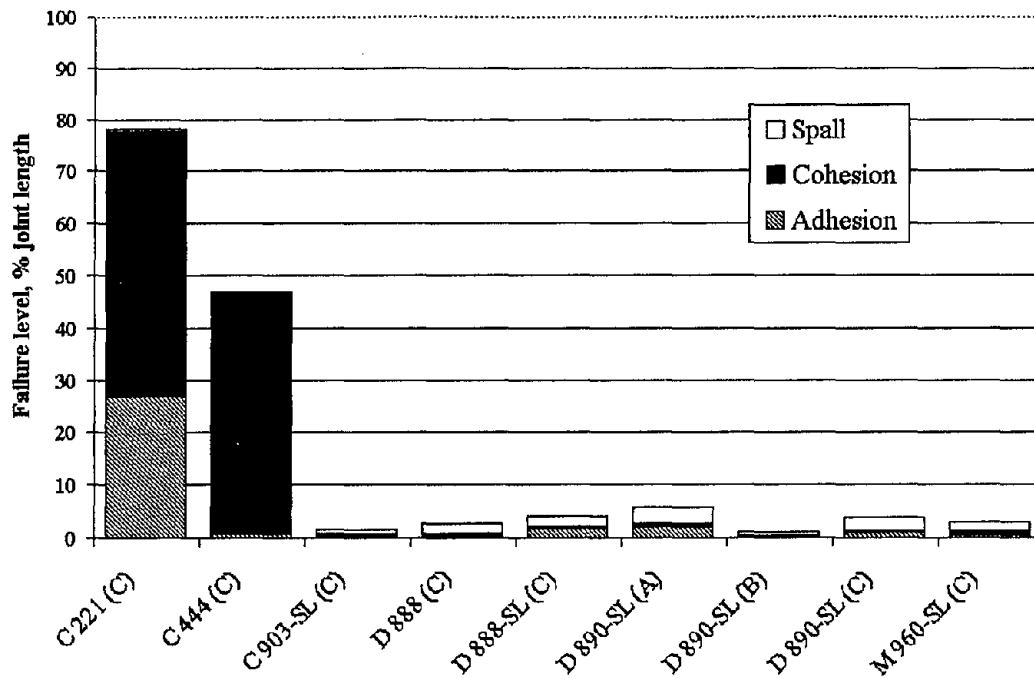
Figure 33. Overall failure of longitudinal joint seals placed at Mesa, Arizona test site.

Figure 34. Overall failure of longitudinal joint seals placed at Wells, Nevada test site.

Longitudinal joints were sealed with the same material as the transverse joints at the Mesa and Wells sites, and similar evaluations were conducted on these seals. The overall failure levels and failure mode breakdowns for each seal type placed at these two sites are displayed in figures 33 and 34. For the most part, the failure levels and modes for these seals are similar to those of the transverse joint seals. The primary exception is that the polyethylene sealant placed at the Wells site is performing significantly better in the longitudinal joints than in the transverse joints. This can probably be attributed to less joint movement at the longitudinal joint.

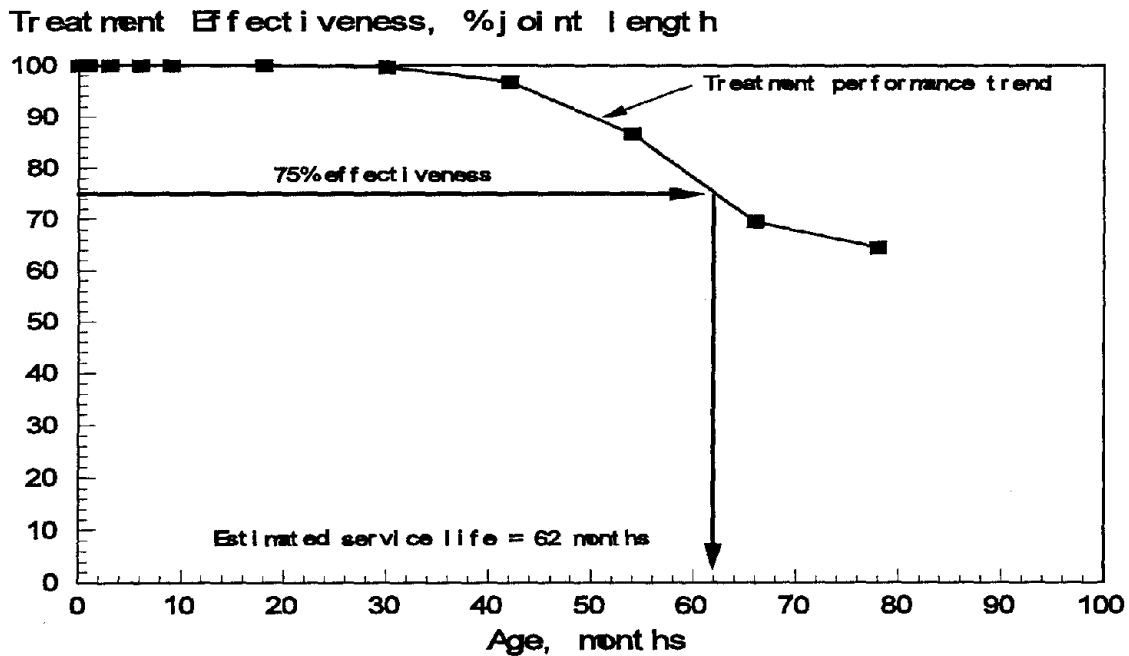
Figure 44. Illustration of service life estimation, based on 75 percent effectiveness.

To conduct a service life analysis, it was first necessary to define a minimum acceptable effectiveness level. Because of the highly varying levels of failure observed throughout the SPS-4 test sites, a value of 75 percent effectiveness was chosen for this analysis. Figure 44 illustrates the service life determination concept. In this figure, a particular joint seal treatment has exhibited varying losses in effectiveness over time. After 54 months, the treatment maintained an 88 percent effectiveness rating. However, after 66 months, the treatment dropped to a 69 percent effectiveness rating. At the level of 75 percent effectiveness, the corresponding estimated age (i.e., service life) is 62 months.
