BRIDGING THE IMJIN

**CONSTRUCTION OF LIBBY AND
TEAL BRIDGES
DURING THE KOREAN WAR
(OCTOBER 1952-JULY 1953)**

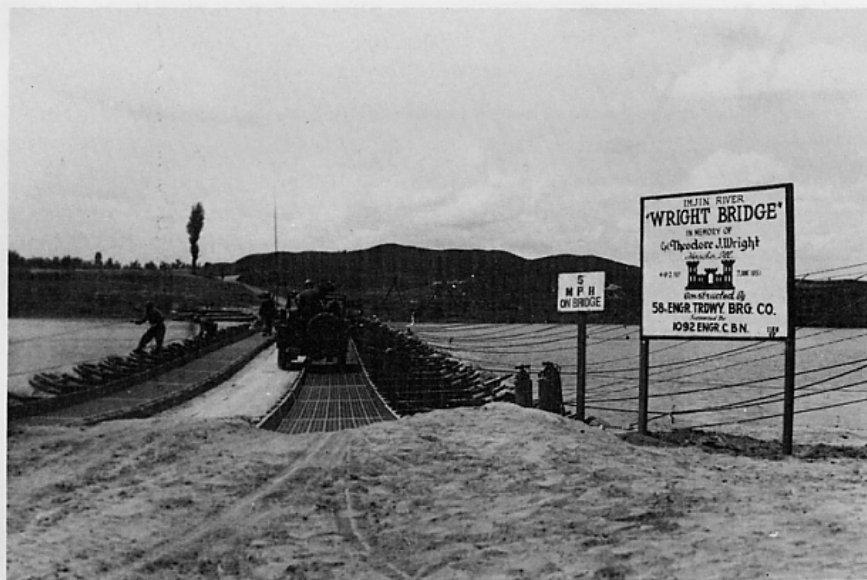
Figure 1. Jeep crossing the Corporal Wright ponton bridge on 13 June 1951.

The same company, aided by elements of I Corps' **1092d Engineer Combat Battalion**, began on 6 June to construct a **492-foot M-2** floating **treadway** bridge across the Imjin roughly $3\frac{1}{2}$ miles to the northwest. Designed to support the drive of the British 28th Independent Brigade, then attached to the 1st Cavalry Division, the bridge's ponton rafts had to be assembled one-half mile downstream from the bridge site and then towed there by amphibious trucks (**DUKWs**), utility boats, and manpower. Construction was interrupted by enemy mortar fire around dark and was not completed until early the next afternoon. It was named the Corporal Wright bridge in honor of Corporal Theodore Wright of the 58th Engineer Company, who died of wounds received during its construction.² (*Figure 1*) (*Map 2*)

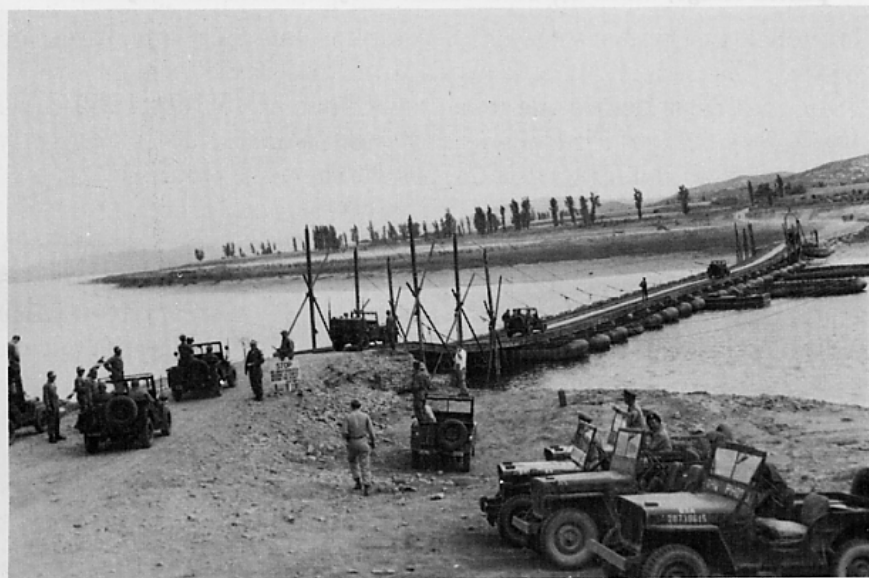
Figure 2. U.N. delegates and newsmen crossing Honker ponton bridge on 15 July 1951 en route to an early peace conference session at Kaesong.

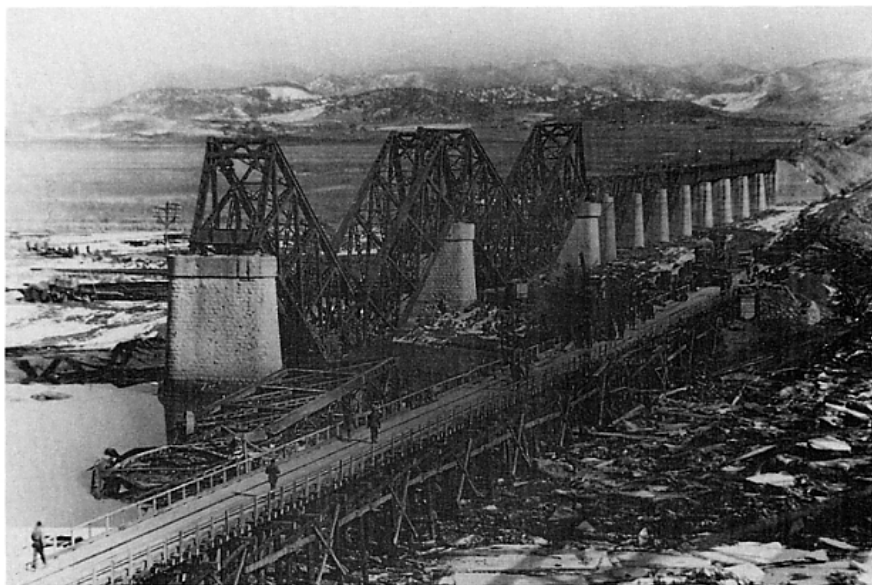
Figure 7. The low-level pile bridge at the Freedom Gate site that the 84th Engineer Construction Battalion erected in January–February 1952 between two destroyed railway spans. The shadow cast by the more southerly of the railway bridges, which the 84th would reopen in July 1952, is visible at the right of this 10 March 1952 photo.

Assigning two companies and devoting over 140,000 man-hours to this project, the battalion made rapid progress and was able to open the bridge on 15 February. (Figure 7) Six days later friendly aircraft mistakenly bombed the bridge and damaged seven bents. The 84th replaced all of the damaged bents except one which stood dangerously close to an unexploded 1,000-pound bomb that could not be removed. That area was spanned by a 36-inch I-beam supported on specially braced bents.²⁰

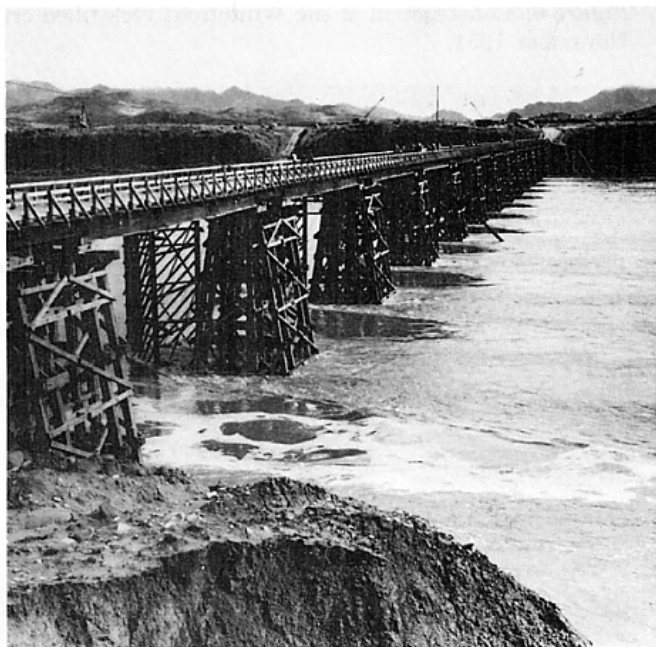
Figure 9. The high-level Pintail bridge on 27 July 1952, just three days after the 62d Engineer Construction Battalion had opened it.

The Pintail bridge progressed more slowly. Company C of the 62d poured the concrete foundations in late April and installed the steel pile and reinforcing rods in early May. The company launched the bridge's 48-inch I-beams in late May and June and poured the concrete decking in July. The bridge opened on 24 July, just days before the disastrous flood of 30 July 1952. Like the X-Ray bridge, Pintail was designed to have a 50-ton capacity as a two-way bridge or to support 80 tons one way.²⁵ (Figure 9)

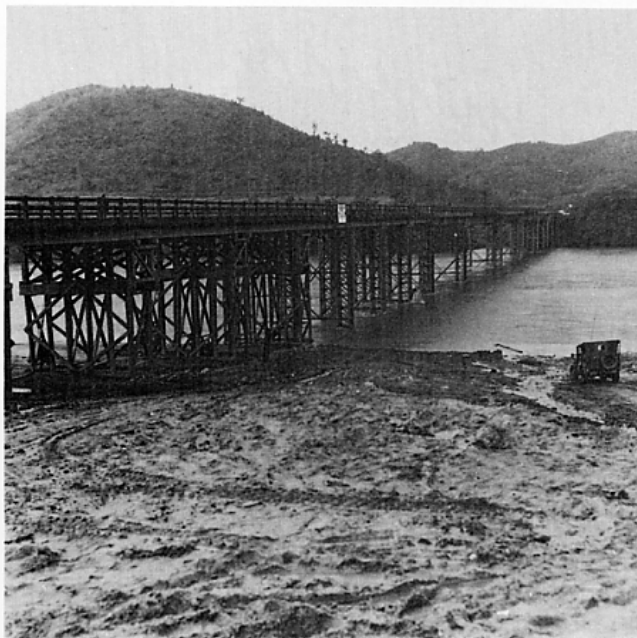
Figure 10. The high-level White-front bridge on 27 July 1952.

As the 62d began work on the new X-Ray and Pintail bridges, the 84th Engineer Construction Battalion began a high-level bridge of similar capacity at the Whitefront site. The bridge was 1,184 feet long and stood 44 feet above low water on 13 timber trestle bents supported by steel piles. (Figure 10) Timber piling was tried, but it would not penetrate adequately even when a pile shoe was used. Company B of the 84th completed the bridge by the end of May, investing 111,000 man-hours in its construction.²⁶

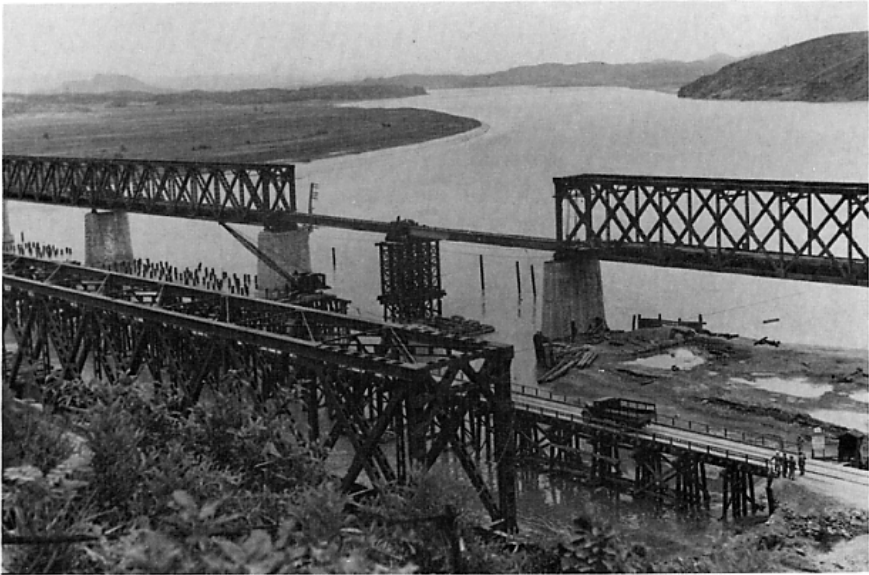
Figure 11. Construction under way to reopen the more southerly railroad bridge at the Freedom Gate site. The low-level pile bridge is visible at the right of this 9 July 1952 photo.

southerly of the two earlier railway bridges at the site. One of the concrete piers of this bridge had been destroyed, and the battalion had to replace it with a pier comprised of a wooden-pile bent cluster and prefabricated steel trestle. In addition the westernmost span had to be replaced and another span jacked and rebraced. The engineers contracted with the Korean National Railway to assist in the work. On 5 July the battalion launched a 206-foot-long, 48-inch I-beam across the new pier from one original concrete pier to another. (*Figure 11*) Completed soon after, this second high-level bridge was opened and dedicated on 17 July, just before the start of the 1952 flood season.²⁷

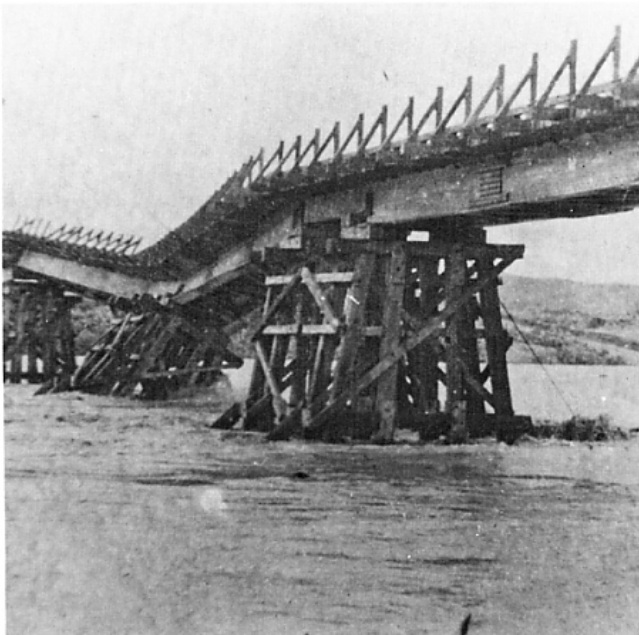
Figure 12. The high-level Teal bridge collapsing under the pressure of floodwater on 30 July 1952.

Heavy rains at the end of July raised the level of the Imjin by 13 feet on 27 July, causing the new Mallard bridge to collapse and forcing the removal of the Honker floating treadway. The rains continued for the next three days, and by 30 July the Imjin at Pintail had risen 38 feet. At noon that day, after river currents as fast as 15 to 20 feet per second had exposed the base of some of the piles supporting the Teal bridge, two of the bridge's spans washed out. Debris from Teal washed downstream to X-Ray, where it struck a bridge that had already been moved about four feet downstream by the floodwaters. Two piers of the X-Ray bridge failed at 1:30 PM. (*Figure 12*) Debris also lodged against the high-level Freedom Gate bridge near the river's mouth, leading the engineers to close it for four hours on 31 July while they removed the debris with a crane.²⁹ (*Figure 13*)

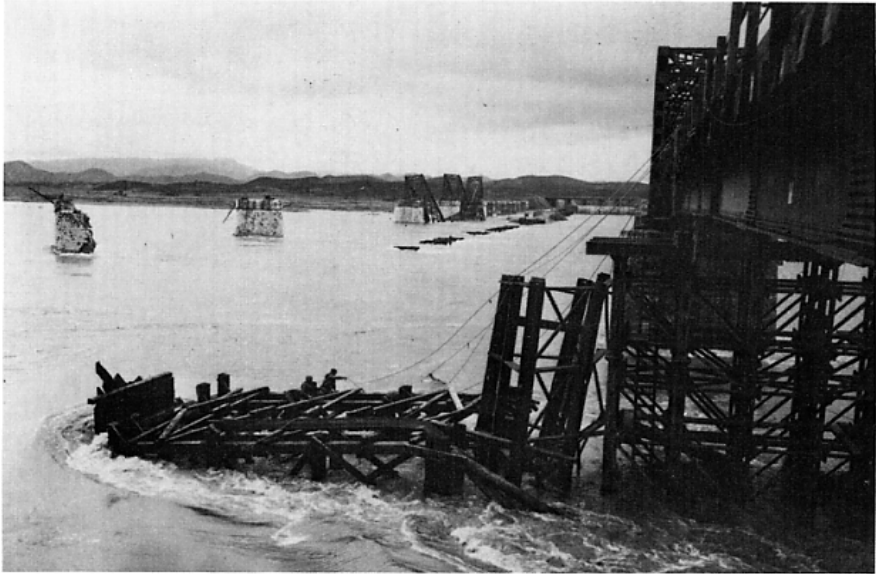
Figure 13. Pier from the collapsed high-level Teal bridge lodged against protective fender piles at the reopened span of the Freedom Gate bridge on 30 July 1952.

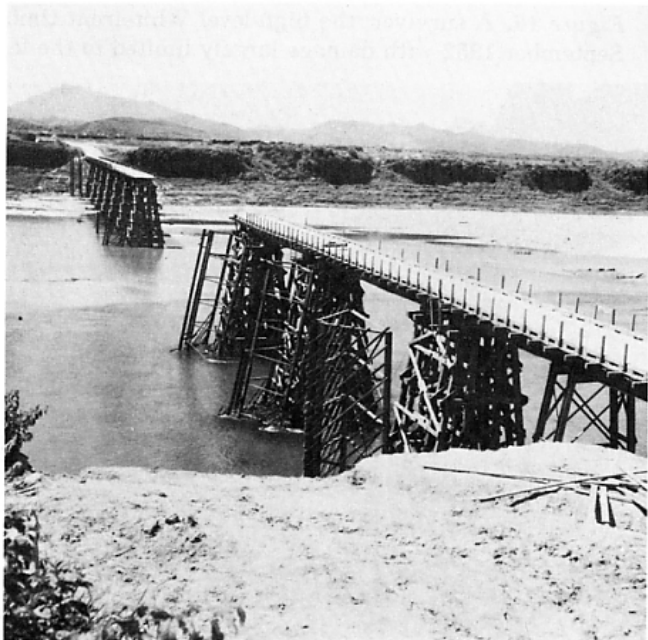
Figure 15. The high-level Teal bridge after the flood of 24-25 August 1952.

An even greater flood roared down the Imjin on 24 and 25 August, fed largely by rains that fell in North Korea. Raising the Imjin 40.5 feet in ten hours at Pintail, these waters destroyed the Widgeon bridge and swept away additional piers of the Teal and X-Ray bridges. (*Figure 15*) This was the year’s last significant flood on the Imjin. At the end of the 1952 flood season, the I Corps engineer observed with some satisfaction that three high-level bridges—at Whitefront, Pintail, and Freedom Gate—had survived the summer unscathed, and each supported a different division across the river. (*Figure 16*) But more than 16 miles separated the Freedom Gate and Pintail bridges, and this stretch of open river could have threatened the U.N. forces if the enemy had launched a serious offensive in August 1952.³¹

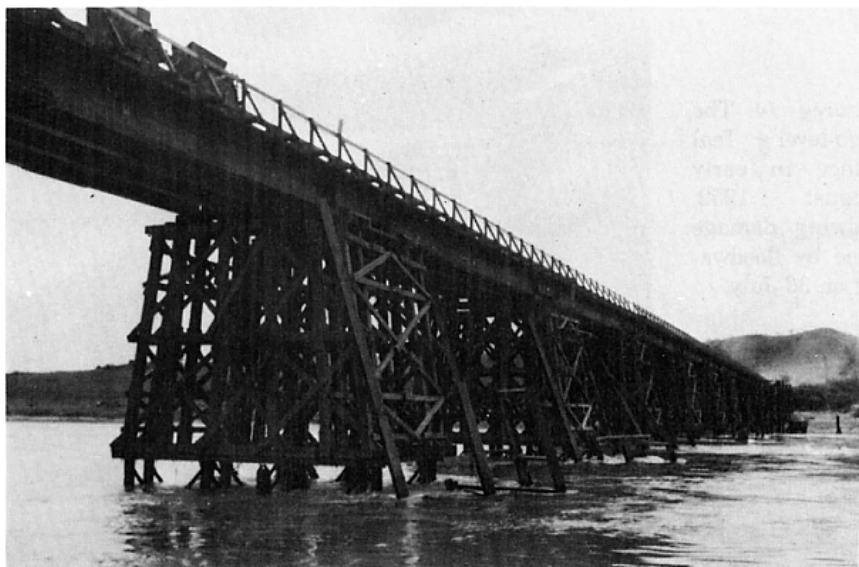
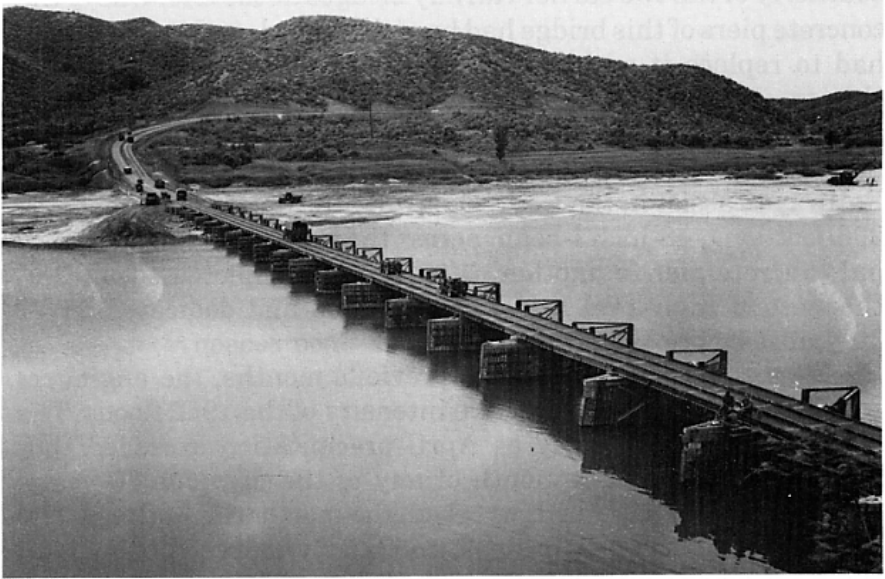
Figure 17. Spoonbill bridge on 20 June 1953.

The need for bridges in that reach of the Imjin led I Corps to install new floating treadway bridges at the X-Ray and Teal sites in September and to build a rock-crib pier bridge at the naturally defiladed Spoonbill site three miles south of the X-Ray crossing. (*Figure 17*) With its piers strengthened by piles made from railway rails, the Spoonbill bridge opened to traffic on 30 October.³² But these bridges too would be temporary, and the need to construct permanent bridges to replace the two high-level crossings that had been destroyed by the summer floods of 1952 remained. Eighth Army’s 84th Engineer Construction Battalion undertook the job, constructing a submersible, low-level bridge at the Teal site and the high-level, steel and concrete Libby bridge at the X-Ray site. Standing 49 feet above mean low water, the Libby bridge remains in use today. (*Figure 18*) The Teal bridge provided eight years of useful service before it was removed in late 1961. It was replaced the following spring by a new low-level bridge made of reinforced concrete. These superb wartime bridges were responses to a river-crossing problem that had faced the American

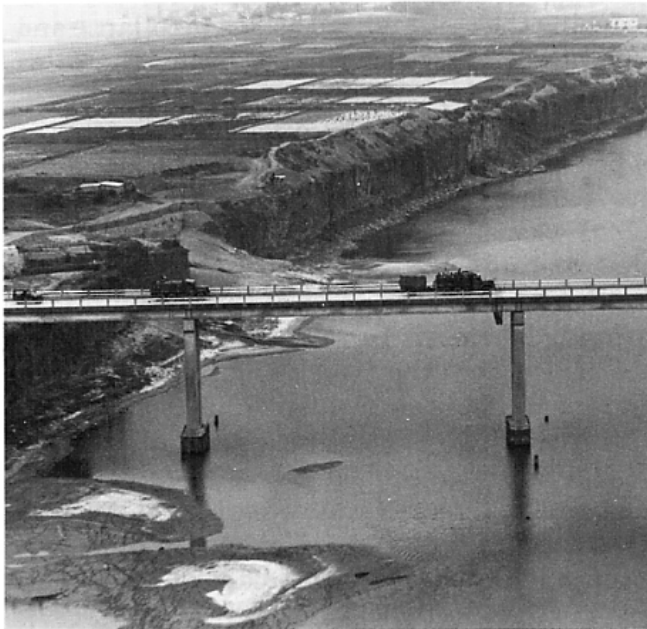
Figure 18. South Korean artillery convoy crossing Libby bridge on 23 May 1983.
