## **Appendix A – Test Screens**

## **Appendix B – Drawings**

### H.1 Quick-Look Report for PNNL Test 060321\_NO\_0405\_LP1, Test Condition BM-1, Preliminary PNNL Head Loss Test Data

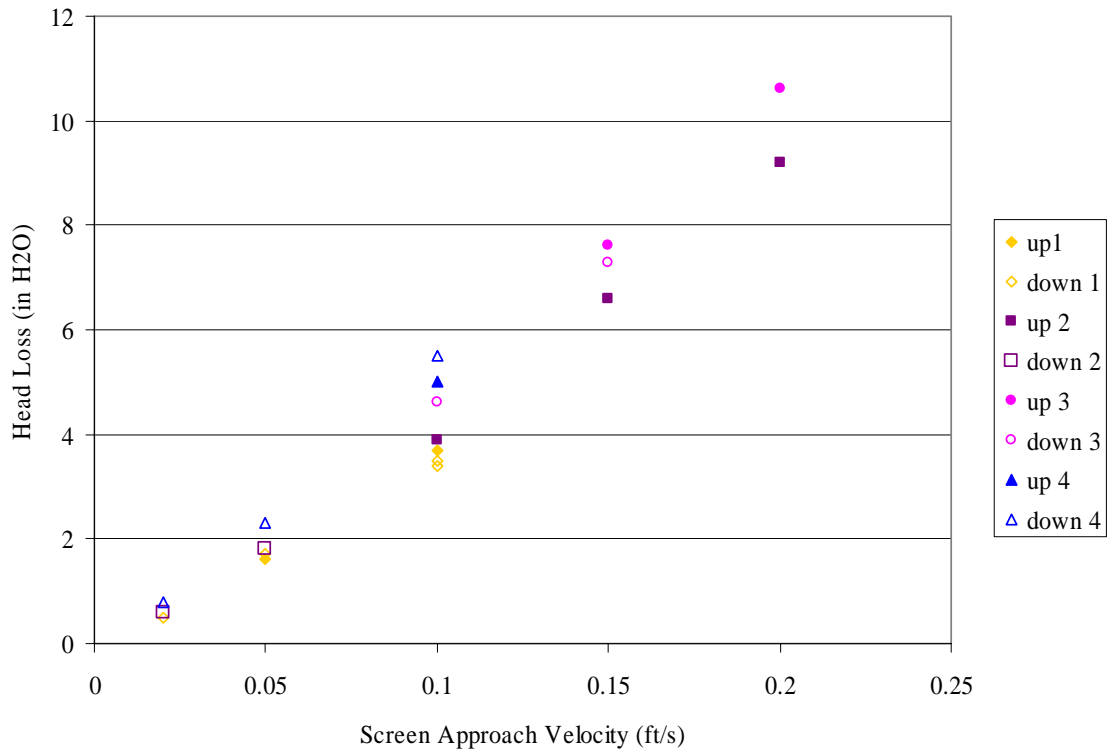
**Figure H.1.1. Preliminary PNNL Data; 060321\_NO\_0405\_LP1**

Table H.1.1 lists the test conditions. Manual debris bed height measurements are reported in Table H.1.2 and Figure H.1.1. The top of the perforated plate assembly support ring was used as the reference datum to obtain the debris bed height measurements under flow conditions. The actual top of the perforated plate is approximately 0.0625 in. below this datum. Therefore, 0.0625 in. has been added to the reported measurements. The test apparatus during testing is shown in Figure H.1.2.

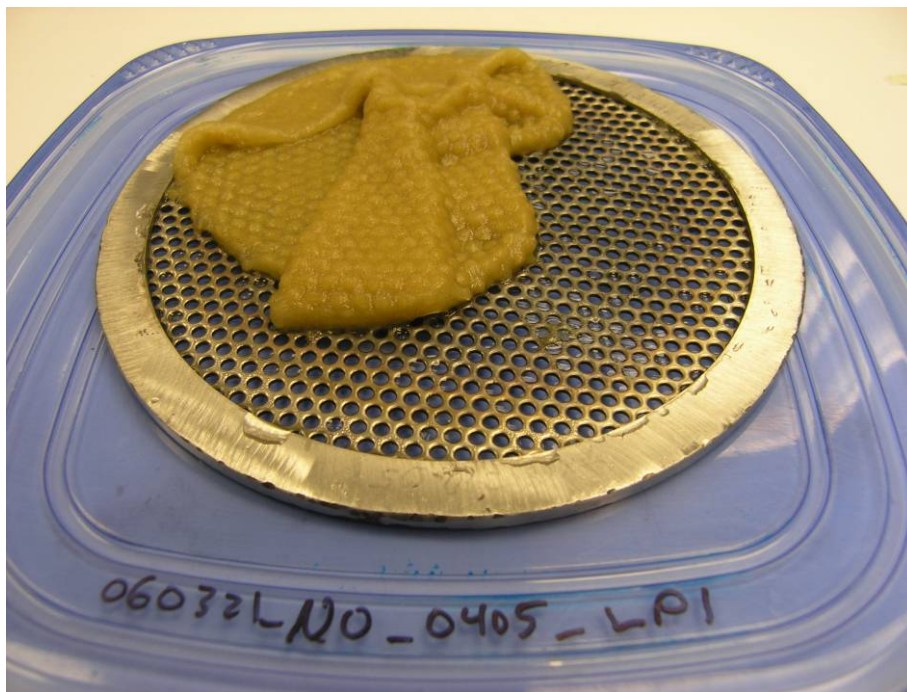
**Figure H.1.3. 060321\_NO\_0405\_LP1 Debris Bed After Retrieval. The disturbance consisted of the entire debris bed floating up under severely reduced flow conditions, flipping over and folding up, and then re-depositing on the plate once flow was increased. The debris bed was visually observed to remain essentially intact.**

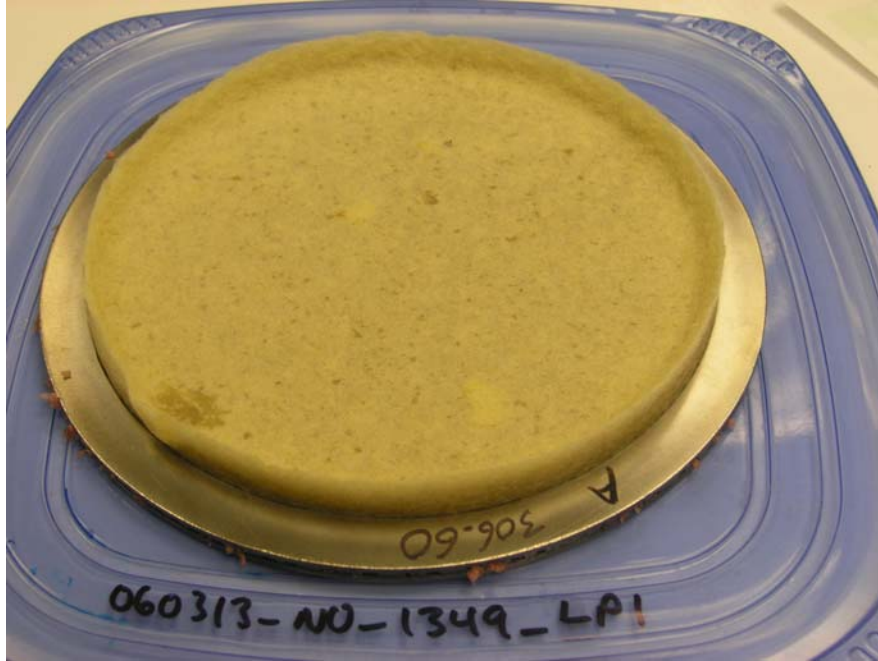
**Figure H.2.4. 060313\_NO\_1349\_LP1 Debris Bed After Retrieval from Test Section**

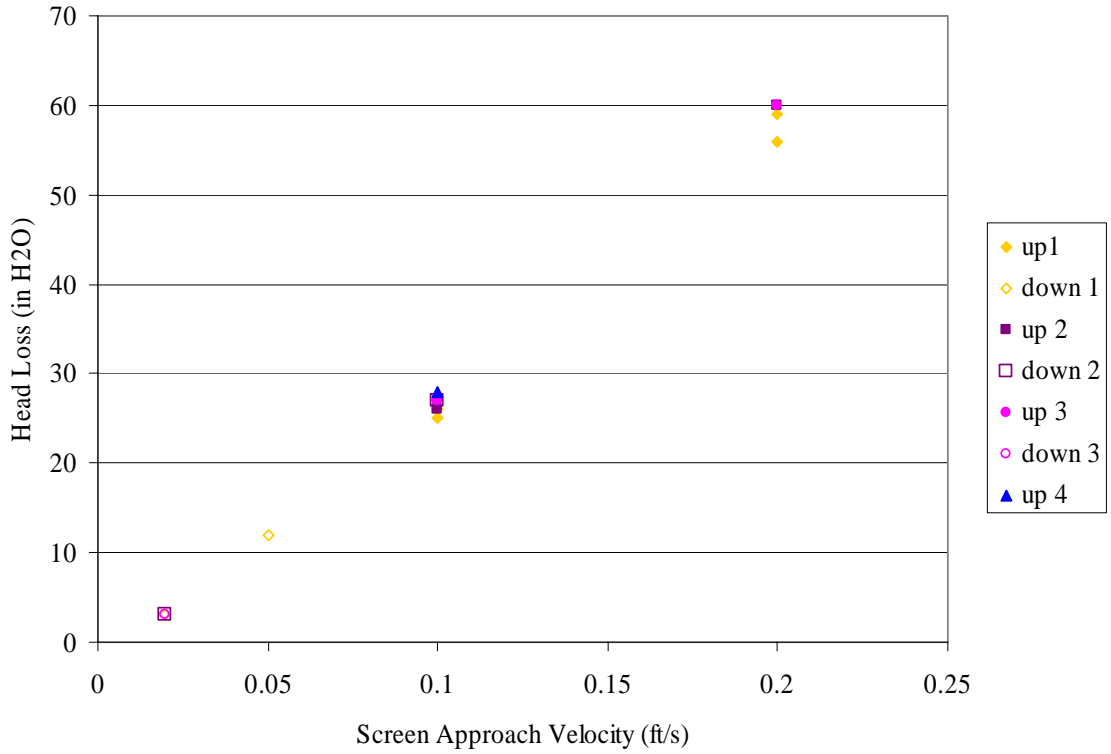
**Figure H.3.1. Preliminary PNNL Data, 060425\_NO\_2703\_LP1**

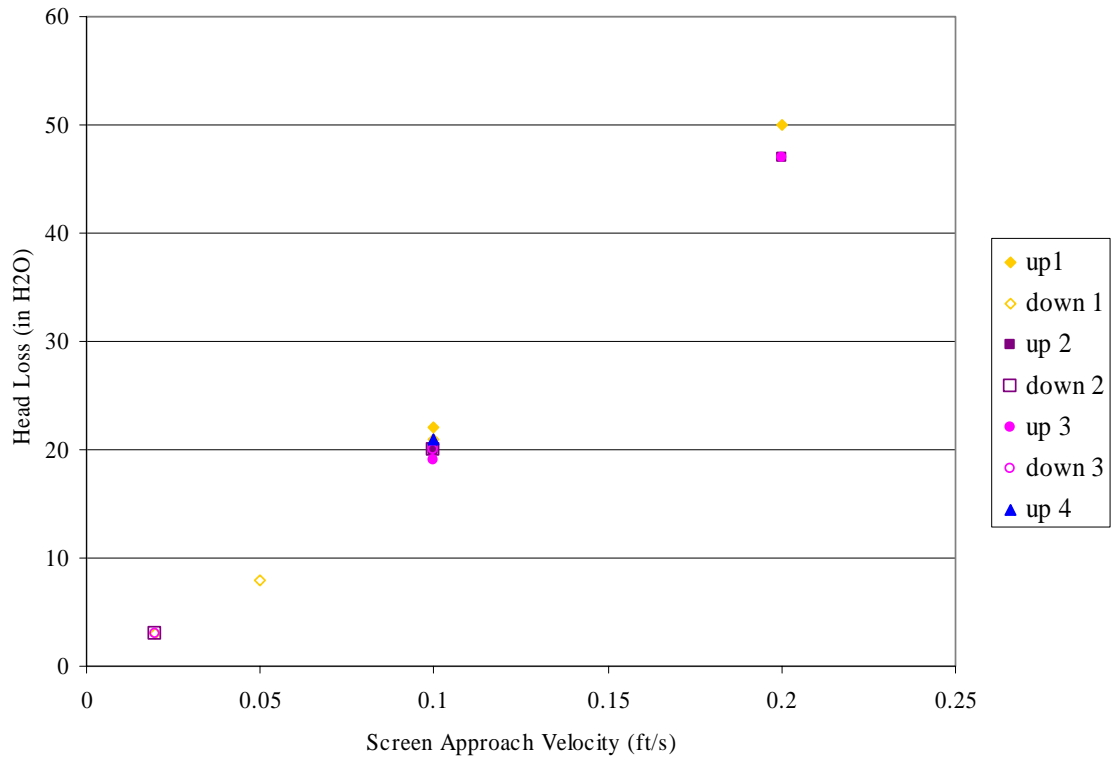
**Figure H.3.3. Preliminary PNNL Data, 060425\_NO\_2703\_LP3**

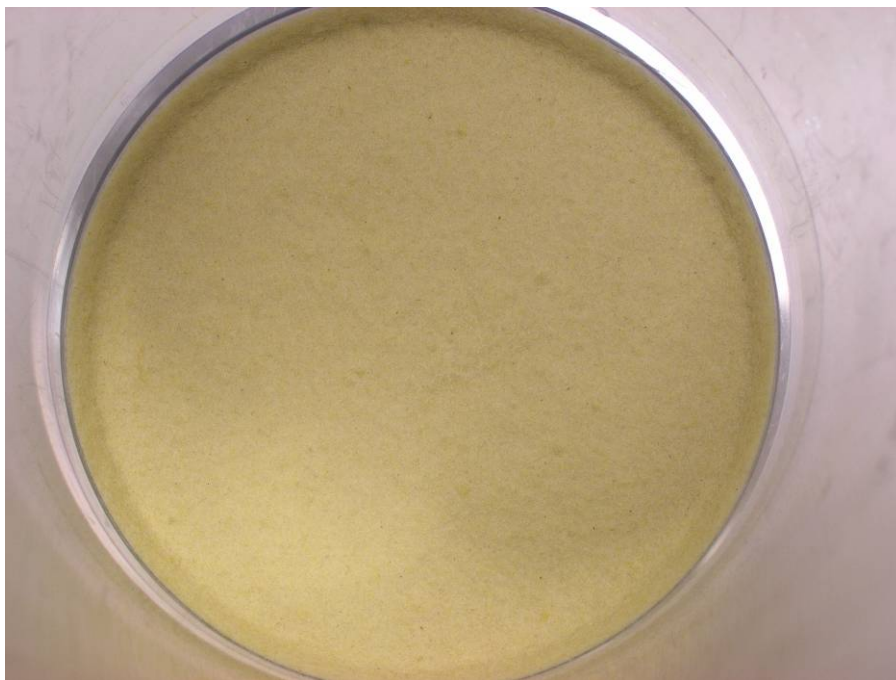
**Figure H.3.4. 060425\_NO\_2703\_LP1, LP2, LP3 Debris Bed in Test Section After Retrieval, Top View**

The debris bed formed had a raised annular ring, or rim, of material against the wall of the test section that was thicker than the body of the debris bed. During testing, the height of the rim is a direct measurement taken at the wall of the test section. The height of the body of the debris bed was estimated by visually observing and manually measuring the elevation above the screen at which a difference in the backlighting showing through the rim was observed.

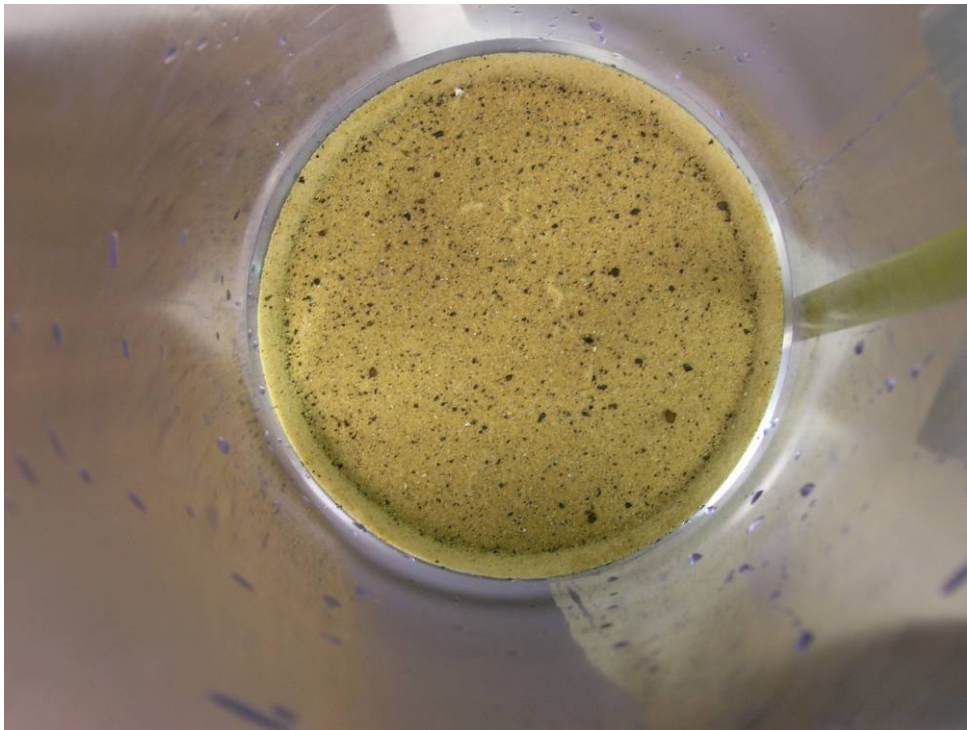
**Figure H.4.4. 051108\_NO\_3067\_L1 Debris Bed in Test Section After Retrieval, Top View**

(a) Metal/rust particulate from substitute gate valve is readily apparent on/in debris bed; see photographs, Figures H.4.4–H.4.6.

Table H.4.1 contains test conditions. Manual debris bed height measurements are reported in Table H.4.2 and Figures H.4.1. Figure H.4.2 compares preliminary data to prior benchtop results. The top of the screen assembly support ring was used as the reference datum to obtain debris bed height measurements under flow conditions. The actual top of the screen is 0.06 to 0.08 in. below this datum; thus 0.06 in. was added to the reported measurements. Figure H.4.3 shows the test setup; Figures H.4.4 through H.4.6 show the debris bed after the test.

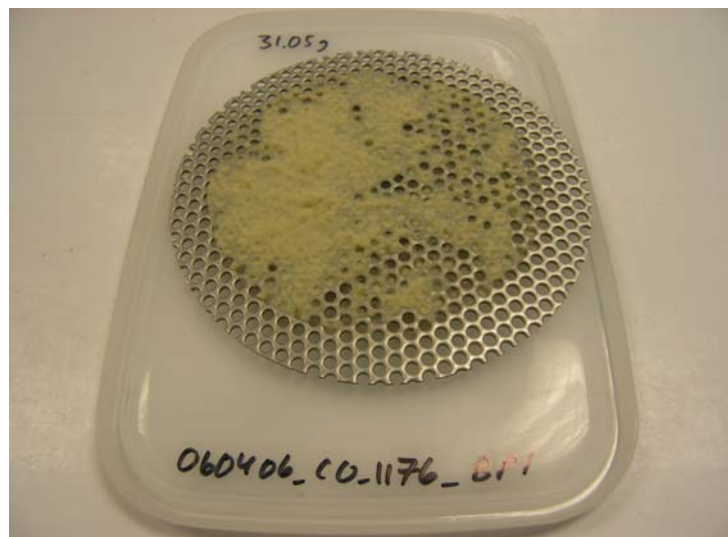
**Figure I.1.1. 060406\_CO\_1176\_BP1 Debris Bed Post-Retrieval**

For debris bed removal, the standard procedure was used. Because there was little to no head loss, the test section water may have been removed too fast (compared with completely formed minimum loading NUKON-only debris beds), and a potentially significant portion of the retained CalSil debris was observed to be flushed off the screen. The area of plate exposed due to lost debris can be described as that portion exposed on the right side of Figure I.1.1 (prior to retrieval, this screen area may have been covered) that still has some residual debris and is within the flow area. The total plate diameter is approximately 5 in., and that exposed to the flow is 4 in. With water being observed to be removed at an accelerated rate, it may be assumed that there were holes already in the debris bed before retrieval, creating relatively small restriction to flow.

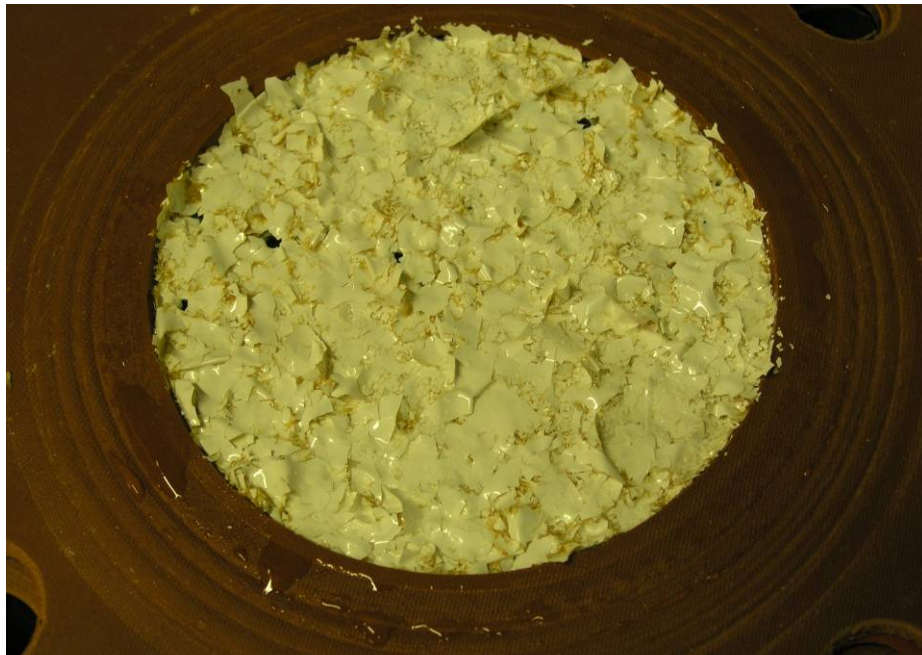
- The paint chips when wet have a tendency to adhere easily to surfaces. Therefore, when premixing constituents, 1/4-inch-square material was placed dry in a mixing container and the other slurried constituents added wet to the paint chips. For this initial test, the 1/4-inch-square material had been added to water before mixing with the processed material.

**Figure J.2.1. Paint Chip Debris Bed from Test 060428\_PQC\_1136\_BP1 before Removing Debris Bed from Test Section. The target debris loading was 1.4 kg/m<sup>2</sup> with a 1 to 1 ratio of 1/4-inch-square to processed material.**

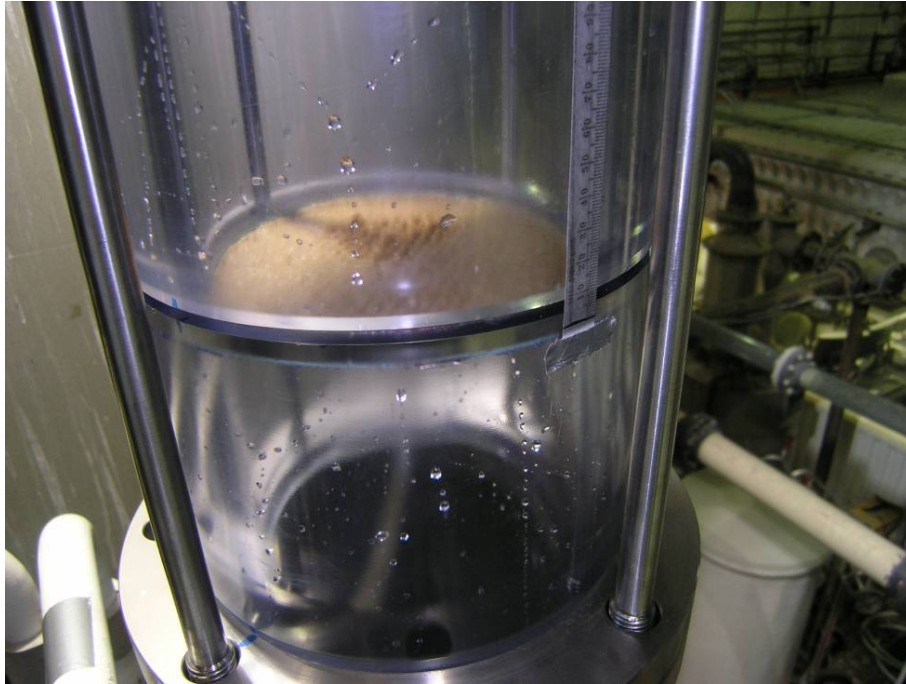
**Figure J.3.3. Ruptured 051110\_NC\_0595\_L1 Debris Bed After Draining; Rupture Caused Post-Test**

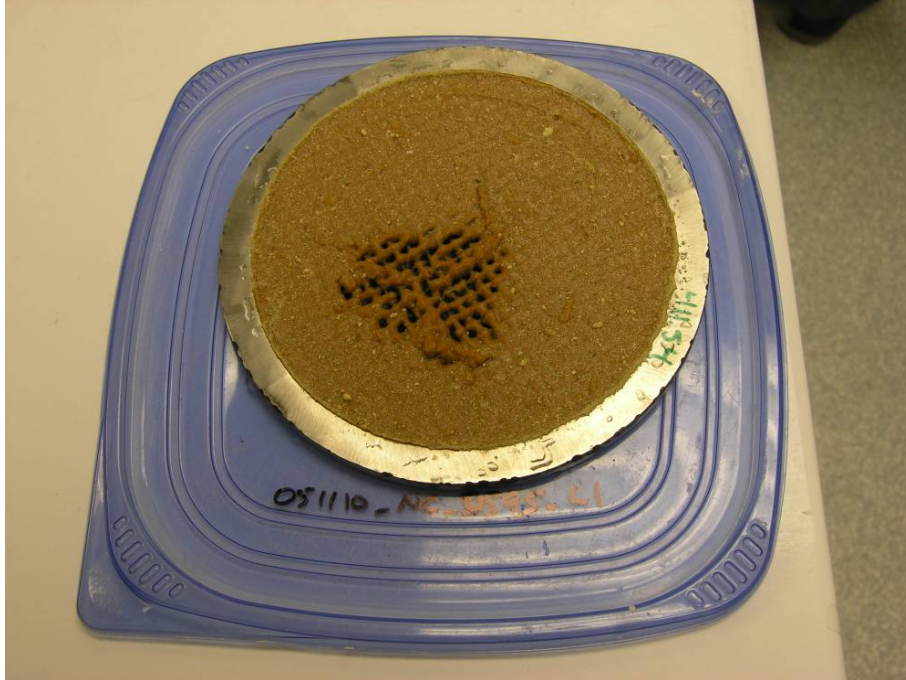
**Figure J.3.5. Ruptured 051110\_NC\_0595\_L1 Debris Bed After Retrieval from Test Section; Rupture Caused Post-Test**

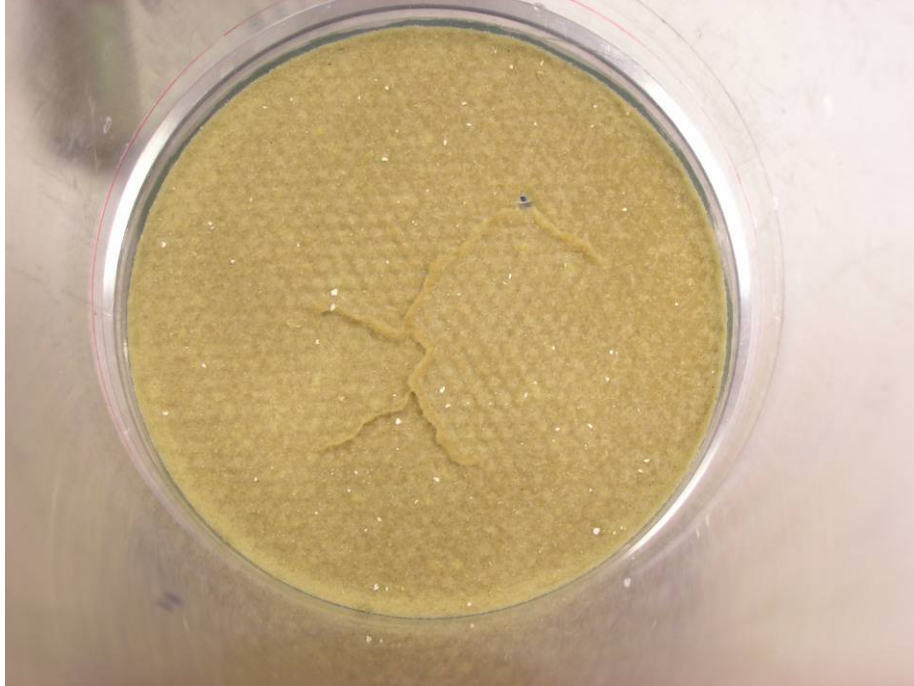
**Figure J.4.2. Debris Bed in Test Section After Retrieval, Top View; Disturbed Post-Test**

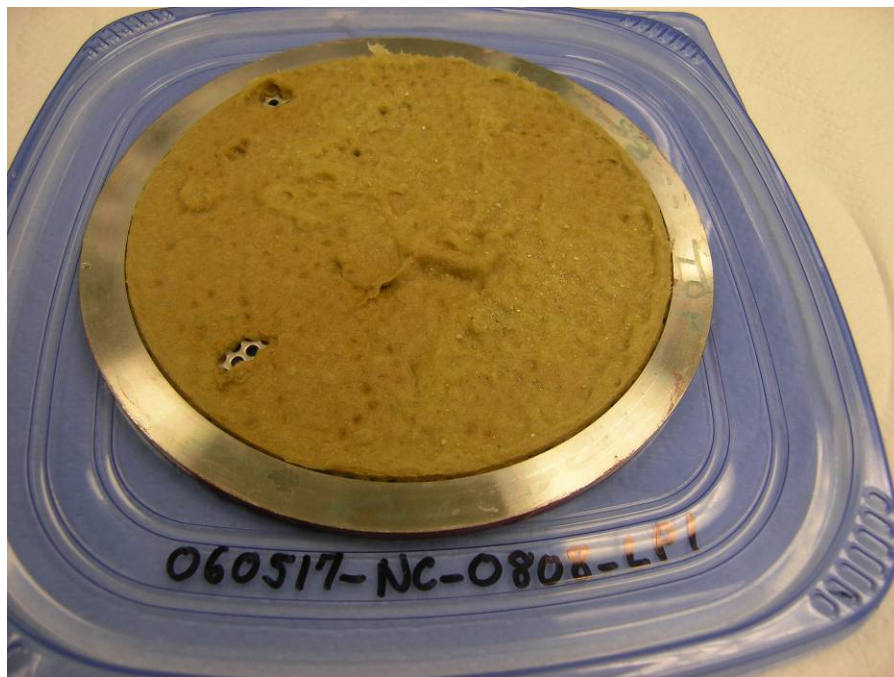
**Figure J.6.6. 060517\_NC\_0808\_LP1, LP2 Debris Bed After Retrieval from Test Section. Debris bed disturbed during retrieval (see Figure J.6.3 caption).**

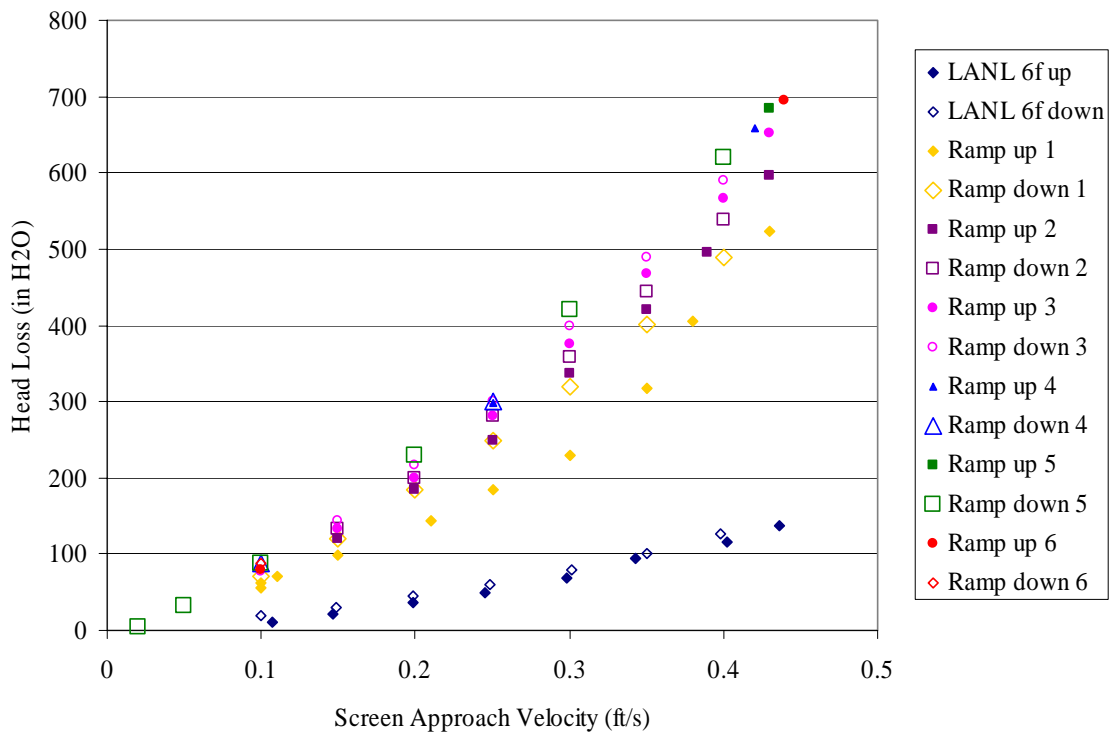
**Figure J.7.2. Comparison of Preliminary PNNL Data and Previous Results (BT denotes PNNL benchtop)**

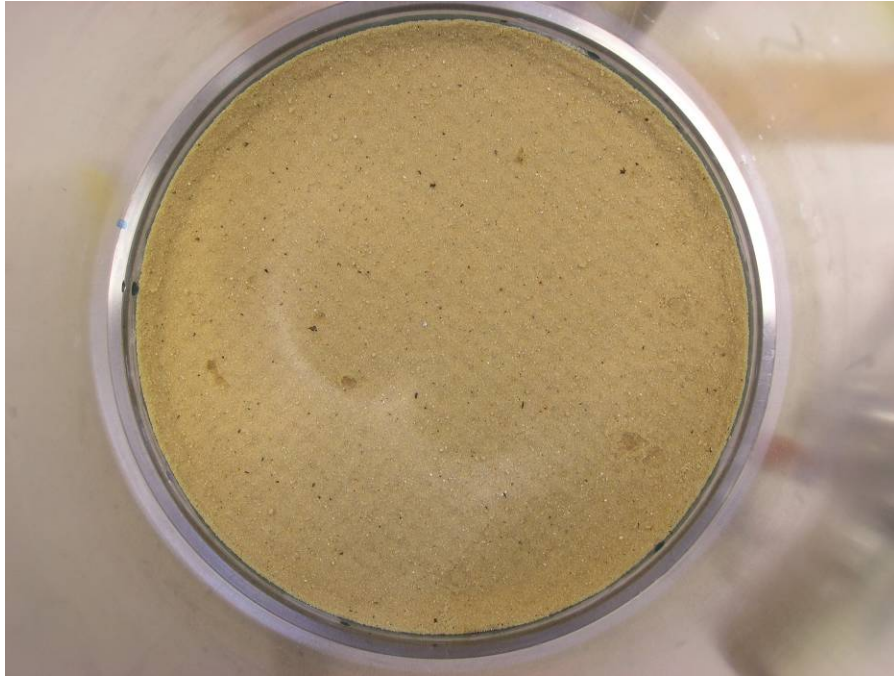
**Figure J.7.4. 051121\_NC\_1586\_L1 Debris Bed in Test Section After Retrieval, Top View. Screen pattern is observable on debris bed surface; dark pock-marks are from post-retrieval water drips.**

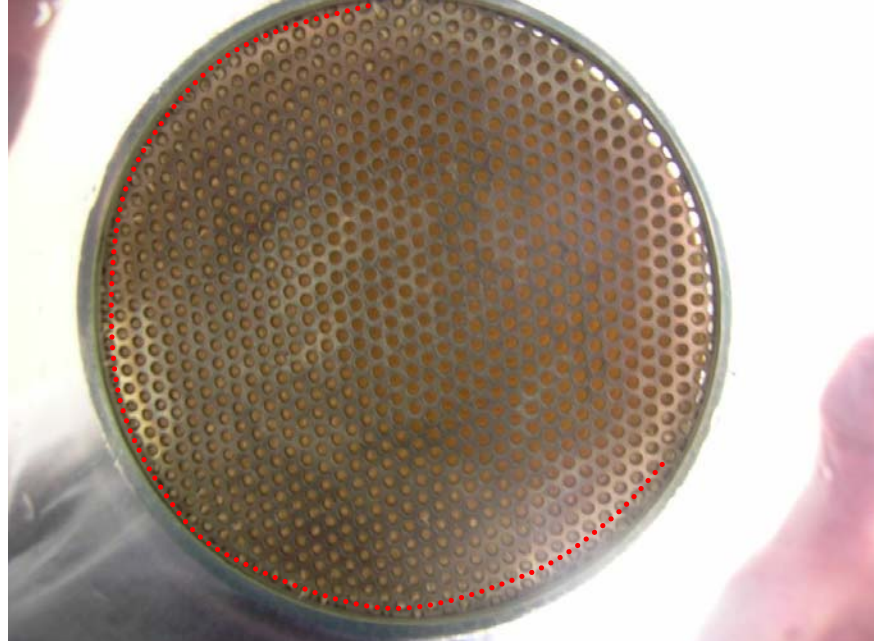
**Figure J.8.4. 060323\_NC\_1619\_LP1 Debris Bed in Test Section After Retrieval, Bottom View.** (The post-test disturbance during retrieval is postulated to have resulted from unequal cover-gas pressure around the debris bed post-draining as retrieval was conducted. This issue will be rectified for subsequent tests. The postulated higher pressure under the debris bed resulted in an uplifting of a region of the debris bed. The region affected is visually observable by the open perforations from the 1:00 to 3:30 orientation at the debris bed edge. Roughly enclosed by the dashed red line is the area where the debris was visually observed to not protrude into the perforations of the plate. Refer to Quick Look Report BM-1, Photo 2, to observe evidence of how the debris material apparently protrudes into the perforations.)

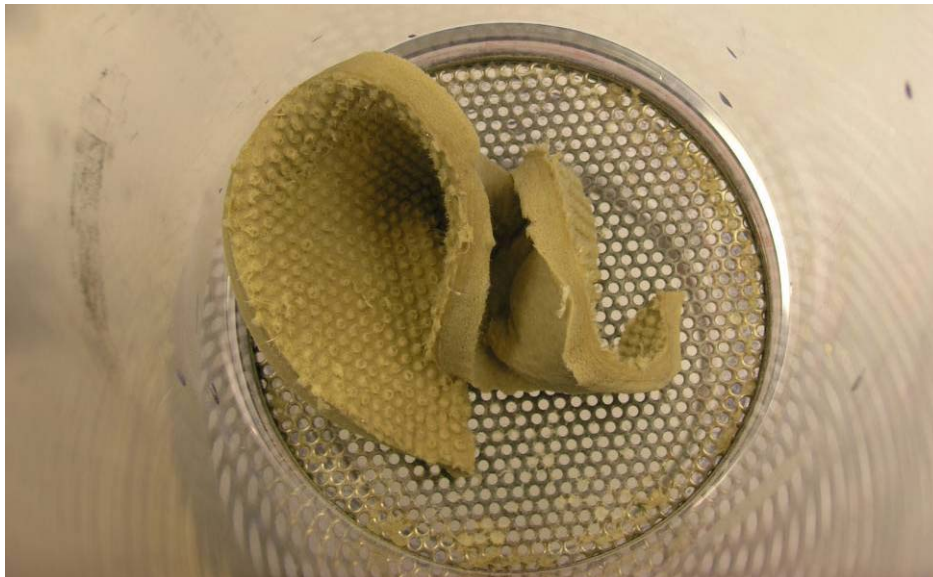
**Figure J.10.4. 060404\_NC\_2698\_LP1 Debris Bed in Test Section After Retrieval, Top View. The disturbance resulted from unequal cover-gas pressure around the debris bed post-draining. After test BM-3, a vent was added below the debris bed to allow the test loop to be drained and gas pressure equalized without rupture (Figure J.10.3), even with the relative impermeability of the debris bed. The impermeability resulted in water being held above and an air void below. While removing the water, a portion of the test loop below the debris bed was isolated while under pressure. Subsequent opening of this portion of the test loop before removing the debris bed resulted in the rupture. Test procedures will be modified to prevent reoccurrence.**

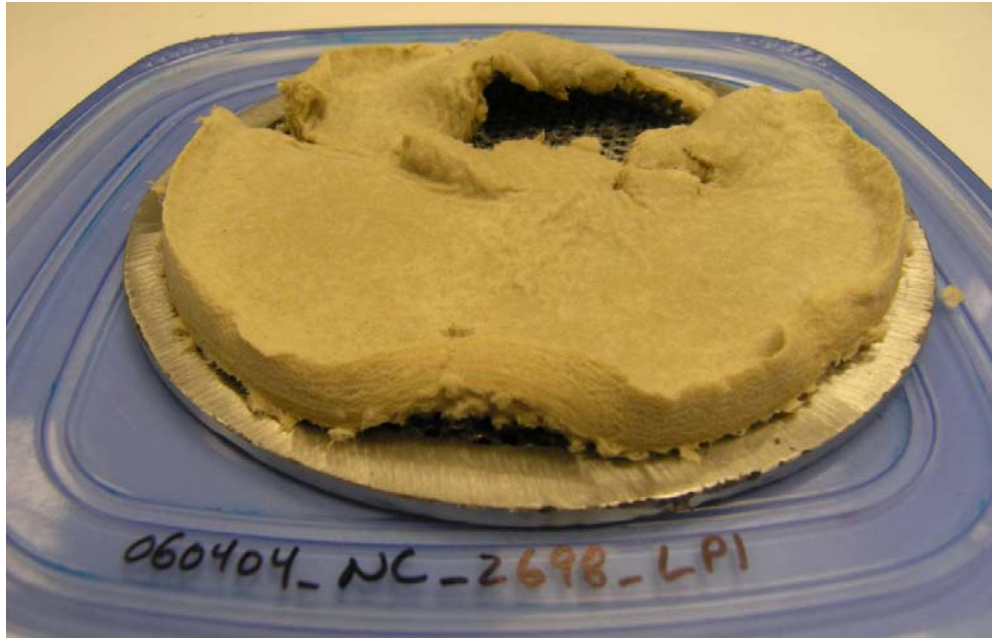
**Figure J.10.5. 060404\_NC\_2698\_LP1 Debris Bed After Retrieval from Test Section (laid flat after rupture of Figure J.29)**

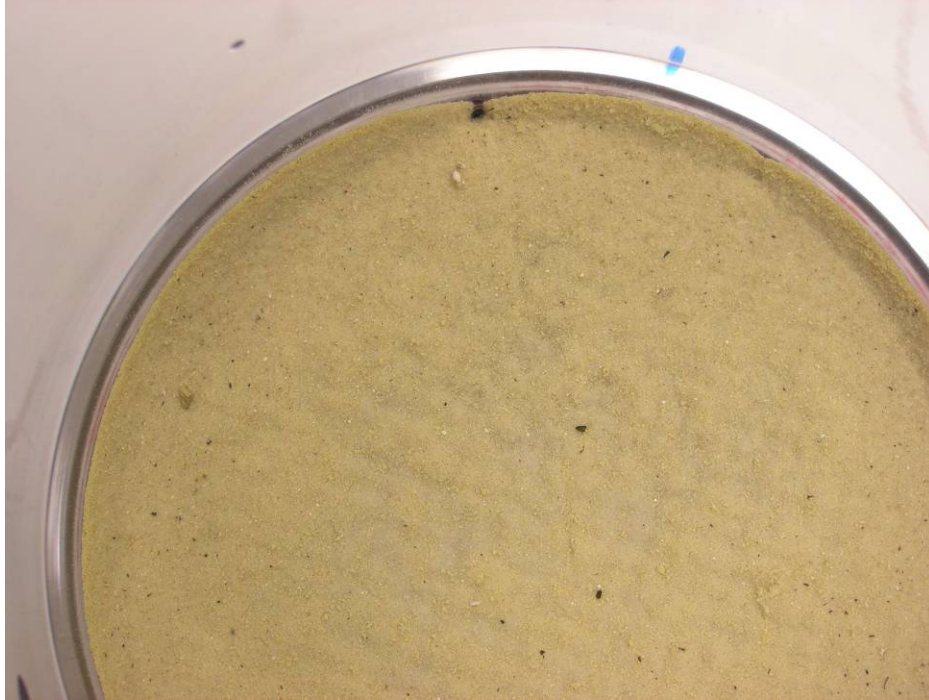
**Figure J.11.5. Close-Up of 051123\_NC\_2181\_L1 Debris Bed in Test Section After Retrieval, Top View. Screen pattern is observable on debris bed surface; flow channels are observable at 11:45 and 1:30 orientations.**

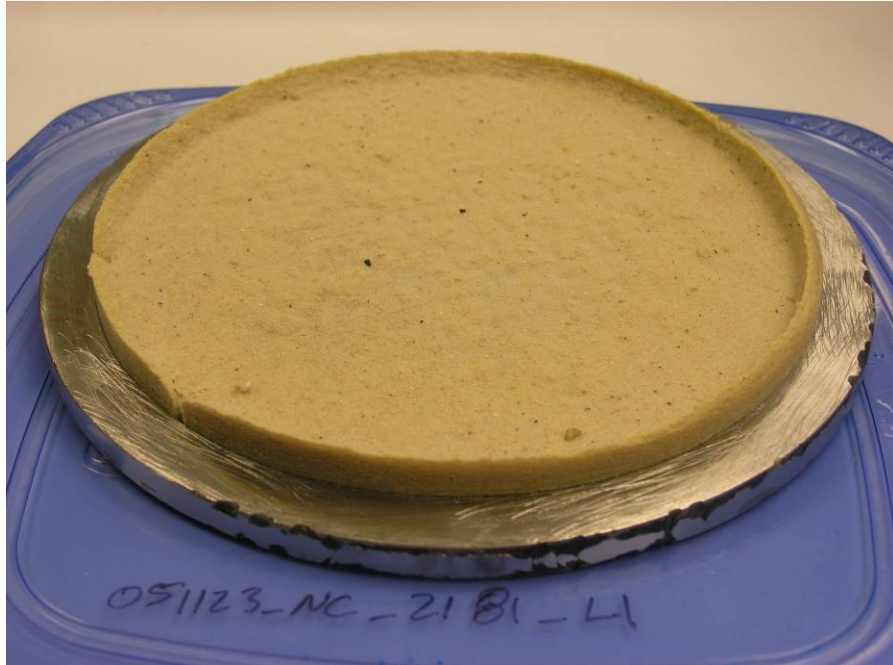
**Figure J.11.7. 051123\_NC\_2181\_L1 Debris Bed After Retrieval from Test Section. Screen pattern is observable on debris bed surface; flow channels are observable on left side of debris bed.**

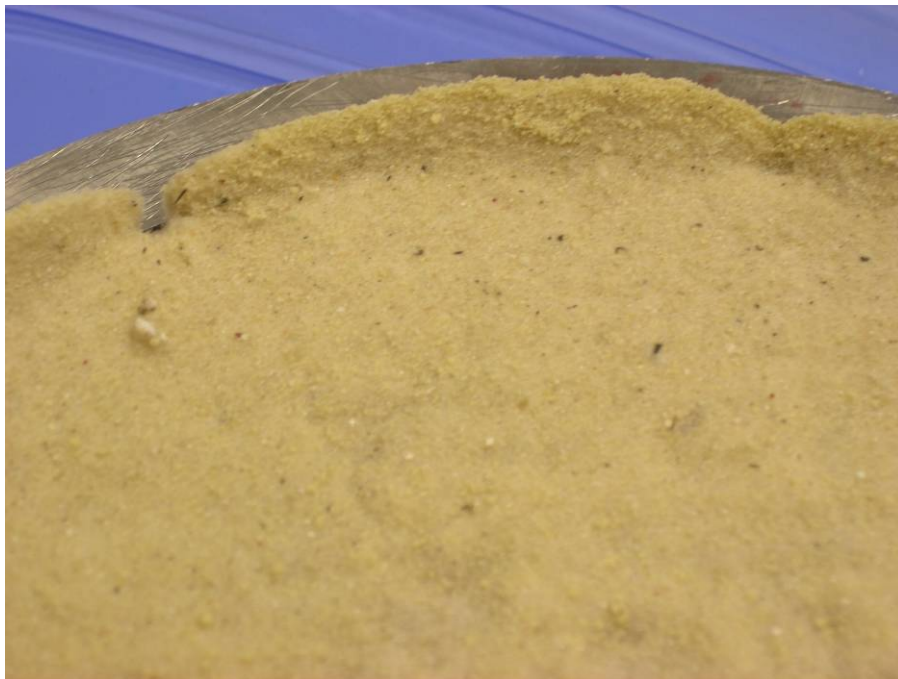
**Figure J.11.8. Close-up of 051123\_NC\_2181\_L1 Debris Bed After Retrieval from Test Section. Screen pattern is observable on debris bed surface; flow channels are observable on debris bed edge.**

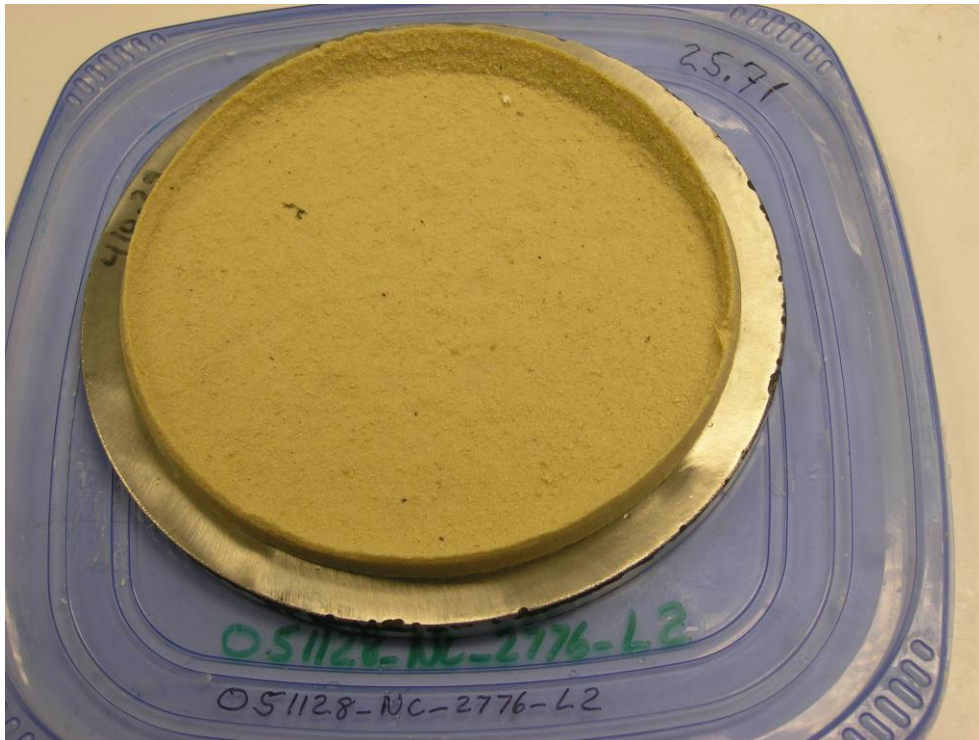
**Figure J.13.6. 051128\_NC\_2776\_L2 Debris Bed After Retrieval from Test Section. Indentation on Debris Bed Rim at 3:15 Orientation Due to Post-Retrieval Handling.**

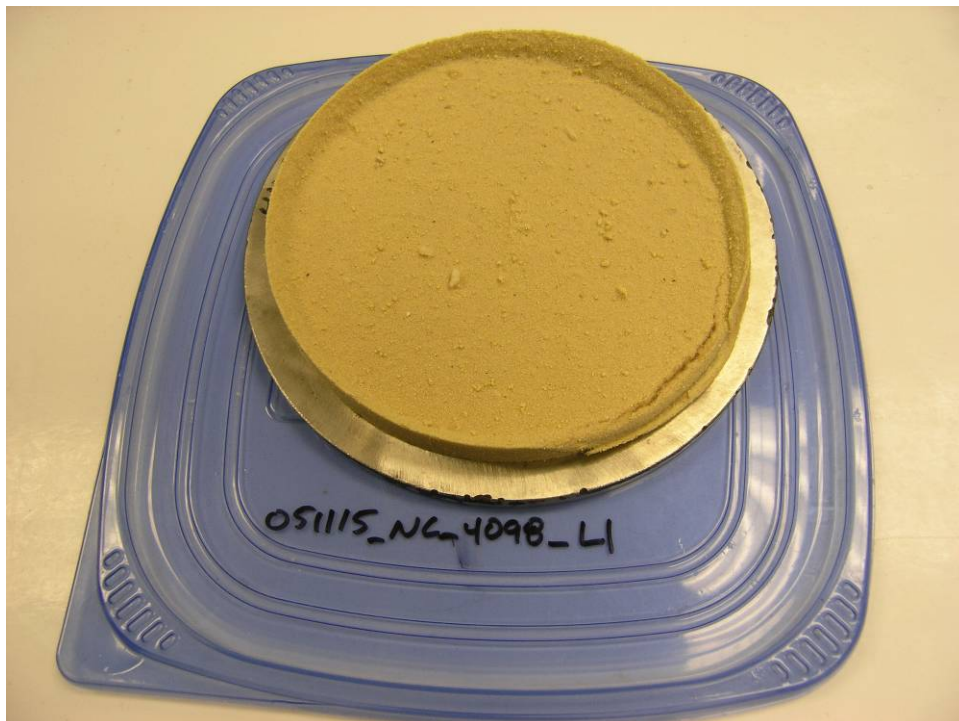
**Figure J.14.6. 051115\_NC\_4098\_L1 Debris Bed After Retrieval from Test Section. Collapsed rim was caused following test section retrieval from test loop.**

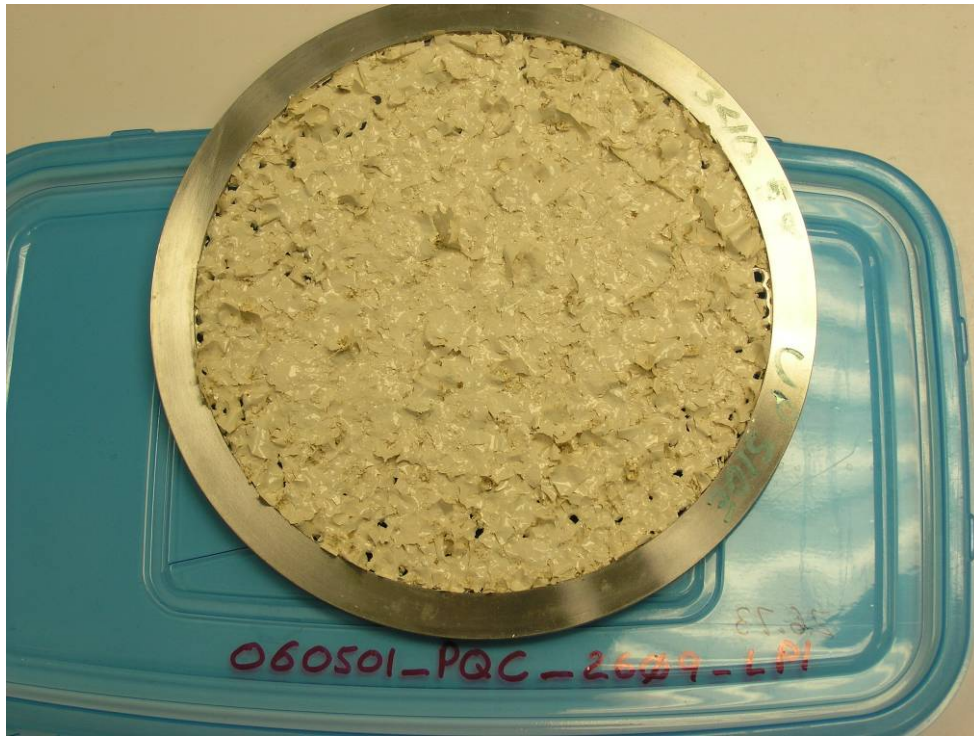
**Figure K.1.7. 060501\_PQC\_2609\_LP1, LP2 Debris Bed After Retrieval from Test Section, Top View**

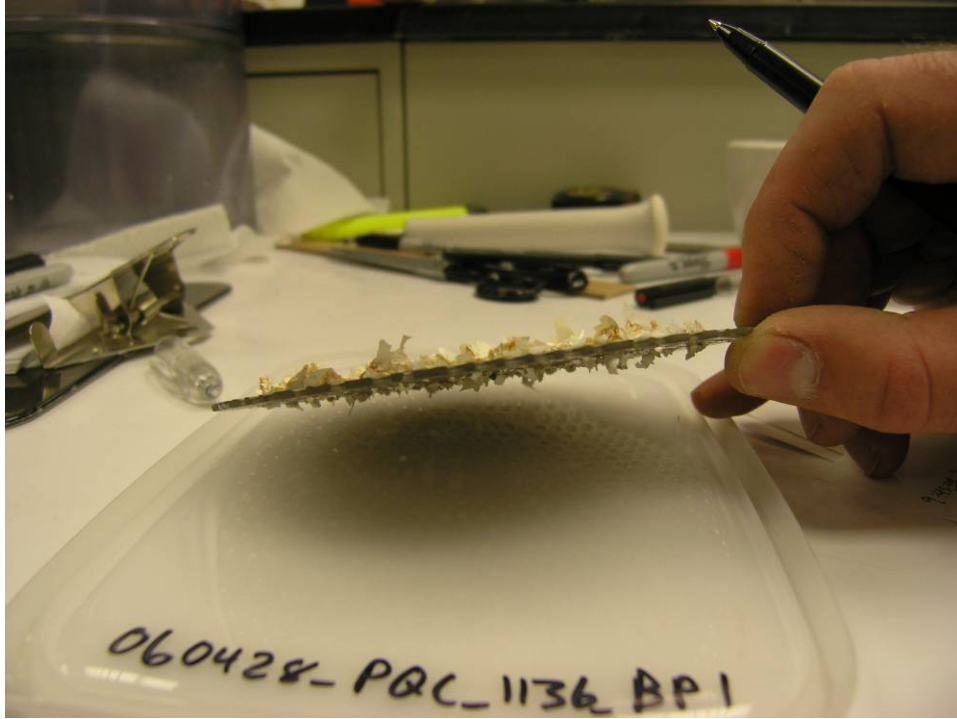
**Figure K.1.13. 060428\_PQC\_1136\_BP1 Debris Bed Post-Retrieval, Edge View (note penetration of ALK debris into perforations of plate)**

As reported, a debris bed was formed for the ALK coating Priority 5 test in the benchtop loop. Despite the small number of open channels observed, a head loss in excess of 100 in. H<sub>2</sub>O was measured for an approach velocity of 0.20 ft/sec. Benchtop test conditions are reported in Table K.8 and preliminary test data in Table K.9. The test had a fluid temperature of nominally 21°C. Testing was conducted in accordance with *060404 April test program memo.doc* as applicable in the PNNL benchtop test loop and under the flow conditions in the table; the benchtop loop test section inside diameter is 0.1016 m (4.0 in.).

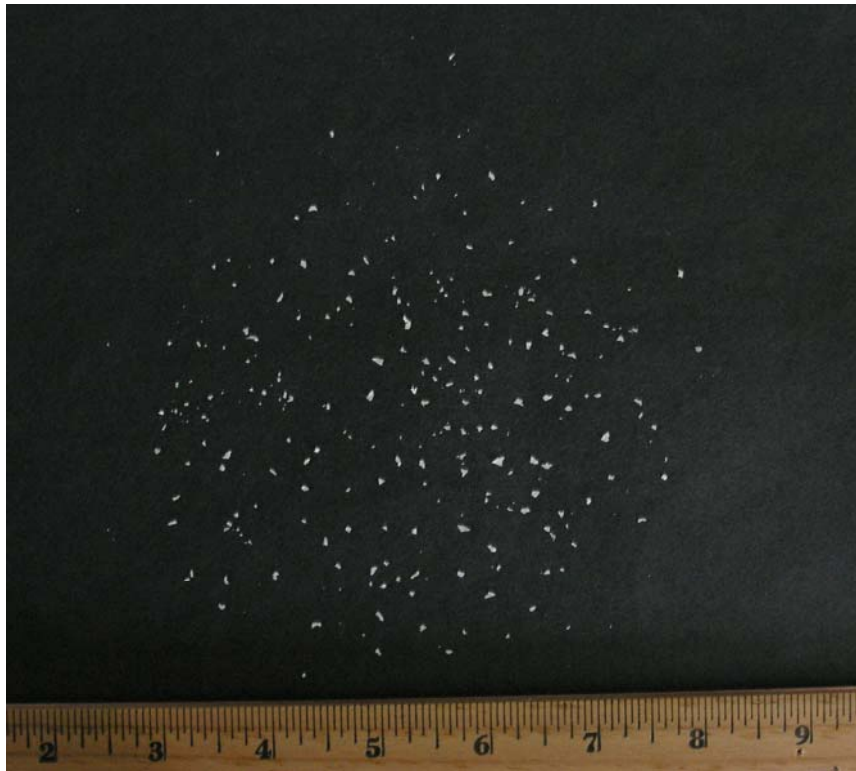
**Figure O.1.1. Size Characterization Photo for ALK-Processed Debris. Total mass of particulate in photo was 0.01 g.**

For each of the four coating debris tested; ALK-processed, ALK-Chips, ZE-processed, and ZE-chips, samples were prepared, arranged, and photographed. To arrange the coatings material the particles were spread onto a black background and manually spaced so that no particles were touching. The underside and topside of the ZE material are different colors so the particulate was arranged with a uniform colored side showing. Figures O.1.1 through O.1.4 contain the characterization photos for the ALK-processed, ALK-chips, ZE-processed, and ZE-chips debris, respectively.

The four photos were provided to the Naval Surface Warfare Center (NSWC) for size characterization using photo imaging and analysis software. The particle sizing software used for the analysis was developed by Jason Carneal of NSWC using Matlab<sup>®</sup> and was titled ChipSizer. Anne Fullerton of NSWC performed a two dimensional analysis of the photos to determined the maximum (major axis) and minimum (minor axis) dimensions for each particle pictured. Tables O.1.1 through O.1.4 provide tabular size distributions based on both the major and minor axes for the ALK-processed, ALK-chips, ZE-processed, and ZE-chip debris, respectively. The tables also provide the mass and particle count for each coating debris evaluated. Figures O.1.5 through O.1.8 are histograms of the particle distributions obtained for the ALK-processed, ALK-chips, ZE-processed, and ZE-chip debris, respectively.

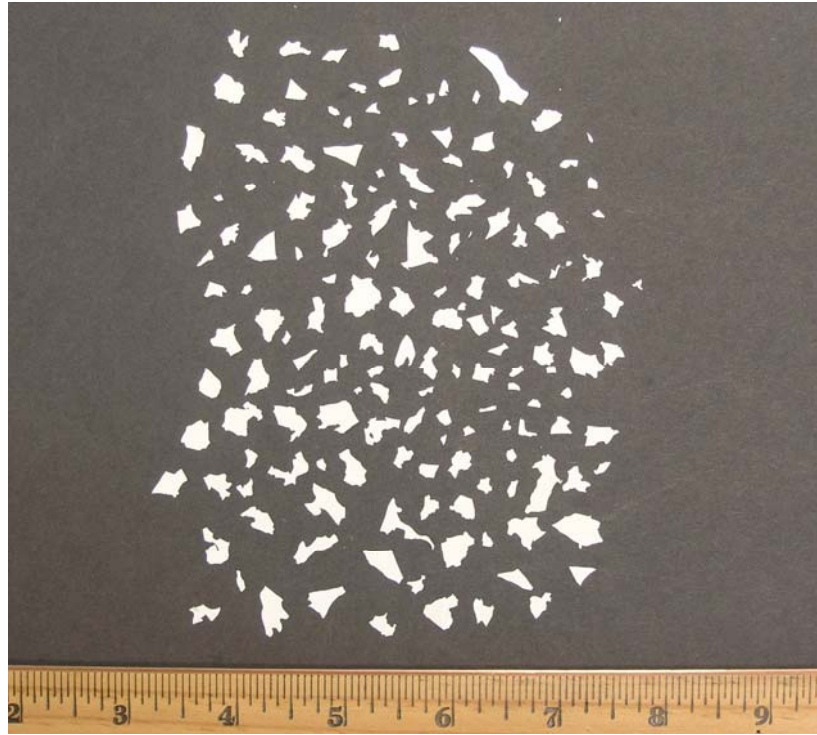
**Figure O.1.2. Size Characterization Photo for ALK-Chips Debris. Total mass of particulate in photo was 0.17 g.**

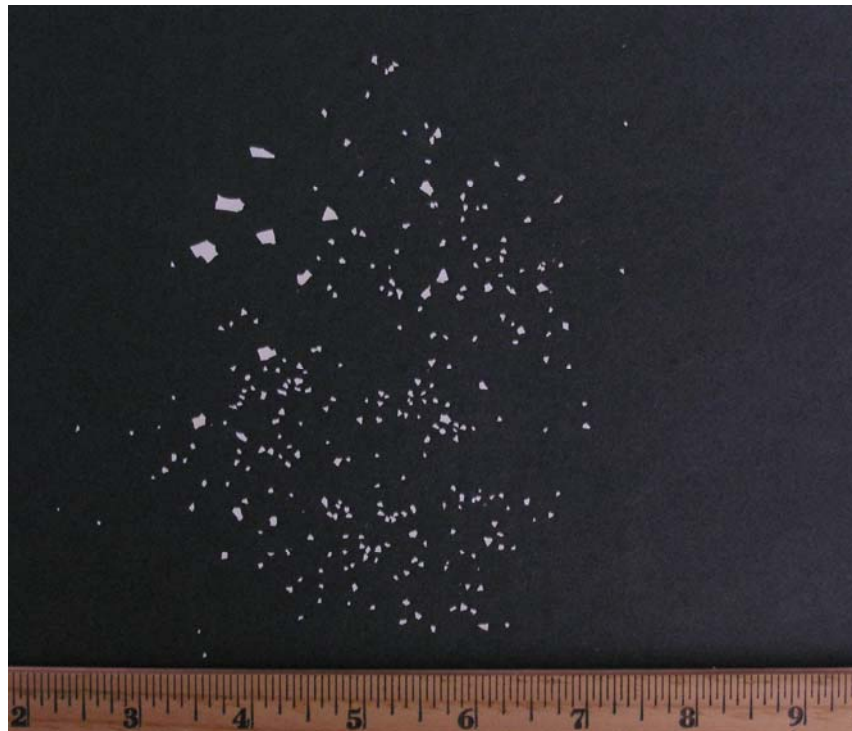
**Figure O.1.3. Size Characterization Photo for ZE-Processed Debris. Total mass of particulate in photo was 0.12 g.**

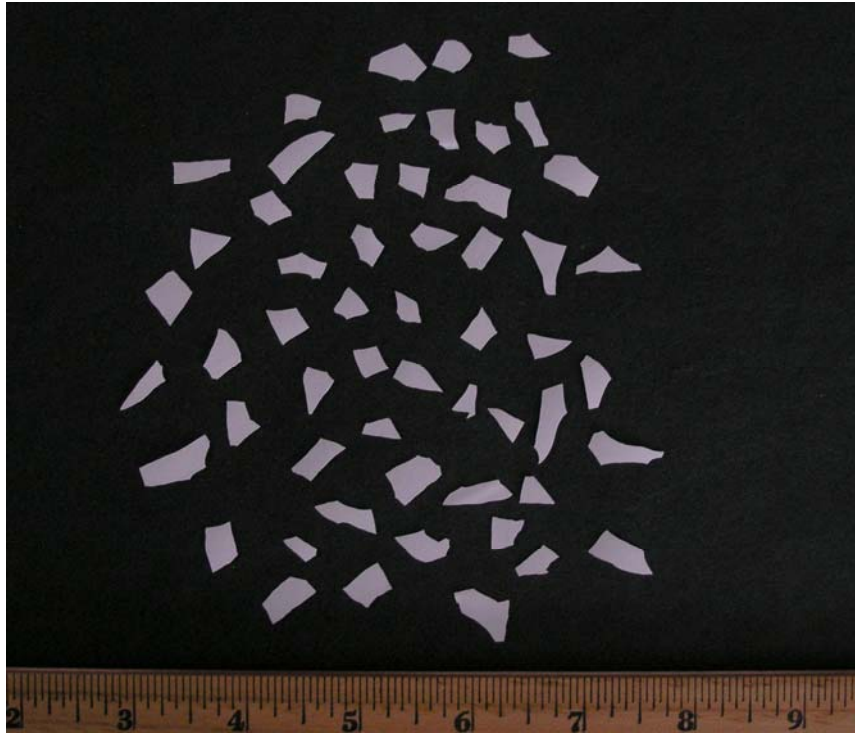
**Figure O.1.4. Size Characterization Photo for ZE-Chips Debris. Total mass of particulate in photo was 1.0 g.**
