2008/2009 Annual Report Volume I

JOINT OBSERVATIONAL STUDY (JOS)

Seaway Shoreline Icebreaking Impacts Between Snell Lock & Lake St-Francis

BMT FLEET TECHNOLOGY LTD

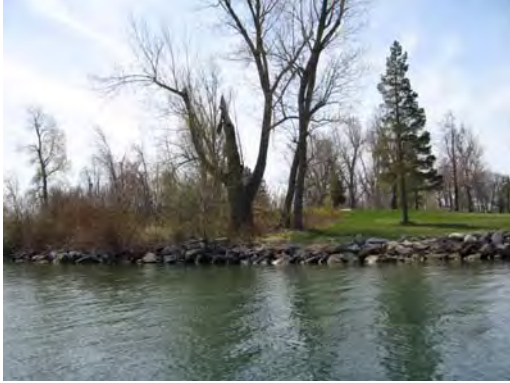
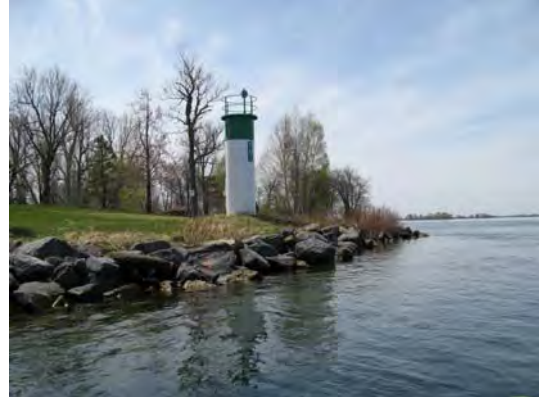
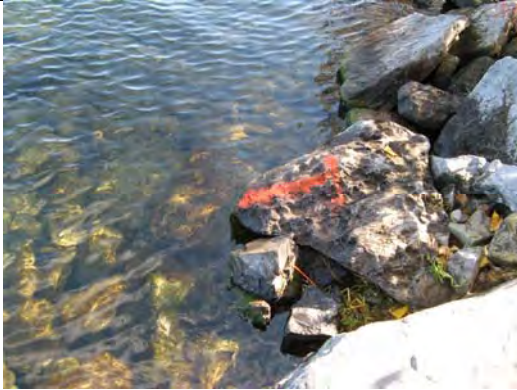
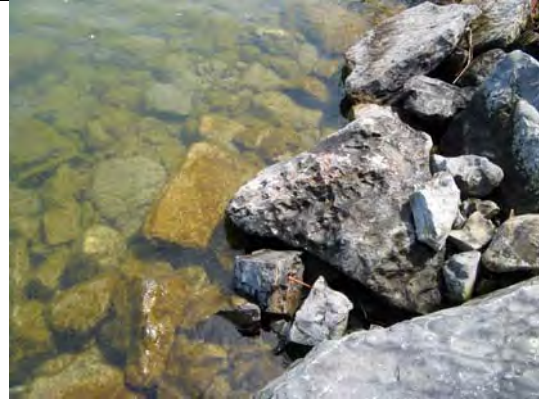
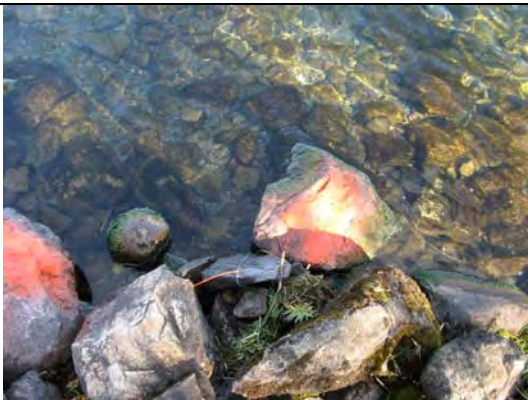
Figure 5.2 Marked Rip-Rap Stones at Stanley Island

The surveyed rip-rap stones were all located on a point that is almost adjacent to the nearest edge of the shipping channel (**Figures 5.1** and **5.3**). This is one of the points between **Snell Lock** and **Lake St. Francis** where the shipping channel is closest to shore.

General View of Shoreline at Stanley Isl.

Marked Rip-rap (#1): October 23, 2008

Marked Rip-rap (#1): May 4, 2009

Marked Rip-rap (#4): October 23, 2008

Marked Rip-rap (#4): May 4, 2009

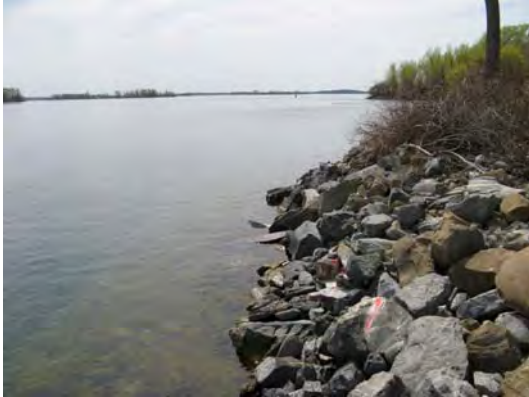
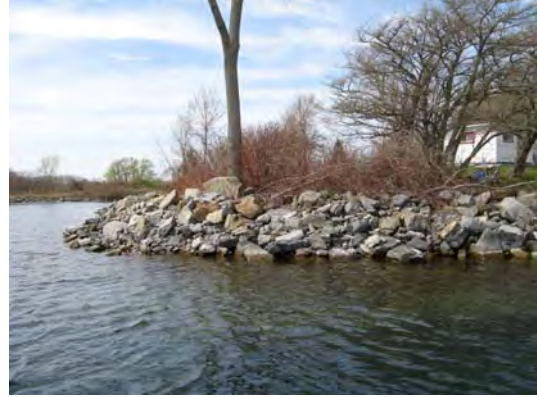
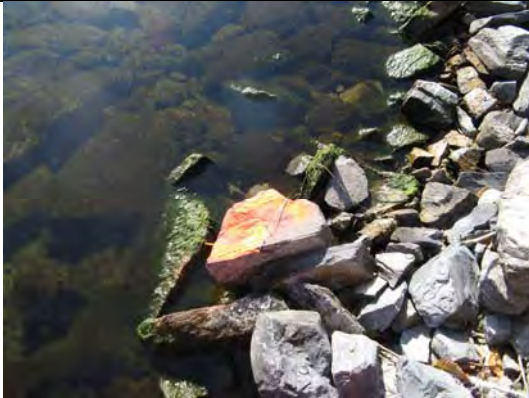
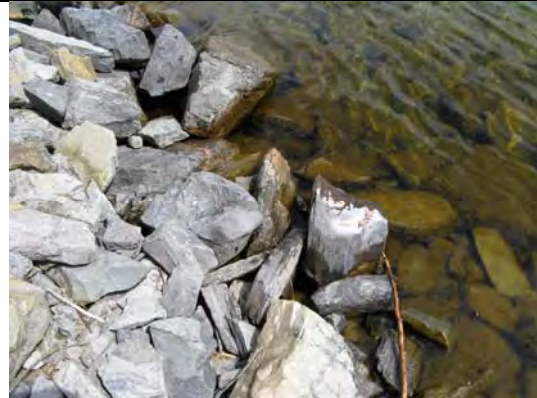
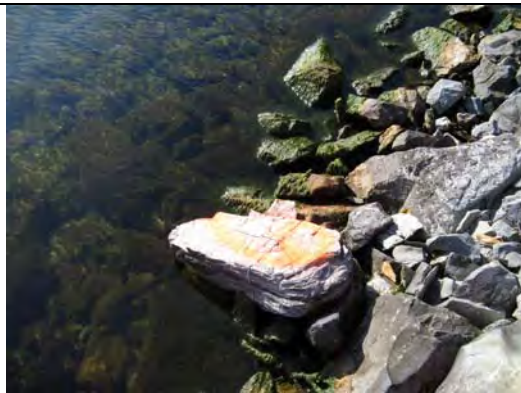
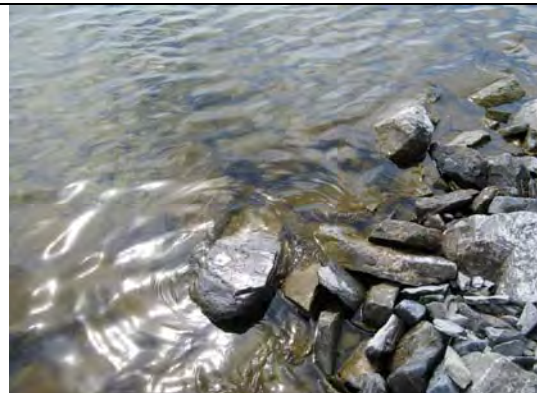
Figure 5.4 Marked Rip-Rap Stones at Clark Island

Movements ranging from 0.3 to 6.8 feet were measured over the period from **October 23, 2008** to **May 4, 2009**. The stones with the largest movements were all located on the south side of the promontory of **Clark Island** that was surveyed. This location is closest to the shipping channel. The movements were all generally alongshore (**Figure 5.4**).

General View of Shoreline at Clark Isl.

Marked Rip-rap (#5): October 23, 2008

Marked Rip-rap (#5): May 4, 2009

Marked Rip-rap (#6): October 23, 2008

Marked Rip-rap (#6): May 4, 2009

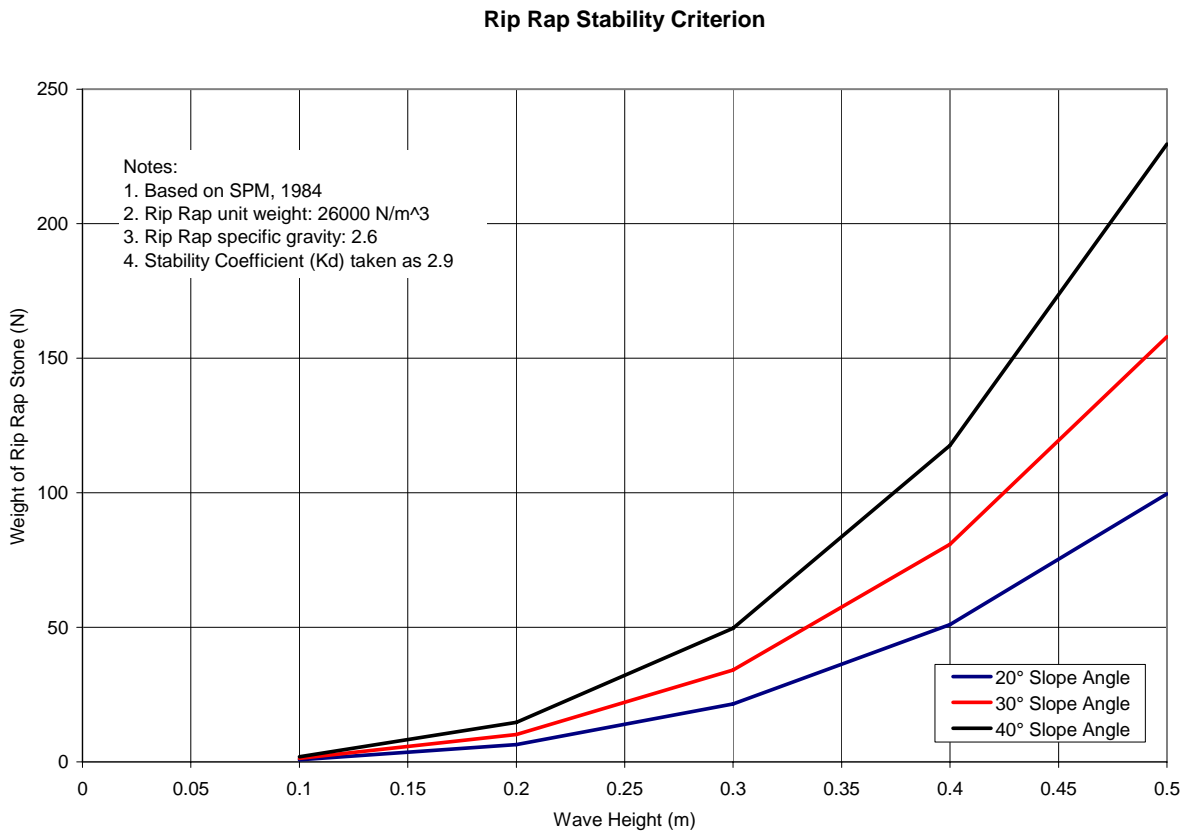
Figure 5.8 Rip-Rap Stability Criterion from the SPM (USACE, 1984)

As part of the **2007/2008** study season (ref.: **2007/2008 Annual JOS Report**), preliminary investigations were completed by referring to the **Shore Protection Manual (SPM)** developed by the **US Army Corps of Engineers (USACE, 1984)**. **Figure 5.8** was developed during last years analyses as a stability criterion for the rip-rap stones and is based on **SPM** methods (ref.: **2007/2008 Annual JOS Report**).

Simple checks with the **2009** spring observations (e.g., based on the approximate sizes of the rocks) suggest that this criterion would still be applicable, and thus, the hypothesis that the observed rip-rap movements were ship-induced is still considered to be a valid one.

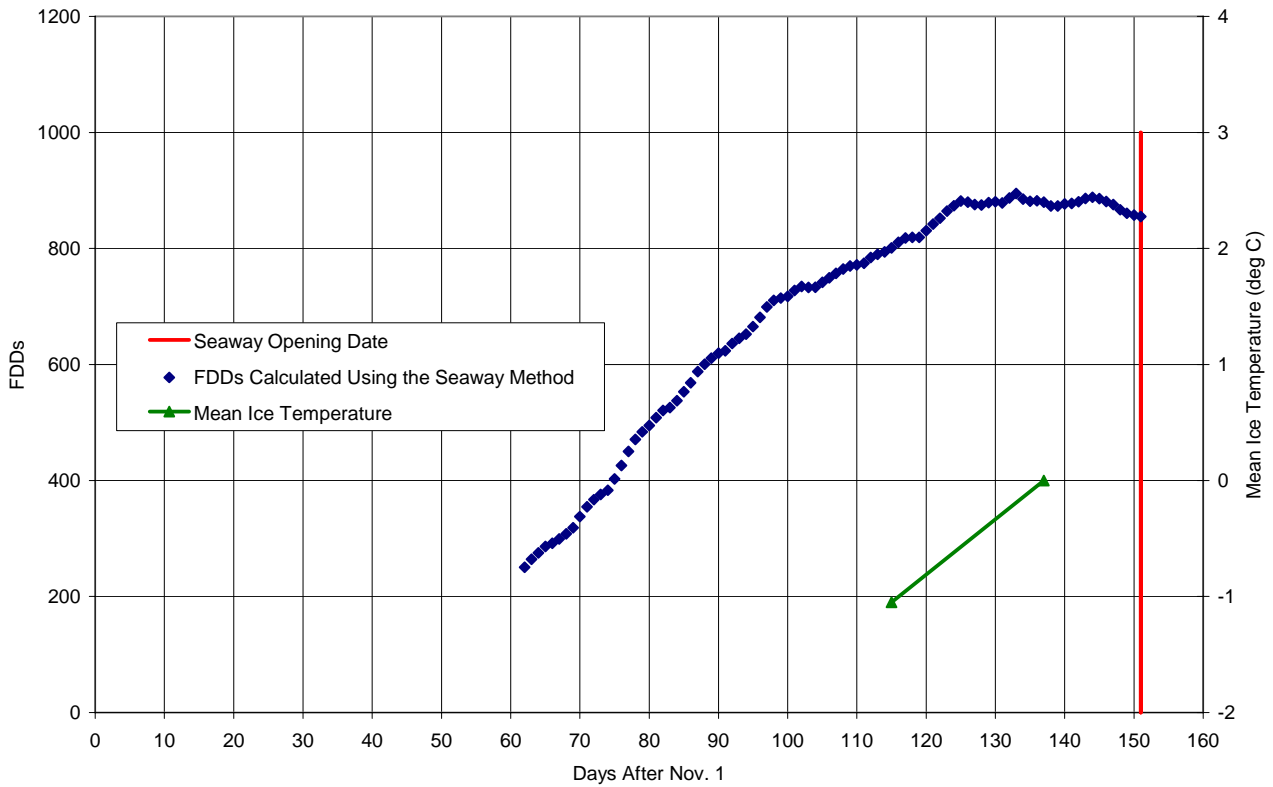
Figure 6.2 FDDs at PET Airport for the 2008-2009 Winter

Figure 6.2 shows the accumulated **FDDs** at **Pierre Elliot Trudeau (PET) Airport** in **Montreal** over the winter of **2008-2009**. The **FDDs** accumulated fairly steadily over the **2008-2009** winter, in a pattern that is similar to that observed for past winters (see **2007/2008 Annual JOS Report**).

It should be noted that the **FDD** values shown in **Figure 6.2** were obtained from the **St. Lawrence Seaway Management Corporation (SLSMC – L. Lefebvre, SLSMC, personal communication)**, and thus they were calculated using the **SLSMC's** usual approach. As shown in the **2007/2008 JOS Report** (ref.: **2007/2008 Annual JOS Report**), the **FDD** calculation approaches differ to some extent among investigators which does result in somewhat different values. For consistency, the results discussed here are based on the **SLSMC's** usual approach for calculating **FDDs**. This assumption is not crucial as similar conclusions and trends would be expected based on each **FDD** calculation approach.

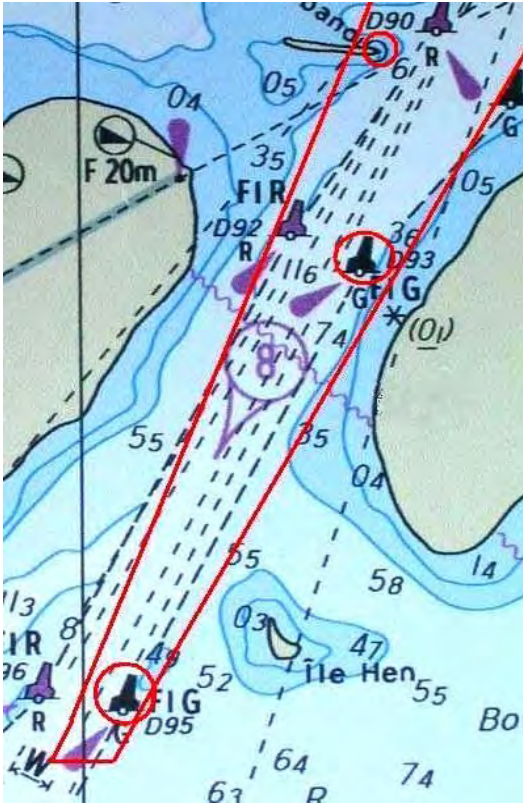
Figure 6.11
Field of View for
Video Camera

Observation Type	General Output	Scope
Video camera	Continuous time-lapse photography, from a video camera that was set up in the water treatment plant at Cecil Garrow Bay. See Figure 6.11 for a drawing showing the camera's field of view.	The video camera provided continuous coverage of the channel between St. Regis and Cornwall Islands from February 24 to March 20.
Aerial reconnaissance with fixed-wing aircraft	Notes and photographs defining the ice conditions	A mission was conducted on February 24
RADARSAT imagery	High-resolution maps of the ice conditions in the whole region from Lake St Francis to Snell Lock	RADARSAT imagery was obtained for: (a) February 10; (b) February 25; (c) March 21, and; (d) March 28
Ice-based observations	Observations of the ice conditions as well as ice properties data (described subsequently)	Site visits were made on: (a) February 23, and; (b) March 17.

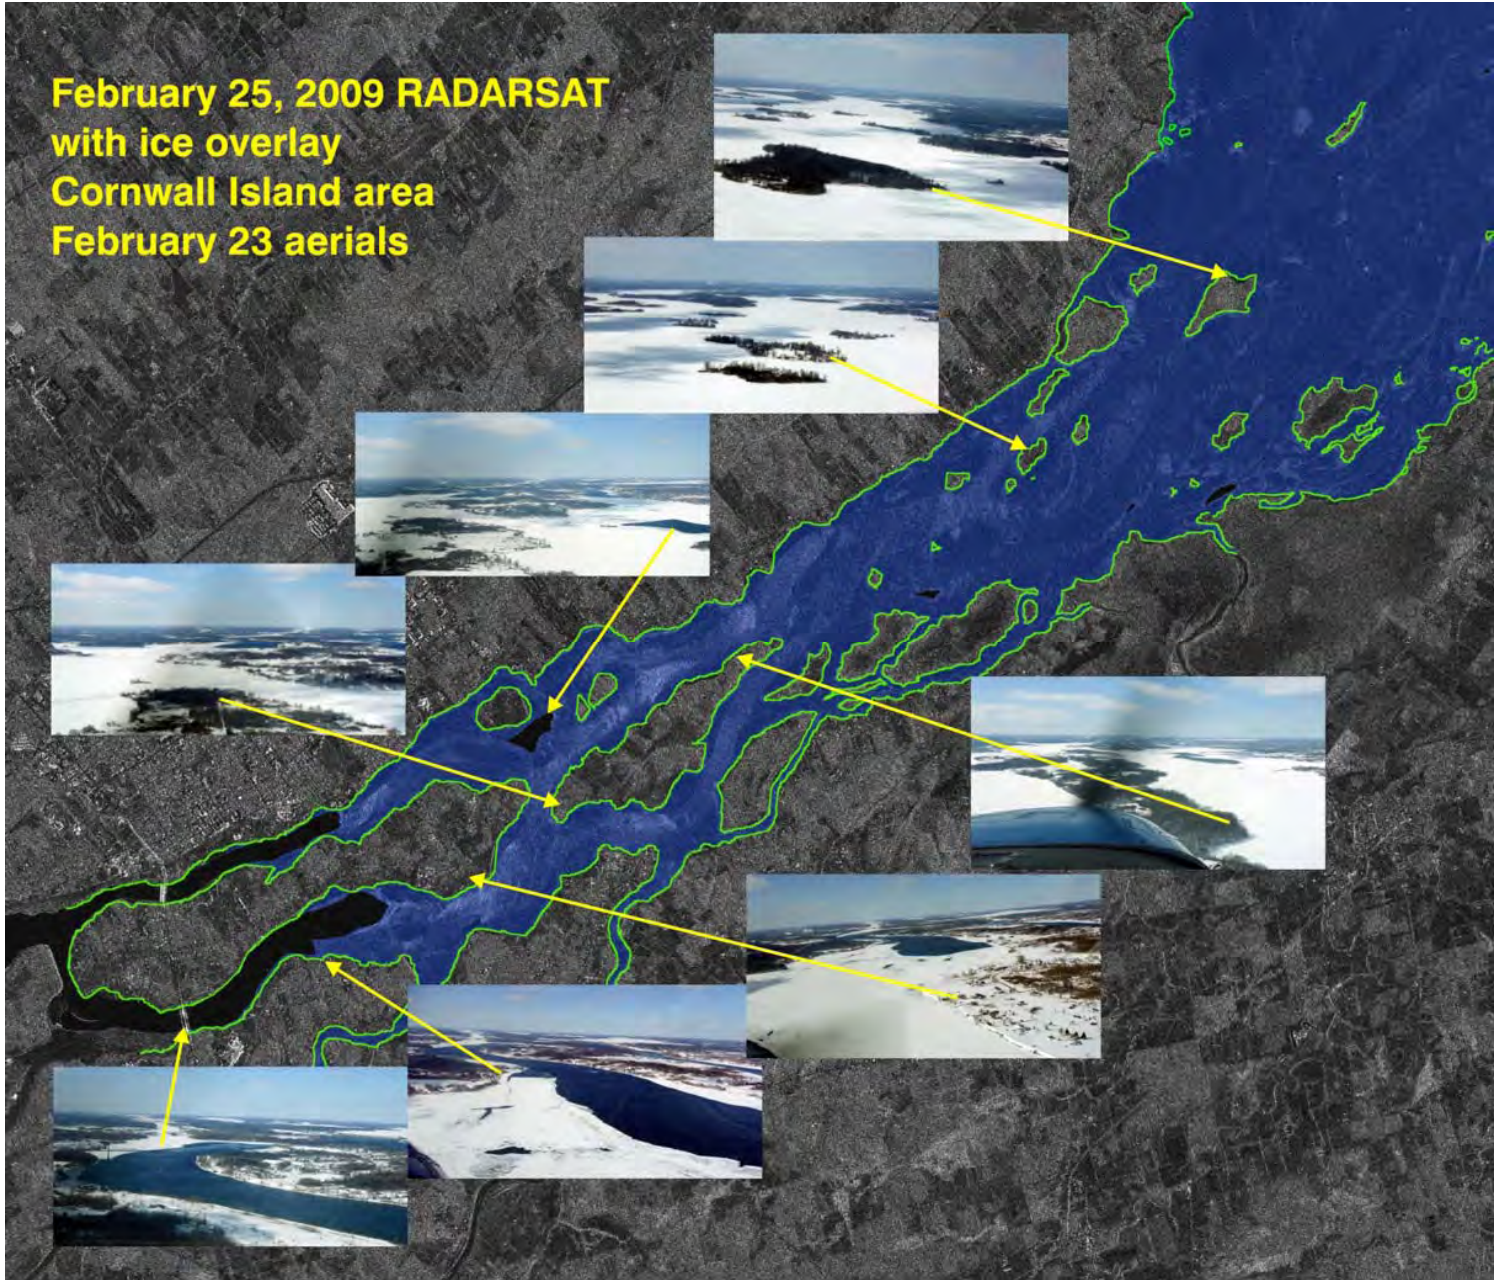
Figure 6.13 Annotated RADARSAT Image: February 25, 2009

Figures 6.12 and 6.13 show large-scale **RADARSAT** maps of the ice cover from **Cornwall** to **Lake St Francis** on **February 10** and **February 25** respectively. These **RADARSAT** images have been annotated (by **BMT FTL**) to show the ice cover (in blue). As well, these figures include relevant photos for ground truth. A complete record of annotated **RADARSAT** images is provided in **Appendix E**, including information for **Lake St. Francis**.

Figures 6.12 and 6.13. The ice cover extent shown in these annotated **RADARSAT** images is probably close to the maximum that was reached during the entire **2008/2009** winter.

No major ridges or cracks were observed in the ice cover. The data show that ice rubble was present along the channel from south of **Cornwall Island** to north of **St. Regis Island** on both **February 10** and **February 25**, which is indicated by the lighter-coloured portions in the images. This likely represents ice rubble on the ice surface, which was formed due to "ice packing", where ice pieces are shoved under or over the leading ice edge causing ice rubble on the surface. This is the same general location where ice surface relief and packing has been observed during previous years of the **JOS**, which forced the **CCGS Martha L. Black** to back and ram in order to transit through it.

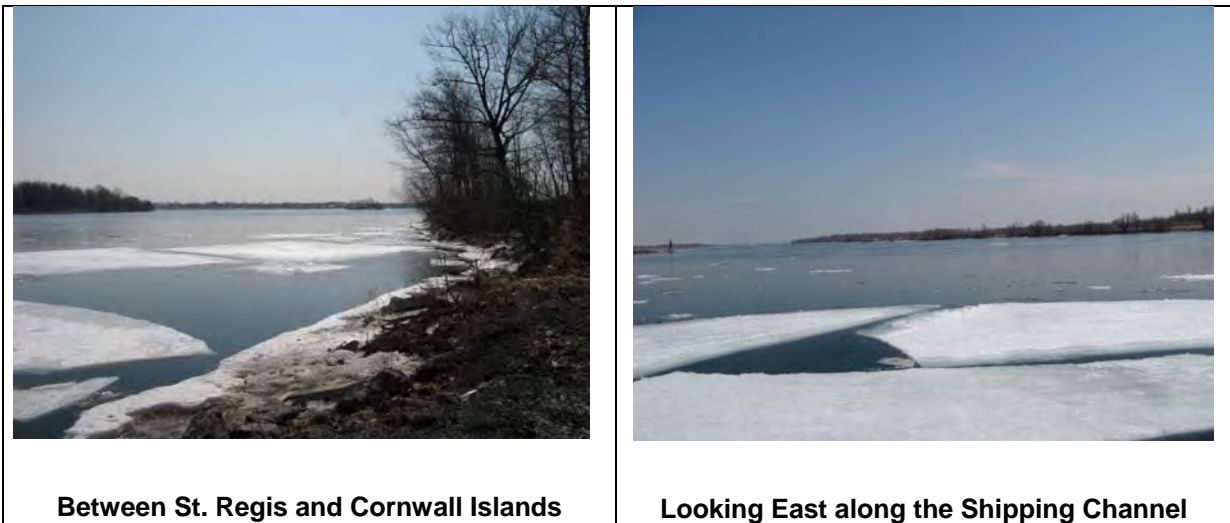
Figure 6.15 Views From the Eastern Tip Of Cornwall Island: March 17, 2009

Photos taken during a site visit made on **March 17** (**Figure 6.15**) showed that:

- (a) the channel between **St. Regis** and **Cornwall Islands** was almost entirely ice-free, and;
- (b) the shipping channel north of **St. Regis Island** was also almost entirely ice-free.
