# Appendix 2

## New Orleans East Basin

### NOE – Background

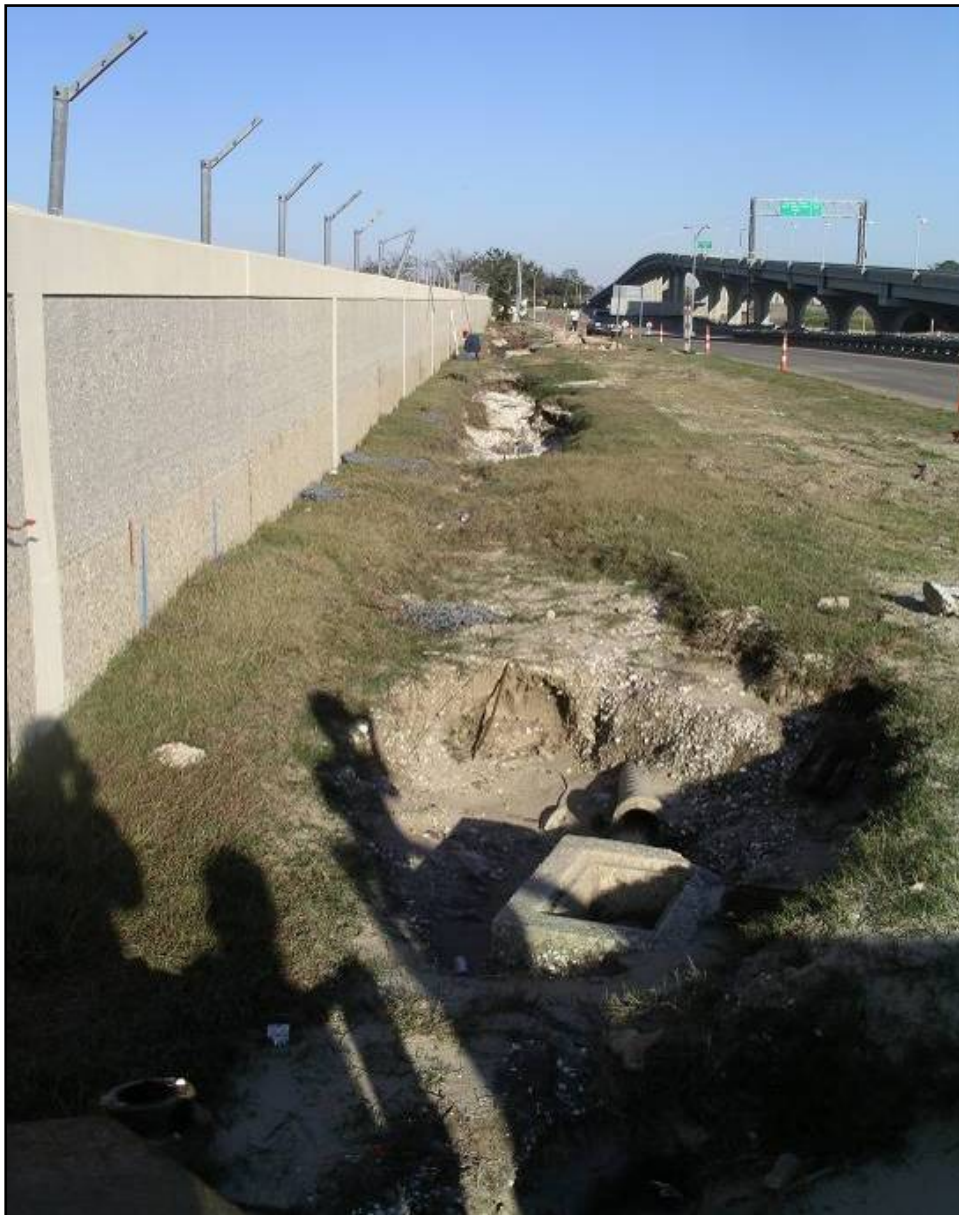
The reach ends just after the second closure gate for Hayne Boulevard. The weighted average elevation of the top of this wall is shown in the table below, and is based upon a physical survey taken November 2005 and data from MVN surveys in 2006. There was significant scour from limited overtopping and/or wave splash along this section of I-wall, as shown in Figure NOE 4, but there was no permanent deformation of the wall.

Figure NOE 4. Scour Behind Lakefront Airport FW from Overtopping

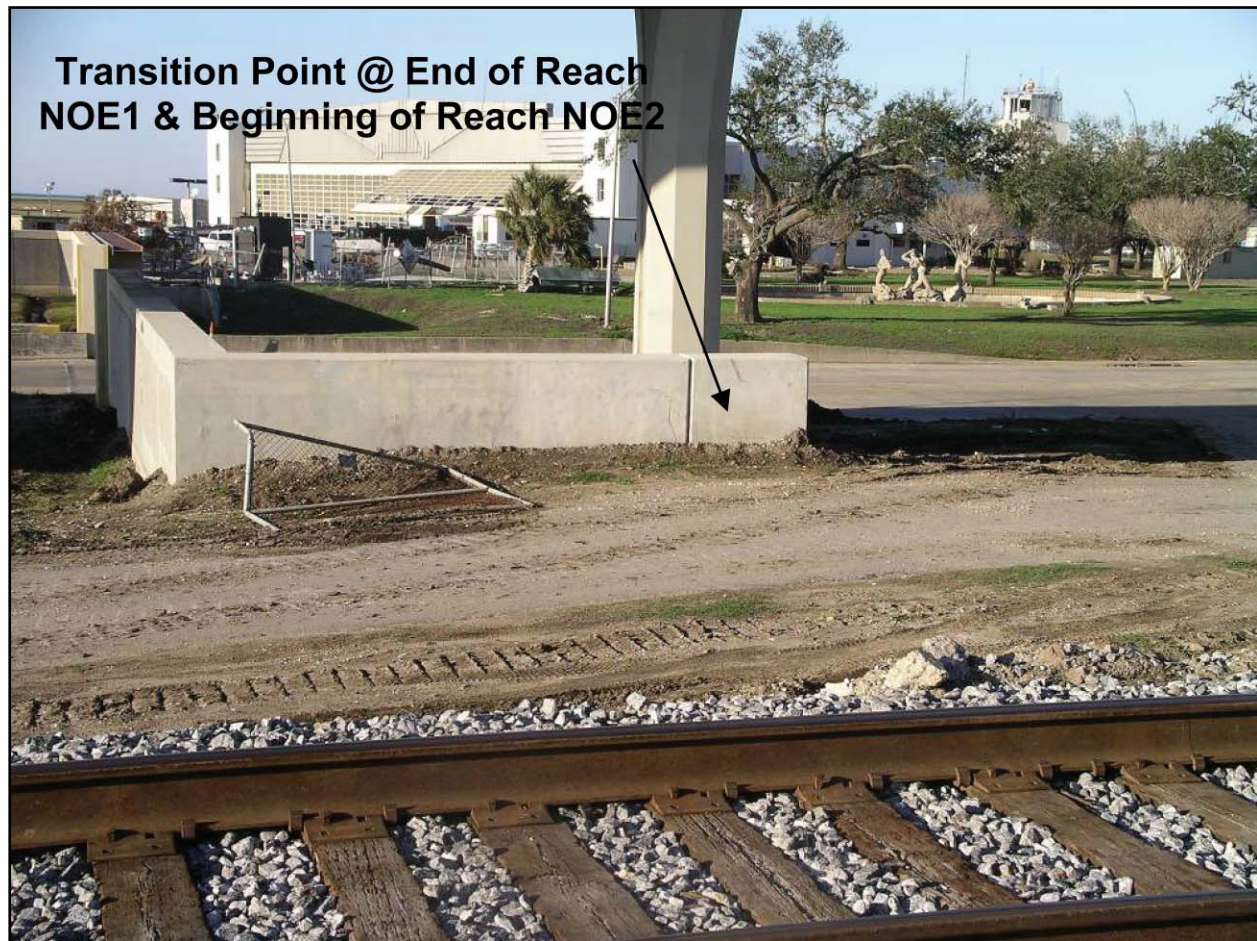
This reach is defined by a short transition levee between the end of the Lakefront Airport floodwall, goes up the CSX railroad beds and ends at the beginning of the west Stars & Stripes floodwall. There are no features within this reach; however, there is one transition which is a ramp where the levee ties from the concrete capped I-wall to the railroad track. One of these transition points is shown in Figure NOE 5 where the scour occurred during Katrina. The weighted average height of this reach is shown in the table below, and was based upon MVN survey data in 2006.

Figure NOE 5. Transition Point Between Reaches (NOE 1 & NOE 2) (Viewed from Reach NOE2 looking north towards Lakefront Airport)

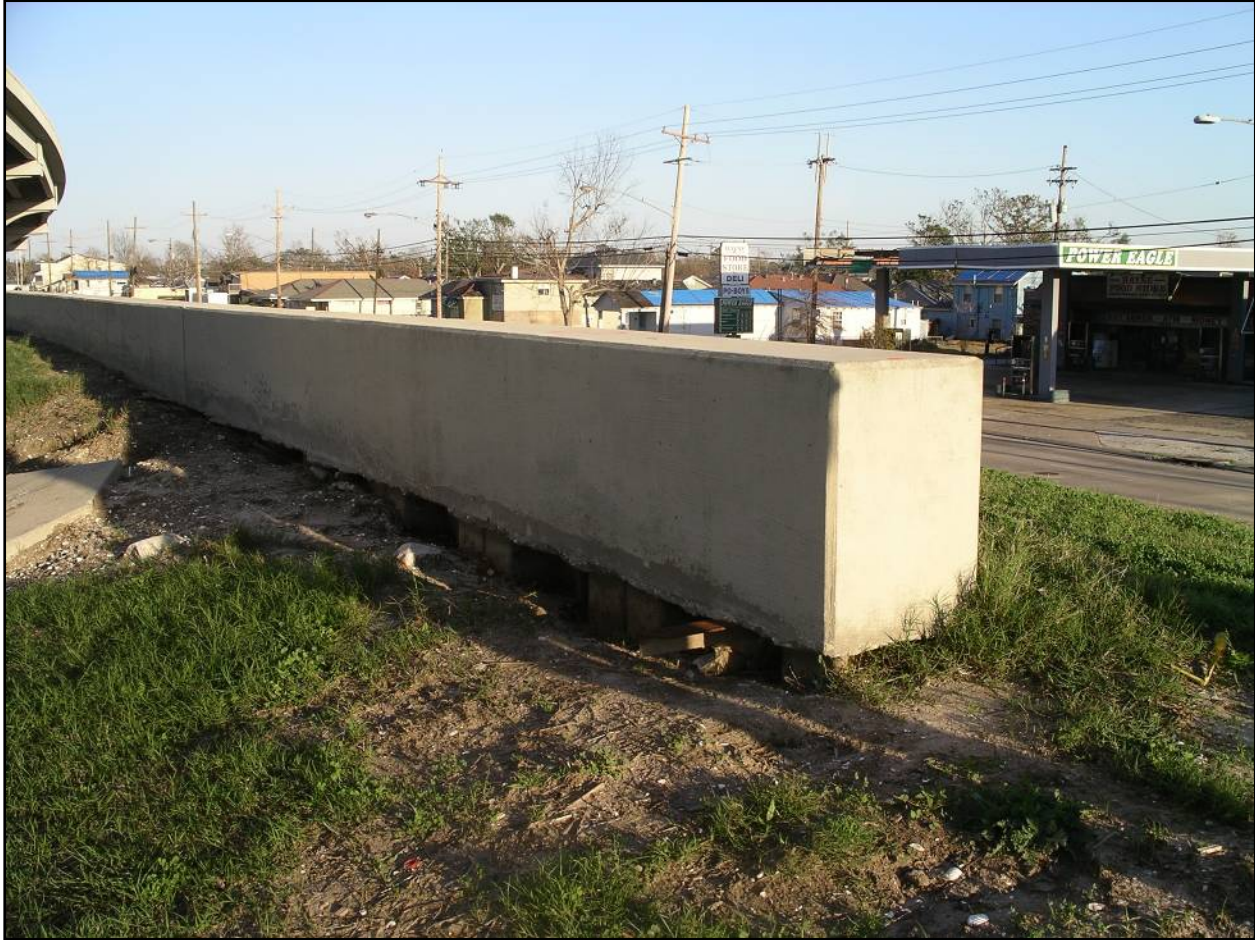
This reach is composed of a concrete capped I-wall. This reach is commonly referred to as the west Stars & Stripes floodwall. There are two basic types of floodwall along this reach, each consisting of about ½ the length of this reach. The first type is a concrete capped I-wall with levee on both sides and the second is a concrete I-wall section where the protected side has a concrete sidewalk adjacent to a road. There are two transition points at each end of the I-wall/levee interface at the ends of this reach. The weighted average top of wall elevation along this reach is shown in the table below, and is based upon a physical survey taken by MVN in 2006. The transition between the levee and the east Stars & Stripes floodwall is shown in Figure NOE 6.

Figure NOE 6. Transition between Reaches NOE4 (Levee) and NOE5 (FW)

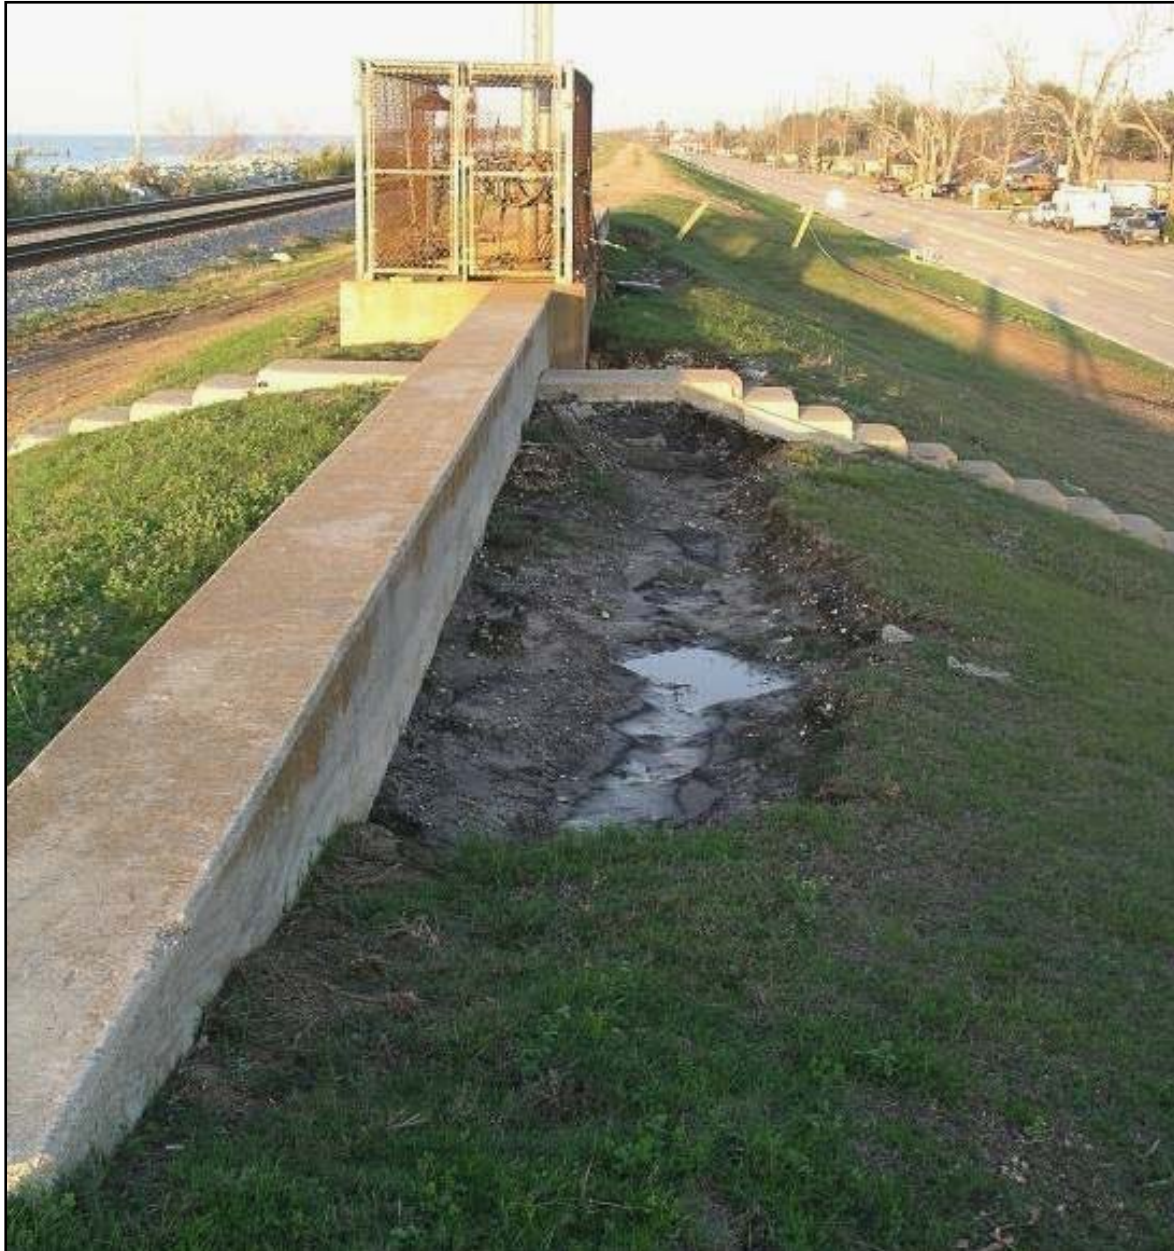
The weighted average elevation for the top of this reach is shown in the table below, and was based upon a physical survey done taken by MVN in 2006. There was some minor overtopping and/or wave splash over this levee at various locations, as indicated in Figure NOE 7, but no significant damage to the levee.

Figure NOE 7. Minor Scour from Overtopping at Jahncke Pump Station

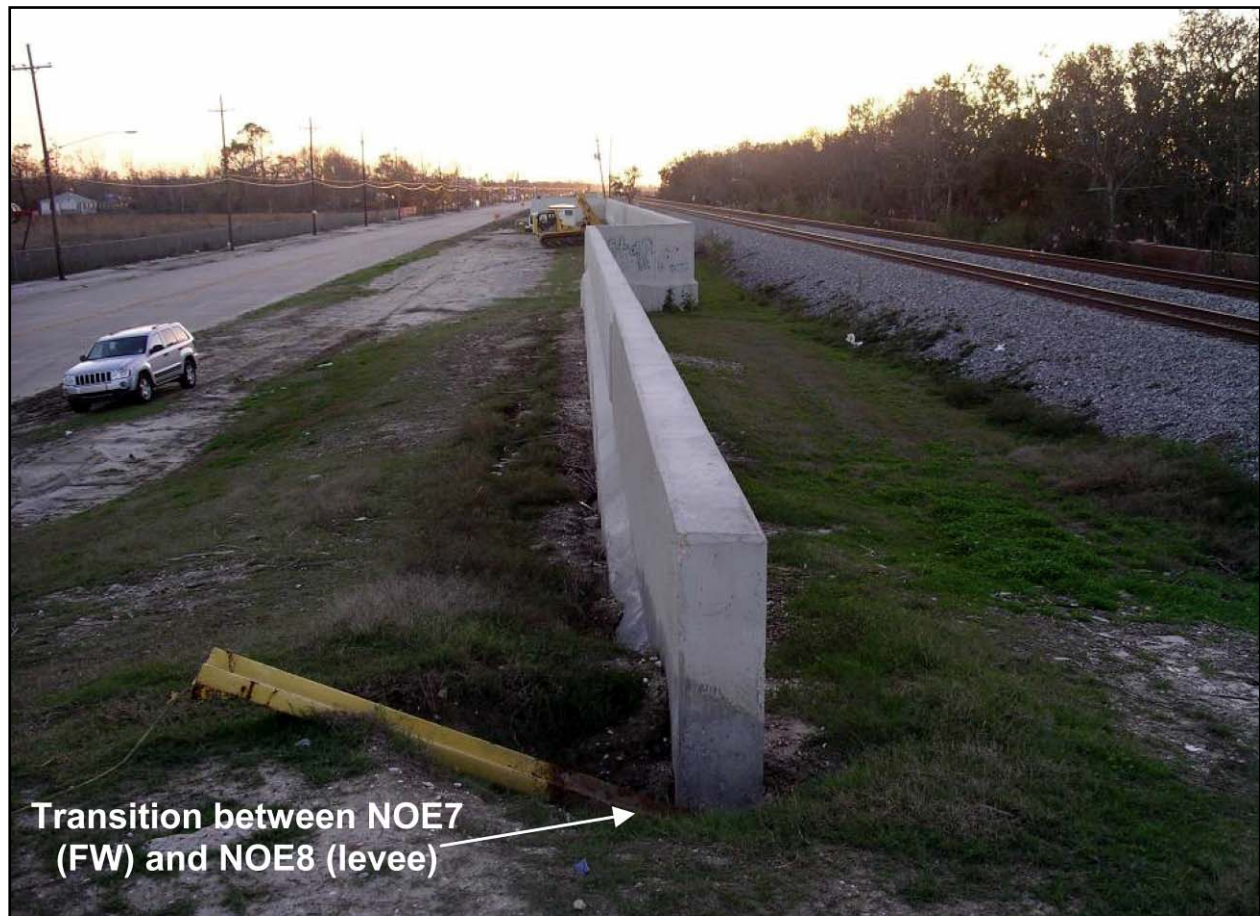
This reach is defined by a concrete I-wall located at Lincoln Beach. There is one key point located in the flood wall, which is a closure gate that is approximately 100 feet wide. Short concrete T-walls surround the gate. There are two transitions at the I-wall/levee interface at both ends of the wall. The weighted average top of wall elevation for this reach is shown in the table below, and was based upon a physical survey taken by MVN in 2006. The wall was overtopped during Katrina and performed very well. The Lincoln Beach floodwall is shown in Figure NOE 8 for reference.

Figure NOE 8. Lincoln Beach Floodwall (Reach NOE7) (Looking west from Reach NOE8)

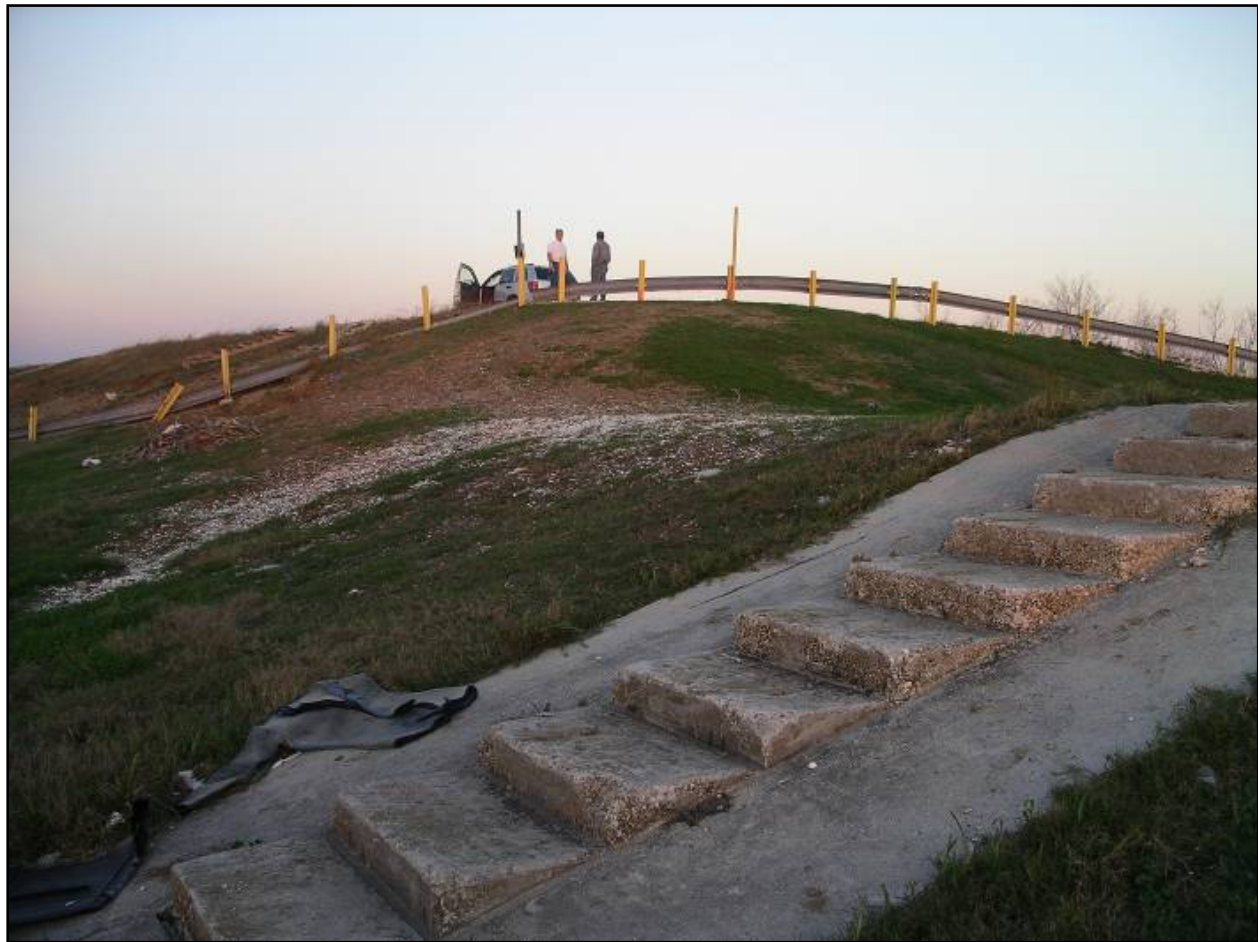
are no features or transitions within this reach. The weighted average top elevation of this levee is shown in the table below, and was based a physical survey taken by MVN in 2006. This section was overtopped and damaged during Katrina, primarily in the area where the lower Citrus Lakefront levee section transitions to the higher East Lakefront Levee section as shown in Figure NOE 9.

Figure NOE 9. Begin Lakefront Levee at Citrus Lakefront and Paris Road (Lakefront Levee @ El. 18.6± and Citrus Lakefront Levee @ 12.6±)

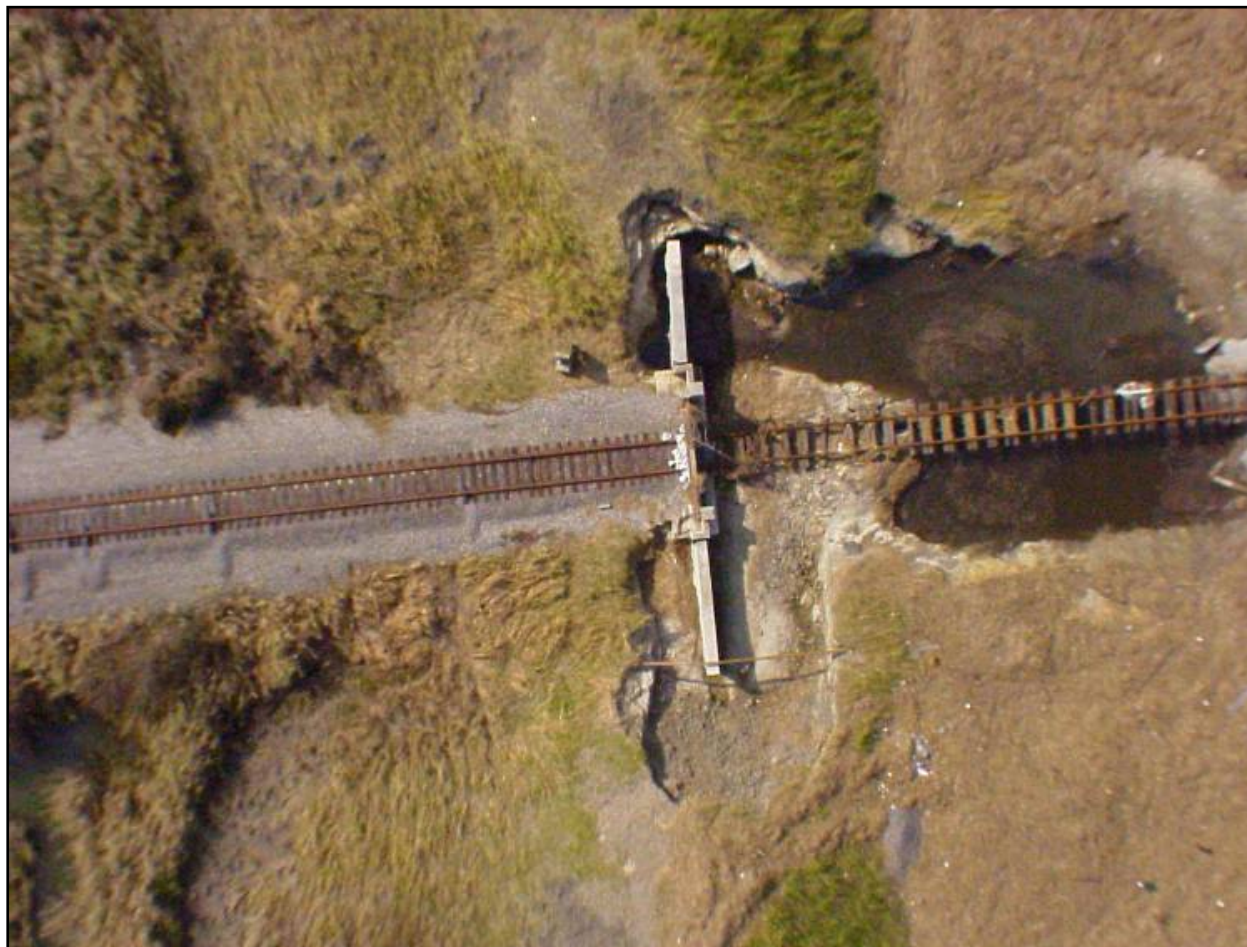
The final reach of levee along the East section extends to the GIWW with a weighted average top elevation as shown in the table below. This elevation was based upon based a physical survey taken by MVN in 2006. There are two transition points within this reach including a short sheet pile wall around a drainage structure and transition concrete I-walls around a railroad crossing. There is one key point, the railroad gated closure, which is included in this reach. At the time of Katrina, the railroad closure gate and transition walls were roughly 4 feet lower than the adjacent levee and was overtopped and heavily damaged during the storm. An aerial view of this damage is shown in Figure NOE 10.

Figure NOE 10. Aerial View of Damage at RR Closure Along East Levee

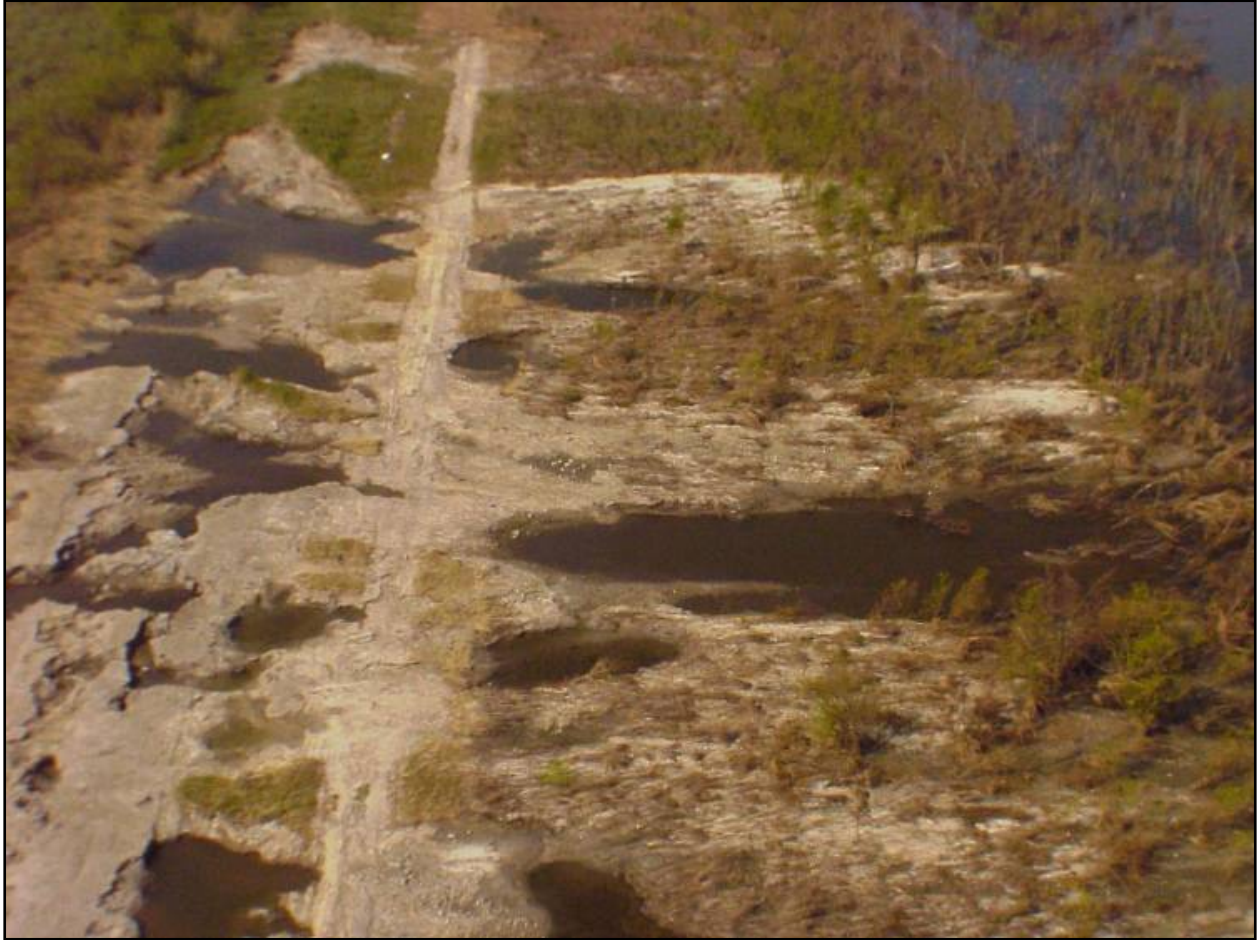
This section of levee was heavily damaged during Katrina from overtopping. Prior to Katrina, it had a weighted average top elevation as shown in the table below, and was based upon an adjusted LIDAR survey that was taken before the storm. It begins at the east end where it ties into the southern edge of the East Levee and continues to the east end of the floodwall around the Orleans Parish Pump Station #15. There are no features or transitions within this reach. Much of this levee was destroyed, as shown in Figure NOE 11.

Figure NOE 11. Failure of Levee by Overtopping East of Pump Station #15 (East Back Levee)

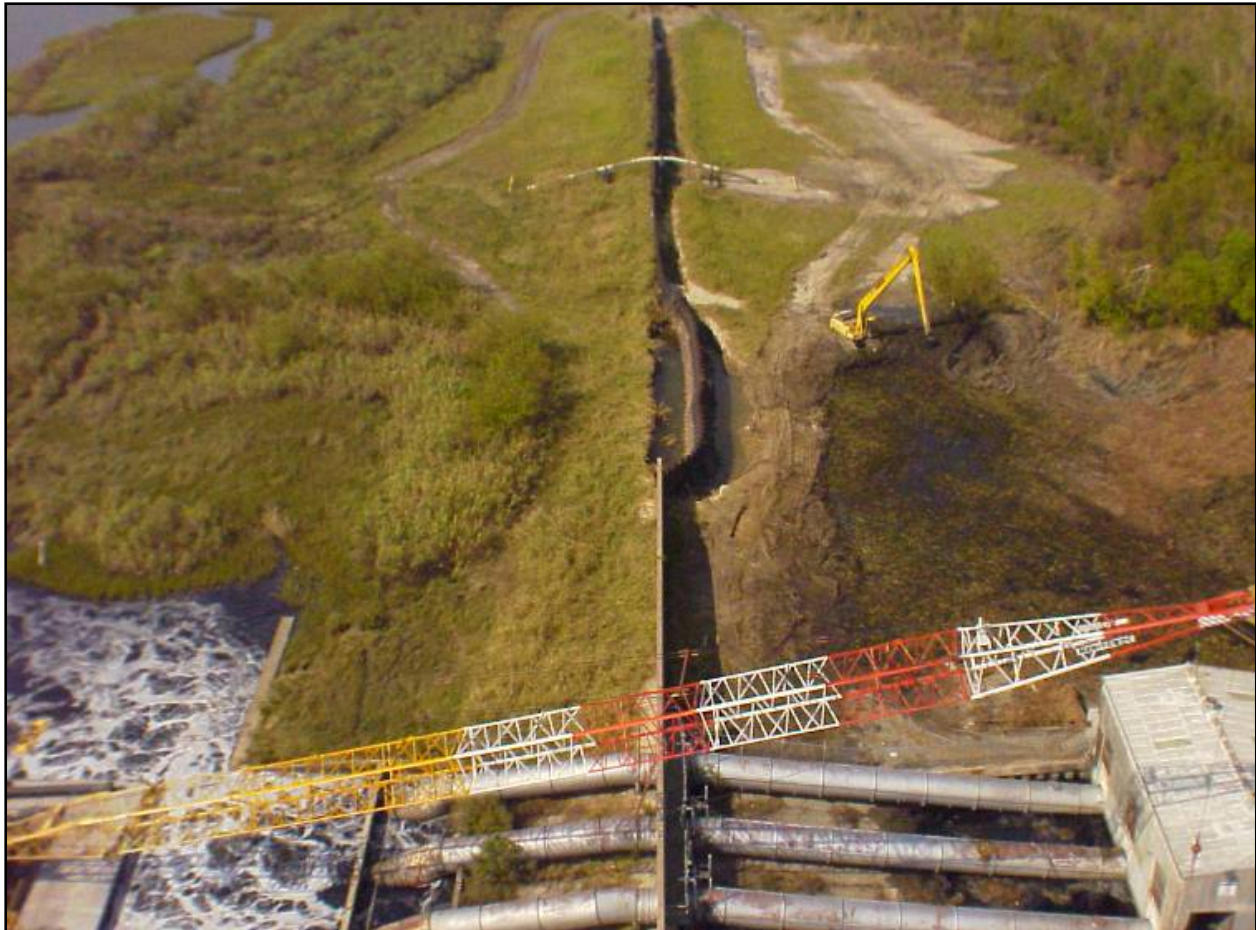
This reach is defined by the floodwall around Orleans Parish Pump Station #15. There were two types of walls within this reach prior to Katrina, two 120-ft transition sheet pile walls at the both ends of a middle 253-ft T-wall section. The total length of this reach is 493 feet. Portions of the transition sheet pile sections were heavily damaged during Katrina as shown in Figure NOE 12. There are no key or transition points assigned to this reach.

Figure NOE 12. Floodwall Failure Near Orleans Pump Station #15

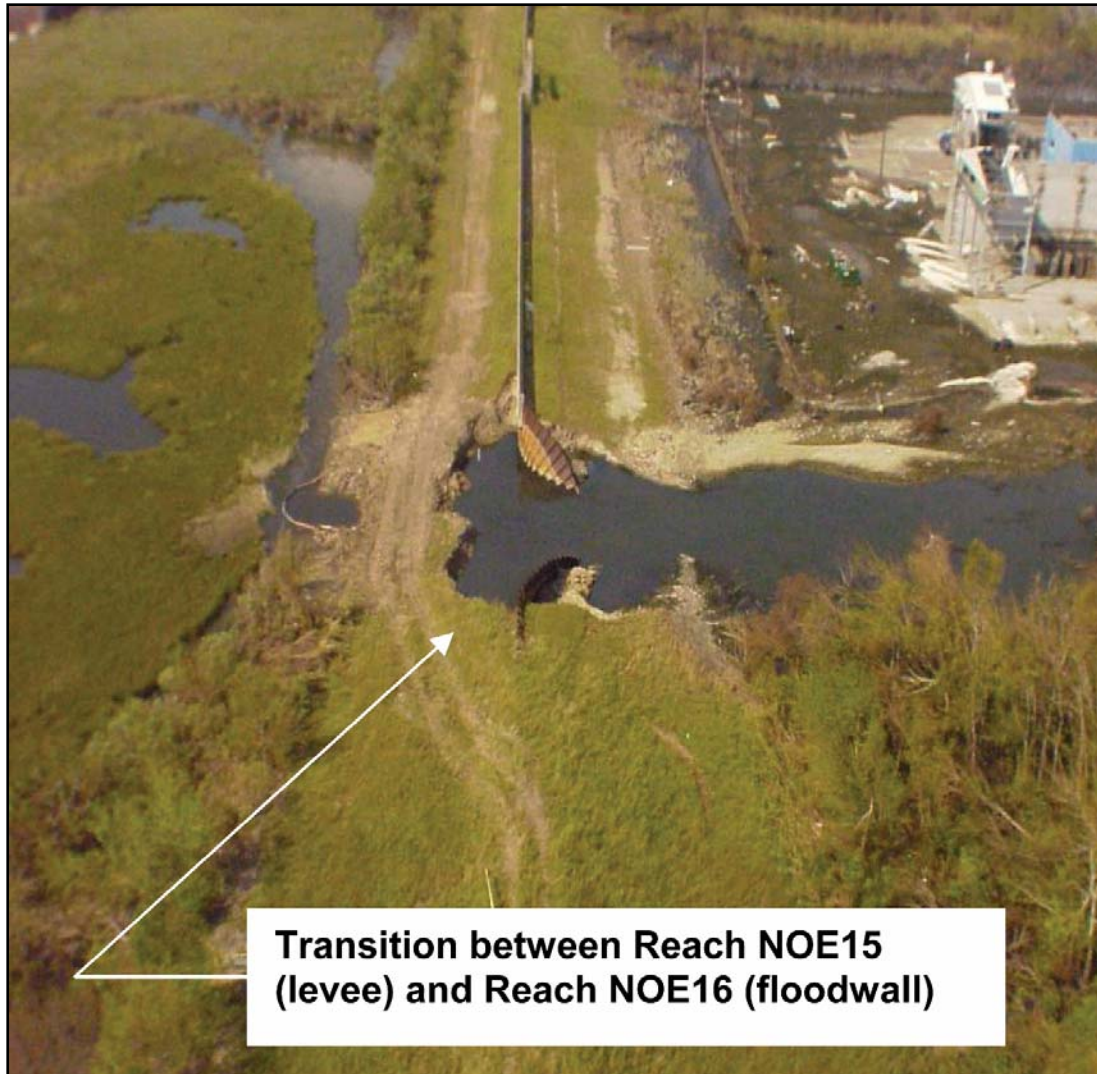
Figure NOE 13. Floodwall Failure at East End of Michoud Canal FW

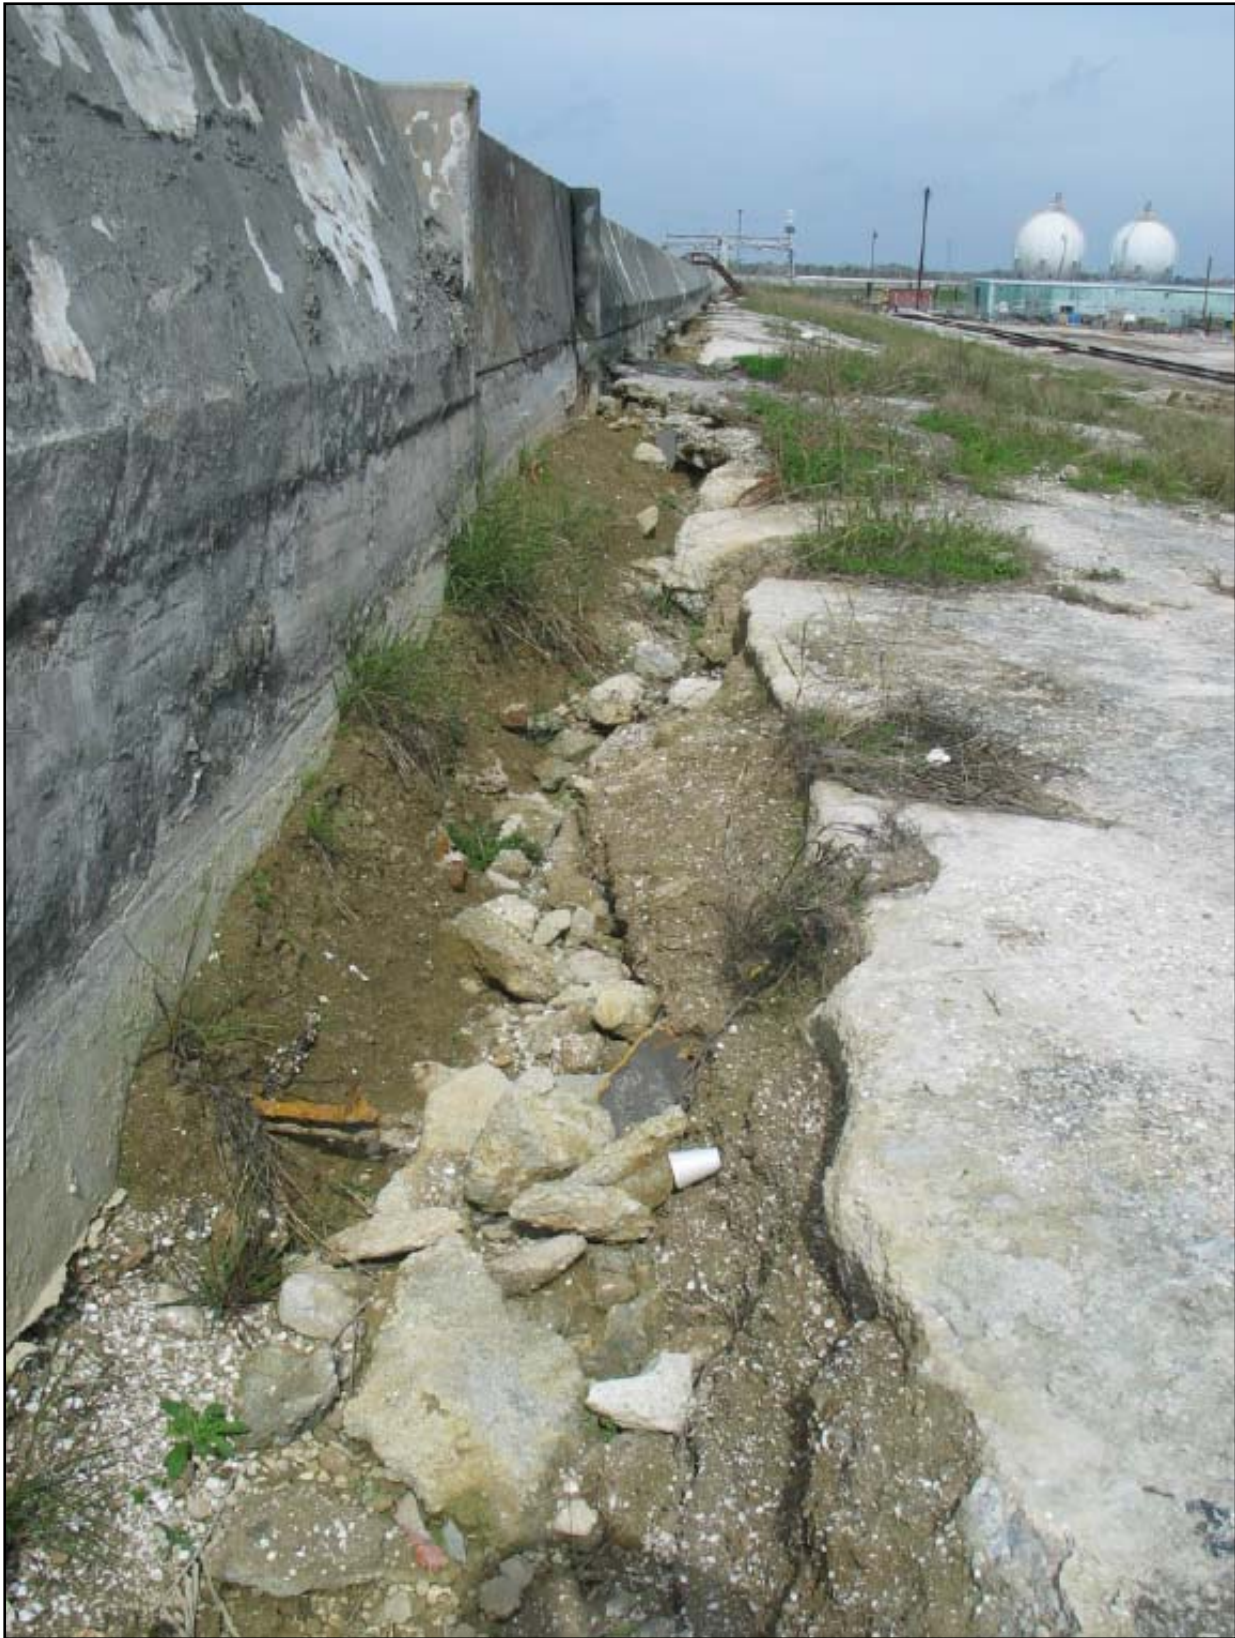
weighted average top elevation as shown in the table below, and was based upon a physical survey taken by MVN in 2006. The reach starts at the GIWW and continues along the Michoud Canal where it joins with the Citrus Back floodwall. There are 18 key points along this reach for gated closures at industry and road crossings. However, from site inspections, it appears as if five of these gates are placed in the permanently closed position. As shown in Figure NOE 13, the transition sheet pile floodwall at the beginning of this reach failed during Katrina. This section was rebuilt under TFG. The concrete capped I-wall section was overtopped and suffered significant scour as shown in Figure NOE 14, but performed well. There are no transition points assigned to this reach.

Figure NOE 14. Scour Damage Behind Michoud Canal Floodwall

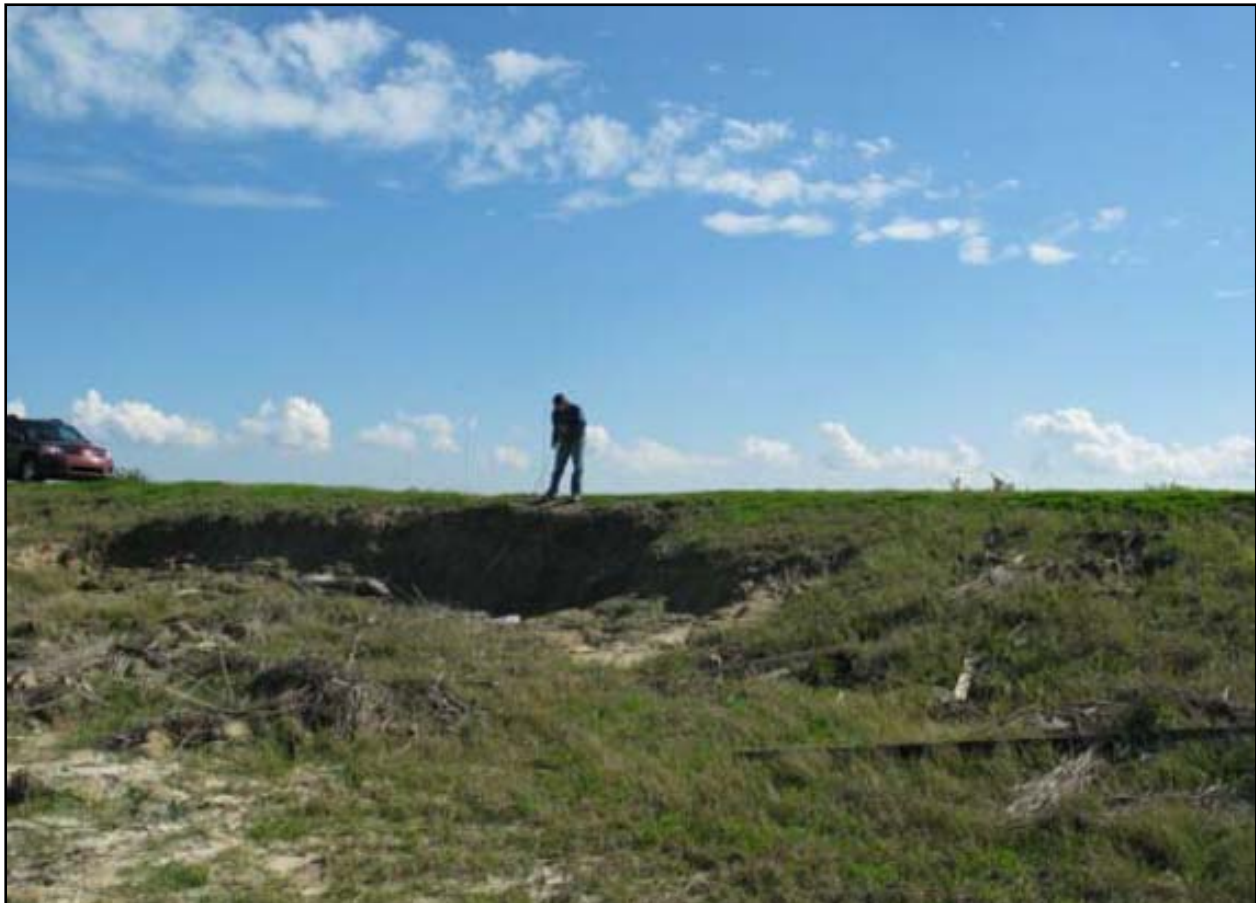
Katrina with moderate areas of scour damage, as shown in Figure NOE 15, but there were no major breaches in this reach

Figure NOE 15. Scour Damage Along Citrus Back Levee

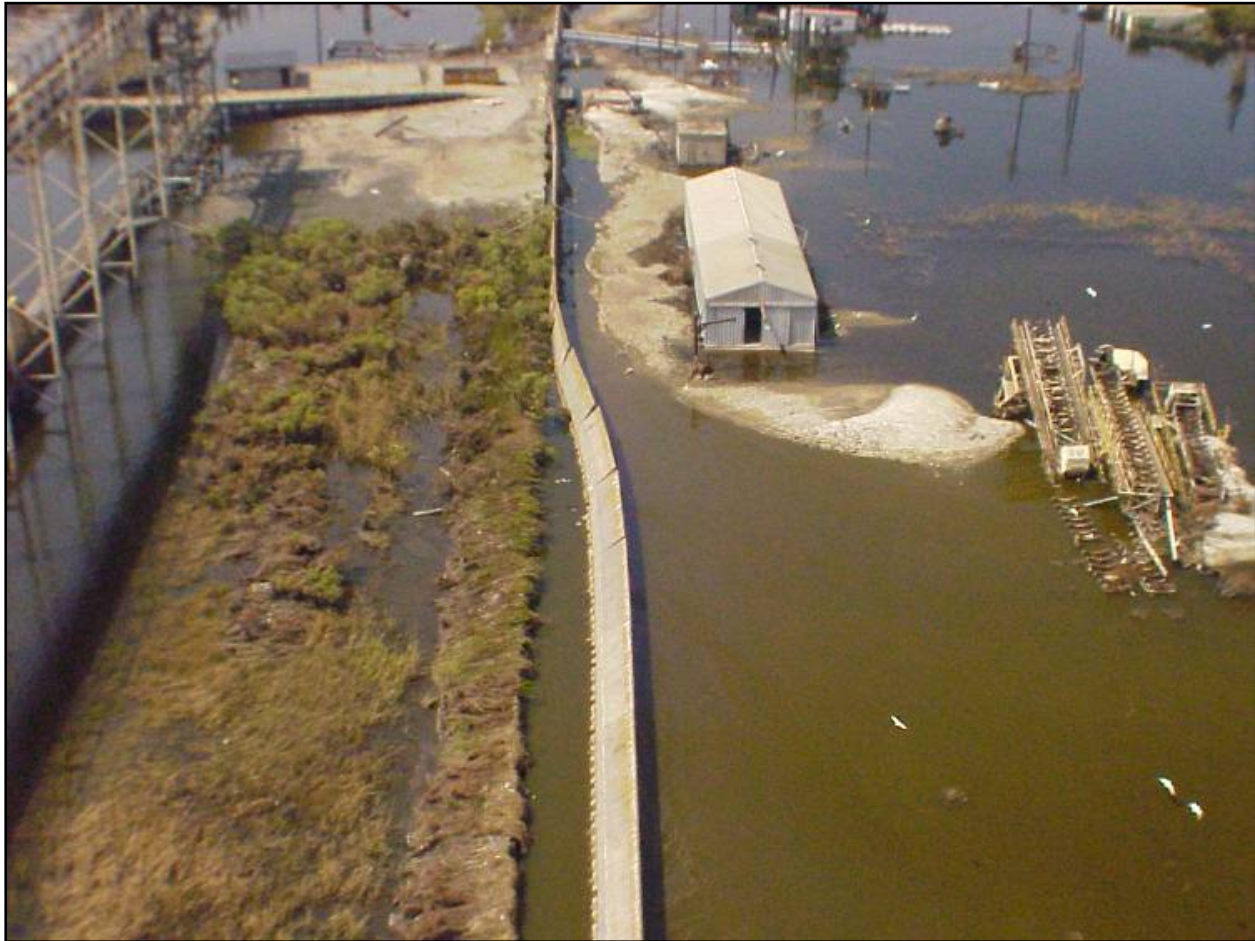
This reach is defined by the combination floodwall built for the Bulk Loading Facility and Elaine Pump Station. This wall was heavily damaged during Katrina, as shown in Figure NOE 16, and was repaired under TFG. Prior to Katrina, it had a top elevation as shown by the table below, and was based upon both physical survey by MVN in 2006. There is one key point, gate N1 for the Bulk Loading Facility, within this reach. There are no transition points assigned to this reach.

Figure NOE 16. Floodwall Failure at Bulk Loading Facility/Elaine PS

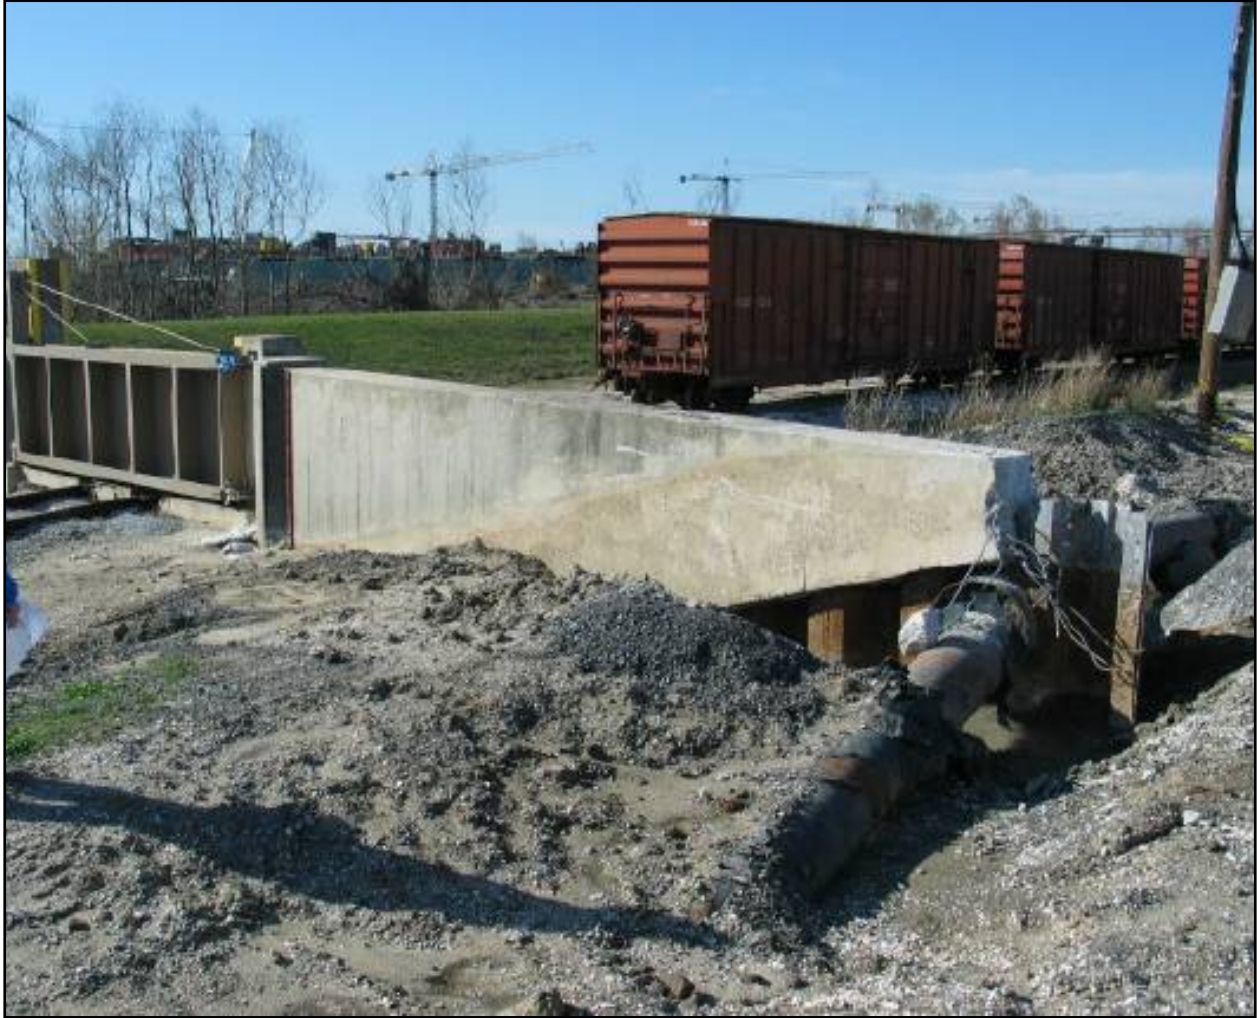
The final reach of the Citrus Back Levee stretch is a levee extending from the end of the floodwall just east of the Amid Pump Station to its tie in with the Inner Harbor Navigation Canal (IHNC) east levee. There is one key point (railroad closure gate) located within this reach and two transition points (railroad closure transition I-walls and the end of the I-wall near the Amid Pump Station). The transition around the railroad closure structure was overtopped and sustained significant scour damage, as shown in Figure NOE 17. This reach had a weighted average top elevation as shown in the table below, and was based upon an adjusted LIDAR survey taken prior to Katrina.

Figure NOE 17. Erosion Damage Around RR Closure (Near GIWW and IHNC Intersection)

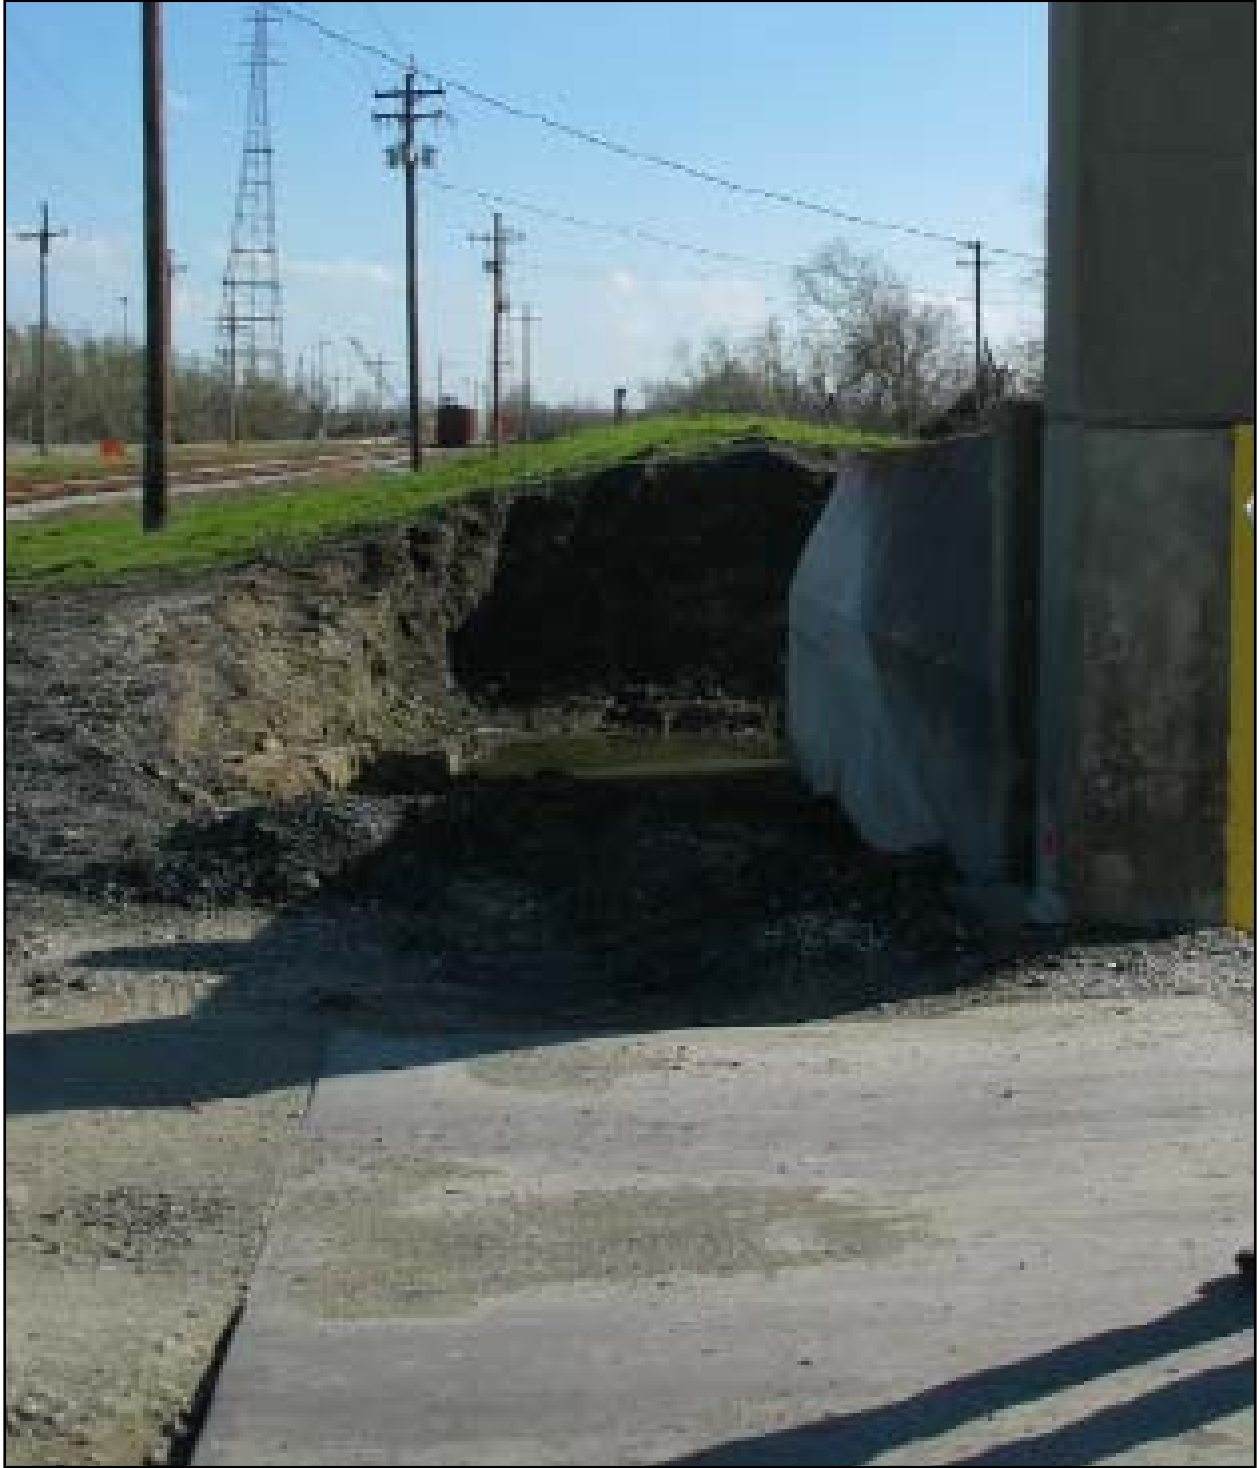
This reach consists primarily of levee with several gated closures. The weighted average top elevation of this reach is shown on the table below, and was based upon an adjusted LIDAR survey taken prior to Katrina. There are four closure gates, each a key point, within this reach; all of which suffered erosion damage from overtopping during Katrina. Each of these four closure structures has short adjoining I-walls which represent four transition points that are assigned to this reach. There is one additional transition point assigned to this reach where the end of the levee ties into the beginning of the floodwall, as shown in Figure NOE 19. A typical example of the scour damage around these closure structures is shown in Figure NOE 18. Structural damage was minimal to these closure structures. The very end of this reach suffered a major washout area where the levee serves as a ramp just near the I-10 overpass. A photograph of this washout damage is shown in Figure NOE 19.

Figure NOE 18. Scour Damage around Gated Closure Along IHNC
