# Appendix 2

## New Orleans East Basin

### NOE – Background

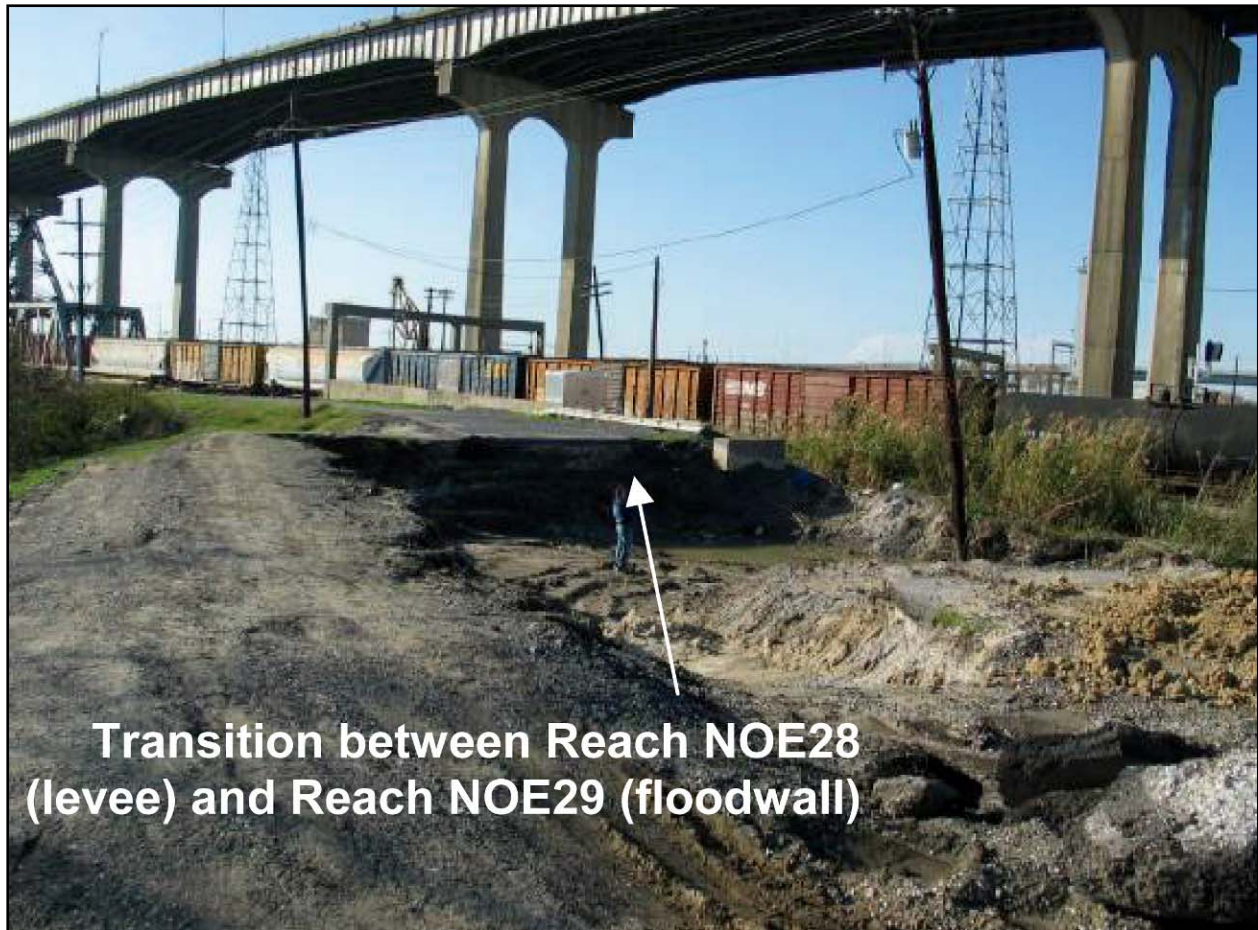
This reach consists primarily of levee with several gated closures. The weighted average top elevation of this reach is shown on the table below, and was based upon an adjusted LIDAR survey taken prior to Katrina. There are four closure gates, each a key point, within this reach; all of which suffered erosion damage from overtopping during Katrina. Each of these four closure structures has short adjoining I-walls which represent four transition points that are assigned to this reach. There is one additional transition point assigned to this reach where the end of the levee ties into the beginning of the floodwall, as shown in Figure NOE 19. A typical example of the scour damage around these closure structures is shown in Figure NOE 18. Structural damage was minimal to these closure structures. The very end of this reach suffered a major washout area where the levee serves as a ramp just near the I-10 overpass. A photograph of this washout damage is shown in Figure NOE 19.

Figure NOE 19. Major Washout Area from Overtopping Near I-10 Overpass (Note: Located Along IHNC East Side)

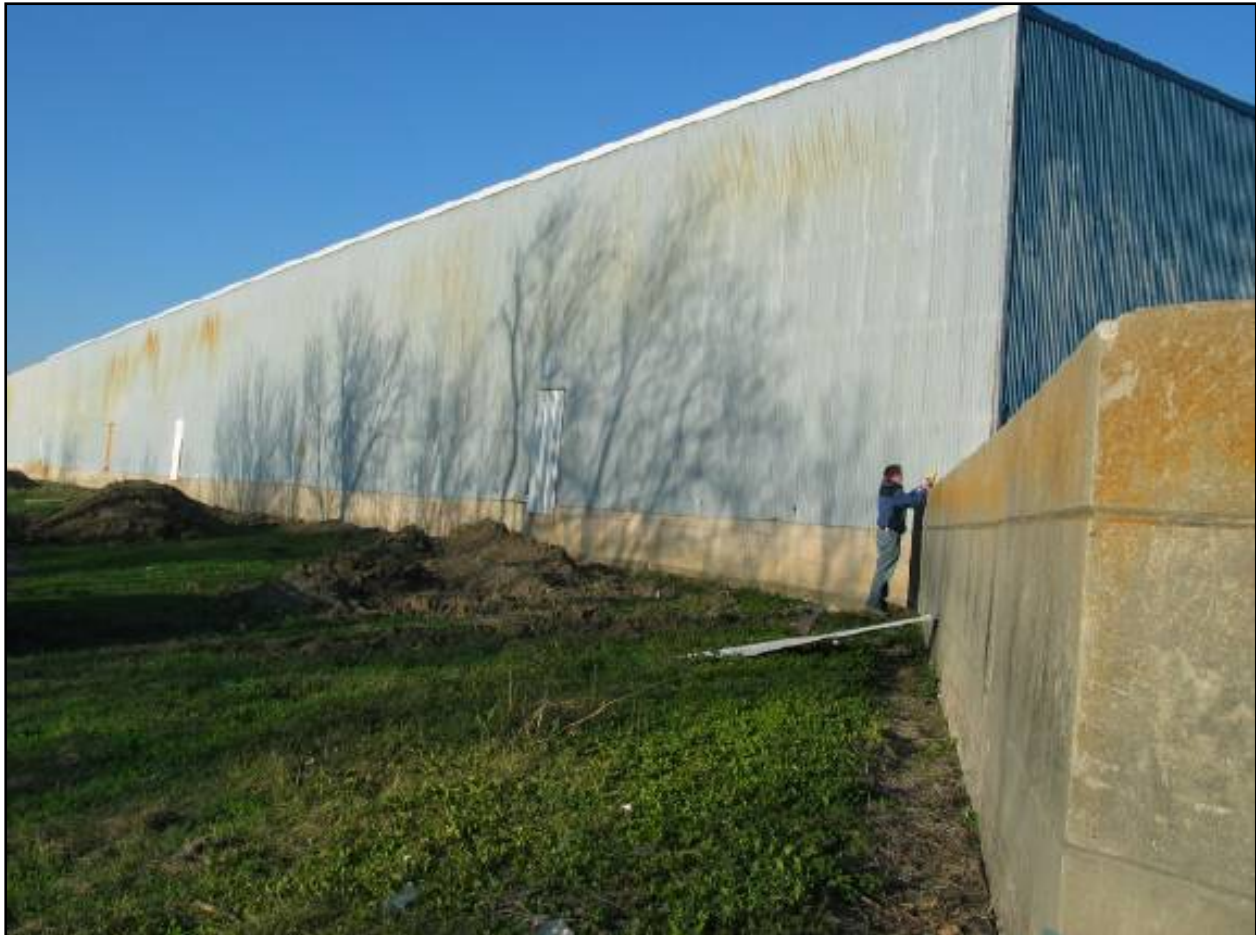
This section of floodwall starts between the I-10 and Highway 90 overpasses and ends where it serves as the foundation for the Dupuy Storage Facility (see Figure NOE 20). There are no key points, but there is one transition point in this section, which is the old Highway 90 overpass location. It does not appear as if remedial repairs were made to this transition section when the overpass was relocated. The weighted average top elevation of this reach is as shown in the table below, and was based upon a physical survey taken during November 2005. This reach was overtopped with minimal damage during Katrina.

Figure NOE 20. Floodwall Serves as Building Foundation (Dupuy Storage Facility – IHNC East)

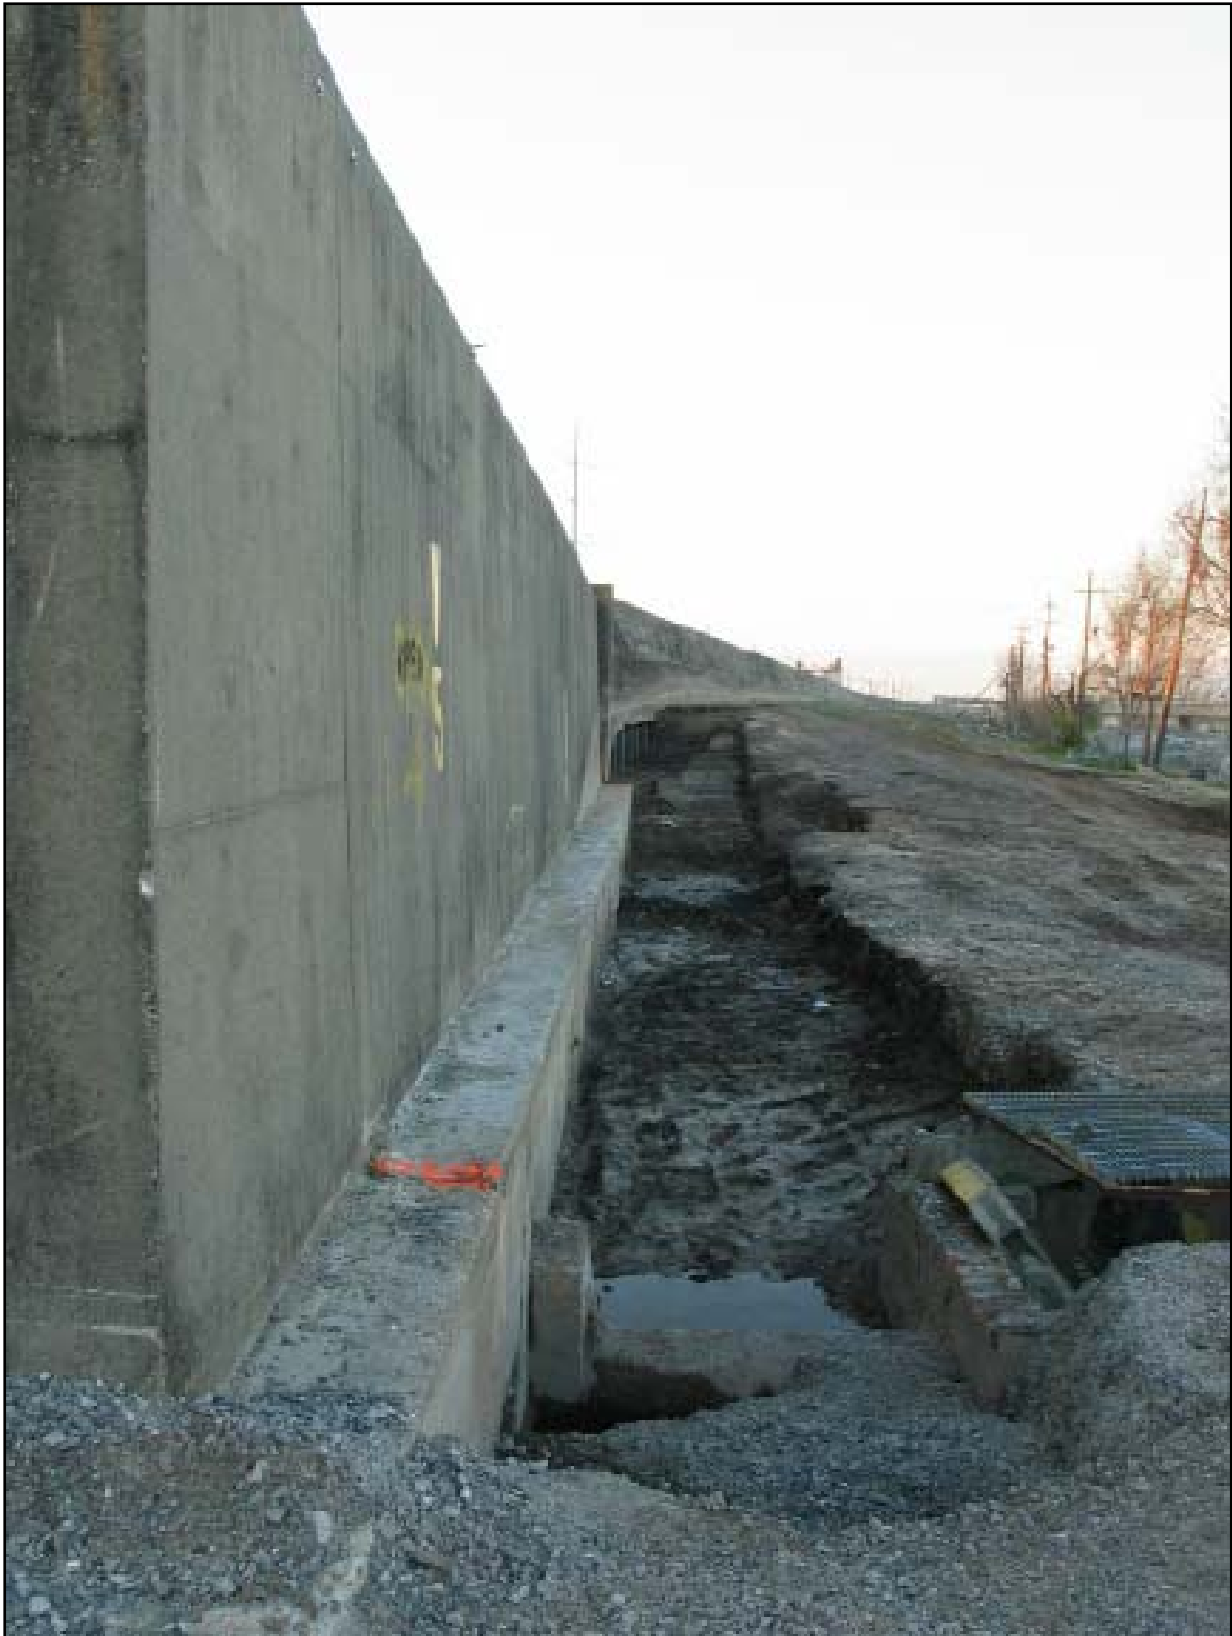
The last reach of the basin consists of floodwall. There are several key points (closure gates) within this reach. There is one transition within this reach at the Jourdan Road crossing. The weighted average top elevation of this reach is as shown in the table below, and was based upon a physical survey taken in November 2005. This includes the shorter sections of T-walls located around closure gates. Portions of this wall were overtopped as indicated by the erosion behind the floodwall adjacent to closure gate E-13 and shown in Figure NOE 21. This erosion, which measures approximately 8-ft wide by 2.5-ft deep, did not cause major structural problems for the wall at this location.

Figure NOE 21. Erosion Behind Floodwall Adjacent to Gate E-13 (IHNC East)
