**AN EVALUATION OF
NORTH CAROLINA DEPARTMENT OF TRANSPORTATION
WETLAND MITIGATION SITES: SELECTED CASE STUDIES**

Phase 2 Report

March 2002

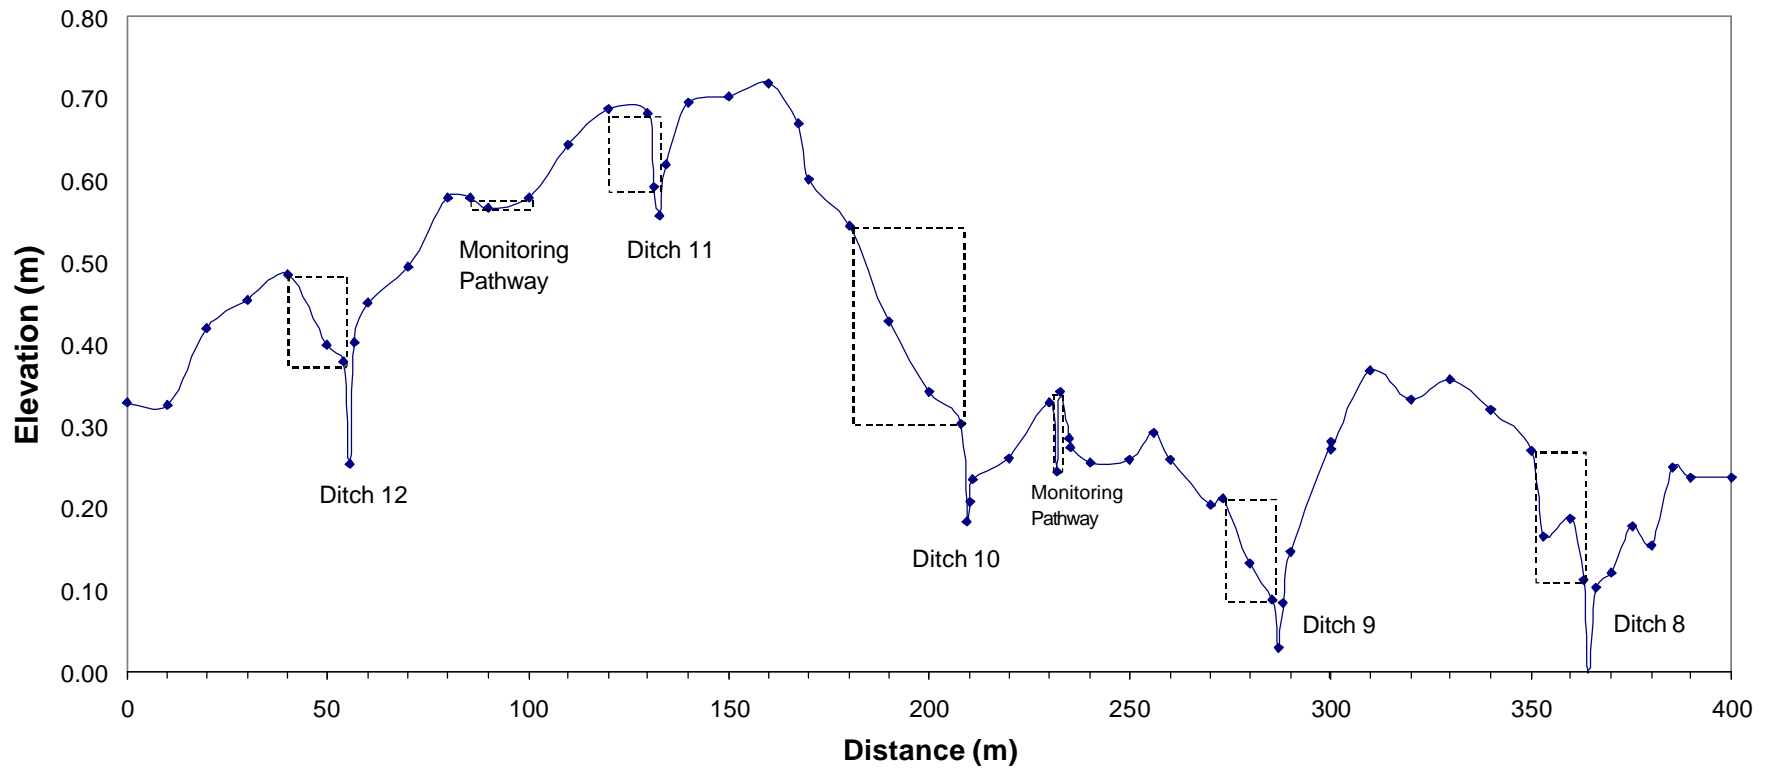
Figure 8. Surveyed cross-section of ground elevations at Ballance site (west to east) relative to the lowest elevation recorded. Ditches are numbered from east to west. Dashed rectangles mark locations of scraped areas. Monitoring pathways are dirt roadways used to access water level monitoring gauges and/or vegetation-monitoring plots. Vertical scale is exaggerated.

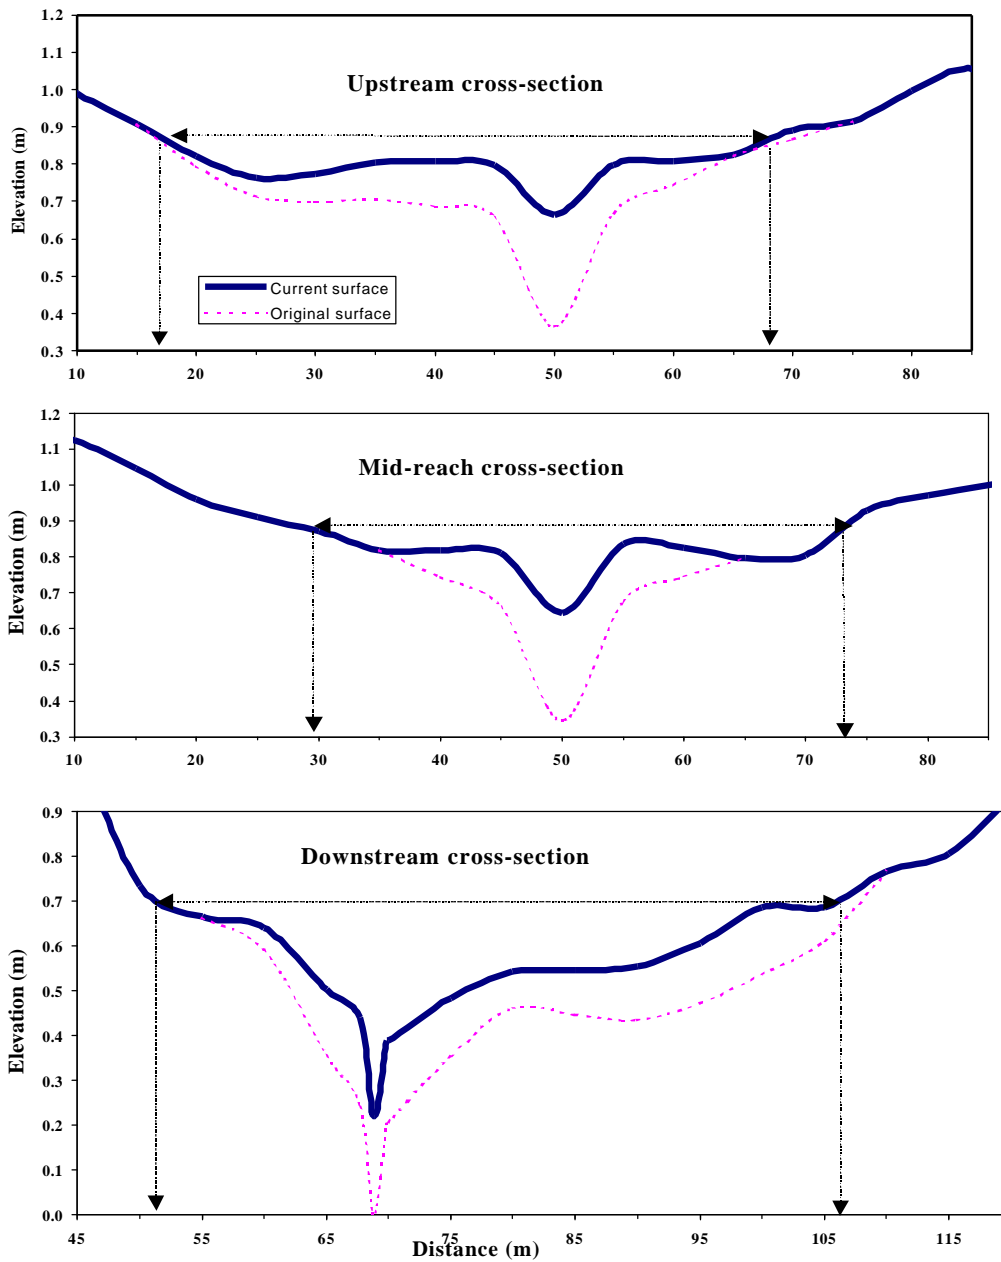
The cross-sectional profile (Fig. 11) of the most upstream cross-section showed a gradual rise in the profile on the south side of the stream at between m-65 and m-70. This rise in profile, at approximately 0.9 m above our benchmark elevation, likely indicates the approximate floodplain boundary. This same elevation occurred on the north side of the stream between m-15 and m-20. Recently deposited alluvium (accreted sediment) decreased from the channel (30-cm thick) outward 10-15 m from the channel center, from m-15 to m-75 (Table 22). This indicated that the stream was carrying and reworking the sediment within this zone. Therefore, all areas of active sediment accretion (m-20 to m-65) could be assumed to be within the active floodplain. Based on our cross-sectional profile, it seemed that the floodplain began between approximately m-65 and m-70 on the south side and between m-15 and m-25 on the north side (Fig. 11).

Figure 11. Cross-sectional profiles across Horsepen Creek floodplain. The upstream x-section was the western-most transect. Transects were parallel to one another and approximately 50-m apart.

Along the upstream transect, herbaceous vegetation changed from *Solidago*-dominated (upland) assemblages north of m-25 to *Leersia*-dominated (hydrophytic) assemblages between m-25 and m-65 (Table 23). This corresponded to the floodplain boundary inferred from the cross-sectional profile. *Leersia* sp. and *Typha* sp. co-dominated the wettest portion of the floodplain area on both sides of the stream channel, between m-45 and m-55. This near channel area was the portion of the cross-section where the thickest sediment deposition occurred. A mixture of hydrophytic and upland species dominated the transect area south of m-65 (beyond the inferred floodplain boundary).

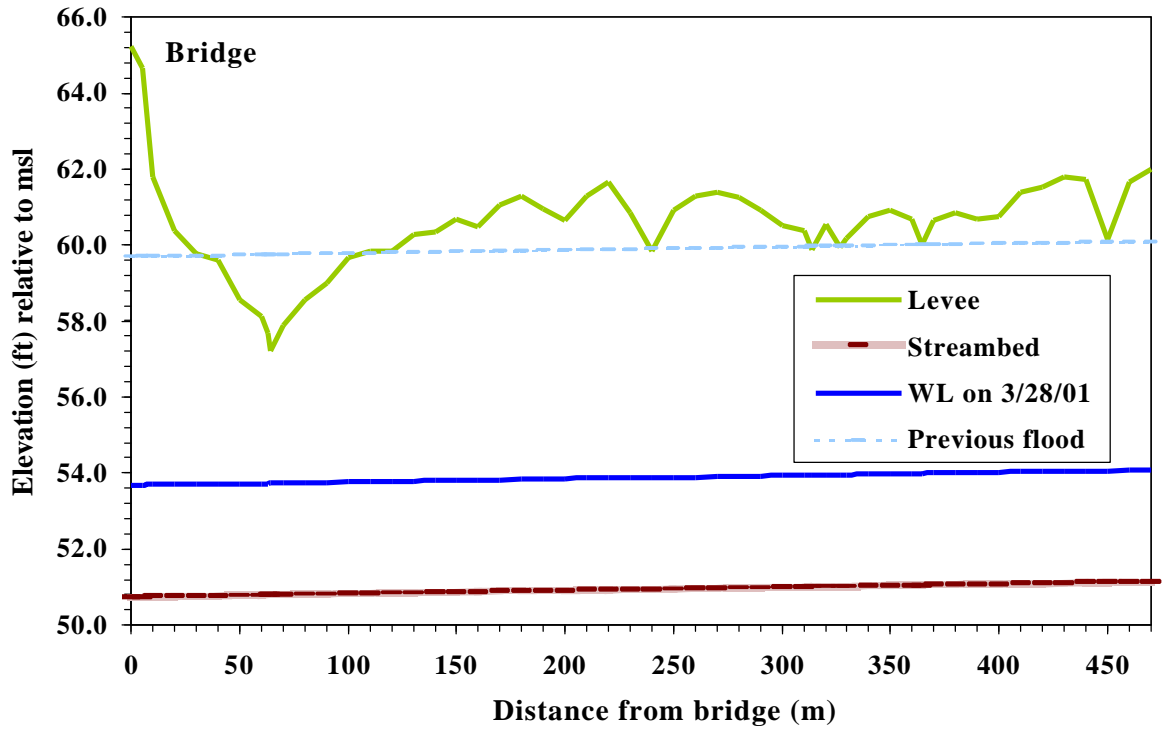
Figure 12. Surveyed elevations at Gurley of Nahunta Swamp Creek upstream from the bridge and the levee located on the north side of the creek.

Notches excavated from the existing levee were, at their lowest point, designed to be 0.5 m (1.5 ft) above the relic floodplain. This was based on the observation that streams in eastern North Carolina of similar order and drainage basin size have levees about 0.5-m high. However, the streambed of Nahunta is lower than it was prior to channelization, meaning that the former floodplain is now located higher above the streambed than it was before channelization. This also means that the stage at which overbank flow would occur is now higher. As constructed, the Nahunta would have to rise to a stage of 57.2 for water to flow through the lowest notch and onto the former floodplain.

During our initial reconnaissance of Gurley, it appeared to us that the stone rip-rap placed at intervals along the levee of Nahunta were an attempt to block drainages (a creek and ditch) entering Nahunta Creek and prevent erosion of the bank rather than facilitate overbank flow. This seemed like an excellent way to increase the duration of water retention on the former floodplain and enable it to once again process water (albeit, the water would not originate from overbank flow as it did before Nahunta was channelized). However, we later learned that notches were cut in the levee to encourage overbank flow from Nahunta channel to the former floodplain

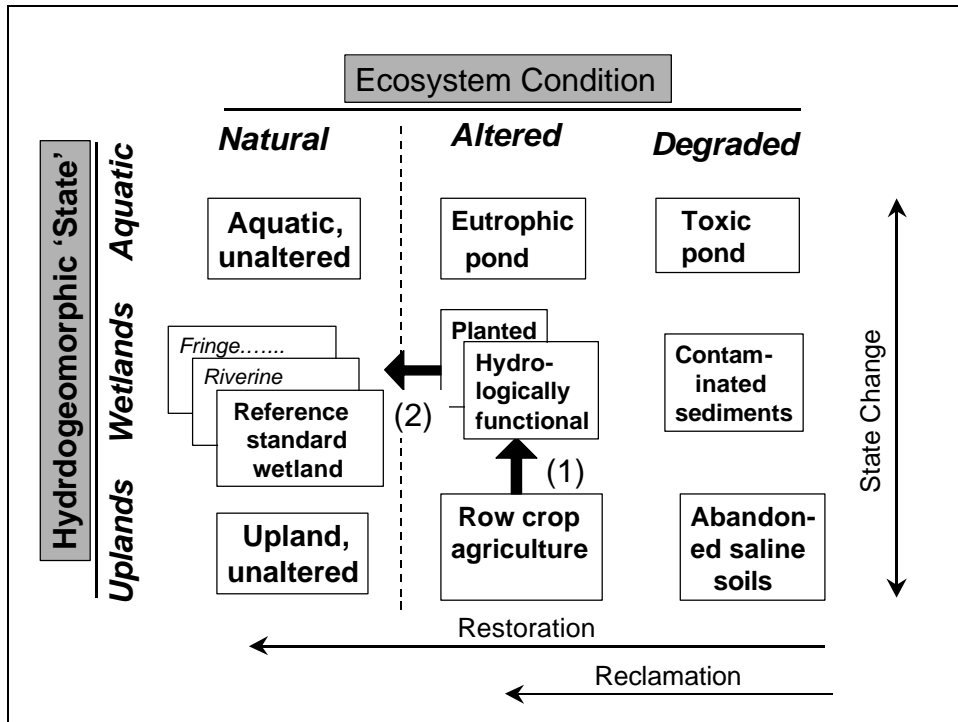
Figure 13. The distinction between restoration and state change. Restoration represents processes that move ecosystems of any type from a degraded or altered condition to the left. Strictly vertical movements are considered state change, and do not necessarily reflect a change in condition. Many wetland restoration projects initially change a former wetland (or upland) to an altered wetland, or from the bottom center box to the center box (arrow 1) as in the case of restoring prior converted croplands. Restoration requires moving sites from the right to the left, e.g., arrow (2).

The effectiveness of NCDOT's mitigation program could be improved if the regulatory community adopted a more flexible and scientifically-based view of restoration, like the one proposed recently by the Wetlands Concerns Committee of the Society of Wetland Scientists (Appendix A; <http://www.sws.org/wetlandconcerns/restoration.html>). This committee defined restoration as "actions taken in a converted or degraded natural wetland that result in the re-establishment of ecological processes, functions, and biotic/abiotic linkages and lead to a persistent, resilient system integrated within its landscape." The definition emphasizes restoration of ecosystem processes and sustainability. By incorporating this definition into the mitigation lexicon, the term "enhancement" would not be considered to be a reasonable option. Rather, mitigations currently defined as "enhancements" would be considered restoration if the manipulation restores structure and functioning to the ecosystem; a manipulation that increased certain functions (usually at the expense of other functions) would not be considered restoration
