# Pavement Edge Treatment

WA-RD 798.1

**Post-Construction Report**  
Experimental Feature WA 11-01

Contract 8017, SR 395  
Lee Road to Junction I-90

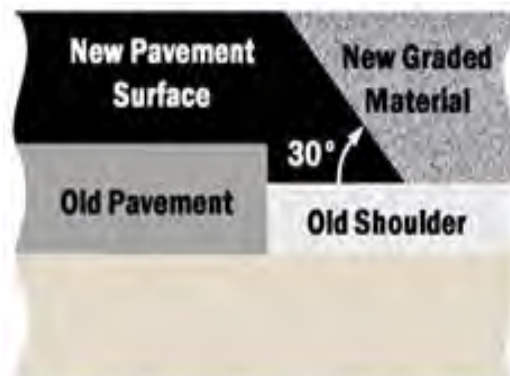
Figure 2. Safety Edge<sub>SM</sub> detail. (FHWA Safety Edge PowerPoint)

The Safety Edge<sub>SM</sub> pavement edge treatment provides a non-vertical wedge at the edge of the pavement which reduces the steering forces needed for re-entering the roadway. With this treatment, the pavement edge is sloped at a 30° angle (see Figure 2). The presence of a slope instead of a vertical face makes it easier for a vehicle to re-enter the roadway after inadvertently driving off the edge of the pavement. Figures 3 and 4 are diagrams of a pavement edge without and with the pavement edge treatment. Figures 5 and 6 are photos of a pavement with a vertical edge and one with the pavement edge treatment. Figure 7 shows a pavement under construction with no edge treatment and with edge treatment.

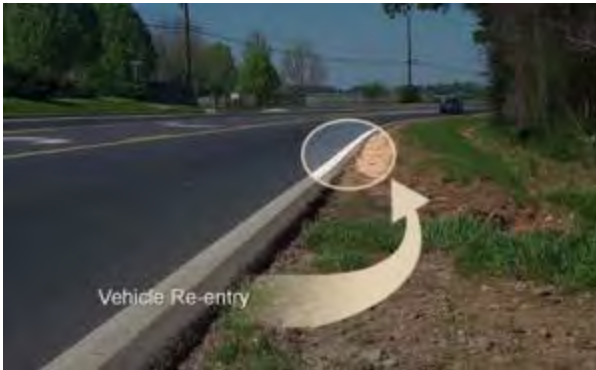
Figure 5. Vertical drop off at pavement edge. (FHWA Safety Edge<sub>SM</sub> PowerPoint)

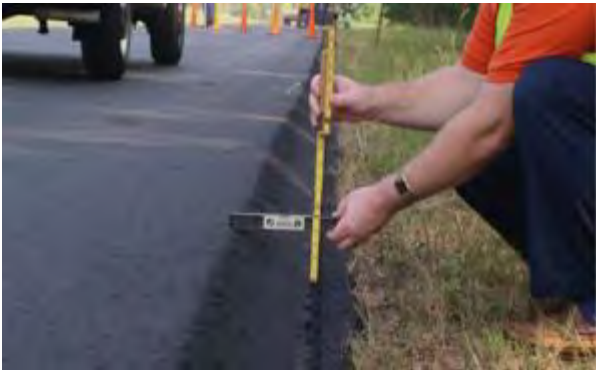
Figure 6. Sloping edge produced by pavement edge hardware. (FHWA Safety Edge<sub>SM</sub> PowerPoint)

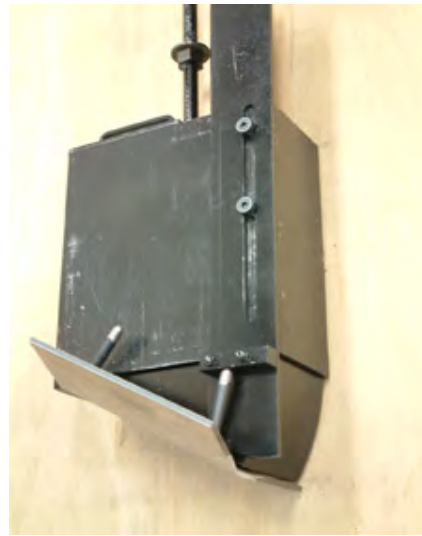
Figure 13. The Advant-Edge Ramp Champ™ forms a tapered safety edge or a longitudinal center lane joint.

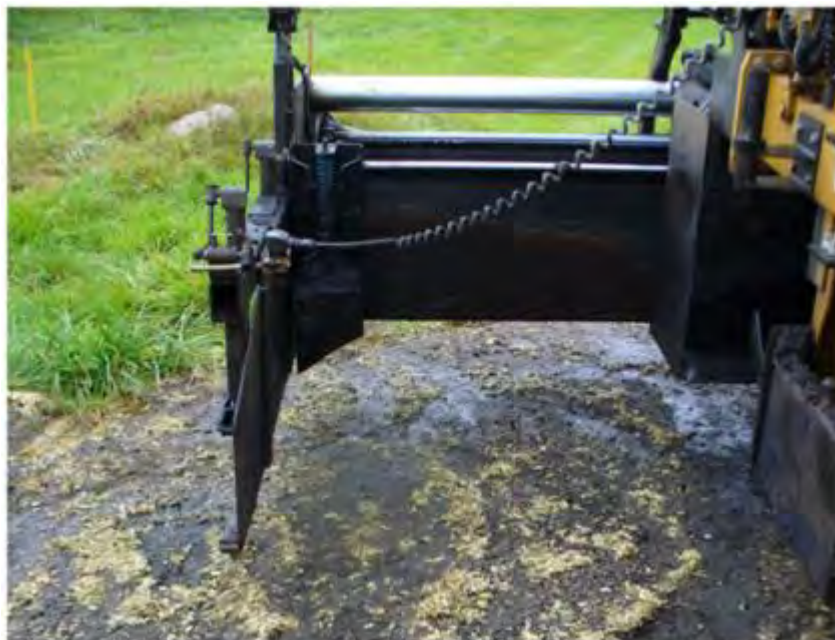
Figure 14. Advant-Edge™ mounted on a paver. Unit is designed to automatically adjust to shoulder elevation changes (driveways and intersections).

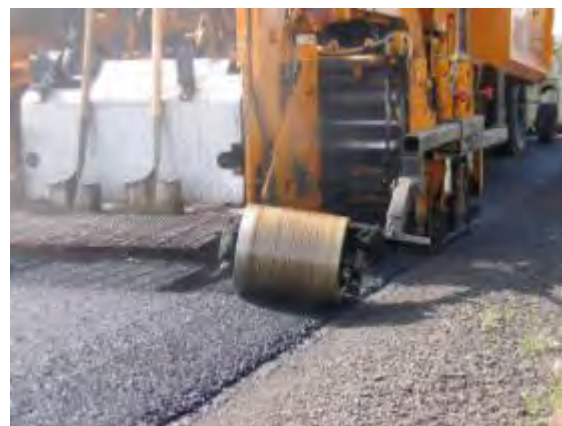
Figure 17. Paver forming and compacting pavement edge treatment.

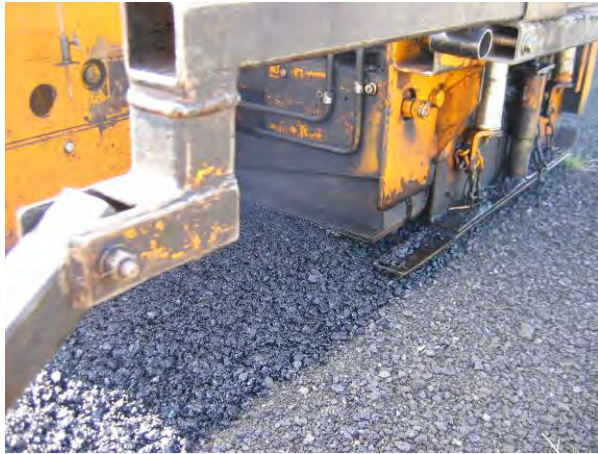
Figure 18. Close-up of paver screed.

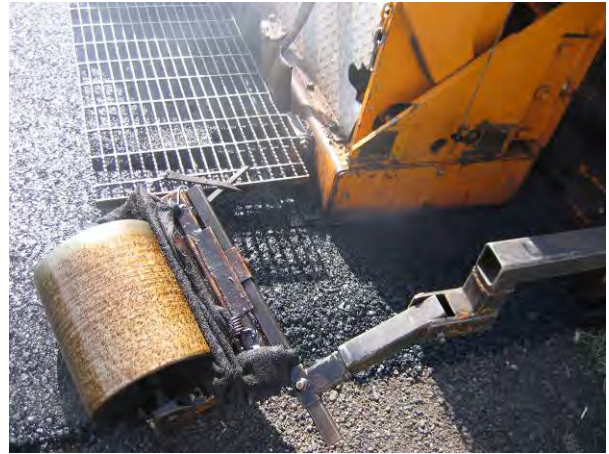
Figure 19. Close-up of roller hardware.

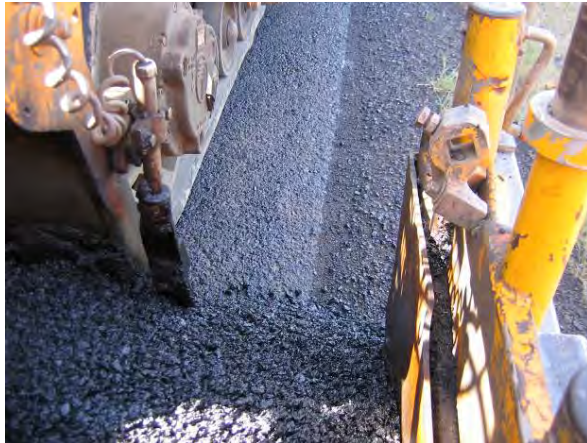
Figure 20. Close-up of sloped pavement edge showing top of slope at existing pavement edge.

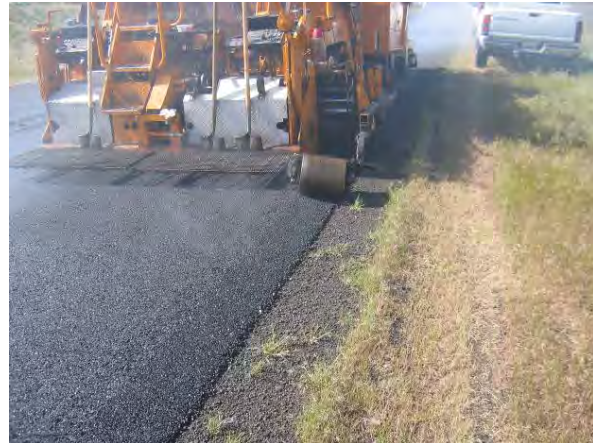
Figure 21. View of rolled pavement edge treatment.

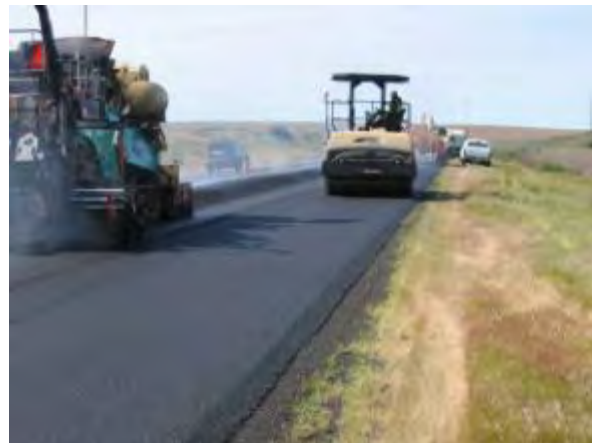
Figure 22. Distant view of paver with edge rolling hardware.

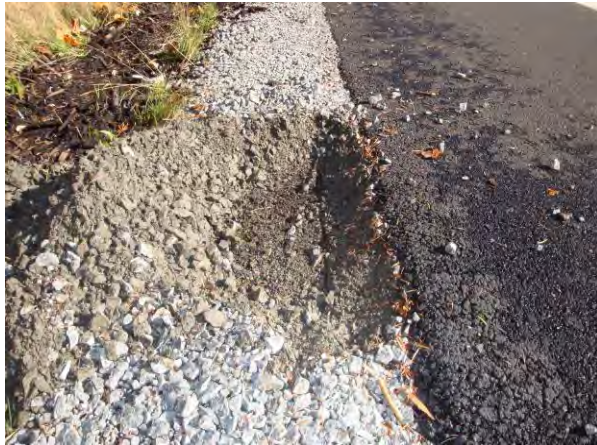
Figure 35. Dig out showing slope of pavement edge.

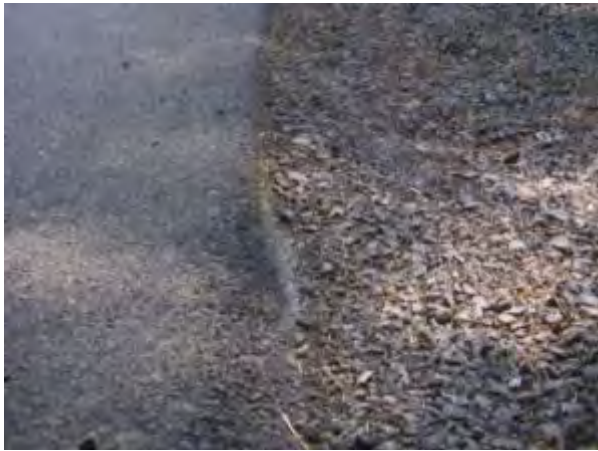
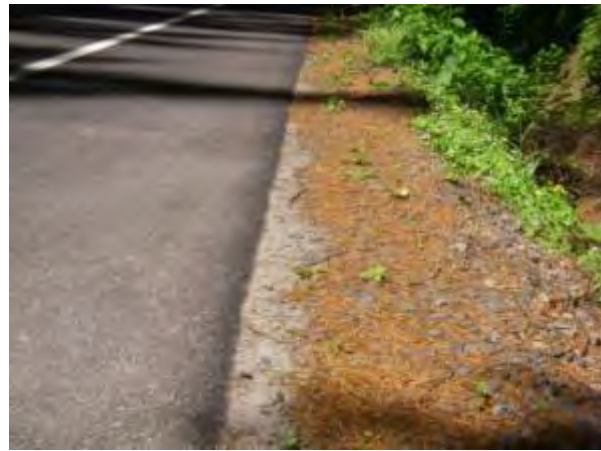
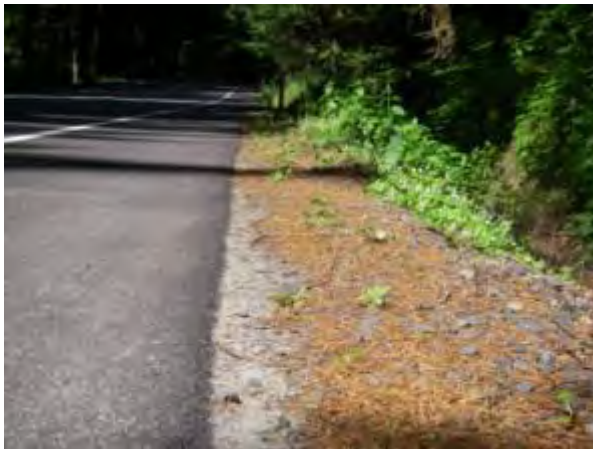
Figures 37 through 40 show the SR 410 pavement edge treatment one year after construction. Some erosion can be seen of the shoulder material exposing the pavement edge treatment.

Figure 37. Pavement edge treatment close-up one year after construction.

Figure 38. Pavement edge treatment on SR 410 one year after construction.

Figure 39. Another photo of the SR-410 pavement edge treatment one year after construction.

Figure 40. Close-up of pavement edge treatment on SR 410 one year after construction. Shows some exposure of pavement edge treatment.

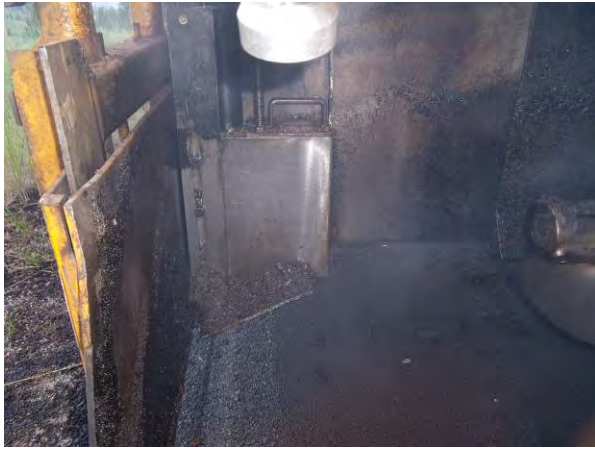
Figure 42. Advant-Edge™ used to produce the pavement edge treatment.

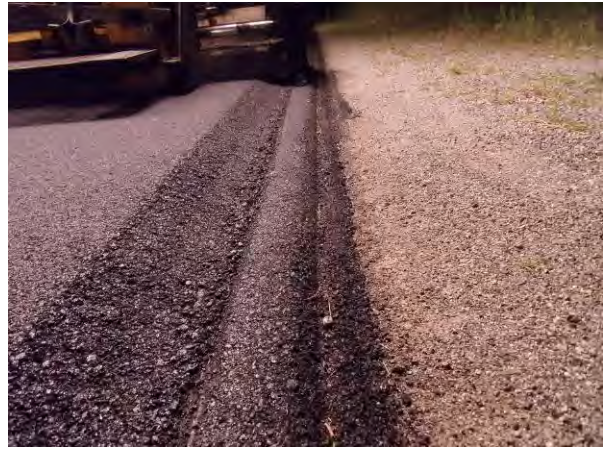
Figure 43. Pavement edge treatment produced by the Advant-Edge™.

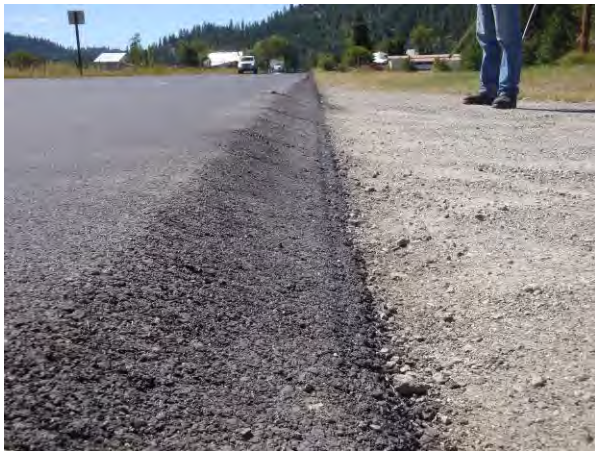
Figure 50. Slope of edge treatment across a road approach.

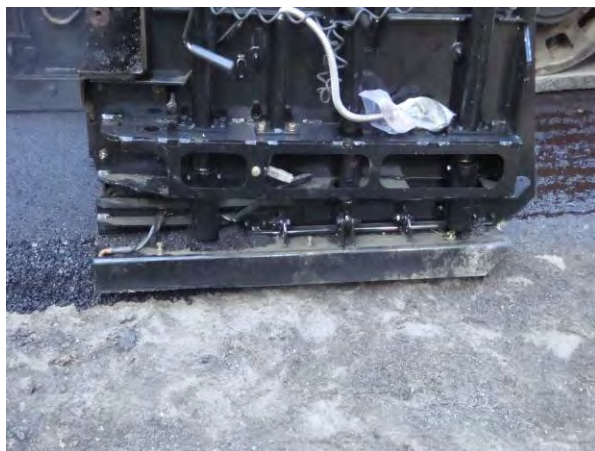
Figure 53. Side view of Carlson end gate.

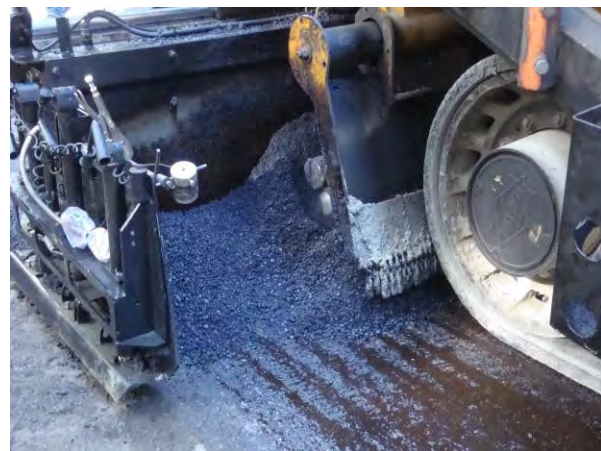
Figure 54. Mix passing through the end gate.

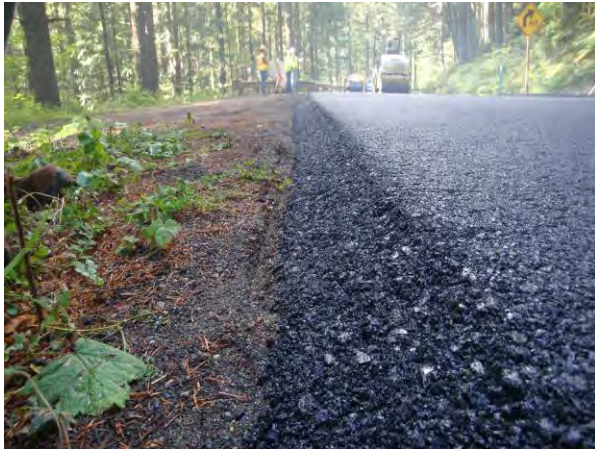
Figure 55. Pavement edge treatment produced by the Carlson end gate.
