Patient Safety Alert

AL09-21

May 4, 2009

-
- Item:** Arjo Carendo Shower Chair Model BIB 2003-01 or BIB2003-01KT
- Specific Incident:** A caregiver reclined an Arjo Carendo Shower Chair backward while showering a patient resulting in the patient's genitalia being pinched in the seat.

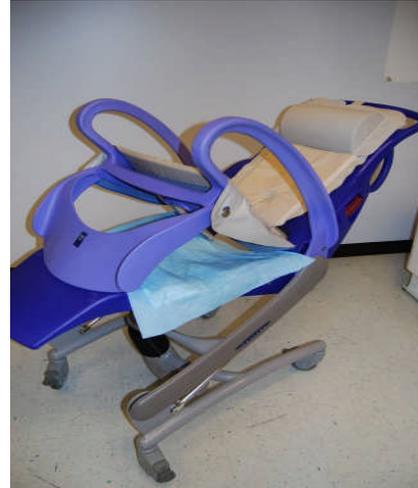
VA Carendo Shower Chair Application for Incontinent Patients Step #1 of 2

- When the Care Raiser is in a fully-raised position, place a chux across the bottom seat portion of the lift, beneath the Care Raiser seat, to avoid pinching of male genitalia of incontinent Patient or Resident.

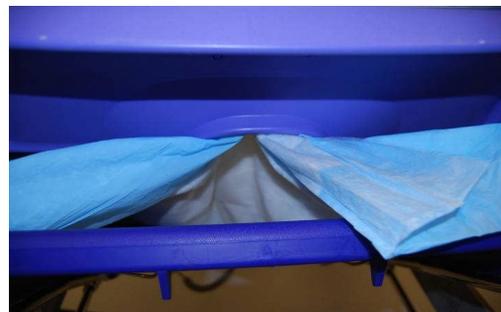
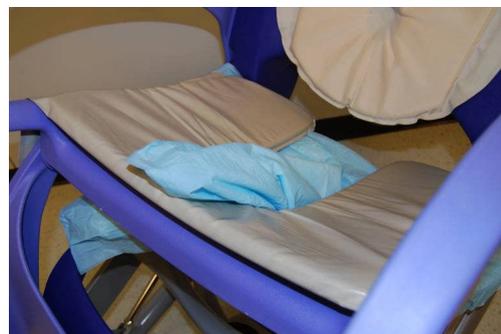
VA Carendo Shower Chair Application for Incontinent Patients Step #2 of 2

- To avoid pinching of male genitalia of incontinent Patient or Resident, pull the chux up through the front of the u-shaped opening of the Care Raiser seat.
- Insure that the Patient or Resident is comfortable before proceeding to lower the Seat

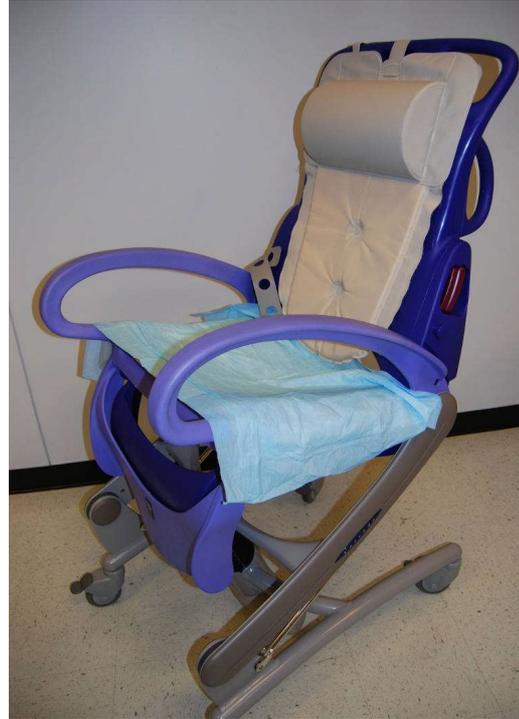
VA Carendo Shower Chair application
for Continent Patients

- To avoid pinching of male genitalia with Patient or Resident that is continent, the chux can be placed across the seat of the Carendo before the resident is placed in the chair, adding to the comfort of the resident.
