Patient Safety Alert

AL09-25

Item: Operable exterior windows in locked inpatient mental health units

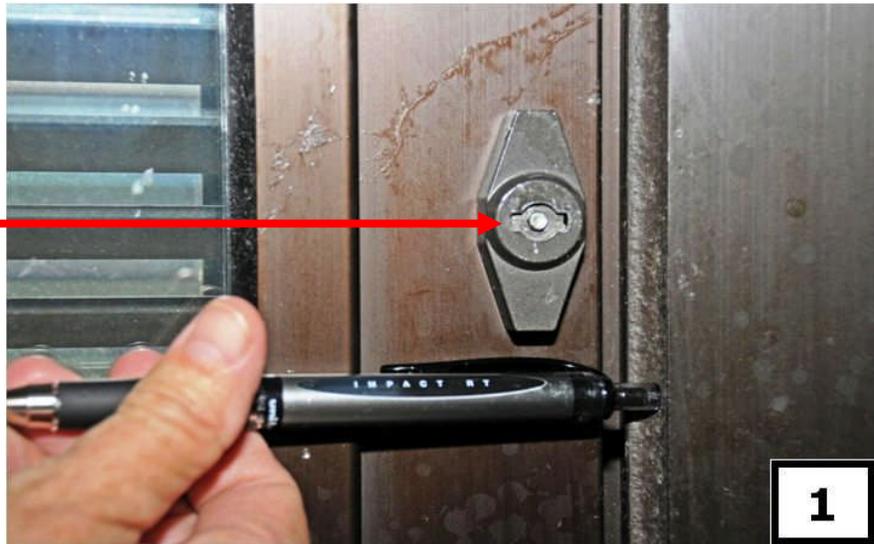
Attachment: Photos of Windows with Locking Mechanisms

**Wrench lever to
unlock window
inserts here.
Center of lock
resembles a
temper-resistant
screw.**

Specific Information: A patient in a seclusion room of a locked VAMC mental health unit opened a window using just their fingers and dropped two floors to the ground resulting in a serious injury. The patient was being observed using a television monitor. A bracket initially installed to limit the window opening to a maximum of 4 inches was missing, permitting the window to open to 12 inches. The window is designed to be locked using a wrench (similar to an Allen wrench) which turns a 'tamper resistant' screw. The wrench is supposed to be able to be removed only if the locking mechanism is engaged; however, the wrench was absent and the window was not locked. See photos # 1 and # 2 in the attachment.

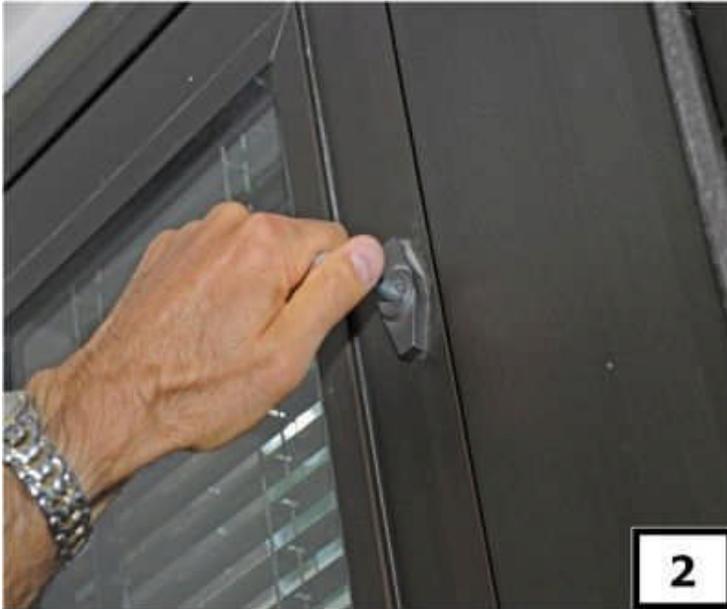
Attachment: Photos of Windows with Locking Mechanisms (cont.)

Wrench lever inserted.

Wrench lever shown in horizontal position = Locked position

When wrench lever in vertical position = Unlocked position

- b) ensure staff inspect any window locking wrenches or keys to make certain that they engage and activate the locking mechanism securely and are not worn.

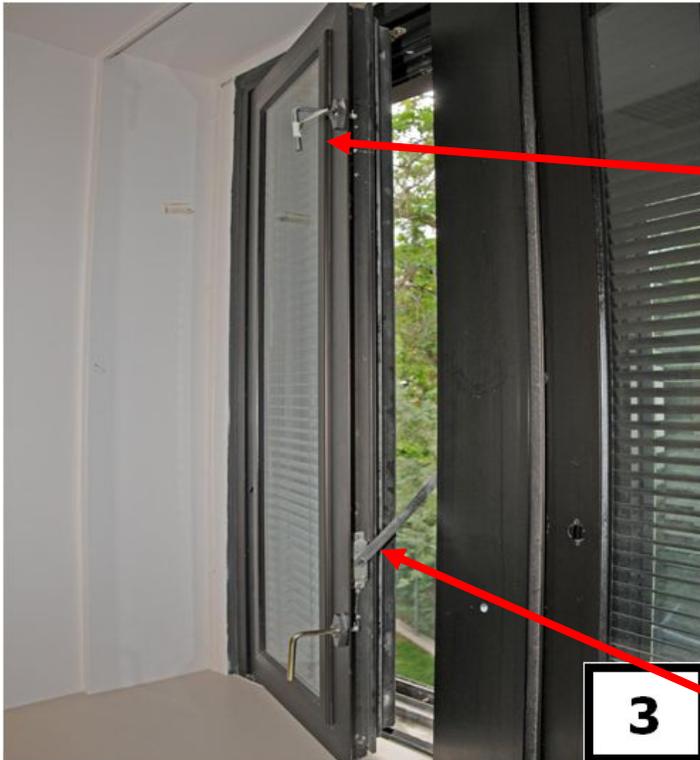
Attachment: Photos of Windows with Locking Mechanisms (cont.)

Wrench Levers are supposed to stay locked in place as long as window is unlocked, providing a visual cue.

But, wrench levers were removed and window was shut in the unlocked mode allowing patient to open.

The window is deeply inset into the frame and will stay shut if unlocked and pushed closed.

Note also the anchor point at the bracket.

Note that the addition of a bracket limits the window opening (see Photo #3 in the Attachment), but it creates a hanging anchor point requiring patient supervision when the window is open.

- c) if vulnerabilities are found in a) or b) above, corrective actions must be taken. Possible actions include, but are not limited to, arranging for repair or replacement of the locking mechanism and wrenches, covering the windows with Lexan, installing security screens (e.g., Chamberlin Screens), or replacing the windows.
