Office of Marine and Aviation Operations

SAFETY NEWS

TWELFTH EDITION

JANUARY 2013

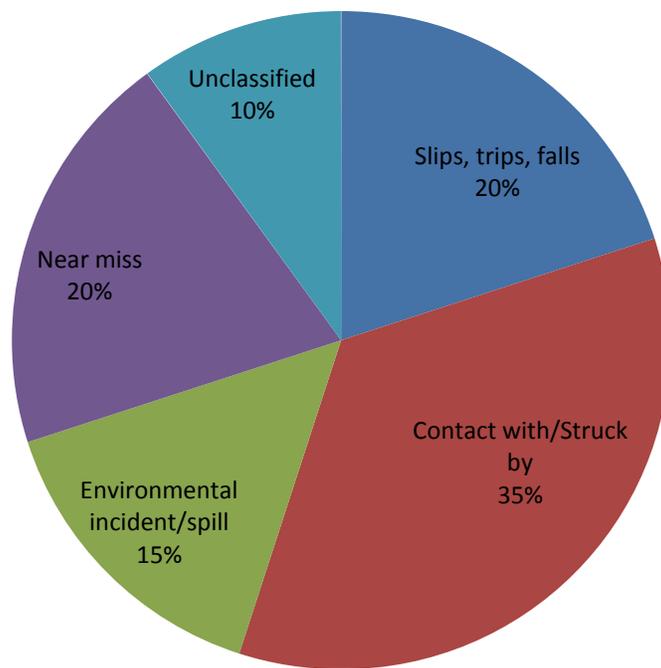
Percentage of Total Number of Incidents by Type

The total number of OMAO near miss; minor/first aid; medical treatment; lost time/light duty; and other incidents reported during the first quarter of FY2013 (October – December 2012) is listed in the table below and is shown as a percentage by incident type on the pie chart that follows. Arrows indicate changes from the previous quarter. Accident rates over the past 15 months are also shown on the bar graph that follows.

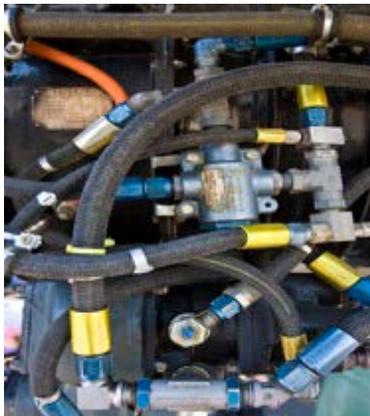
Some folks may think they don't need Human Factors training because it is just common sense. Nothing could be farther from the truth. For example, look at the picture of the aircraft plumbing fittings below:

It should just be common sense that everyone would know to tighten every single one of those fittings. Yet, in all too many aircraft accident investigations very qualified, conscientious maintenance personnel with great common sense left a line loose on an aircraft. Human Factors training is nothing more than training the person on how to avoid the error they never intended to make. It calls for making the person aware of the things that set him/her up to make an error and more importantly, what “safety nets” the person can put in place in order to prevent an error from occurring or to prevent any error from becoming an accident.

Taking another look at the plumbing lines from above, a safety-net example might be to always use *TorqueSeal* to mark lines as you tighten each fitting which would let you and others know that each fitting is correctly tightened. A dual inspection by a second person would also help ensure no lines were left loose.

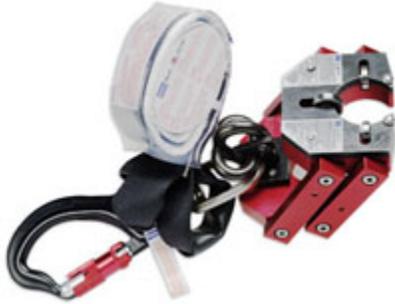
The North Saf-T-Climb system is designed to utilize a red safety sleeve.

While the poles of both of these units appear similar, they are brand specific and not interchangeable. The only way to tell the two apart is by measuring the spacing between mounting bolts (on the back side of the rail); North mounting holes are spaced 9” apart, while the Antenna are nearly 10” apart. Ships that have the North product must use a Y lanyard when going aloft or replace North poles with the Antenna poles to utilize the ladder climbing device.

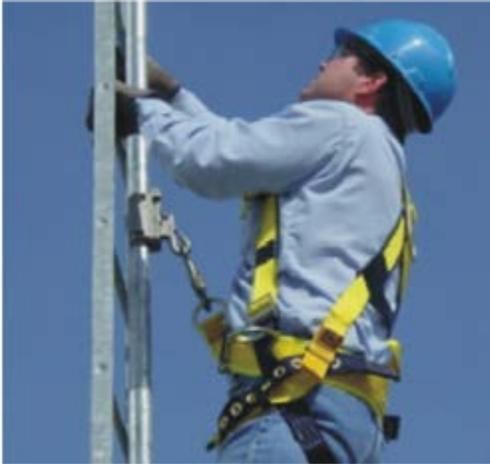
The Antenna ladder climbing device uses a stainless sleeve marked with an “M”
