Programmatic Agreement Attachments 1-18 MCB Hawaii Basing of MV-22 and H-1 Aircraft in Hawaii

MCB Hawaii Basing of MV-22 and H-1 Aircraft in Support of III MEF in Hawaii EIS P-836 MAG-24 HEADQUARTERS AND PARKING Programmatic Agreement (PA) Attachment 9

HANGARS 1-4: AIRCRAFT APRON SURFACE DAMAGE SURVEY

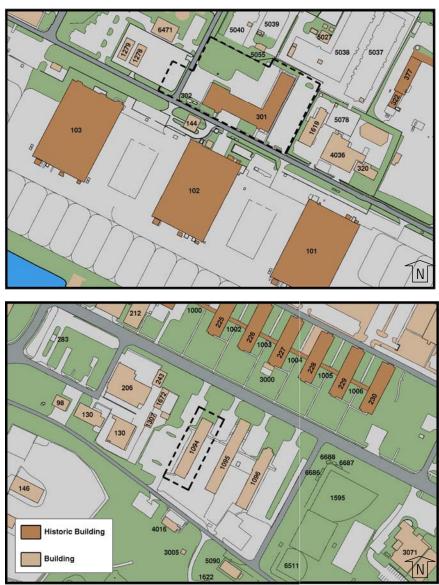
Figure 2-1: Partial site plans of MCB Hawaii Kaneohe Bay. The heavy dashed lines indicate the project areas. Site A is above. Site B is below.

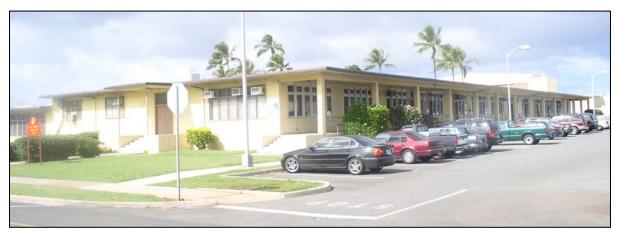
Figure 2-3: Photograph of the Squadron Offices & Storage Building. Photo taken in May 2004.

It is a one-story L-shaped concrete building with a steel roof structure. It has a low-slope gable roof in one section of the building and a flat roof in another section. There is an open lanai along most sides of the L-shaped plan. Historically the windows were steel framed multi-lite casement and fixed units, but many of the windows have been replaced with aluminum units. The historic massing of the facility and general fenestration pattern remain.

Several modifications have been made to the building since WWII, most of which affect the interior. Some historic open, interior spaces have been partitioned into small offices. Many historic, interior, single-lite doors remain. Most exterior windows have been replaced with aluminum windows, airconditioning units, or painted over. Portions of the historic tongue and groove roof sheathing have been concealed by hung ceilings. Most of the historic bare concrete floors have been covered with resilient tiles or carpeting.

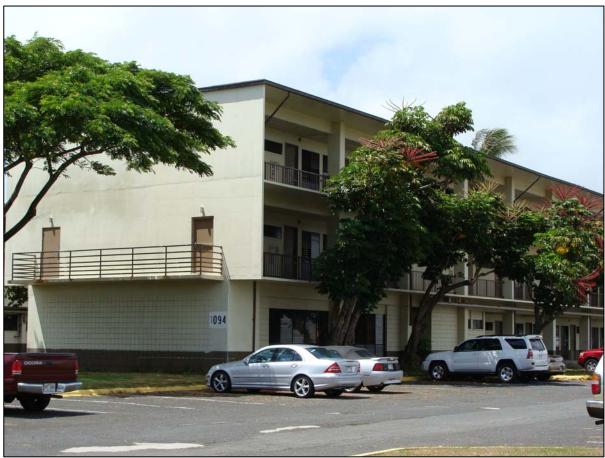
Facility 1094 was constructed in 1953 as unaccompanied personnel housing, is not a contributing element of a listed or eligible National Register of Historic Places district, nor does it have religious or cultural significance for Native Hawaiian organizations. The Advisory Council of Historic Preservation has issued *Program Comment For Cold War Era Unaccompanied Personnel Housing (1946-1974)*.

Figure 2-4: Facility 1094.

The project plans are to renovate this facility; therefore, the Program Comment applies. Renovation is an action requiring no further review by the Program Comment. A photograph of the facility is provided.

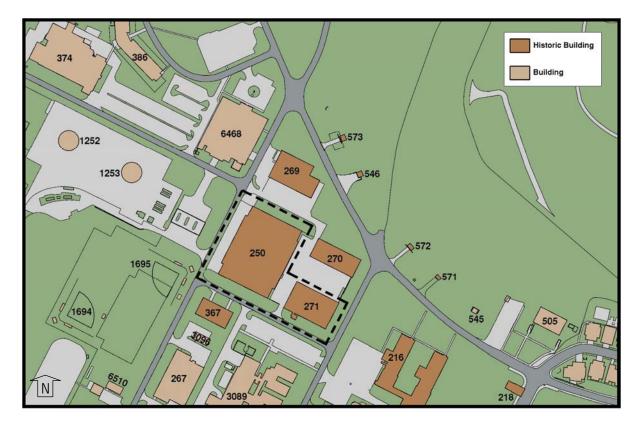
Figure 3-1: Partial site plan of MCB Hawaii Kaneohe Bay illustrating site A. Work on warehouse facilities 250 and 271 will primarily be reorganization of the interior storage systems.

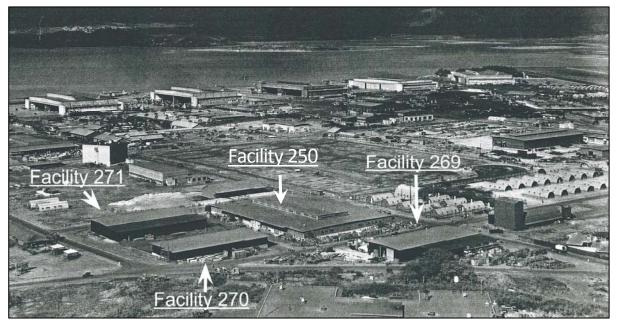
Figure 3-4: Photo dated August 26, 1945 showing Facilities 250, 269, 270 & 271 shortly after they were built. Note the additions along the long sides of Facilities 271 and 269. In the original photo it is not clear if these are already enclosed additions or just roofed over open air areas. Source: -- National Archives.

The project plans are to reconfigure the interior, non-permanent fixtures of both facilities and add a restroom to facility 271.

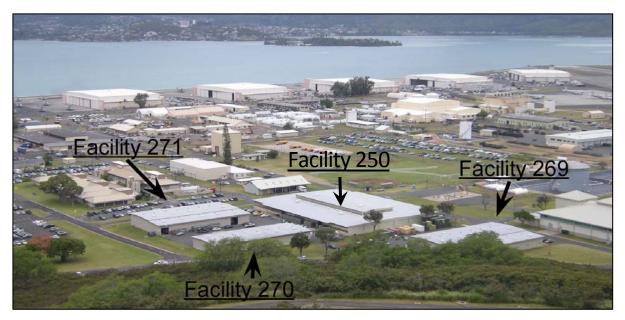
Figure 3-5: Facilities 250, 269, 270, & 271. Photo taken in 1999.

Facility 250 constructed in late 1942 or early 1943 as part of the supply system for the aviation operations of the Naval Air Station. The building is a unique design for industrial buildings of the period, an International Style building designed by the noted architect Albert Kahn, with features that reflect the scarcity of building materials during World War II.

low slope gable roof and a roof monitor. The exterior walls of the building consist of a concrete wall about 3'-6" high with a continuous band of fifteen-light metal-frame windows above it. The north and south sides of the building have corrugated metal siding which fills the gables above the level of the windows. Some window lights on the west and south sides are opaque, either replaced with solid panels or painted over. All four sides of the roof monitor have a continuous band of metal-frame windows with pivot sections. The eaves are open, and there are square metal gutters with metal downspouts.

Facility 271 was built in 1944 as 160' x 60' temporary storehouse. It was constructed of metal siding over a wood frame with corrugated metal roofing and concrete footing foundations with concrete slab on grade floors. Many of the WW II buildings built at the base were permanent buildings authorized, designed, and constructed before the Japanese attack of December 7, 1941 made the utilization of cheaper, temporary

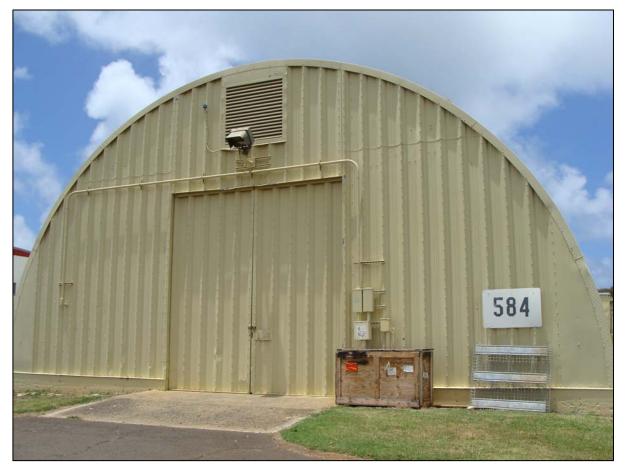
Facility 584 was constructed as a 40 foot by 100 foot Quonset hut in 1943. Typically Quonset huts are eligible under Criterion C for their distinctive form and construction. The setting of this facility in 1943 according to base maps was one of relative isolation unlike the majority of the Quonset huts on the base which were in groups. Today the runway extends much farther running near the area of facility 584 and several other storage buildings have been built in the general vicinity of the Quonset hut, altering the original setting. The characteristic texture of the sinewave siding Quonsets had during WWII has also changed. The current siding is box ribbed siding which is also attached differently than the original siding. Thus, the setting, design, materials, workmanship, feeling, and association have all been compromised to some degree; therefore, this building has been surveyed as not eligible for the National Register of Historic Places.

Figure 3-8: Photograph of the facility 584.

The project plans are to demolish facility 584.

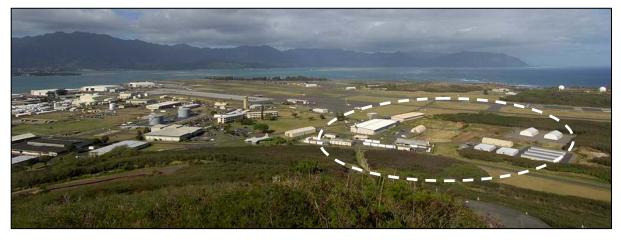
Figure 3-9: Photograph taken from Kansas Tower looking toward the runway. The cluster of storage facilities is visible at the far right. Facility 250 is visible at the far left. Photo taken in 2006 by Franzen Photography.

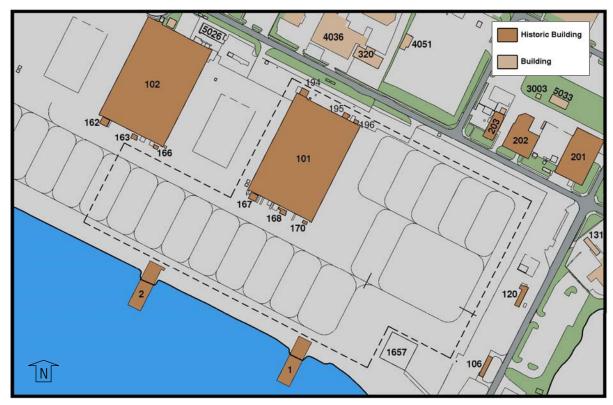
Figure 4-1: Site A. Partial site plan of MCB Hawaii Kaneohe Bay. The heavy dashed line indicates the project area.

This project affects four areas of the base. For organizational purposes they are divided into Sites A, B, C, and D as indicated in the following figures.

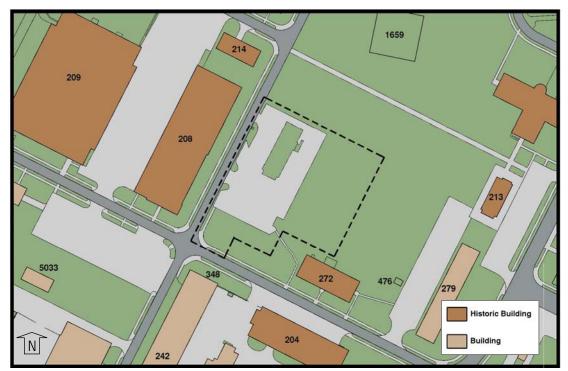
Figure 4-3: Site C. Partial site plan of MCB Hawaii Kaneohe Bay. The heavy dashed line indicates the project area.

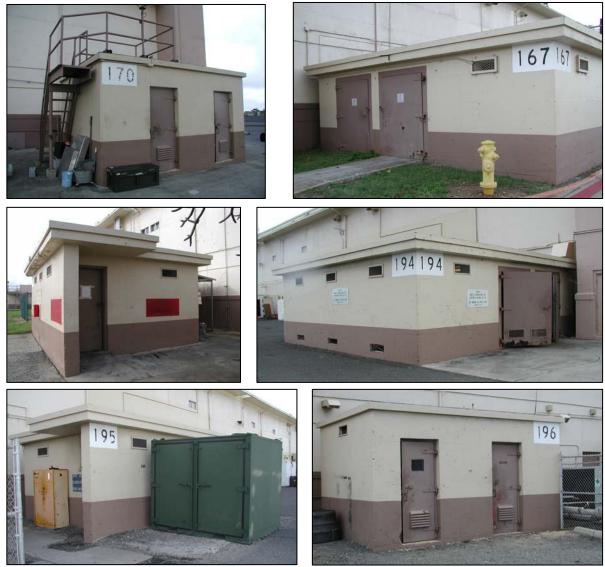
These facilities are eligible for inclusion on the National Register of Historic Places under Criterion A for their association with the initial development of Naval Air Station Kaneohe Bay in anticipation of U.S. involvement in WWII. These facilities are part of a group of twenty-one buildings constructed around the hangars as support storage facilities. All the facilities are small, concrete structures with flat roofs, small overhangs and few doors and windows. The facilities are separate structures from the hangar; however, they are located within a few feet of the hangar. They were surveyed and found eligible as part of the *Marine Corps Base Hawaii, Kaneohe Bay, Historic Building Inventory* dated June 2005.

Figure 4-7: Photos above all showing the adjacency to Hangar 1. Top left: Facility 170. Top right: Facility 167. Middle left: Facility 168. Middle right: Facility 194. Lower left: Facility 195. Lower right: 196. Photos taken in 2004.

This project plans to fill the space between each of these buildings and the hangar. The Anti-Terrorism Force Protection Standards do not allow for small spaces between buildings; therefore, rather than demolish the small buildings, the area will be filled. The filled areas will be slightly recessed from the current planes of the buildings.

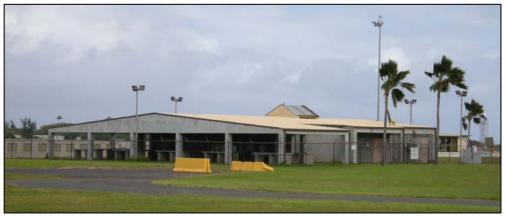
Figure 4-8: Facility 4054. Photo taken in January 2009.

This project plans to renovate and construct an addition to facility 4054, which was constructed in 1986. This facility is not of a distinctive type nor has been found to be directly associated with significant Cold War history.

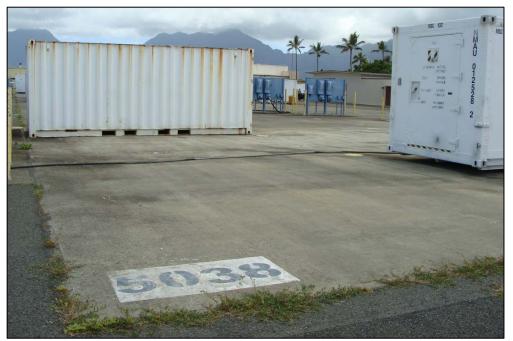
Figure 4-9: Facility 5038. Photo taken in 2009.

Facility 5038, a van pad constructed in 1988, will be upgraded. The van pad is a concrete pad with utility service outlets and has no permanent vertical structure.

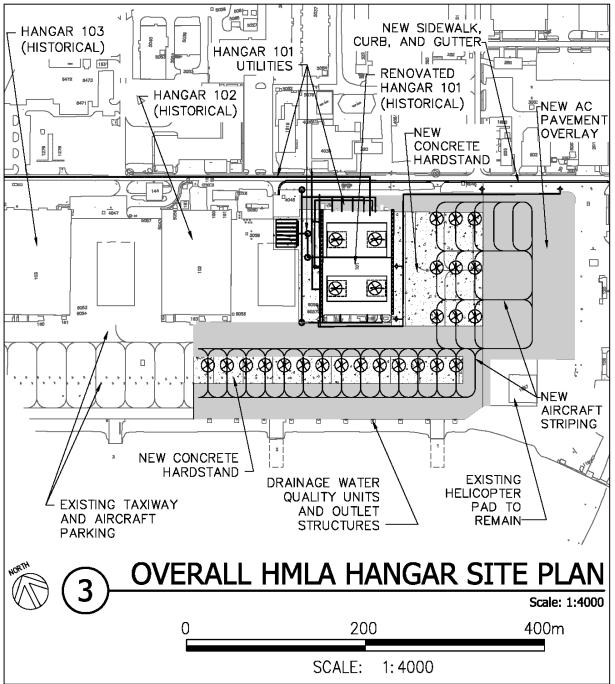
Proposed work on the aircraft apron area includes: resurfacing, sealing, striping, modernization of the sewer and drainage collection systems, installation of AFFF infrastructure, fire protection upgrades, and the installation of a concrete parking ramp at aircraft parking locations. Also, storm water quality units along with outlet structures on the bay-side of the facility will be required to mitigate runoff of contaminates. The AFFF fire protection requires the addition of an external collection and holding system. An additional fire waterline loop system and fire hydrants will provide protection to the apron and exterior of Hangar 1.

Figure 4-10: Site plan of proposed work on the aircraft apron around Hangar 1.

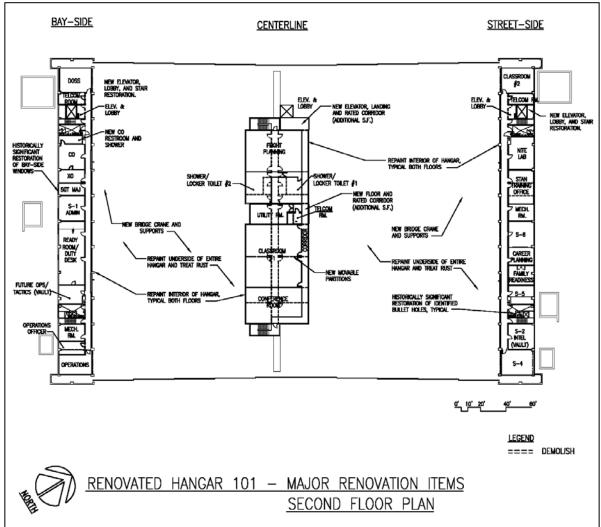
Figure 4-12: Proposed second floor renovation work for Hangar 1.

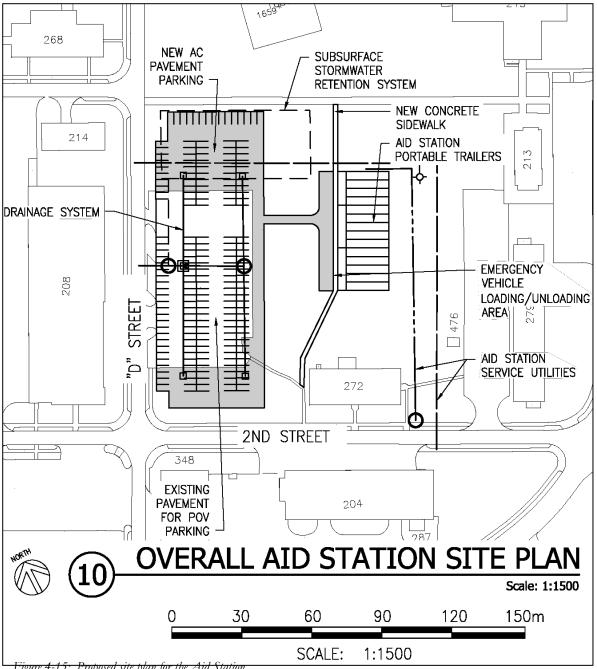
Figure 4-15: Proposed site plan for the Aid Station.

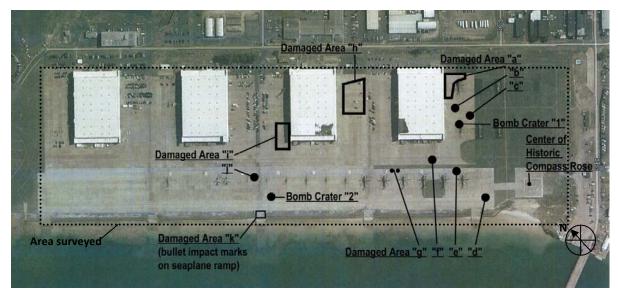
On 15 and 17 February 2011, Mason Architects surveyed the concrete aircraft areas surrounding Hangars 1 through 4 to record visible damage from the 7 December 1941 Japanese attack on Naval Air Station Kaneohe. This was accomplished by walking the concrete paved areas, noting any apparent attack damage or other historic features on the map below, and photographing the features so they can be identified for later detailed studies. The features identified include; two repaired bomb craters, eleven areas of spalled concrete damage (some with concrete repairs), and the center point and remnant ghost lines of a historic compass rose. The compass rose is in the area of a current active helicopter-landing pad and was not closely approached.

The damage at the eleven spalled concrete areas presented the widest variation in forms and appearances. Three of the areas (areas a, h, & i, see Figures 3-10) are large sections covered with small individual pits or pockmarks on the surface of the concrete. Some of these pits resemble bullet impact marks and others appear to be formed by chips of concrete spalling off, leaving a sharper edge to the resulting pit and revealing a piece of aggregate at the bottom. One of the other areas (area k, at the seaplane ramp between Hangars 2 and 3) has a collection of several apparent bullet impact marks that are more widely spaced than the individual pits at the pockmarked areas. The remaining seven damaged areas exhibit pitting that has conglomerated to form larger spalled depressions, several inches across in all directions. Some of these areas have been partially or completely repaired by filling the spalls with concrete that is finished flush with the surrounding surface.

Figure 3-10: Aerial photo indicating the area surveyed and the locations of features.

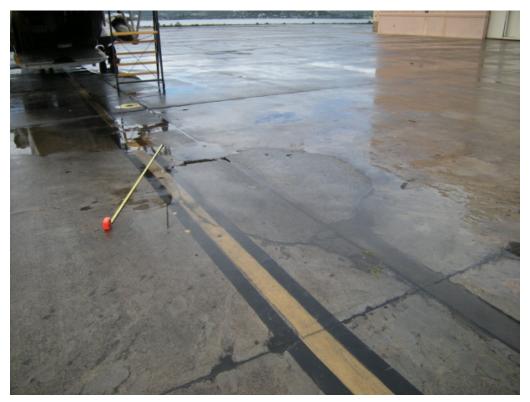
The two bomb craters are irregularly shaped, typically between about 7 feet to 11 feet in diameter. Each bomb crater has a distinctive pattern of radial scars in the surrounding concrete that were formed by the impact of fragments thrown from the exploding bomb. Some of these radial scars are found over 40 feet from the center of the bomb crater. The bomb craters themselves have been filled with concrete. Although some areas of concrete near the craters have been replaced, thereby removing evidence of radial scars, the extant scars have not been repaired.

Figure 3-11: Bomb Crater "1" in the center of the photo; radial scars in the lower left corner; the corner of Hangar 1 at the upper right, and the bay in the upper center.

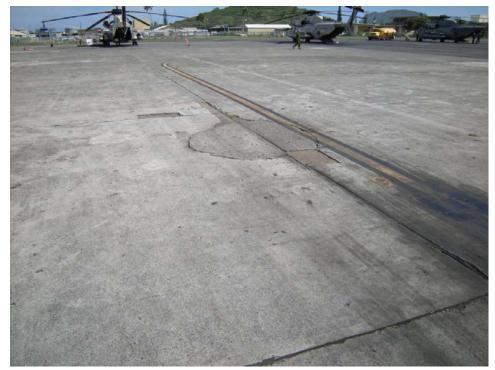
Figure 3-12: Bomb Crate "1" in the center of the photo. Photo taken looking southeast.

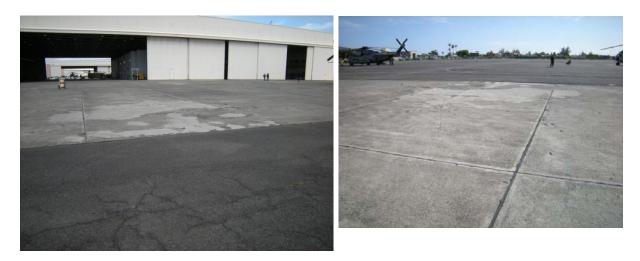
Figure 3-17: Damaged Area "c," the repaired concrete area in the center of the photo. Photo taken looking toward Hangar 1.

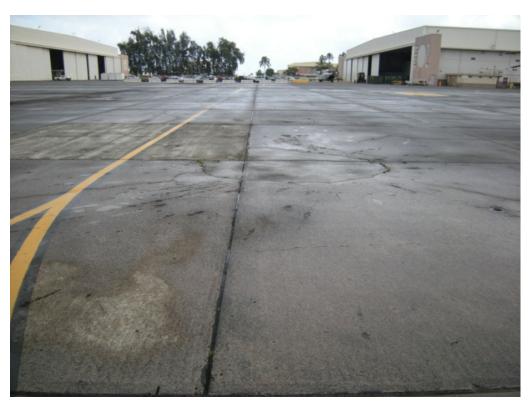
Figure 3-29: Bomb Crater "2," Large repair in the center of the photo; radial damage surrounding the repair; replaced concrete section in the center left of the photo. Photo taken looking northeast, between Hangars 2 & 3.

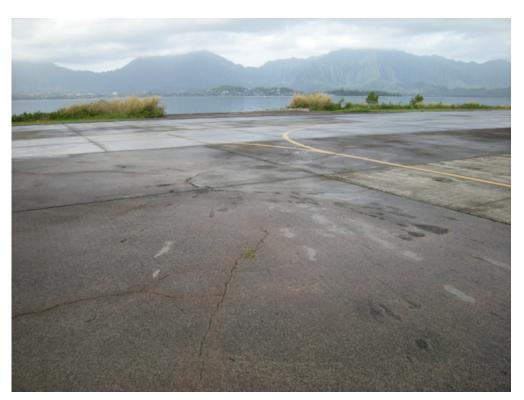
Figure 3-30: Bomb Crater "2." Photo taken looking south, toward the bay.

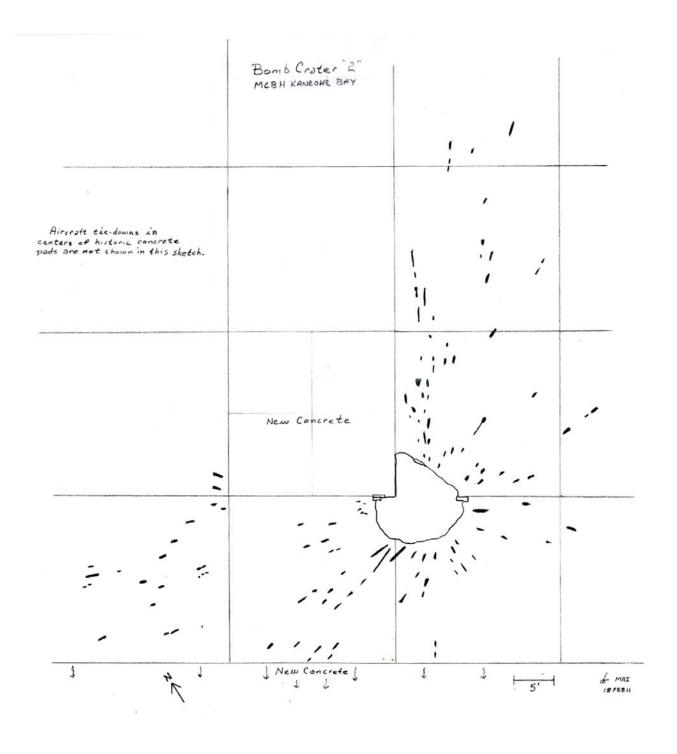
Figure 3-312: Bomb Crater "2." Sketch depicting the extent of the apparent features from a bomb; large repaired area and radiating damaged areas.

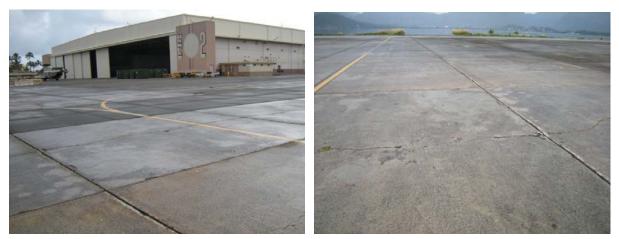
Figure 25: Damaged Area "j," pitted and repaired areas in the center and lower left of the photo. Photo taken looking east, toward Hangar 2.
