### HYDROLOGY AND WATER QUALITY OF THE LEVITTOWN LAKE, TOA BAJA, PUERTO April 2010 – June 2011

**US Geological Survey**

Puerto Rico Department of Natural and Environmental Resources

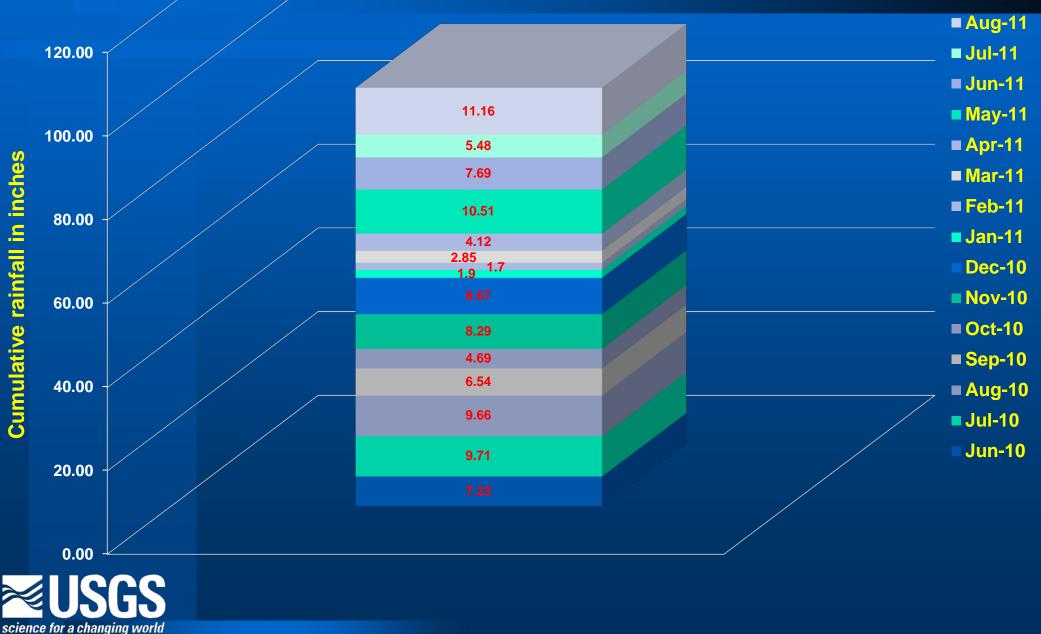
## **Rainfall – Continuously**

TOTAL RAINFALL = 98.50 INCHES IN 15 MONTHS

**RAINFALL AVERAGE FOR NORTH COAST = 70 INCHES/YEAR**

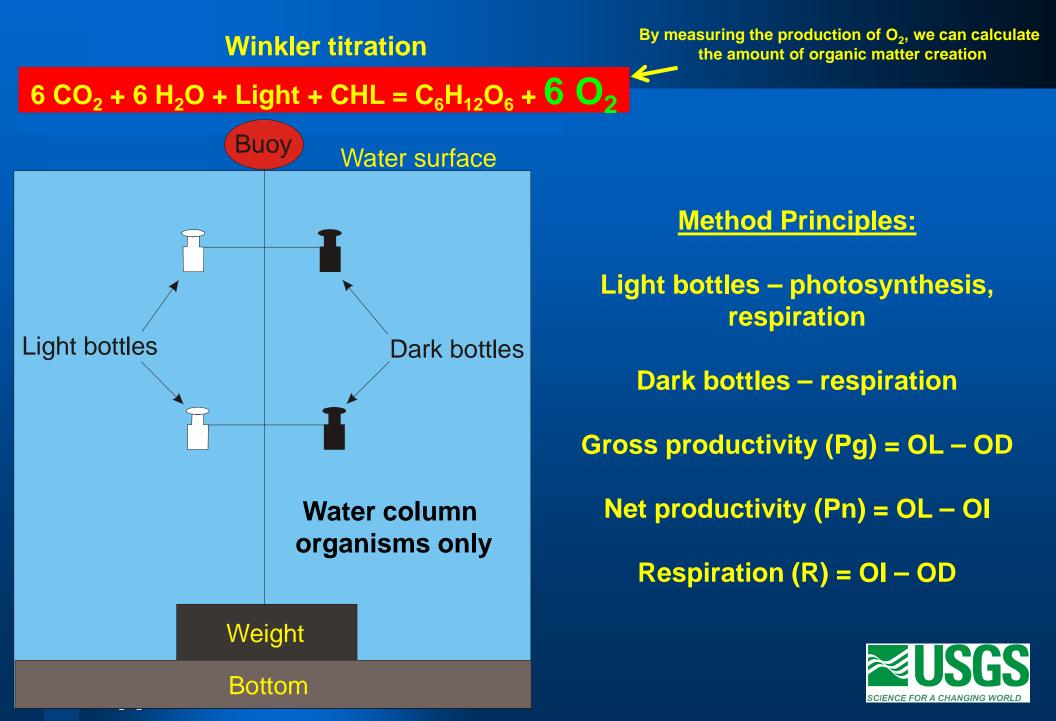
#### Primary Productivity

#### Light/Dark bottles method – plankton productivity and respiration

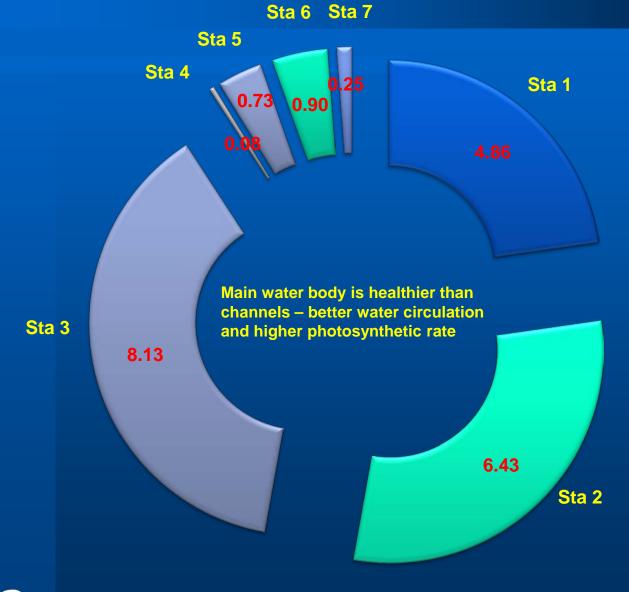
#### **EXAMPLE – July 2010 top DO in milligrams per liter**

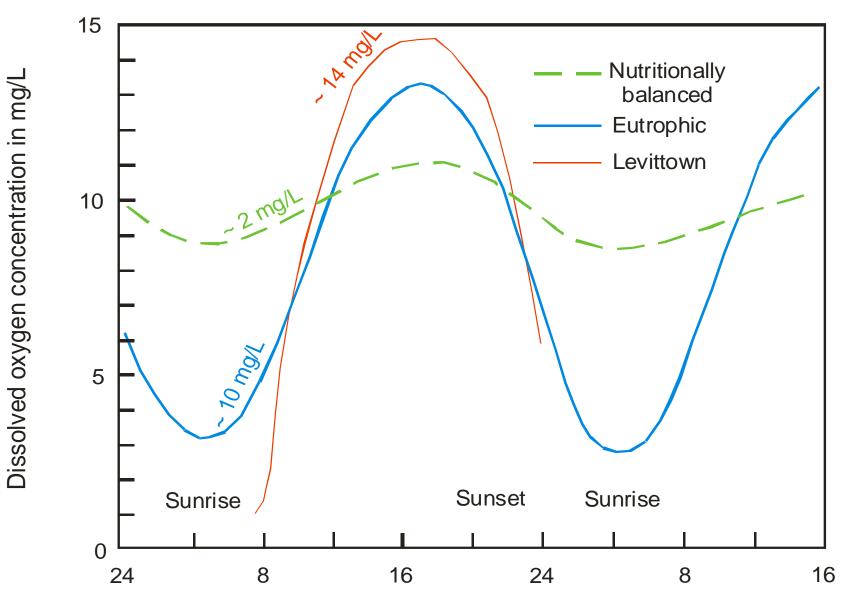
#### DO diurnal variation example conceived by Wetzel

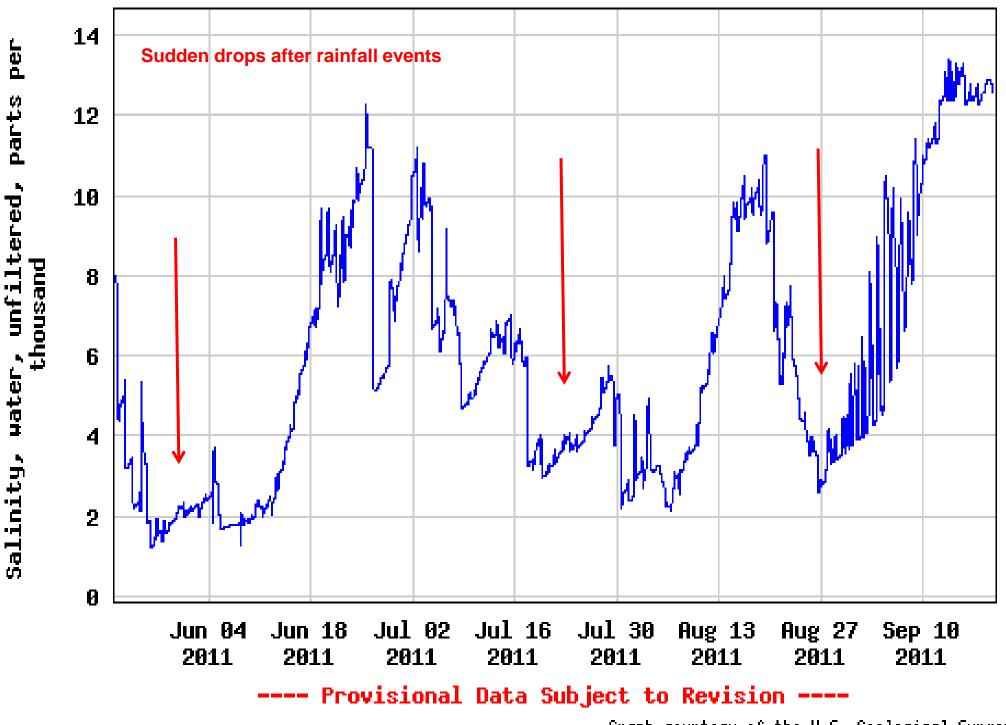
USGS 50046510 LEVITTOWN LAKE 8, TOA BAJA, PR

Salinity,

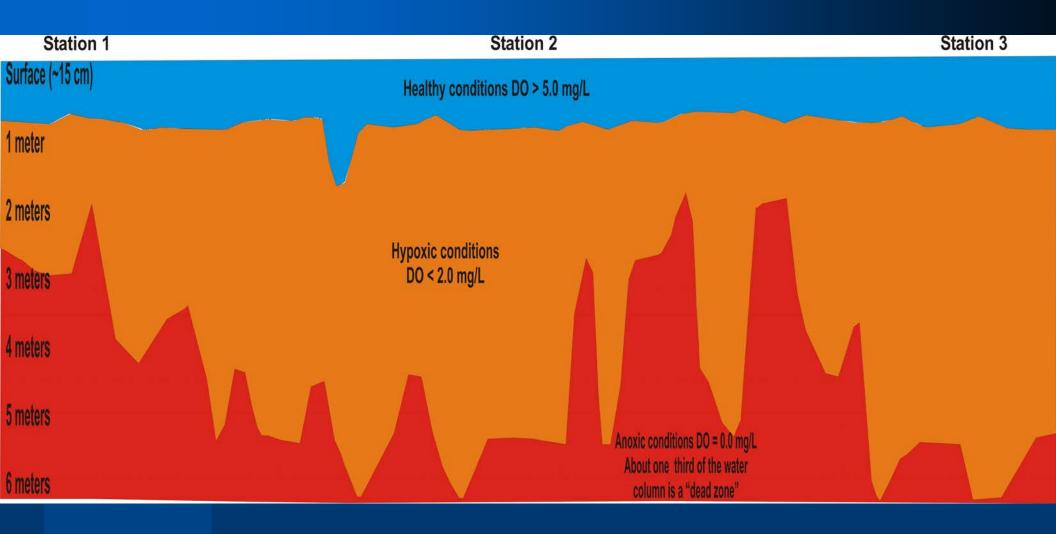
## Levittown Lake Side View – May 2011

Station 1	Station 2	Station 3
Surface (~15 cm)	Healthy conditions DO > 5.0 mg/L	
1 meter	Hypoxic conditions DO < 2.0 mg/L	
2 meters		
3 meters	Anoxic conditions DO = 0.0 mg/L	
4 meters	More than two thirds of the water column is a "dead zone"	
5 meters		
6 meters

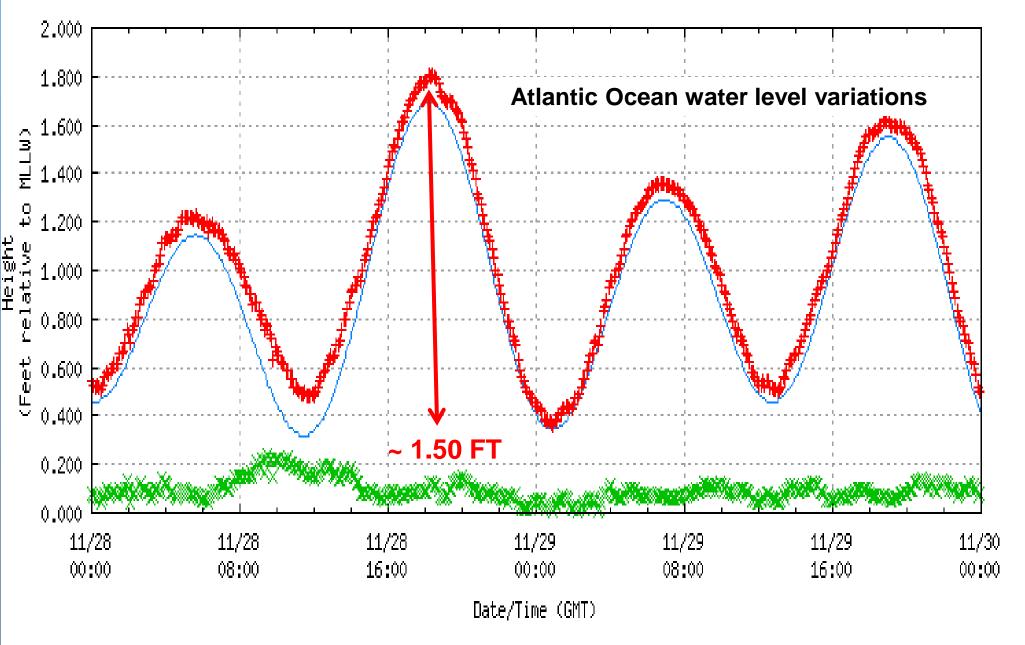
NOAA/NOS/CO-OPS Verified Water Level vs. Predicted Plot 9755371 San Juan, PR from 2010/11/28 - 2010/11/29

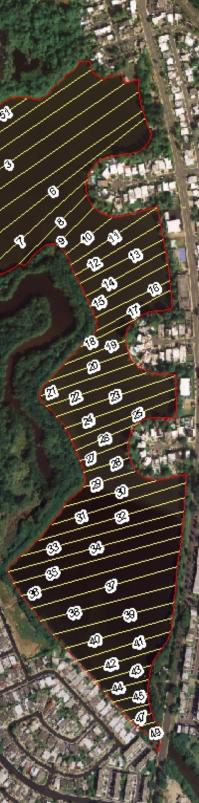
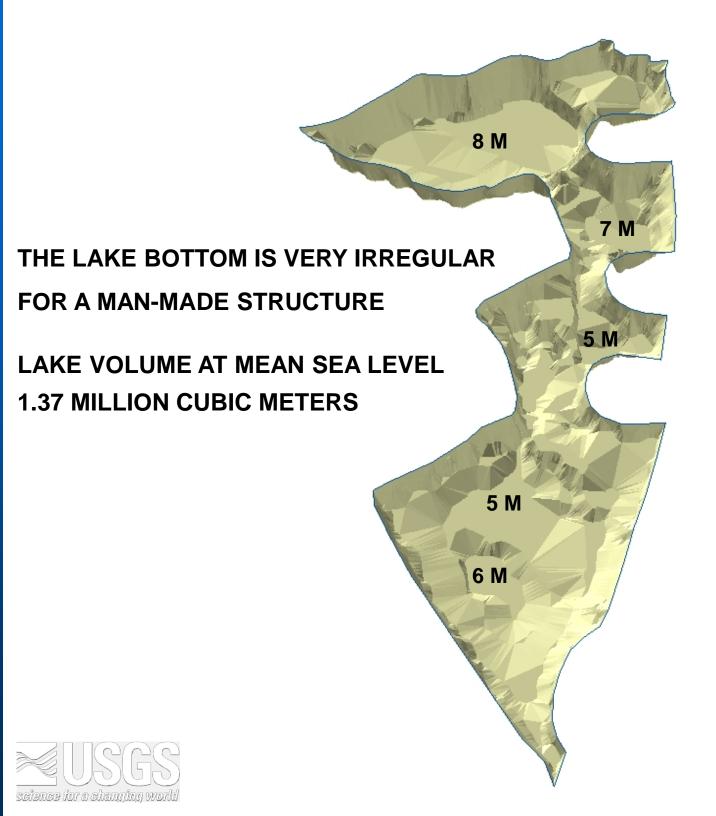
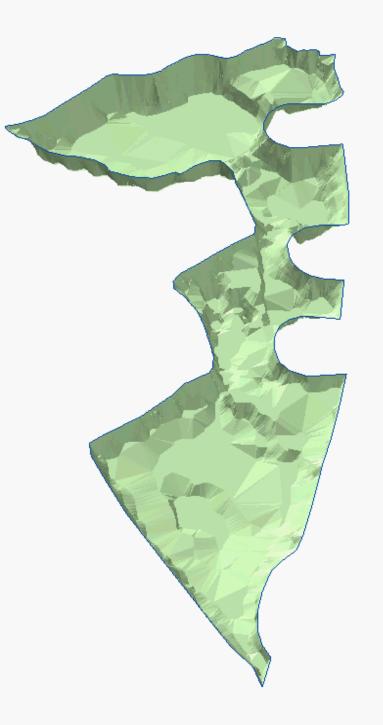
### Navigation guides for bathymetry

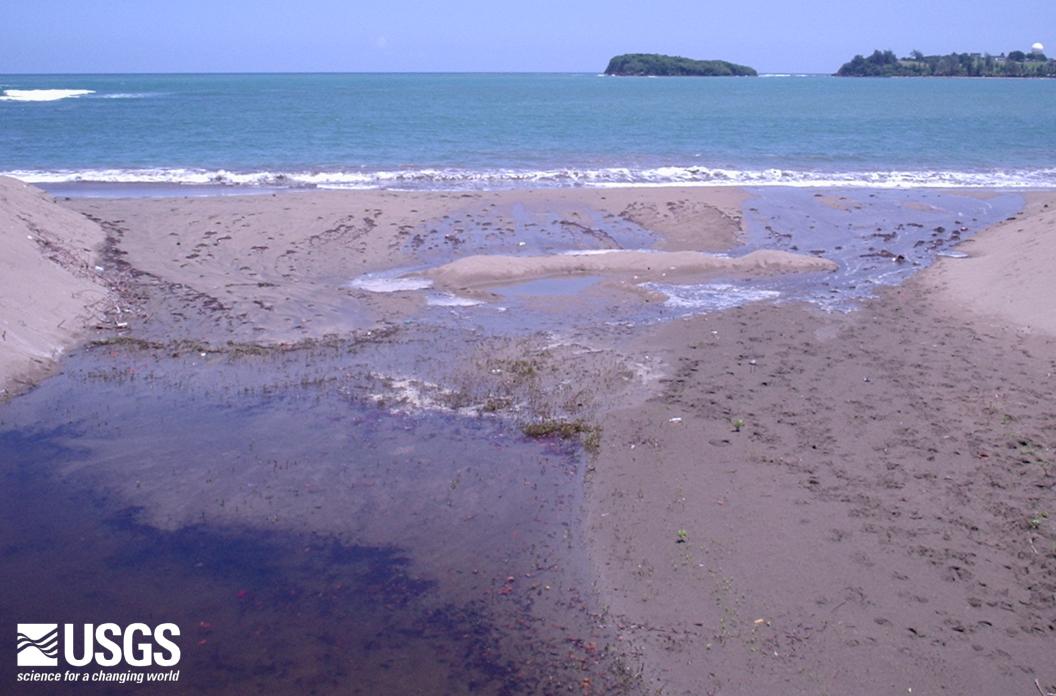
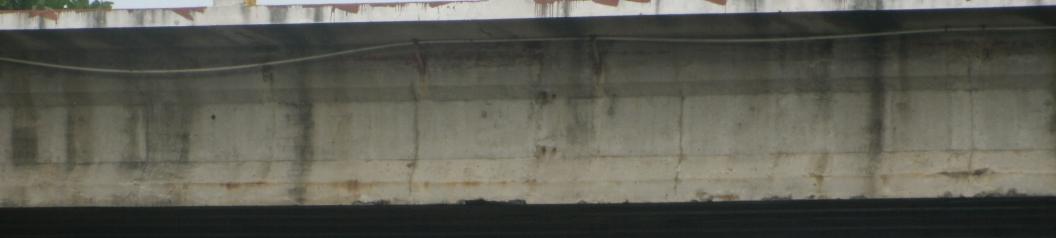
### VIRTUAL TOUR – PARTIALLY BLOCKED OCEAN CHANNEL

FLUSHING RATE COULD BE INCREASED SUBSTANTIALLY BY WIDENING AND DEEPENING THE CHANNEL – POTENTIALLY FROM 2 TO 120 %
