# Corrective Action Report and Conditional Closure Request

## Municipal Garage Demolition and Contaminated Soil Removal

NOAA Site 20/TPA Site 9e

April 8, 2008

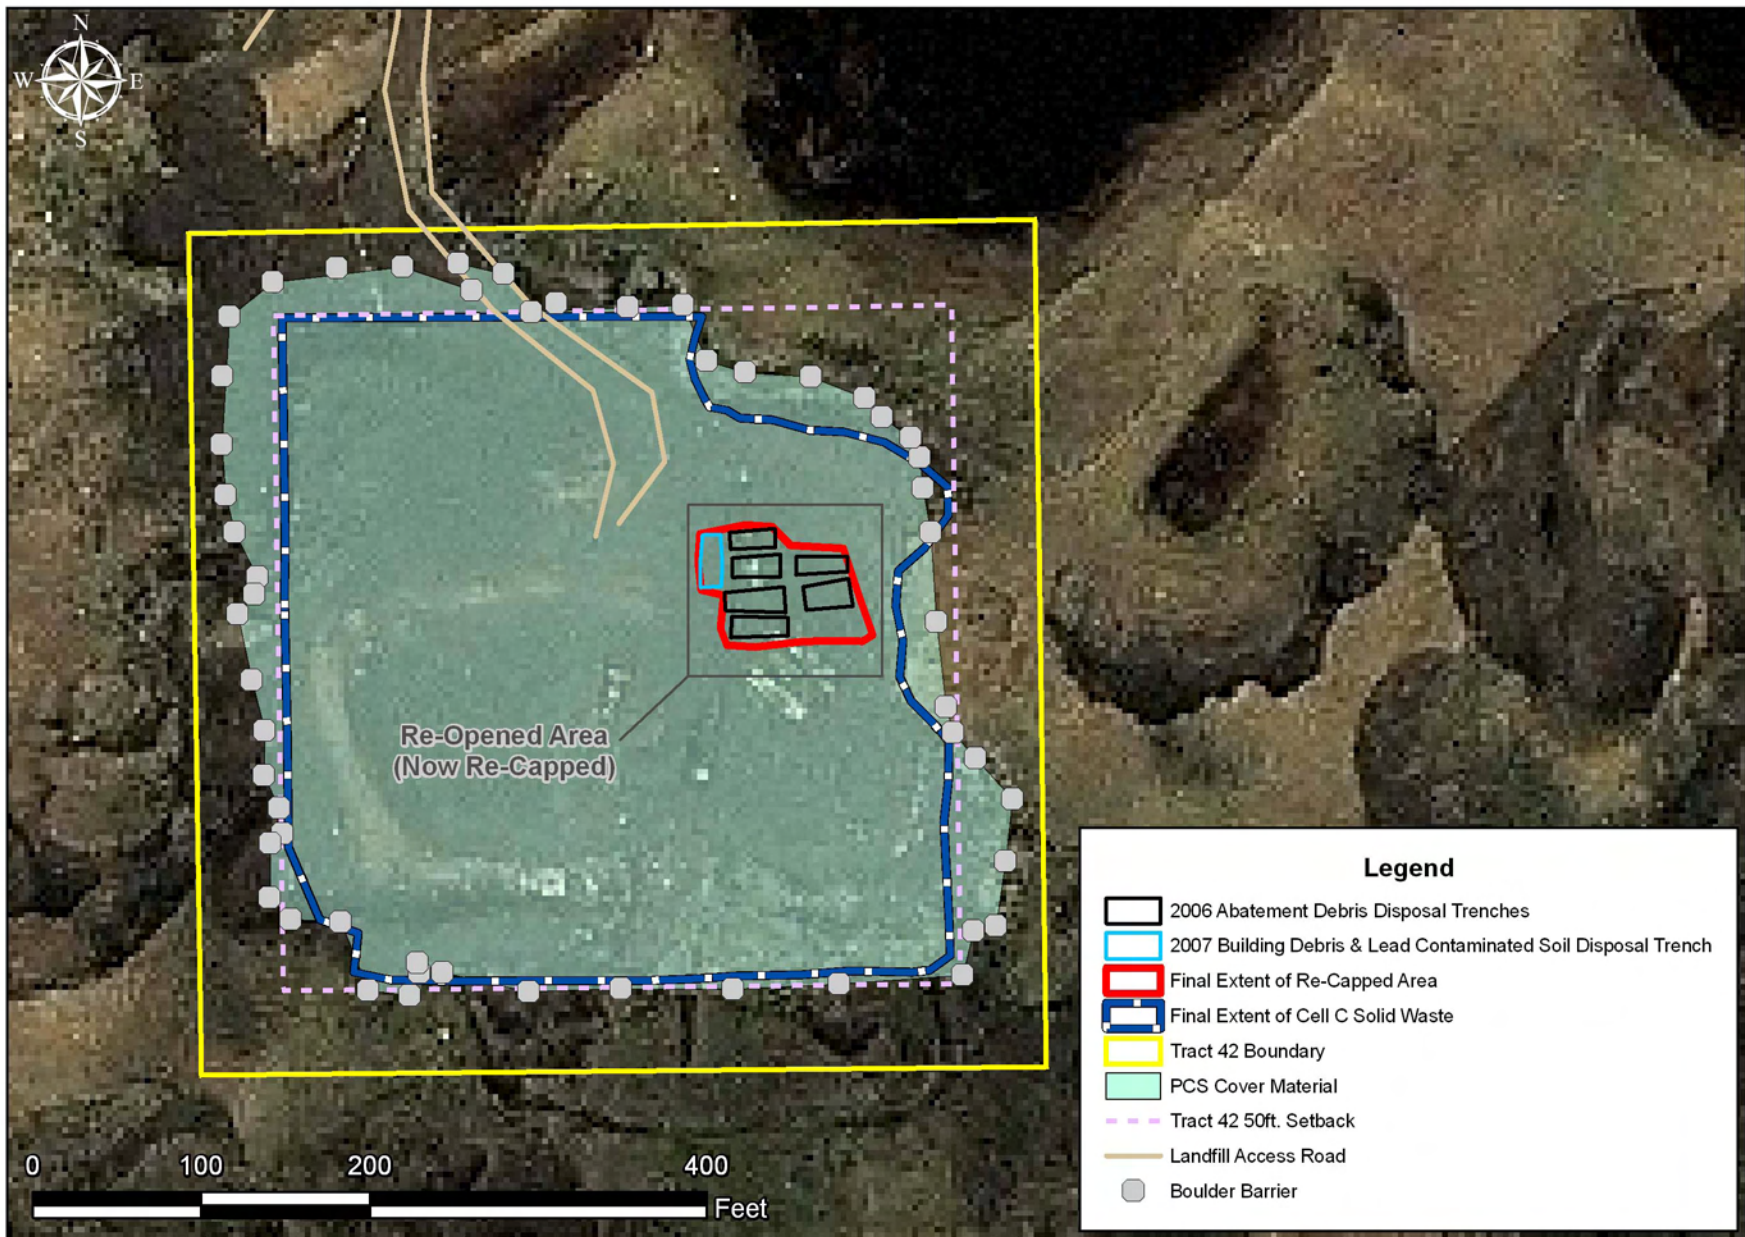
**Figure 6**  
**Lead Contaminated Soil Disposal Cell in Tract 42**  
**Municipal Garage Demolition**  
**Corrective Action Report/Conditional Closure Request**  
**NOAA Site 20/TPA Site 9e**  
**St. Paul Island, Alaska**
